National Park Service  
Cultural Landscapes Inventory  
2005

Chevy Chase Circle  
Rock Creek Park - DC Street Plan Reservations

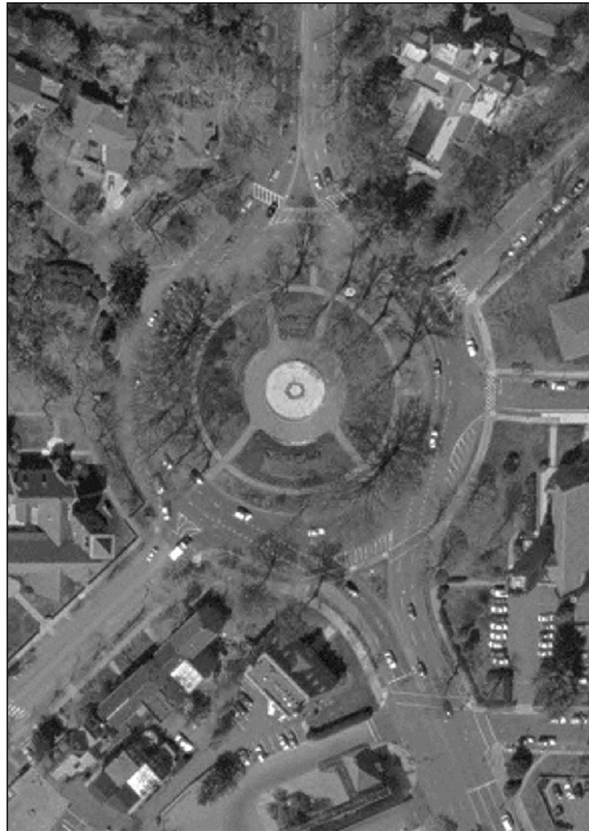
*Aerial image of Chevy Chase Circle, 2001, National Park Service*

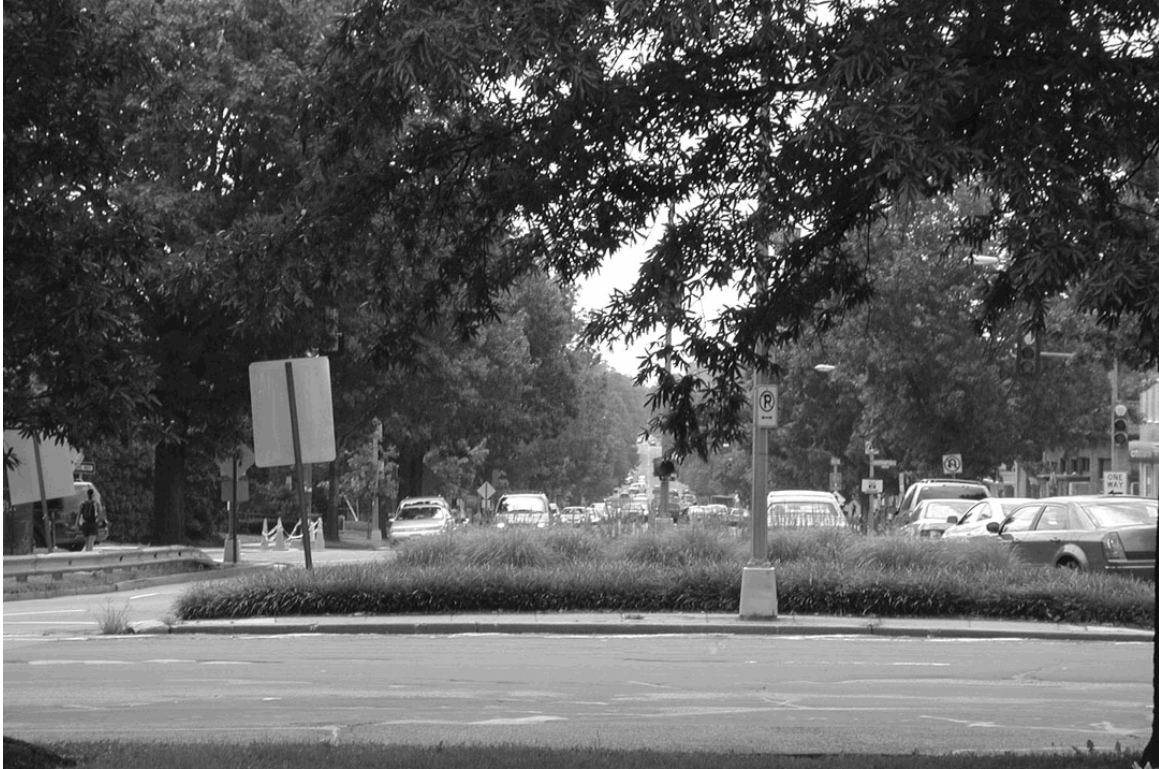
*The view south on Connecticut Avenue from Chevy Chase Circle depicts the area's heavy traffic into and out of the rotary, as well as the planted traffic island nearby (CLP digital photofile, June 18, 2004).*

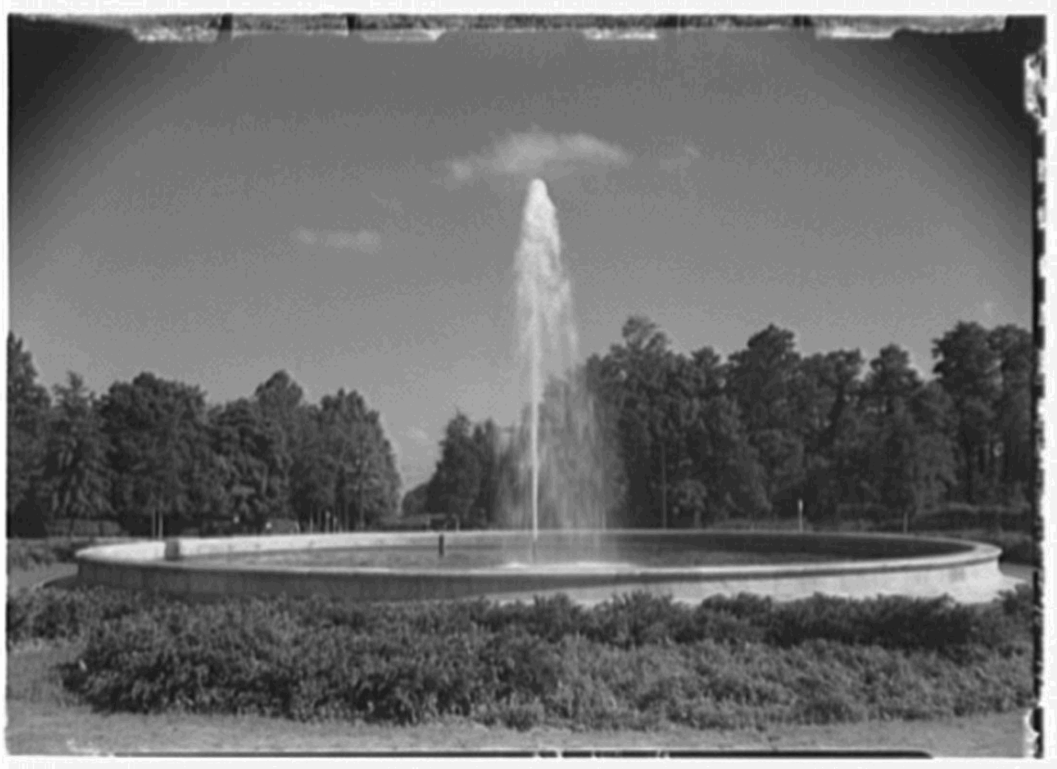
*The memorial fountain with yew shrubs. "Fountain in Chevy Chase," ca. 1920-1950, Theodor Horydczak Collection, Library of Congress Prints and Photographs Division.*

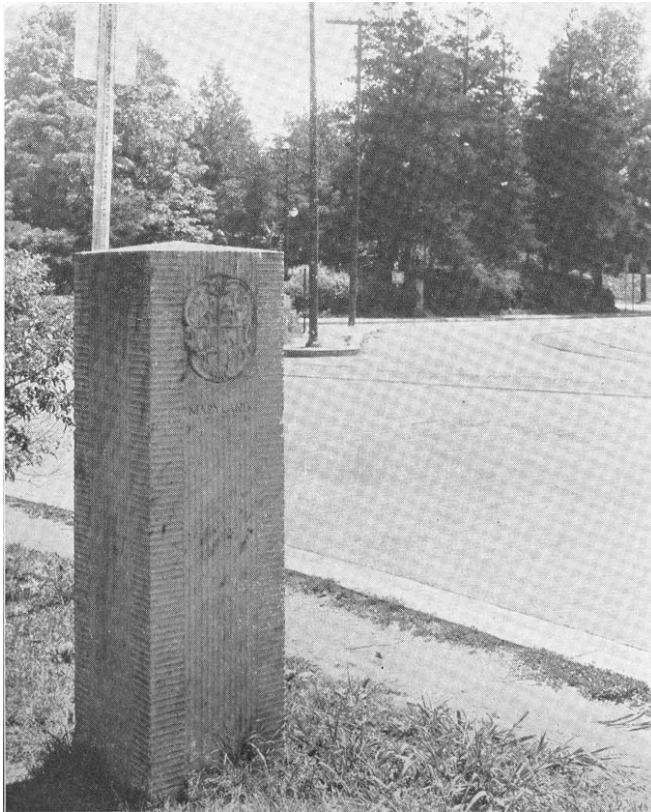
*Garden Club of America marker at Chevy Chase Circle. Reprinted from the Report of the Commission of Fine Arts "July 1, 1929, to December 31, 1934."*

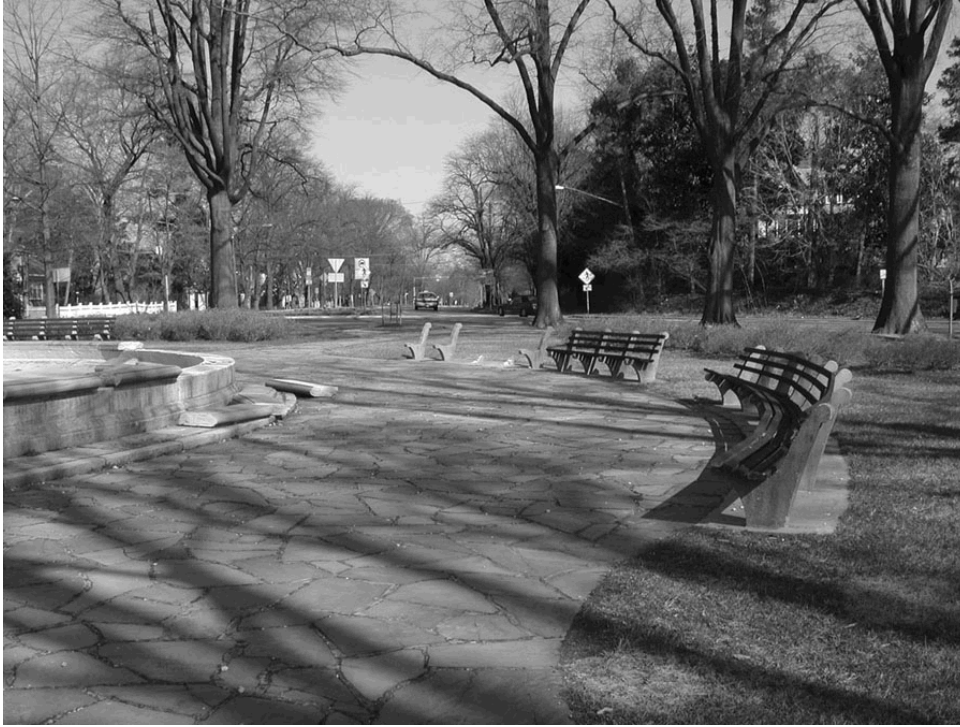
*An automobile accident in 2001 destroyed portions of the park's benches and fountain, which were not repaired until 2003 (CLP digital photofile, March 2002).*

| AD 2001 | Damaged | In early January, a driver crashed into the fountain, damaging that feature and nearby benches and azalea beds. |

Unfortunately, the carefully restored fountain at Chevy Chase Circle once again experienced significant damage due to an out-of-control vehicle in 2001. A driver crashed into the site early in the morning on New Years' Day, causing large cracks in the fountain's east side and destroying nearby benches and azalea beds (Dvorak 2001: B12). This accident caused about \$25,000 in damages to the fountain alone (Dvorak 2001: B12).

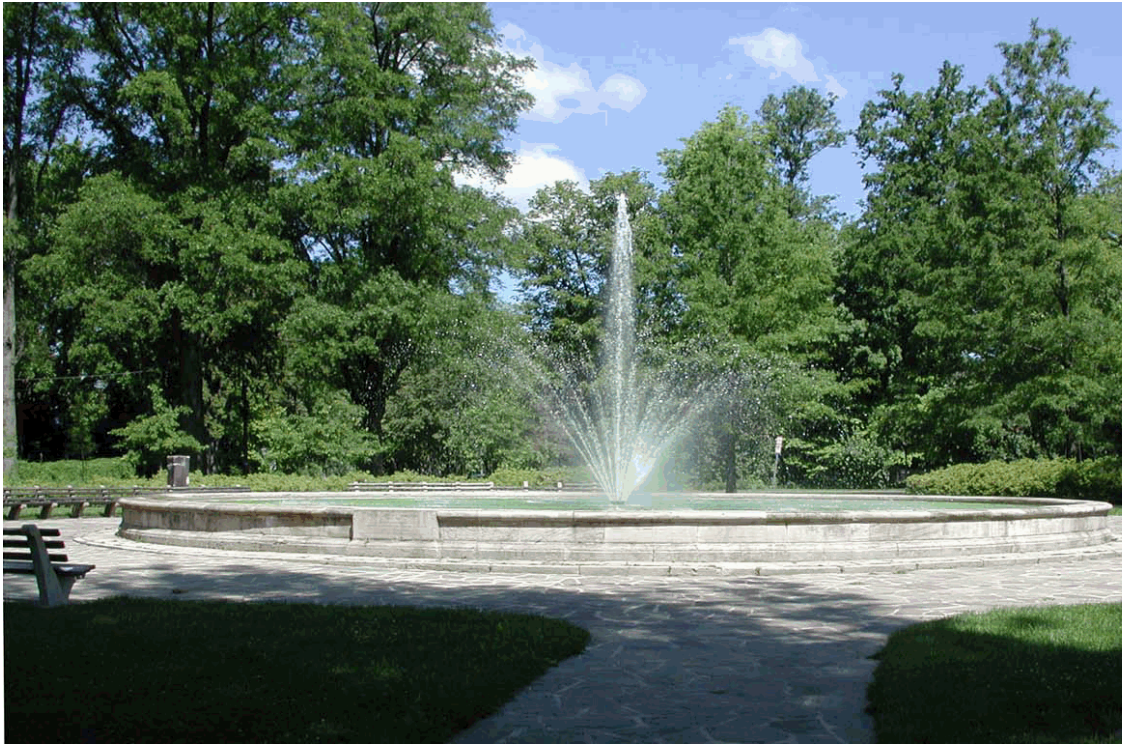
*Restored Newlands memorial reclaims the former splendor of the fountain (CLP digital photofile, May 26, 2005).*

Several restorations and repairs have been undertaken on the Newlands fountain. The 1990 restoration was made possible, funded by the Chevy Chase Land Company. Replacement of damaged Aquia sandstone with blocks of the same type of stone from the US Capitol and careful construction techniques preserved the integrity of the fountain (Kittleman 1990). As the fountain was disassembled during the restoration, each stone was numbered according to the treatment it would receive. Deteriorated stones were replaced with the sandstone blocks from the Capitol, broken stones were reinforced with steel, and the pool bottom was rebuilt and resealed (Durkin 1990).

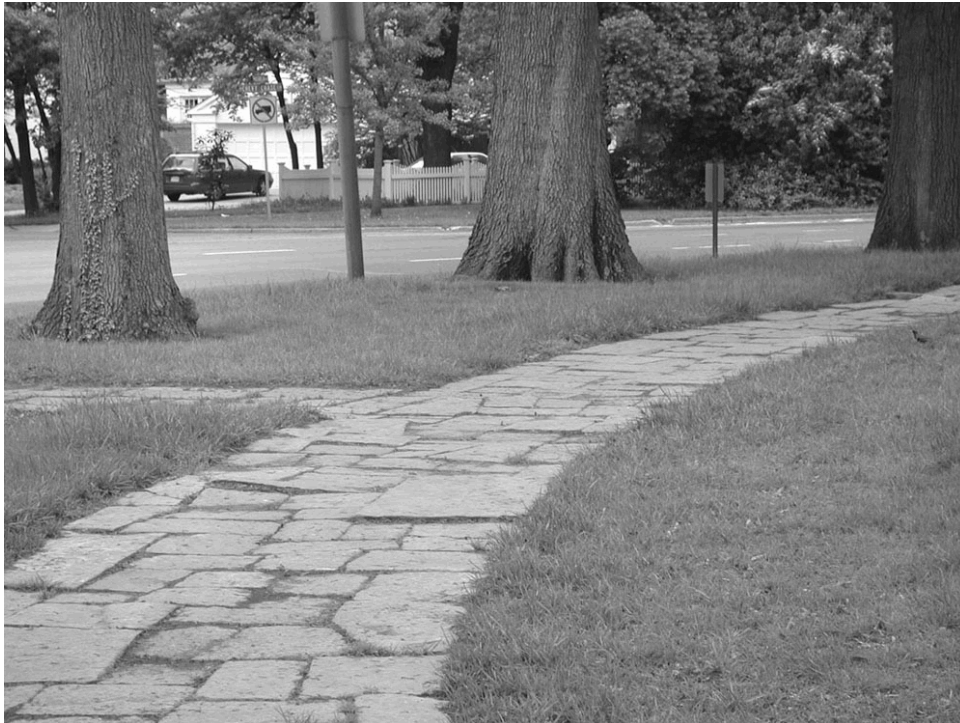
*The circular pattern is shown in the outer walkway's form and ring of willow oaks (CLP digital photofile, June 18, 2004).*

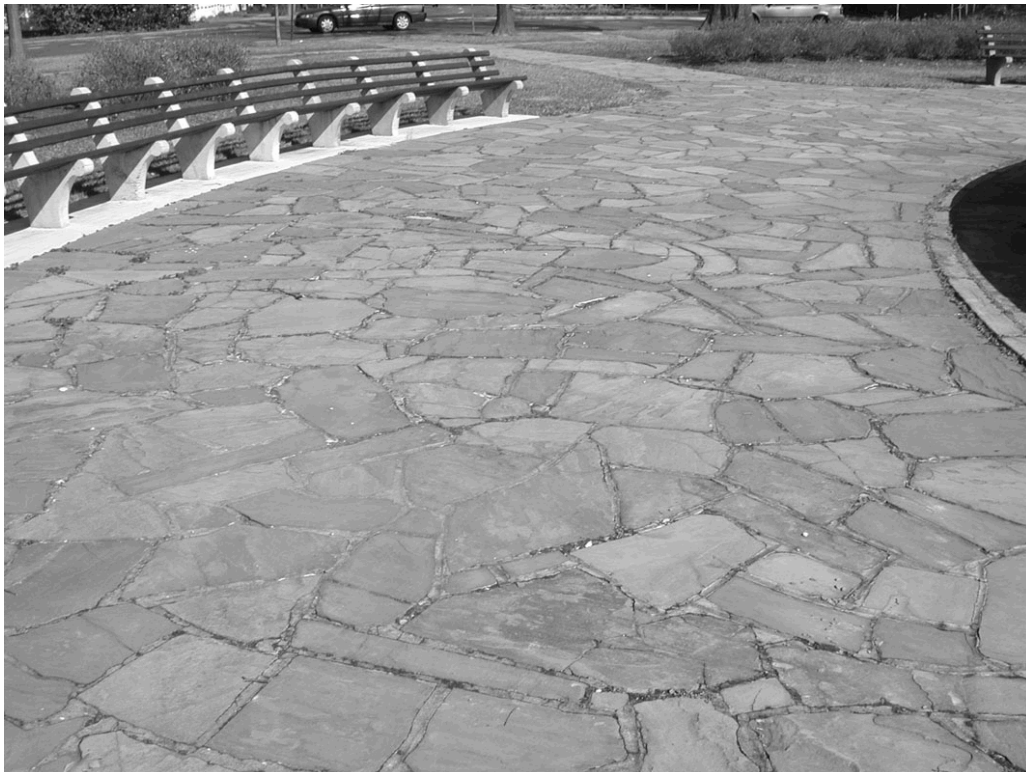
*The deteriorated fountain plaza before the flagstones were reset/replaced. (CLP digital photofile, March 2002).*

Since the 1933 walkways remain in place, the layout of the original circulation system retains its integrity. The addition of the plaza and connecting walks after 1956 changed the approach to the central fountain, but it also greatly enhanced the use of the circle. Next year, the 1956 walkway may be considered historic by National Register standards, as it will be fifty years old. In terms of condition, certain sections of the 1933 walkways are uneven where the stones have settled and heaved, mostly caused by root growth of the nearby willow trees.

Restoration work on the 1956 plaza has improved its condition. In 2003, the NPS reset loose stones around the fountain, many of which had become damaged over time. About ten percent of these stones were cracked or broken, and the rest were loose or uneven. Taking care to retain integrity at the site, the park service replaced broken or cracked stones with stones of similar color, texture, size, and shape, and replaced deteriorated mortar with a mortar consistent in color and texture to the existing mortar (Wheelock, “Assessment of Effect Form, Repair/Rehabilitate Chevy Chase Circle, Res. 335A” 2002). Though the original walkways may need resetting as well, the 2003 work on the plaza improved the overall condition of the circle.

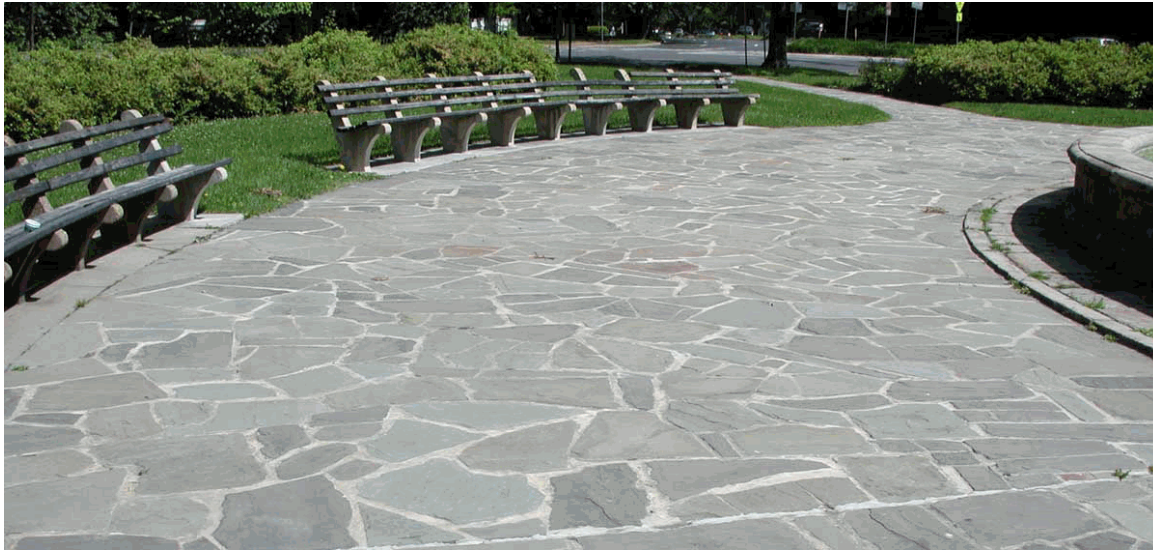
*Repaired flagstone plaza eliminated severe cracking (CLP digital photofile, May 26, 2005).*

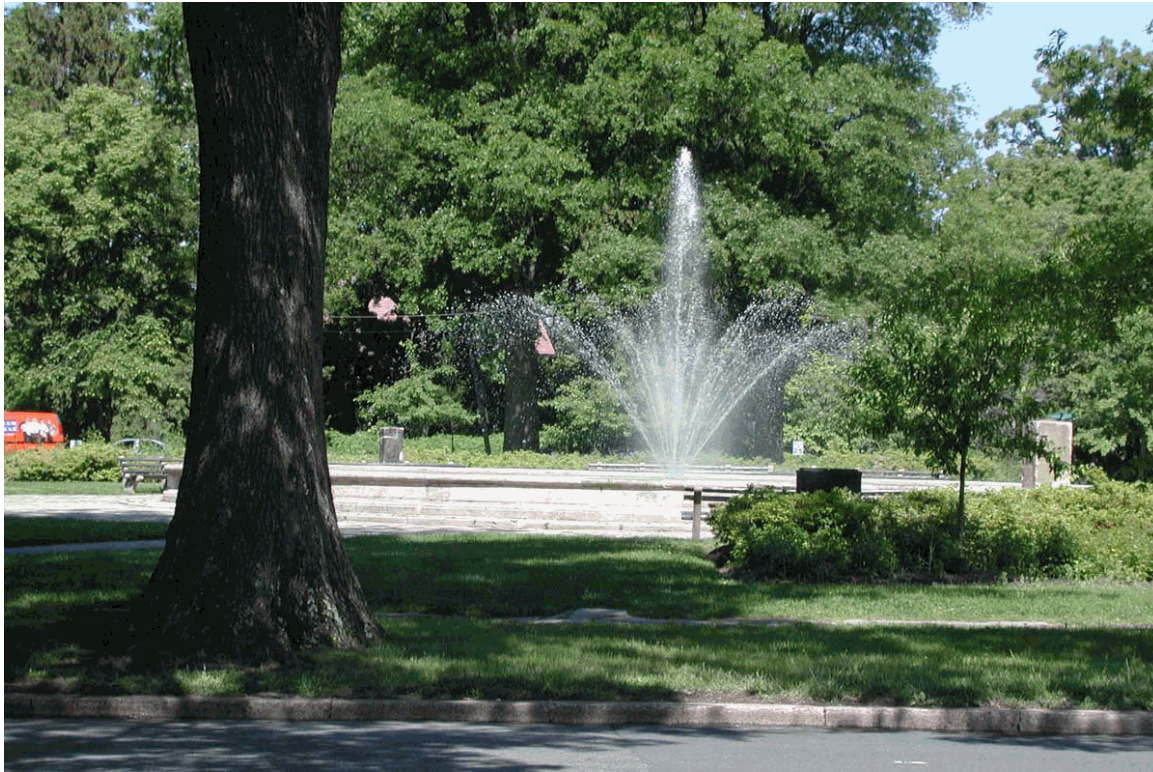
*The fountain restored to its original splendor (CLP digital photofile, May 26, 2005).*

Other restorations have also maintained the integrity of the fountain. In 1998, the Friends of Chevy Chase Circle raised \$24,000 to improve the circle, including restoring the fountain's underground pumping system and installing a new brass fountainhead (Patner 1998: A1). Recent restoration and repair work by the National Park Service in 2003 also proceeded in a manner appropriate to the fountain's materials and design (Dvorak, "Keepers" 2003). After an automobile accident in 2001 left the fountain damaged, NPS reset eleven stones, fabricated three, and repaired nine. The work also involved removing the fountain's old membrane liner and installing a new membrane. New mortar associated with the stone work was consistent in color and texture with the existing mortar, which dates to the 1990 restoration (Wheelock, "Assessment of Effect Form, Repair/Rehabilitate Chevy Chase Circle, Res. 335A" 2002).

Because of this sensitive work, the fountain retains high integrity of materials. The 30-foot-high stream of water is an important characteristic of the fountain, and was part of the symbolism relating to Newlands' reclamation work. Due to natural weathering processes and the effects of acid rain, the fountain's sandstone displays some signs of deterioration.

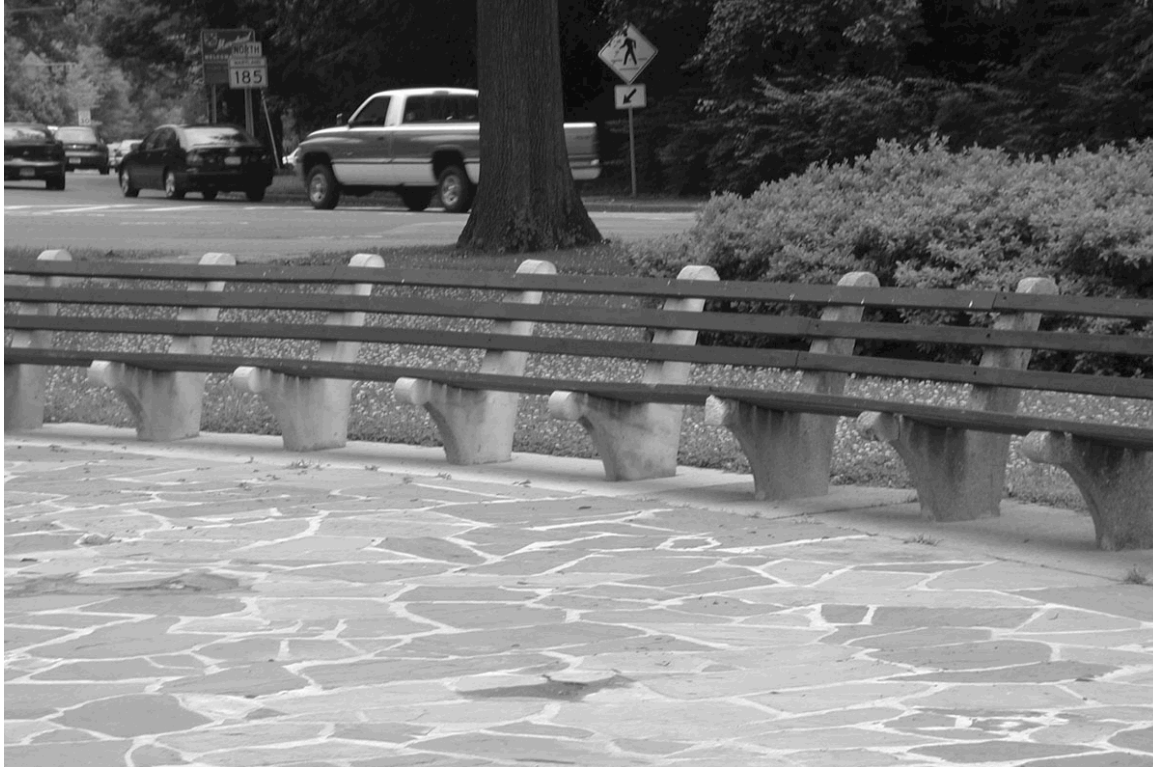
*Standard National Park Service benches line Chevy Chase Circle's inner walkway (CLP digital photofile, June 18, 2004).*

First installed in 1956, the benches at Chevy Chase Circle are placed in an arc along the outer edge of the plaza that surrounds the fountain. The benches are placed facing the fountain, so visitors can view the memorial fountain. ("Revised planting plan/ Res. 335A – Chevy Chase Circle/ Rock Creek" 5 February 1956: TIC 892\_81029). Composed of reinforced concrete supports with wood slat seats, these benches were commonly used by the NPS throughout the city. Over the years, the benches have been repaired numerous times due to automobile accidents at the site. Most recently, a 2001 accident left four benches damaged, and another accident in 2003 necessitated repairs to even more. (Dvorak, "Keepers" 2003). The National Park Service has been careful to replace damage pieces in the same materials and style as the original (Wheelock, "Assessment of Effect Form, Repair/Rehabilitate Chevy Chase Circle, Res. 335A" 2003). There is one noticeable difference between the original benches and the newly repaired ones – many of the concrete supports appear smoother and whiter than the older weathered concrete supports.

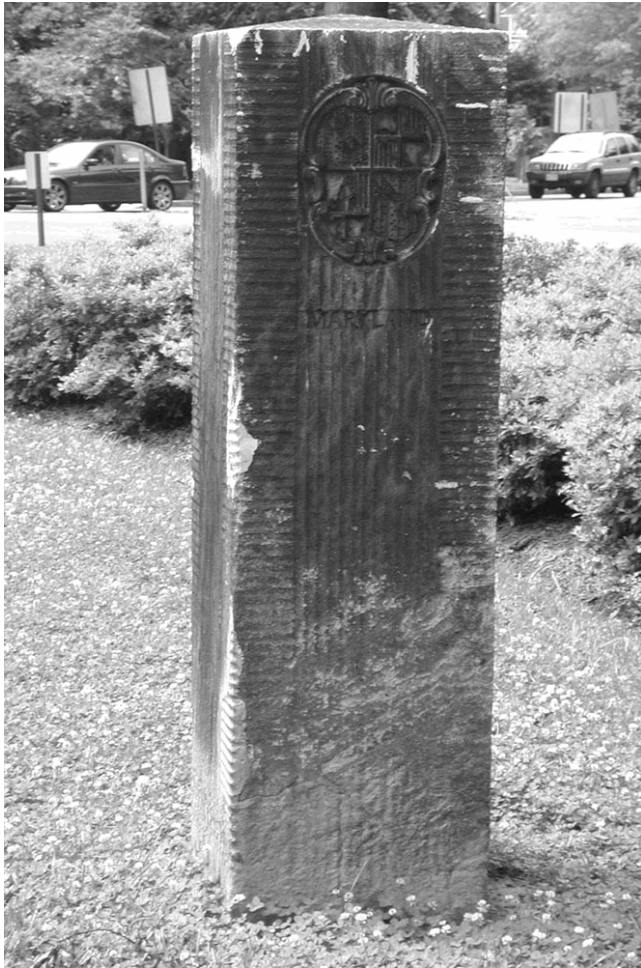
*Sandstone Garden Club of America marker (CLP digital photofile, June 18, 2004).*

According to the National Park Service, during the 1950s the markers at Chevy Chase Circle were removed from the center of the circle and relocated to small median triangles nearby on Connecticut Avenue. This placement left the markers vulnerable to vehicular accidents, and shortly after the installation, one marker was damaged in a crash. This marker was then removed at some point from the median and in 2000 the NPS retrieved the marker from a nearby backyard. The following year the remaining marker suffered damage as a result of an automobile accident (Hopper 2001). The Garden Club of Chevy Chase, a branch of the Garden Club of America, repaired and conserved both markers before NPS reinstalled them within the circle. National Park Service personnel placed each marker along an off-axis line on either side of the fountain, in between benches and azalea beds that contained wooden bollards. Additional protection for the markers was achieved by installing them on concrete foundations. The current location is meant to be temporary until a formal design for additional bollards or other protection devices around the entire circle is completed (Wheelock, “Assessment of Effect Form, Reinstall Garden Club Markers at Chevy Chase Circle” 2003).

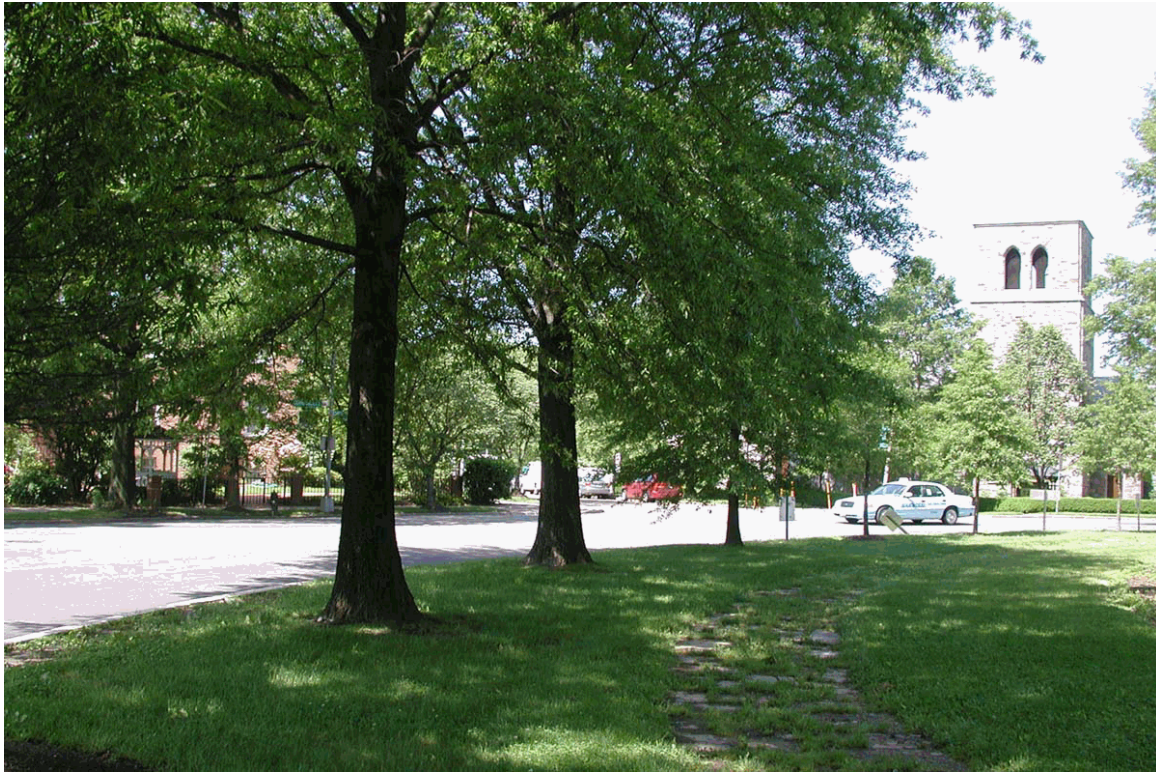
*Ring of willow oaks remaining along the perimeter of the circle (CLP digital photofile, May 26, 2005)*

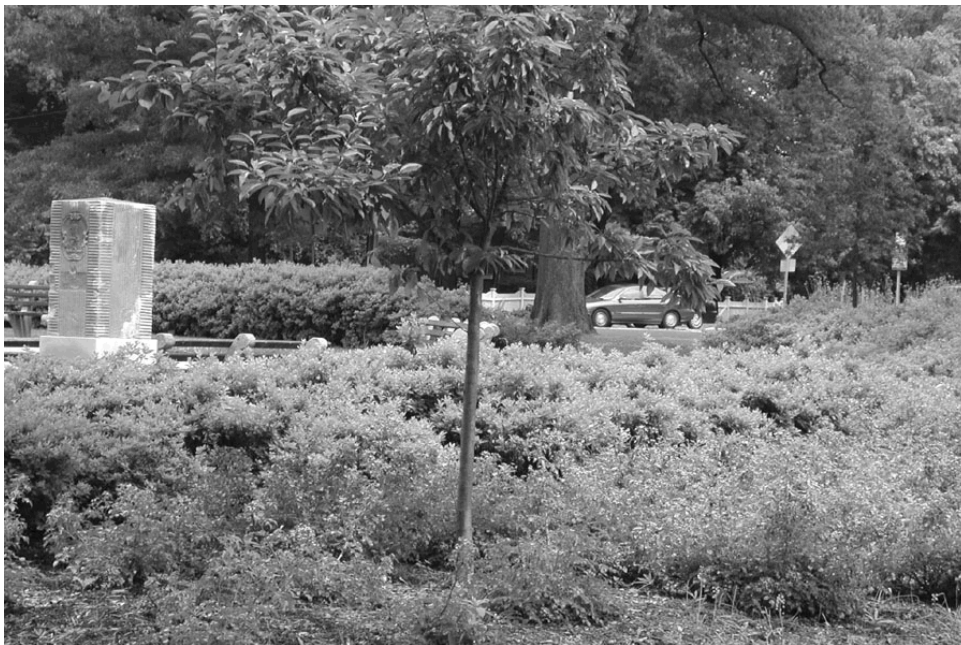
*Crabapples and roses, both recently added, accompany azaleas in shrub beds (CLP digital photofile, June 18, 2004).*

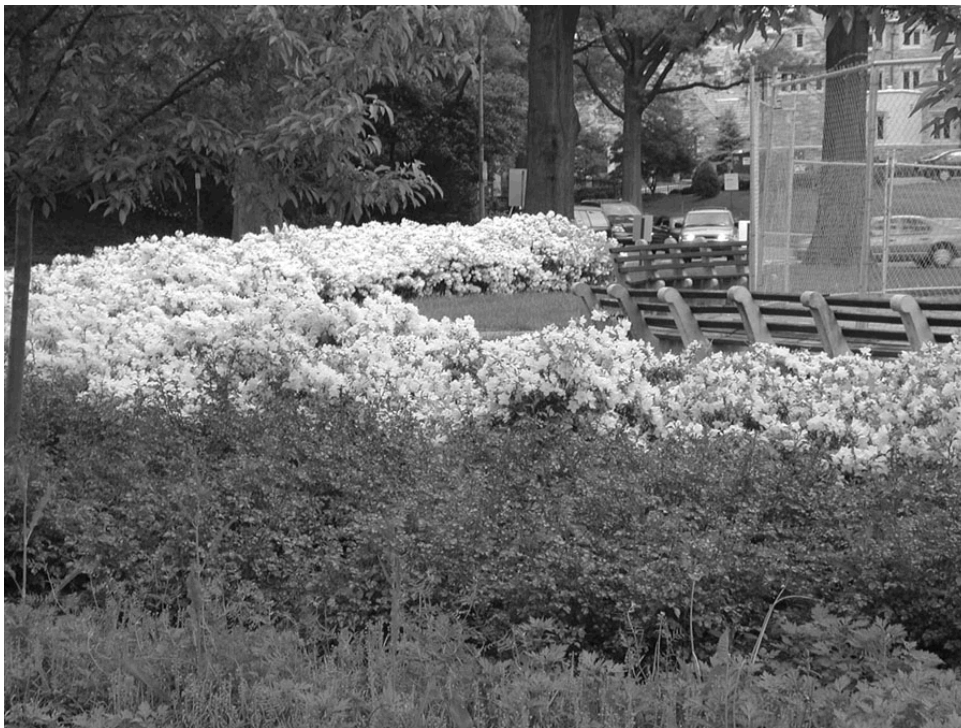
*Azaleas in bloom (CLP digital photofile, May 7, 2003).*
