National Park Service  
Cultural Landscapes Inventory  
2007

Montrose Park  
Rock Creek Park - Montrose Park

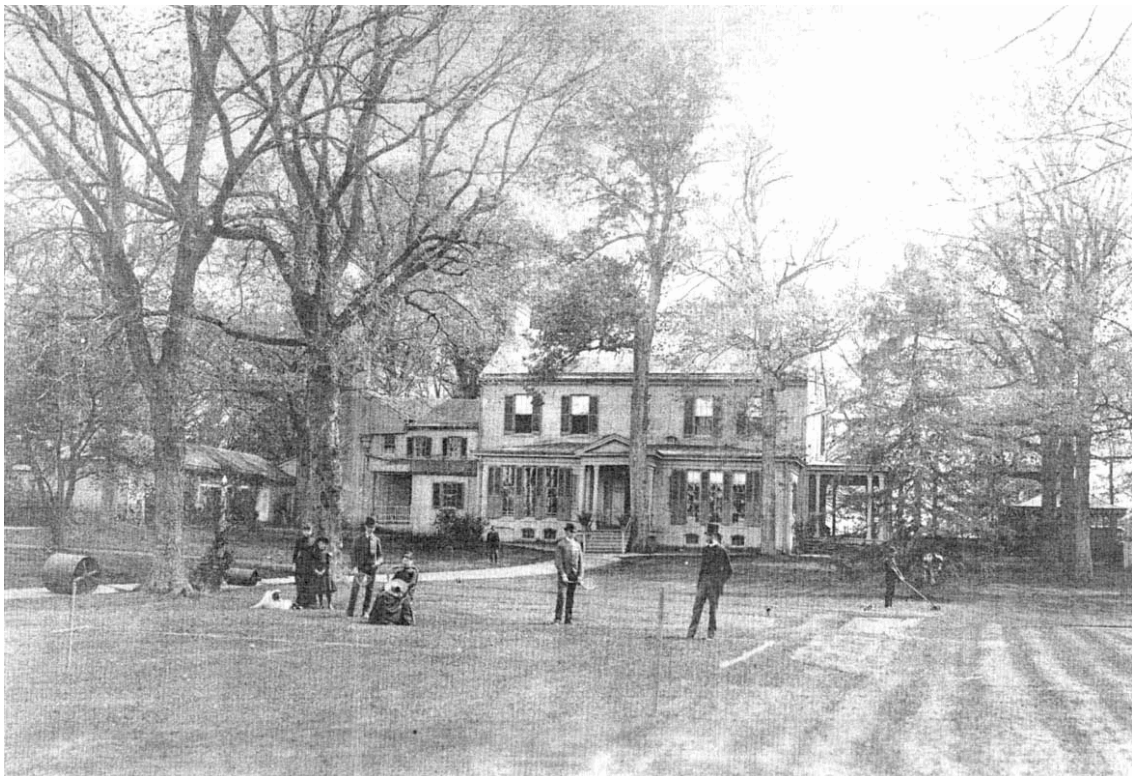
*North elevation of house and grounds, no date. Note the lawn rollers on the walk on the axis north from the house, and men holding badminton rackets (Library of Congress, Prints and Photographs Division).*

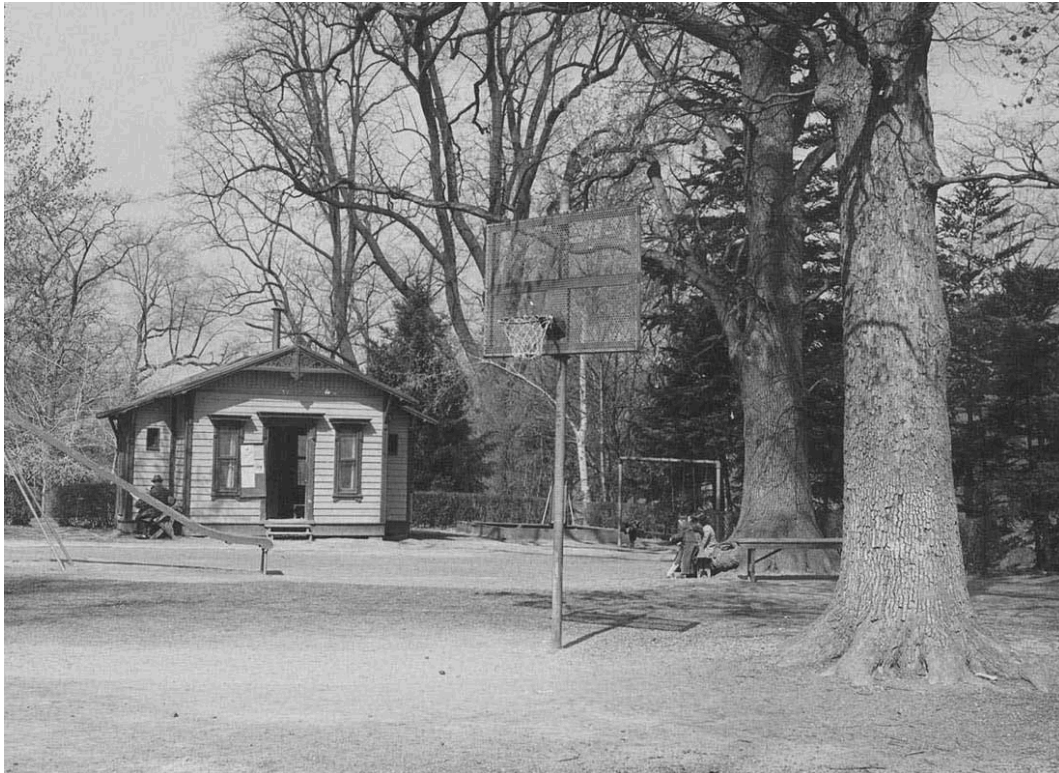
*View of play area on March 15, 1944 showing slide, basketball court and shed building originally from Lincoln Park (ROCR Cultural Resources, Historic Photograph files).*

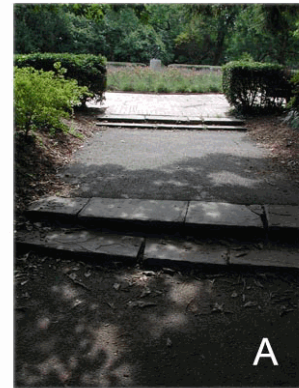
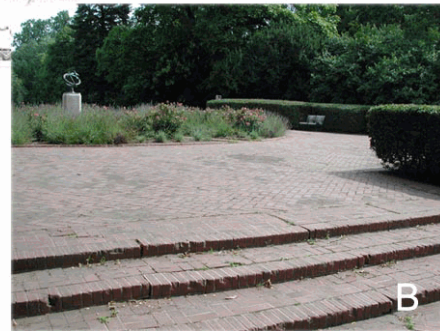
**Peaslee - 1917**  
**Entrance Ellipse and Summerhouse**

*At left, Peaslee's 1917 design for the Entrance Ellipse and relocated Summerhouse (DSC TIC 891/80032). A) Flagstone steps leading to the Entrance Ellipse; B) Brick paved Entrance Ellipse with redesigned center portion (CLP 2008).*

Peaslee's Entrance Ellipse remains similar to its original layout, with the exception of the four diagonal brick pathways that lead to the Rittenhouse Memorial located in the center of an elliptical planting bed. These non-contributing diagonal pathways date to 1956 during the Rittenhouse Memorial installation and redesign of the center portion of the Entrance Ellipse. The herringbone brick plaza is cracked and shows signs of heaving due to an unsettled base. Brick deterioration can also be seen in the entry steps. The alignments of the pathways extending east and west from the ellipse are present, but are now asphalt instead of gravel. A recent NPS project repaved a section of deteriorated asphalt pathway leading from the ellipse to the Summerhouse. The series of flagstone steps remains, however. The pathway by the Summerhouse is covered with a layer of soil. This build-up gives the area an un-kempt feel. The southern set of stairs that lead to the Summerhouse tennis court is blocked by wisteria vines, which prevents anyone from using them.

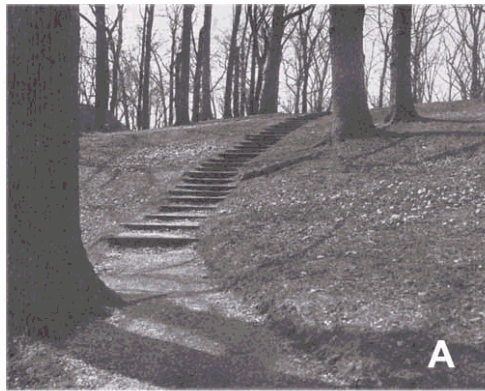
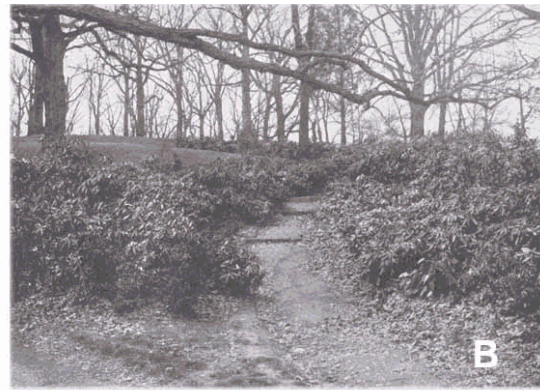
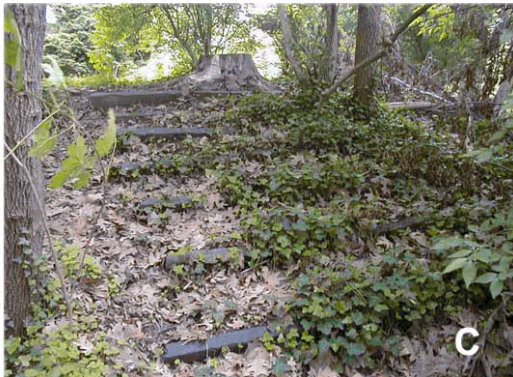
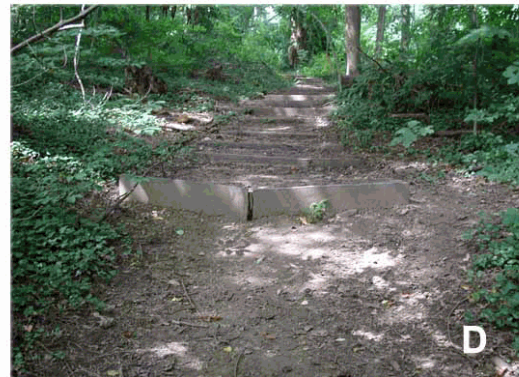
*Comparison photos of historic flagstone steps in the woodland: A and B, from c. 1916 (from *Parks: Their Design, Equipment, and Use* by George Burnap, 1916); C) Remnant steps covered in 2003 (from *Montrose Park CLR* 2004:89); D) Steps uncovered (CLP 2008).*

Remnant sections of the northern woodland paths still remain in use, although they are deteriorated. A recent Rock Creek Park trail project removed vegetation and debris and reset some of the stone risers for a steep section of path. Still other areas of the woodland paths are either ill-defined where encroaching vegetation covers the paths, or the path surface is washed out and heavily eroded.

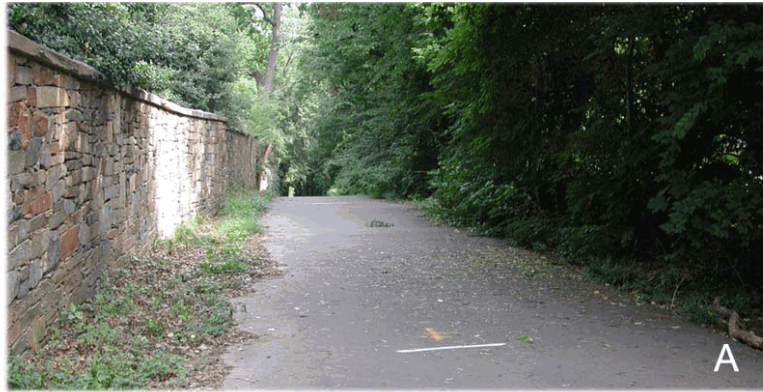
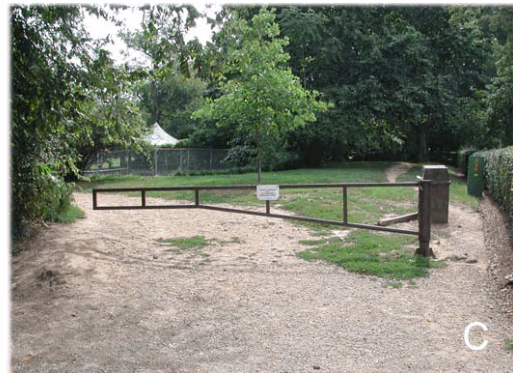
*A) Lovers' Lane corridor; B) Brick-lined asphalt path leading from the Summerhouse; C) Worn access road and path from Lovers' Lane (CLP 2008).*

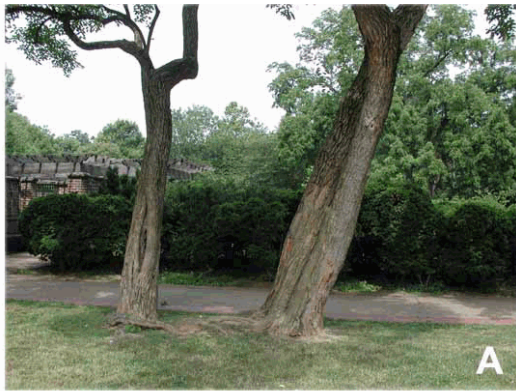
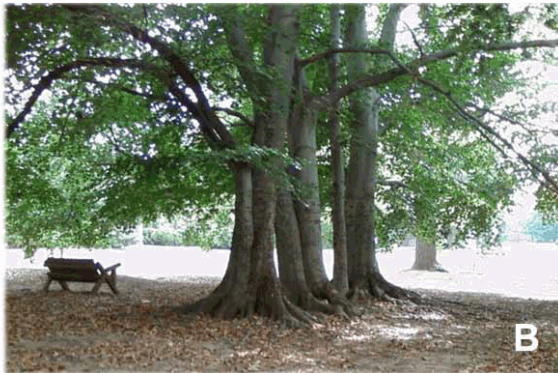
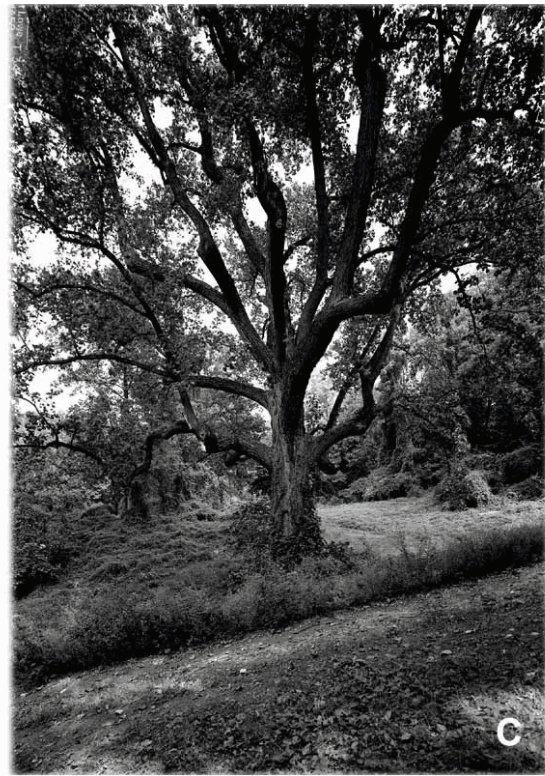
*Historic vegetation from the estate period: A) Osage orange trees along Ropewalk (CLP 2008); B) Grove of American beech trees on northernmost edge of plateau (CLP 2007); C) Tulip poplar witness tree (Photograph by Jet Lowe, HALS DC-10, 2007).*

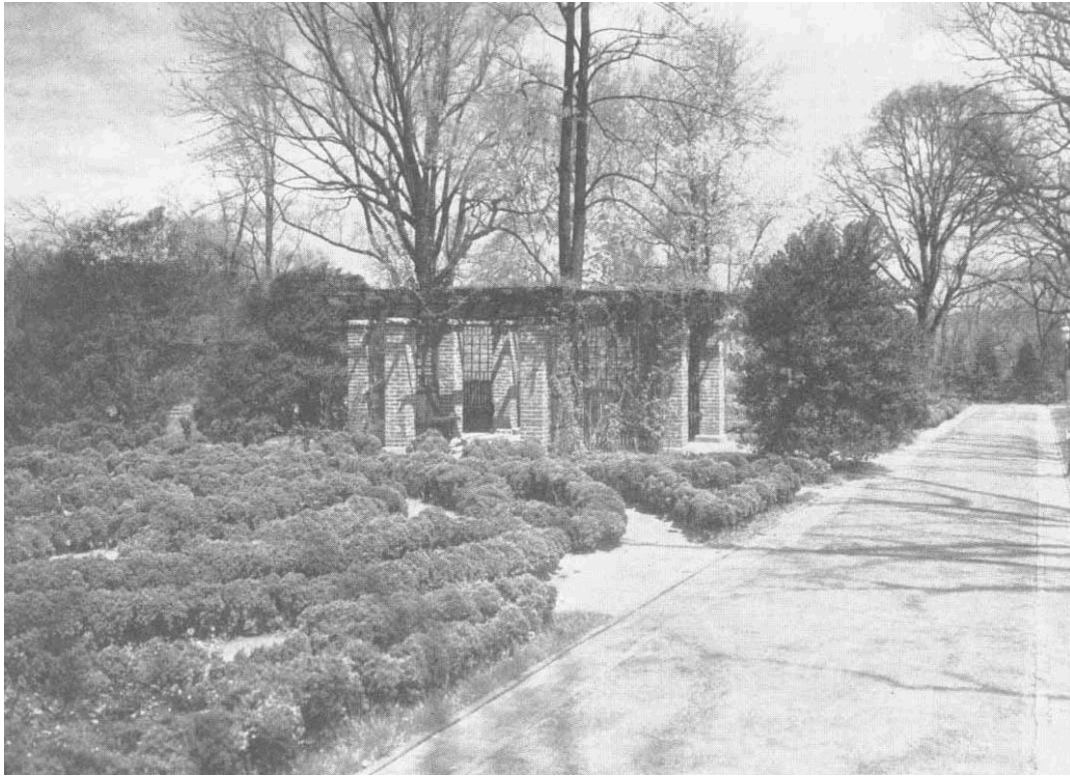
*The Boxwood Gardens, as they appeared around 1916, and the newly constructed Pergola (Parks : Their Design, Equipment and Use'by George Burnap, 1916).*

| | Built | The Pergola is constructed on the site of the nineteenth-century gardener's house in the Boxwood Gardens, based on plans by George Burnap. |

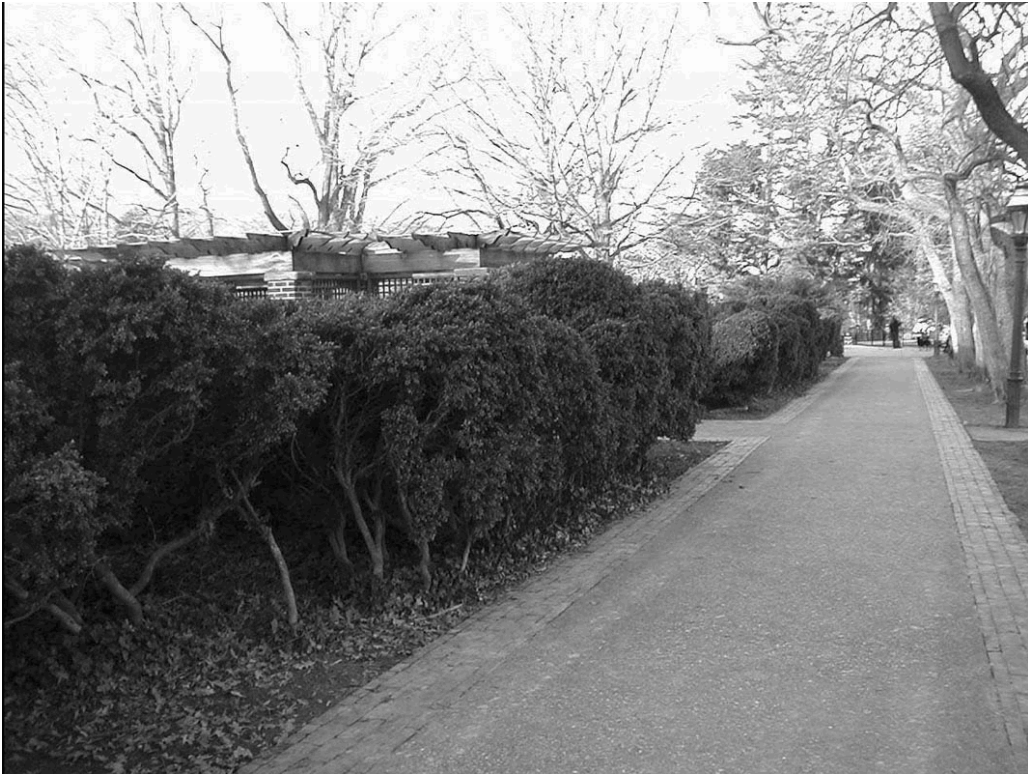
*View of Boxwood Gardens as they appeared in 2003, in an overgrown condition (Montrose Park CLR 2004:165).*

Gardens, the shrubs are overgrown, declining, and no longer exhibit the size and form of their originally intricate layout. Burnap's perennial garden along the Ropewalk is gone, along with most of his plantings around the Summerhouse. But Peaslee's planting layout for the Entrance Ellipse remains. Here an Osmanthus hedge surrounds the plaza, along with beds of azaleas (*Rhododendron* sp.) in four quadrants, similar to what was shown in his 1917 plan. There are however, a few differences from the original plan. The two oaks that once framed the view north of the Ellipse are gone, and a bed of roses and lavender now grows in the center of the Ellipse, where Peaslee designed a water basin.

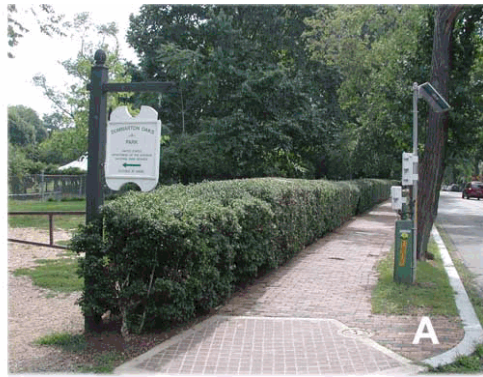
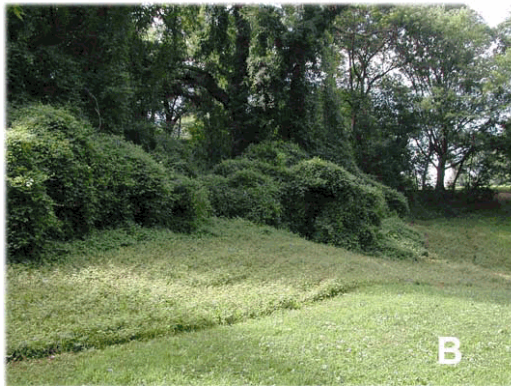
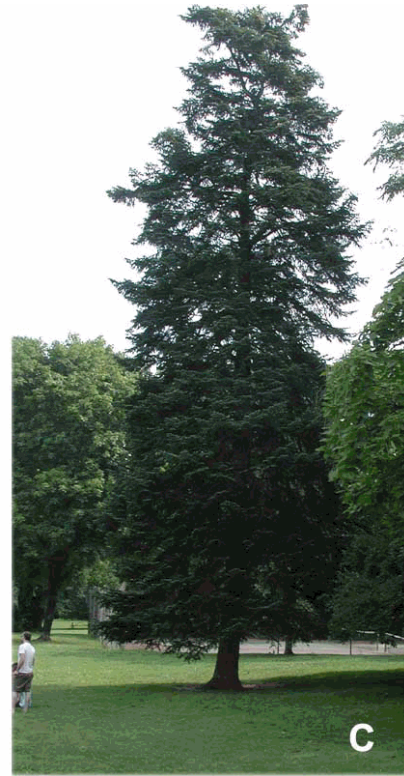
*Other vegetative features: A) Osmanthus hedge along R Street boundary; B) Invasive vegetation encroaching on the woodland edge, on open sloping ground; C) Georgetown Garden Club Nordman fir Christmas tree (CLP 2008).*

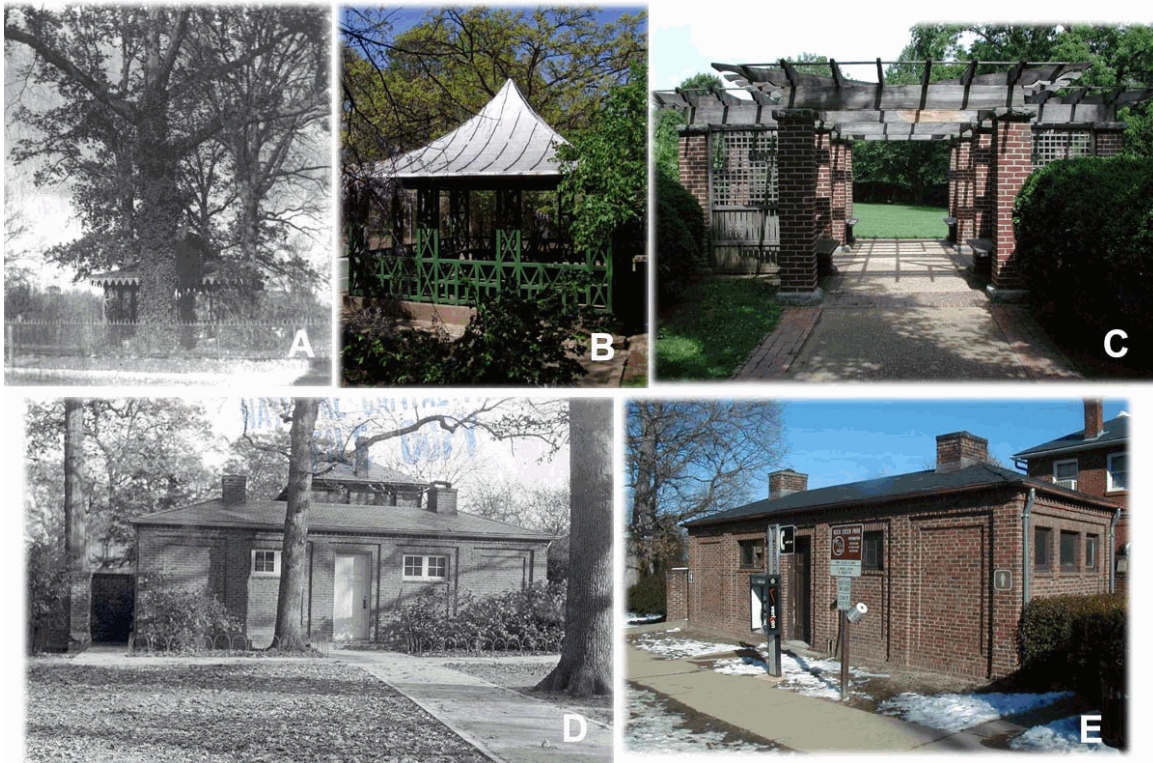
*A) Summerhouse in original location, late 1800 (Library of Congress, Prints and Photographs Division); B) Summerhouse (CLP 2008); C) Pergola (CLP 2008); D) Lodge in 1926 (ROCR Historic Photograph files); E) Lodge in 2003 (Montrose Park CLR 2004:87).*

Montrose Park still retains its most prominent structures, with the exception of the utilitarian tool shed, which was demolished in 1979. The Summerhouse remains largely intact and is the oldest structure on the property. All wood elements of the structure are painted green, and some portions are suffering from minor wood rot and deterioration. The standing seam ‘tin’ roof is painted with aluminized paint and may either be a replacement roof from 1915 or have originated in the late-nineteenth-century. The roof is otherwise in good condition.

The Pergola is “indistinguishable from the structure described in Burnap’s January 11, 1913 drawings” and is in excellent condition (CLR: 110).

The remaining structure, the Lodge, shows signs of wear and deterioration, although its exterior appears similar to its historic condition. The service yard pier is tilted, causing the wooden gates to the yard to be out of plumb. The slate roof and gutters are in relatively good condition, though several of the downspouts are failing.

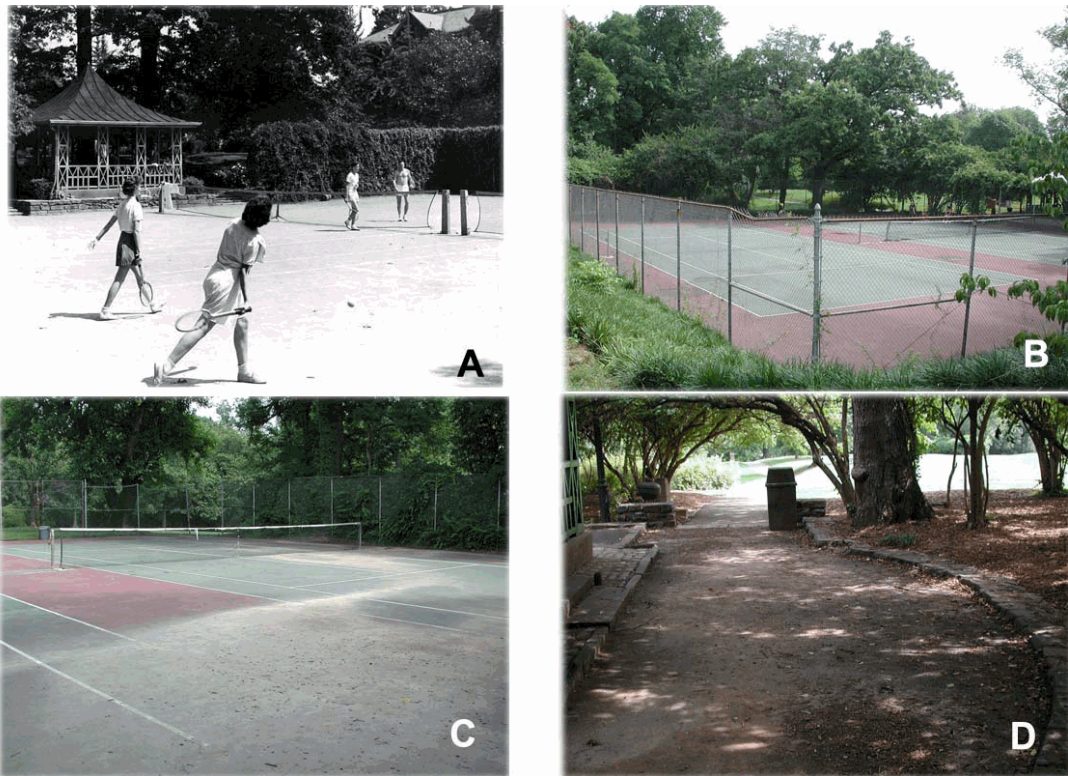
*A) View of Summerhouse tennis courts and Summerhouse, c. 1950 (ROCR Historic Photograph files); B) Summerhouse tennis courts; C) Ropewalk tennis courts and sediment build-up; D) Summerhouse fieldstone walls (CLP 2008).*

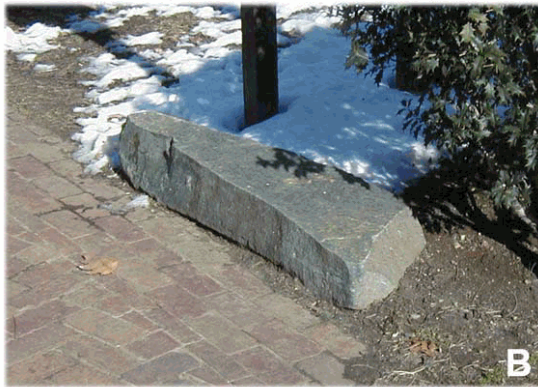
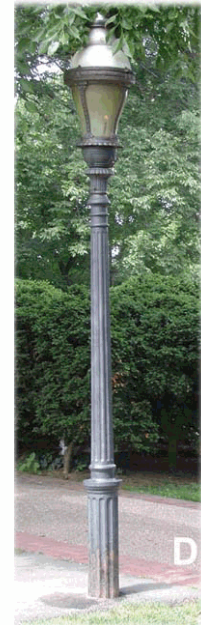
*A) Location of two curb stones at Ropewalk entrance, c. 1900 (Library of Congress, Prints and Photographs Division); B) Possible remnant curb stone lying on its side, 2003 (Montrose Park CLR 2004:185); C and D) Newport's style light fixtures (CLP 2008).*

None of the historic fences remain today, but the alignment of the current chain-link fence separating Montrose Park and the Oak Hill Cemetery is the same. One of the curb stones that marked the entrance to the driveway/Ropewalk may still remain, but now lies on its side at the Ropewalk entrance. All the historic walls remain, and are mostly in good condition, with the exception of the stone retaining wall along Lovers' Lane. Its condition ranges from fair to poor where large sections of capstones or wall stone are missing. Although the wall is outside the boundary of Montrose Park, it is an important feature and acts as a visual definition of the park's western boundary.

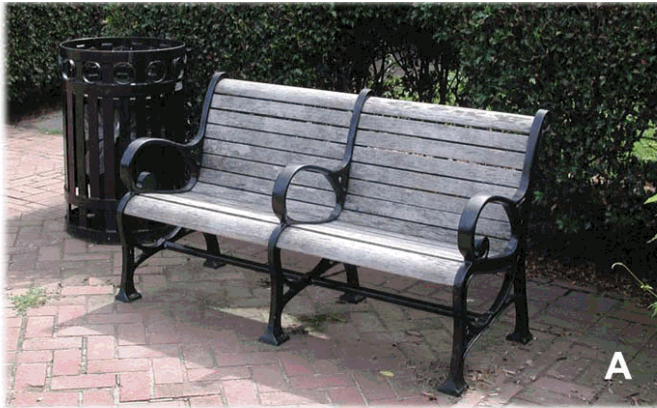
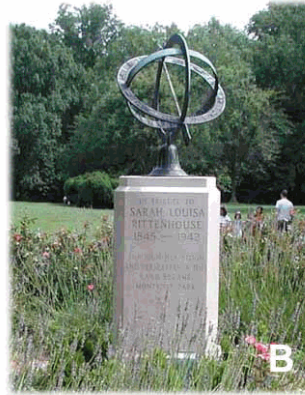
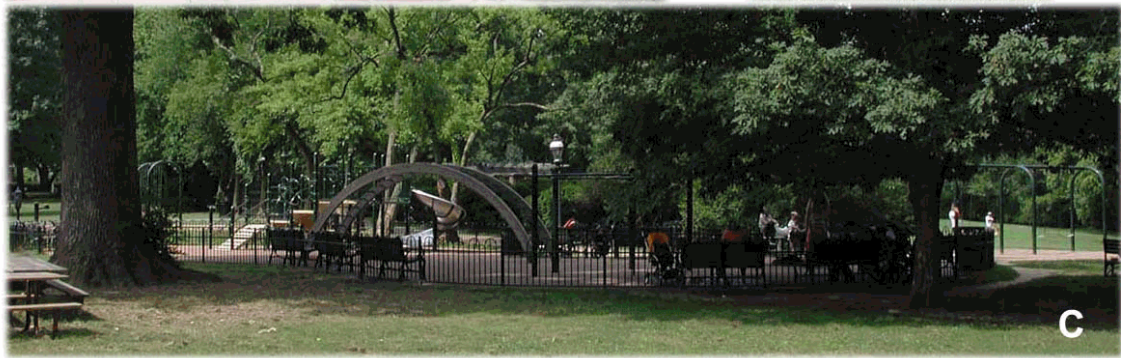
*A) Contemporary bench with cast iron frame and wooden slats; B) Sarah Louisa Rittenhouse Memorial; C) Fenced-in play area (CLP 2008).*
