National Park Service  
Cultural Landscapes Inventory  
2002

Rancho del Norte  
Channel Islands National Park

**Rancho Del Norte**  
Channel Islands National Park

CONDITION ASSESSMENT:      **FAIR**

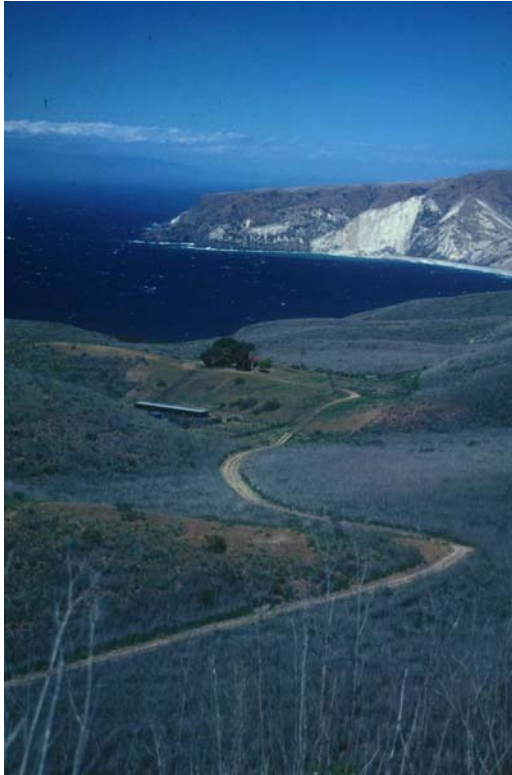
*History #2: Rancho del Norte from Rancho del Norte Road showing the topography and surrounding landscape in which the complex is nestled. The grey areas are where the fennel has spread. (PGSO, CLI, CHIS-S-0007-16, 2002)*

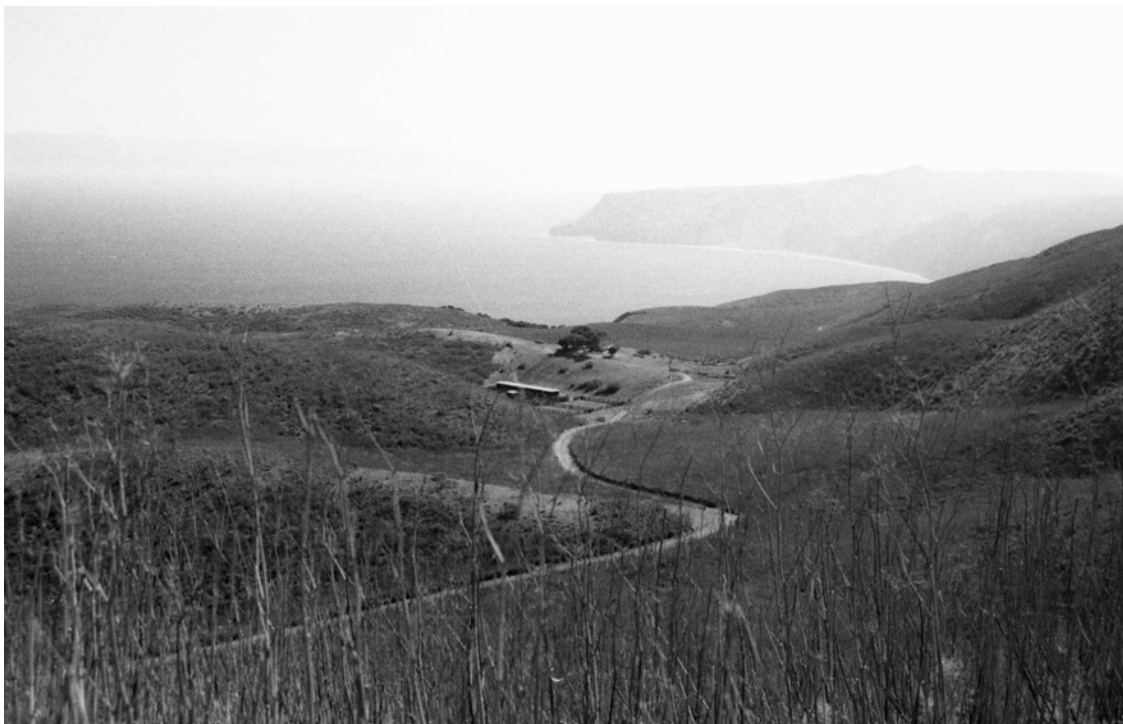
*Natural Systems and Features #1: View of Rancho del Norte within the protective folds of the rolling topography. (PGSO, CLI, CHIS-N-0011-18, 2002)*

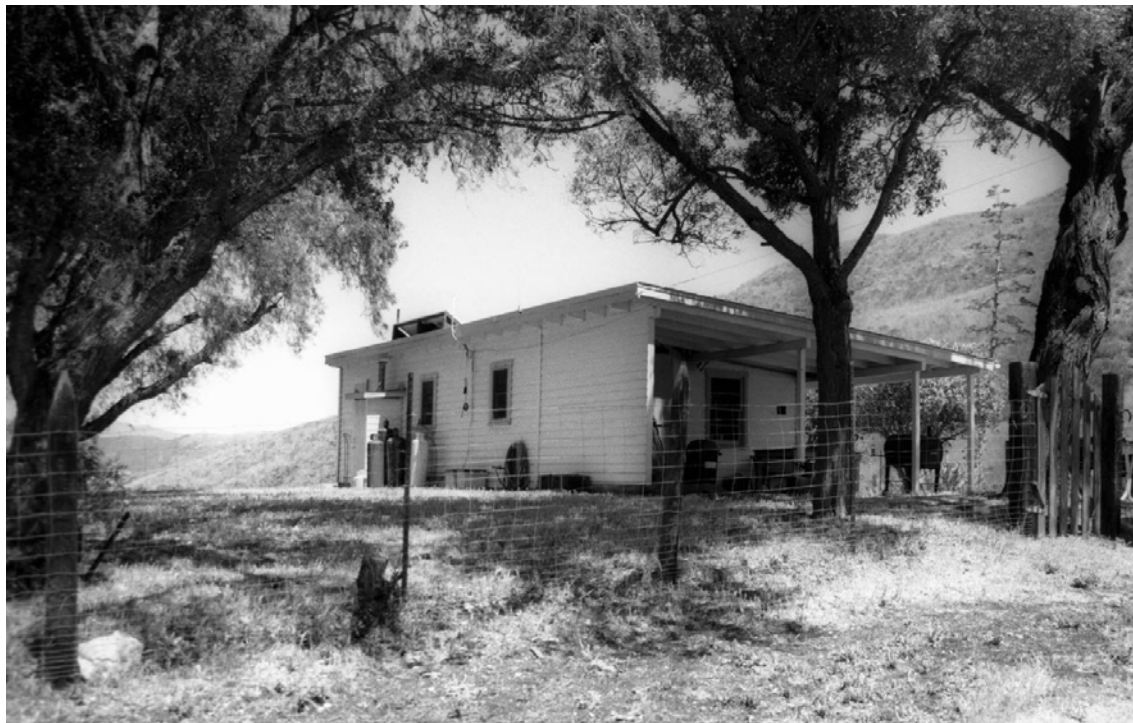
*Vegetation #1: View of the rear of the ranch house with the two black acacia to the right. (PGSO, CLI, CHIS-N-0018-24, 2002)*

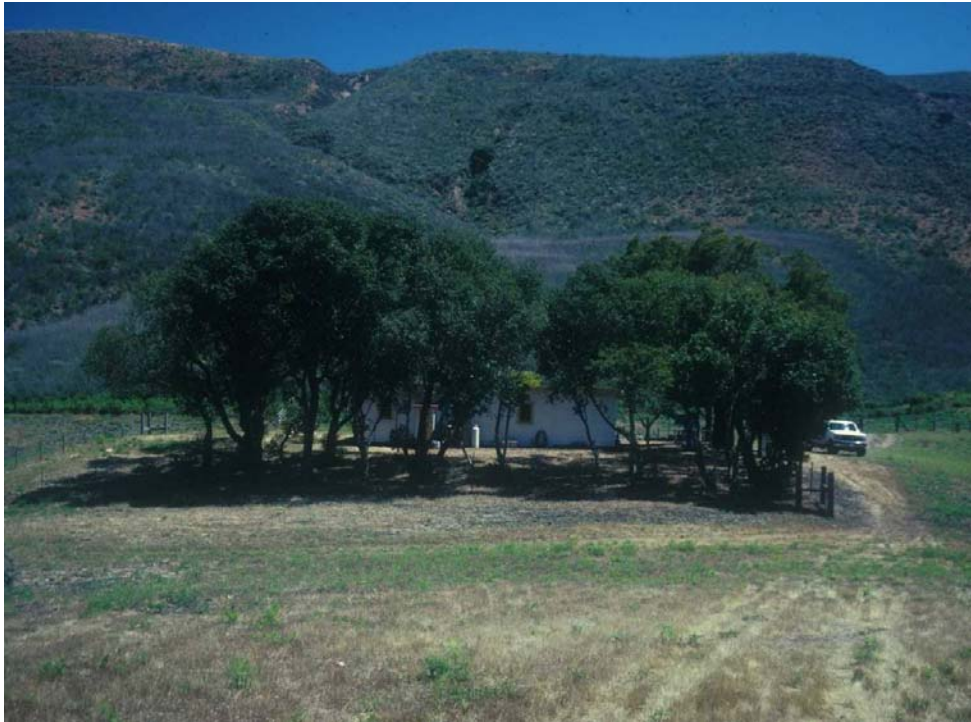
*Vegetation #2: Image of the row of hollyleaf cherries to the rear of the ranch house. Two stumps are located in the gap in the center of the row. (PGSO, CLI, CHIS-S-0007-2, 2002)*

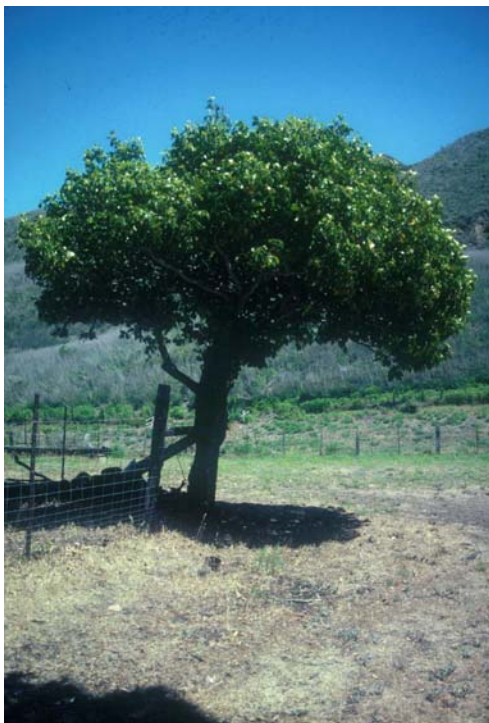
*Vegetation #3: Algerian ivy, pruned into a small tree, is located at the southwest corner of the house fence. (PGSO, CLI, CHIS-S-0007-4, 2002)*

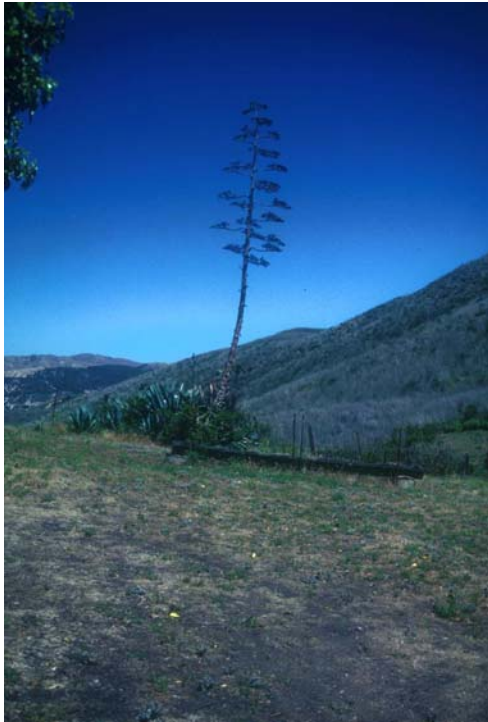
*Vegetation #4: A view of the clump of agave just south of the ranch house with a single flower stalk. (PGSO, CLI, CHIS-S-0007-5, 2002)*

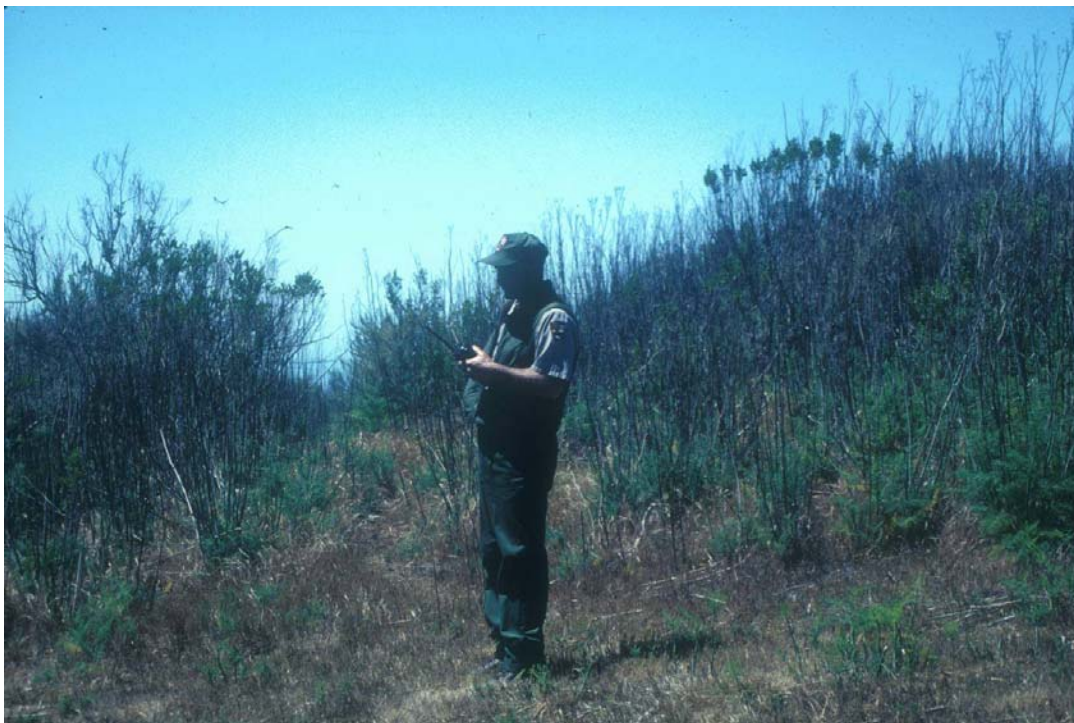
The native grasslands on Santa Cruz have been extensively grazed and replaced with exotic species typical of grazed lands. Of these, fennel, has spread across the isthmus creating massive thickets that crowd out native species and make hiking across the island difficult. Portions of The Nature Conservancy land to the west are still grazed by a small herd of cattle. The most dense fennel area is in the Anisal (fennel) field just west of Rancho del Norte, and small amounts have crossed over the Montañon to the eastern portion of the island.

*Vegetation #5: Image of the fennel overtaking the pasture land. (PGSO, CLI, CHIS-S-0007-11, 2002)*

Continue to maintain the mow line around the ranch complex to minimize damage to the ranch house, barn, shed, and corrals in the ranch complex. A mow strip around the fencelines surrounding the isthmus would allow the fences to be visible and provide a buffer from fire until the fennel can be eradicated.

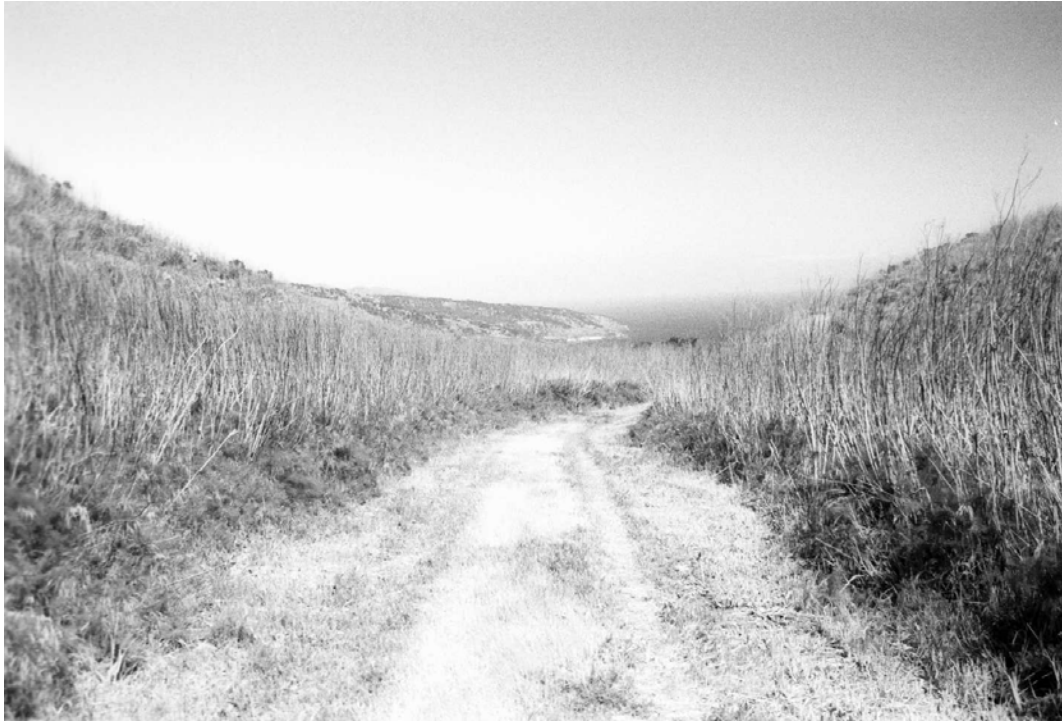
*Circulation #1: View down the road to the del Norte Campground. (PGSO, CLI, CHIS-N-0011-20, 2002)*

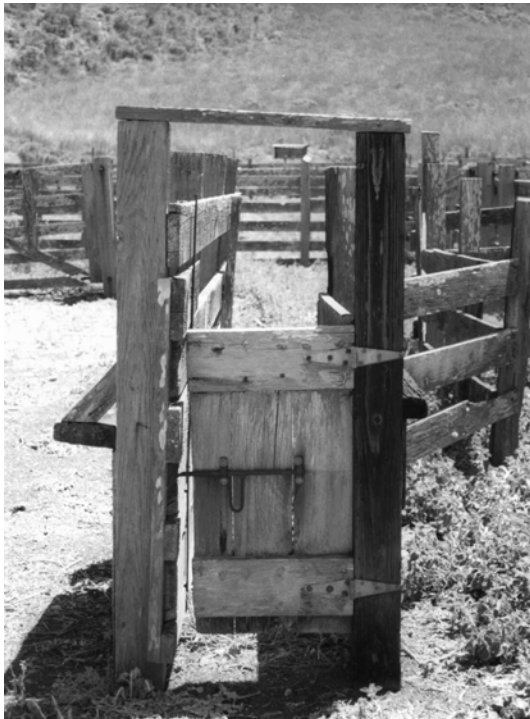
*Circulation #2: One of the small gates at the end of a chute used to funnel cattle through the corral complex. (PGSO, CLI, CHIS-N-0008-2, 2002)*

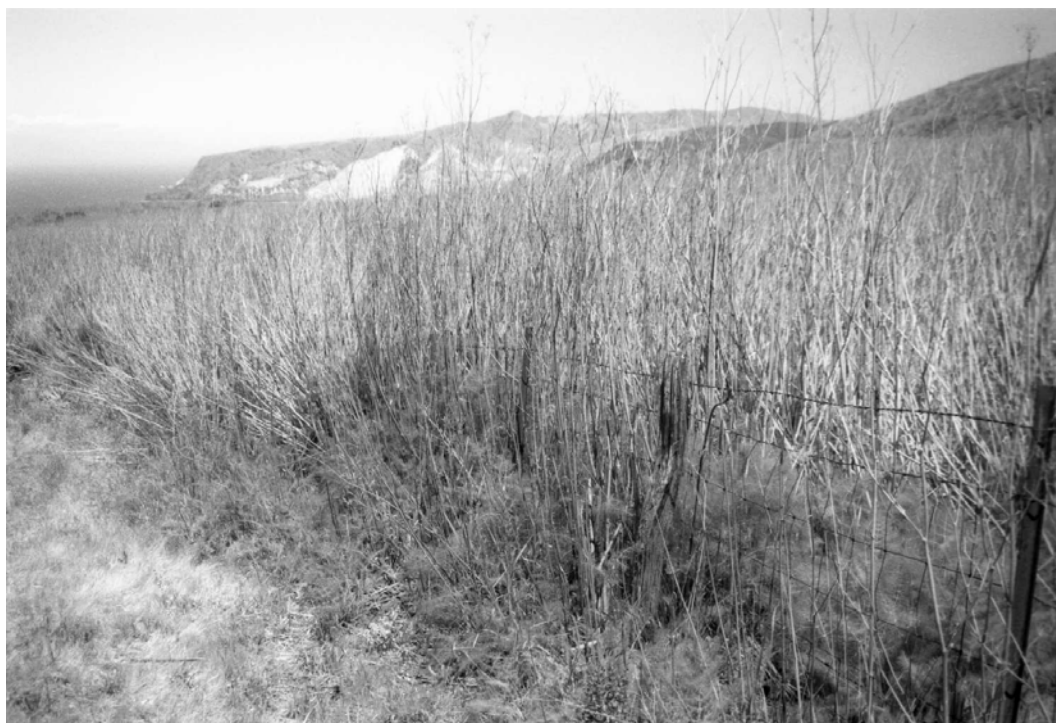
The fences have been adversely impacted by the spread of fennel whose bulbs have uprooted some of the fence posts, while the stalks have obscured the fences from view.

*Circulation #3: Barbed wire fencing running into fennel thicket. (PGSO, CLI, CHIS-N-0008-11, 2002)*

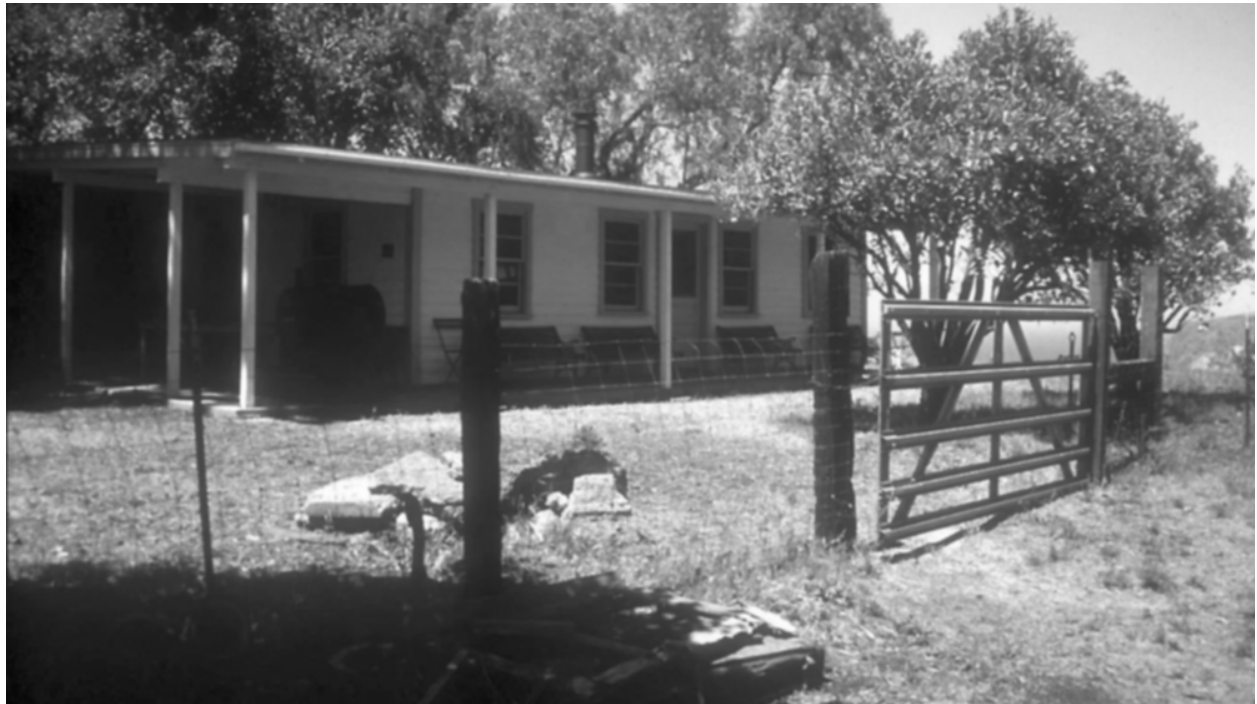
The small ranch house was designed for the Stantons in 1952 by Los Angeles architect H. Roy Kelly (see photo, Buildings and Structures #1). Although the house is located on a hill above Chinese Harbor, the front door faces south toward the island's hills and part of the corral system employed at the ranch. The eighteen by thirty-and-a-half foot building sits on a concrete foundation and is covered with composition shingles. A concrete porch wraps around the south and west sides of the house. The covered porch is five feet wide on the south side and nine-and-a-half feet wide to the west. The north wall of the house extends west, providing shelter to the porch. Access to the house includes a door to the pantry on the west side in addition to the front door to the south. A main room in the center of the house serves as the kitchen, dining room, and living room. The house is further divided to include a pantry, bathroom, and two bedrooms.

After Carey Stanton's death in 1987, the house was abandoned. The Santa Cruz Island Foundation raised money and organized the restoration of the house in 1995-96. Custom two-over-two double hung wood sash windows were installed during the restoration, the wood siding was painted white with bright yellow trim, and a portion of the concrete porch pad was removed, re-poured, and dated "1996". The house is in good condition, though birds often peck holes in the siding.

*Buildings and Structures #1: A view toward the ranch house backed by hollyleaf cherry trees, and two orange trees in front and to the right. In the front center is the fire pit. (PGSO, CLI, CHIS-S-0007-6, 2002)*

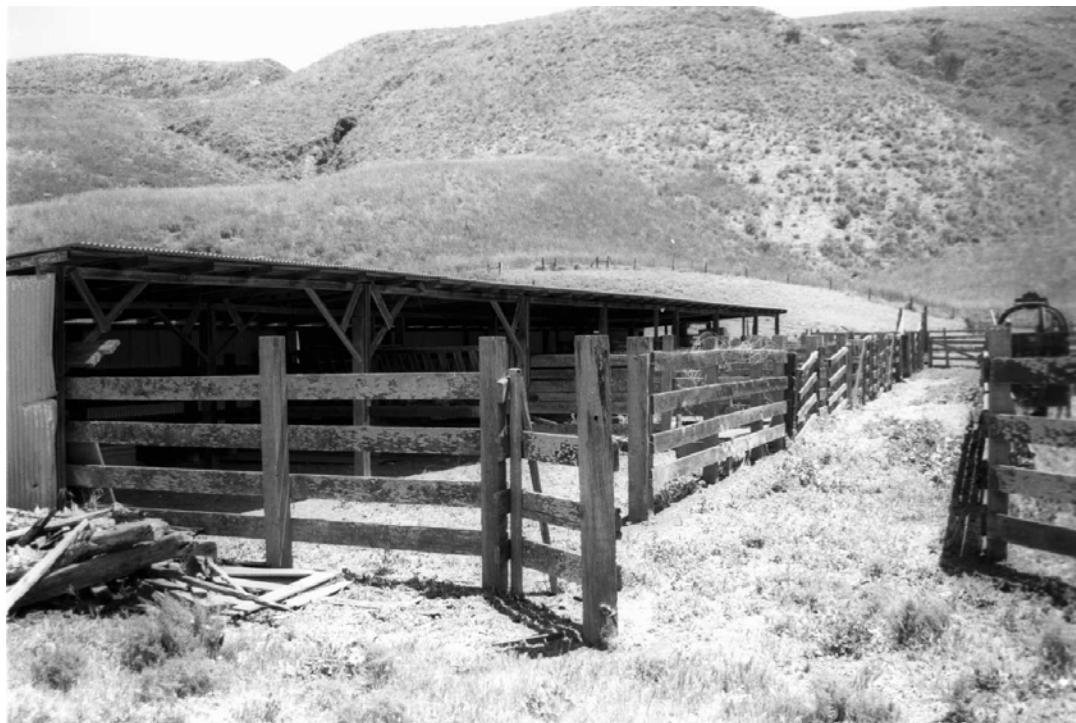
The large open-air barn is located east of the "medicine shed". The seventeen feet by ninety-two feet shed consists of three walls, with the long side open to the west and a series of small pens within (see photo, Buildings and Structures #3). A corrugated metal roof covers the structure once used to shelter horses and/or cattle. The horse barn is in fair condition.

*Buildings and Structures #3: A view along the horse barn within the corral complex. The cattle squeeze is on the right. (PGSO, CLI, CHIS-N-0008-5, 2002)*

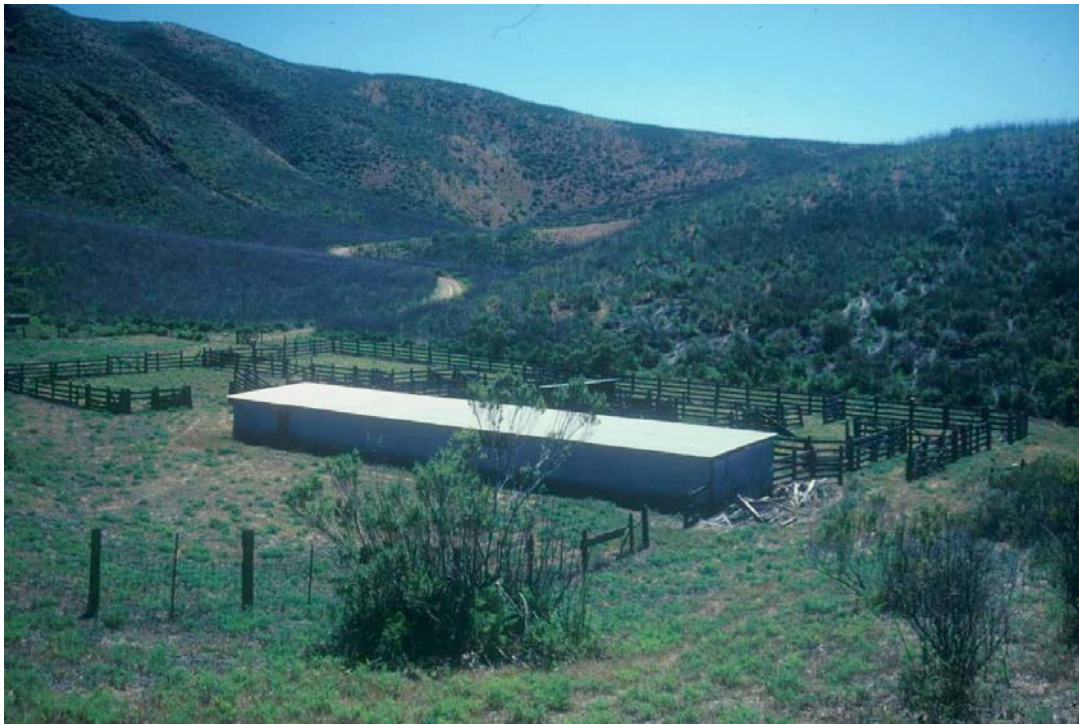
*Cluster Arrangement #1: A view of the corral complex. (PGSO, CLI, CHIS-S-0007-12, 2002)*

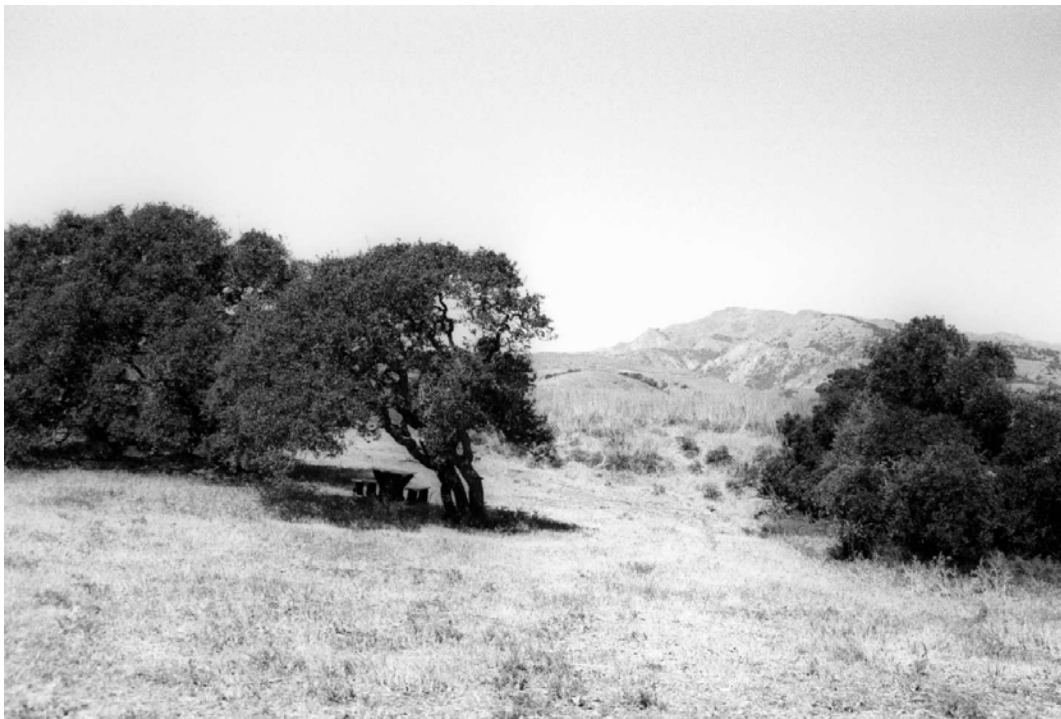
The third cluster, the del Norte campground on the western slope of the knoll was developed around 2001 by the NPS and consists of a small number of campsites with picnic tables under oak trees (see photo, Cluster Arrangement #2).

*Cluster Arrangement #2: A view of the del Norte campground. (PGSO, CLI, CHIS-N-0011-21, 2002)*

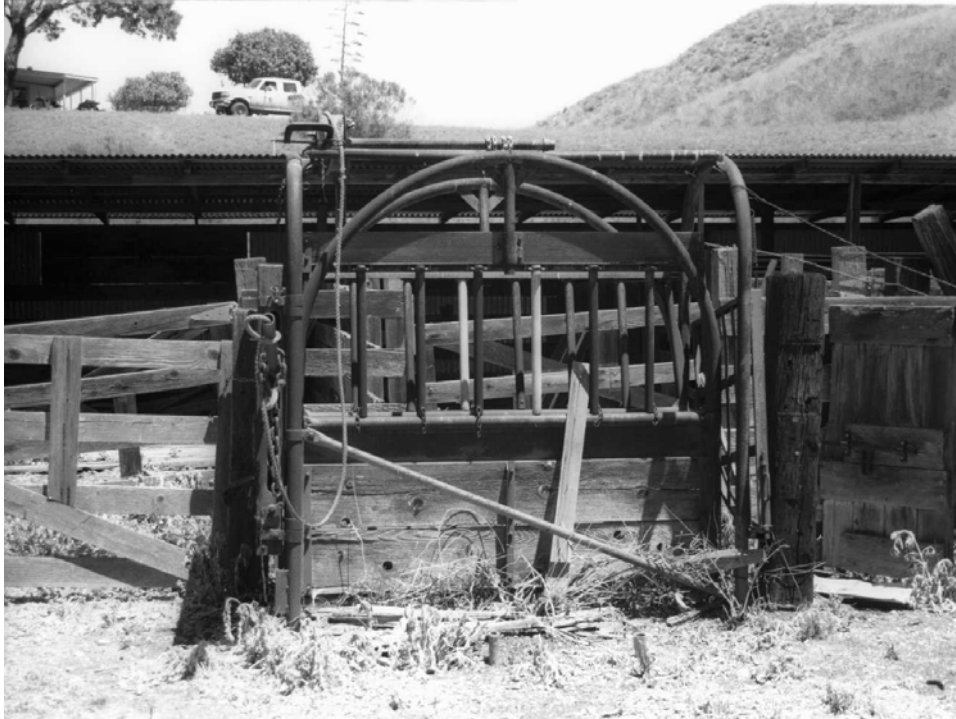
A single cattle squeeze, used for holding the stock during castration, vaccination, and branding, is found within the wooden corrals adjacent to the horse barn (see photo, Small Scale Features #1).

*Small Scale Features #1: The metal cattle squeeze, located near the horse barn and medicine shed. (PGSO, CLI, CHIS-N-0008-4, 2002)*

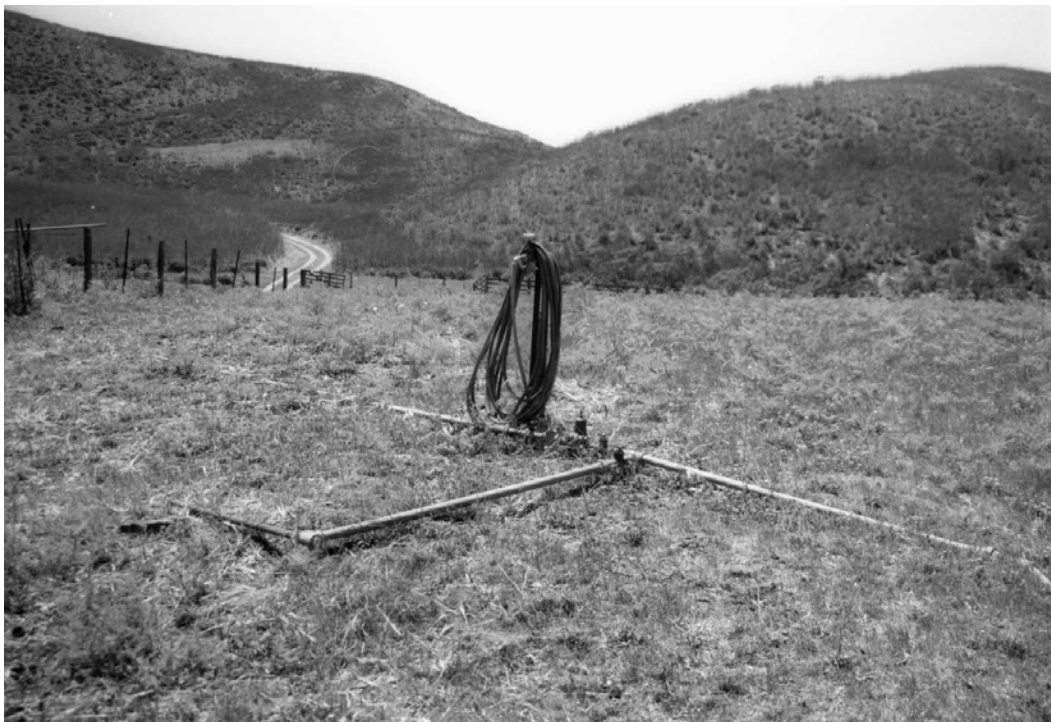
*Small Scale Features #2: The water spigot and some of the pipes that run throughout the isthmus. (PGSO, CLI, CHIS-N-0008-15, 2002)*

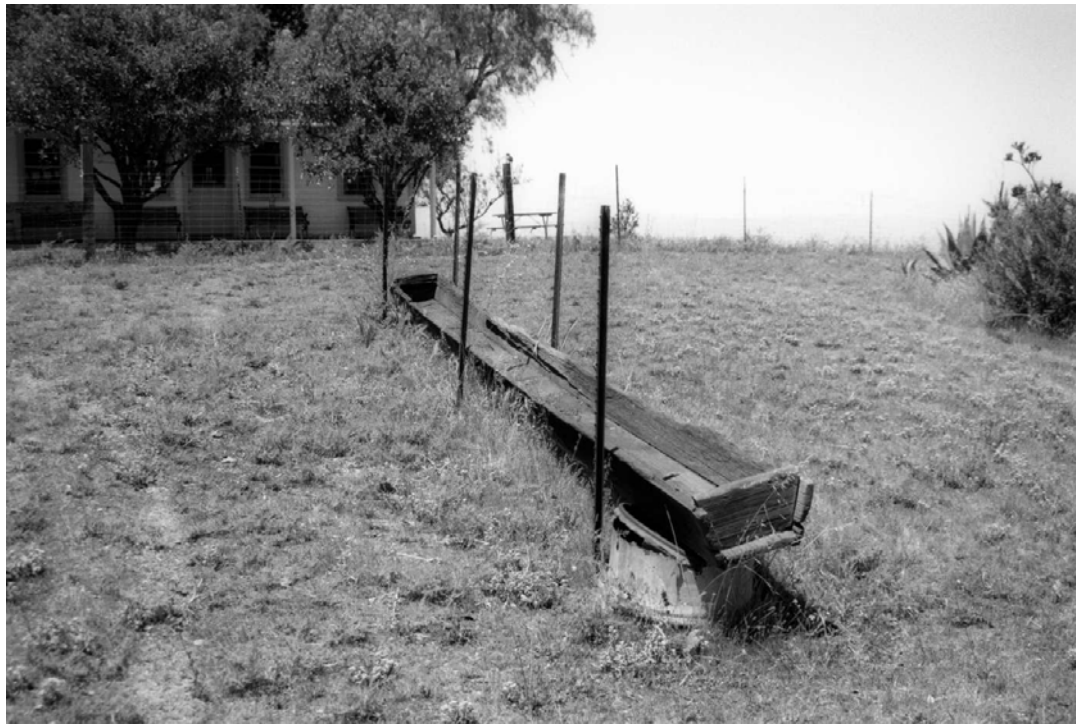
*Small Scale Features #3: A view of the long wooden feed trough between the ranch house and agave patch. (PGSO, CLI, CHIS-N-0008-19, 2002)*

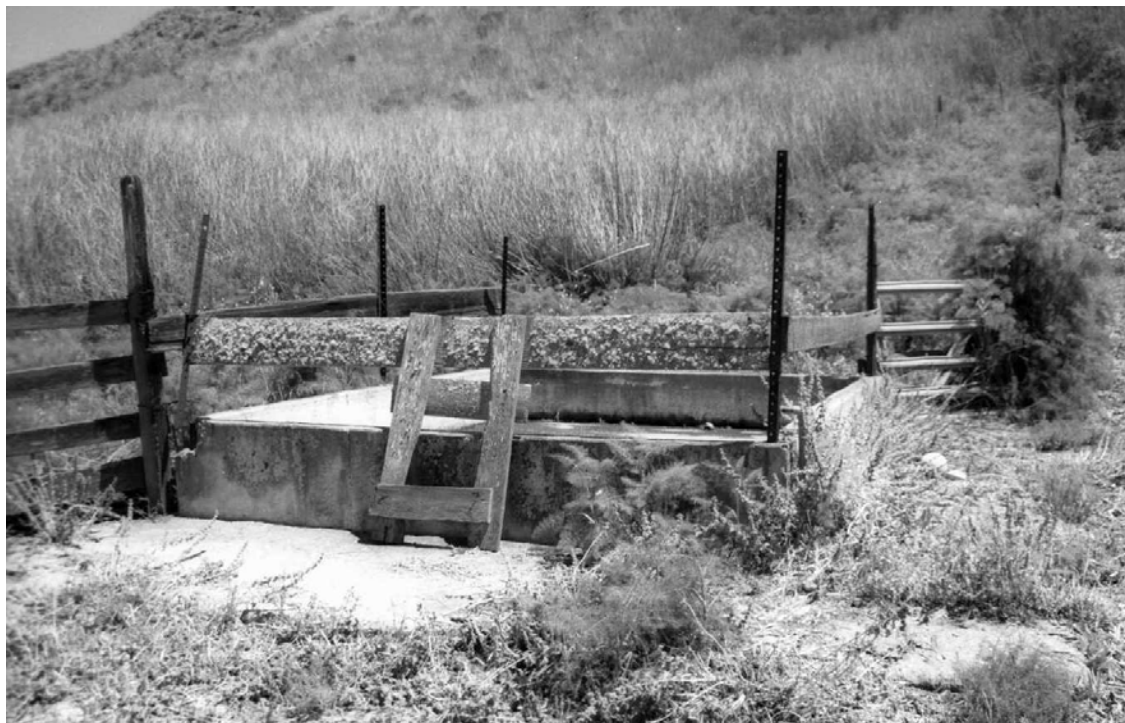
The two remaining troughs are in the pen at the southeast corner of the complex (see photo, Small Scale Features #4), and in the eastern edge of the southwestern pen (see photo, Small Scale Features #5). These troughs are typical of those found throughout the isthmus. They are fourteen by sixteen feet wide, two feet high, and have a wall six inches thick. A concrete bib surrounds them to a distance of five feet. Those found at Rancho del Norte are both located along pen fencelines and consequently have wooden boards running from corner posts along all four sides to prevent cattle from crossing through. Water levels are controlled by floats connected to valves, although only the trough at the west end appears to collect water.

*Small Scale Features #4: One of the two concrete troughs within the corral complex at Rancho del Norte. (PGSO, CLI, CHIS-N-0008-12, 2002)*

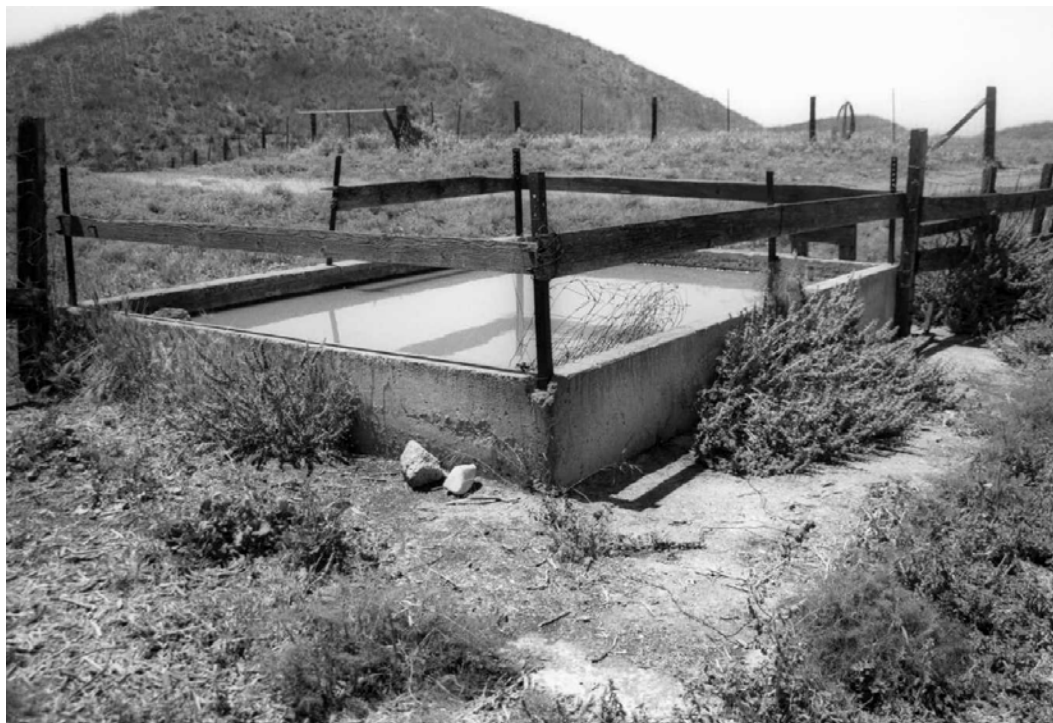
*Small Scale Features #5: The western concrete trough completely within the corral complex at Rancho del Norte. (PGSO, CLI, CHIS-N-0008-14, 2002)*

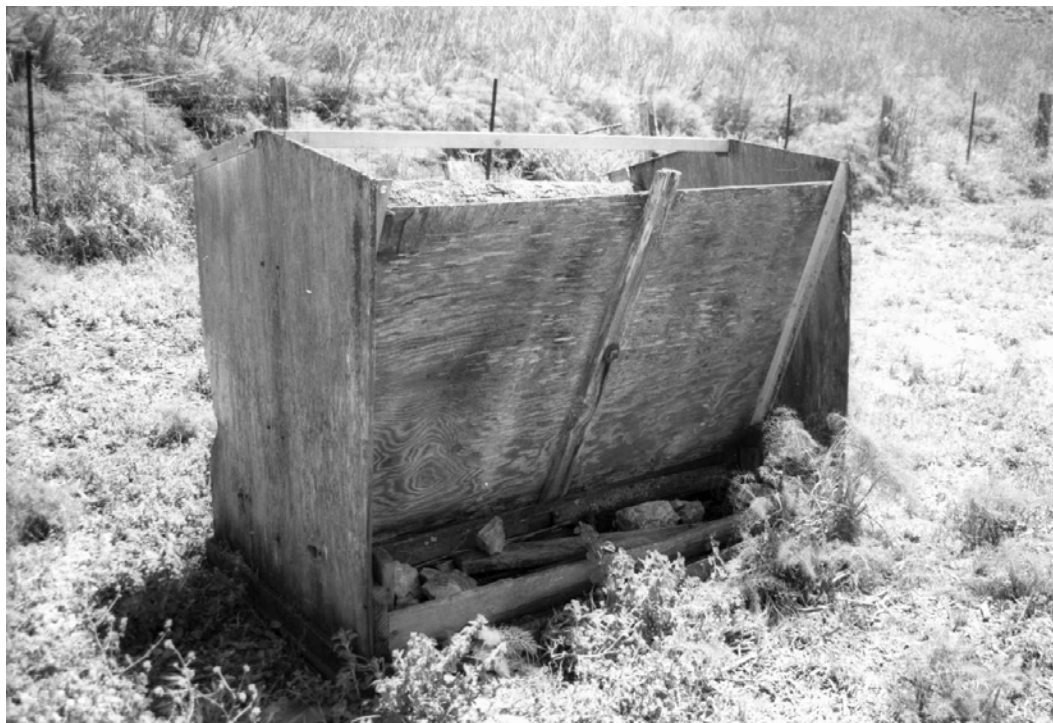
*Small Scale Features #6: A view of the eastern feed crib located in the corral complex. (PGSO, CLI, CHIS-N-0008-13, 2002)*

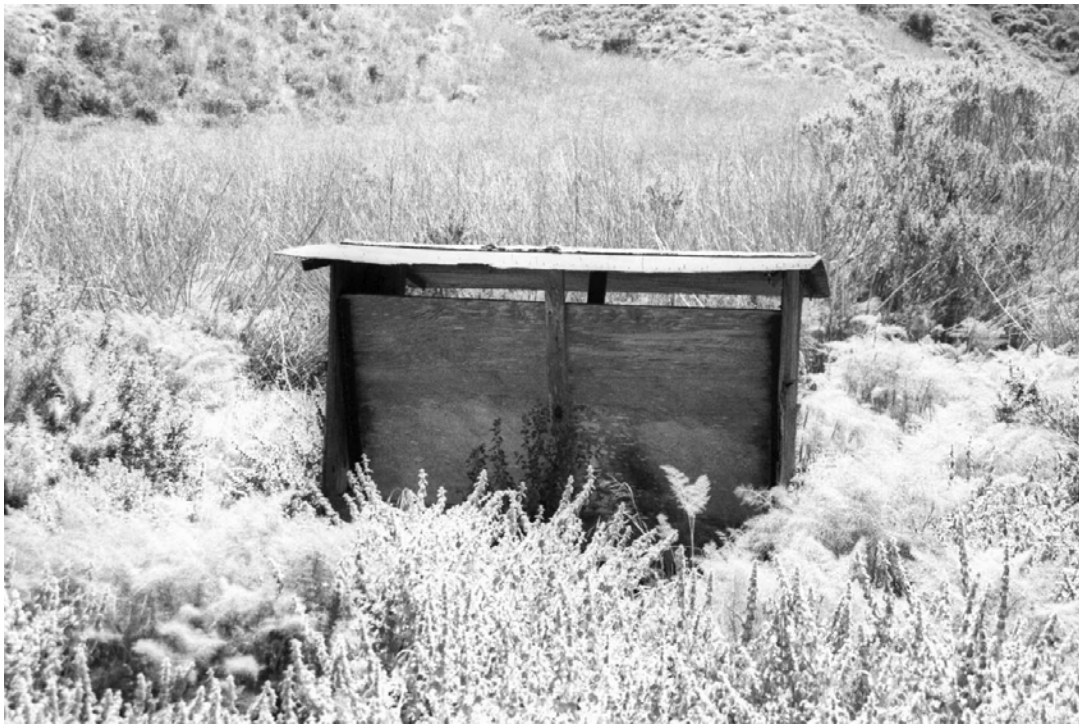
*Small Scale Features #7: A view of the western feed crib located just outside the corral complex. (PGSO, CLI, CHIS-N-0011-23, 2002)*

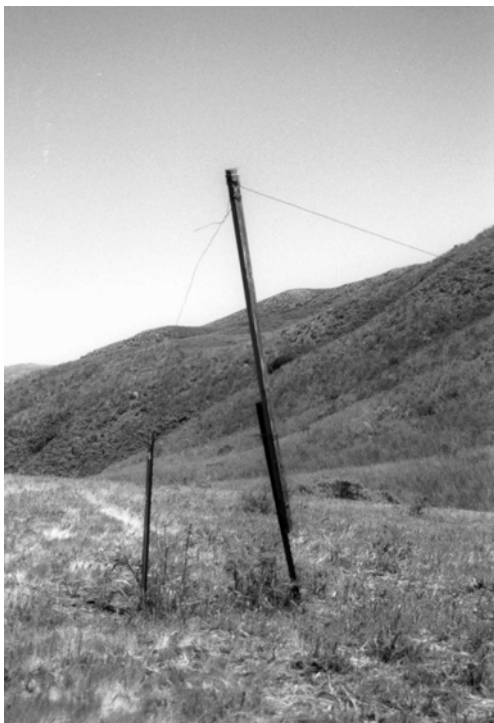
A single pole is located approximately one hundred feet northwest of the ranch house, outside of the house fence (see photo, Small Scale Features #8). The pole is composed of two two-by-fours nailed together. One of the two lines from the pole is connected to another metal pole a few feet away. The second line is connected to the nearest black acacia where it turned ninety degrees to enter the house.

*Small Scale Features #8: A view of the telephone pole serving Rancho del Norte. (PGSO, CLI, CHIS-N-0008-9, 2002)*
