National Park Service  
Cultural Landscapes Inventory  
2004

Fort Baker  
Golden Gate National Recreation Area

**Fort Baker Historic District**  
**Golden Gate National Recreation Area**

# Cultural Landscape Inventory: Fort Baker

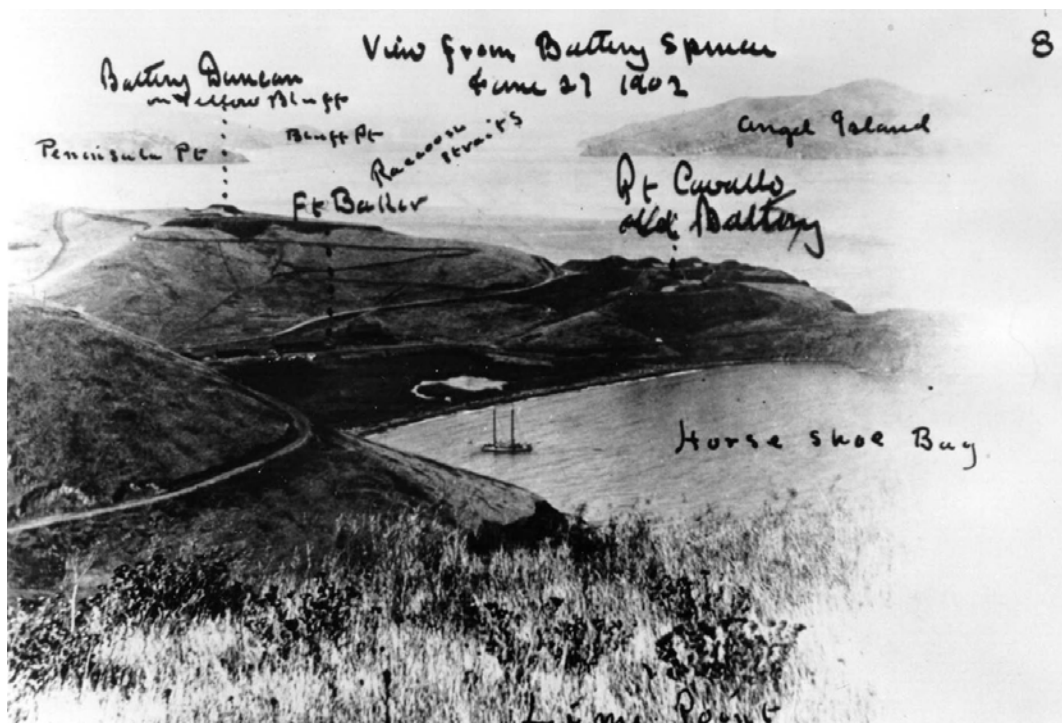
*Historic photograph showing character of Fort Baker's surrounding landscape during the Endicott period. (Circa 1902 GGNRA Collection)*

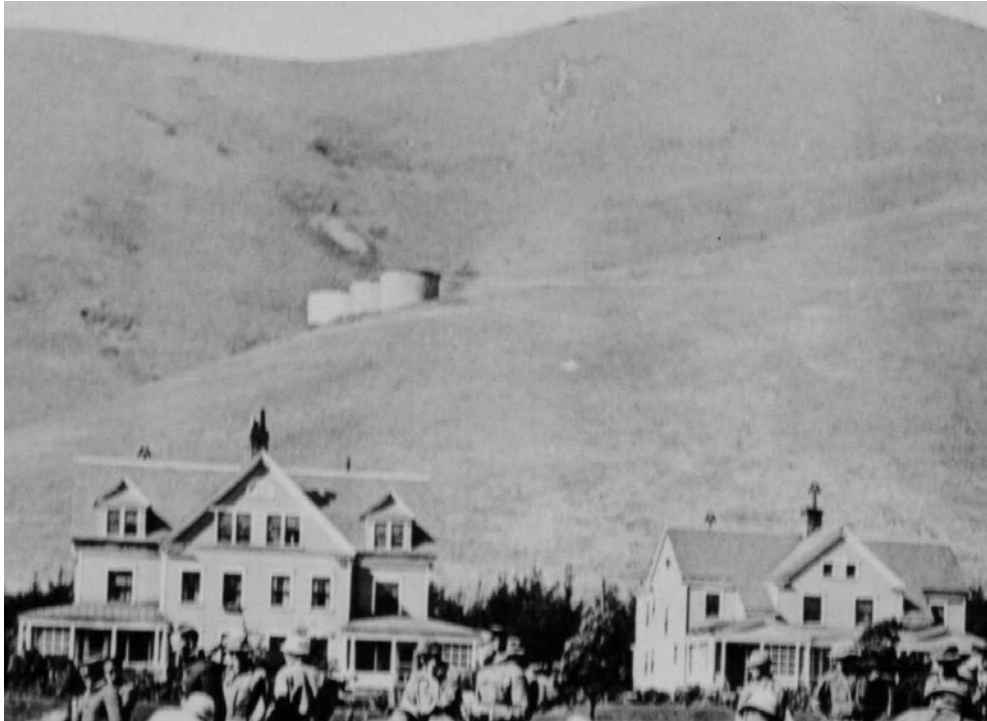
*Water was pumped to storage tanks located on the hills above the cantonment. The hills provided gravity to build water pressure to supply Fort Baker. (Circa 1915, GGNRA Collection)*

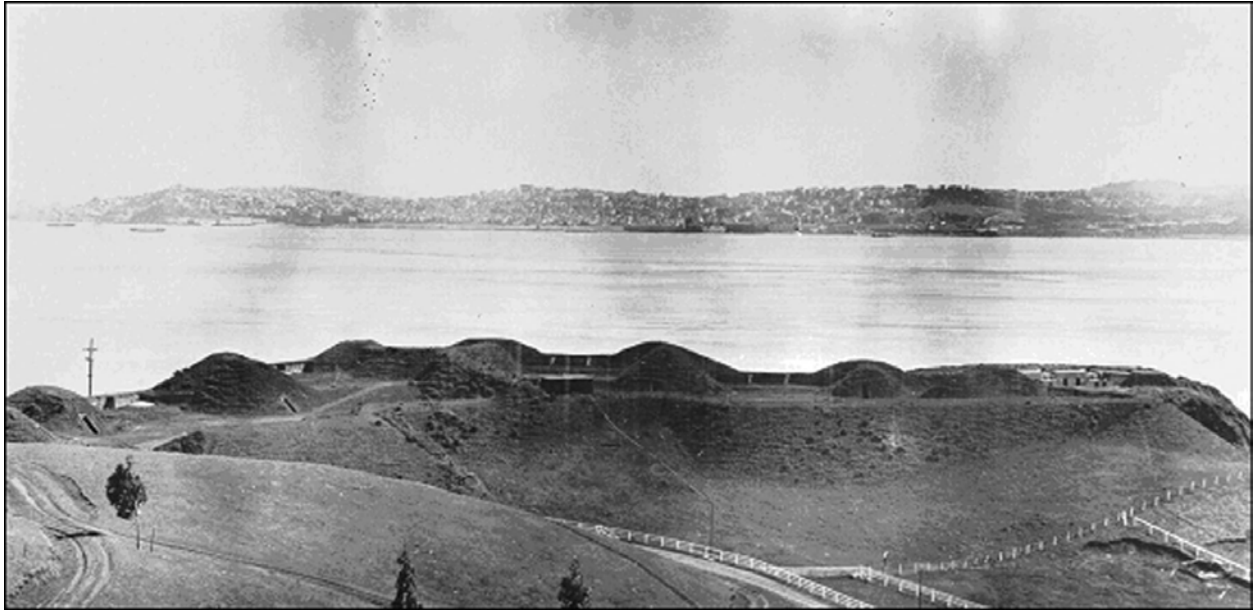
*The silhouette of Cavallo Battery against the San Francisco Bay illustrates the extensive use of earth works in early battery construction. (Circa 1914, GGNRA collection)*

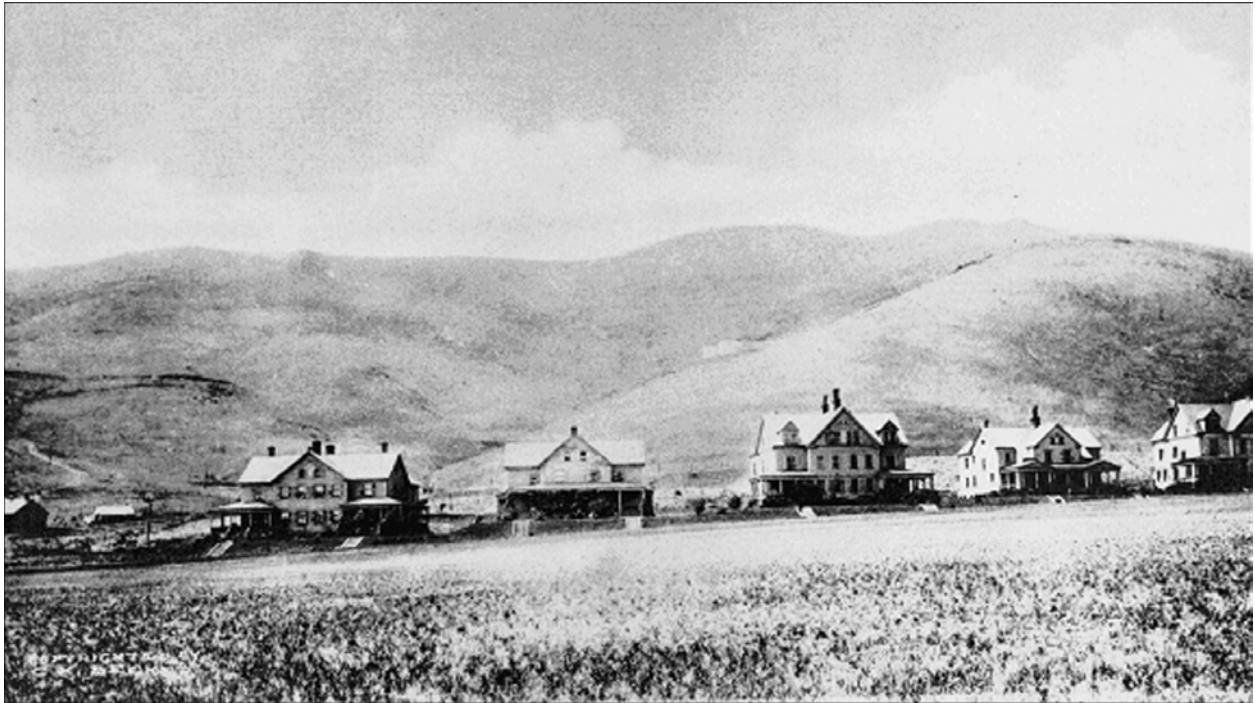
*The buildings located on Murray Circle were constructed on a bench surrounding the Parade Ground. (Circa 1905, GGNRA collection)*

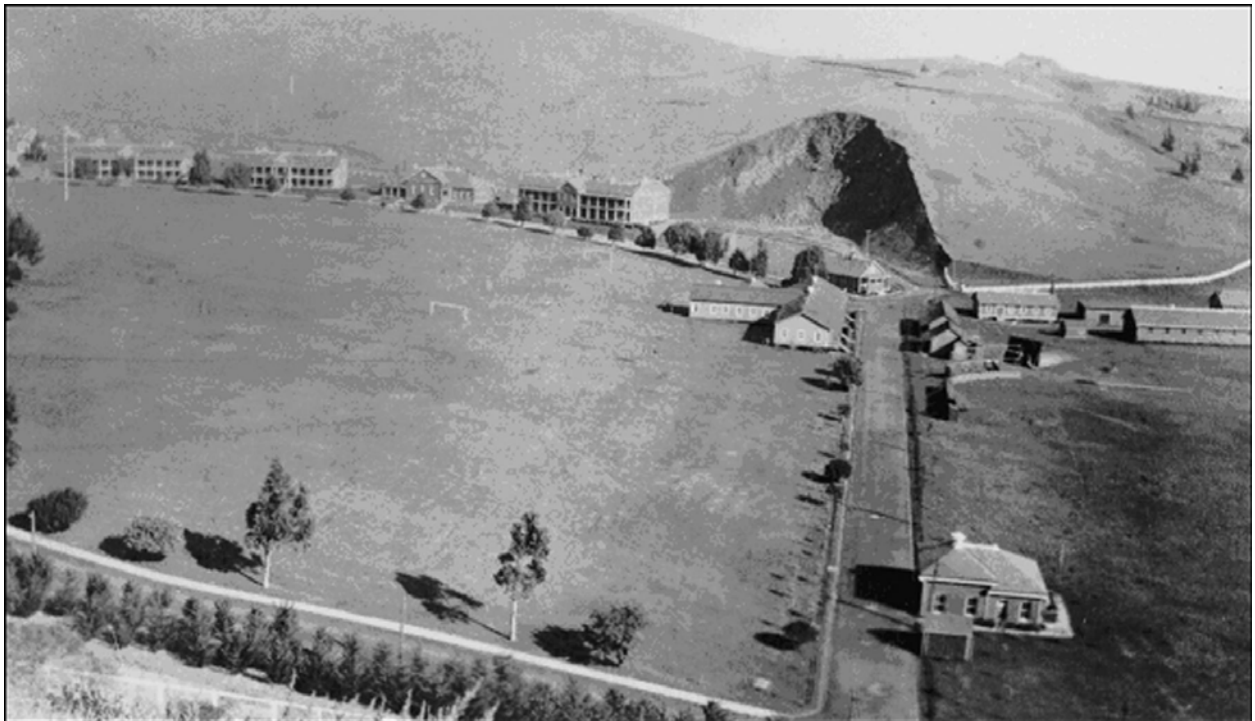
*The sandstone quarry located southeast of the Parade Ground had a significant topographic impact on the landscape. (Circa 1915, GGNRA collection)*

In 1913, a significant alteration of the landscape occurred when the hill that formed the eastern edge of Fort Baker was excavated. More than 75,000 cubic yards of sandstone were removed and barged to San Francisco for use in the 1915 Panama Pacific International Exposition. The hillside east of the hospital on Kober Street was also quarried for the red chert that was used for occasional road repairs.

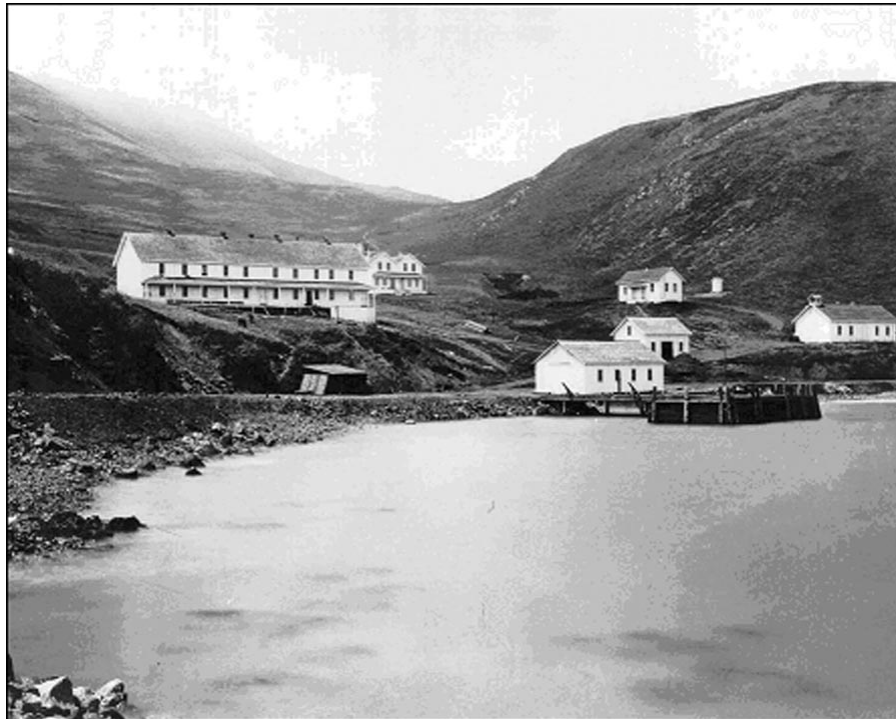
*The Engineers' Camp with the primary components of the early circulation - the wharf and roads were constructed of gravel or dirt. (Circa 1868, GGNRA collection)*

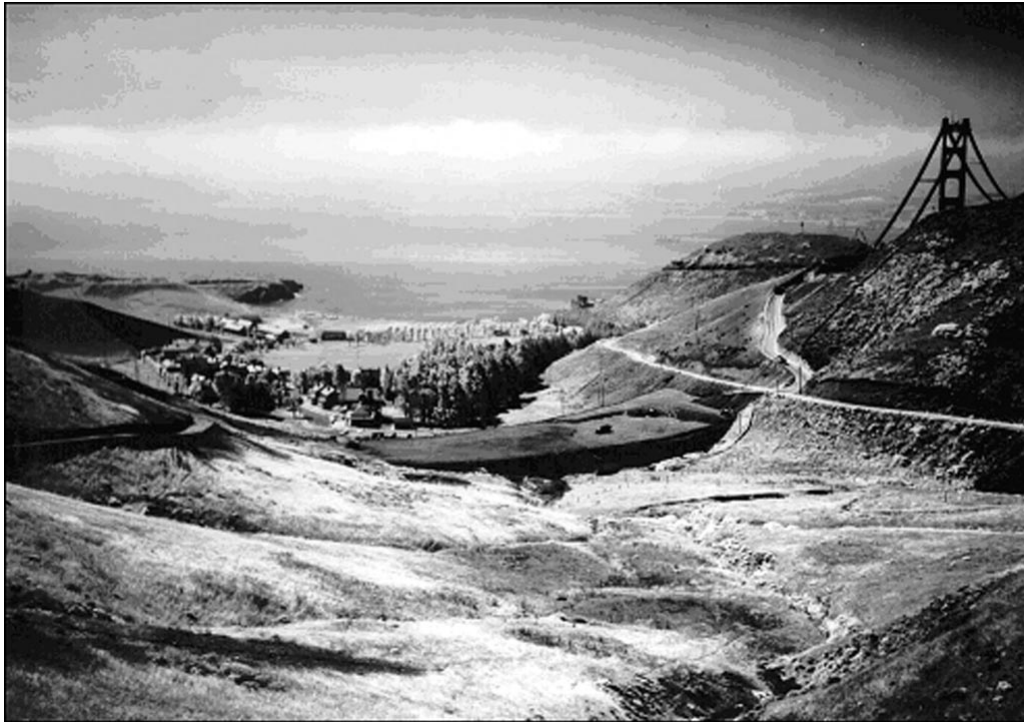
*Construction of the Golden Gate Bridge and its approaches dramatically altered the Fort Baker landscape as well as the circulation system. Construction of the Sausalito Lateral is shown in the foreground. (Circa 1936, California Historical Society)*

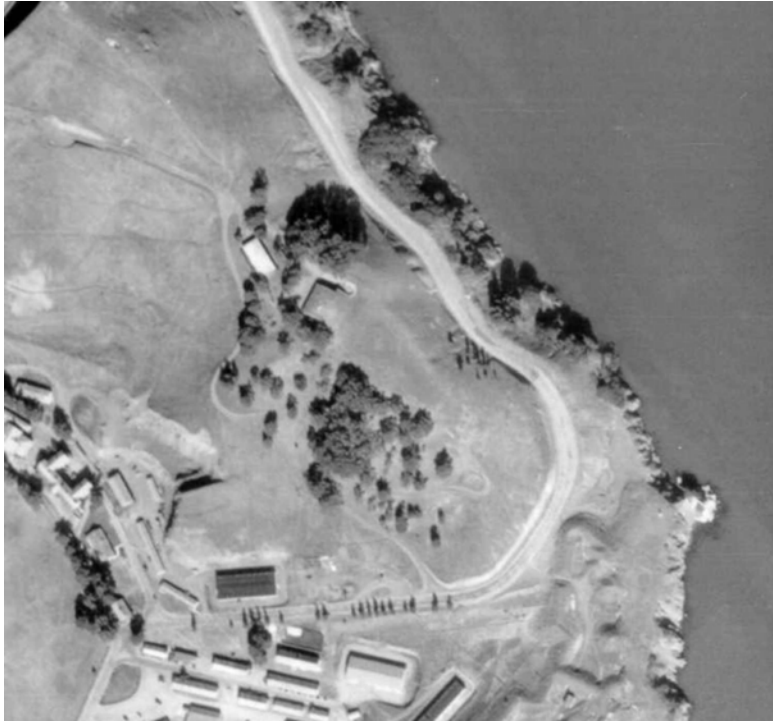
*This 1946 aerial photo shows the vegetation around Battery Duncan. (GGNRA Collection)*

The grove of eucalyptus trees planted at Battery Duncan between 1911 and 1945 remain, however, the trees have spread into open space areas beyond the original boundary for the planting, obscuring historic viewsheds. In this regard, the grove of eucalyptus is considered contributing to the character of the cultural landscape, but is in poor condition.

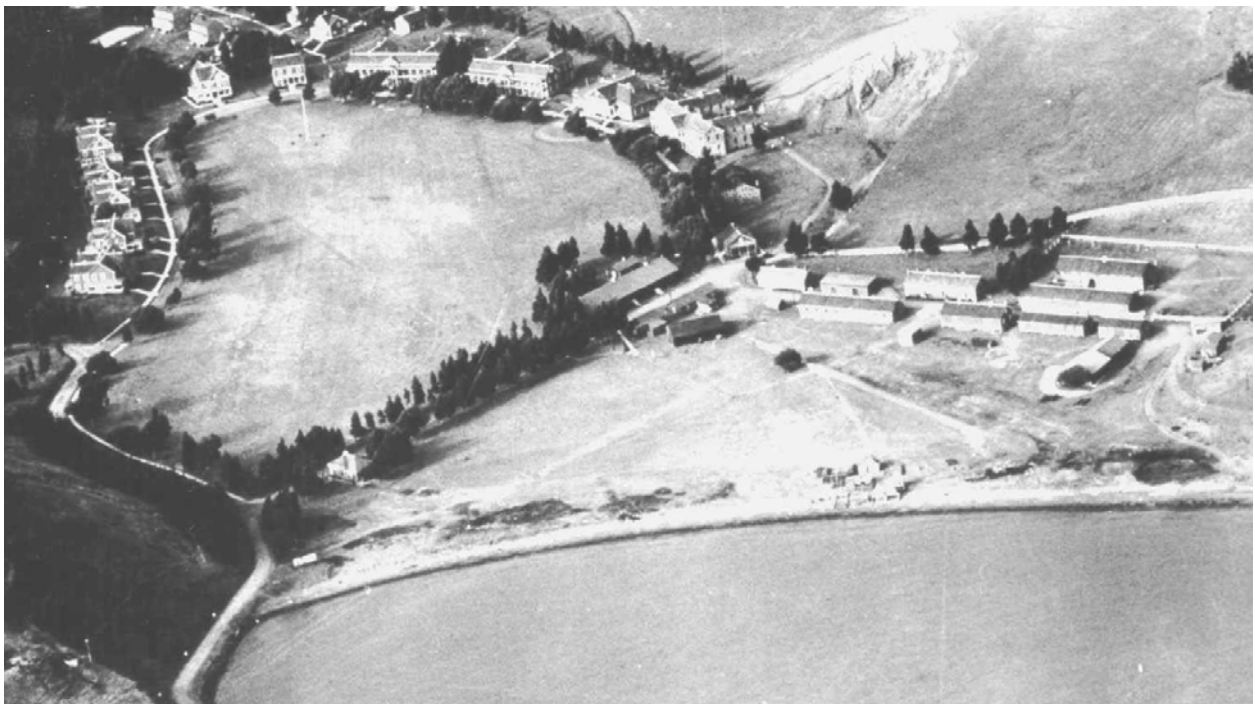
*A 1925 photograph reveals the density of plantings around the parade ground during the early war years. (GGNRA Collection)*

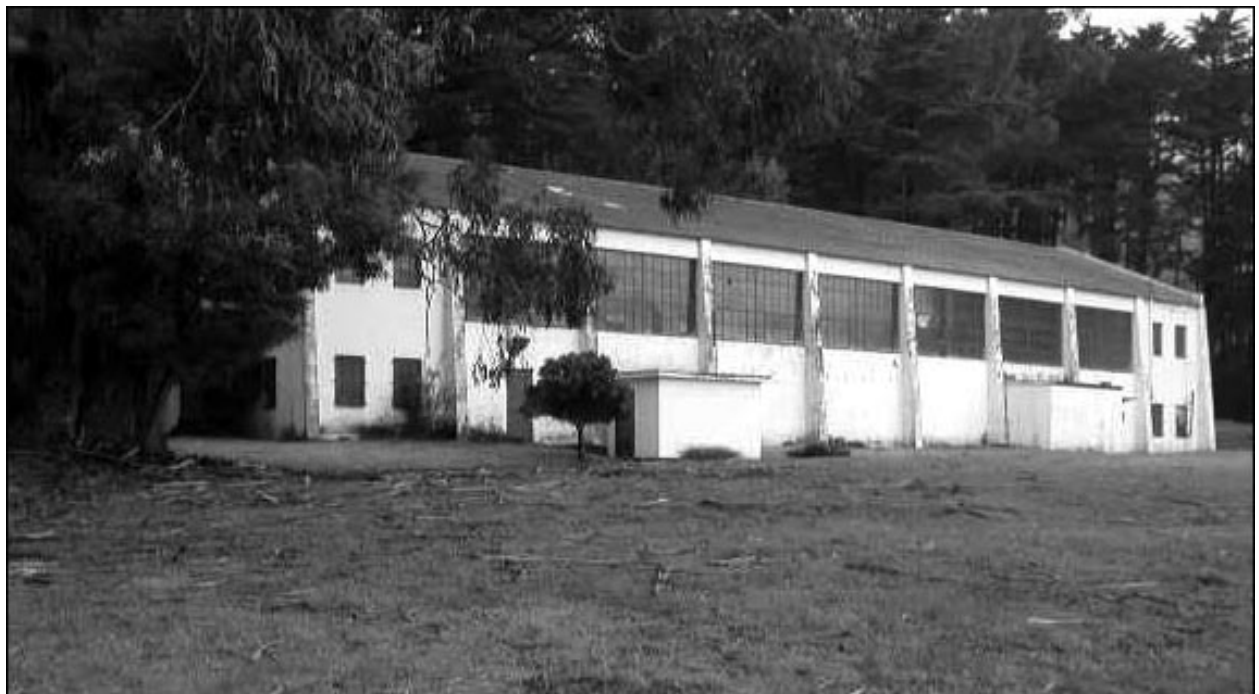
*This warehouse on the south-west edge of the parade ground represents one of the utilitarian buildings on the site. (NPS, 2002)*

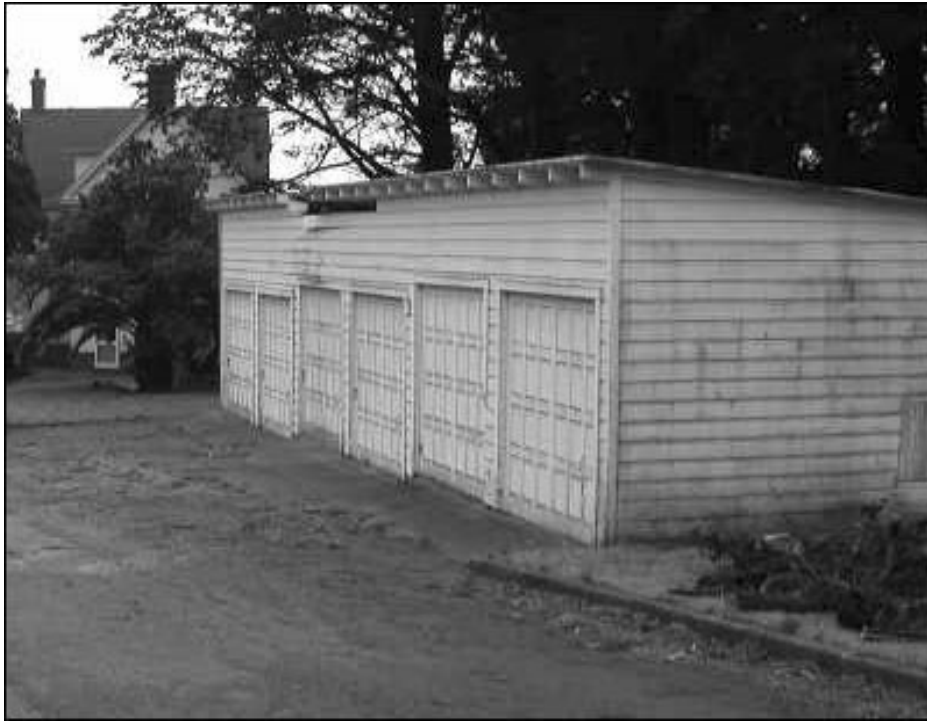
*A collection of garages exist on site; most (like this one) are sited behind residential structures. (NPS, 2002)*

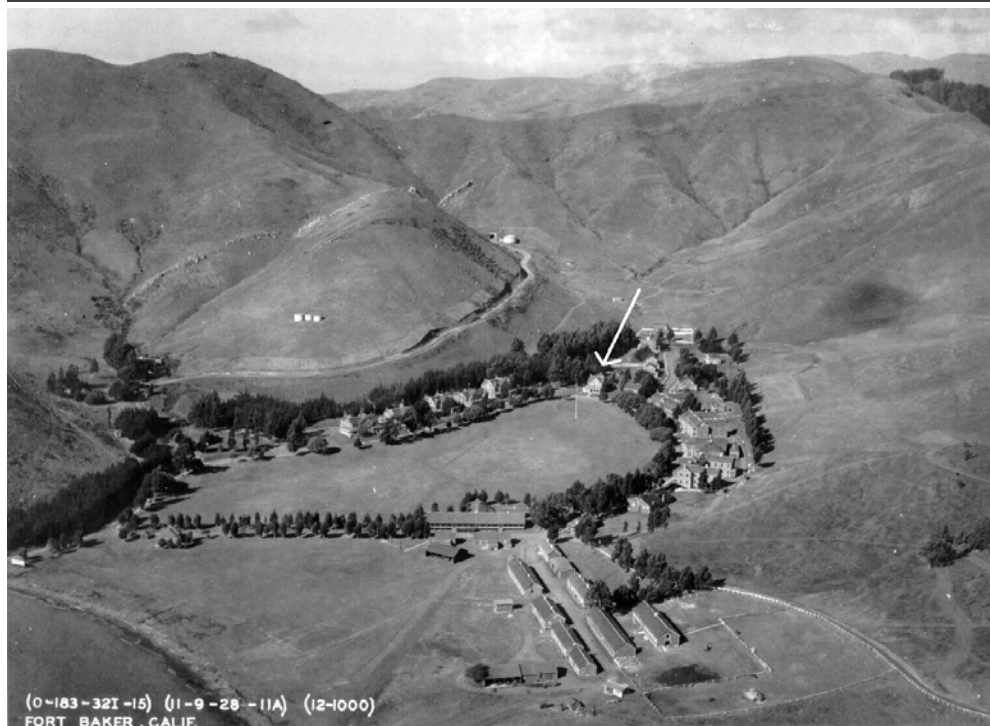
*The area in front of the commanding officer's residence was purposefully excluded from the ring of trees planted around the Parade Ground. (Circa 1928, GGNRA collection)*
