National Park Service  
Cultural Landscapes Inventory  
2007

Kestner Homestead  
Olympic National Park

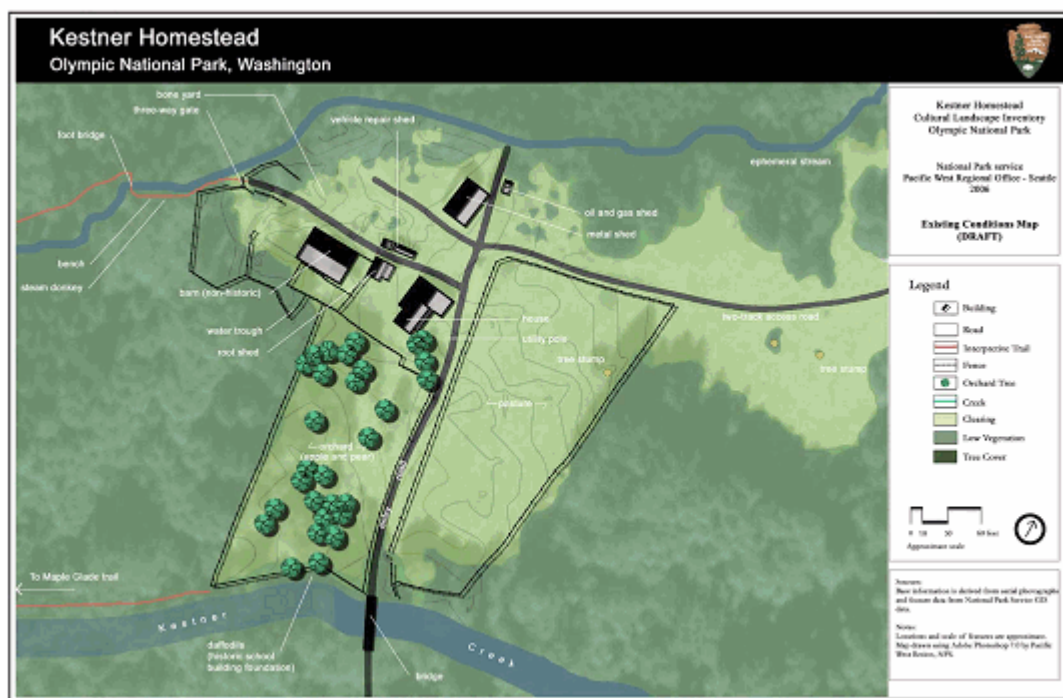
Site Plan #3: Map showing existing conditions of the Kestner Homestead building complex (PWR-Seattle, 2006). See appendix for a full-size version of the map.

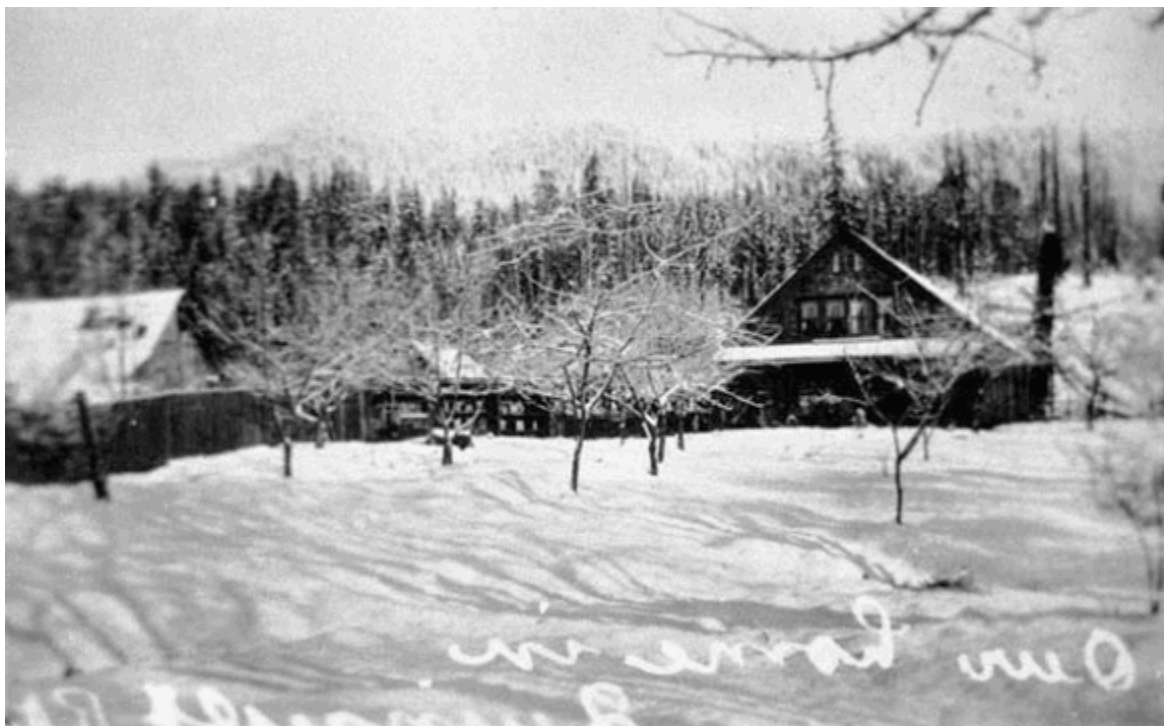
*Historic photograph of the building complex and orchard in the winter. The orchard trees appear to be planted in a loose grid.*

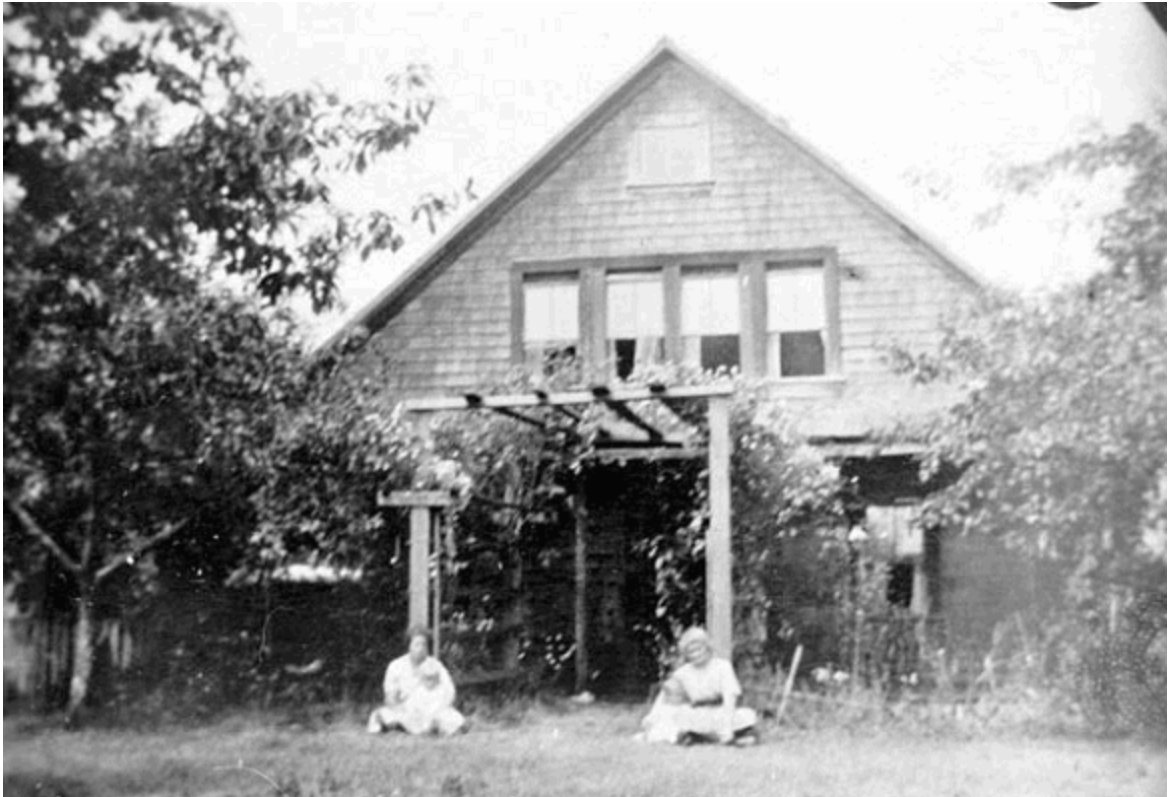
*Historic photograph of the Kestner House. The original front door was located on the southern façade. Here, an arbor has been planted in front of the door. Other photos show a flower garden and a covered porch.*

Other alterations to the house include the replacement of the historic log foundation with a concrete slab-on-grade treatment, the removal of the porch and the relocation of the main entrance from the south to the east side of the house, and the replacement of several double-hung windows with aluminum framed single-pane windows. A contemporary sliding glass door was added between the wood shed and the new entrance on the east elevation.

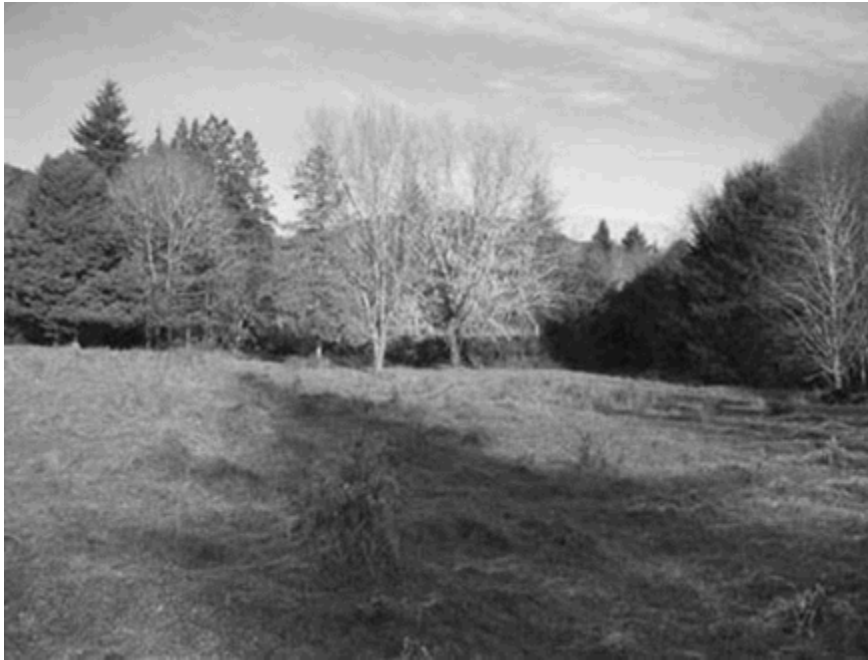
*Photograph of the Dickey property. Ornamental vegetation, cement pads, and road traces reveal the location of the building complex. (PWRO staff, 2006)*

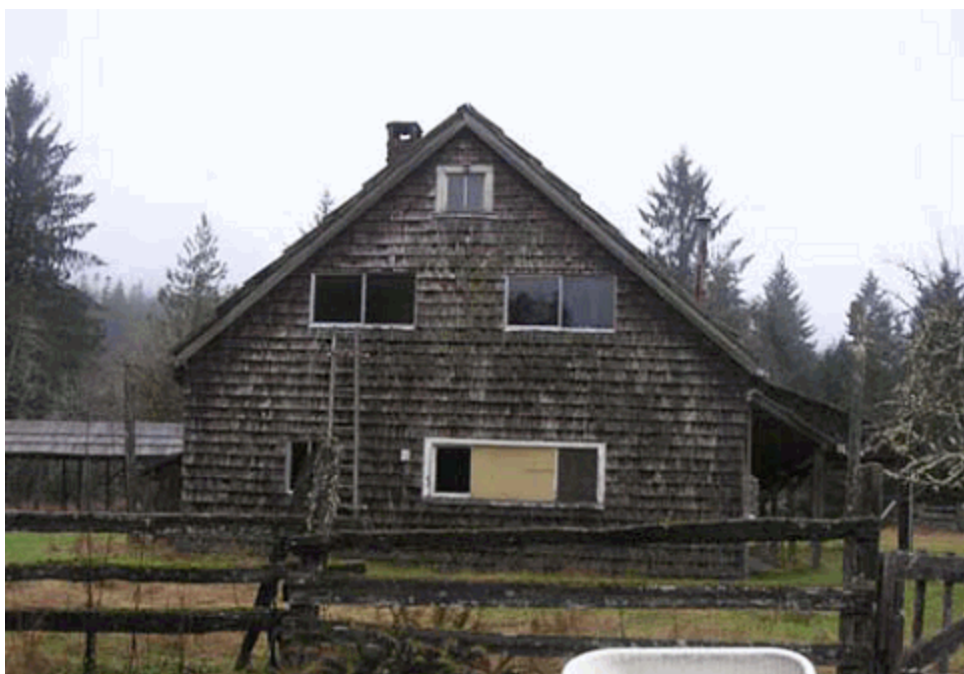
*Kestner House (contributing). (PWRO staff, 2006)*

The house, constructed by Antone Kestner between 1900 and 1905 (and later altered in the 1950s), rests on a concrete, slab-on-grade foundation. It is rectangular in shape, one-and-a-half stories high, and rustic in appearance. The walls are built of logs hewn on four sides to 6-inch by 6-inch dimensions, and covered by cedar-shake siding. The gabled roof is supported with log rafters and finished with 2-foot x 2-foot cedar shakes. The south, east, and west elevations include several single-pane, aluminum framed windows. The east elevation includes a loggia, which extends from the car-port to the main entrance. The north elevation is obscured by the addition which links the house to a woodshed, used today as a storage space.

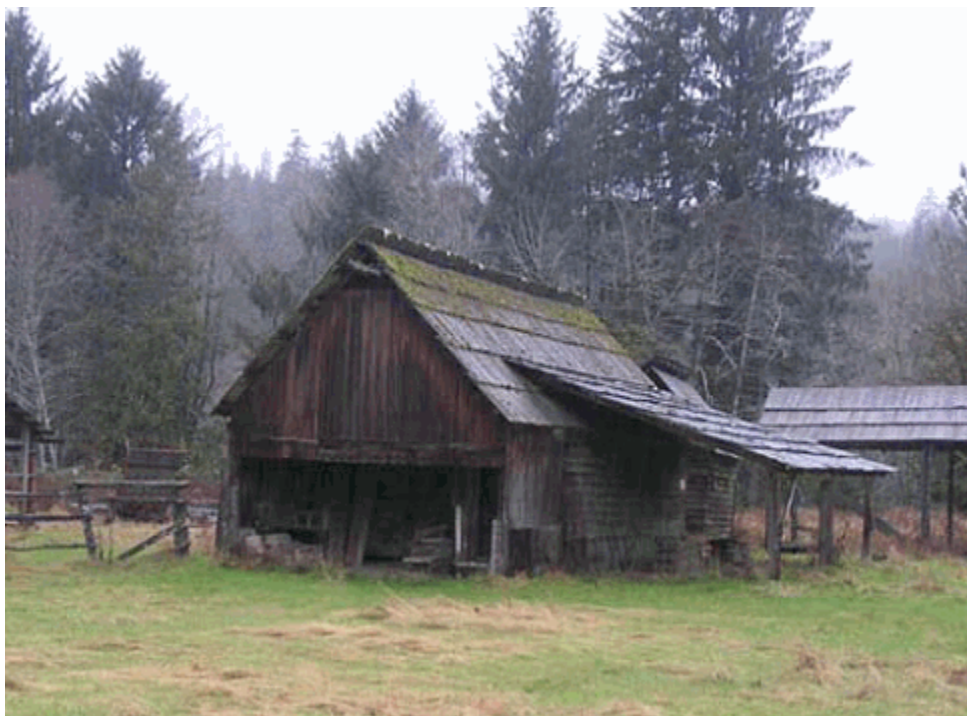
*Root House (or Tack Shed) (contributing). (PWRO staff, 2006)*

Root House (Tack Shed). Constructed by Kestner in the 1890s, the root house stood one and a half stories high with rough hewn logs, split pole chinking inside, and cedar shingles outside. The 20-foot by 60-foot building sat over a dirt floor, but rested on a cedar log foundation that was later stabilized by the NPS with concrete piers and large logs. The gable roof was constructed of log rafters and sheathed with cedar shakes about 2 feet in length. The north gable end of the shed was covered in beveled lap siding. A shelter, consisting of a shed roof supported by three rough posts, was added to the east side at an unknown date. A double hung multi-paned window and door were located on the north elevation. A second door was located on the south elevation. The interior of the building included a loft. During Kestner occupancy, the buildings was called the “root shed” and used to store potatoes and beets. During Higley occupancy, the same building was referred to as the “tack shed.” (41)

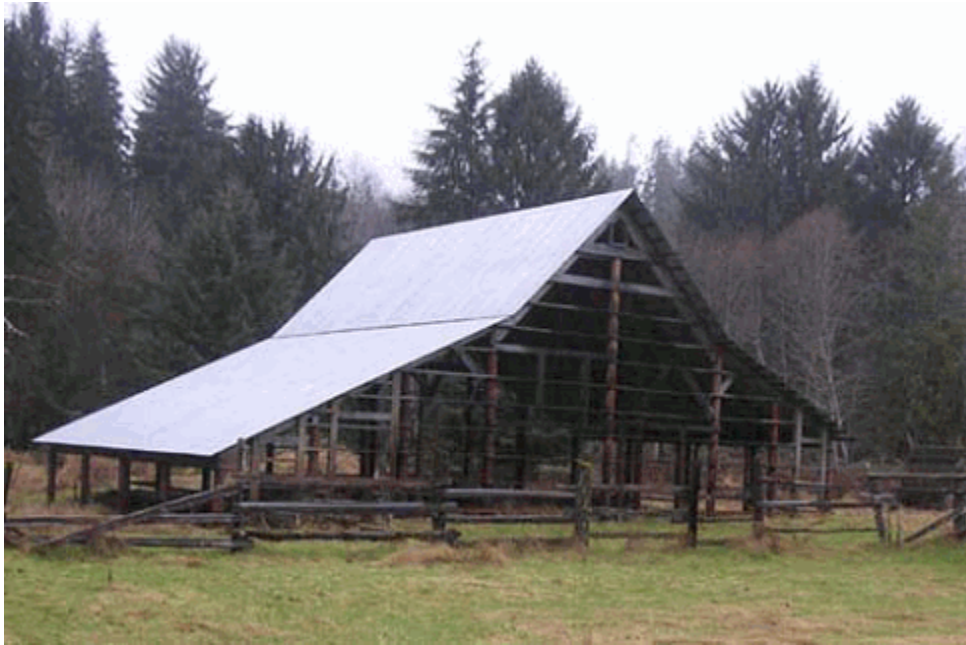
*Replacement Barn – non-contributing. (PWRO staff, 2006)*

In 1994, the NPS considered plans to stabilize and possibly restore the Kestner barn, justified because “the silhouette of the remaining barn structure was visually important in defining the homestead.” (95) By the mid 1990s, however, the Kestner Homestead remained in a state of disrepair. The roof had partially collapsed in heavy, wet snows and the poles were infested with powder post beetles. Because of the extreme climatic conditions and most posts were not set

on a concrete foundation, the base of all posts rotted. It was stated in an NPS Memorandum of Agreement (1997) that the insect infestation and poor maintenance prior to park service acquisition resulted in an unstable structure. By 1997, two thirds of the barn had lost structural integrity resulting in a loss of historic integrity. (96) The barn was subsequently razed and replaced with a wood framed and metal roofed shelter intended to partially mirror the original building in its massing and architectural style.
