National Park Service  
Cultural Landscapes Inventory  
2009

Pu'uhonua o Hōnaunau National Historical Park Visitor  
Center  
Pu'uhonua o Hōnaunau National Historical Park

**Pu'uhonua o Hōnaunau National Historical Park  
Visitor Center**

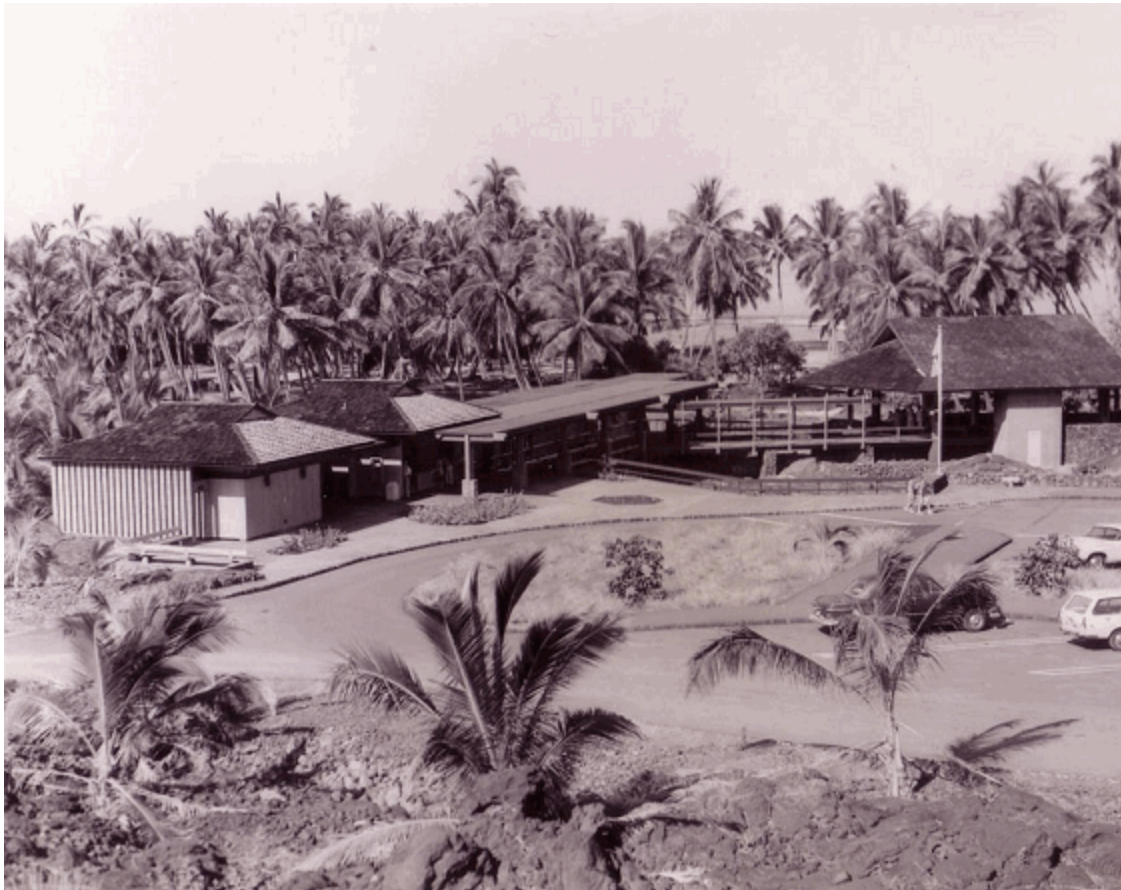
*Pu'uhonua o Hōnaunau National Historical Park  
Visitor Center  
Hawai'i County, Hawai'i  
Photo by Gil Tanaka  
February, 1970  
Park Archives, Photo Records, Buildings & Grounds, Negative No. 3239  
View of visitor center, looking west.*

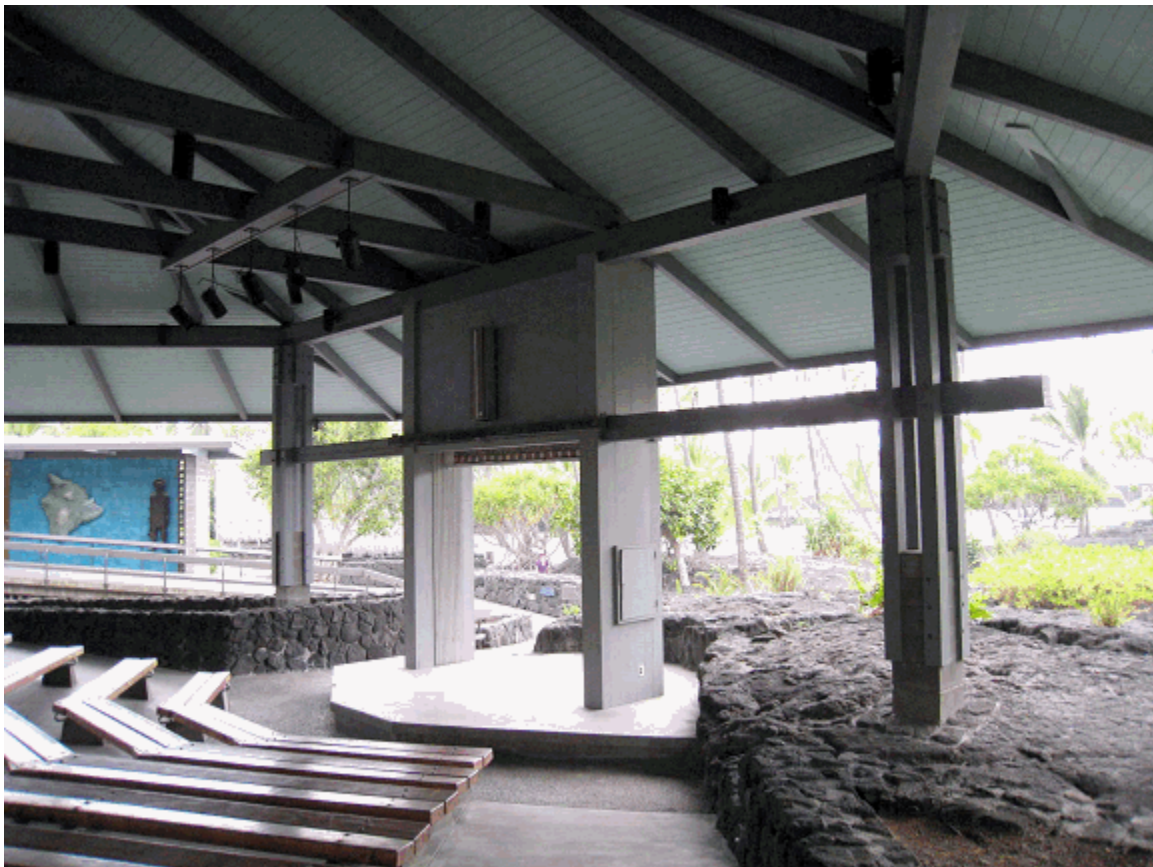
*Spatial Organization #1: View from theater to the Royal Grounds to the west (PWRO, May 2009).*

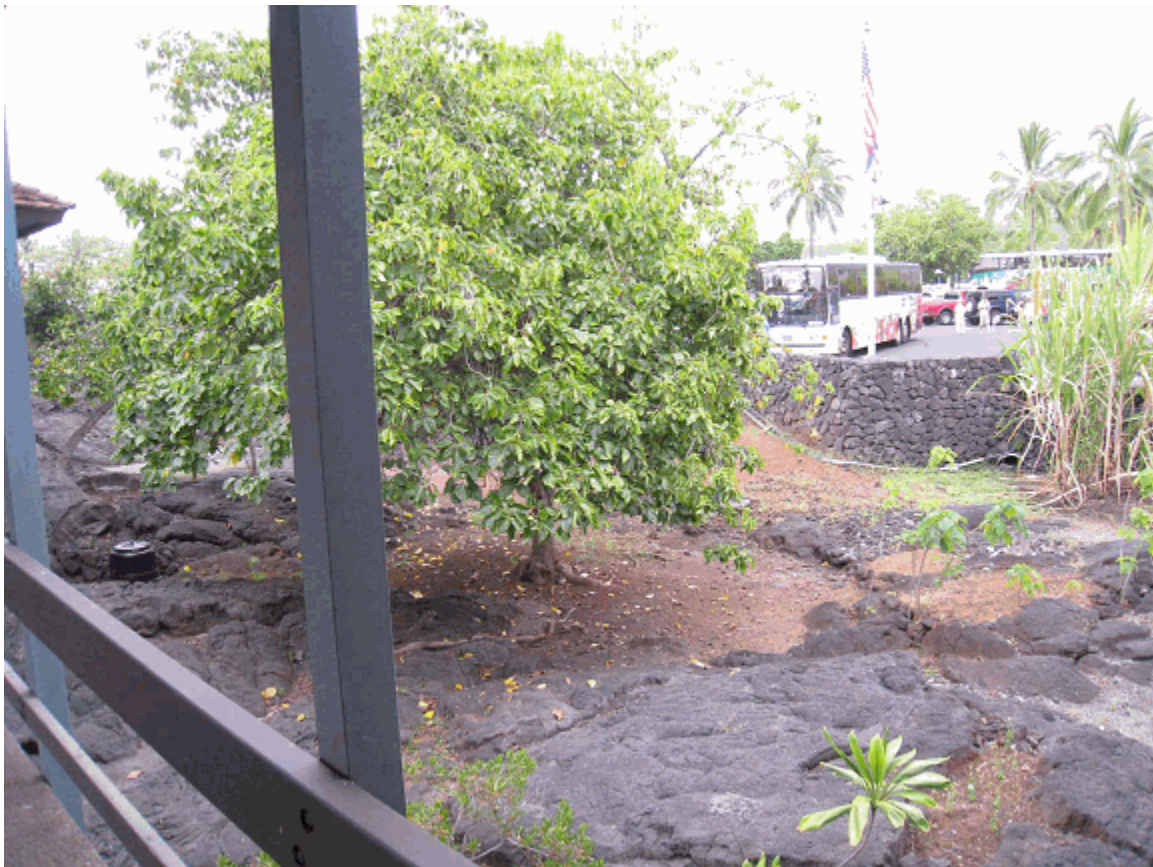
*Vegetation #1: Central planting bed, view looking east from walkway between lanai and theater (PWRO, May 2009).*

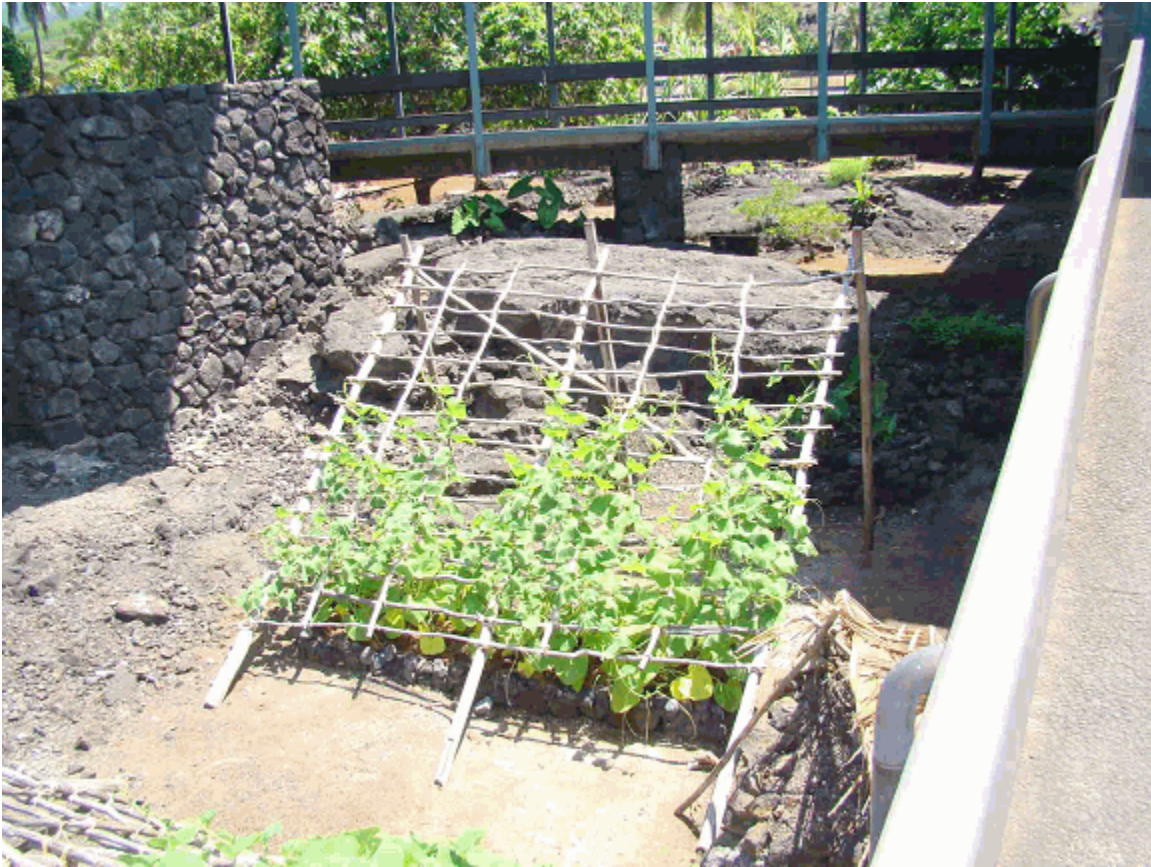
*Vegetation #2: Central planting bed with gourd plantings, view looking east from west end of lanai walkway (PUHO, September 2009).*

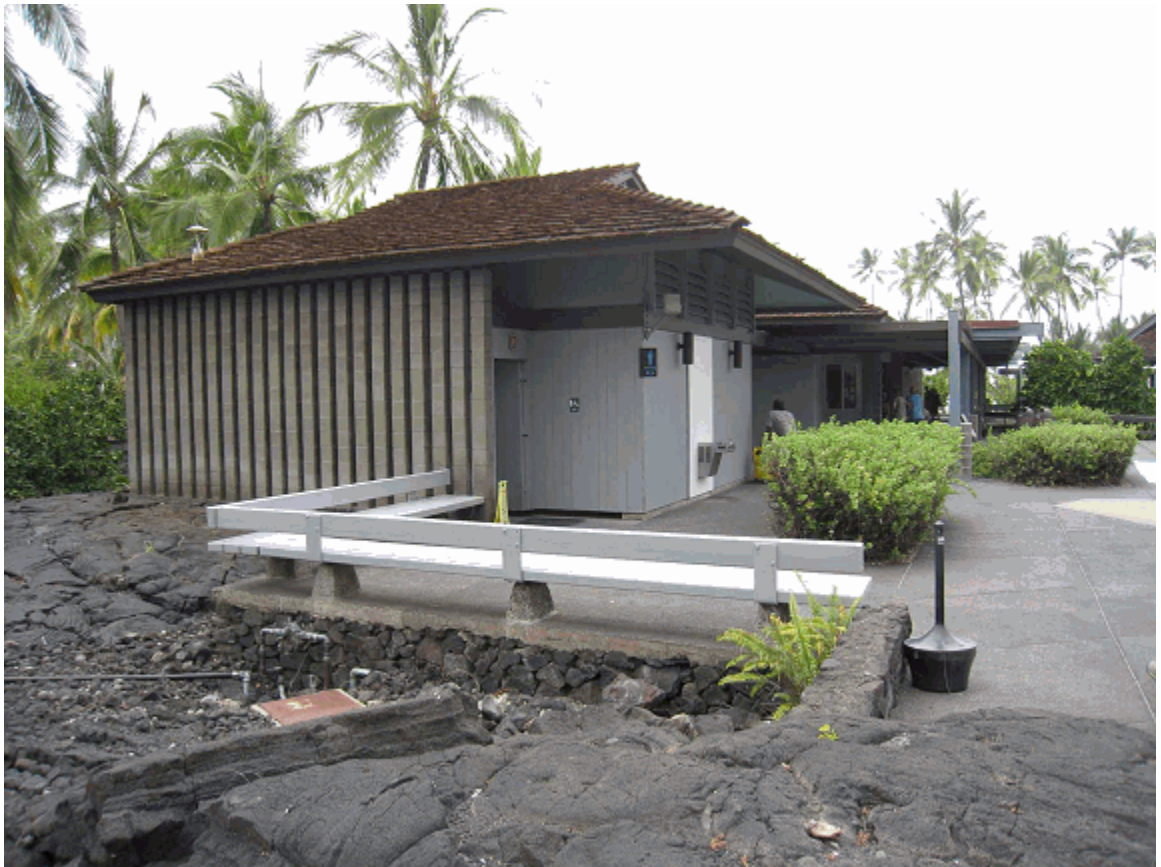
The comfort station is the easternmost building within the visitor center complex and measures approximately 22'x25'. The exterior of the comfort station features a simple redwood façade with a concrete block screen wall that encloses the southwest elevation and partially encloses the southeast and northwest elevations. The low-pitched hip roof dominates the building's profile. The building sits on a concrete pier foundation that rests on an exposed aggregate concrete slab foundation. The building's interior is open to the roof. The building is partitioned into two areas that contain the men's and women's restrooms. Mounted to the exterior of the building are two drinking fountains, canister lighting, and restroom signs. The wall behind the drinking fountains is sided with a waterproof material that is different in color and texture than the redwood siding. Immediately outside the women's restroom, a covered rest area connects the comfort station with the adjacent office/information desk building. The open space is covered with a wooden trellis roof that is supported by glulam beams attached to the two buildings.

*Buildings and Structures #1: Comfort Station, view looking southwest. (PWRO May 2009)*

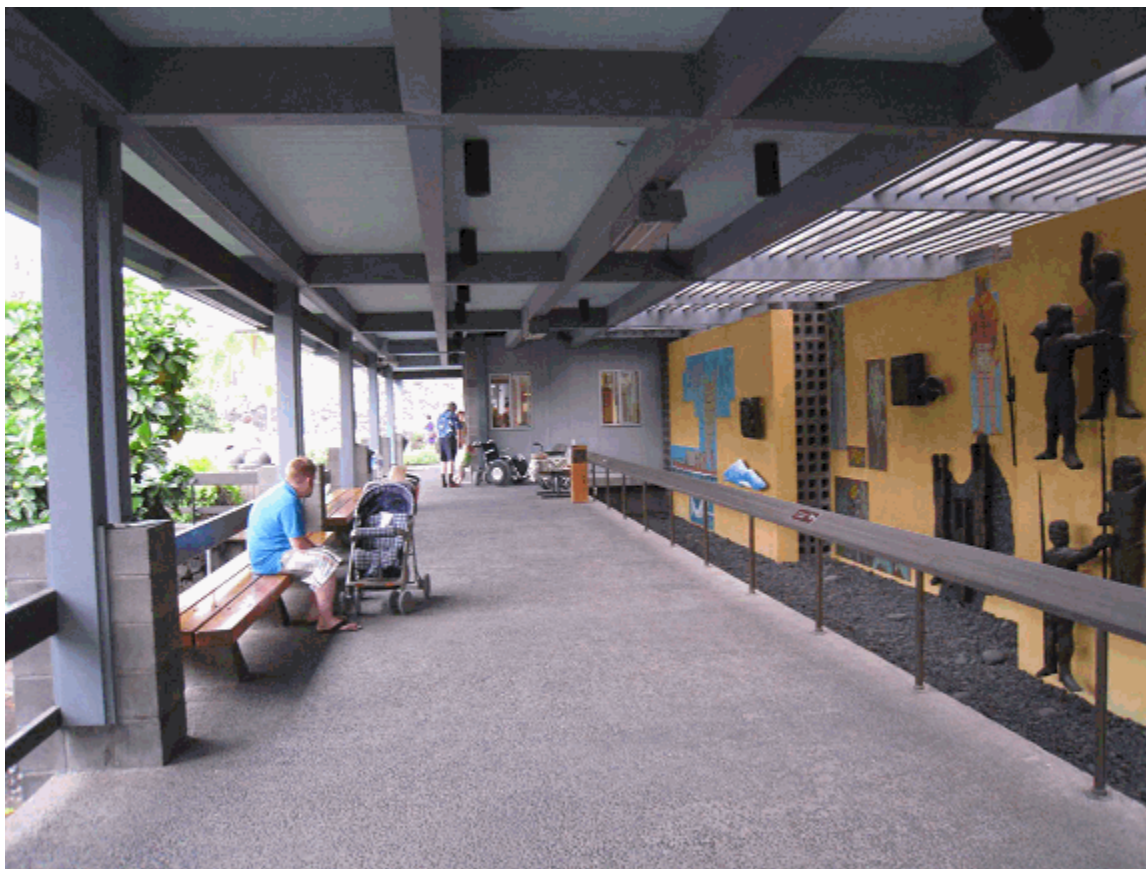
The lanai extends the entire length of the complex, starting at the eastern end of the complex in front of the comfort station, proceeding past the information desk, along the interpretive wall, and terminating with a ramp that joins a trail to the historic site. The lanai is constructed with exposed aggregate (local 'ili 'ili stones) concrete that rests on concrete piers. 'Ili 'ili are small water worn lava stones. The lanai is open-air in front of the comfort station, the area between the comfort station and office structures, as well as at the west end at the exit ramp. The lanai's flat roof commences at the eastern edge of the office/information desk building and continues the length of the interpretive wall. The lanai roof is supported on its north side by seven sets of double wooden columns with concrete block bases. These columns continue below the lanai's concrete slab surface into the compacted fill that the building rests on. The areas between the concrete piers are infilled with mortared lava rock walls. Extending beyond the roof on alternating beams are "canales." These short, three-sided channels allow rain water to drain off the roof. The portion directly over the lanai is covered with tongue and groove siding. Canister lights for lighting the lanai and the interpretive wall are mounted on the ceiling. The north side of the covered lanai is enclosed with a wooden and metal railing. Adjacent to the lanai (on its south side) is a dry moat that is filled with 'ili 'ili and bordered by the interpretive wall. The portion of the roof over the moat and interpretive wall is louvered to illuminate the interpretive objects on the wall.

*Buildings and Structures #2: Lanai and interpretive wall, with information desk in the background. View looking east. (PWRO May 2009)*

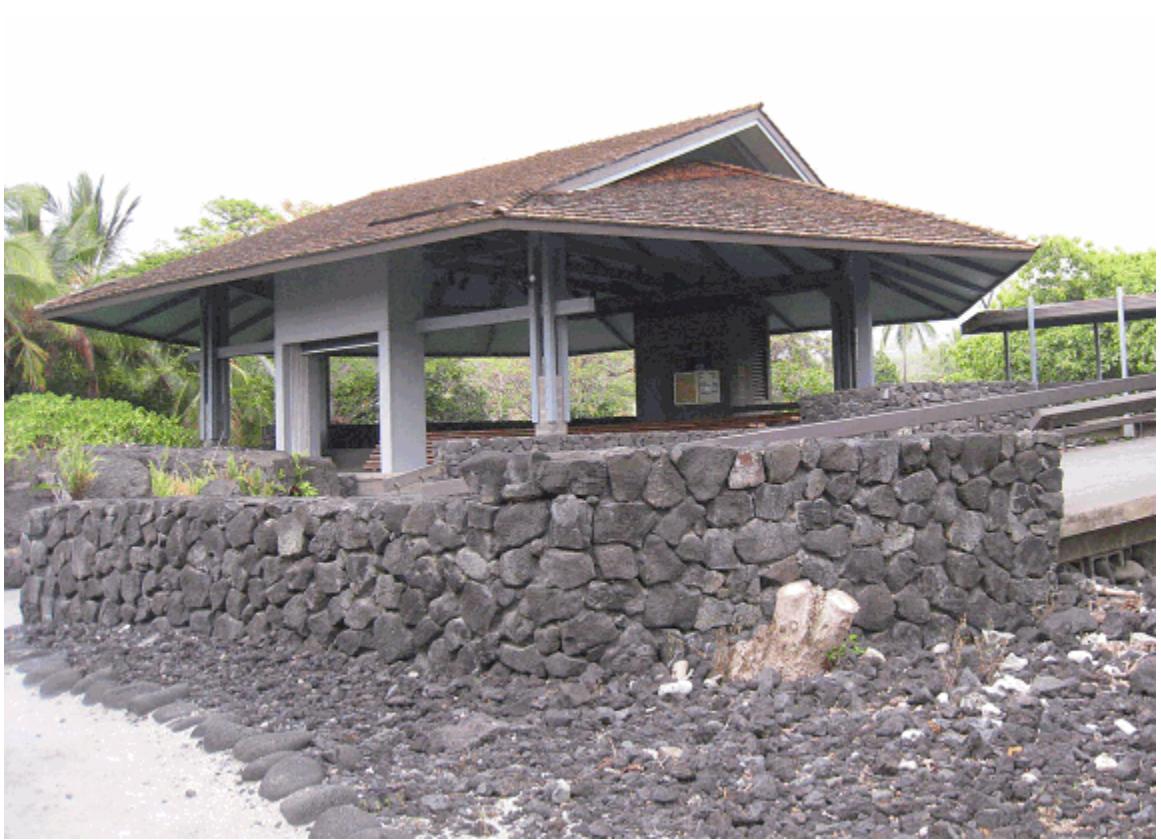
*Buildings and Structures #3: Theater, view looking northeast. (PWRO May 2009)*

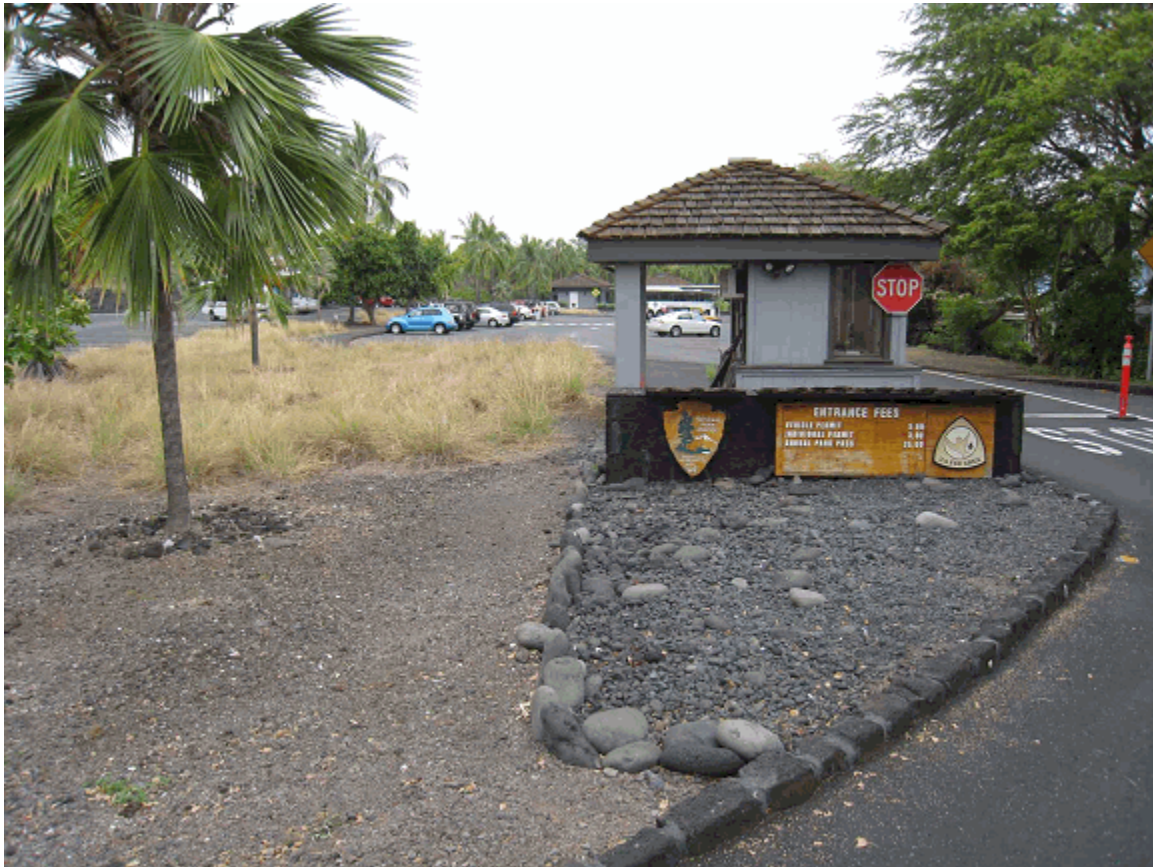
The entrance kiosk is a small, square building that is enclosed on the west half. The wood-frame building has a poured concrete slab foundation with walls clad in plywood paneling with corner boards. The enclosed section of the building has a watertable (a ledge to divert rainwater from the building) and a wide fascia board. The aluminum-frame windows include fixed panes and one vertical sliding window on the west elevation. A single fix-pane aluminum window is located on the south and north elevations. A single door and wall air conditioning unit are located on the east elevation. The pavilion roof is clad with wood shingles. A rain gutter is attached to the fascia board.

*Buildings and Structures #4: Entrance kiosk, view looking south. (PWRO May 2009)*

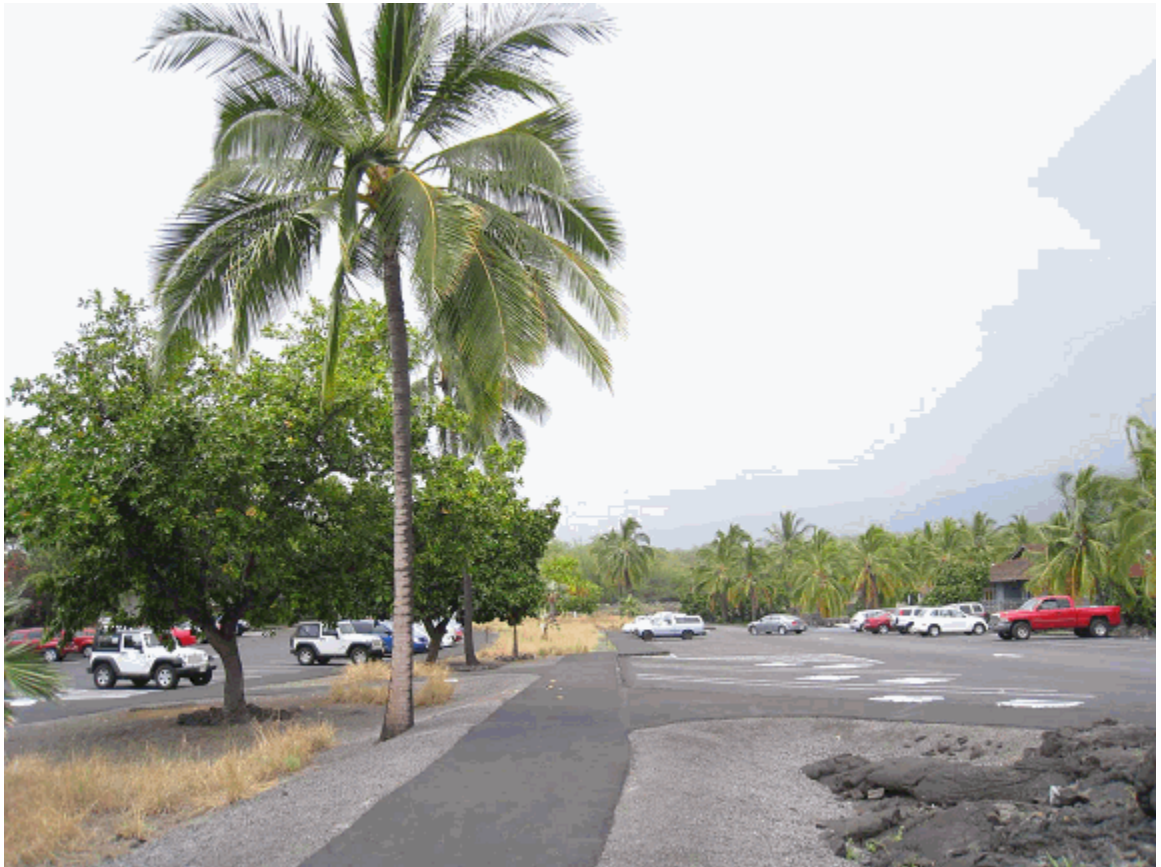
In the center of the parking lot is a traffic island that fans out at the north and south ends. The north end contains the parking kiosk and information sign as well as a non-vegetated section of earth in front of the sign. The traffic island is largely unpaved and is landscaped with native grass, palms, and trees. A small triangle-shaped traffic island located at the north end of the parking lot is covered in loose lava rocks and contains a recently constructed mortared lava park sign.

*Circulation #1: Parking lot, view looking north (PWRO May 2009).*

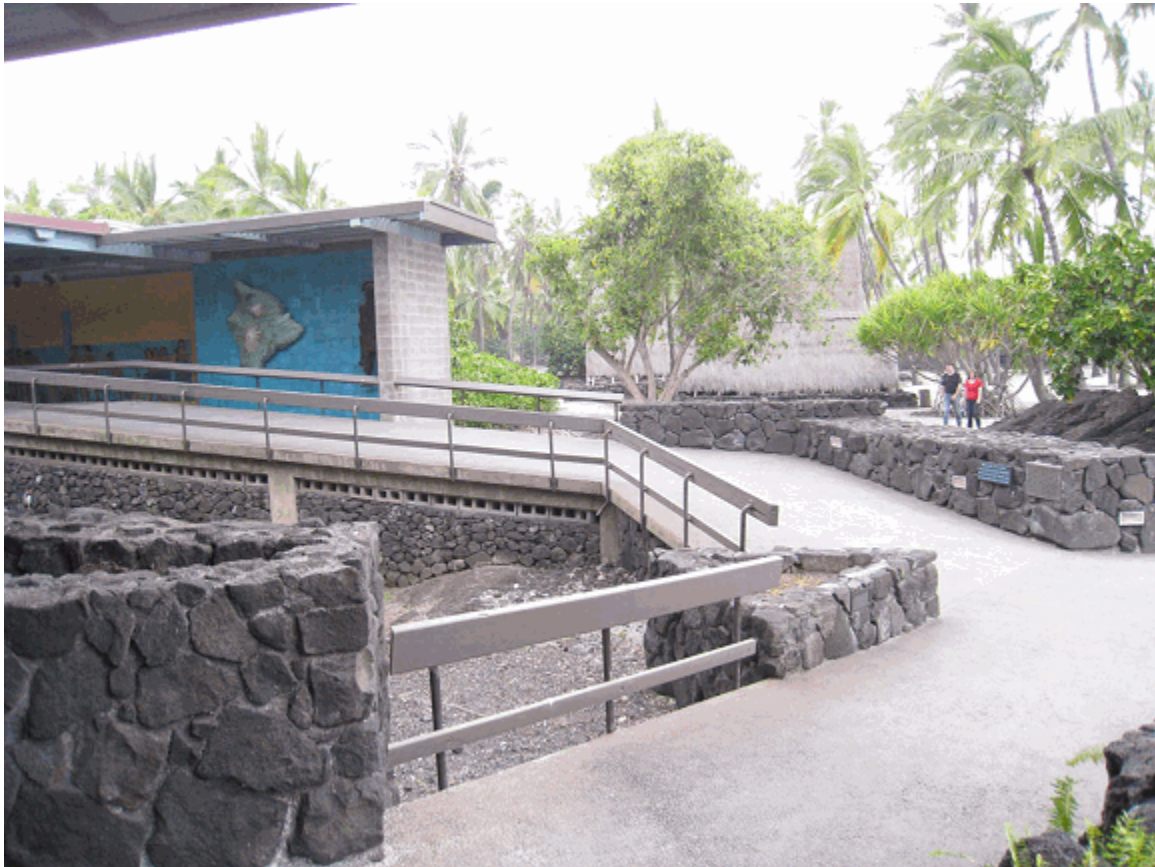
The expansive concrete sidewalk located in front of the comfort station is scored in parallelogram shapes with triangular shapes adjacent to geometric planters in front of the comfort station. The sidewalks located at the lanai, the bridge to the theater, and the ramp to the Royal Grounds are scored into rectangles. All of the scoring is filled with an epoxy moisture barrier. The concrete is surfaced with exposed pebble aggregate.

*Circulation #2: Ramped concrete walkway adjacent to lanai (PWRO, May 2009).*
