National Park Service  
Cultural Landscapes Inventory  
2011

Pioneer Yosemite History Center  
Yosemite National Park

MANAGEMENT CATEGORY: **B: Should be preserved and maintained**

CONDITION ASSESSMENT: **Fair**

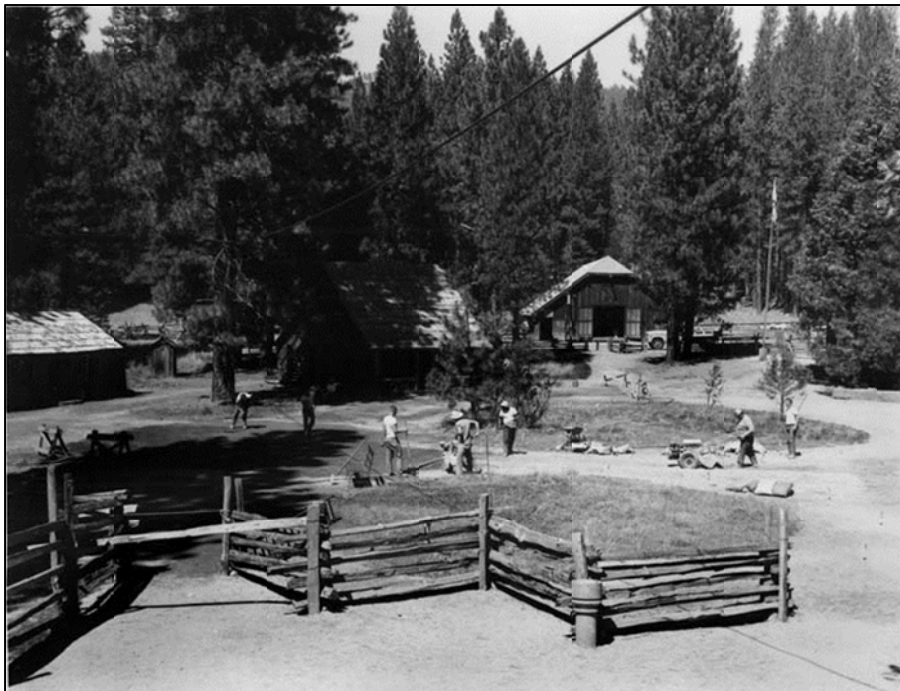
*Historic photo taken from north end of the covered bridge looking north. Workers are installing soil cement pathways. Transplanted trees in grass “islands” are visible behind them. 1962 (YOSE archives, Box 183, Press Release Folder)*

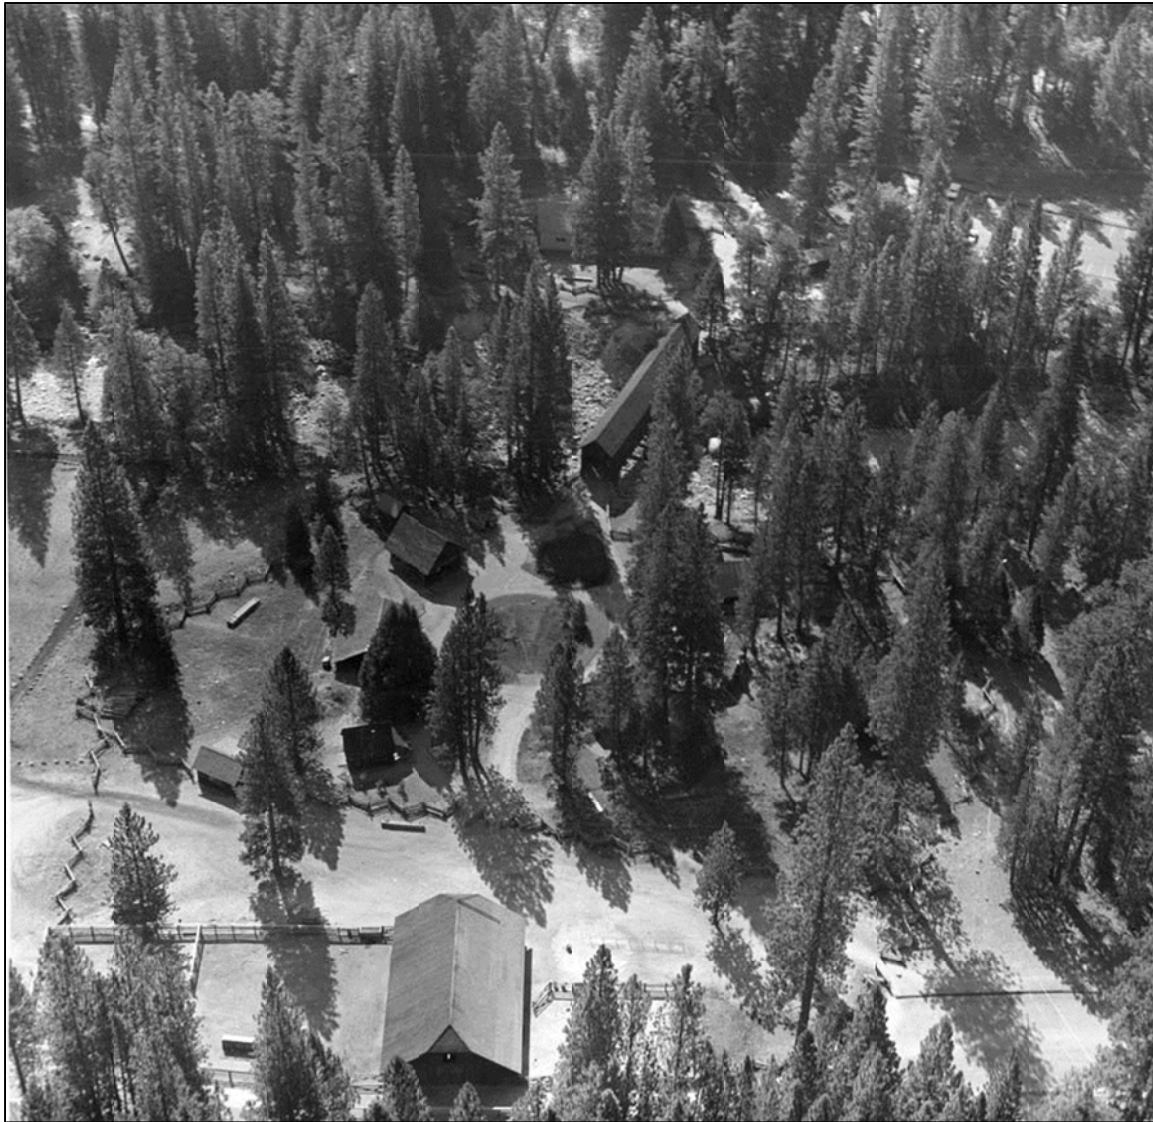
*Aerial photo taken just prior to the dedication of the Pioneer Yosemite History Center in 1964. The Wawona Stable is at the bottom of the photo, The Army Tack Room, Acting Superintendent's Headquarters, Ranger's Cabin, Wells Fargo Office and Covered Bridge are also visible. Buildings on the right side are obscured by trees.(YOSE Archives, Box 183, Press Release Folder)*

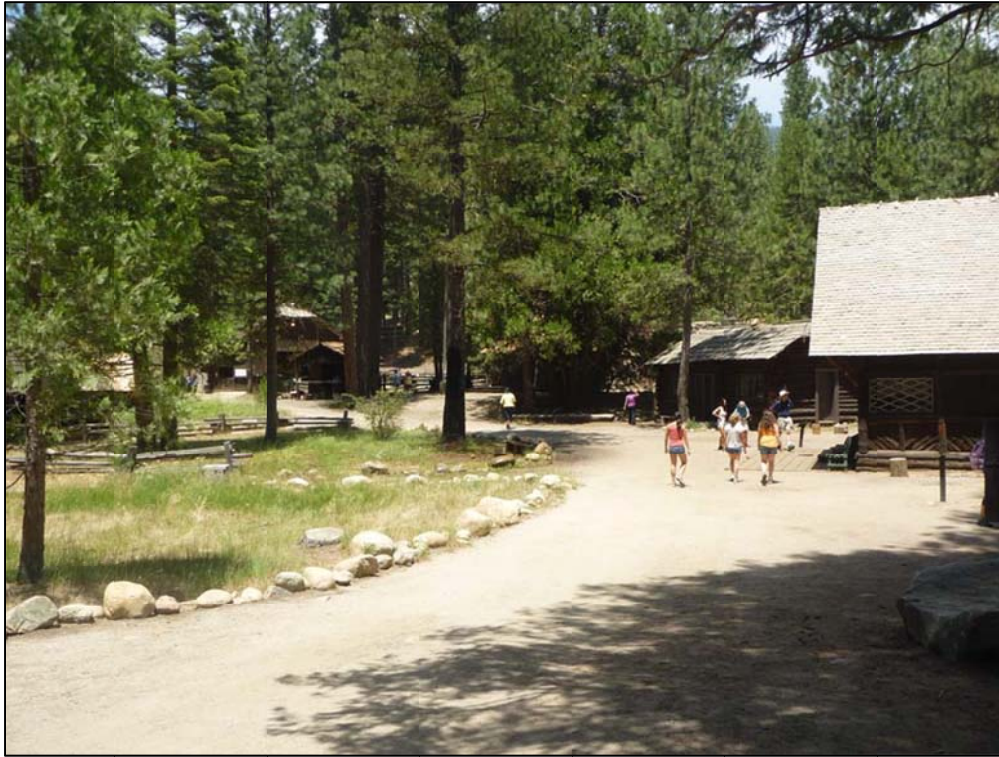
*Contemporary image depicting the historic character of natural systems and features that still remain: the almost complete absence of a shrub layer under the varied-aged stand of trees and the ground plane gently sloping from east to west allow for views of buildings among the trees (YOSE 2010).*

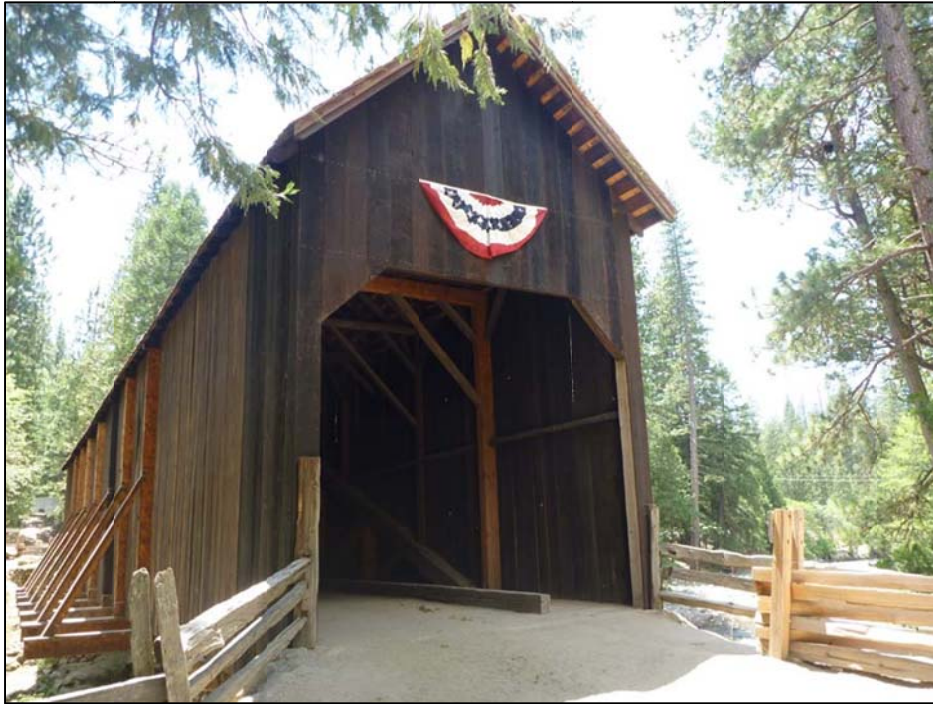
*The covered bridge at the Pioneer Yosemite History Center. (YOSE 2010)*

Following the flood of 1955, an inspection of the bridge by park engineers concluded the bridge was structurally compromised and recommended replacement. Recognizing the historic value and rarity of the structure, Yosemite's Superintendent John Preston along with the head of Park Service's Office of Design and Construction, chief landscape architect Thomas Vint, successfully campaigned to restore the structure. The restoration lead by Park Chief Naturalist Doug Hubbard and contractor Glenn Gordo began in 1956 and proved to be quite a heroic effort, involving the engineering of a system of rails, cables and pulleys that enabled workmen to pull the bridge onto the north shore of the river. Workmen replaced severely damaged timbers with focused attention paid to replicating wood species, dimensions and historical workmanship. Once the restoration was complete and pilings reinforced, the bridge was reinstated to its original location.

Center has involved some replacement of building materials, most have not impacted the integrity of the district as a whole (such as replacement of roofs and exterior stairs). Repairs to the Wawona Covered Bridge between 1972 and 2001 involved replacement of some rough hewn timbers with dimensional lumber, although the bridge still retained enough integrity to be individually listed on the National Register in 2007. Overall, these changes have not compromised the overall integrity of the Pioneer Yosemite History Center which still reflects its historic design and purpose as an interpretive center associated with the park's Mission 66 master plan.

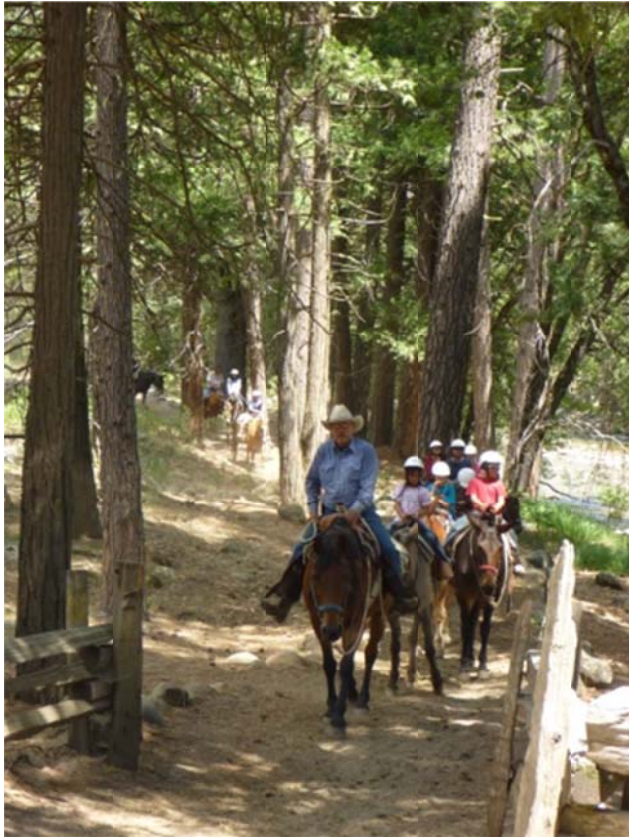
*The bridle trail traces the eastern edge of the building complex headed south, toward the river, as it did historically. (YOSE 2010)*

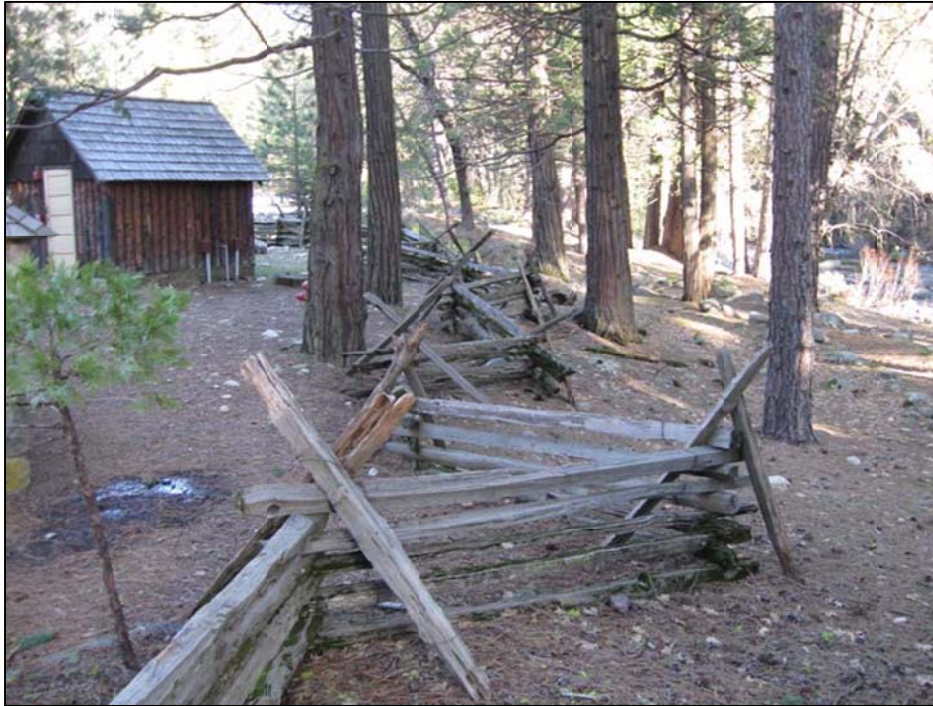
*The zigzag fence line with the Wells Fargo utility building to the left. (YOSE 2010)*

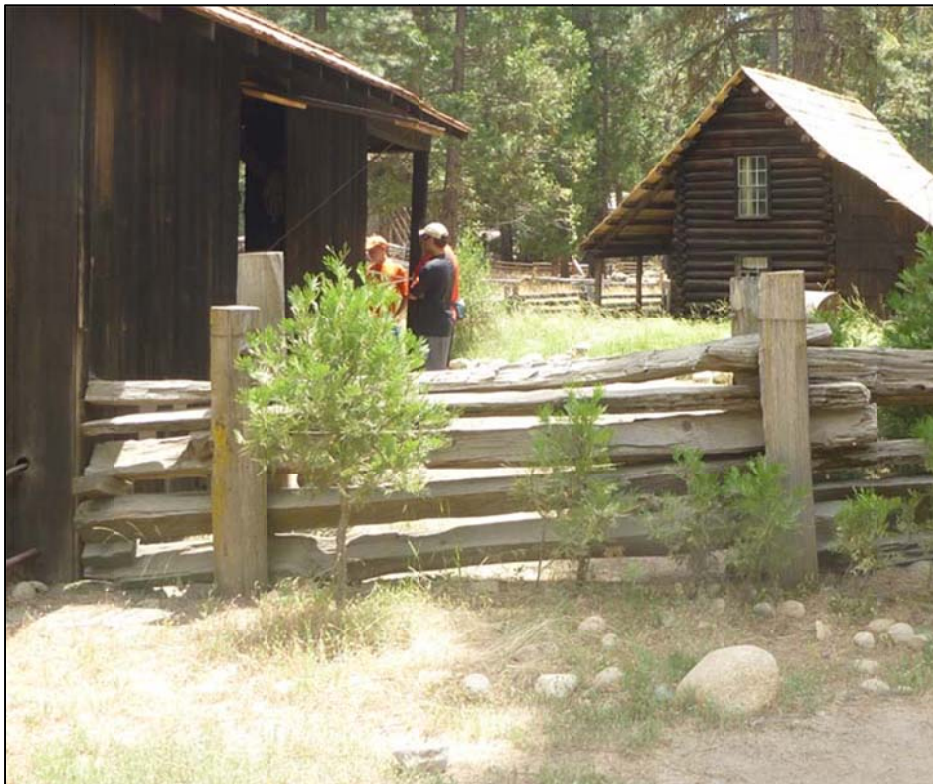
*An example of split rail fence with double vertical supports. (YOSE 2010)*

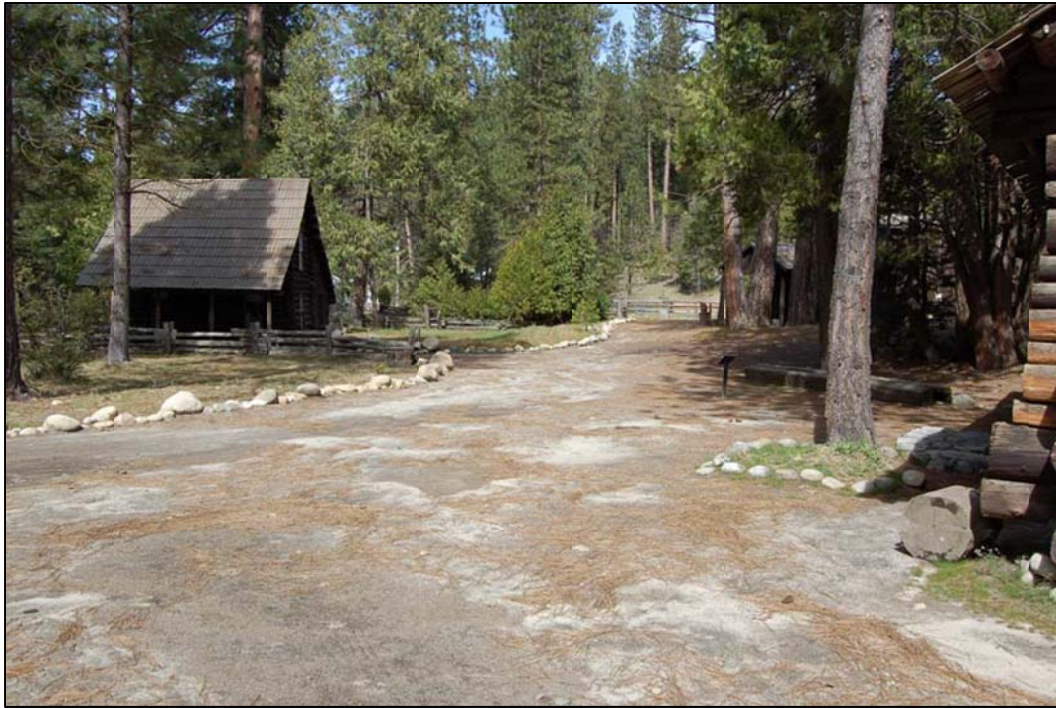
*Rounded stones are used to delineate pathways and indicate “keep off grass” areas. (YOSE 2010)*

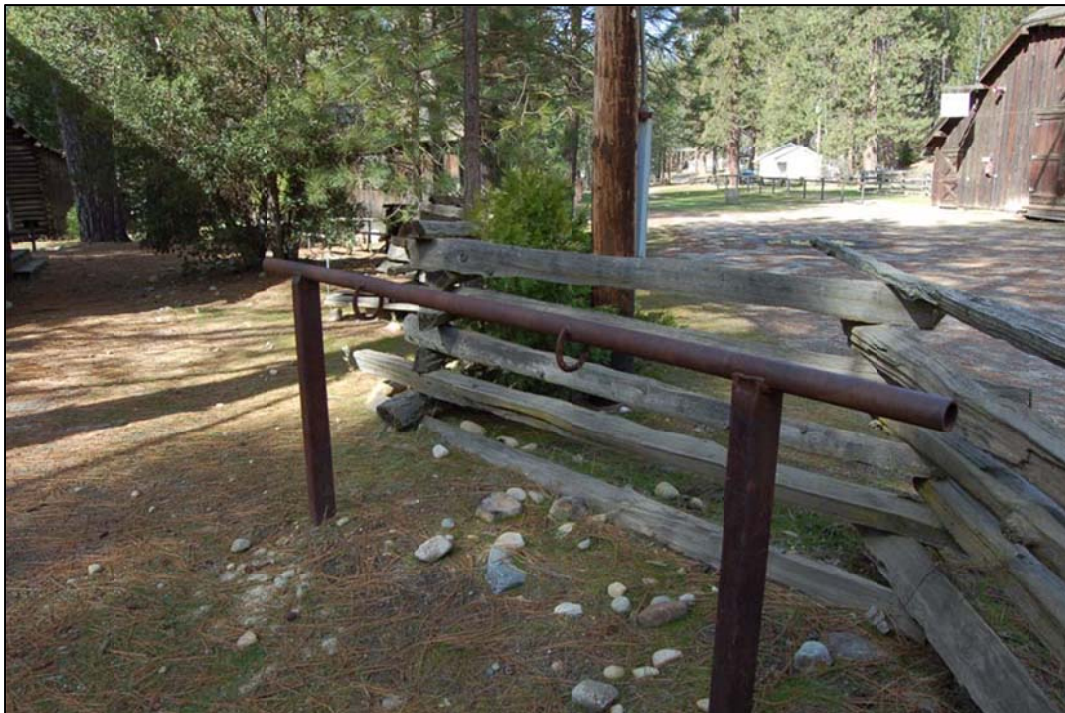
*Hitching post at the Army Tack room and stacked split rail fence without support. (YOSE 2010)*

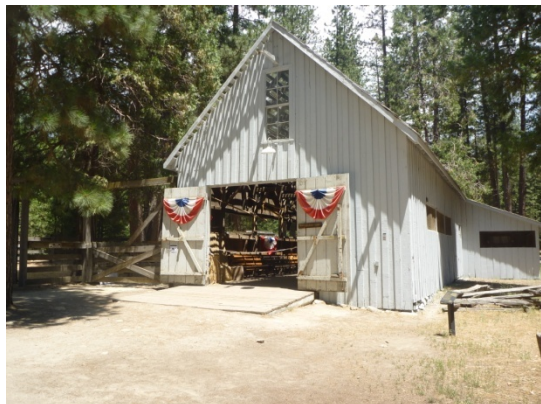
Wawona Grey Barn/ Washburn Barn (Contributing)  
LCS ID: 005796  
Structure No: 4100

The Wawona Grey Barn is a timber-framed structure that measures roughly 80 by 24 feet. The building has a lean-to addition with a shed roof along its southeast corner that is used for storing stage coaches. The building has large barn doors along its east and west façades. It has a wood foundation, dirt floors, and board-and-batten siding painted grey. The building has fixed divided-light windows and screens along the main floor and four-over-four double-hung windows at the gable ends. A wooden corral is attached to the building's north and east facades.

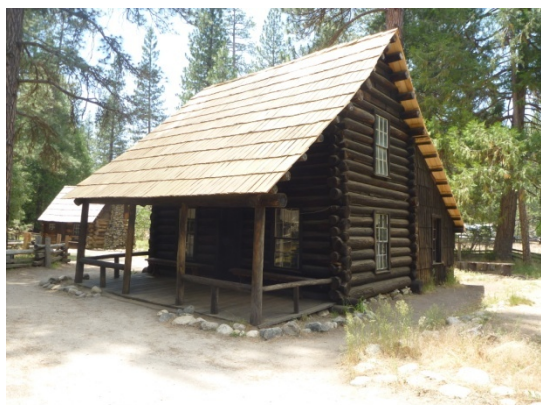
Hodgdon Homestead Cabin/Homestead Cabin  
(Contributing)  
LCS ID: 005776  
Structure No: 4101

The Hodgdon homestead cabin is a two-story log structure with exterior dimensions of 22x30 feet. The building has a rear shed addition that gives the building the appearance of a saltbox. The main portion of the cabin is built of peeled logs laid in alternating rows and interlocked at the corners with a saddle notch joint. The horizontal spaces between the joints are chinked with split log wedges. The cabin features a large porch on the front and it originally had exterior stairs to the second floor on the south side; however, these stairs were removed in 2002 and replaced in-kind in 2008. Two double-hung six-over-six windows are on the front façade and flank a board-and-batten door. The shed addition is of frame construction and is sheathed in wood shingles.

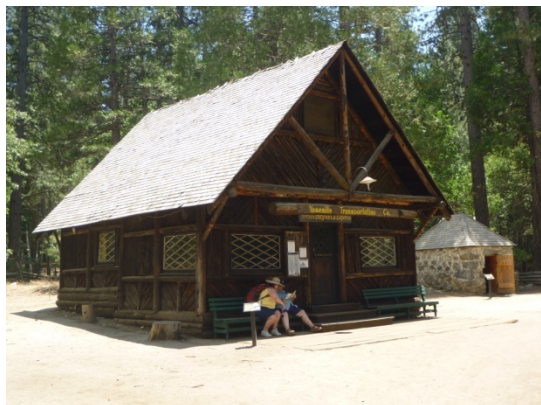
Yosemite Transportation Company Office/Wells  
Fargo Office (Contributing)  
LCS ID: 005797  
Structure No: 4102

The Yosemite transportation company office was constructed by the Yosemite Valley Railroad Company in 1910. It was originally constructed as a stagecoach transportation depot (which connected to the train station in El Portal) and as a telegraph and express office in Yosemite Valley's Old Village. In the 1930s the building was converted into an employee residence and in 1960 it was moved to the Pioneer Yosemite History Center in Wawona where it remains today. The justification for the move was two-fold. It is a rare example of early rustic architecture in the park. This type of early rustic building later influenced park designers who, according to Linda McClelland, developed the Park Rustic style at Yosemite. It was also slated for demolition as part of the park's Mission 66 program, which called for the restoration of the meadow at the Old Village site.

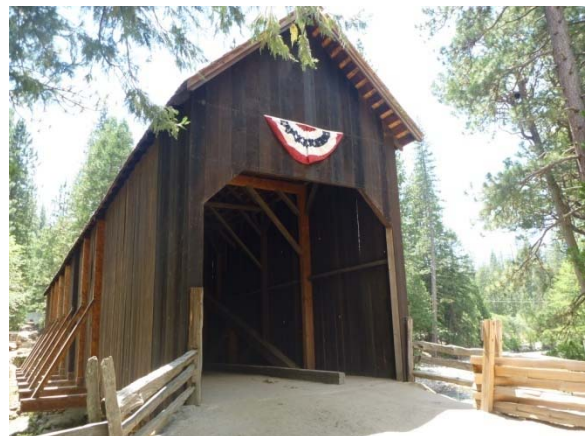
Wawona Covered Bridge (Contributing)  
LCS ID: 005838  
Structure No: 4134

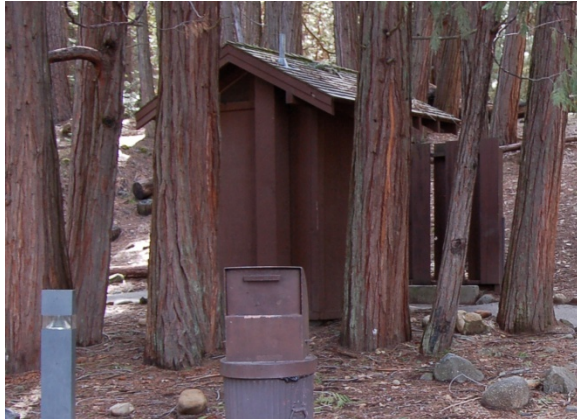
Pit Toilet/Pioneer Yosemite History Center Comfort Station (Non-Contributing)  
Structure No: 4108

This 1952 pit toilet was salvaged from the Old Village in Yosemite Valley and brought to the Pioneer Yosemite History Center in 1960. Modern flush toilets were installed upon its arrival to Wawona. It was almost entirely rebuilt in 1988 and is no longer contributing. The original comfort station had board and batten siding, lattice gable ends and two windows while the current building has screen gable ends, no windows and plywood siding painted brown. This building is nearly identical to the other comfort station in the center (#4108), however this comfort station has a wider door and meets ADA accessibility standards.
