# Gulf Coast Network Water Quality Report

## *Status of Water Quality of San Antonio Missions National Historical Park*

Natural Resource Technical Report NPS/GULN/NRTR—2012/588

June 2012

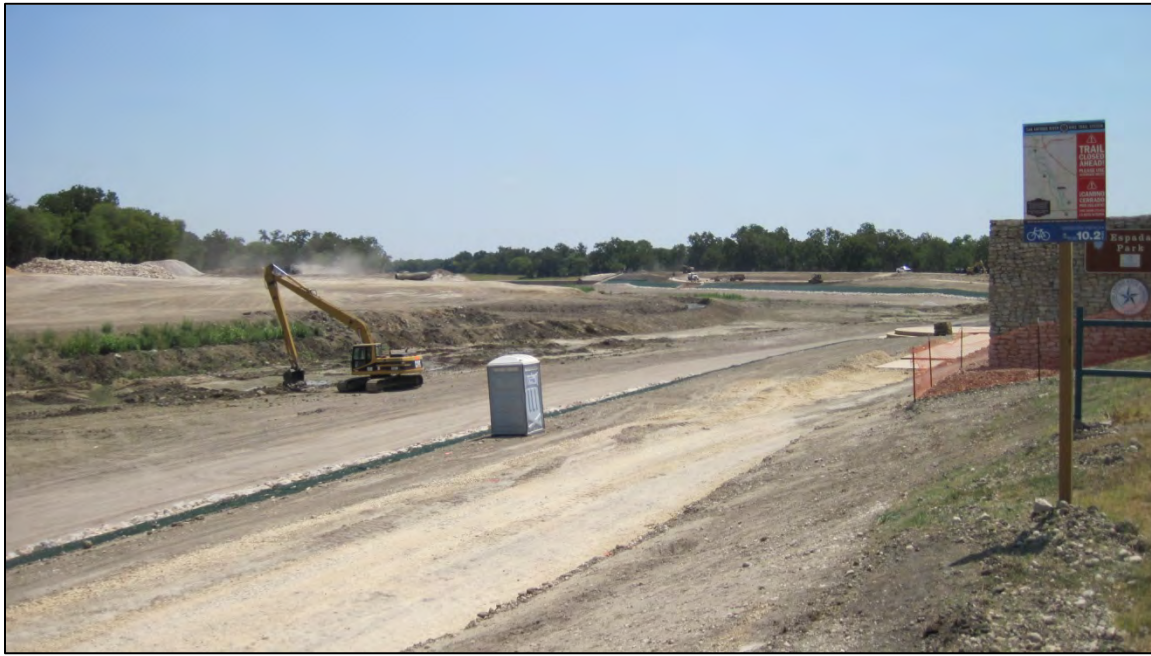
Figure 1. The San Antonio River Mission Reach restoration at Espada Park, facing downstream. The river is temporarily contained in a ditch visible on the left descending bank. Photo by Joe Meiman, August 30, 2011.

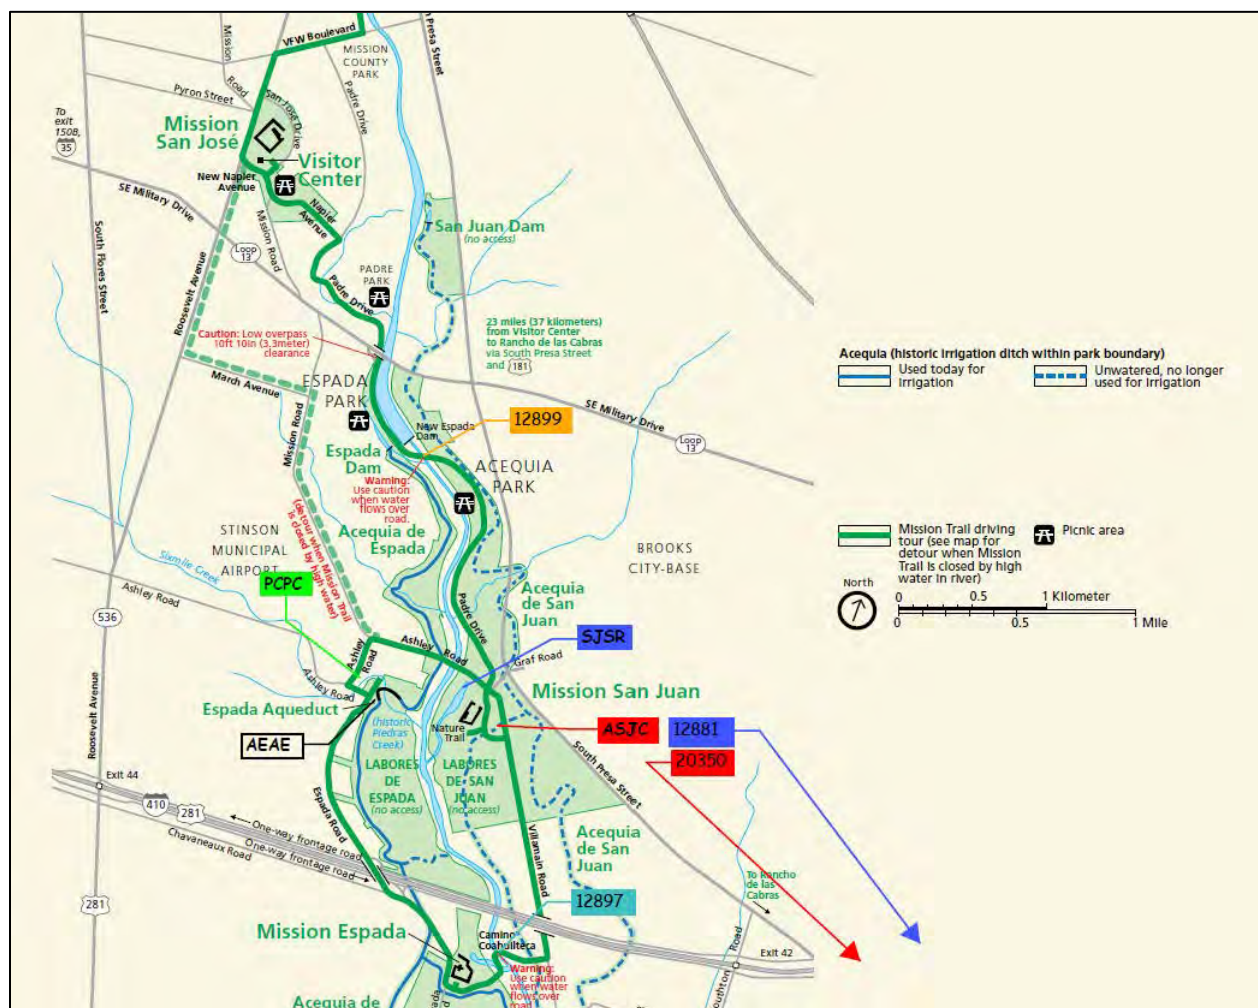
Figure 2. Map of water quality sampling sites at SAAN.

The SARA routine monitoring sampling sites, core parameters, sample frequency, sampling protocols and analysis were considered when designing the SAAN sampling plan to allow comparison of SAAN samples with the upper watershed at large. Through a fee-for-services contract, SARA now includes an additional four sites within the SAAN in their bimonthly sampling schedule as part of the TCEQ CRP. Sampling at the four park-specific sites began in October 2007 and SARA's sampling of related sites in the Upper San Antonio River dates back to 1999 (Figure 2). The 5-digit numeric codes are the TCEQ CRP sites monitored by SARA that have direct monitoring benefits to the park. Four-character alpha codes represent the additional four sampling sites added within GULN. SARA site 12881 is on the San Antonio River just upstream of the Rancho de las Cabras unit and site 20350 is on the intermittent Picos Creek.

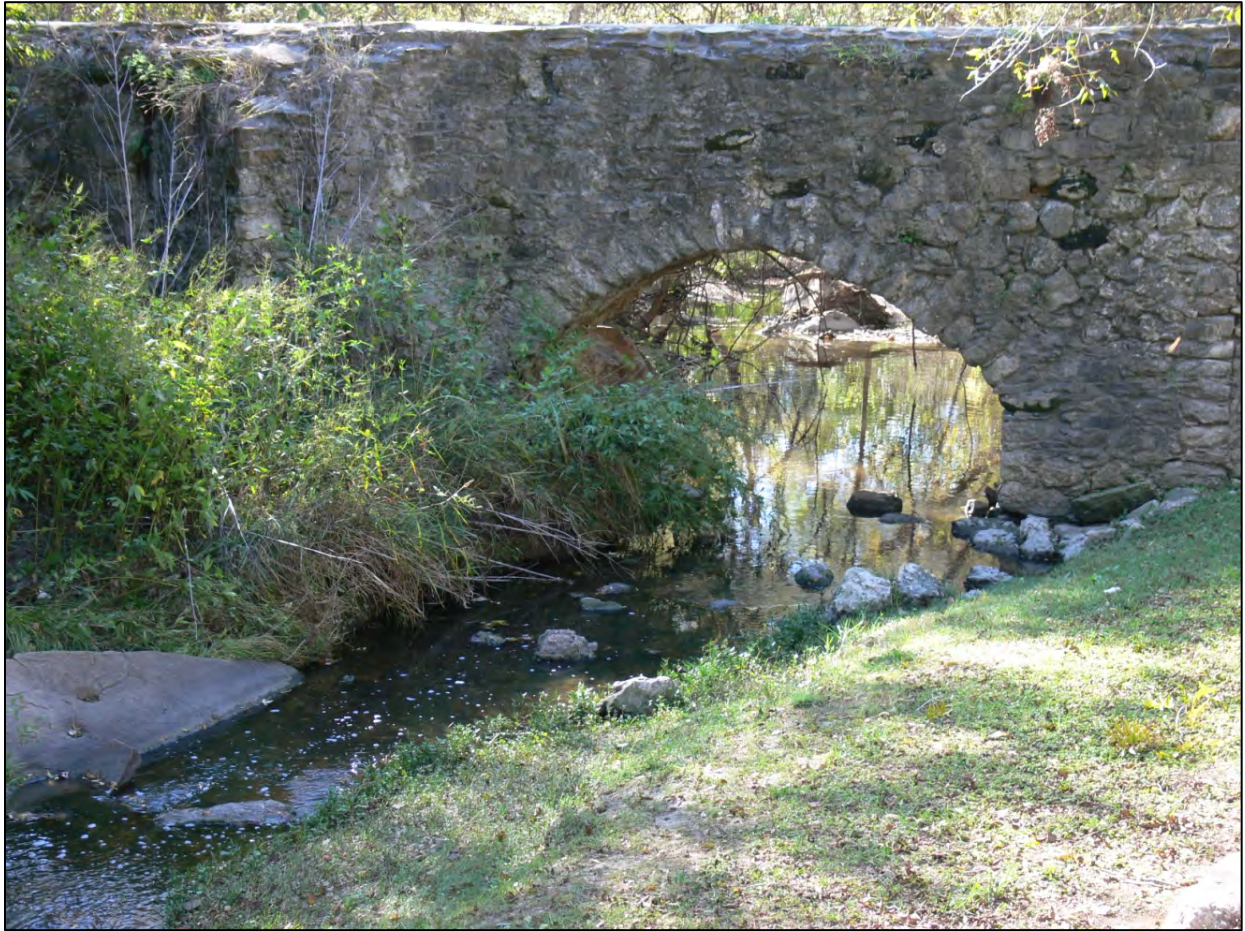
**Piedras Creek (PCPC):** Piedras Creek is monitored as it enters park lands at the crossing of Acequia de Espada aqueduct. Also known as Six Mile Creek, PCPC drains a highly urbanized watershed west of the river.

Figure 3. Piedras Creek, facing downstream.  
The Acequia de Espada aqueduct is visible crossing the creek as it enters the park.  
Photo by Joe Meiman, September 26, 2006.

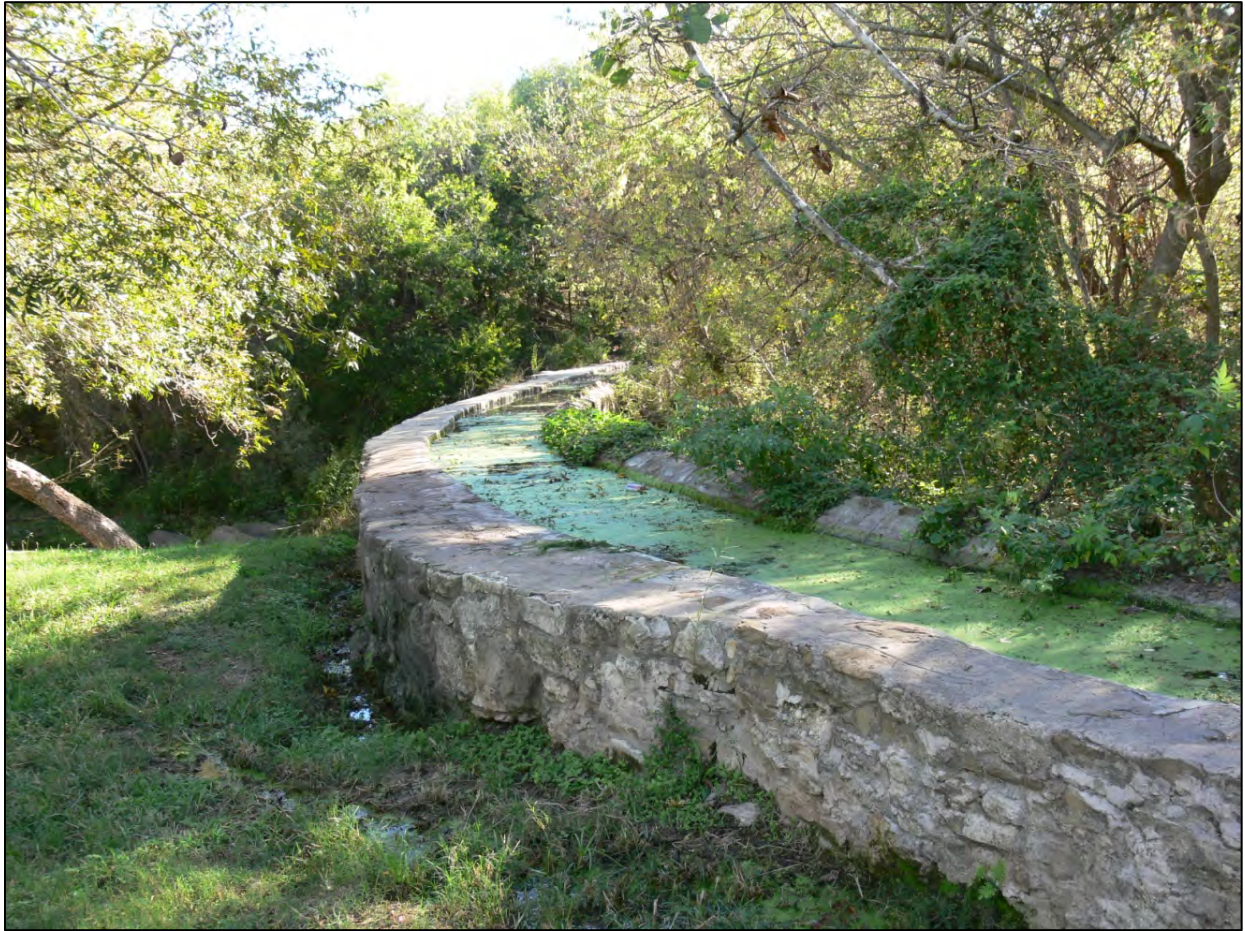
**Acequia de Espada (AEAE):** This acequia is sampled immediately downstream of its Piedras Creek crossing. The acequia headgate, the Espada Dam, draws water directly from the Urban Reach (the portion of the San Antonio River upstream of Loop 410).

Figure 4. Acequia de Espada, facing upstream.  
Note heavy growth of duckweed compared with the same scene in August 2011 (on cover).  
Also, much of the thick vegetation overhanging the acequia has been removed as compared  
with the latter scene.  
Photo by Joe Meiman, September 26, 2006.

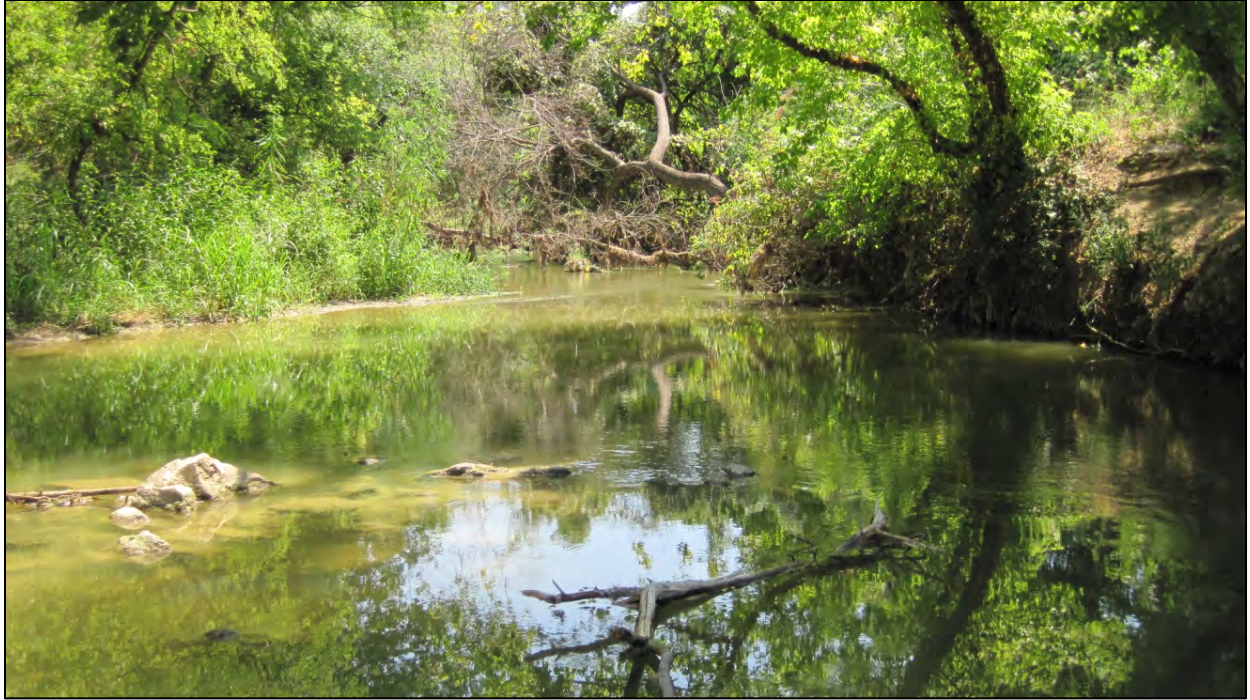
**San Antonio River at Mission San Juan Capistrano (SJSR):** The San Antonio River emerges from three concrete culverts as it enters the only natural reach of the Urban Reach. The river flows through this stretch, complete with heavy riparian vegetation, passing through the Mission grounds, and reentering the modified channel after approximately 1 km.

Figure 5. San Antonio River at San Juan Capistrano Mission, facing downstream. Photo was taken from the culvert outlet that empties into this only remaining natural section of the Urban Reach. Photo by Joe Meiman, August 29, 2011.

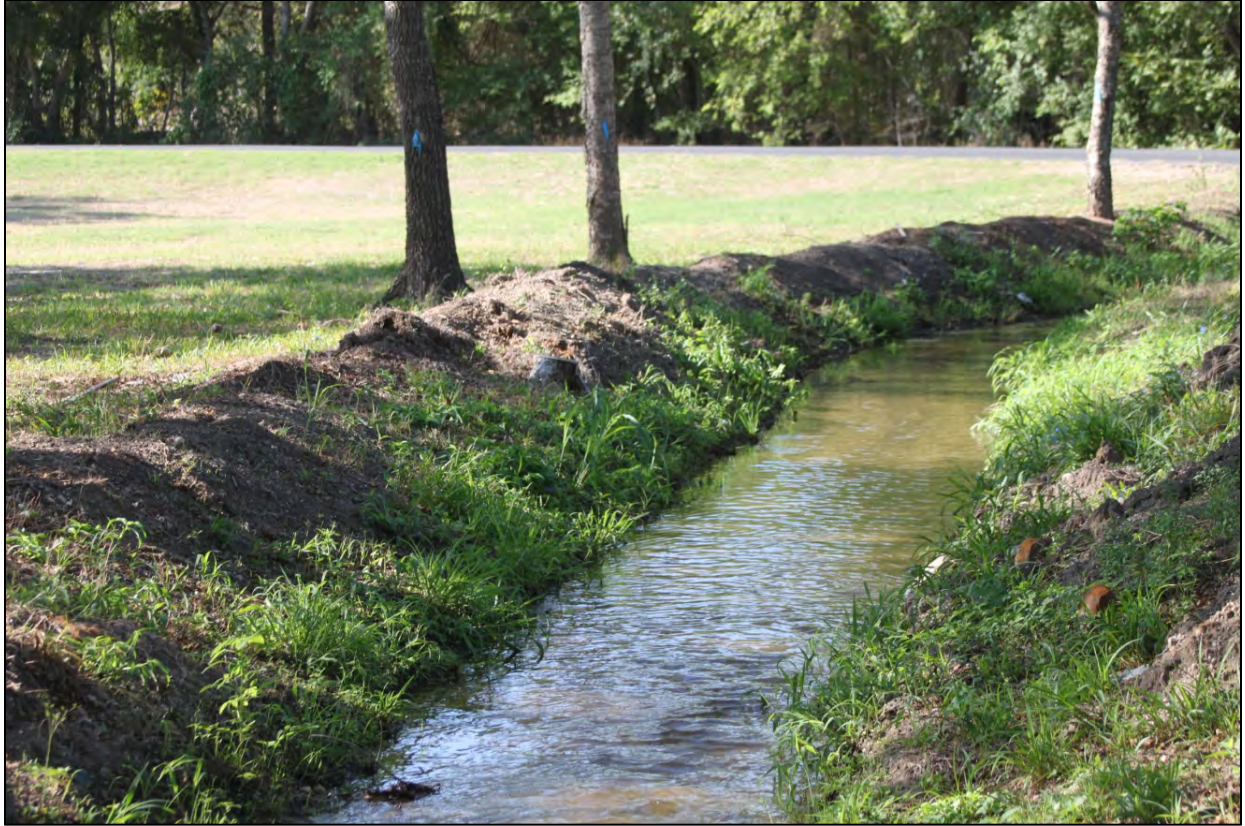
**Acequia de San Juan at Mission San Juan Capistrano (ASJC):** Flow was returned to the Acequia de San Juan in September 2011 for the first time since 1978. Water sampling began in October 2011. The acequia headgate, the Archimedes Screw, draws water directly from the Urban Reach (the portion of the San Antonio River upstream of Loop 410).

Figure 6. Acequia de San Juan, facing downstream.  
Photo by SAAN staff, September 27, 2011.

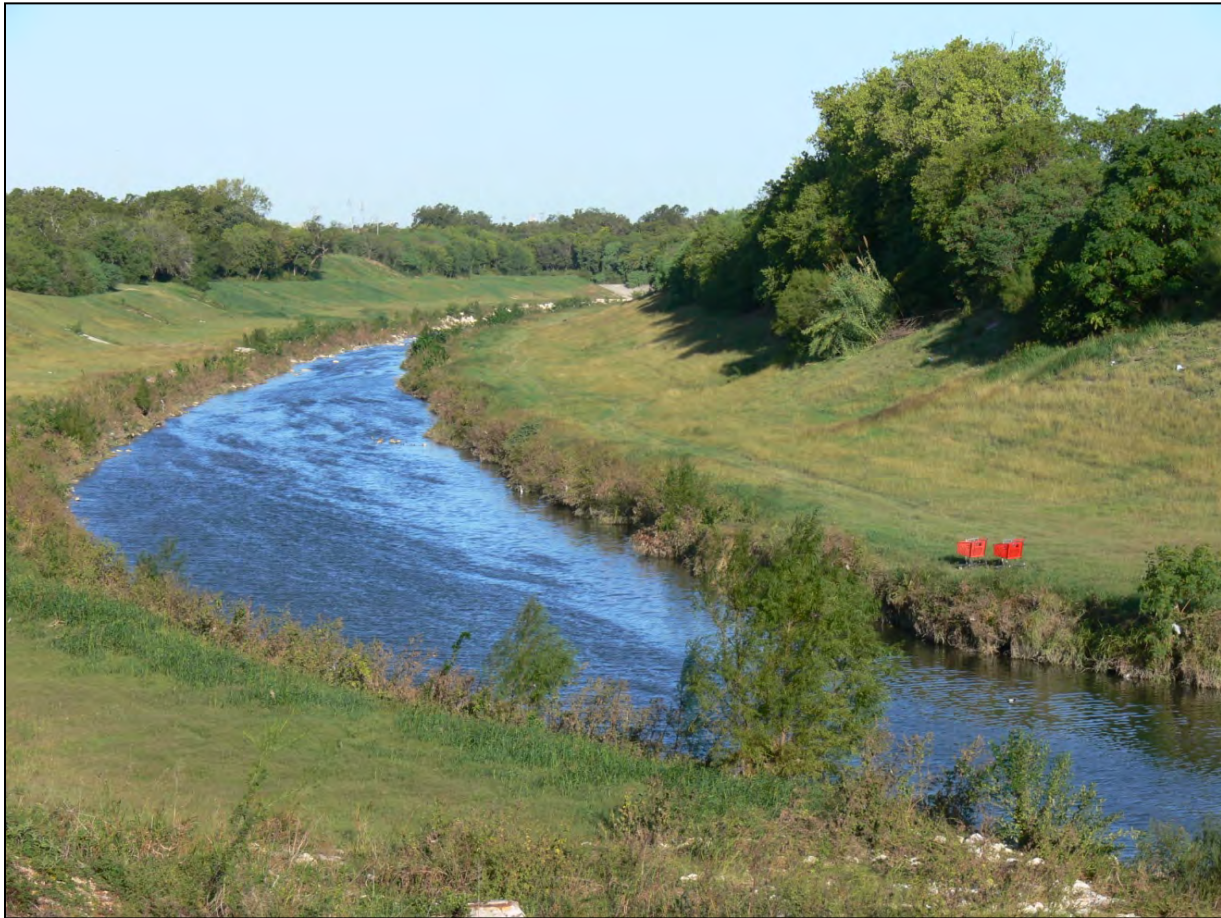
**San Antonio River (SARA site 17066):** This site is at Mission Road downstream of the confluence of San Pedro Creek. The river flows within a flood control channel over this reach, typical of the San Antonio River within city limits. This site is within the Mission Reach Restoration Project and has since undergone major changes to stream channel and riparian habitat.

Figure 7. SARA site 17066 on the San Antonio River, facing upstream.  
Red shopping carts in right mid-ground provide scale.  
Photo by Joe Meiman, October 26, 2006.

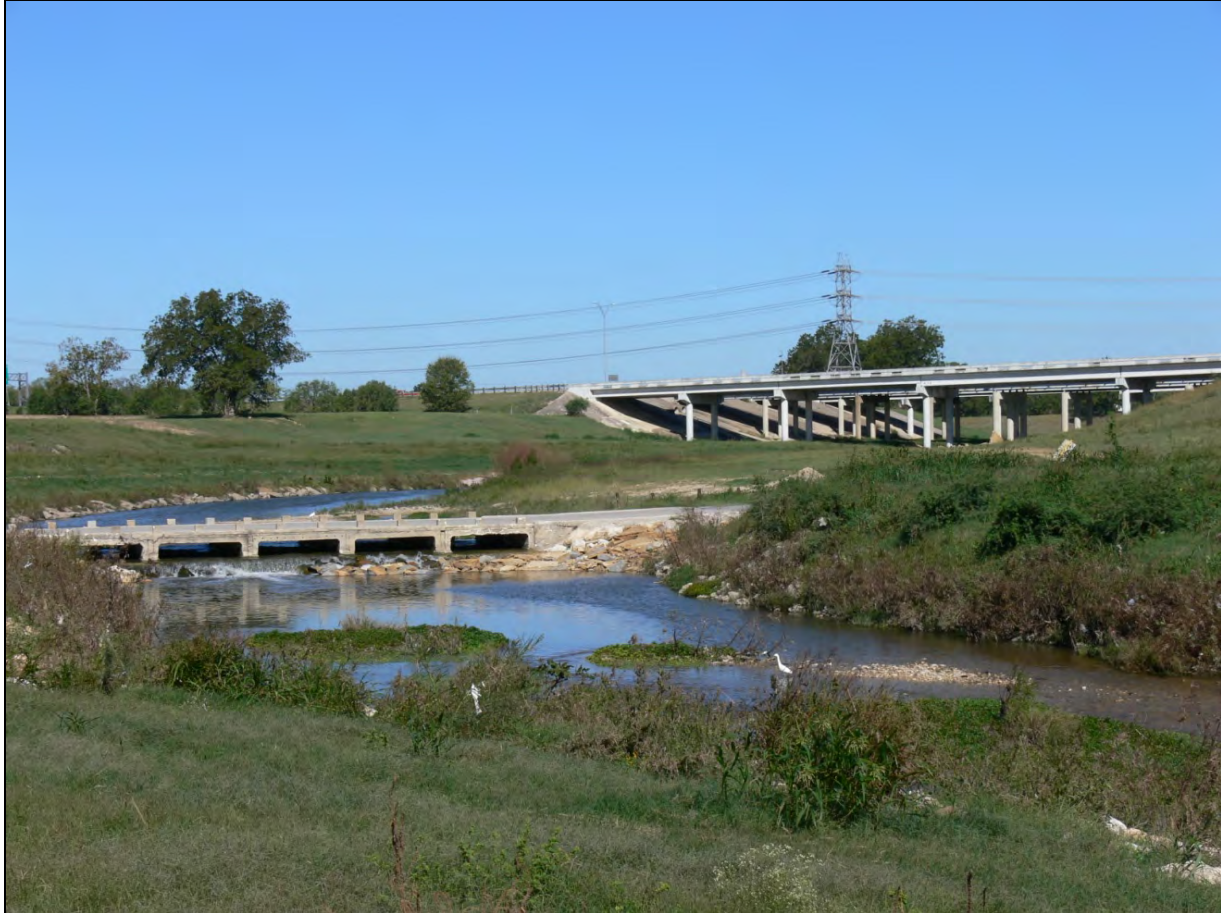
**San Antonio River (SARA site 12897):** This site is located immediately downstream of the Missions unit, adjacent to Mission Espada. The river still flows within a flood control channel, but is soon to be restored as part of the Mission Reach. Shortly downstream of this site the river returns to its natural channel.

Figure 8. SARA site 12897 on the San Antonio River, facing upstream.  
Photo by Joe Meiman, October 26, 2006.

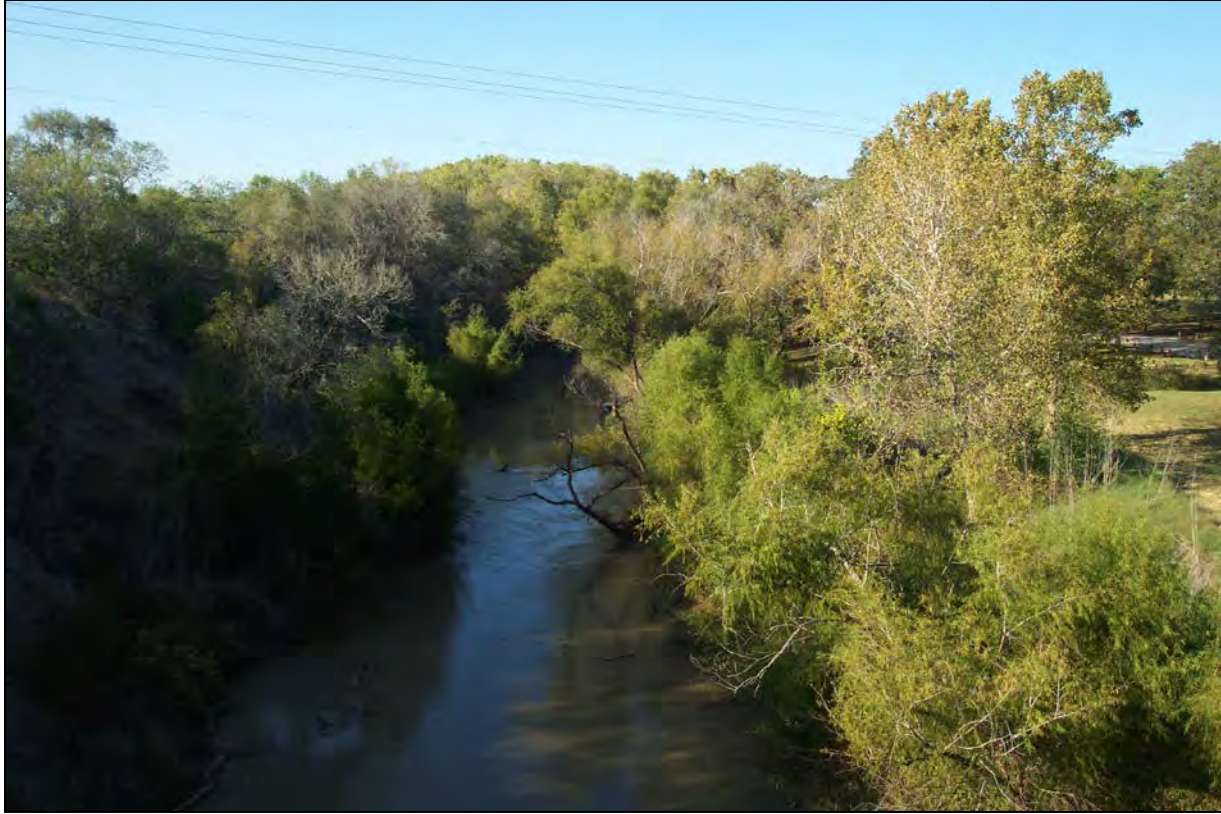
**San Antonio River (SARA site 12881):** This site is directly upstream of the Rancho de las Cabras unit. Unlike river sites upstream, the San Antonio River channel retains a relatively unaltered condition by the time it reaches the Rancho de las Cabras. At this point the river is free flowing in a natural channel.

Figure 9. SARA site 12881 on the San Antonio River, facing upstream from the State Highway 97 bridge. Photo by Greg Mitchell, November 9, 2006.

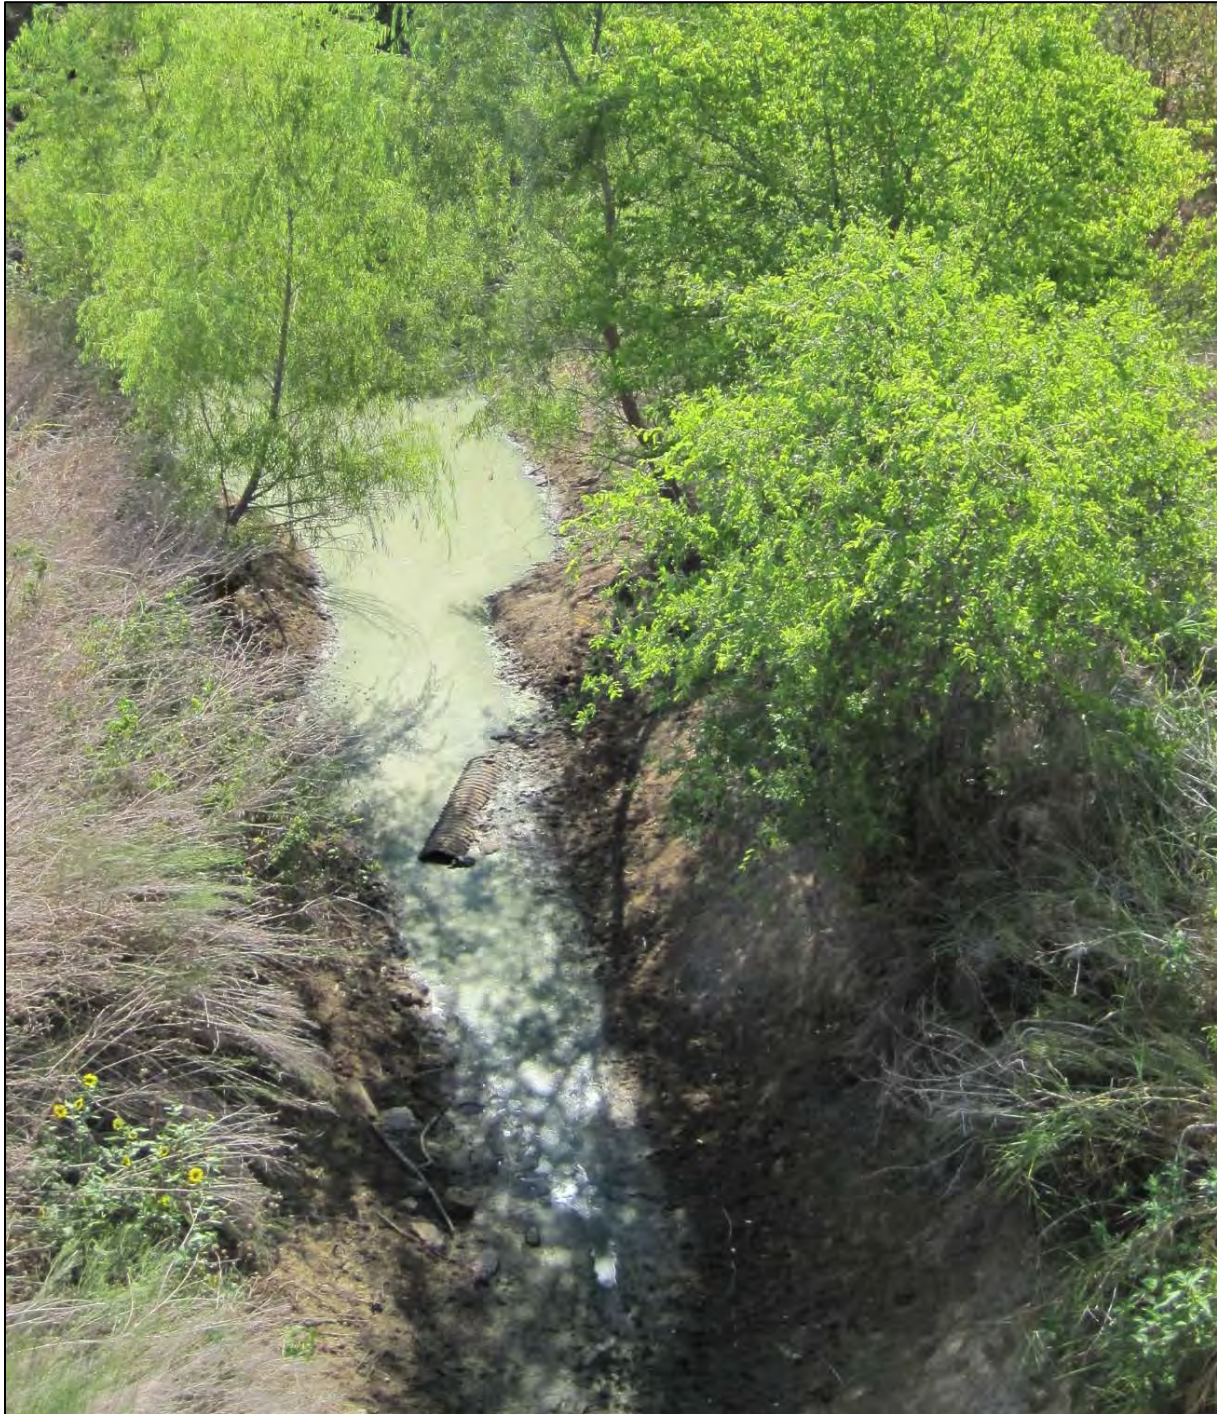
**Picoso Creek (SARA site 20350):** This stream is sampled upstream of the Rancho de las Cabras at State Highway 97 (SH 97). Picoso Creek is a seasonal stream and was reduced to isolated pools during the drought of 2011.

Figure 10. Picoso Creek from the SH 97 bridge, facing downstream. Texas was experiencing a severe drought when this photo was taken. Picoso Creek was reduced to a series of isolated, stagnant pools. Photo by Joe Meiman, August 29, 2011.
