National Park Service  
Cultural Landscapes Inventory  
2004

Assateague Beach Coast Guard Station  
Assateague Island National Seashore

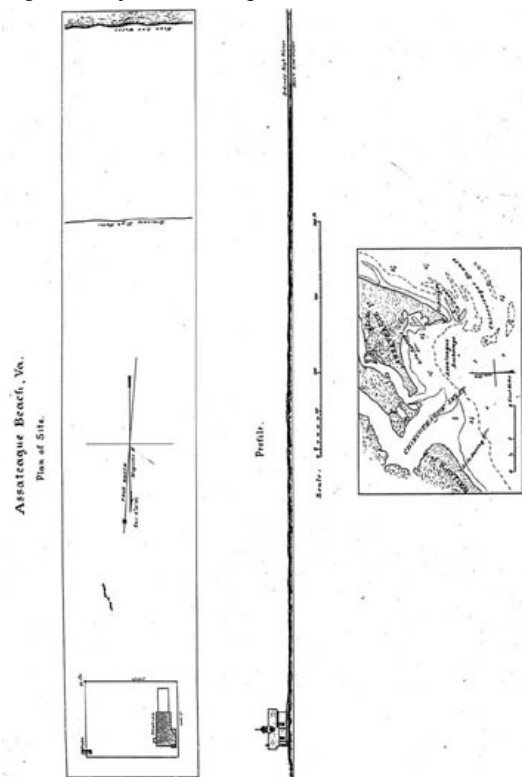
Fig. 5: 1874 site plan for Assateague Beach Life-Saving Station. [U.S.C.G. Library, Microfilm Archives, New London, CT, nd.].

The station architecture was constructed in the 1874-type standardized plan [Shanks, 1998, 120]. The 1874-style station, a combination of Carpenter Gothic and Stick Style, was only built on the East Coast; it was distinctive by the exterior ornamentation of decorative scroll work and bracketing beneath the gable and side eaves, as well as, a center roof observation platform [217]. The grounds of the Assateague Beach station, like many at this time, was defined by a 3 foot tall white picket fence centered on a narrow 175 foot wide tract of land. The plan for the station locates the station building 600 feet from Assateague Anchorage and with only one other building, a stable, for at least one horse that was used to assist in pulling surfboats to the launch site [110] [Fig. 5,7].

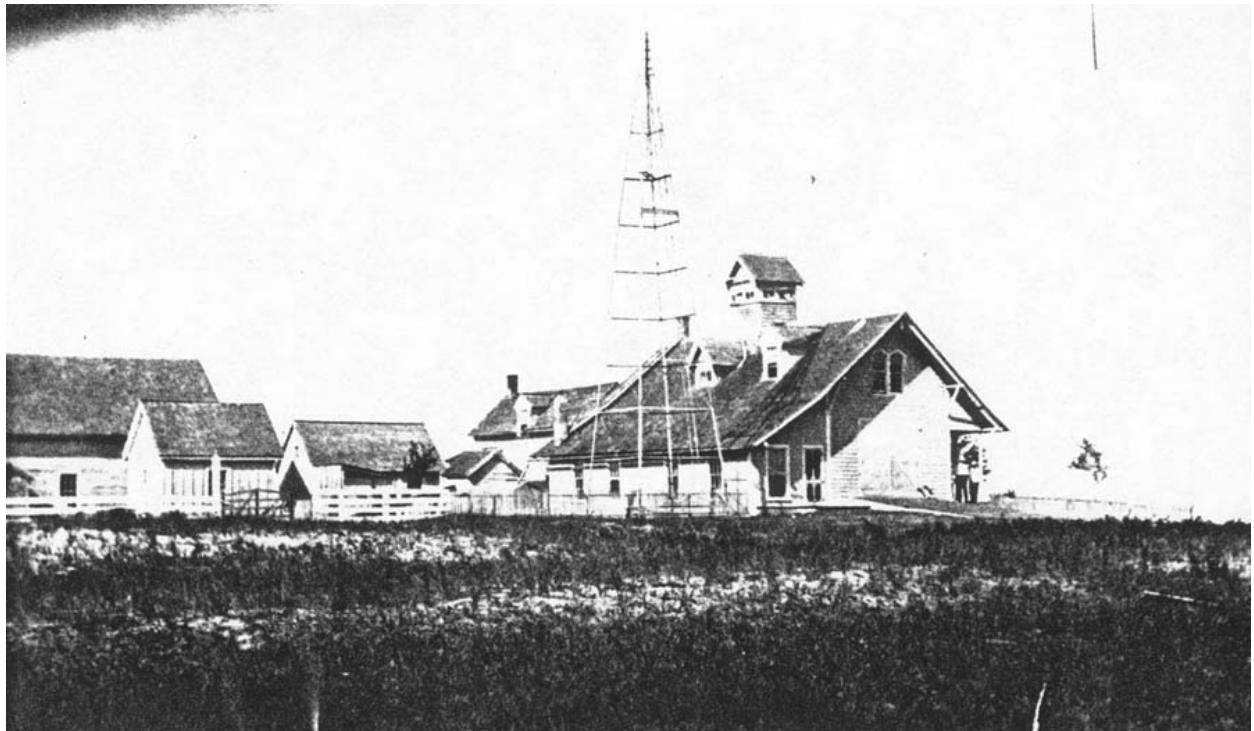
Fig. 7: Photo of the 1874 Assateague Beach Life-Saving Station [U.S.C.G. historian office, archive collection, nd].

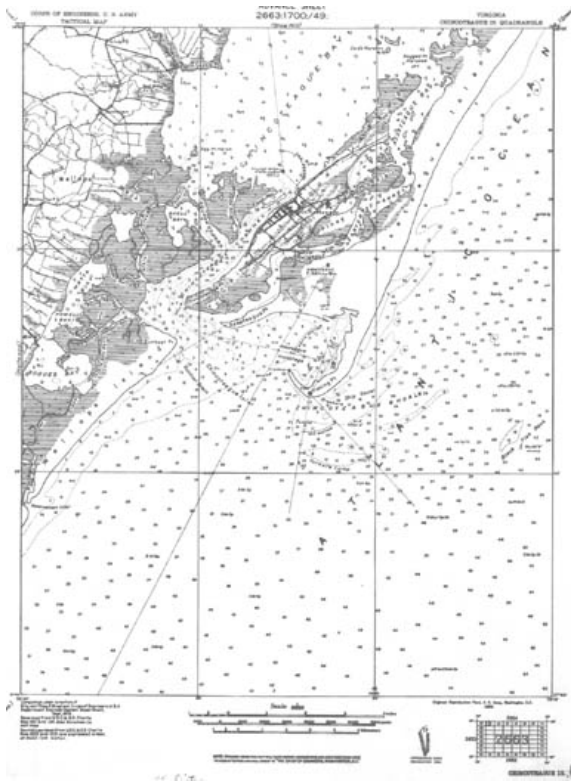
Fig. 8: 1920 Corp. of Engineers, U.S. Army TACTICAL MAP [U.S. Geological Survey Historical Files].

A U.S. Army Tactical Quadrangle Map dated 1920 indicates that there was possibly a tower with a red sector light at Fishing Point near the site of the future station [Fig 8]. The symbol considered to be a light tower at Fishing Point is also on the 1942 War Department quadrangle map and a symbol on the 1943 quadrangle in the same position is labeled, "light" [Fig. 9-10]. Several buoys are shown on the 1920 and 1942 maps including bell buoys and whistle buoys. By 1920 the hook has formed and is encircling the Anchorage which is renamed Assateague Cove on the 1943 quadrangle maps.

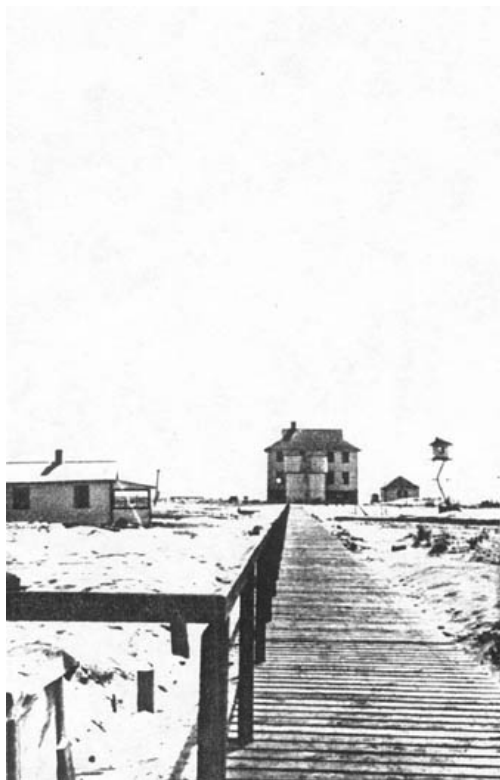
*Fig. 12: 1931-1938 photograph of the station from the north, taken after the walkway was built and before the tower was raised [U.S.C.G. archives, Washington D.C.].*

A dock had been built at the station by 1933 [U.S.C.G. logbooks, Aug. 23, 1933]. A plan for the dock, wharf, and wooden walkway was drawn in April 1931 and has a note on it for a contract with W. Henry Bartlett for \$8,925.00 dated in June. As mentioned, a dock was in existence in 1933 and in 1935 the crew was employed painting the handrail on the walk and the dock [U.S.C.G. log, Sept. 3, 4]; thus, this structure, with a small structure on the t-shaped dock, was built sometime between 1931 and 1935 [Fig. 12, 14].

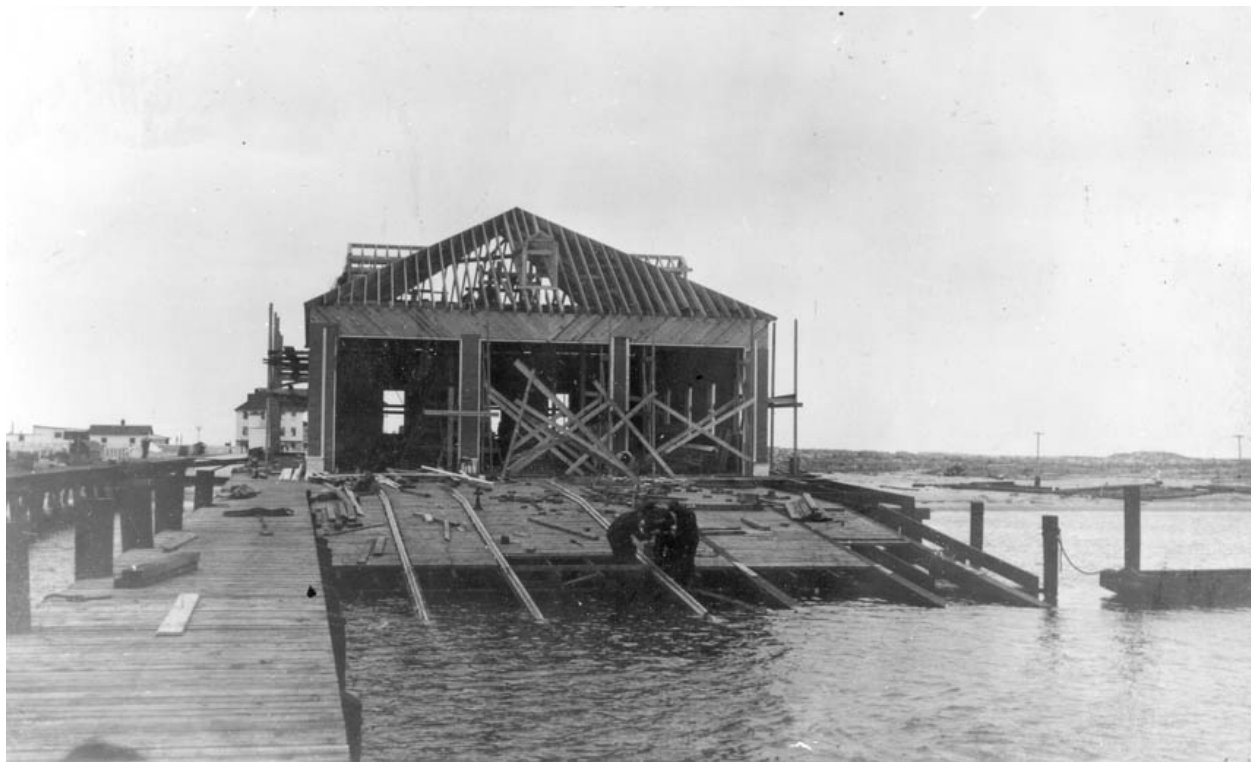
*Fig. 13: The 1939 boathouse during construction, looking south [U.S.C.G. archives, Washington D.C., Dec. 1938].*

Because of the effects of shifting sands and larger heavier boats, the need for a boathouse located on Toms Cove was evident by 1938 when construction began on a 46' x 62' Colonial Revival Style boathouse [Fig.13]. The structure was connected to the wharf via catwalks and surrounding walkways. To ease the heavy boats into the water and pull them back into the boathouse, a two-stall launchway equipped with three sets of marine railways and a motorized pulley was constructed on the north facade. At the same time that the boathouse was being built, a porch addition was being added to the station house and the lookout tower was raised from two stories to three. The Navy also built a 50' tall Triangulation Tower sometime before this, which remained until sometime between 1976 and 1994 [period photographs].

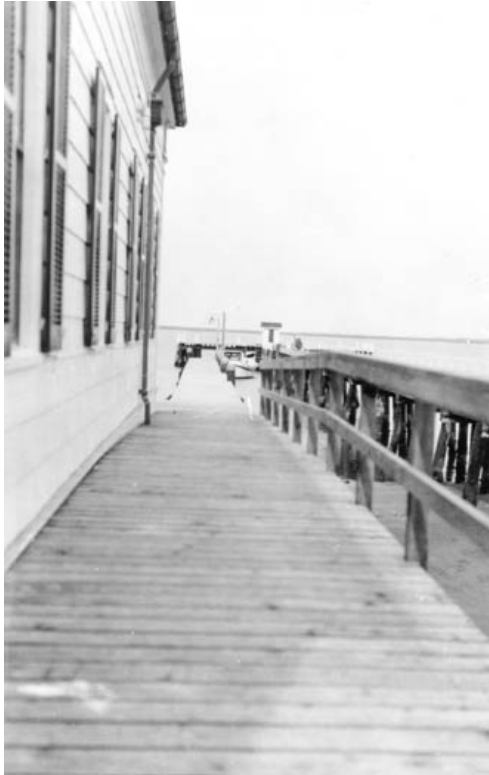
*Fig. 14: Looking north from the boathouse walkway. Note the pump house [U.S.C.G. archives, Washington D.C., Feb. 16, 1939].*

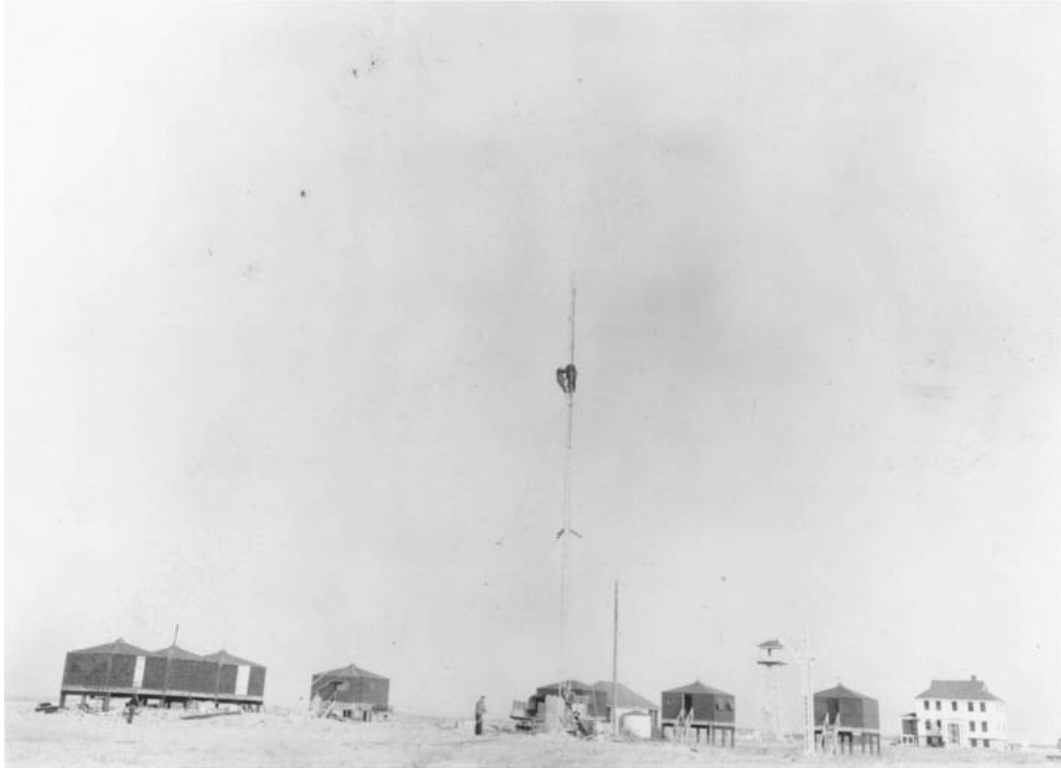
*Fig. 15: The station complex in 1943 looking north. [U.S.C.G. archives, Washington D.C., Report on Construction of Radiator Tower, 1943].*

In 1943, the crew was employed to build a Vertical Steel Radiator tower south of the 1922 boathouse [see Fig. 15][U.S.C.G. archives, Report to Build Steel Radiator]. The report describes the erection of the tower for the Assateague Test Station with plans for other high frequency towers to be located some two hundred feet away. This appears to have been an advancement to long range aid to navigation, which was

stepped up during the war. The tower was approximately 80 feet tall with four large concrete anchors sunk into the ground below sea level. Other parts included guy insulators, an isolation transformer, and a conduit for a lighting circuit. It is not known when the tower was taken down but it does appear in the 1957 aerial photograph and it is not present in the 1962 hurricane photos.

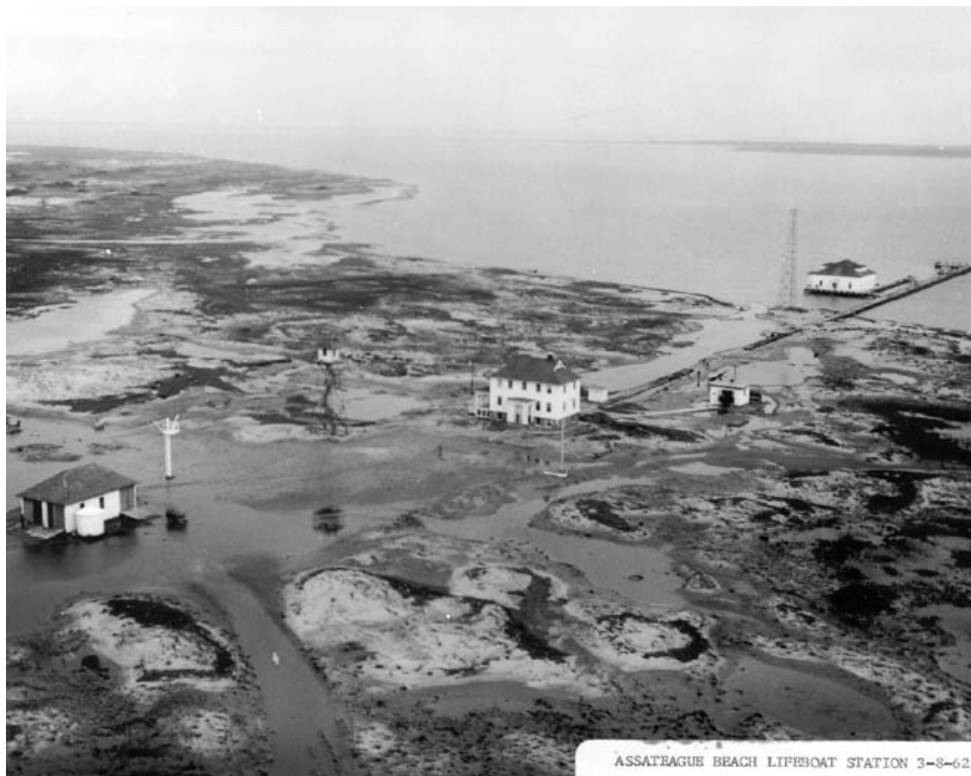
*Fig. 16: Oblique aerial view of the station complex after the 1962 storm [U.S.C.G. archives, Washington D.C., March 8, 1962].*

The hurricane of 1962 may have caused some structural damage to the station [Fig. 16]. As seen in the photograph, the cabin is missing from the tower, the chimney is missing from the boathouse, and the wooden walkway is washed over with sand. This storm may have also damaged the wharf railings.

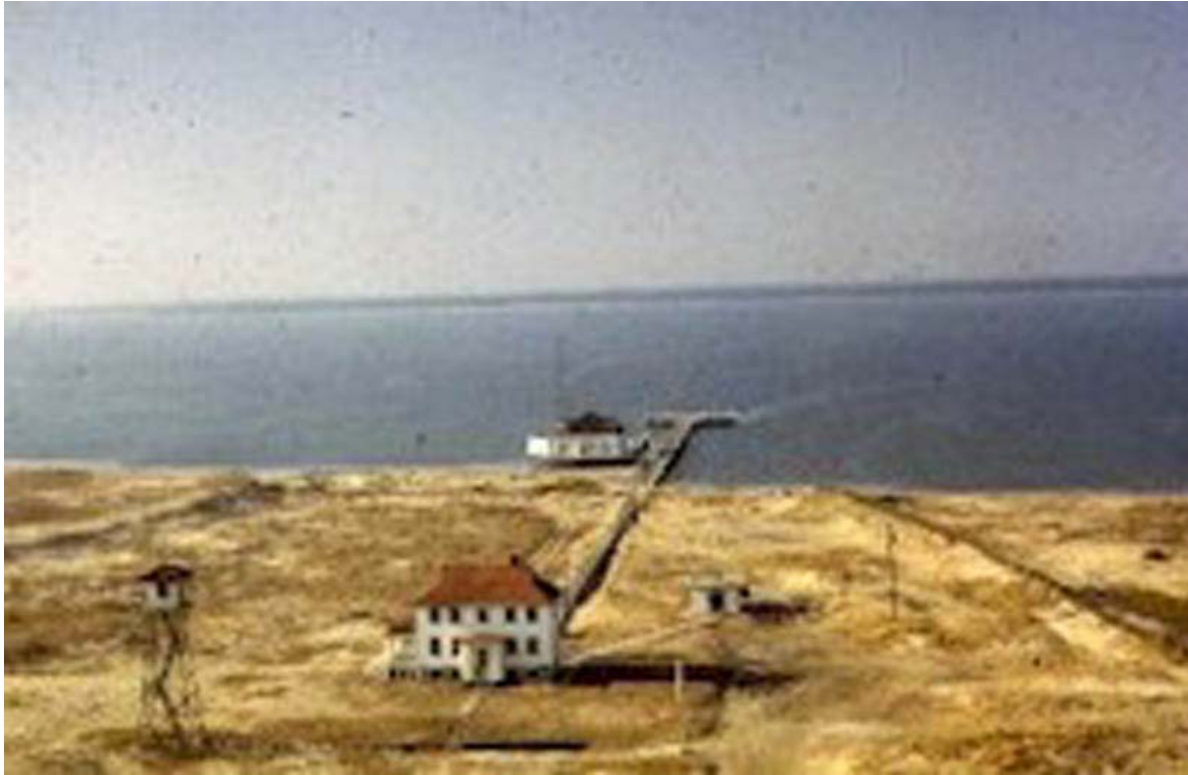
*Fig. 19: Aerial view of the station shortly after the NPS took occupation. Note the topography change due to the sand fences (Photo courtesy Larry Points, ASIS, c. 1969-72).*

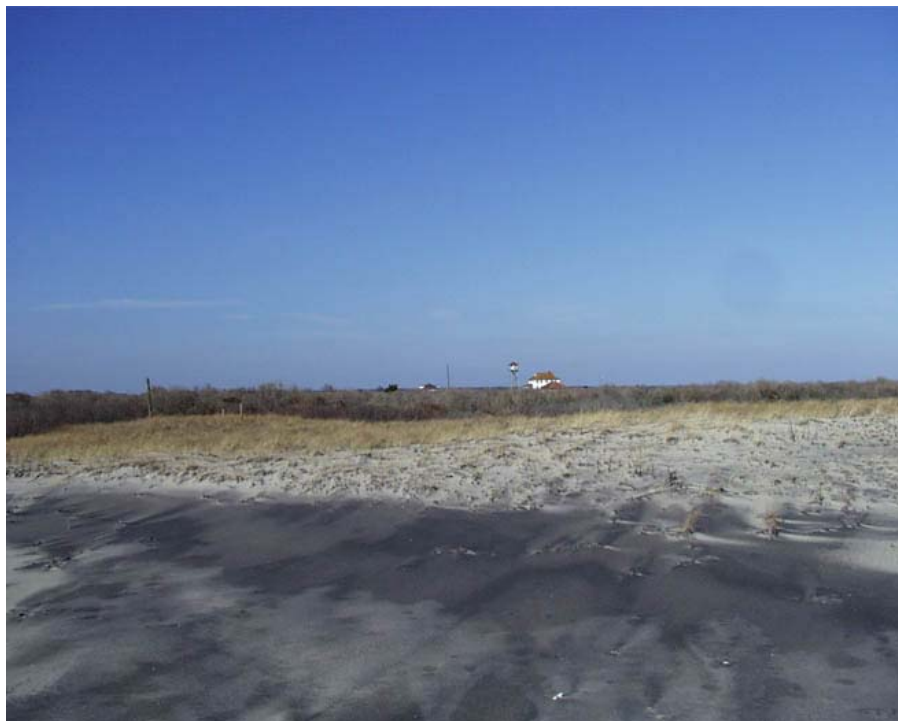
*Fig. 22: View north from the Atlantic Ocean. Due to siltation at the southern end of the hook, the station now sits far from the ocean shoreline [Photo: NPS, 2000].*

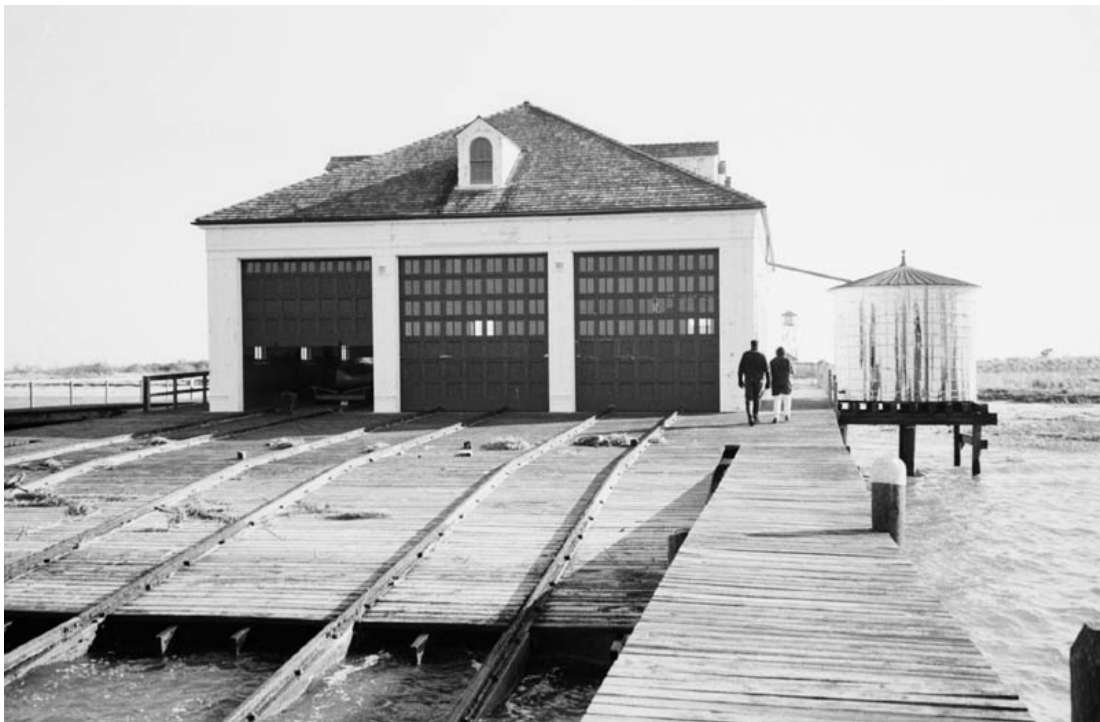
*Fig. 26: The 1939 boathouse with a marine railway for launching boats and access to the station from the cove [Photo: NPS, 2000].*

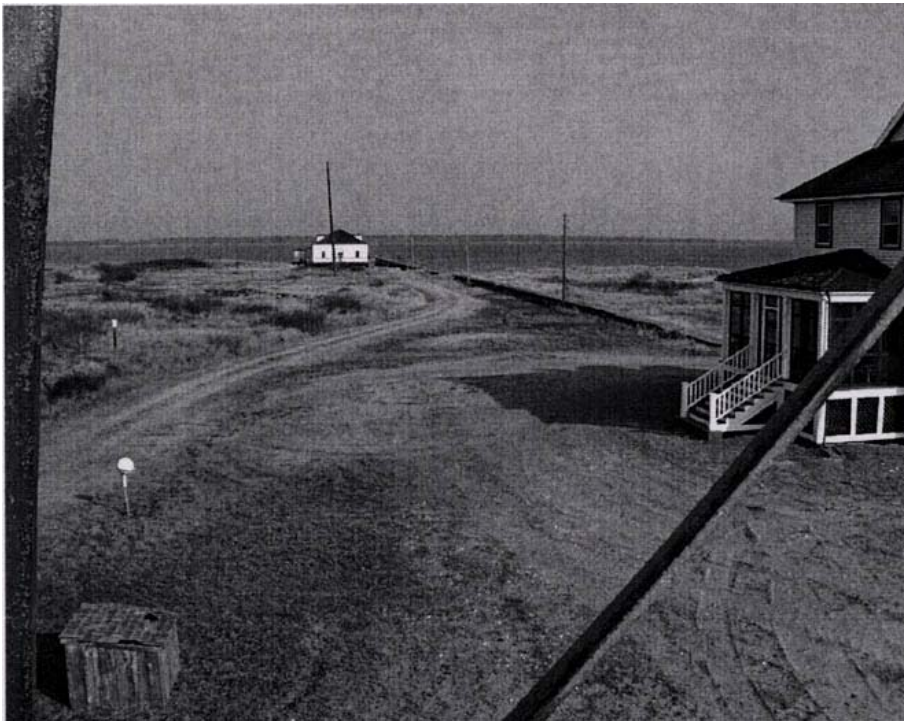
*Fig.: View looking north to the boathouse. The road circles the southern end of the complex then turns north when it meets the wooden walkway system [Photo: J. Hau, NPS, 2000].*

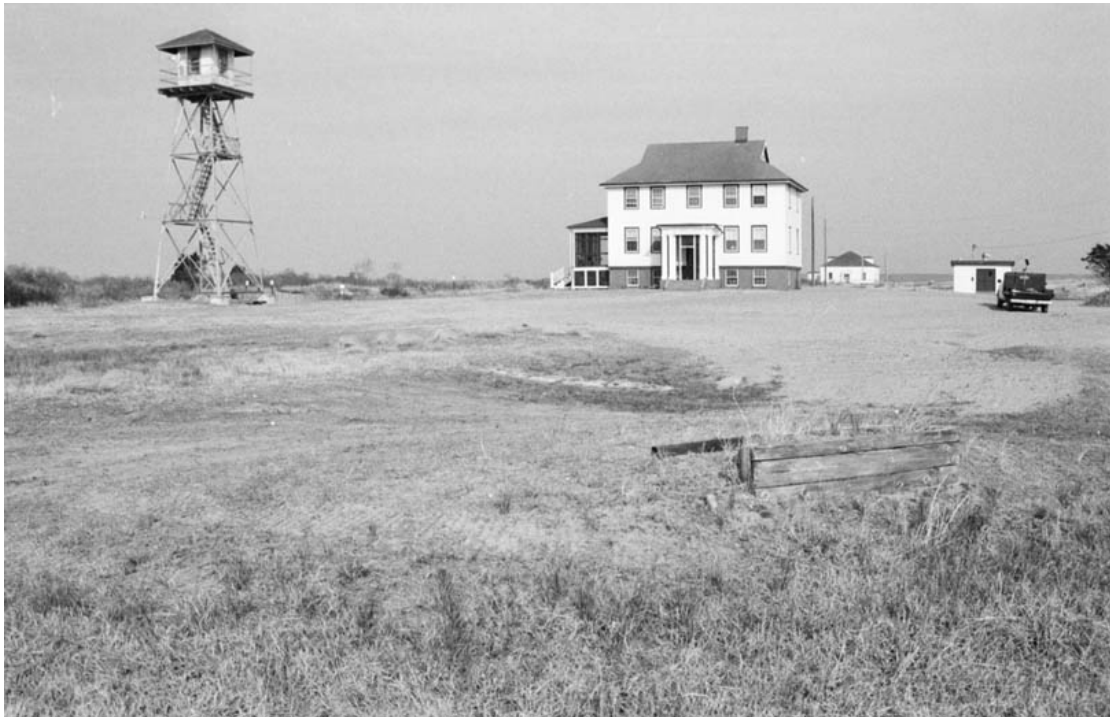
*Fig. 28: View looking north of the station house on a high knoll with gentle slopes [Photo: NPS, 2000].*

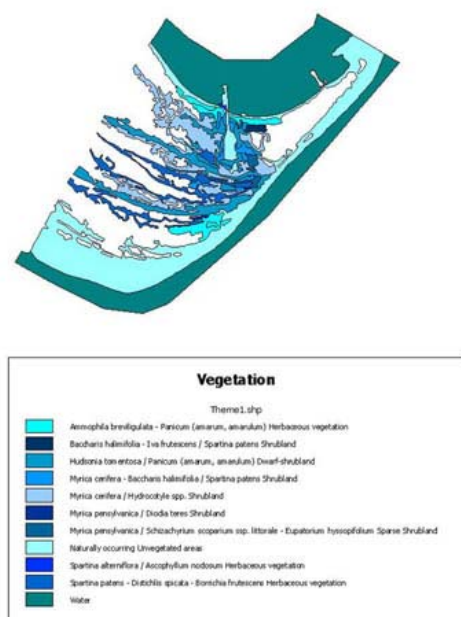
Fig. 29: 1994-95 Natural Resources Vegetation Inventory Map. Unvegetated areas refer to a beach environment [U.S.F.W.S.].

The patterns that the vegetative groups form describe the ocean to cove landscape and are reflective of the fencing practices of the 1960s. From the shorelines moving towards the center of the island there are the following general vegetation distributions: naturally occurring unvegetated areas, or beach, moving to dwarf shrubland, shrubland, and mixed herbaceous species, or dune. Pockets of marshland can be found within the interdune area as well as closer to the shorelines. The taller dunes consisting of dwarf shrubland clearly reflect the fencelines seen in the 1966 aerial photograph [Map 1 & 2].

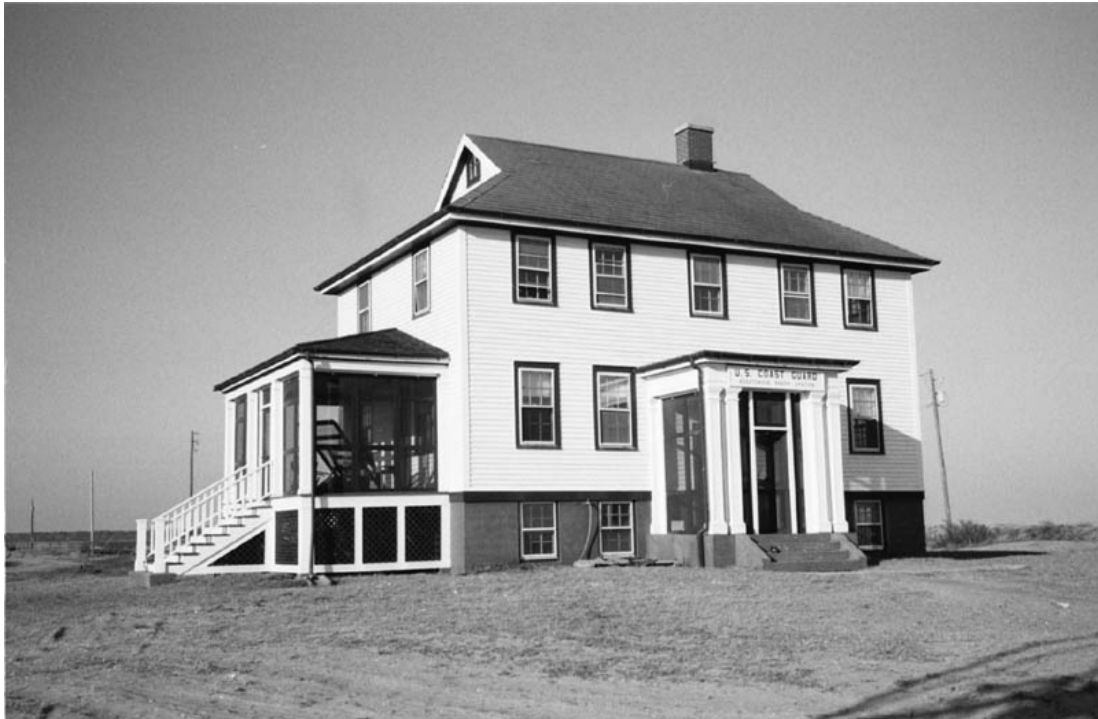
*Fig. 33: 2000 view of Assateague Beach Station House looking Northeast [Photo: NPS, 2000].*

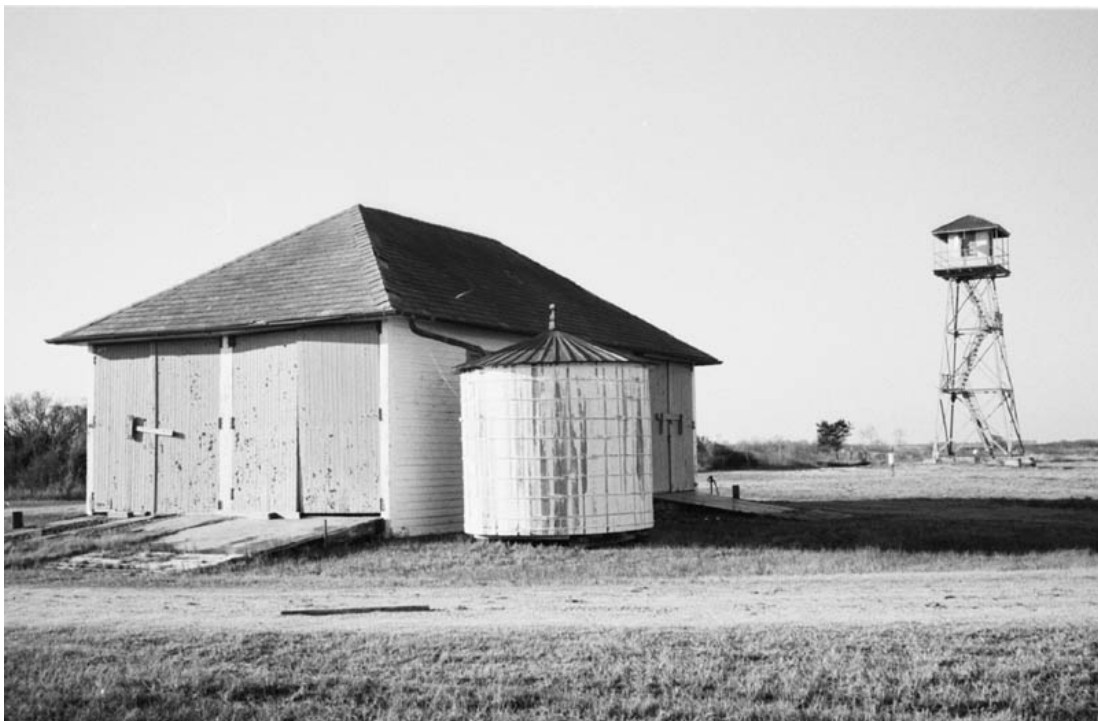
*Fig. 34: View northwest of the garage [1922 boathouse] and cistern [Photo: NPS, 2000].*

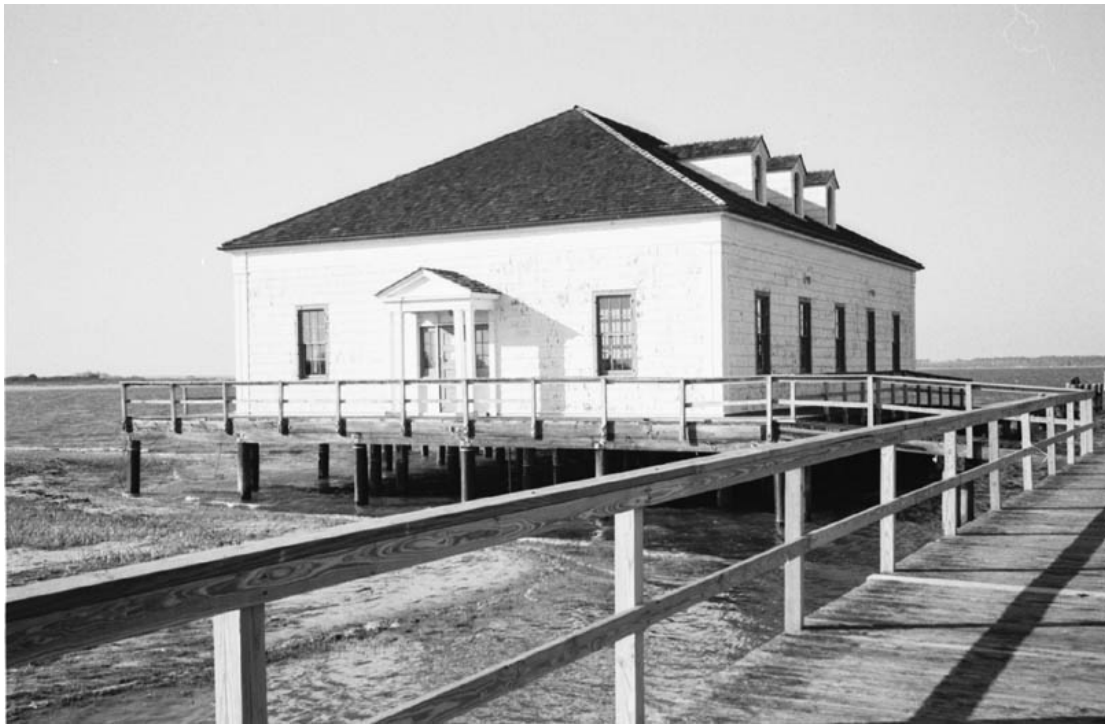
*Fig. 25: View northwest of the 1939 boathouse. Note new railing on the wharf [Photo: NPS, 2000].*

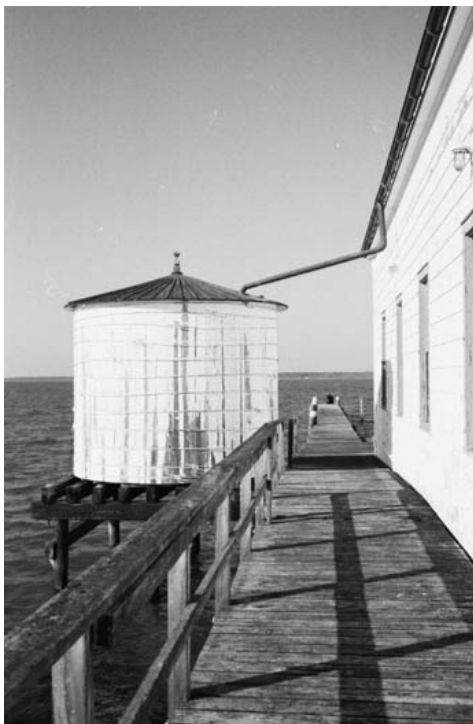
*Fig. 36: View north of the cistern and walkway at the boathouse [Photo: NPS, 2000].*

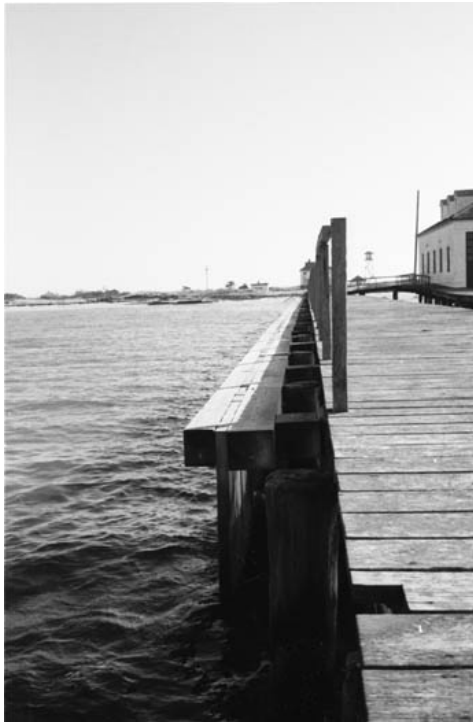
house was constructed behind the station house [LCS]. A breakwater, or bulkhead, was added on the east side of the wharf around 1950 to protect against the damaging conditions and effects of wave action [Fig. 37][U.S.C.G. log, June 28]. A concrete block electric generator building was added to the complex in 1959 and connected to the station house via a concrete walk [Fig.38] [Phillips, 24]; prior to this, a generator was present in the basement of the station house.

*Fig. 37: View south of the remaining breakwater structure attached to the wharf [Photo: NPS, 2000].*

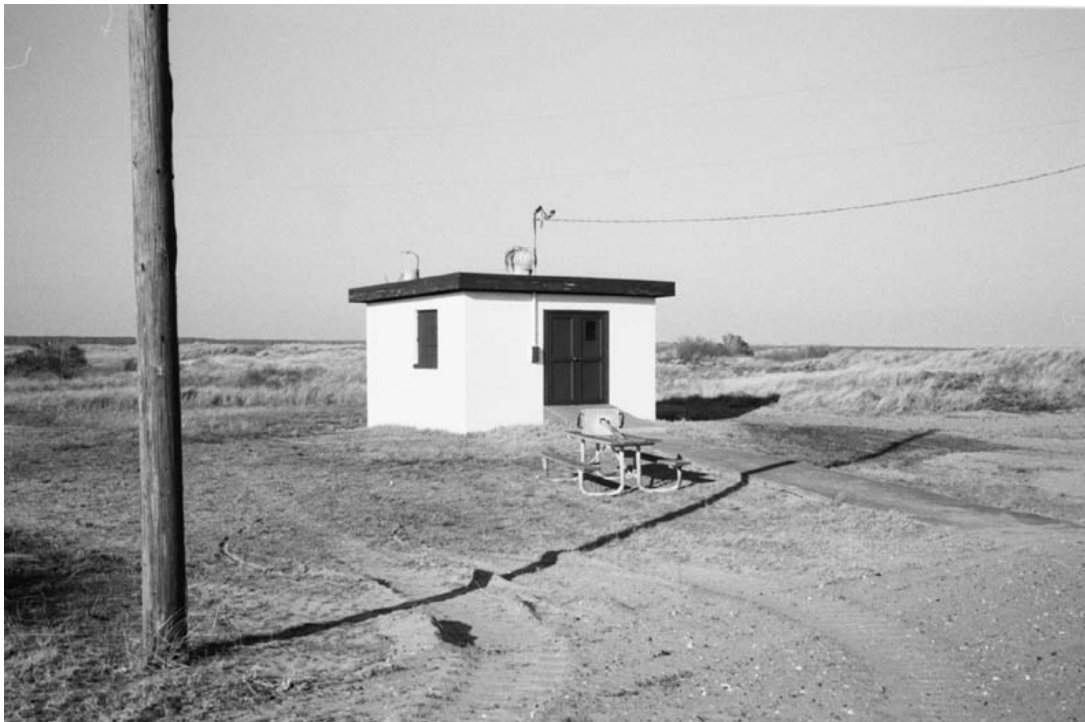
The 1959 generator building is standing and used today. All that remains of the fire pump house is the foundation [Fig. 38, 39]. The Navy Triangulation tower has only left behind traces of its existence in a few broken pieces of concrete. A few utility poles also remain along the wooden walkway.

*Fig. 38: View northeast of the 1959 generator house [Photo: NPS, 2000].*

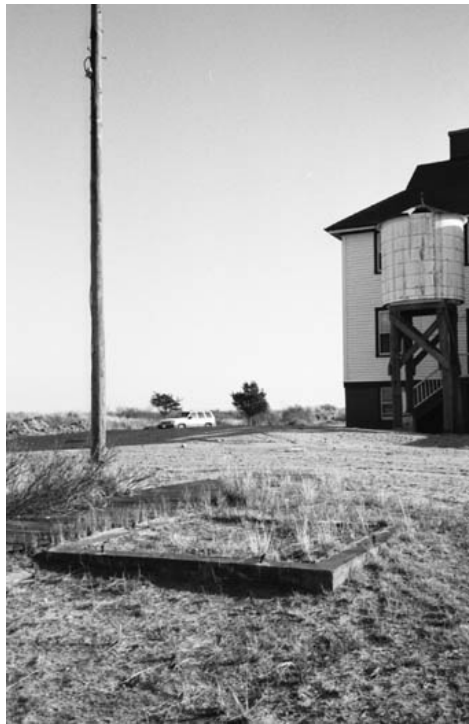
*Fig. 39: View southeast of the remaining pump house foundation. Note where the wooden walkway begins [Photo: NPS, 2000].*

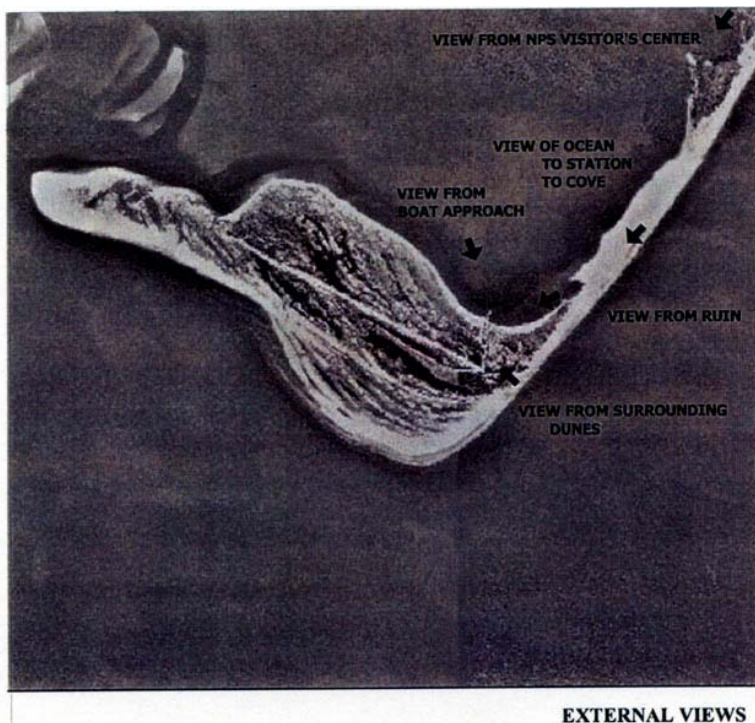
Existing Views and Vistas Map [Created by NPS using 1997 aerial photography , 2001].

On-site views include 360-degree panoramic views from the tower of the ocean, cove, and dune landscape [Fig. 41]. On the beaches, views to the Atlantic Ocean horizon and to Toms Cove are significant. The view north across Toms Cove includes the Assateague Lighthouse; views east include the Seaboard Fish Oil and Guano Factory ruins. From the tower, there is a view of the station building complex.

Other important internal views include a view from the station house to the boathouse and from the boathouse to the station house and a view from the station house across the yard towards the garage and dunes. Similar views are also afforded from the boathouse and station house interiors [Fig.42]. No matter in which direction one looks today, there are no modern intrusions to a scene that has hardly changed since the period of significance.

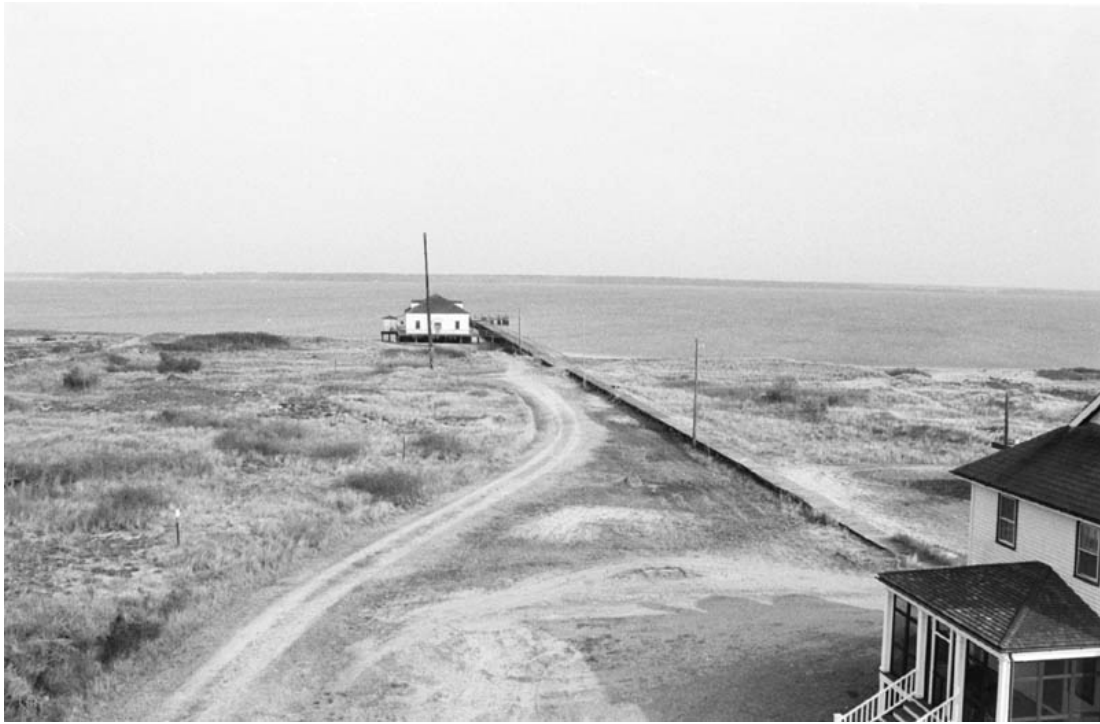
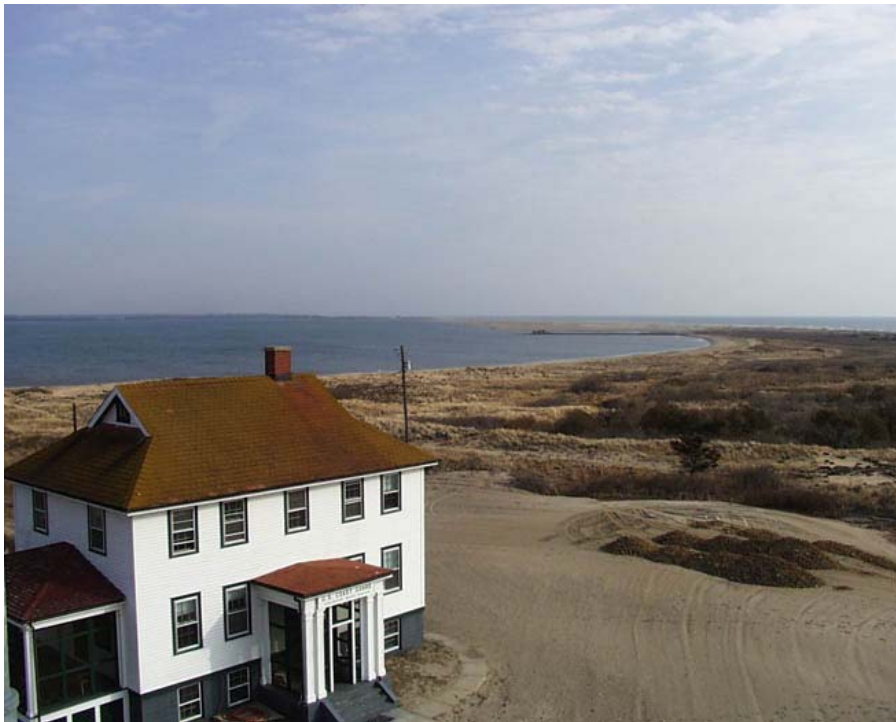
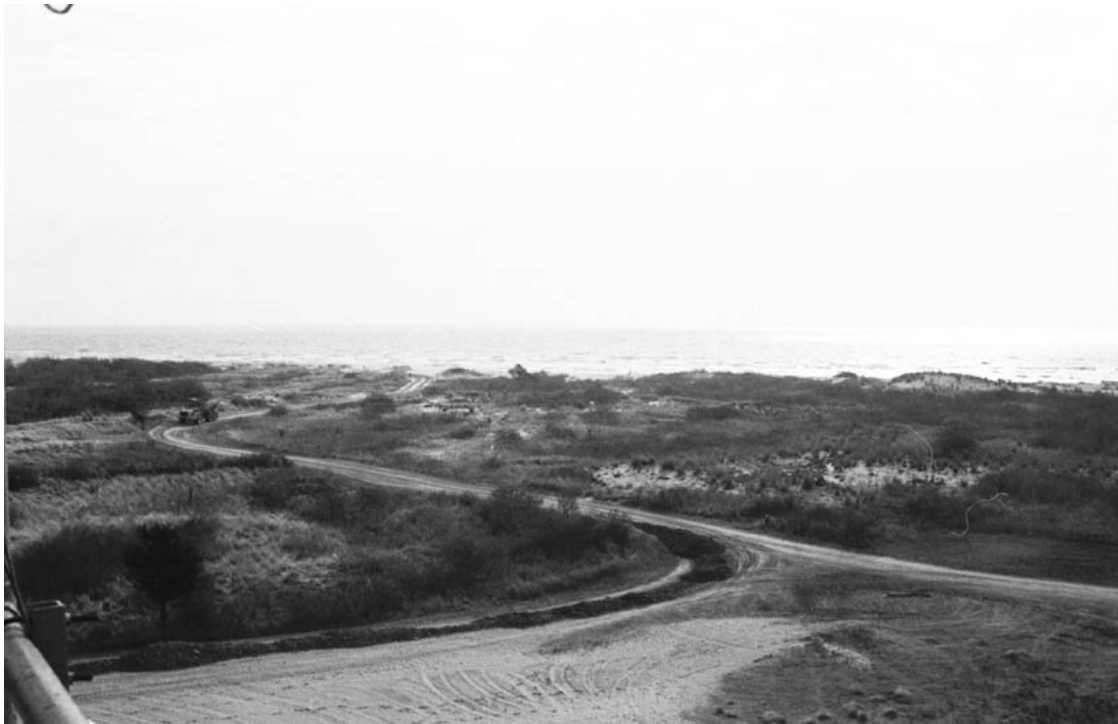
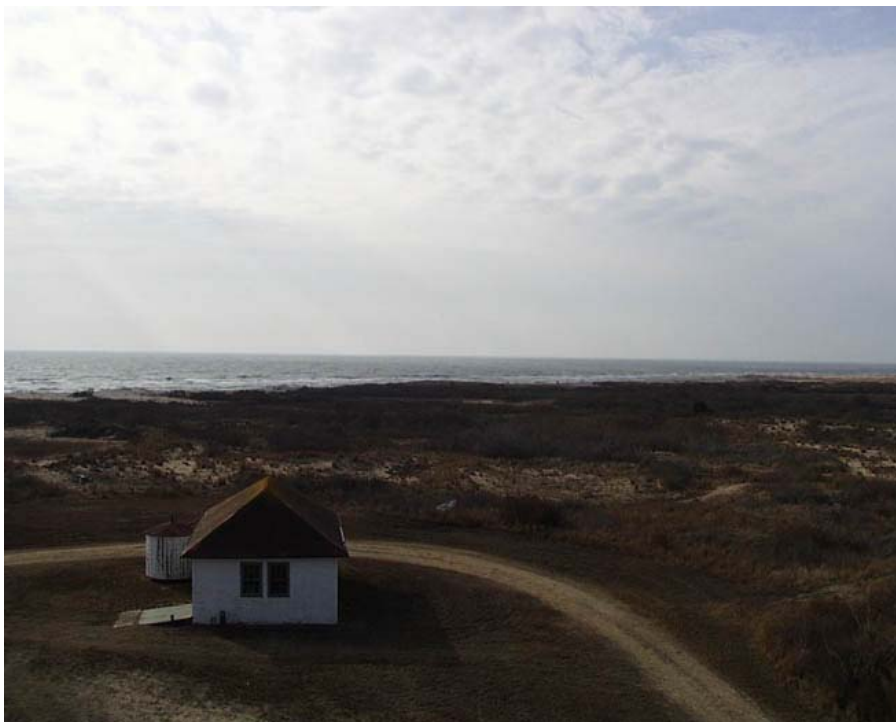
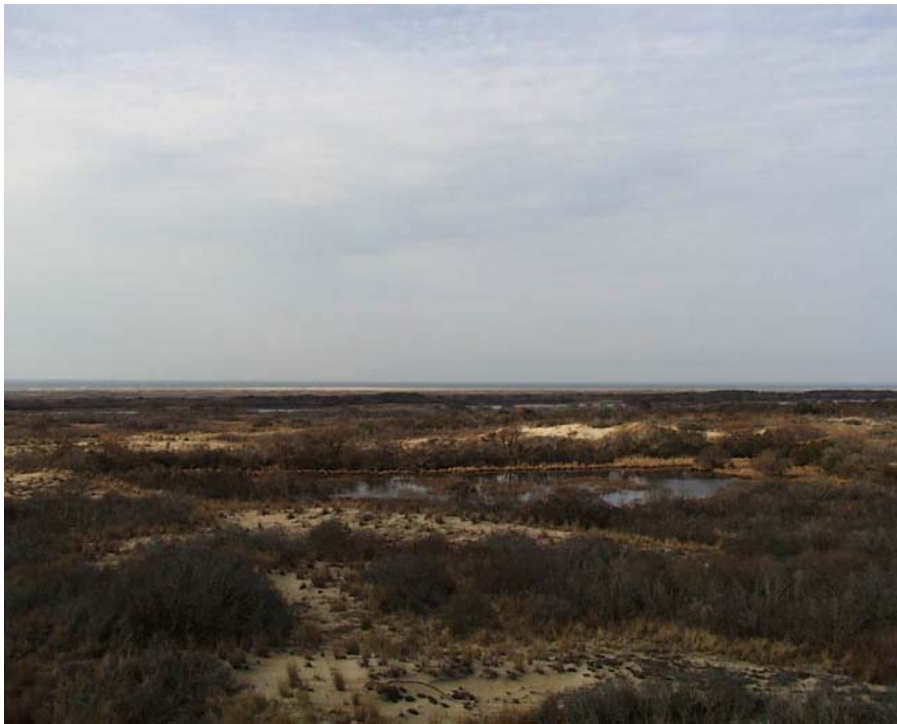
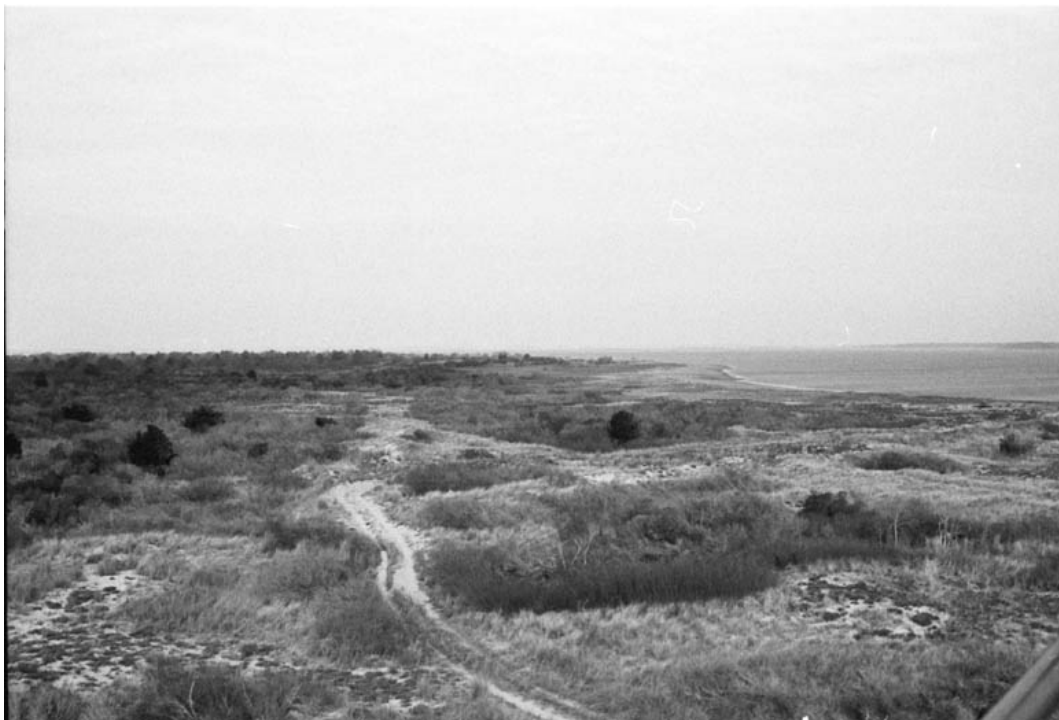
*Fig. 41a: Views from the tower beginning north at the cove and moving clockwise [Photo: NPS, 2000].*

*Fig. 41b: Views from the tower beginning north at the cove (a) and moving clockwise [Photo: NPS, 2000].*

*Fig. 41c: Views from the tower beginning north at the cove (a) and moving clockwise [Photo: NPS, 2000].*

*Fig. 41d: Views from the tower beginning north at the cove (a) and moving clockwise [Photo: NPS, 2000].*

*Fig. 41e: Views from the tower beginning north at the cove (a) and moving clockwise [Photo: NPS, 2000].*

*Fig. 41f: Views from the tower beginning north at the cove (a) and moving clockwise [Photo: NPS, 2000].*

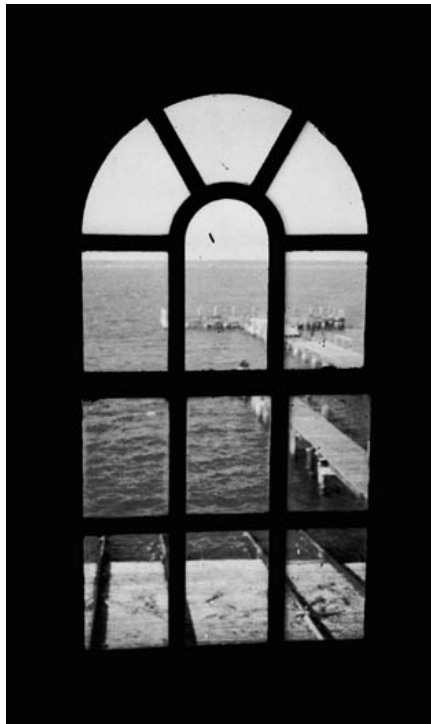
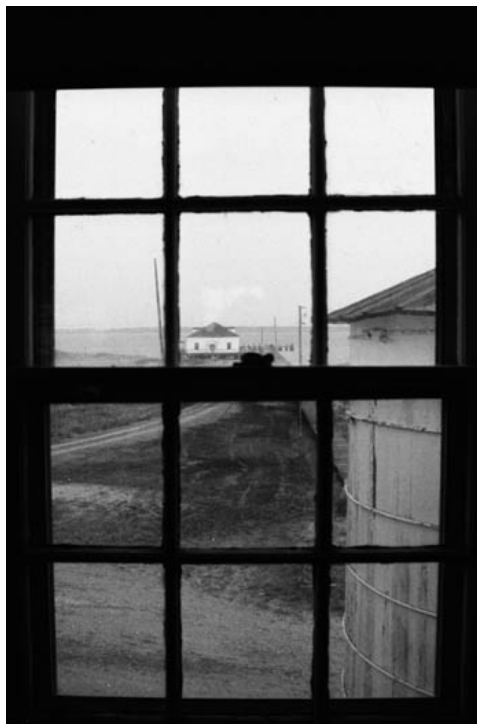
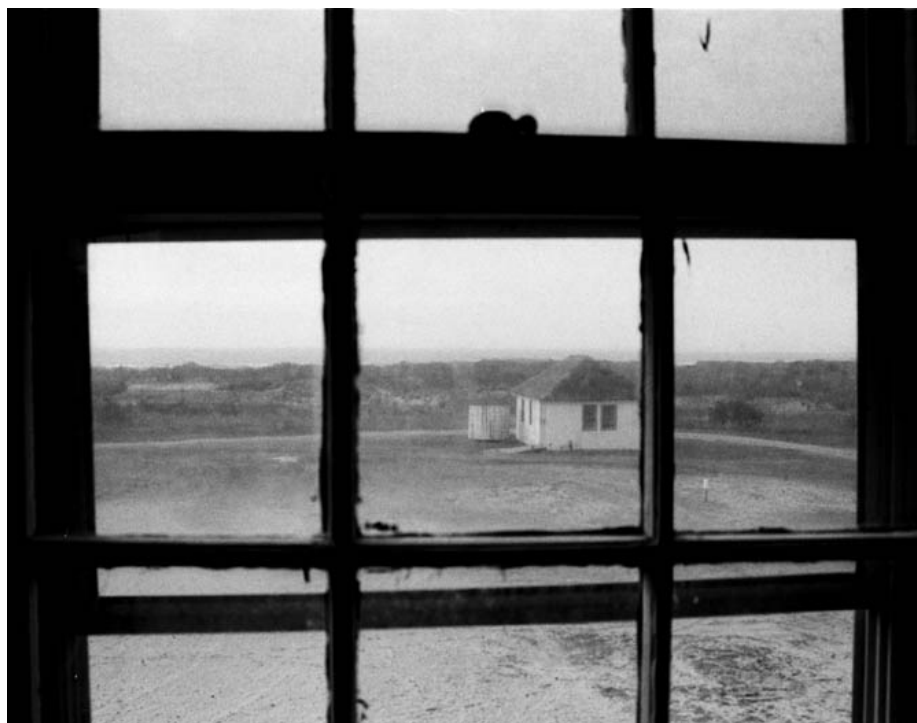
*Fig. 42a: View north from the boathouse loft [Photo: NPS, 2000].*

*Fig. 42b: View north from the Station House [Photo: NPS, 2000].*

*Fig. 42c: View south from the Station House [Photo: NPS, 2000].*

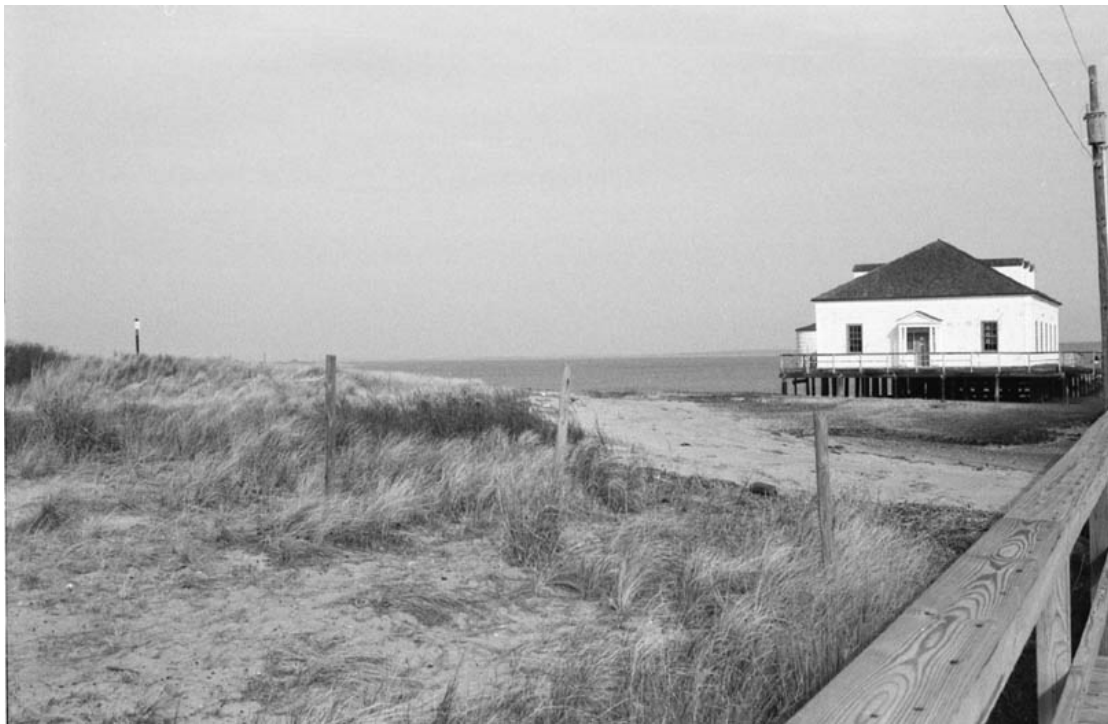
*Fig. 43: View northwest of remnant wooden posts on the shore of Toms Cove [Photo: NPS, 2000].*
