National Park Service  
Cultural Landscapes Inventory  
2004

Assateague Beach Coast Guard Station  
Assateague Island National Seashore

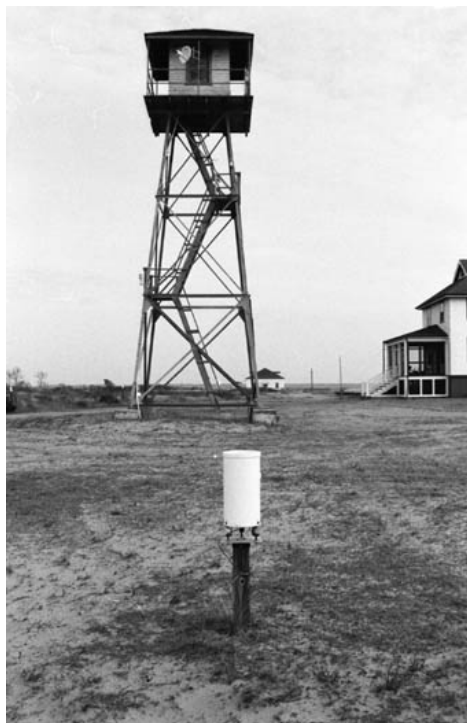
Fig. 44: View north of NASA meteorological equipment and the lookout tower [Photo: NPS, 2000].

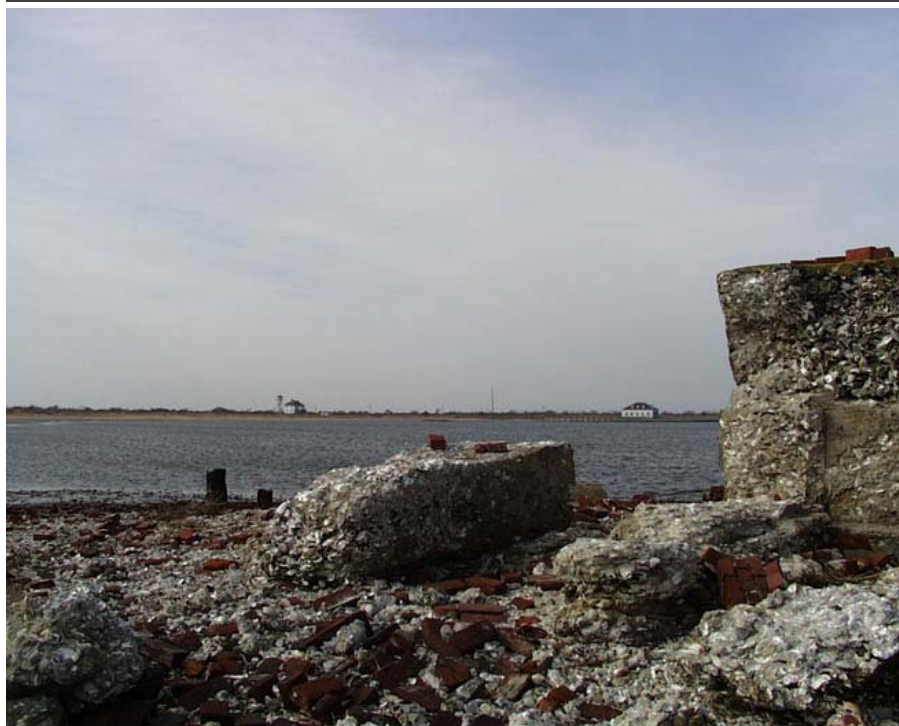
*Fig. 45: View southwest to the station complex from the Seaboard Fish Oil & Guano Factory Ruins [Photo: NPS, 2000].*

Off-site, there is a broad view of the cove and the Coast Guard Station from the Toms Cove Visitor's Center. The station can be seen as a backdrop to the brick artifacts of the Seaboard Fish Oil and Guano Factory Ruins [Fig.45]. The linear organization of the complex from ocean to cove is presented upon approach to the station [Fig. 23]. Other important off-site views include the station with beach and dune in the foreground [Fig. 22] and from Fishing Point upon approach by boat.

In 1984, an archeological survey was completed at the Seaboard Fish and Guano Company located a short distance east of the station complex [Fig. 45][Interview, 2000, Finlay & Cooper]. However, no study has been done for the Chincoteague Fish, Oil, and Guano Company located adjacent to the Coast Guard Station.
