National Park Service  
Cultural Landscapes Inventory

Revised: 3/2025

Poplar Grove National Cemetery  
Poplar Grove National Cemetery

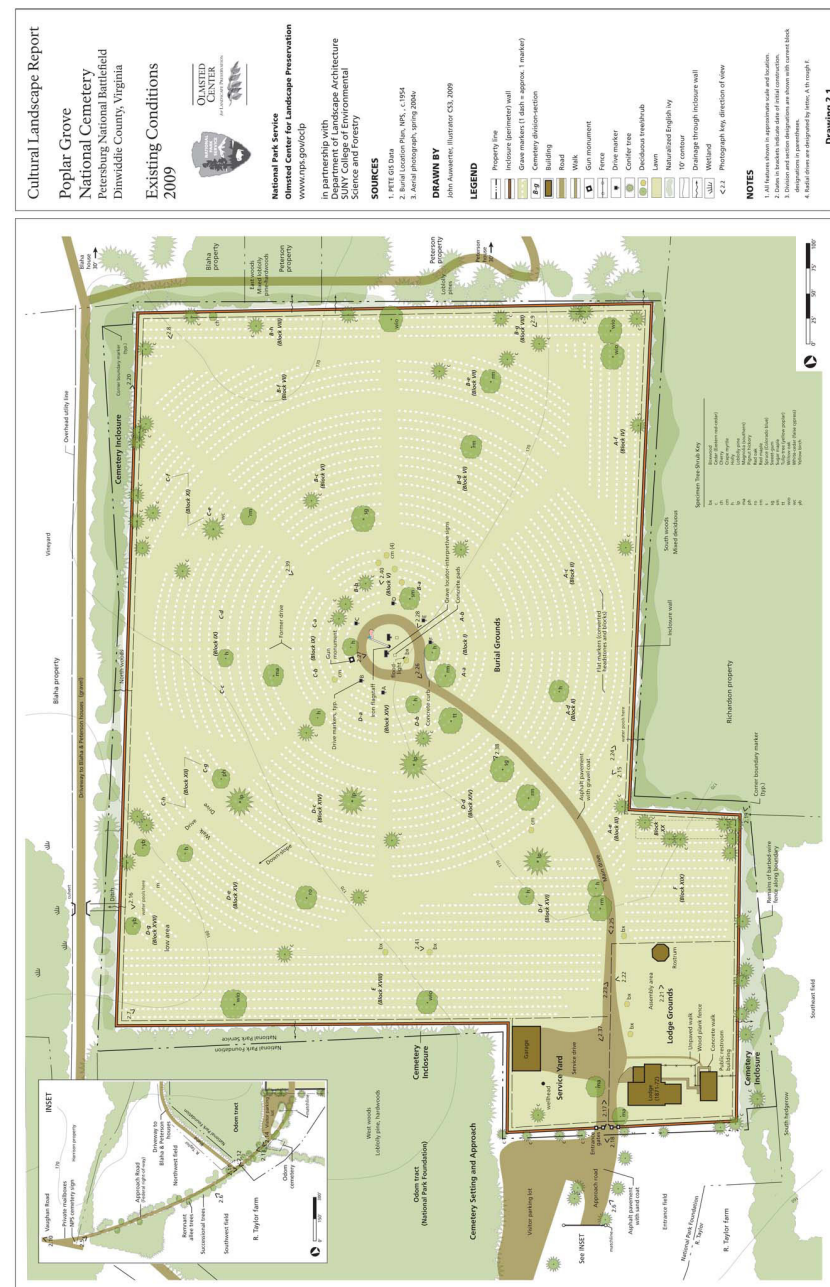
**Site Plan**

*Site plan for Poplar Grove National Cemetery (SUNY ESF, 2009).*

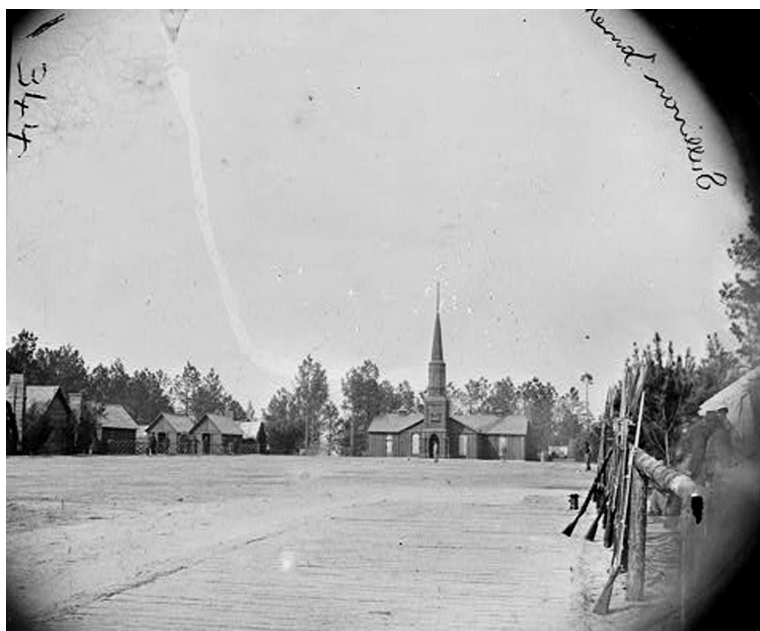
Figure 4. Poplar Grove Church looking north across the parade ground, March 1865, and log fence, corduroy walk, and pine hedge along the barracks area (Poplar Grove CLR:25, Library of Congress American Memory Collection, digital image LC-DIG-cwppb-04329).

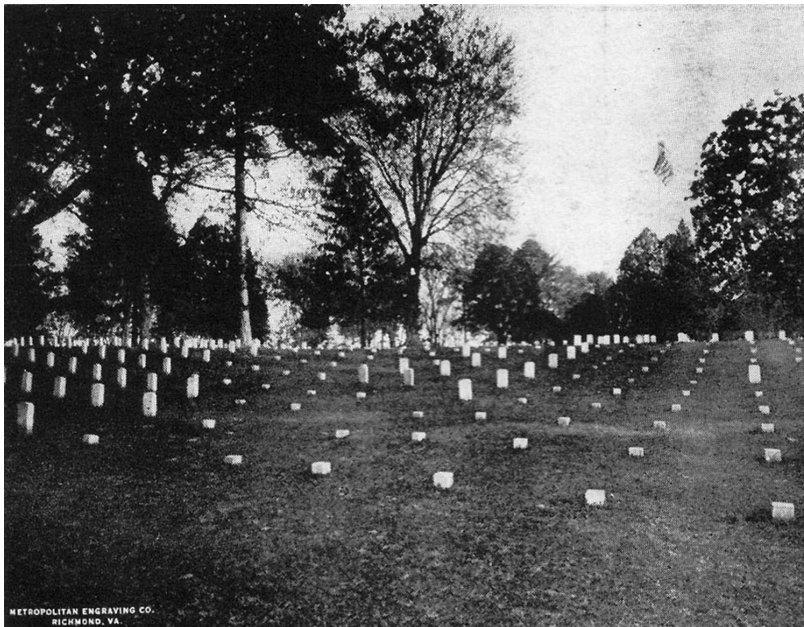
Figure 6. Circa 1930 photograph of the two types of grave markers installed in 1877 (Poplar Grove CLR:69, Metropolitan Engraving Company, reproduced from the City of Petersburg, Metropolis of Southside Virginia, Louise Studio, c.1930).

the work was completed. Although the new headstones continued the same white tablet form in the landscape, the substitution of blocks for the headstones at the unknown graves—amounting to over sixty percent of all grave markers—changed the uniformity of the circular plan (Figure 6). The new stones made clearly visible the enormous number of soldiers who died on the battlefield without proper identification and registration.

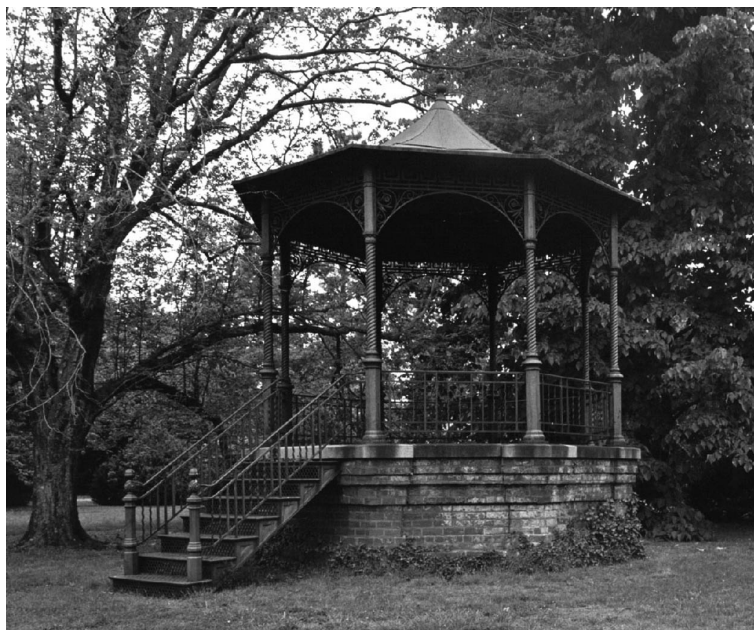
*Figure 8. The Poplar Grove rostrum completed in 1897, looking east from a 1967 photograph by Fred Bell (Poplar Grove CLR:79, Poplar Grove administrative files, Petersburg National Battlefield).*

improvements. Quartermaster inspection reports from the 1880s through the first decade of the twentieth century remarked on the generally good condition of the cemetery. The most notable standard Quartermaster improvement during this time was the addition of a rostrum (bandstand) where speakers gave memorial addresses. The Poplar Grove rostrum, an iron structure completed on January 2, 1897, was a standard design sited in the open area between the graves in Division F and the circular turn-around. It was an octagonal pavilion with cast-iron posts and wrought-iron ornamentation, set on a raised brick foundation, measuring fourteen feet in diameter with a ceiling height of ten and one-half feet (Figure 8).

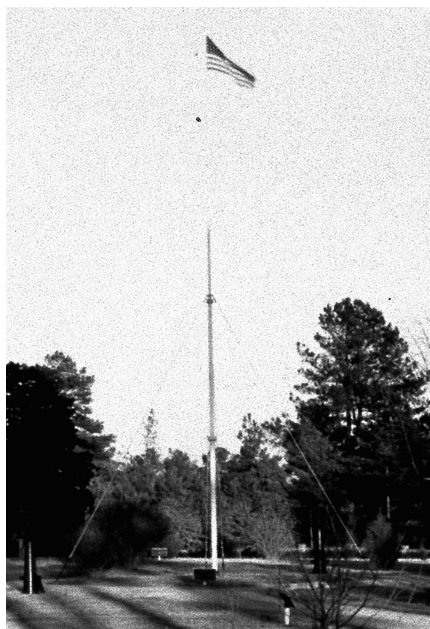
Figure 11. The new iron flagstaff installed in October 1930, from a detail of a 1930 photograph (Poplar Grove CLR:86, The Library of Virginia, from Virginia Room Exhibit at the 1939 World's Fair, image/WF/05/06/017).

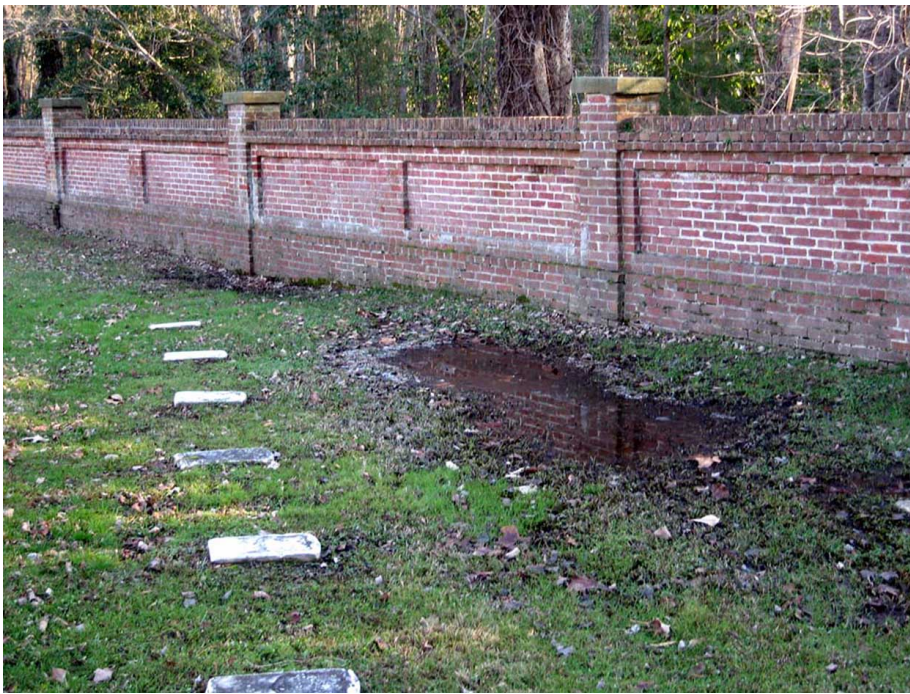
*Figure 18. View of the inclosure wall at the south side of the cemetery where a low area creates drainage issues (SUNY ESF, 2006).*

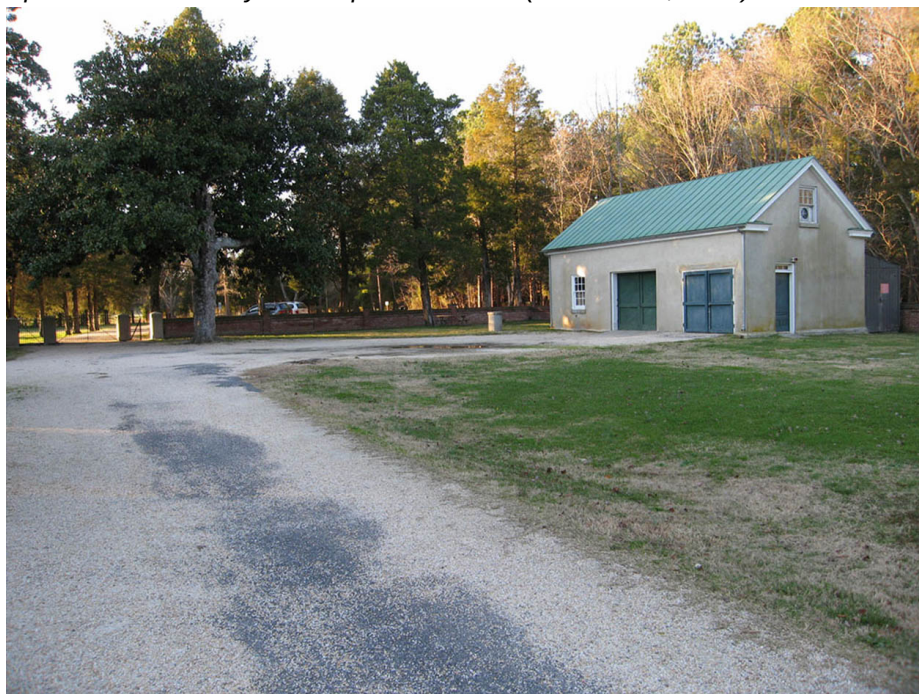
*Figure 20. The garage and service yard, looking west from the burial grounds toward the cemetery entrance gate (SUNY ESF, 2006).*

The service yard, developed beginning in c.1871 as the cemetery's maintenance area, is defined by the inclosure wall, main drive, and burial grounds. It occupies the portion of the one-acre addition (1868) north of the main drive. During the historic period, the service yard was initially enclosed on the south and east sides by a boxwood hedge and lattice fence, which were replaced in c.1888 by an arborvitae hedge. Inside of the hedge, the yard contained several service buildings and a privy at the northeast corner that were replaced in 1929 by the present garage. There was also a well house in the center of the yard, which was removed in c.1939 and replaced by a new well with an inconspicuous wellhead in c.1974. In c.1974, the arborvitae hedge was removed and the limits of the service drive were expanded. Although the historic enclosure provided by the arborvitae hedge has been lost and the drive is much larger than it was historically, the service yard remains a character-defining space in the cemetery landscape (Figure 20).

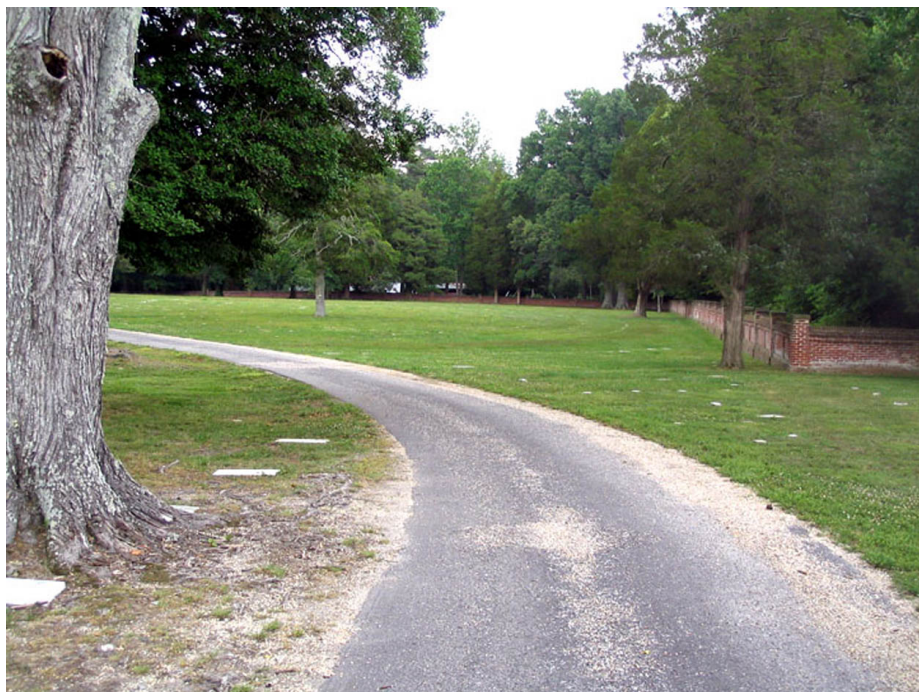
*Figure 21. The main drive, looking east from near the rostrum showing asphalt paving with gravel surface coat (SUNY ESF, 2006).*

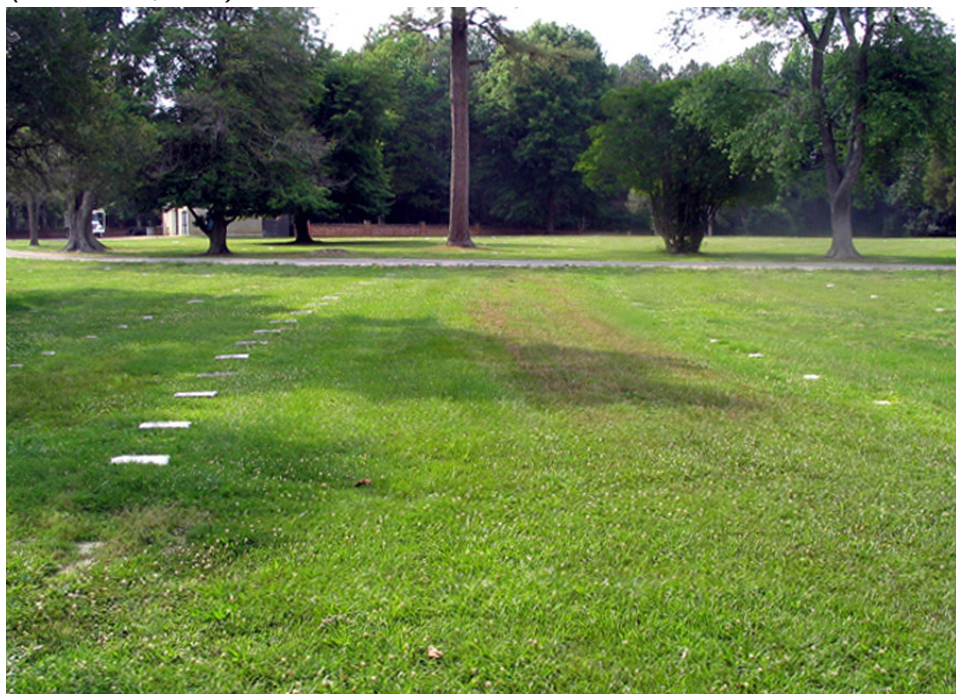
*Figure 22. Characteristic turf drive and walks, looking northwest toward the main drive. The wider space is a drive, the narrower space between the rows of grave markers are walks (SUNY ESF, 2006).*

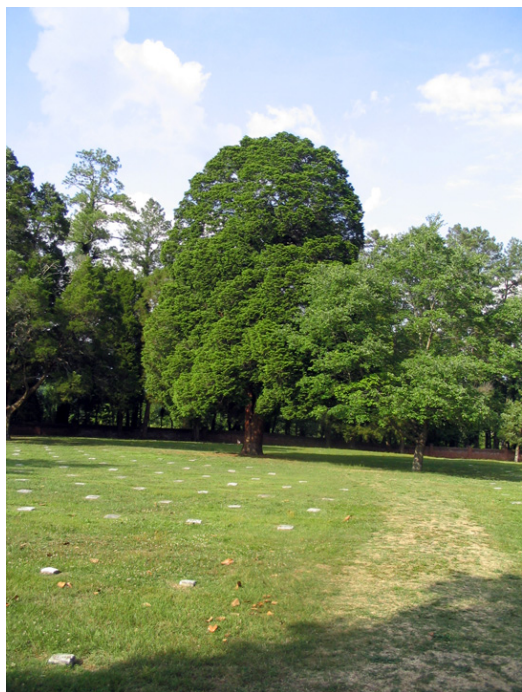
*Figure 23. Eighty specimen trees are located in the cemetery, twenty of which date to the historic period (SUNY ESF, 2006).*

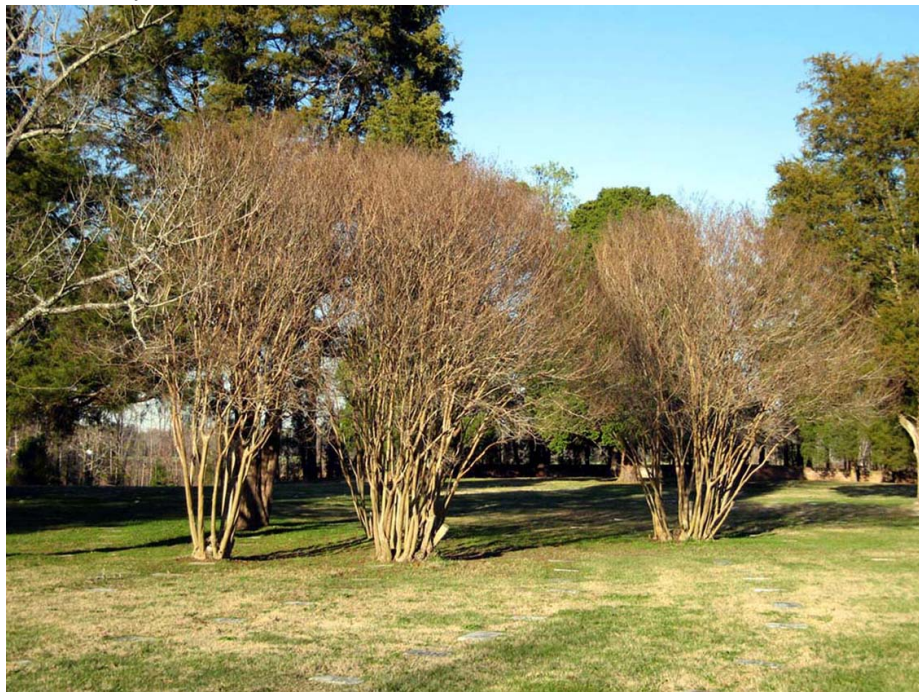
*Figure 24. Many shrubs in the cemetery post-date the period of significance or are over-mature historic specimens (SUNY ESF, 2006).*

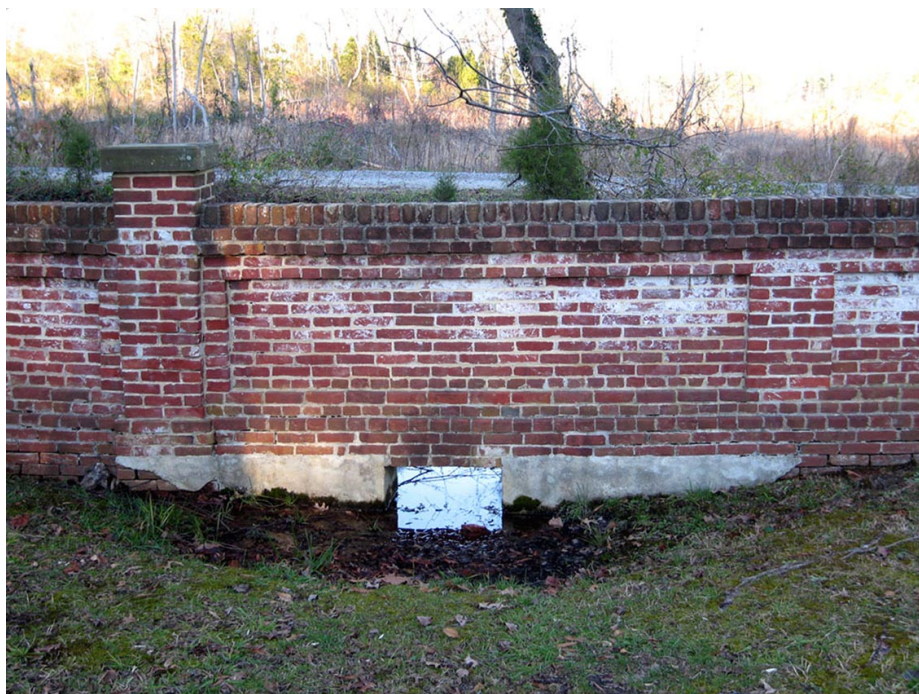
*Figure 25. The brick inclosure wall, showing one of the eight drainage holes (SUNY ESF, 2006).*

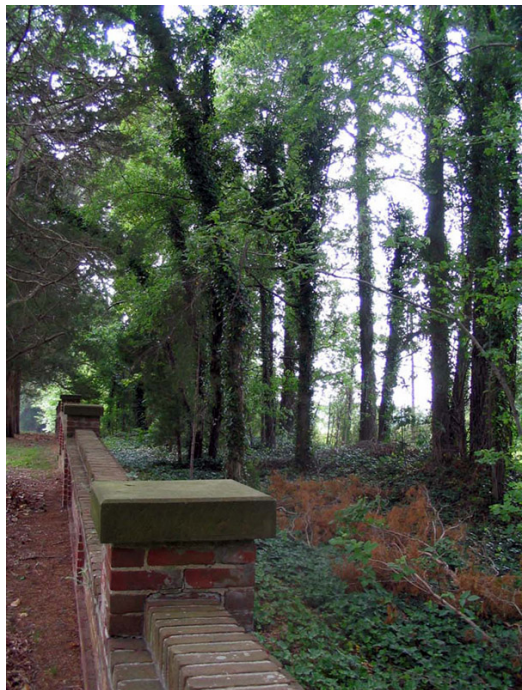
*Figure 26. The woods along the north side of the cemetery, looking west showing English ivy groundcover and high canopy (SUNY ESF, 2006).*

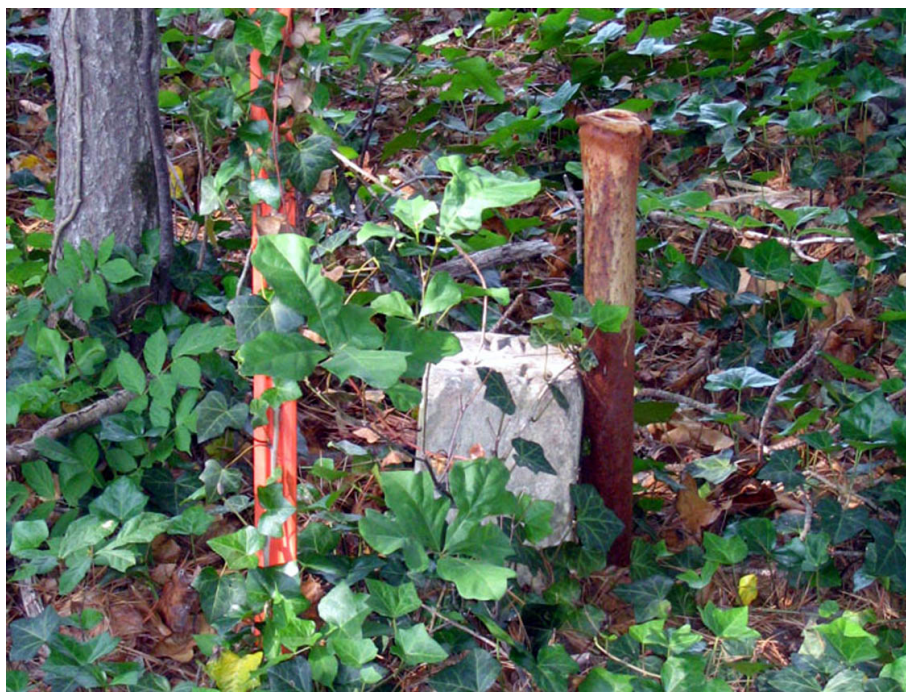
Figure 30. A typical stone boundary marking a corner of the federal property (SUNY ESF, 2006).

The corners of the federally owned cemetery property are marked by low stone posts (Figure 30). These posts were installed in 1877 as part of the resurvey and expansion of the cemetery property undertaken for construction of the inclosure wall. The irregular lines of the boundary are a result of the inaccurate original (c.1868) survey overlaid by the 1877 expansion that added a buffer strip between zero and ten feet to the perimeter of the cemetery. Although the corner boundary markers are not conspicuous in the landscape, they convey the historic limits of the federal property. Pipe posts located next to the stone posts (along with contemporary orange stakes), probably added after 1934, do not contribute to the historic character of the landscape.

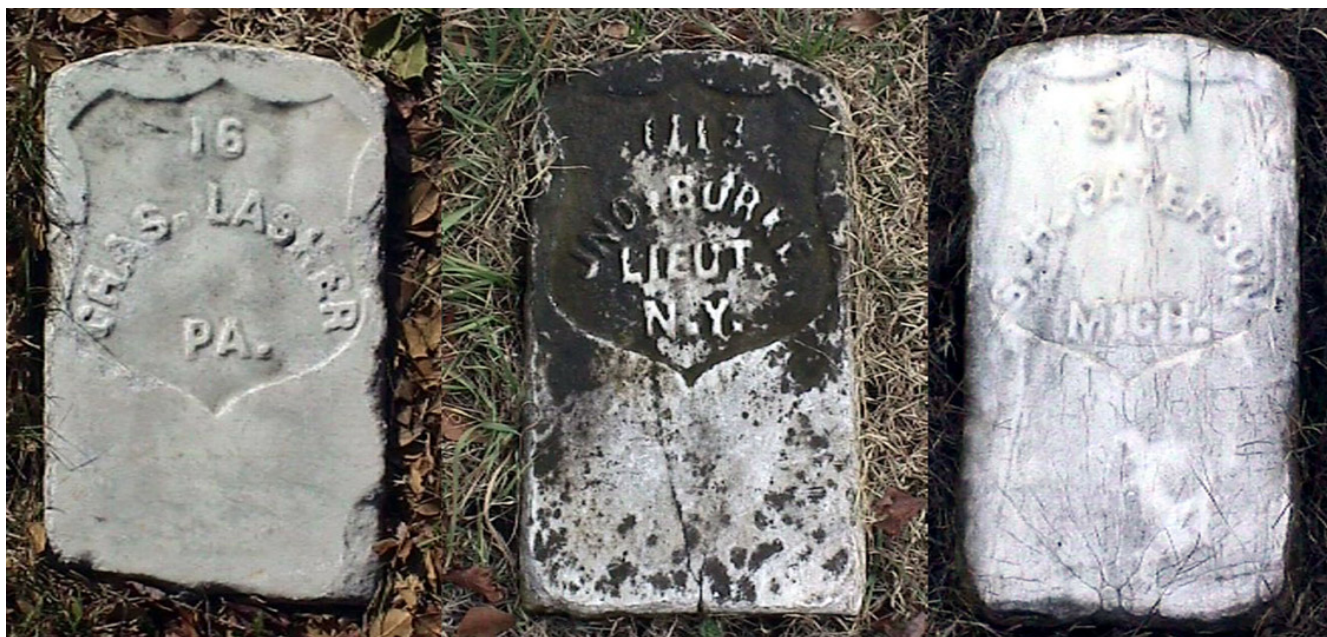
Figure 31. Examples of headstones installed in 1877 and transformed into flat markers in 1934. These photographs illustrate characteristic chipping, cracking, weathering, and staining Petersburg National Battlefield).

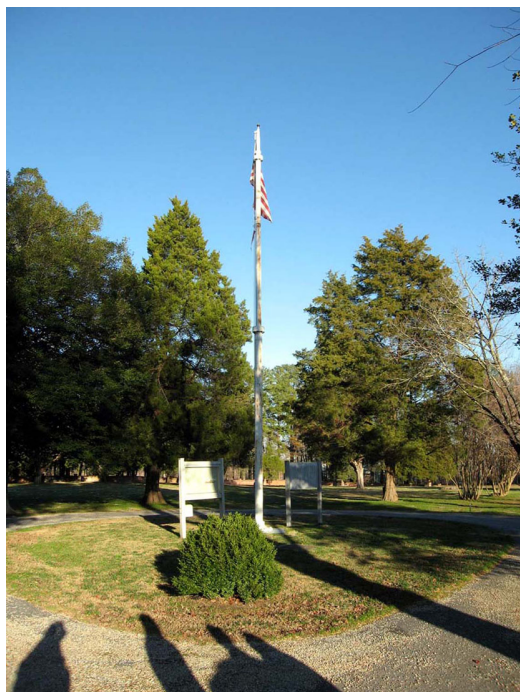
*Figure 32. The center of the cemetery, looking northeast from the main drive showing the flagstaff, teardrop-shaped loop in the main drive, and interpretive signs. The boxwood shrub in the foreground conceals a contemporary floodlight (SUNY ESF, 2006).*

The flagstaff, located within a circular island defined by a loop in the main entrance drive, is the physical and symbolic center of the cemetery (Figure 32). The first flagstaff (height not known) was erected at the start of the cemetery's development in 1866, and was positioned on a six-foot high mound in the shape of frustum of a cone. By 1874, this wooden pole had deteriorated and was replaced under contract to J.C. Comfort of Shiremanstown, Pennsylvania, with a fifty-six foot tall wood flagstaff. At this time, the flagstaff mound was reduced in size to four feet tall and twenty-three feet wide. In 1913, the wood flagstaff, which cemetery inspectors had found to be too short, was again replaced with an iron pole (height not known). This iron pole was replaced in 1930 with a taller pole. It was constructed of sections bolted together with flanges, anchored by four guy wires, and surmounted by a ball finial. National Cemetery regulations called for the flagstaff to be white with the base and guy wire turnbuckles painted black. At approximately eighty feet high, the flagstaff reached above the tree canopy and was visible from Vaughan Road. This same style of flagstaff was installed at Fredericksburg National Cemetery. After the historic period, the pole was reduced in height by roughly half and the guy wires were removed. Due to this extensive change, the flagstaff does not contribute to the historic character of the landscape. It was historically a defining feature.

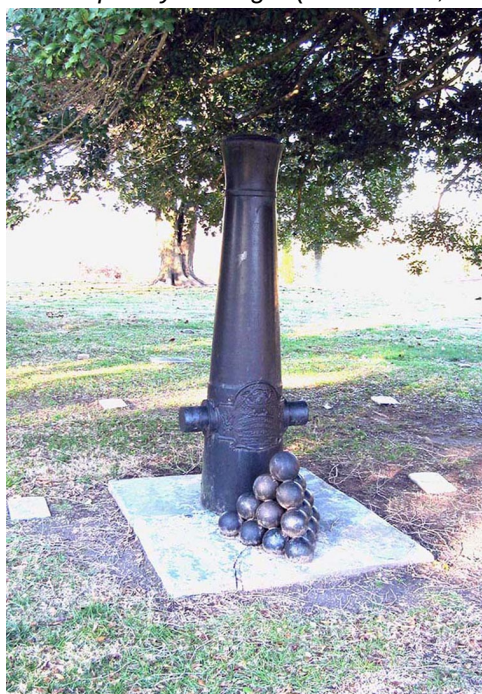
*Figure 33. The remnant gun monument with its painted over bronze plaque and missing cannonball cap, looking northwest (SUNY ESF, 2006).*

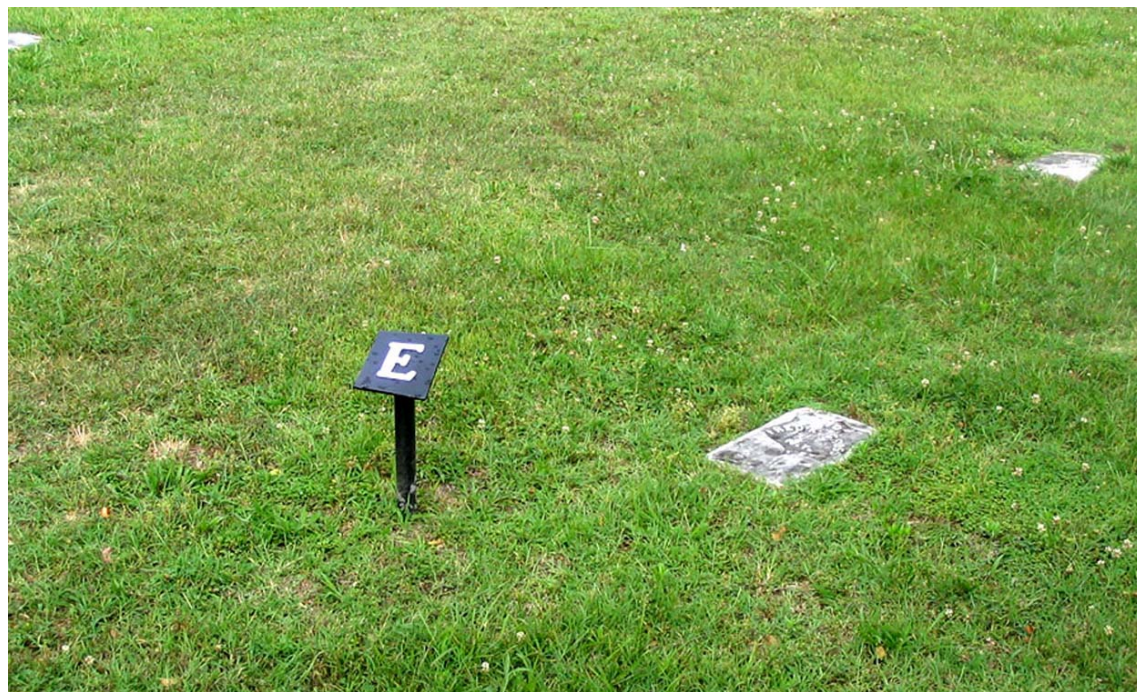
*Figure 34. One of the metal signs along the central circular loop of the main drive identifying radial drive “E” (SUNY ESF, 2006).*
