National Park Service  
Cultural Landscapes Inventory  
2005

Point Bonita Historic District  
Golden Gate National Recreation Area

## Cultural Landscape Inventory: Point Bonita Historic District

CONDITION ASSESSMENT: **Fair**

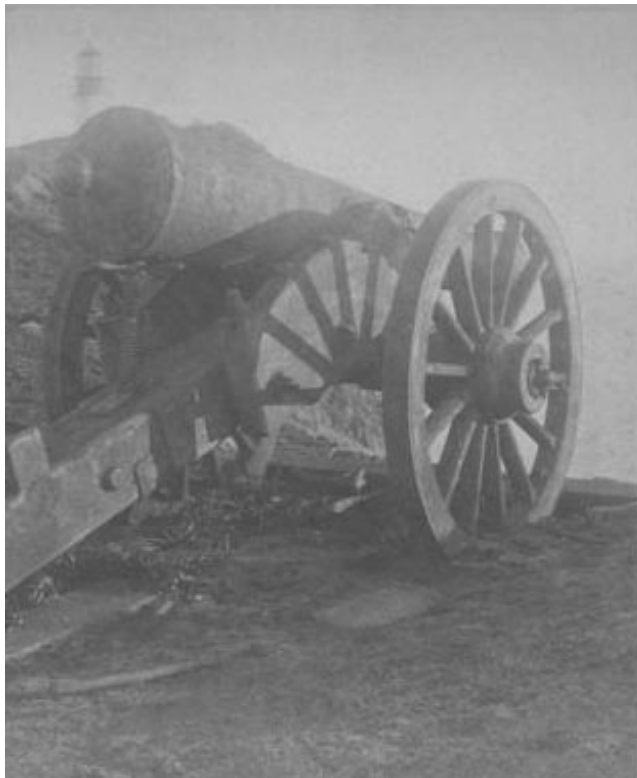
*History #1: The first operating fog-signal on the West Coast, circa 1870; the original 1855 lighthouse can be seen in the background on the far left side. (U.S. Coast Guard, 12th District)*

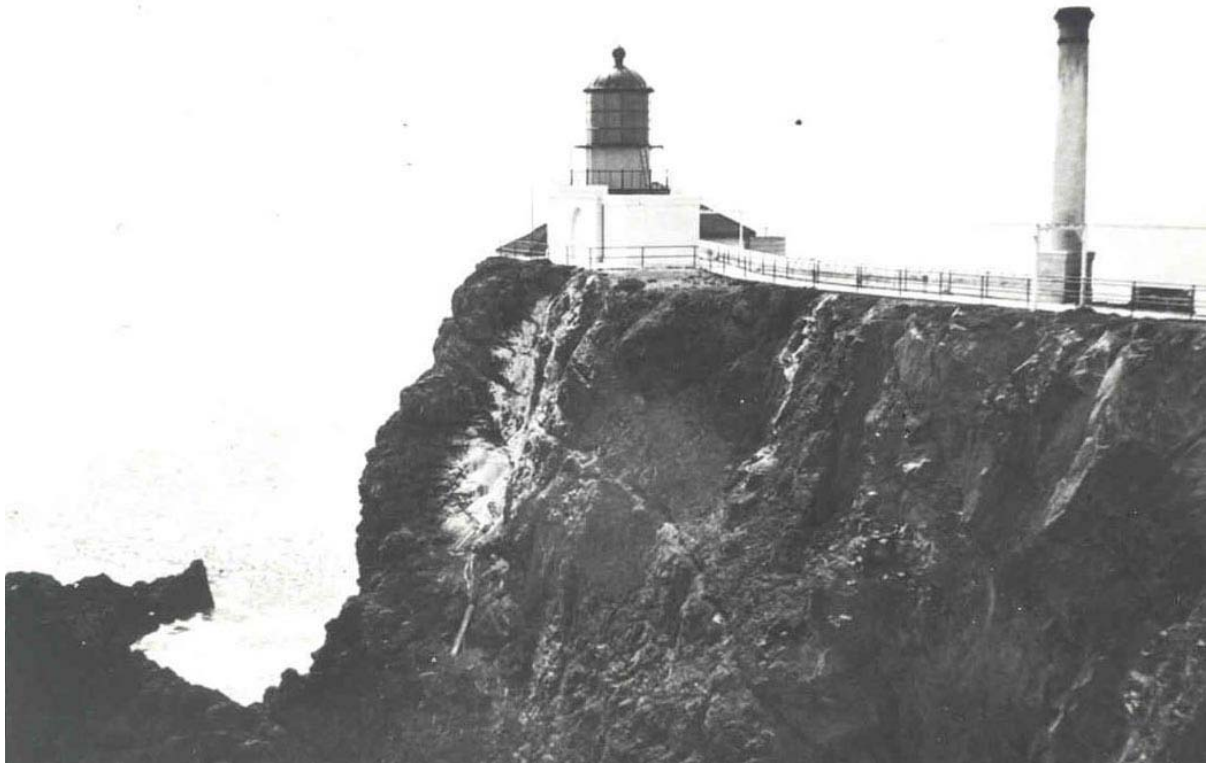
*History #3: Circa 1910 view of the 1877 brick lighthouse, with the 1855 metal lantern and lamp rooms. The 1903 fog-signal building roof is in the background. The brick chimney for the fog-signal boilers is on the right. (U.S. Coast Guard, 12th District)*

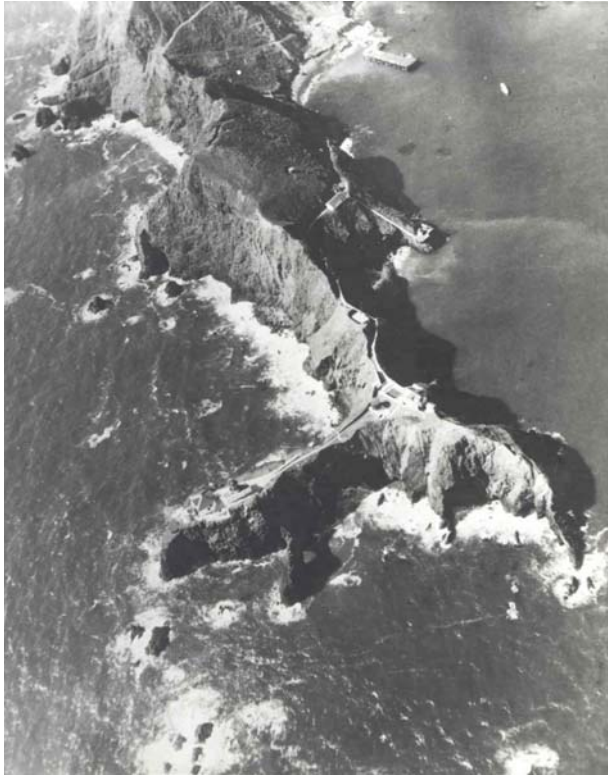
*History #4: Circa 1940, the aerial photo shows the lighthouse tower, 1874 fog-signal building, 1903 fog-signal building, oil tanks, inclined tramway, and the trail to the light. (Golden Gate National Recreation Area Park Archives and Record Center)*

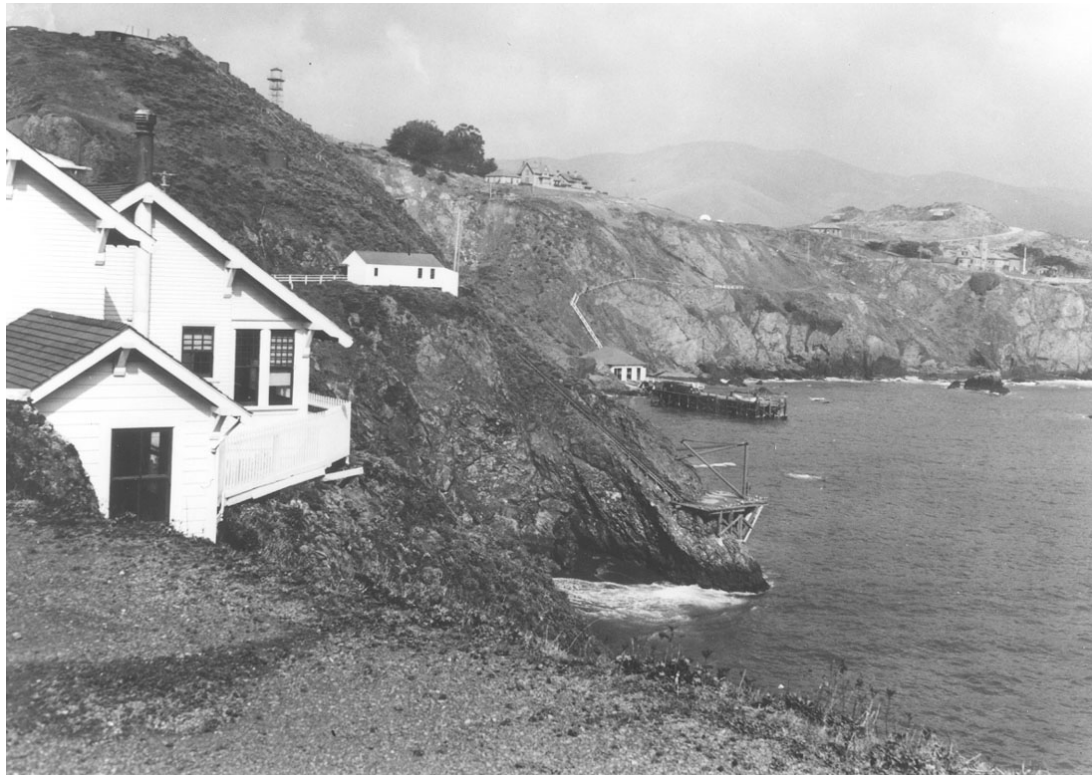
*History #5: Point Bonita Cove, from left to right, with the fog-signal building, turn-around station above the derrick, Keeper's residences, life-saving station and the boathouse on the waterfront. (1908-40, PWR-Oakland, National Register Records)*

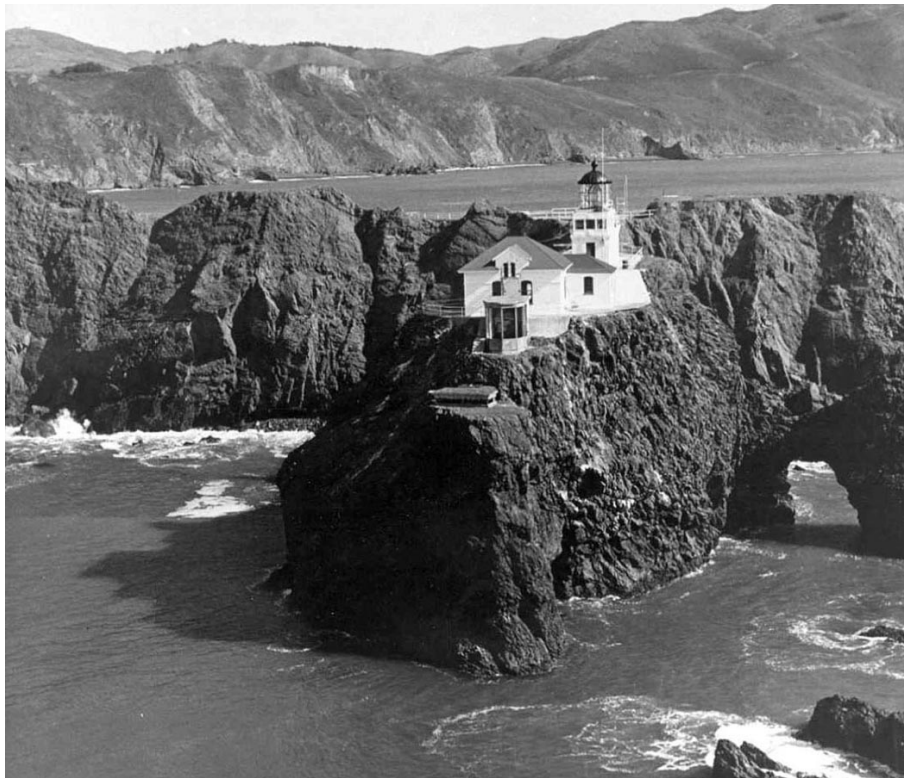
*History #6: 1967 oblique aerial view (looking east) of the abandoned U.S. Army fire control station and searchlight enclosure in front of the 1903 fog-signal building and lighthouse tower. (U.S. Coast Guard, 12th District)*

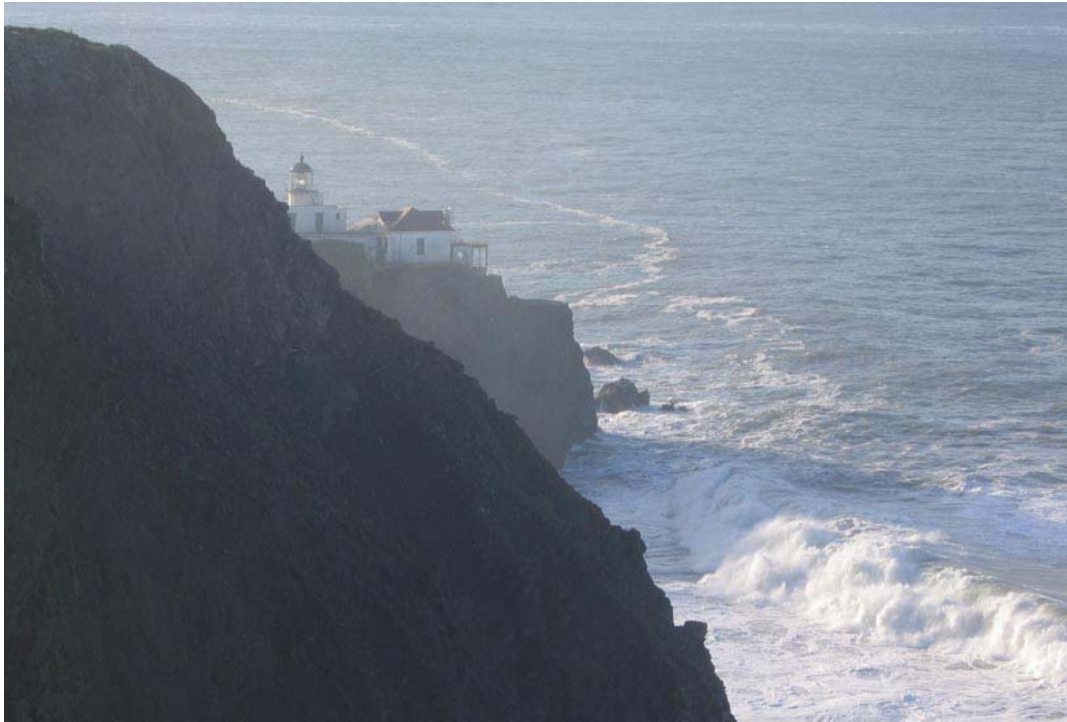
*Natural Systems and Features #2: View from the Point Bonita Ridge toward the lighthouse tower and fog-signal building showing the steep cliffs and rugged coast conditions at Point Bonita. (PWR, CLI, GOGA-D-2-22 013, 2005)*

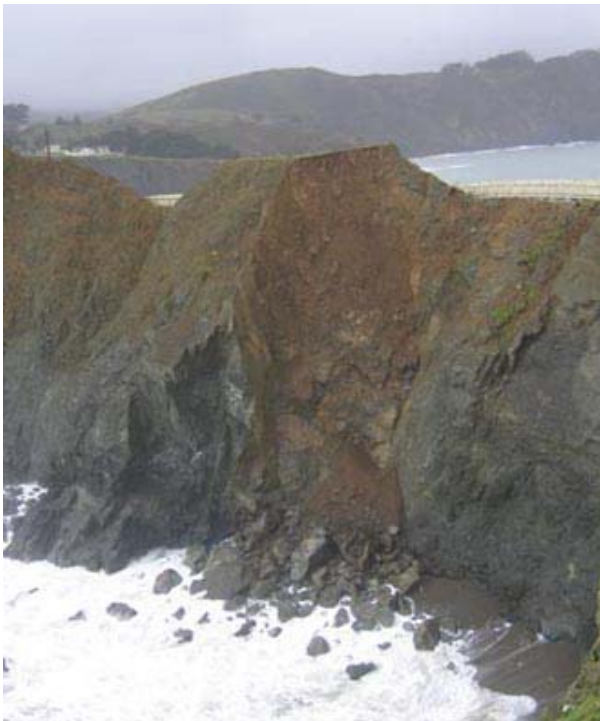
Natural Systems and Features #3: View of the January 10, 2005 landslide from the suspension bridge. (PWR, CLI, GOGA-D-1-25 019, 2005)

*Natural Systems and Features #3: View of the January 10, 2005 landslide from the suspension bridge. (PWR, CLI, GOGA-D-1-25 019, 2005)*

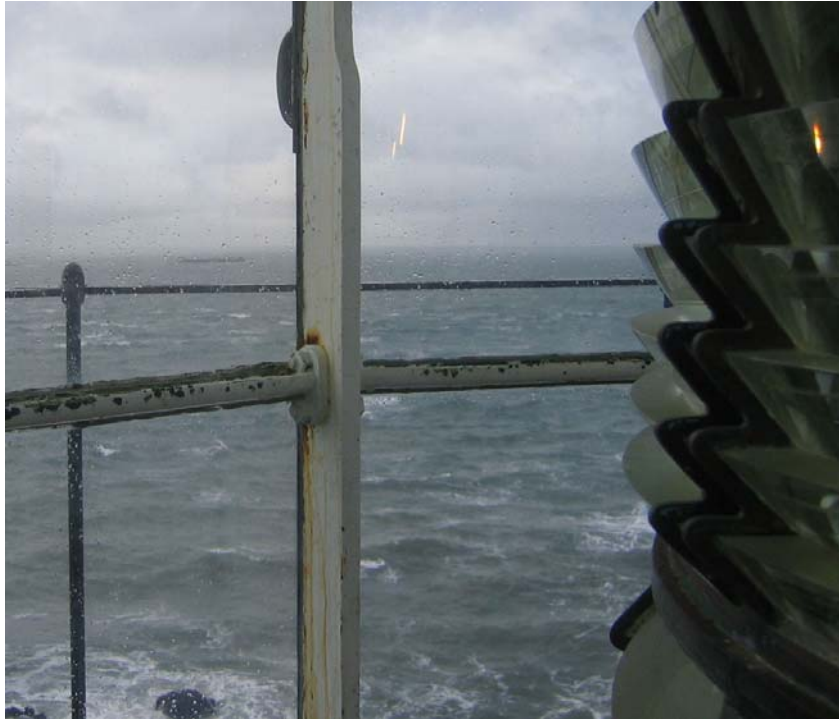
*Land Use #1: View from the lighthouse beacon room, as a container ship approaches the Golden Gate. Fresnel lens at right. (PWR, CLI, GOGA-D-1-25 023, 2005)*

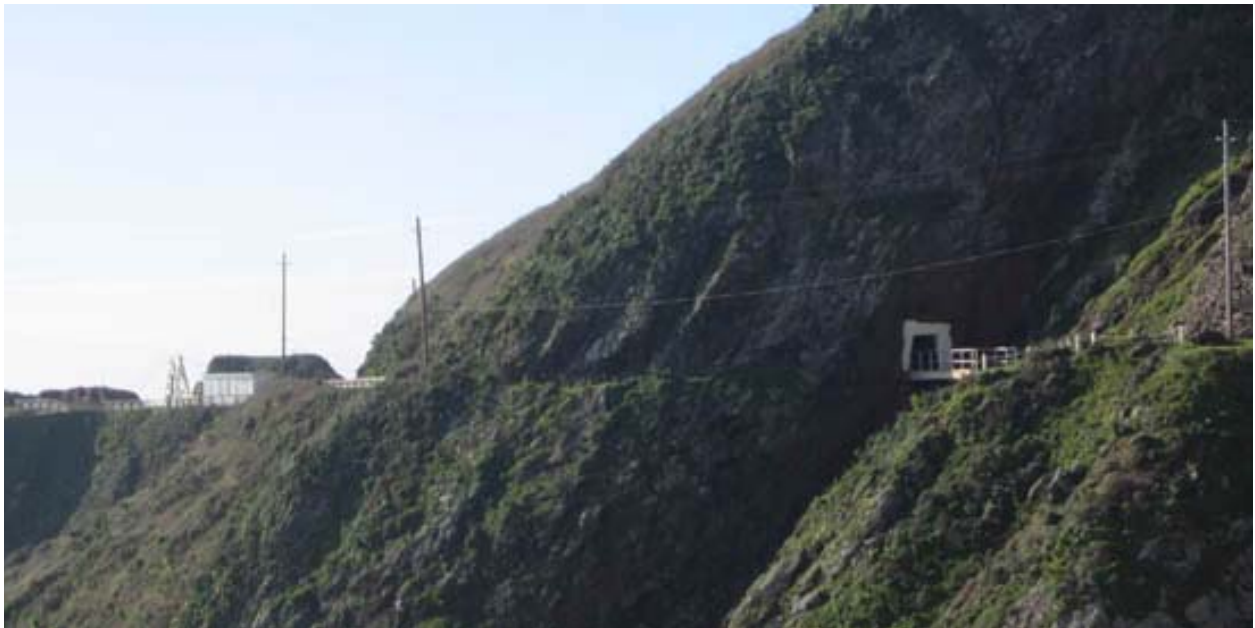
Topography #1: The sidehill cut associated with the wooden galley, which was replaced in 1876 by the tunnel following a landslide, is still visible in the cliff. (PWR, CLI, GOGA-D-2-22 043, 2005)

*Topography #1: The cut associated with the wooden galley, which was replaced in 1876 by the tunnel following a landslide, is still visible in the cliff. (PWR, CLI, GOGA-D-2-22 043, 2005)*

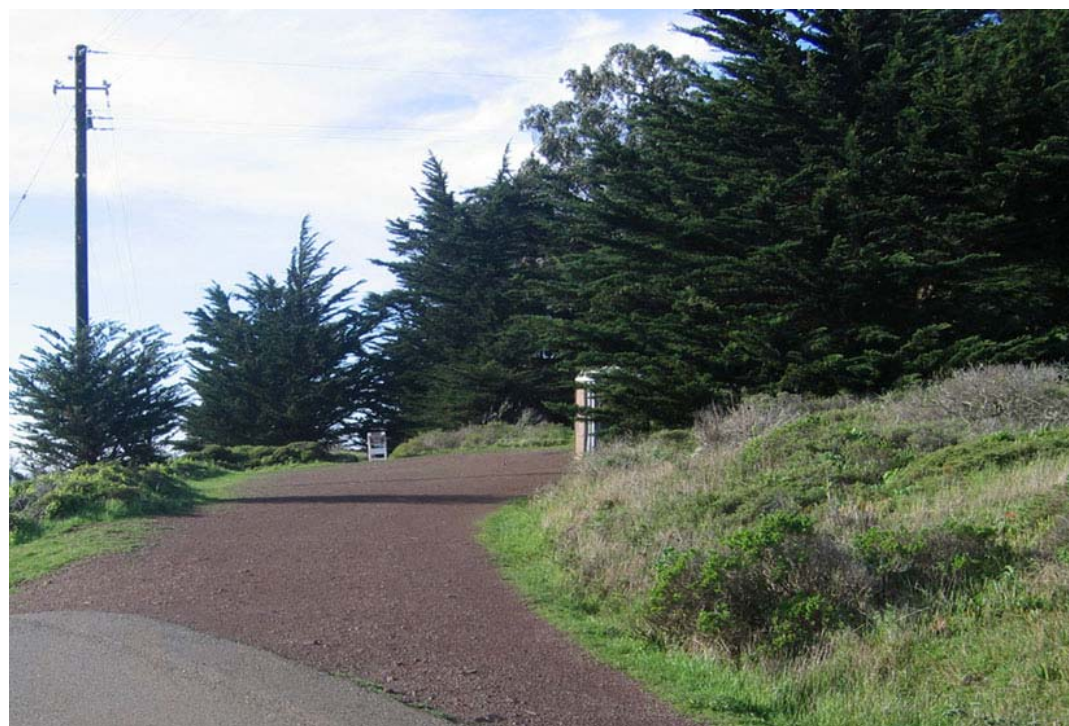
*Vegetation #2: View of the Monterey cypress on Point Bonita Ridge, the parking lot and restroom are in the foreground. (PWR, CLI, GOGA-D-2-22 038, 2005)*

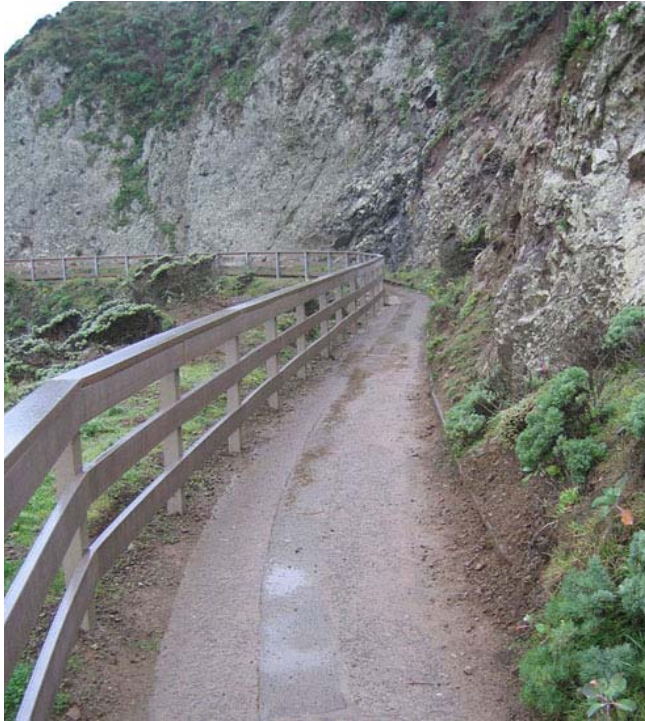
*Circulation #1: View of the Lighthouse Trail and cartway, note the asphalt center strip. The wooden type of hand railing is on the left. (PWR, CLI, GOGA-D-2-25 005, 2005)*

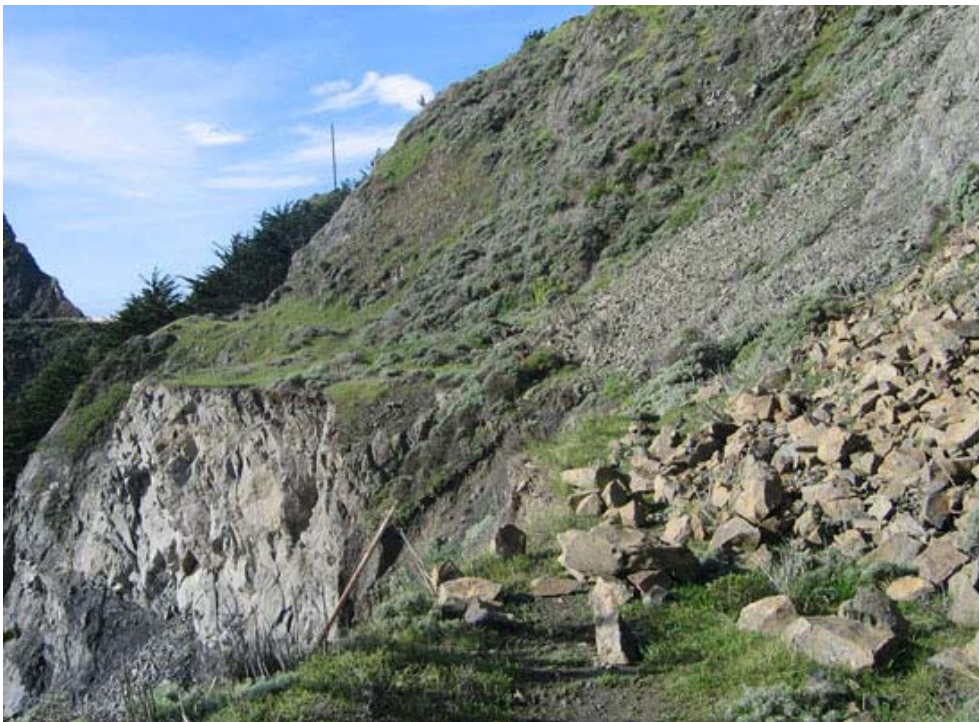
*Circulation #2: View of one area of landslide damage found along the Boathouse Trail. (PWR, CLI, GOGA-D-2-22 047, 2005)*

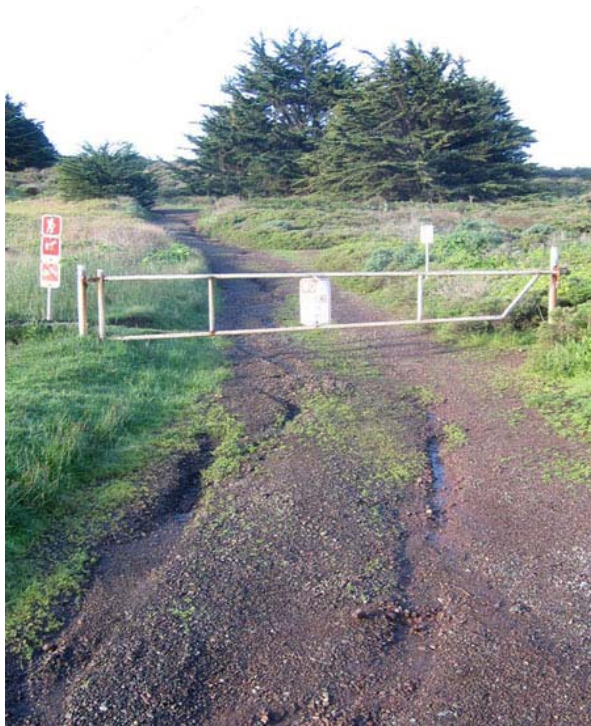
*Circulation #3: View of the east end of the Bonita Ridge Access Road, the red chert gravel is typical of the road surface during the period of significance. (PWR, CLI, GOGA-D-2-22 001, 2005)*

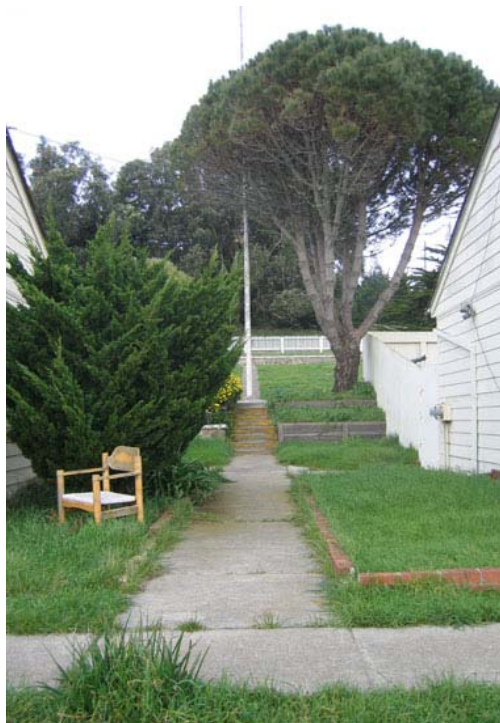
*Circulation #4: View of the axis sidewalk, and flagpole with in the residential complex. The sidewalk in the foreground connects two of the residences. (PWR, CLI, GOGA-D-2-8 020, 2005)*

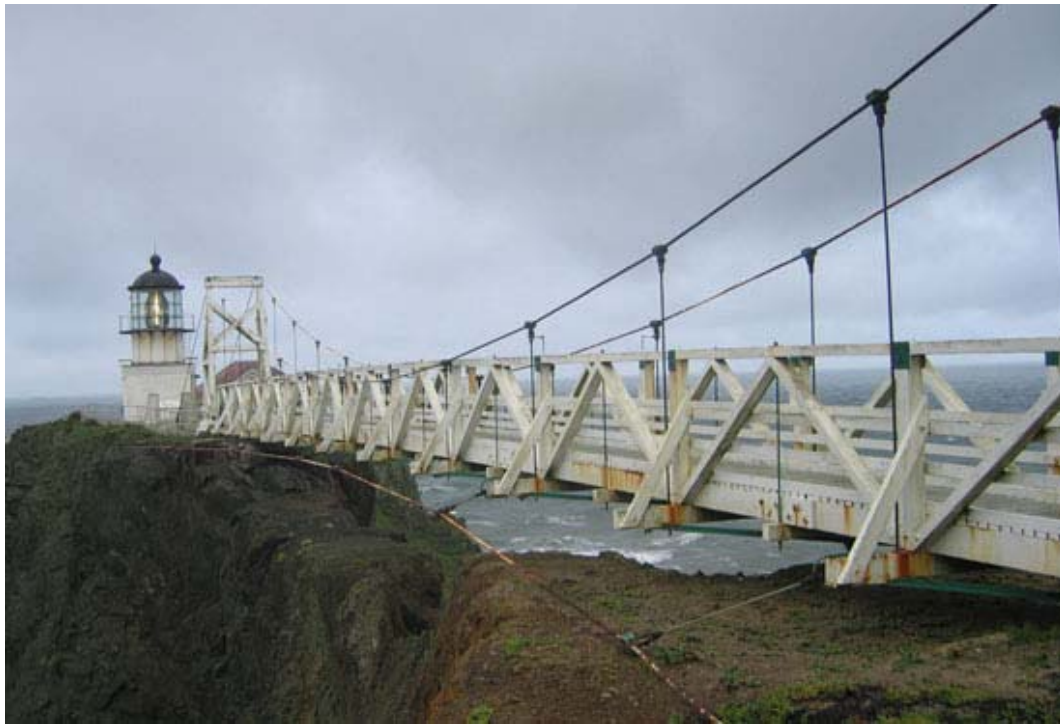
*Buildings and Structures #1: View of the Lighthouse Tower and suspension bridge, the roof of the fog-signal building is visible in the background. (PWR, CLI, GOGA-D-1-25 014, 2005)*

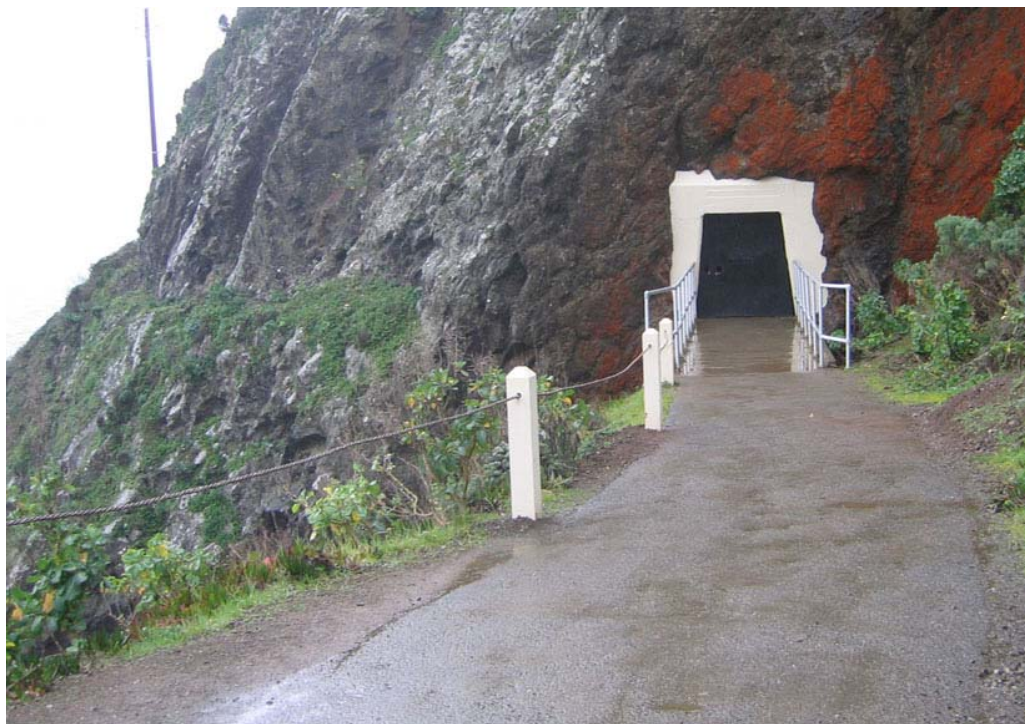
*Buildings and Structures #2: View of the east entrance to the tunnel and a portion of the Lighthouse Trail. (PWR, CLI, GOGA-D-1-25 001, 2005)*

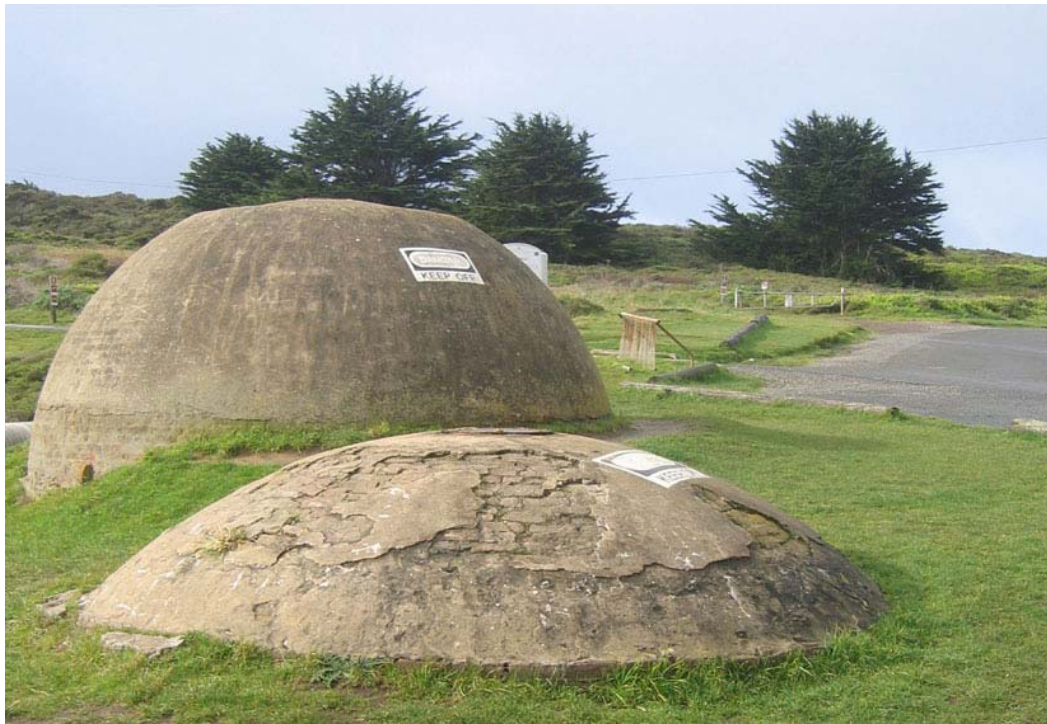
*Buildings and Structures #3: View of two of the three cisterns with the Coast Guard Complex showing the brick structure revealed beneath the flaking plaster. (PWR, CLI, GOGA-D-1-25 035, 2005)*

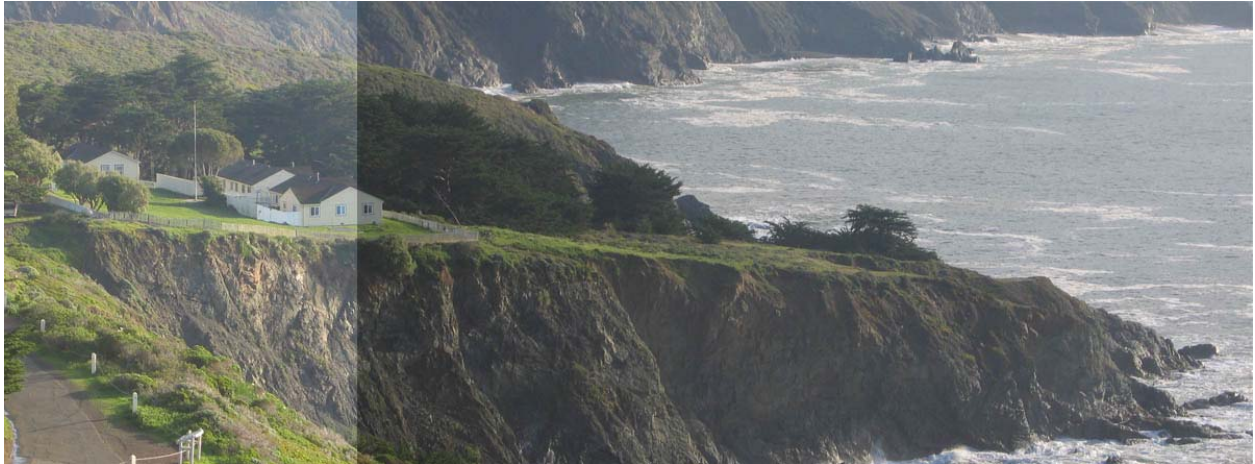
*Buildings and Structures #4: Overview of the Coast Guard residential complex. All three residential structures, copses of Monterey cypress and the picket and board fences can be seen. (PWR, CLI, GOGA-D-2-22 011/012, 2005)*

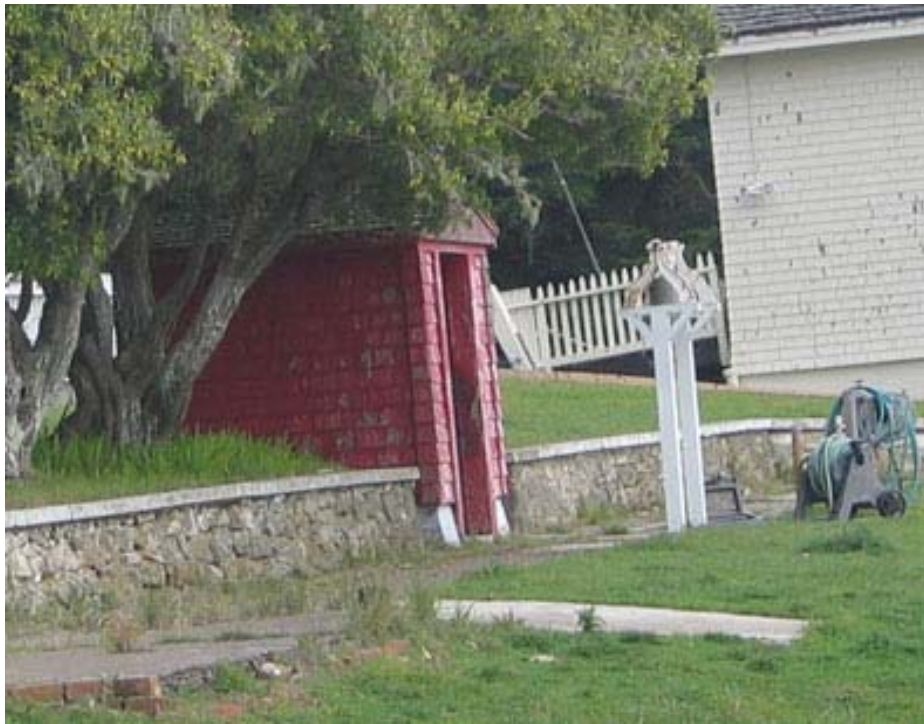
*Buildings and Structures #5: View of the Fire Shed with the fire bell and water pipes to the right. The south stone wall continues around the back of the shed. (PWR, CLI, GOGA-D-2-8 018, 2005)*

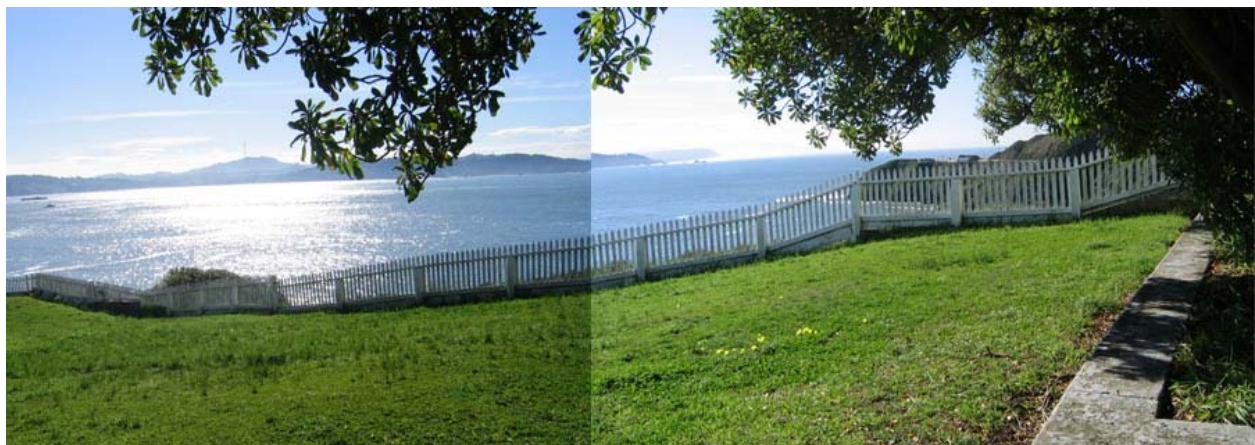
*Buildings and Structures #6: View toward the west of the picket fence from the site of the U.S. Life-Saving Station Building. (PWR, CLI, GOGA-D-2-22 056, 2005)*

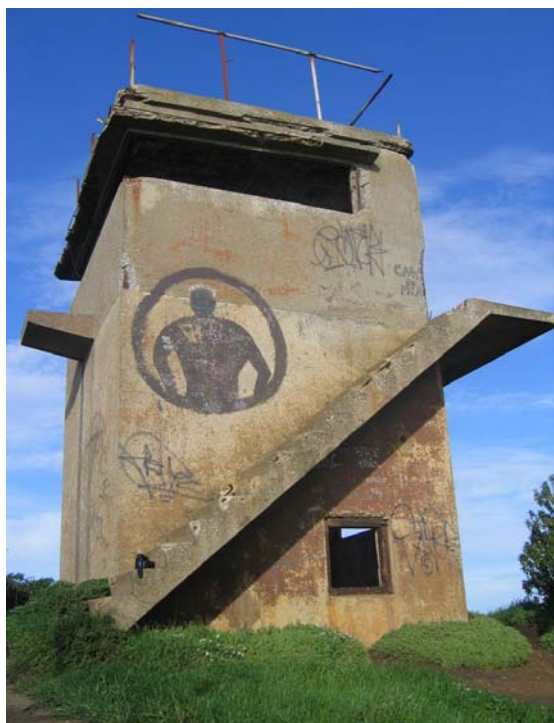
*Buildings and Structures #7: View of the harbor defenses signal tower, following years of neglect and vandalism. (PWR, CLI, GOGA-D-2-22 025, 2005)*

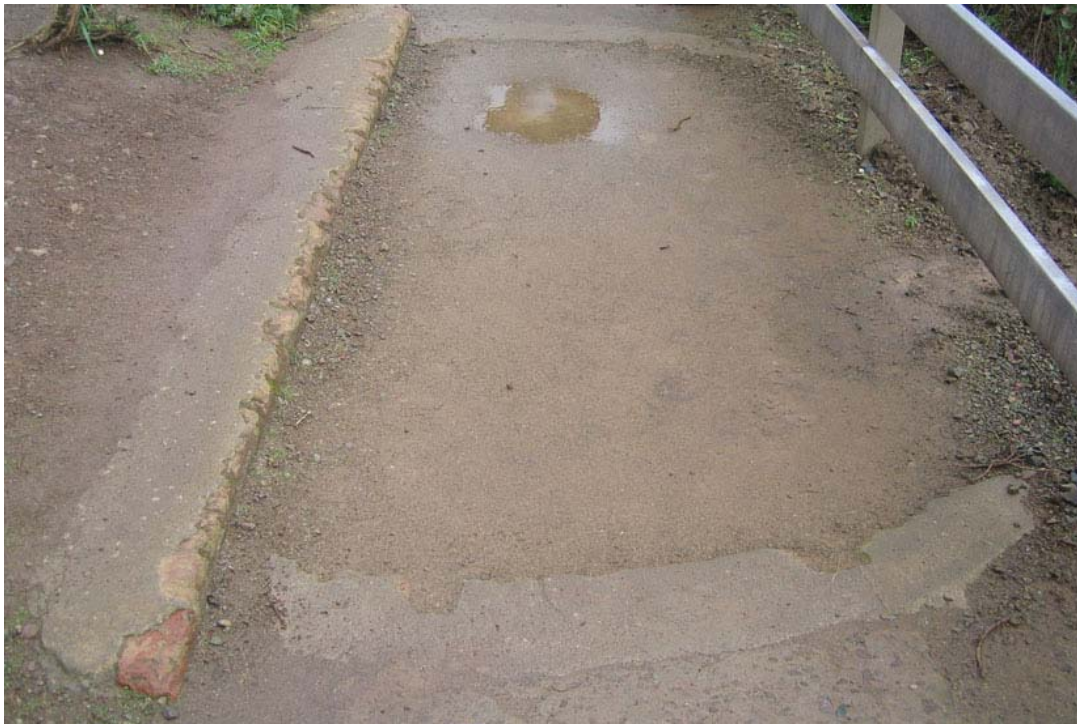
*Archeological Sites #1: View of the brick and concrete winch turnaround. (PWR, CLI, GOGA-D-1-25 030, 2005)*

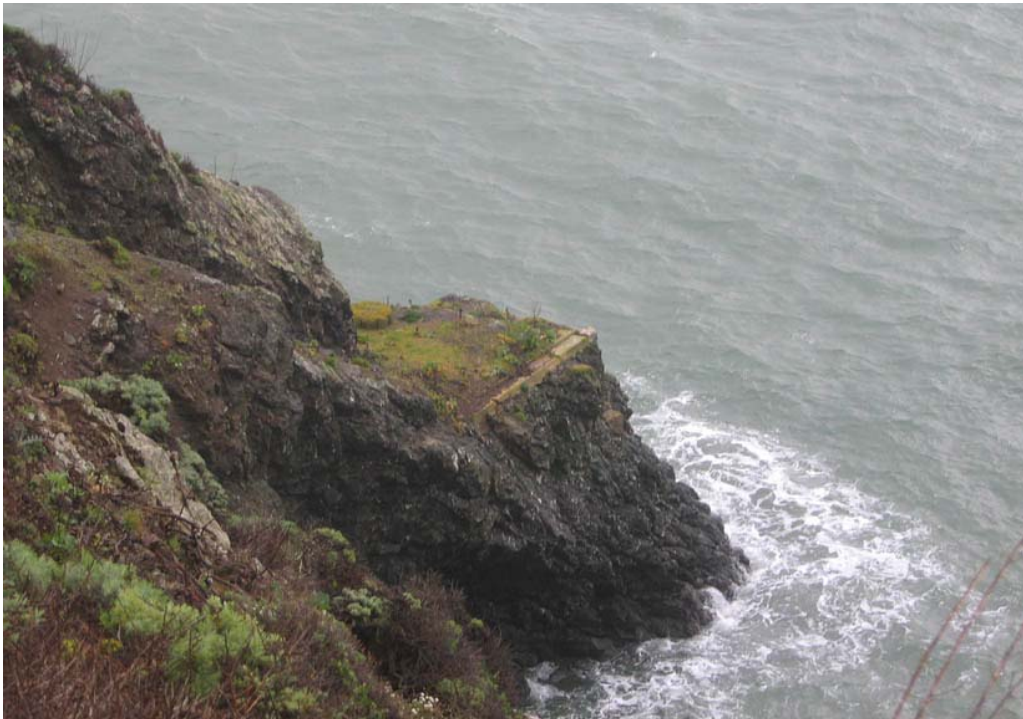
*Archeological Sites #2: View of the remains of the landing structures at the bottom of the incline tramway. (PWR, CLI, GOGA-D-1-25 006, 2005)*

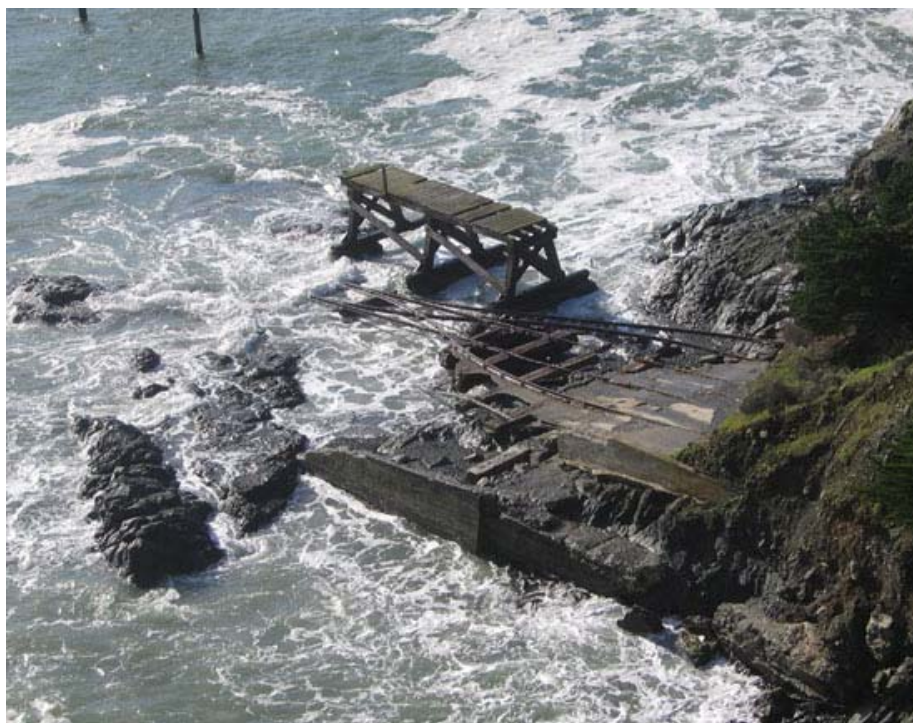
*Archeological Sites #3: View of the marine railway ruins associated with the 1911 U.S. life-saving station boathouse. (PWR, CLI, GOGA-D-2-22 046, 2005)*
