National Park Service  
Cultural Landscapes Inventory  
2005

Alcatraz Island  
Golden Gate National Recreation Area

# Cultural Landscape Inventory: Alcatraz Island

CONDITION ASSESSMENT: **Fair**

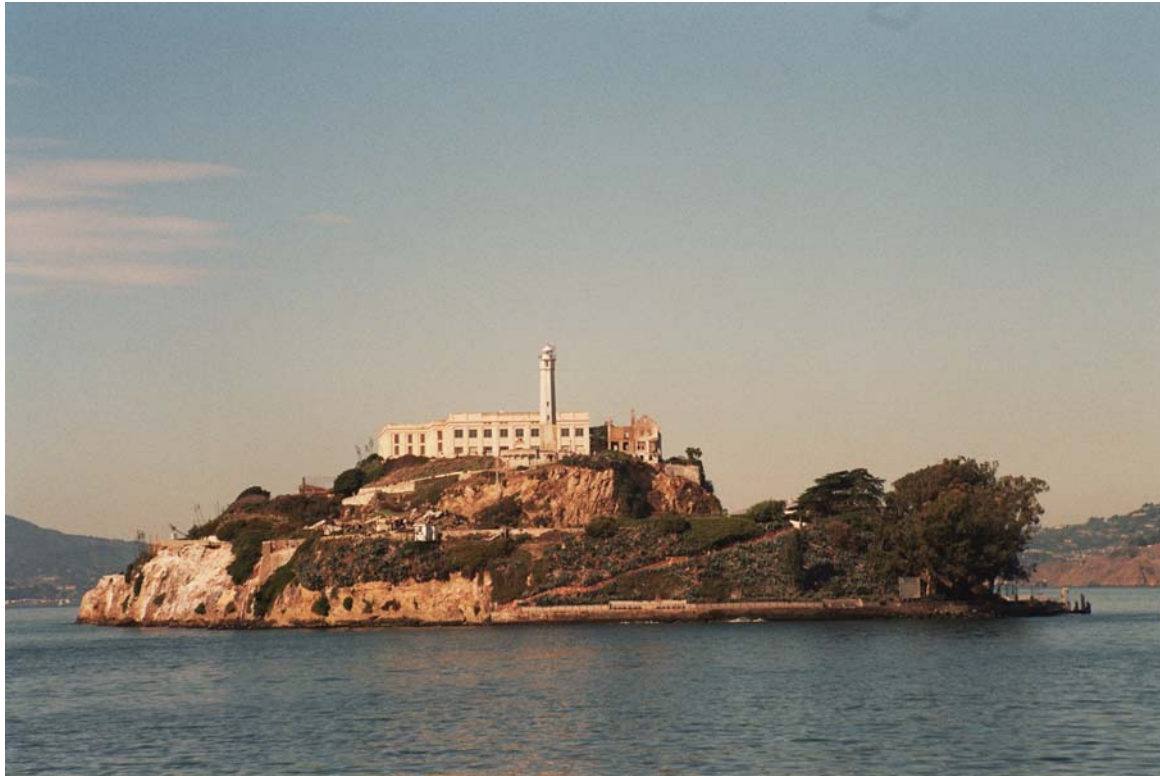
*Alcatraz Island NHL. South side. View to NW. (215\_3A\_0049, D. Bradley, 2004)*

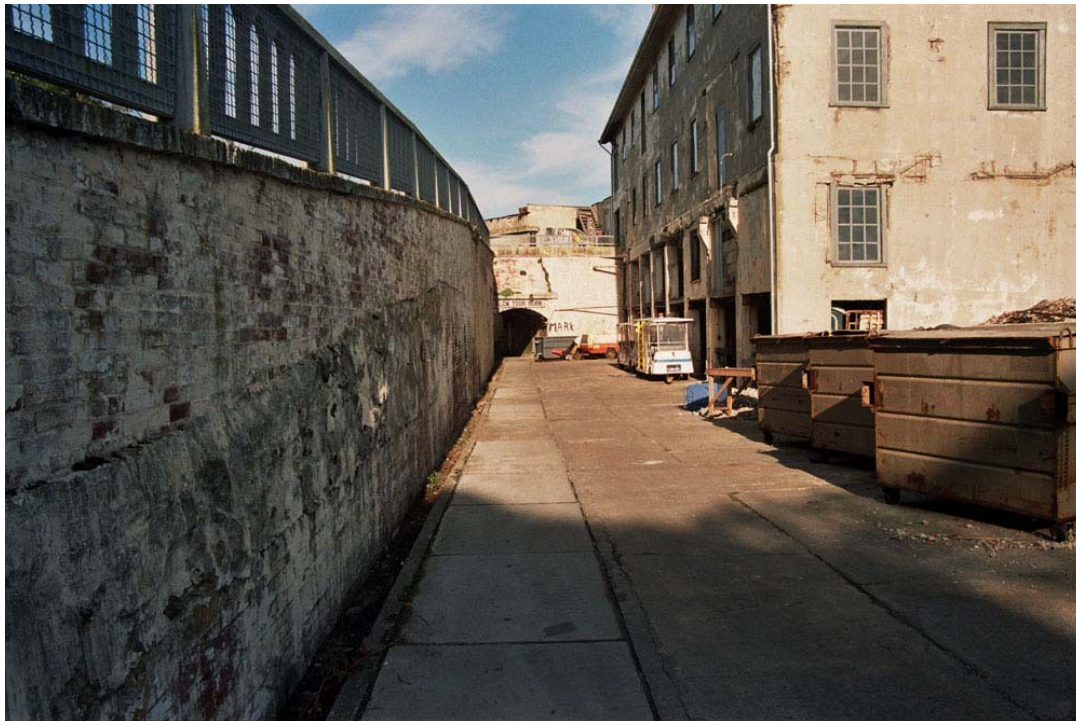
*View of No. 79 (right side), brick retaining wall of fortifications (left side), and tunnel of fortifications (background). View to N. (935\_12A\_0043, D. Bradley, 2004)*

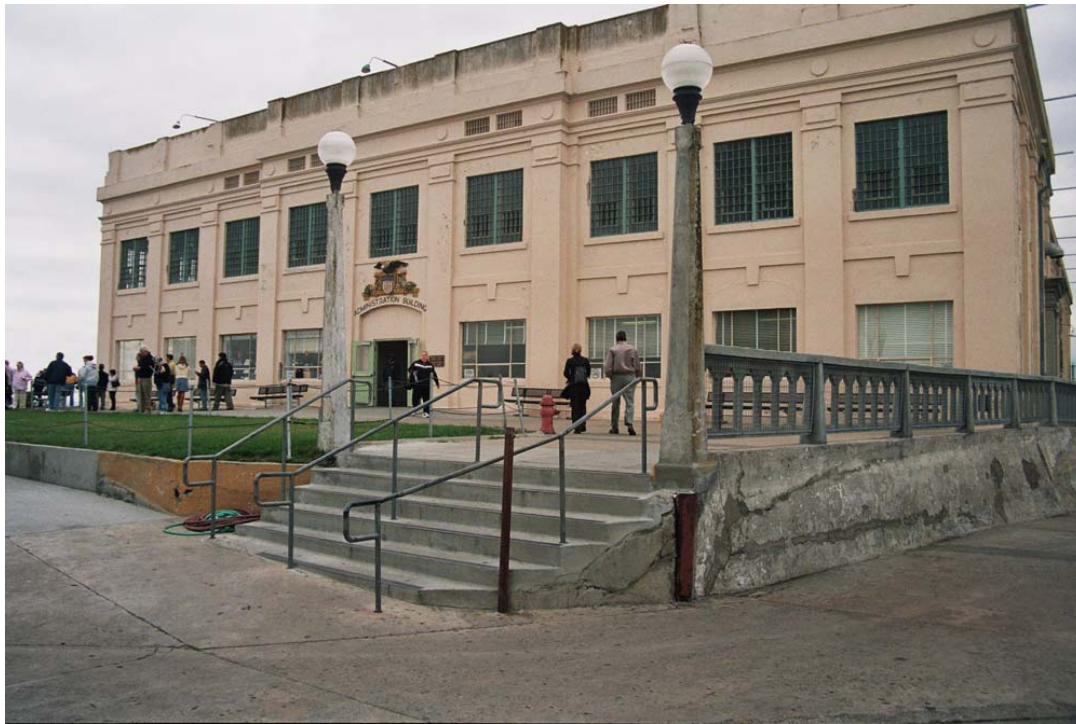
*Cellhouse (No. 68) and front terrace. View to W. (115\_22\_0139, D. Bradley, 2004)*

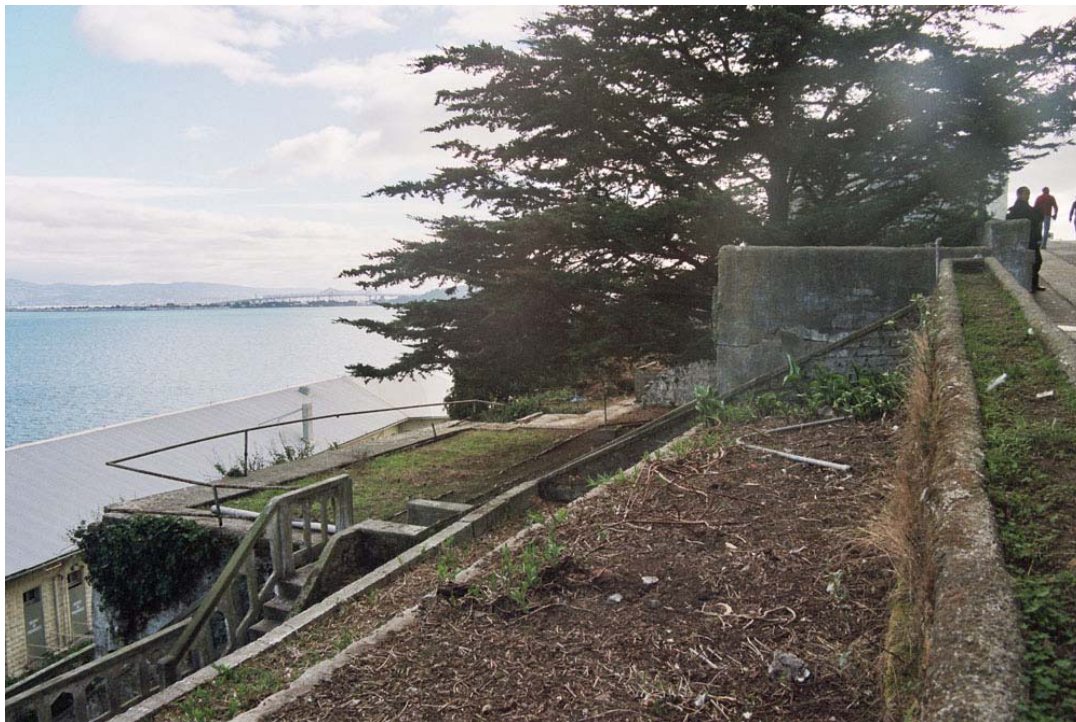
*Planting bed terraces in Officers' Row and Trough Planter (on right). View to E/SE. (116\_17A\_0162, D. Bradley, 2004)*

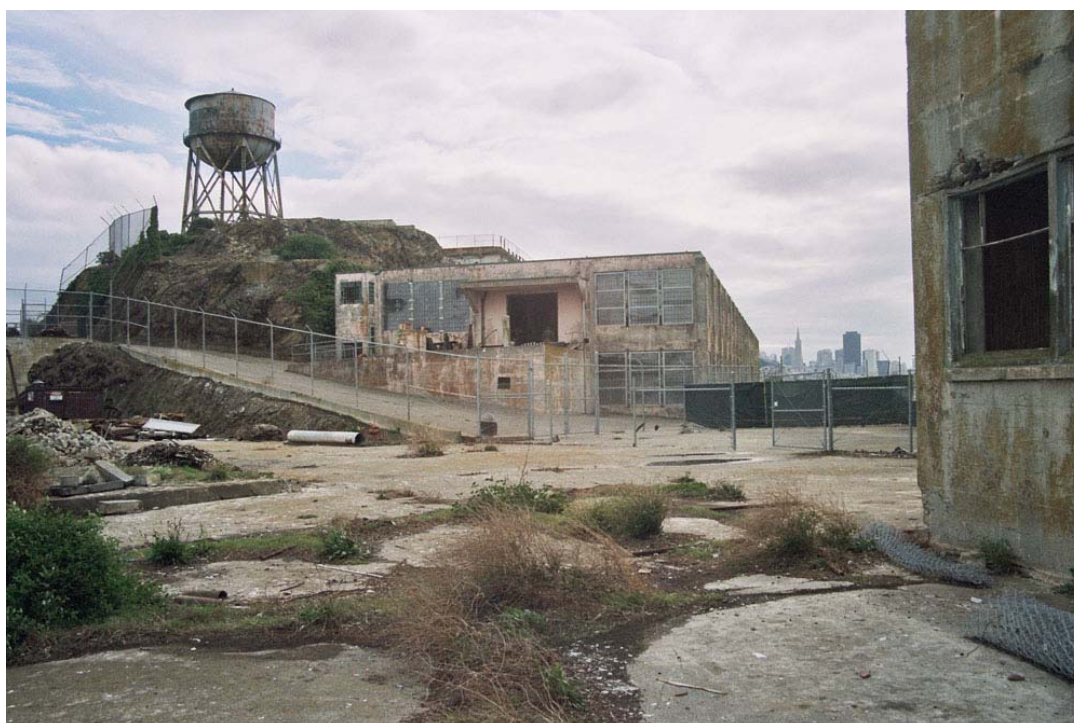
*View of north end of island – from left to right (east to west) watertower, No. 84, view of San Francisco in background, No. 82. View to SE. (115\_12\_0129, D. Bradley, 2004)*

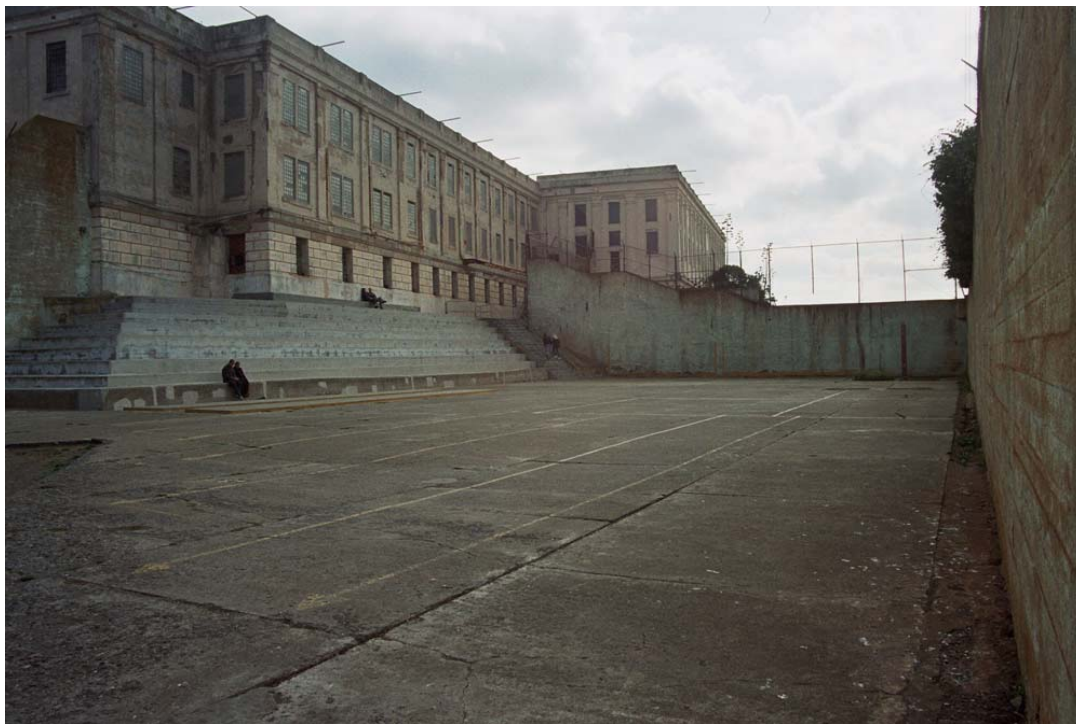
*Recreation Yard. View to E. (752\_17A\_0020, D. Bradley, 2004)*

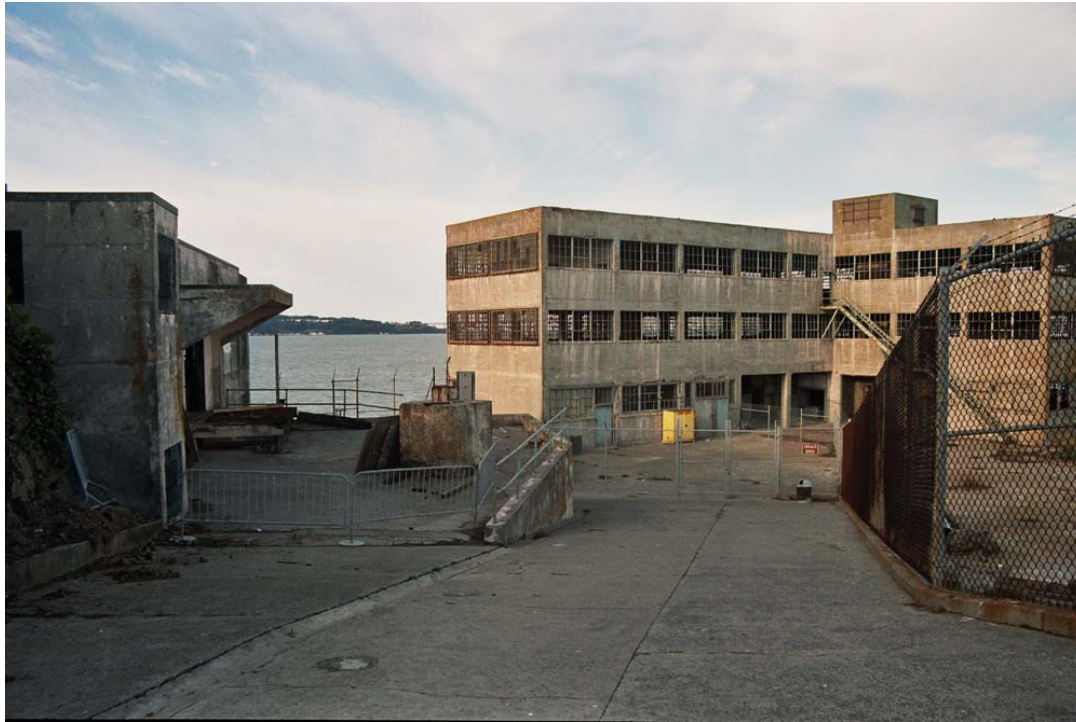
*Overview of north end of island – Model Industries Building (No. 82) (background) and New Industries Building (No. 84) (left). View to W. (935\_4A\_0035, D. Bradley, 2004)*

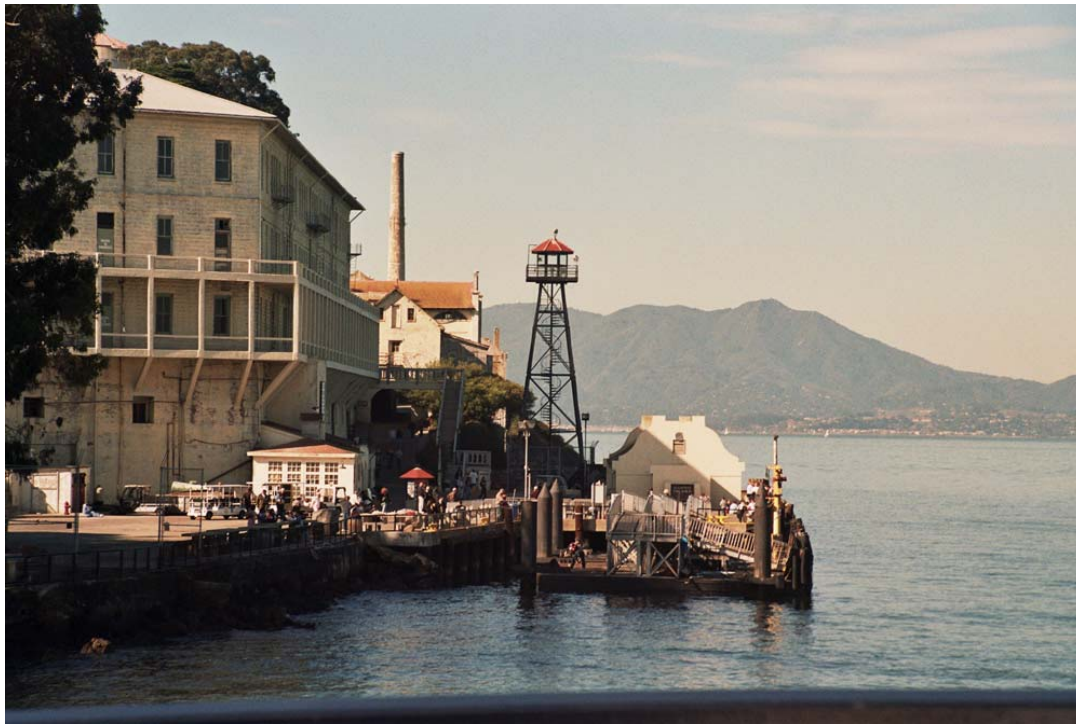
*Dock on southeast side. View to NW. (215\_5A\_0051, D. Bradley, 2004)*

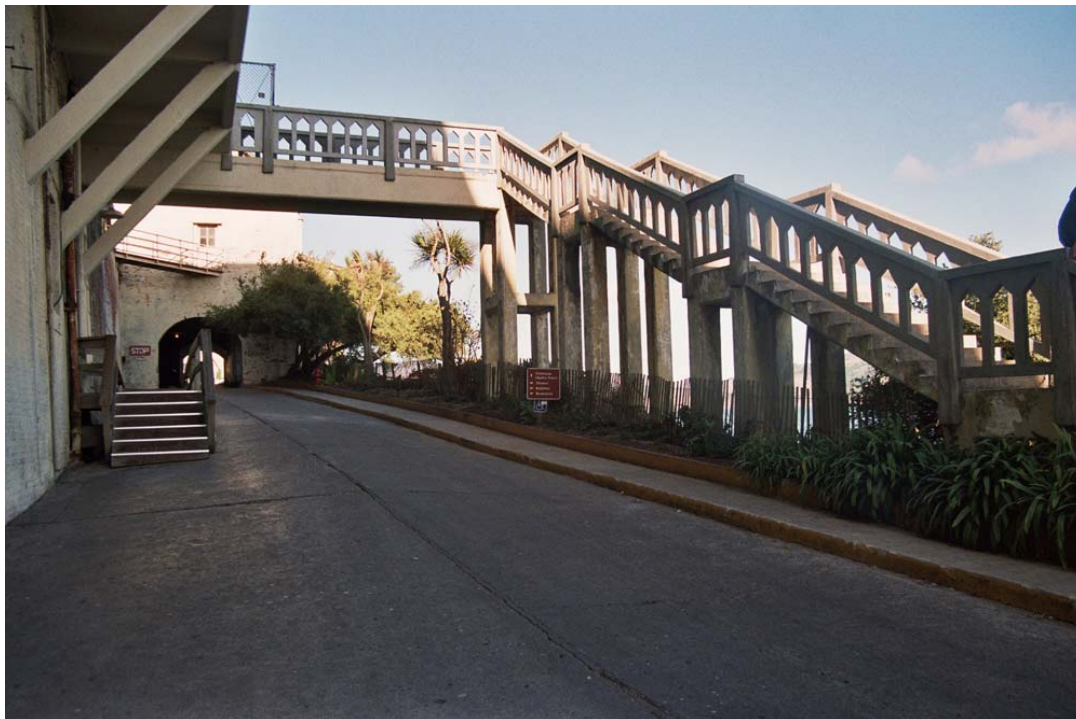
*Road to Sallyport (in background) with view of raised concrete overpass (in foreground). View to N. (113\_15\_0077, D. Bradley, 2004)*

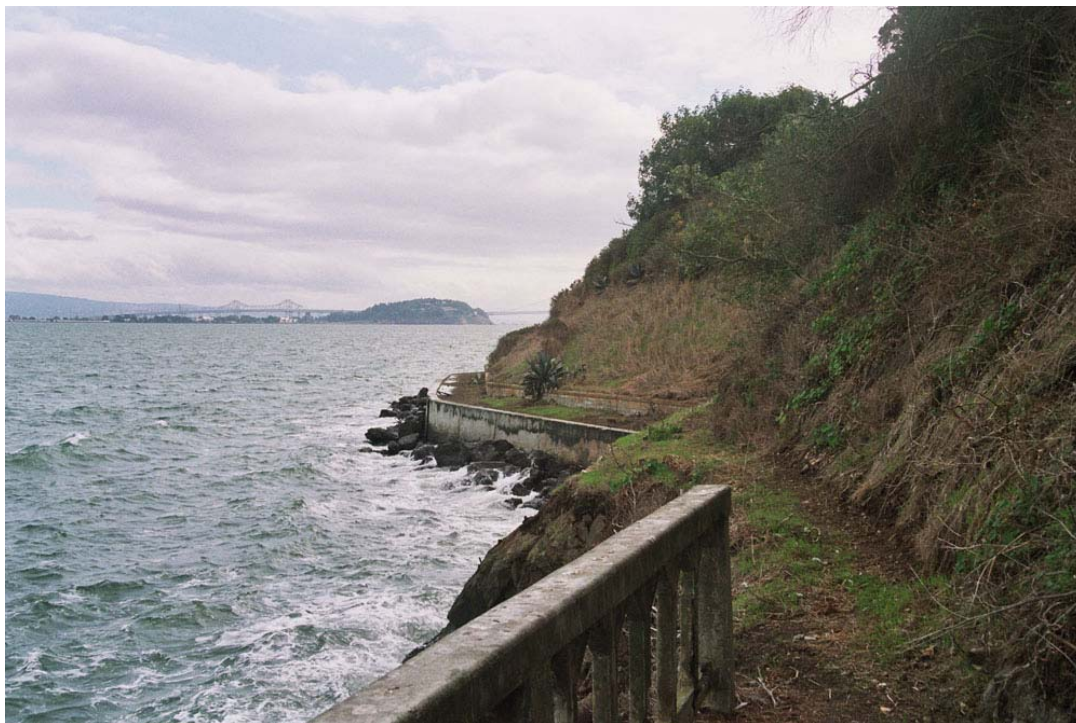
*View of the perimeter walk on the east side of island, taken from the Building 79. View to SE. (115\_4\_0121, D. Bradley, 2004)*

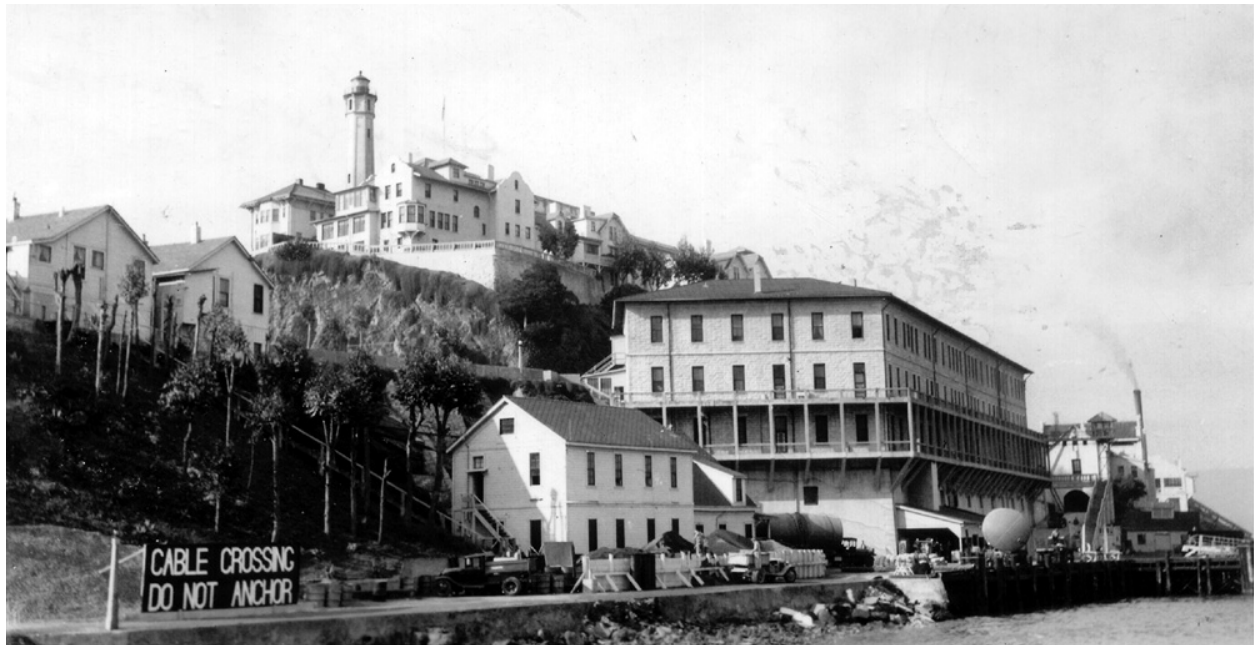
*View of the dock with newly planted (eucalyptus) trees on the hillside, during the Military Prison Era. (Source: Chuck Stucker, Photographs in the Golden Gate Parks Conservancy collection)*

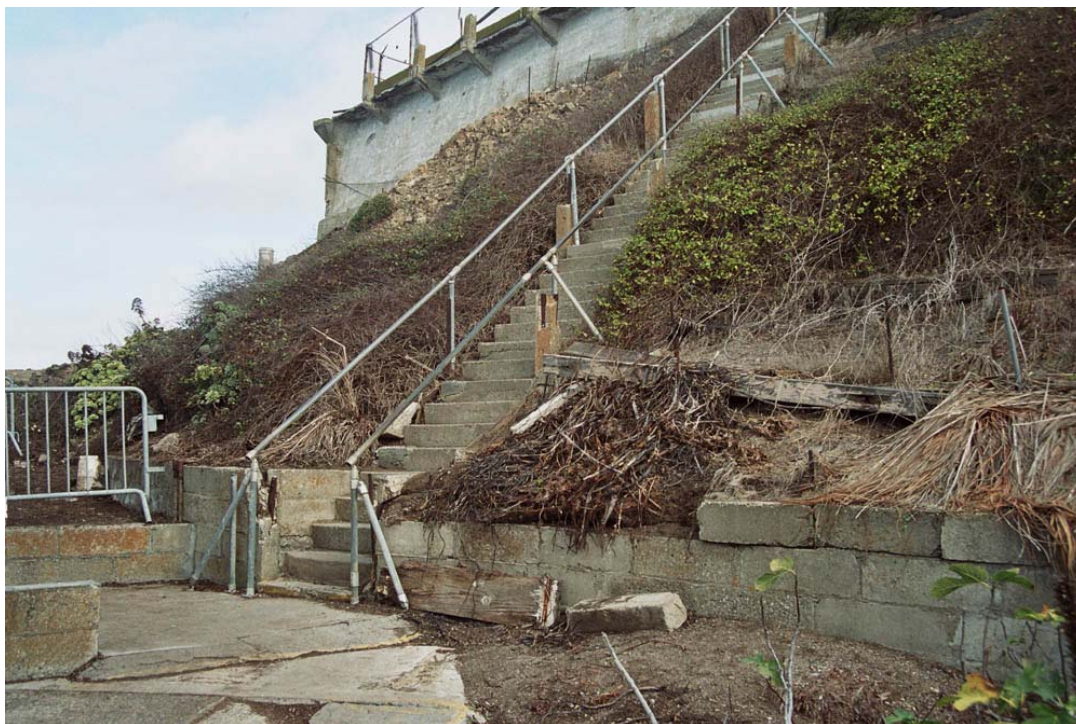
*Steps on Recreation Yard slope. View to N. (752\_15A\_0018, D. Bradley, 2004)*

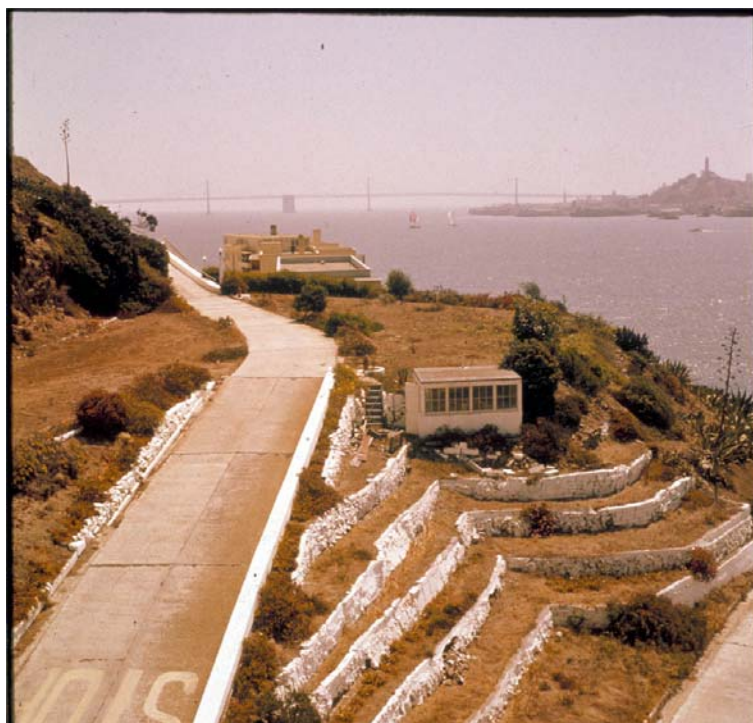
*West Lawn and Tool Shed Terraces in ca. 1960 during the Federal Prison Era. (Source: Fischetti Photographs in GOGA Archives No. 18352-049)*

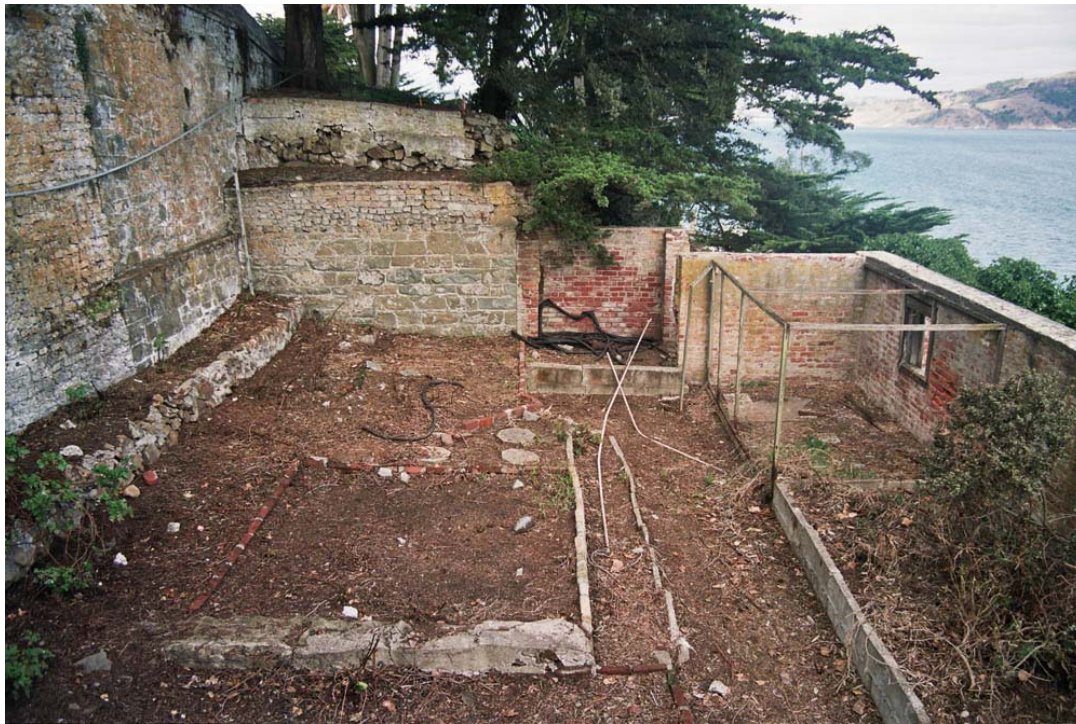
*Planting bed on north end of Officers' Row. Built on foundations of Officers' Quarters No.9. View to NE. (116\_15A\_0160, D. Bradley, 2004)*

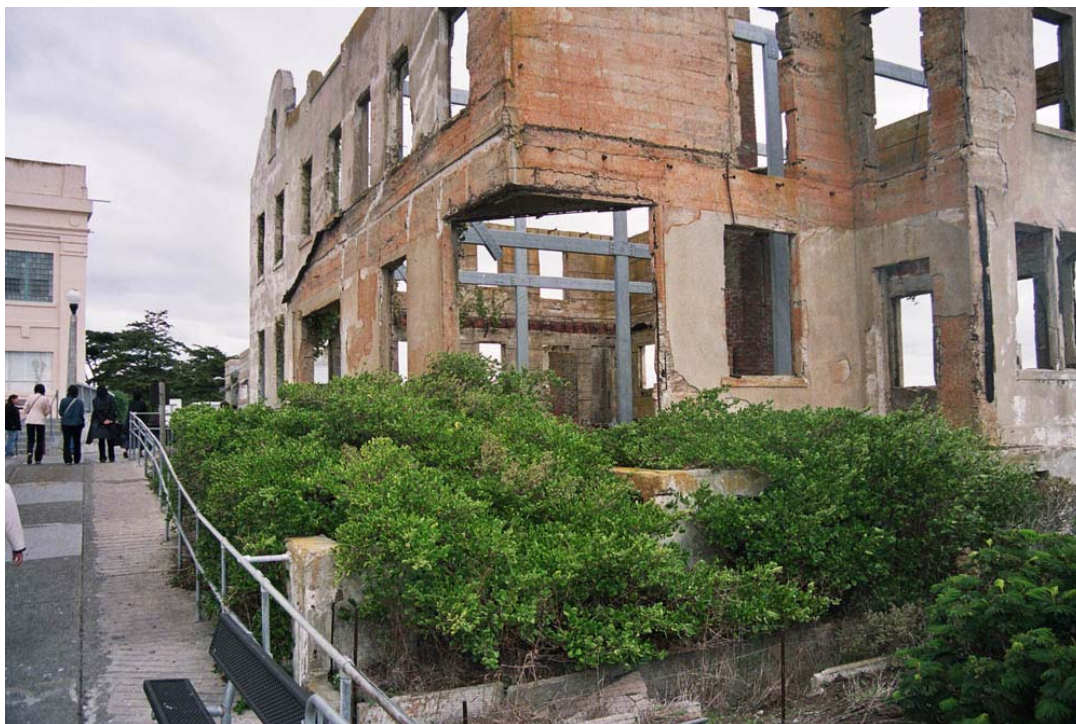
*Remains of the greenhouse foundation on south side of Warden's house (No. 79). View to E. (112\_11\_0049, D. Bradley, 2004)*

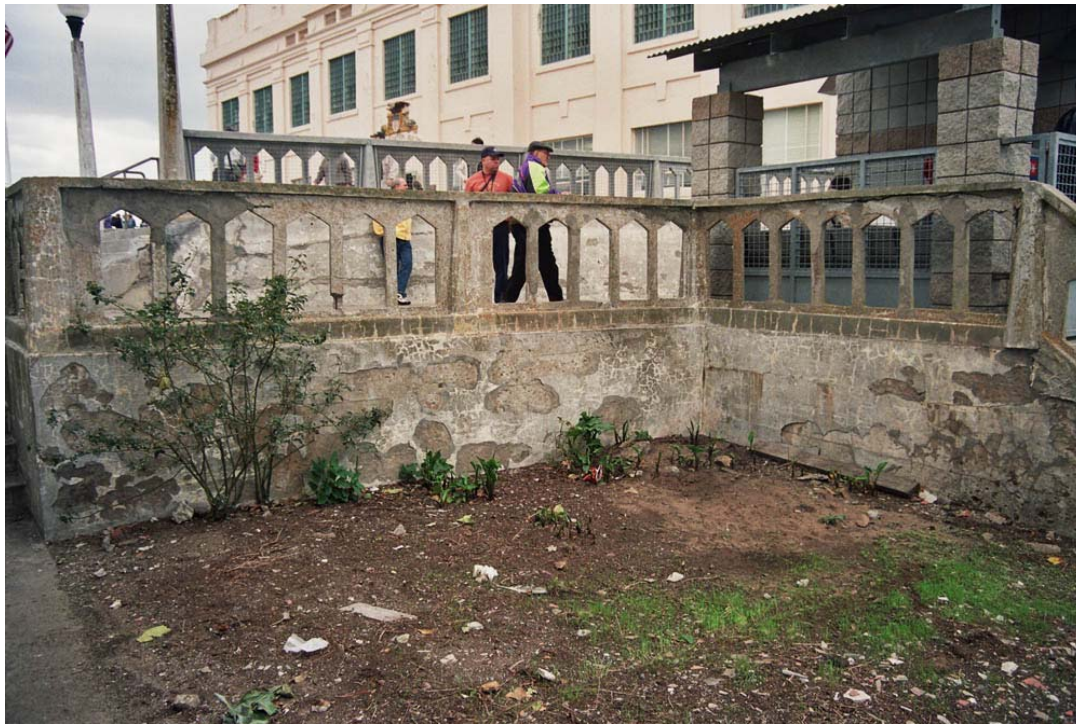
*Garden area on northwest side of Warden's house (No. 79). View to E. (112\_9\_0047, D. Bradley, 2004)*

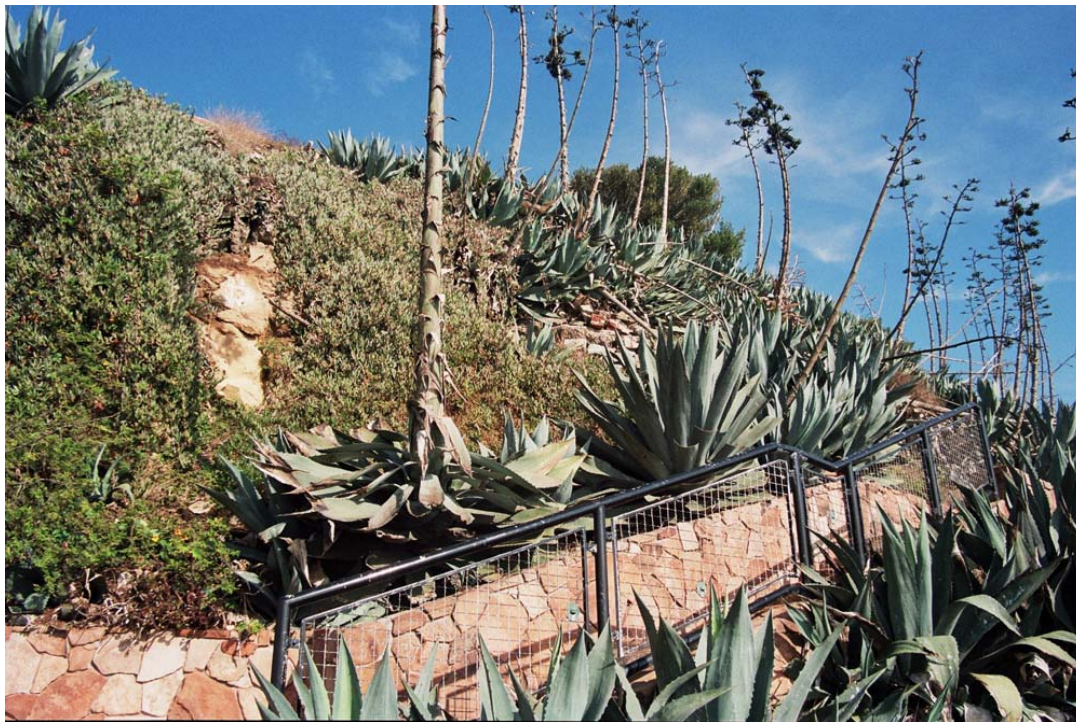
*Plant materials on cliffs at south end of island. View from Agave Trail to N. (934\_14A\_0018, D. Bradley, 2004)*

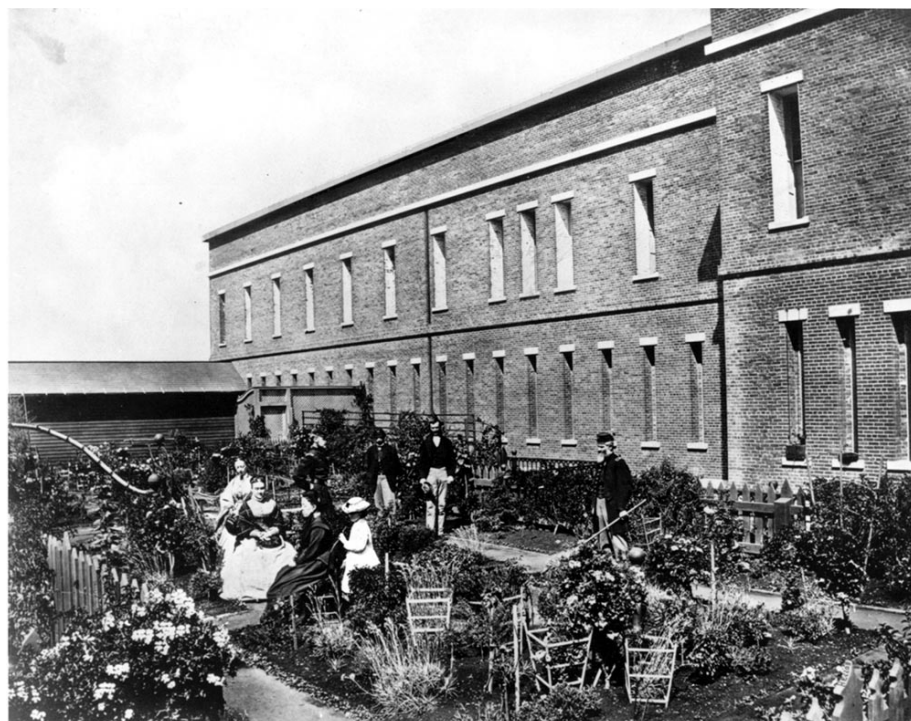
*Muybridge's 1869 photograph of the garden area on the east side of the Citadel during the Military Fortifications Era. (Source: CA Heritage Collection, Bancroft Library [<http://ark.cdlib.org>])*

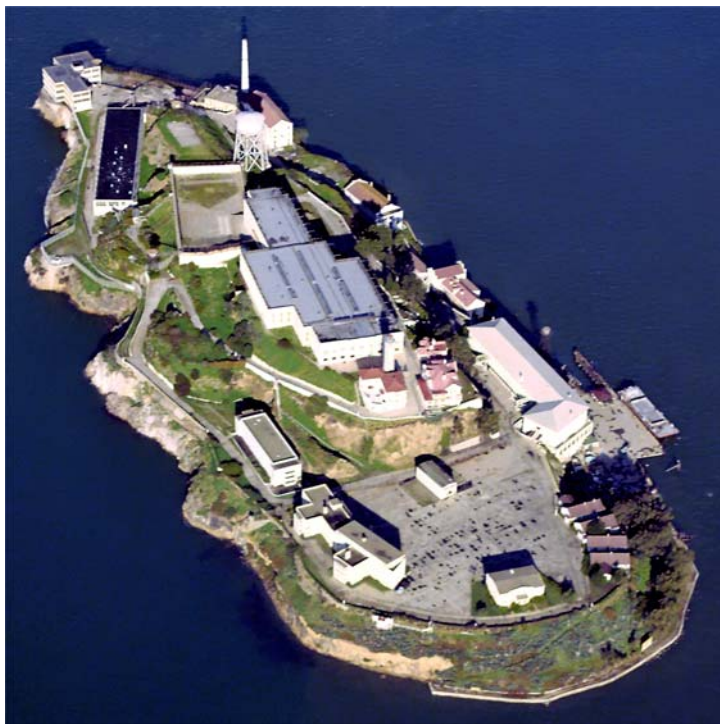
*Aerial photograph of Alcatraz in 1959 during the Federal Prison Era. (Source: Chuck Stucker, Photographs in the Golden Gate Parks Conservancy collection)*

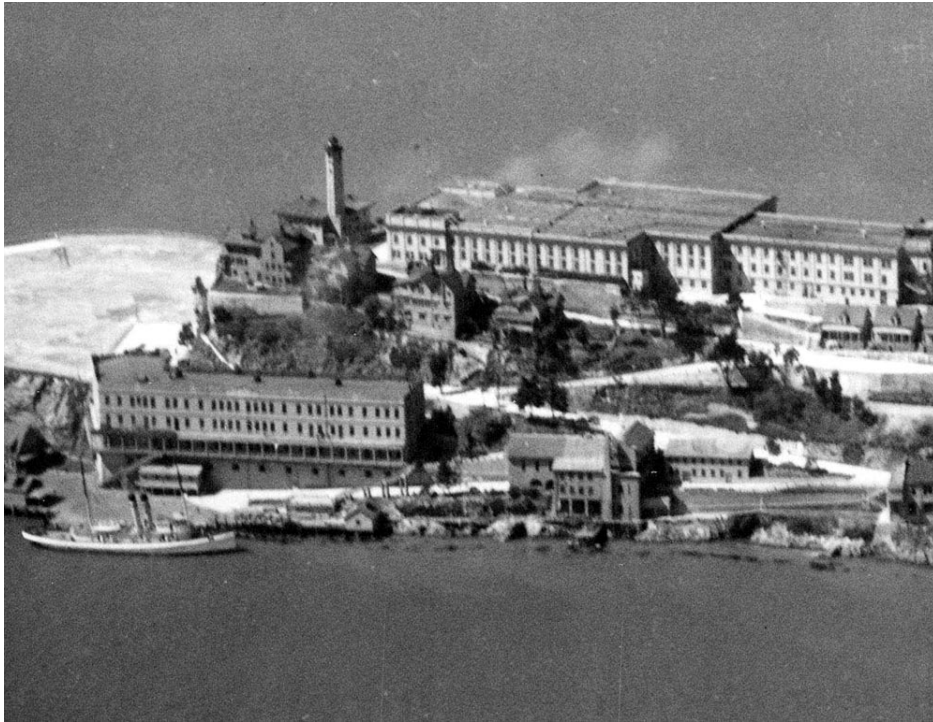
*Aerial view of the east side of Alcatraz in 1927, during the Military Prison Era. (Source: Golden Gate National Parks Conservancy collection)*
