National Park Service  
Cultural Landscapes Inventory  
2005

Sutro historic district  
Golden Gate National Recreation Area

# Cultural Landscape Inventory: Sutro historic district

CONDITION ASSESSMENT: **FAIR**

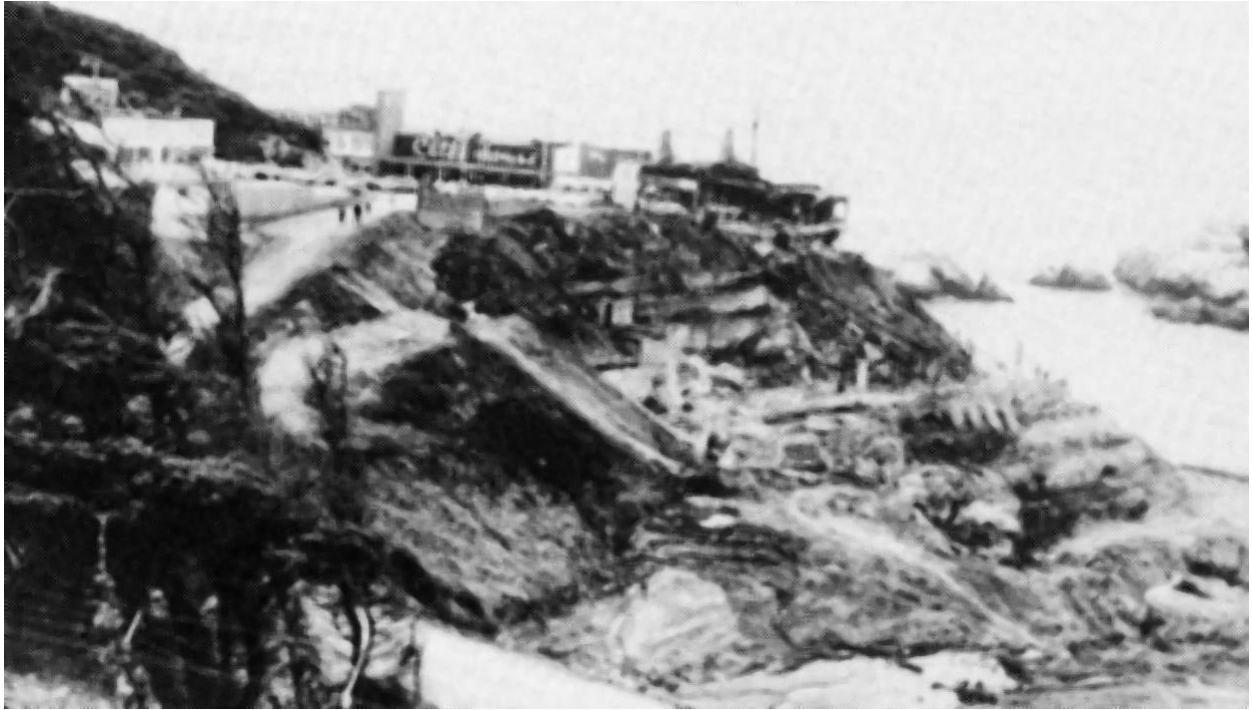
*History #14: Sutro Baths following the fire in 1966. (CLR, 1993)*

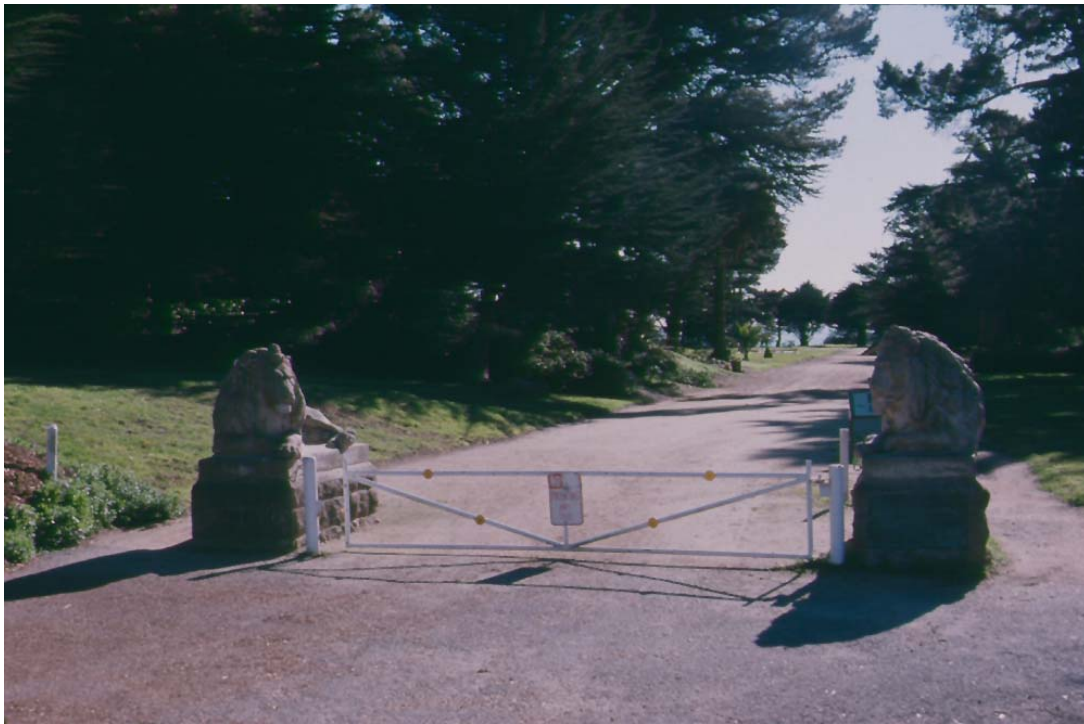
*Circulation #1: View of Palm Avenue looking toward the southwest. (PWR, CLI, GOGS-S-0002-23, 2004)*

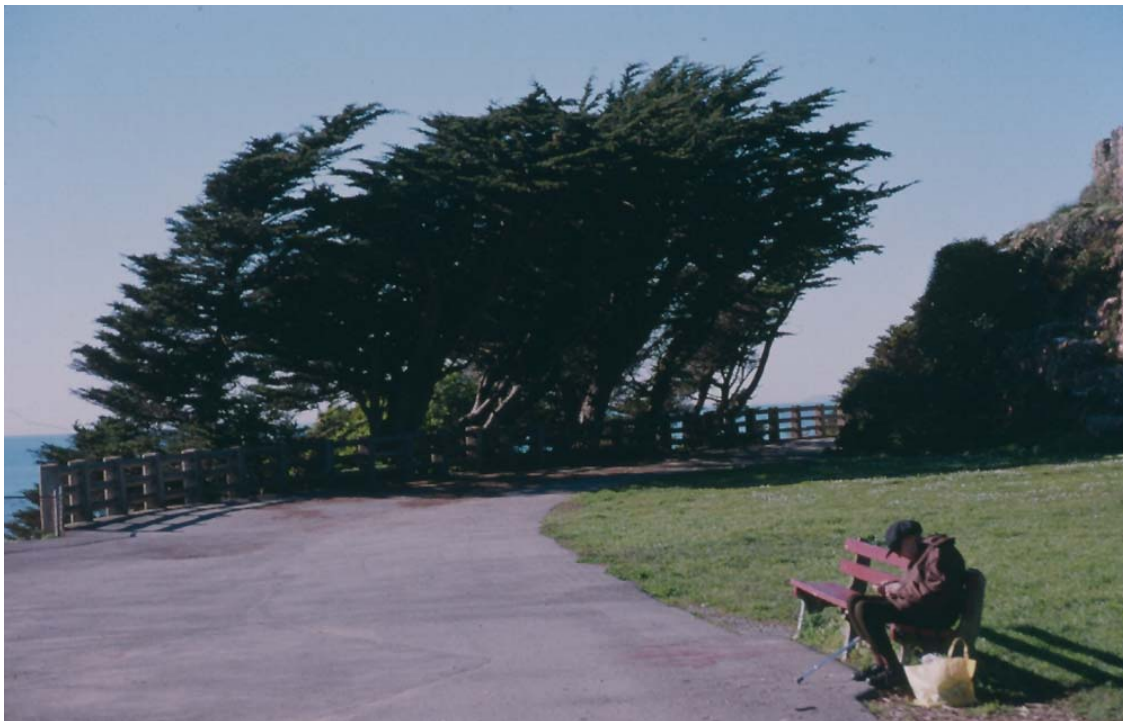
*Circulation #2: View of South Esplanade and the remaining concrete fence. The Monterey cypresses are now blocking the once expansive views of the Pacific coast. (PWR, CLI, GOGS-S-0002-29, 2004)*

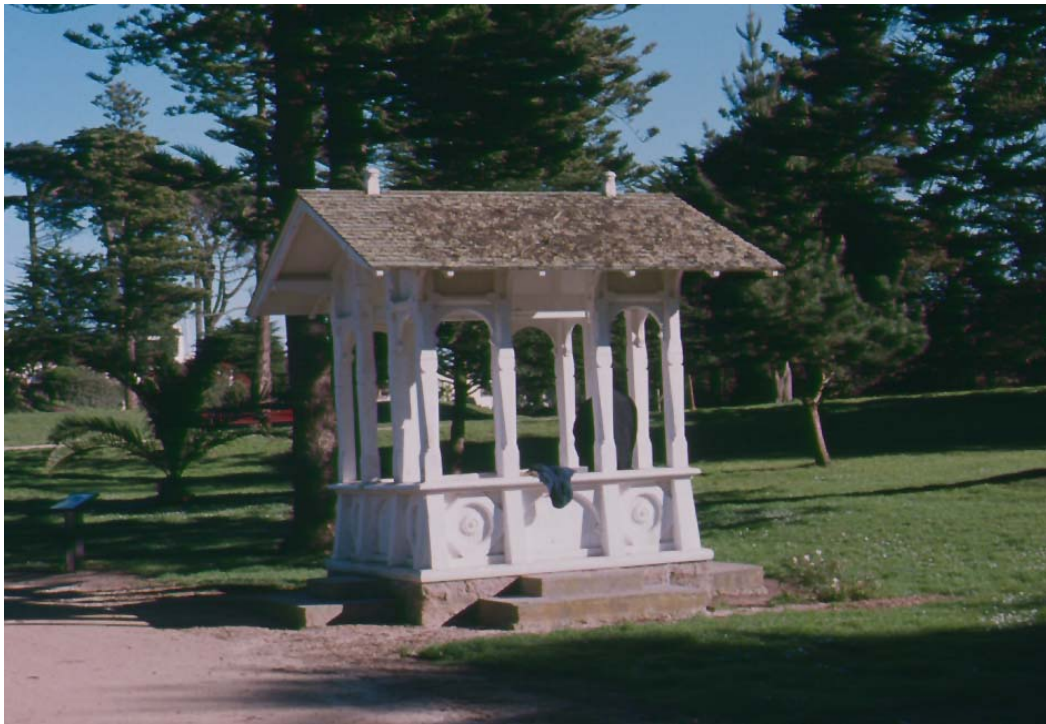
*Buildings and Structures #1: View of the Well House, located within Shady Lawn. (PWR, CLI, GOGS-S-0002-36, 2004)*

The well house, built about 1885, is a small wood frame structure with an elevated foundation of cut and dressed sandstone (see photo: Buildings and Structures #1). It is uncertain whether the well house actually housed a well — more likely it served as a focal point for arriving visitors, and contained the plumbing for a pair of drinking fountains, with scallop shell basins, mounted on opposite sides.

Although the structure remained in relatively good condition through the 1930s, by the time the property was transferred to the National Park Service in 1975, all of the architectural detailing, including the iron grillwork and scallop shell drinking fountains had been removed and painted white. In the 1980s, the National Park Service partially restored the well house.

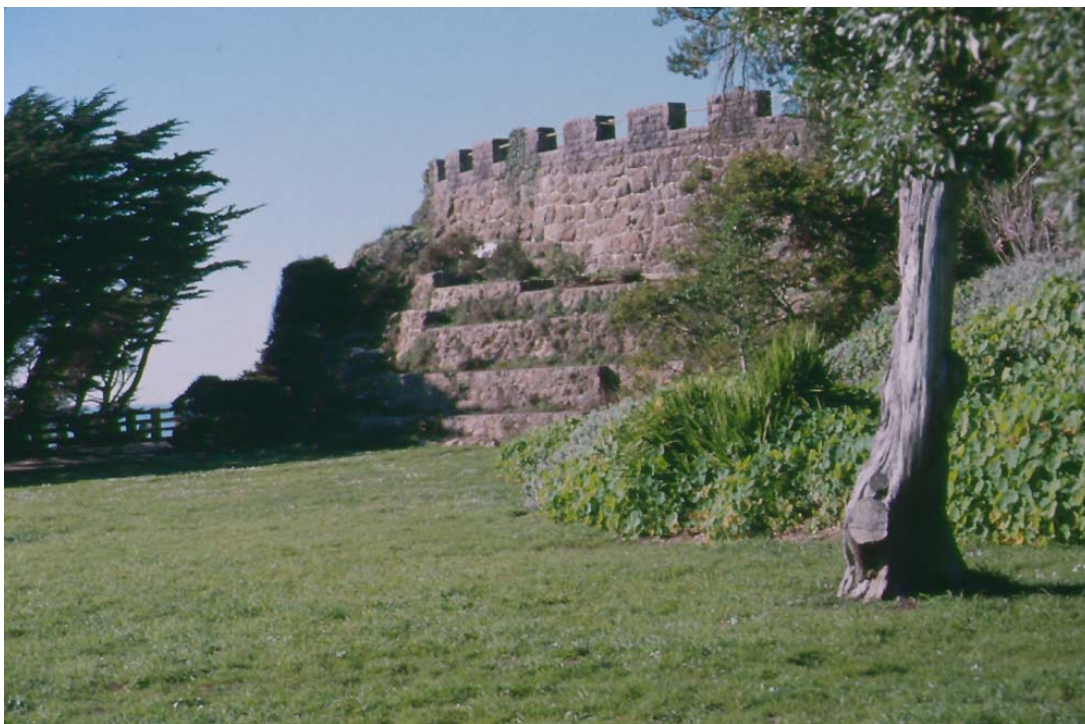
*Buildings and Structures #2: View of the Parapet from the South Esplanade. (PWR, CLI, GOGS-S-0002-29, 2004)*

In later years, the condition of the parapet began to deteriorate. English Ivy, first introduced to the area in the late 1880s, grew over the parapet walls, the lime mortar eroded, and vandals smashed all of the statues and planters on the crenellations. The statues on the rock niches below the parapet were also removed. Corrosion of the iron pipes between crenellations occurred, and the City eventually replaced many of them with one heavy galvanized metal pipe.

The original chairs and cannon soon disappeared — the cannon probably being melted down as a part of the scrap drive efforts of World War II. Concrete and wood benches installed on the parapet by the city were vandalized. The condition of the parapet was surveyed extensively in 1979 by the National Park Service. Vegetation was cleared from the wall and the parapet's masonry joints were repointed as part of the rock garden restoration project.

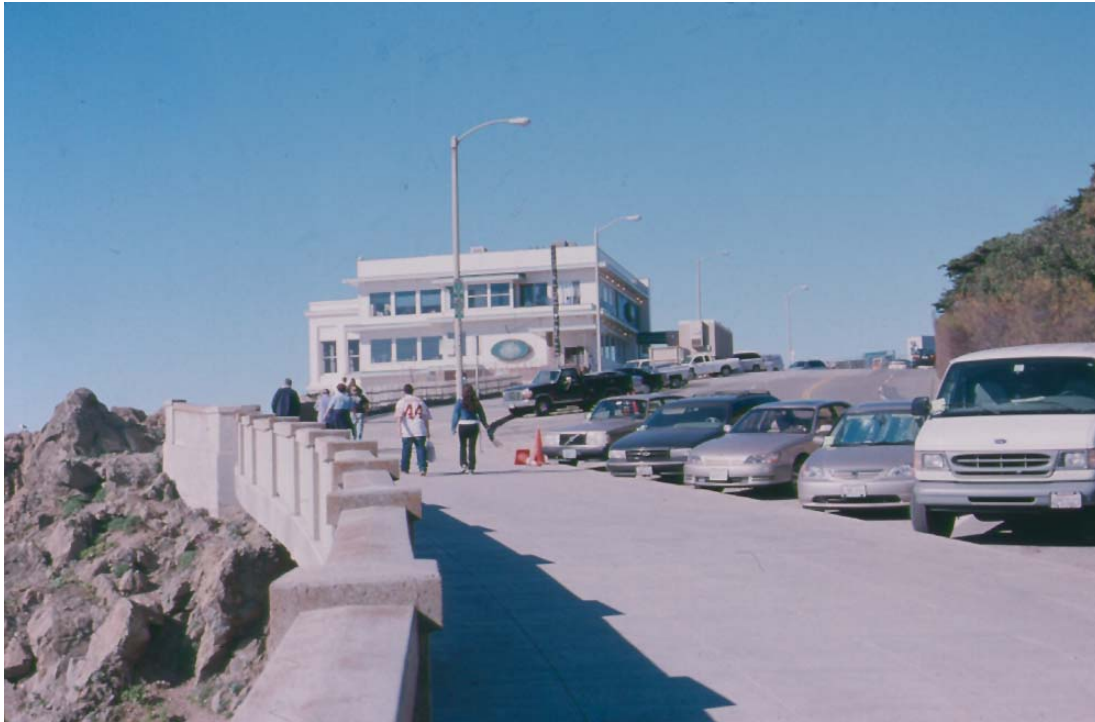
*Buildings and Structures #3: View of the Cliff House from the promenade along the Great Highway. (PWR, CLI, GOGS-S-0002-1, 2004)*

The Cliff House reopened on July 1, 1909 (see photo: Buildings and Structures #3). It embodied the prominent features of design of the time: a well-proportioned building constituting a monumental mass, reinforced concrete walls with steel beams floors for stability and fireproofing, and restrained Classical Revival detailing. In planning the relationship of the building to its site, the Reid Brothers realized Daniel Burnham's concept for a modest building facilitating views, articulated in his 1905 master plan for the city. The Reid Brothers preserved the sweeping ocean vistas from Sutro Heights Park by designing a building that rose just one story above grade at street level. In addition, a wide viewing deck surrounded the rear and sides of the building, bringing visitors into direct contact with the coastline and views of the distant horizon. From the building's interior, rows of picture windows pierced the massive walls on all three floors, framing views of the ocean and headlands beyond (ibid.).

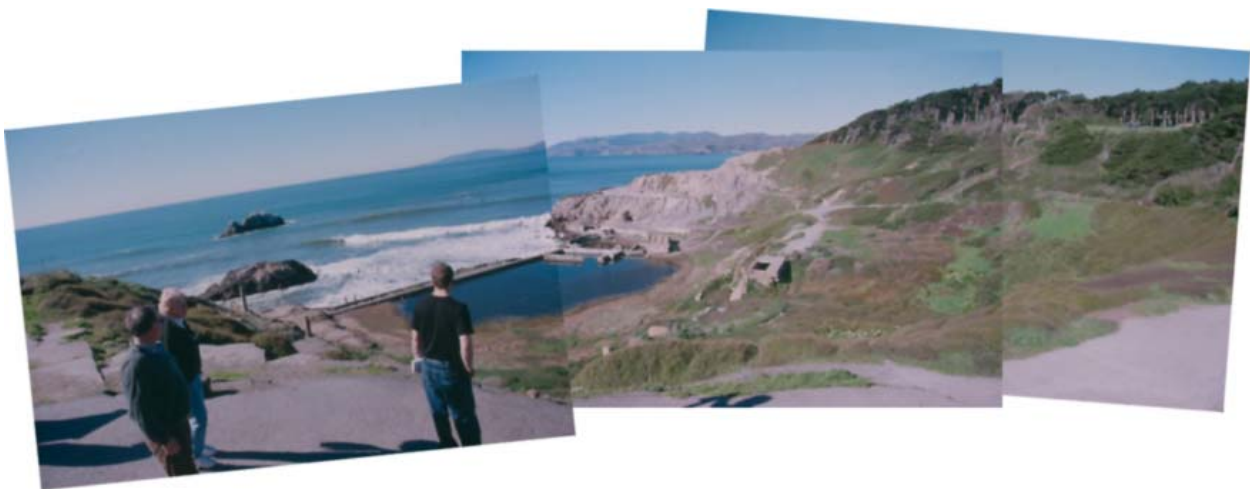
*Buildings and Structures #4: Panoramic view of the Sutro Baths ruins from Louis' Restaurant. (PWR, CLI, GOGS-S-0002-11, 12, 13, 2004)*

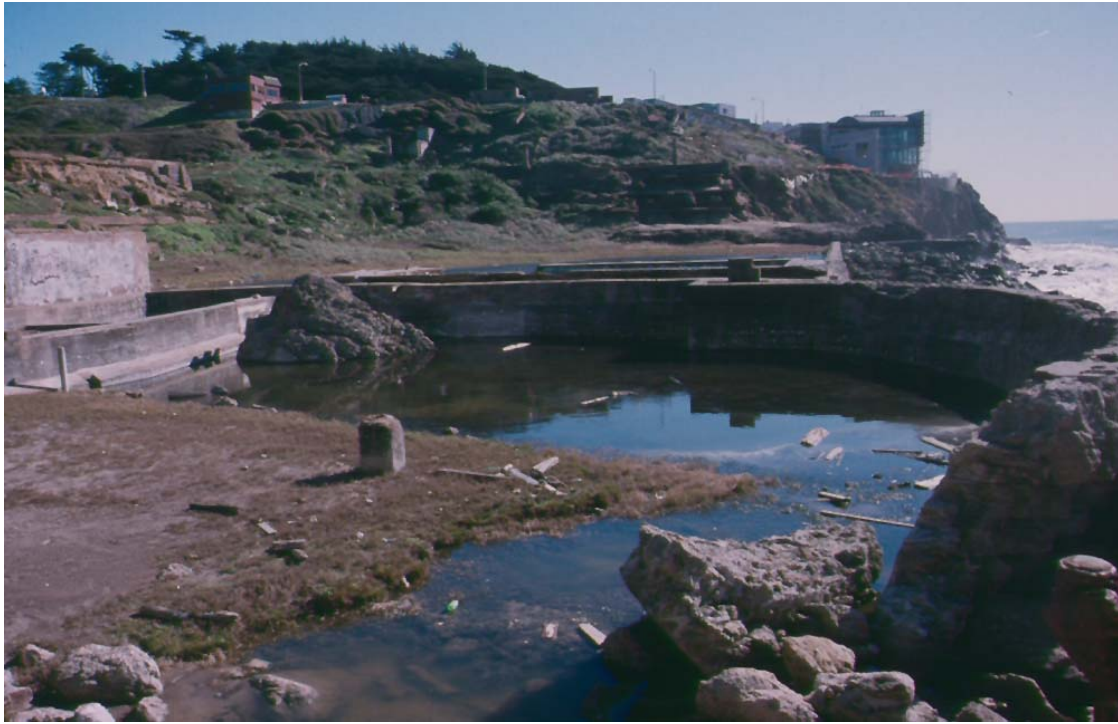
*Buildings and Structures #5: Looking over the receiving basin at the Sutro Baths ruins toward the Cliff House, Louis' Restaurant, and Sutro Heights. (PWR, CLI, GOGS-S-0002-17, 2004)*

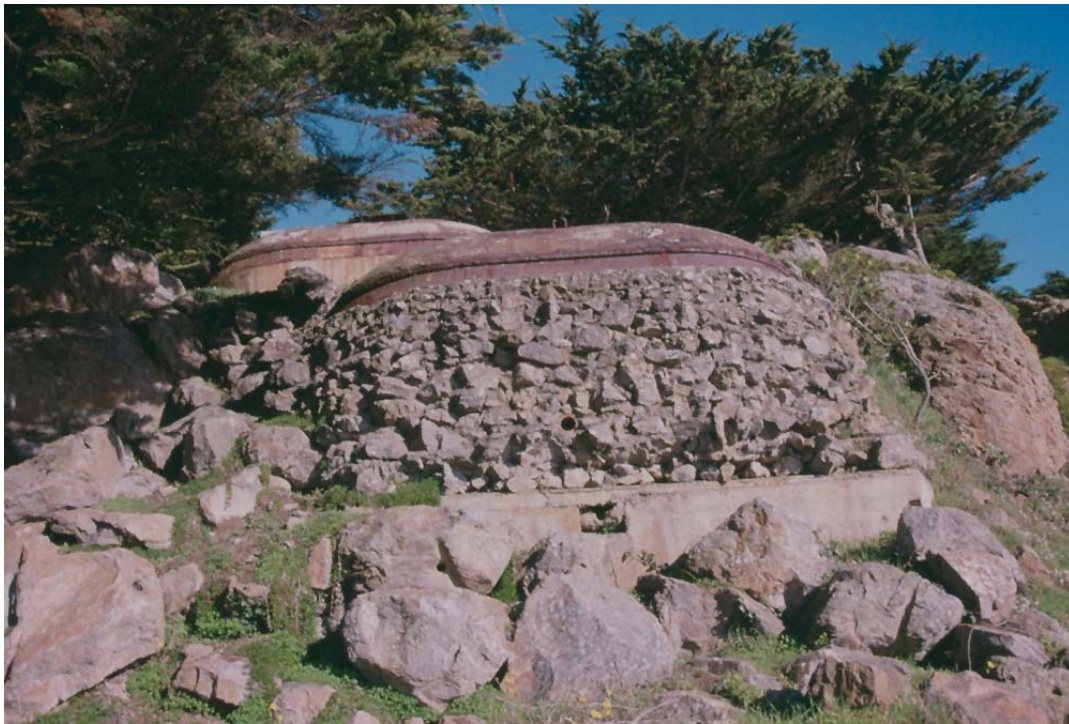
*Buildings and Structures #6: View of the Base End Stations from the North Esplanade. (PWR, CLI, GOGS-S-0002-33, 2004)*

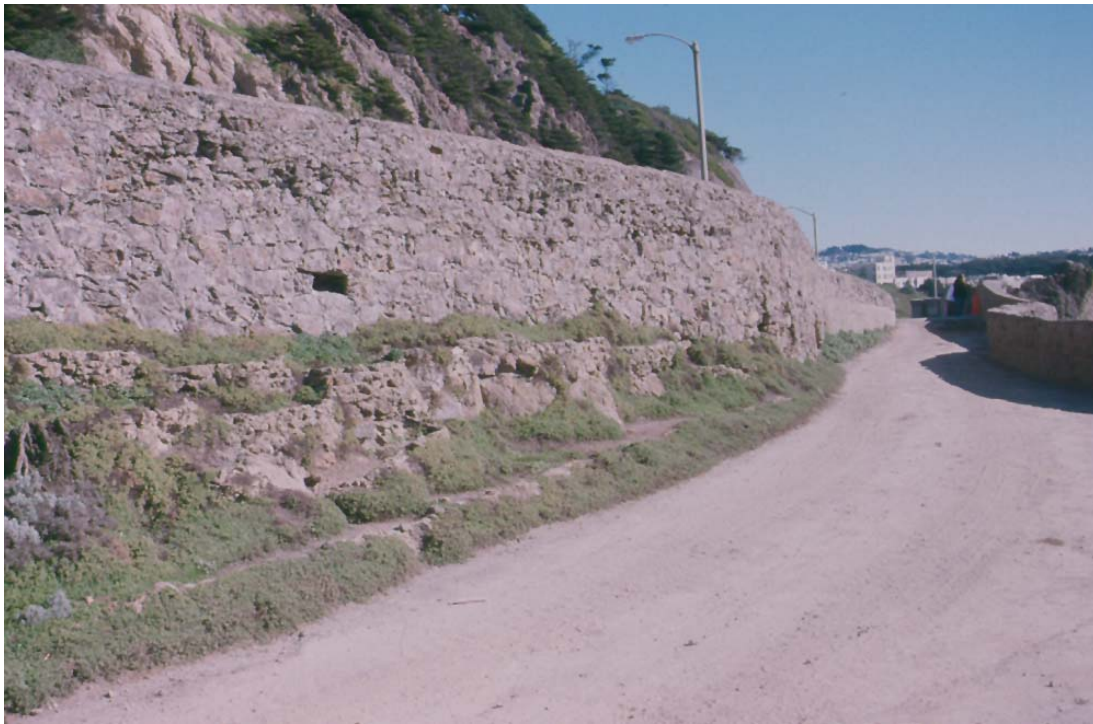
*Small Scale Features #1: Detail view of the concrete freestanding walls along the walkway connecting Great Highway to the Lower Terrace and the associated rock garden. (PWR, CLI, GOGS-S-0002-5, 2004)*

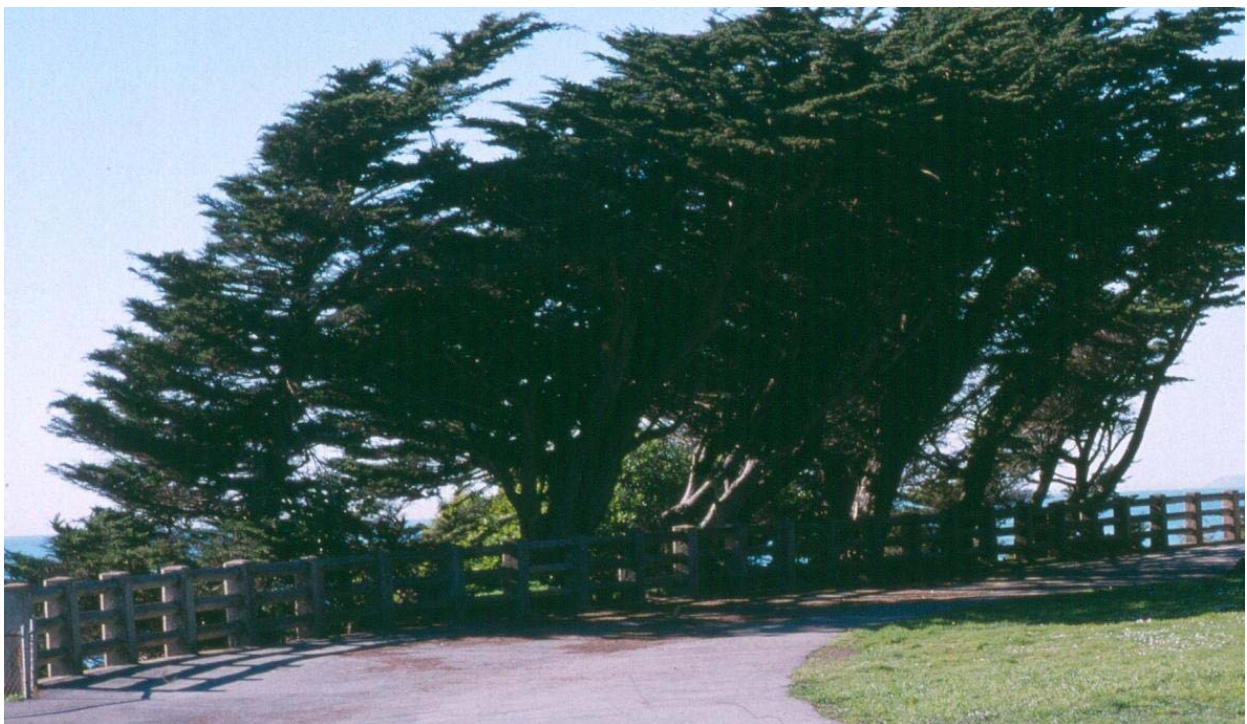
*Small Scale Features #2: Detail view of concrete bar and post fencing along the South Esplanade. (PWR, CLI, GOGS-S-0002-30, 2004)*

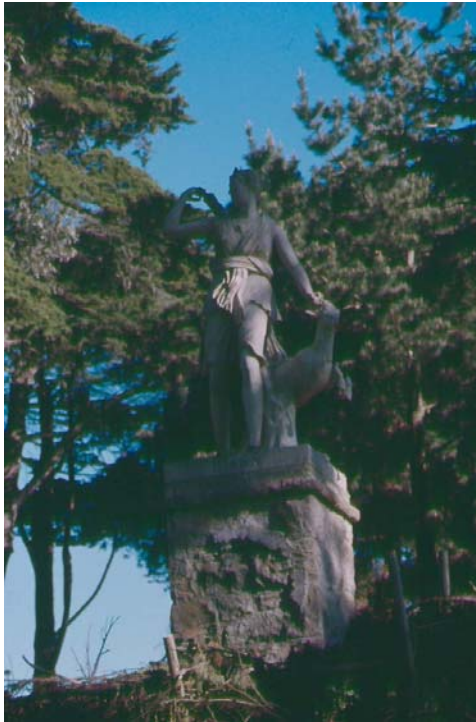
*Small Scale Features #3: View of recast “Diana” statuary. (PWR, CLI, GOGA-S-0002-25, 2004)*

In 1977, the statues were removed and castings were made of the originals with repairs affected to the replicas produced. These four reproductions were placed at Sutro Heights and the originals were put into museum storage. The Lions and "Diana" were placed at their original locations; however, the Stag was moved to a prominent location near the entrance on Palm Avenue. The original statues are in the collections of Golden Gate National Recreation Area.

Today, the replicas of the Lions, Diana, and the Stag remain, along with the fountain bases and one urn exists today (see photos, Small Scale Features #3 and # 4). At various times, broken pieces of statuary, planters, pedestals and bases are found buried, or are located under vegetation during maintenance activities and then moved to museum storage.

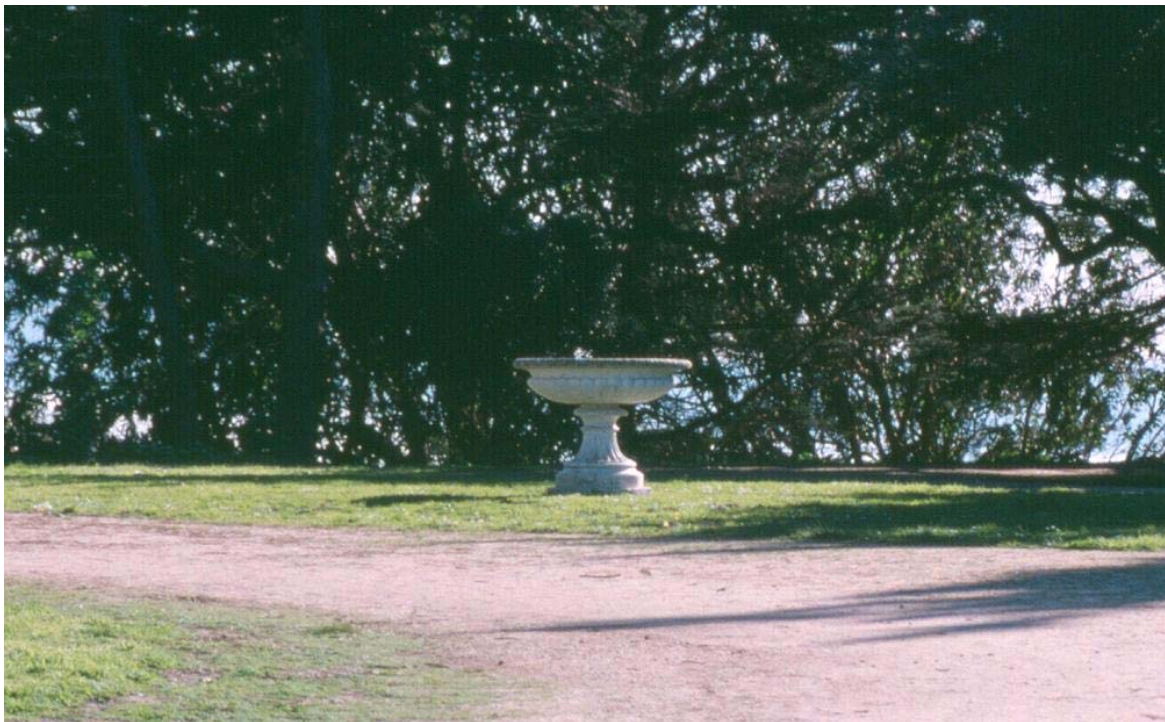
*Small Scale Features #4: View of recast Urn at the carriage turn-around. (PWR, CLI, GOGA-S-0002-28, 2004)*

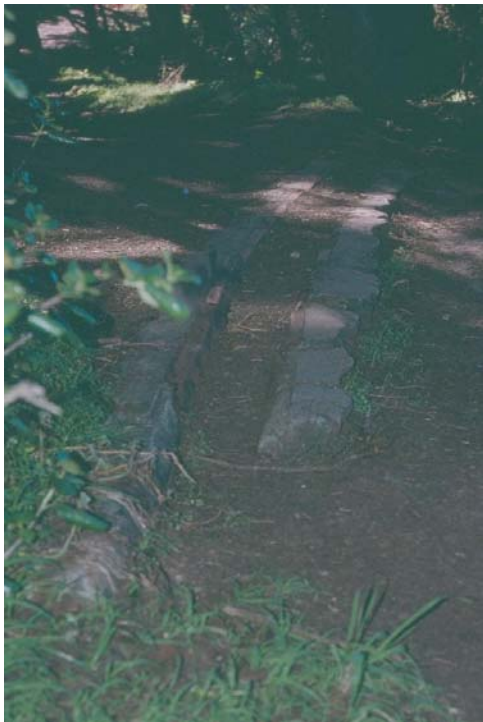
*Archeological Sites #1: View of terra cotta drainage, one of many potential buried features within the Adolph Sutro Historic District. (PWR, CLI, GOGS-S-0002-21, 2004)*
