National Park Service  
Cultural Landscapes Inventory  
2003

Caire-Gherini Ranch Historic District  
Channel Islands National Park

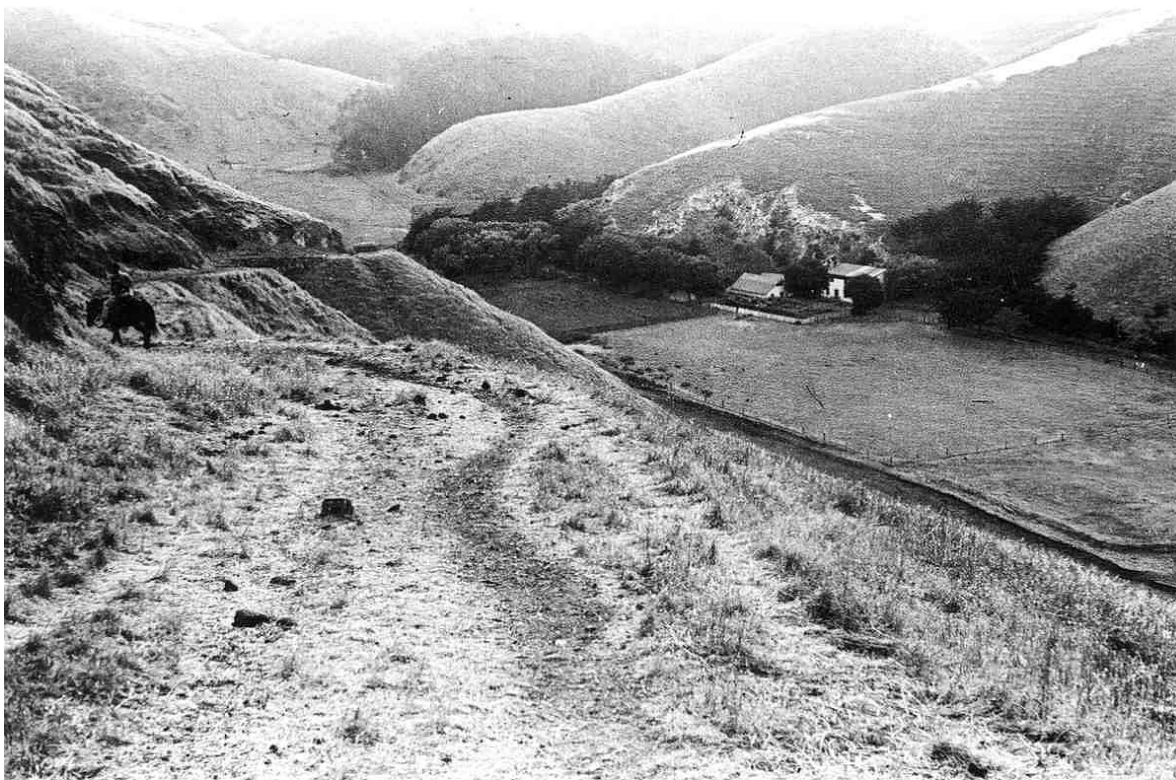
History #2: Historic view of Scorpion Ranch in 1939. (Collection of M. Woodbridge Williams)

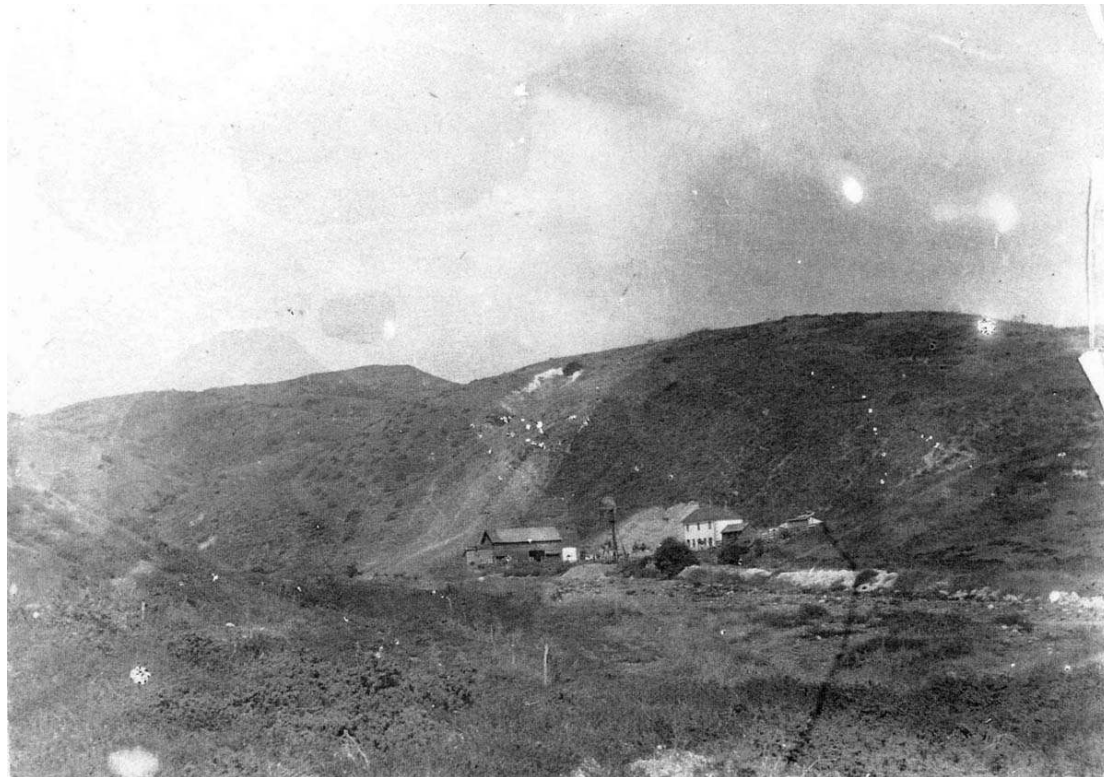
History #5: View of Smugglers Ranch circa 1890-1900. (Photo courtesy of John Gherini)

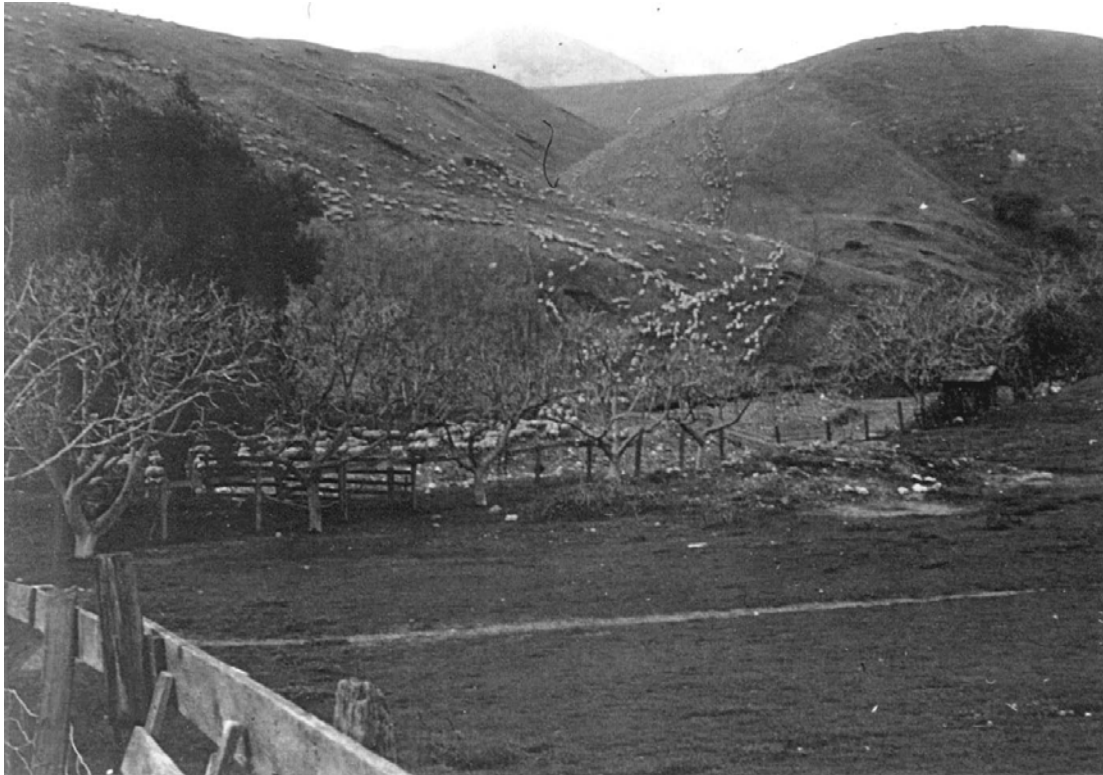
*History #7: The flock from Aguaje Pasture in the wings above Smugglers Ranch, January 1939. Note the row of walnuts in the middle ground. (Photo courtesy of John Gherini)*

Activities at the ranch in the 1880s revolved around planting and harvesting. Immediately surrounding the ranch, fields were found on both sides of valley. A vegetable garden, containing corn and beans, was located in the flats south of creek with adjoining hog pens. Two vineyards were established on the hill to the south of the garden. Much of 1887 was spent planting the olive orchards (this may include the establishment of the grove east of Smugglers Road, as a ca. 1890-1900 photo of the hillside shows no trees, though the grove was in place by 1919 (see photo, History #6). By 1889 figs had been added to the ranch. Ranch diaries in 1890 note the planting of fruit trees which may explain the origins of the lemon, orange, olive and walnut trees found on the site today (the row of walnuts to the south of the house were not identified on a 1919 map, but appear in a 1939 photograph (see photo, History #7).

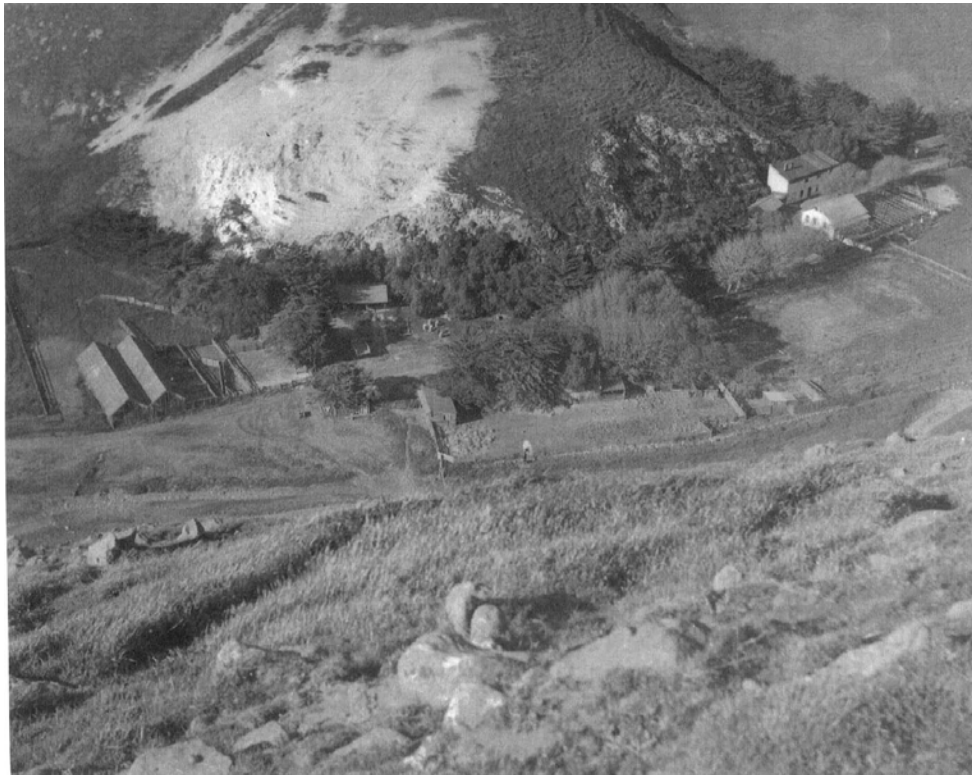
*History #8: Historic view of Scorpion Ranch, post 1914. (Photo courtesy of John Gherini)*

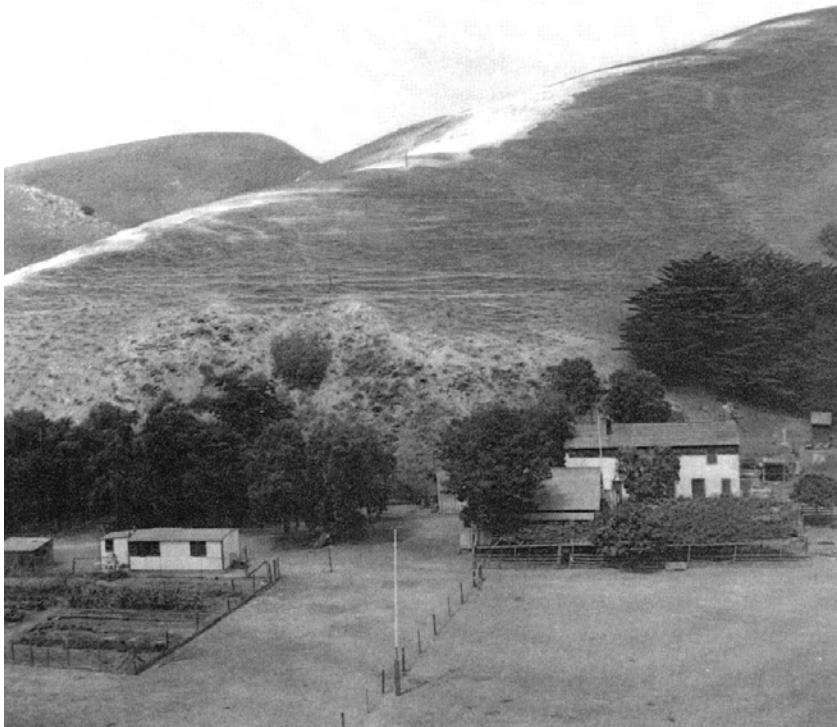
*History #9: Historic view of Scorpion Ranch residential area, September 1959. (Photo courtesy of John Gherini)*

In Scorpion Valley, significant changes were made to the planted tree species and their arrangement around the bunkhouse in the first twenty years of Gherini management. By 1937, a large massing of what appear to have been cypress trees are used southwest of the bunkhouse to provide shade to utilitarian structures and corrals (see photo, History #8). By 1959, these had been removed, along with a group of what appear to be willows, in the approximate area of the existing willows at the southwest corner of the bunkhouse yard. However, a fenced area on the south and east sides of the bunkhouse, possibly containing grape vines, was retained until at least 1959 (see photo, History #9).

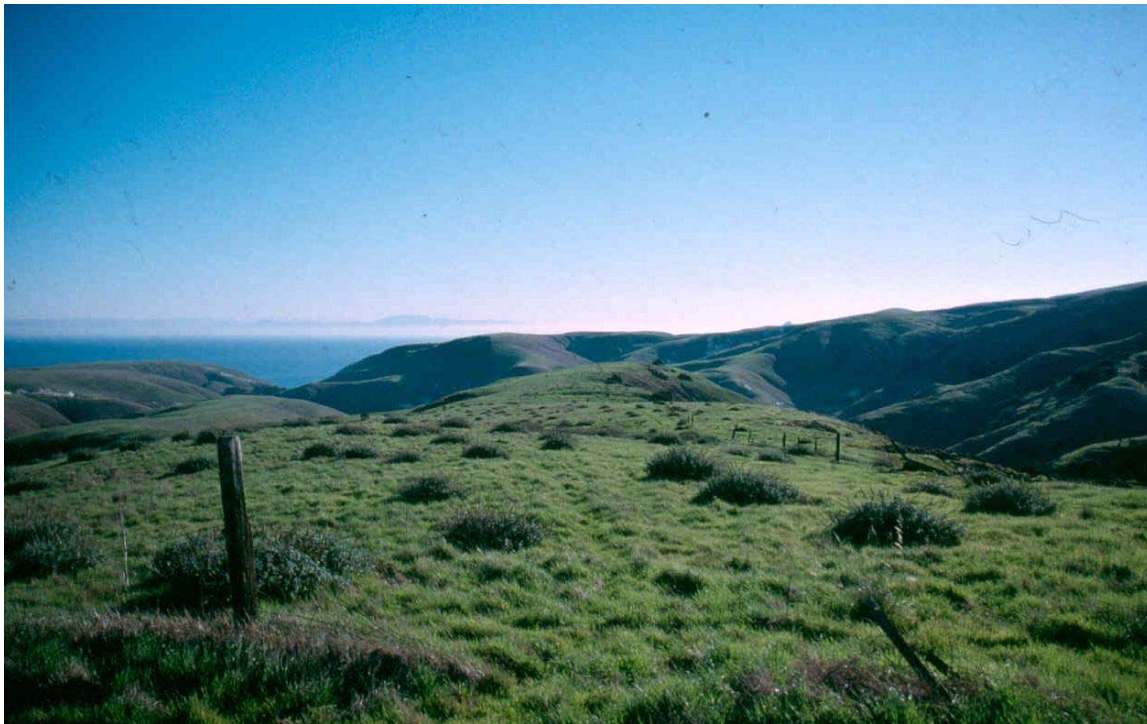
*Natural Systems and Features #1: View of the steep, grass covered pastures on eastern Santa Cruz Island. Note livestock fences crossing over the ridges. (PGSO, CLI, CHIS-S-0007-33, 2003)*

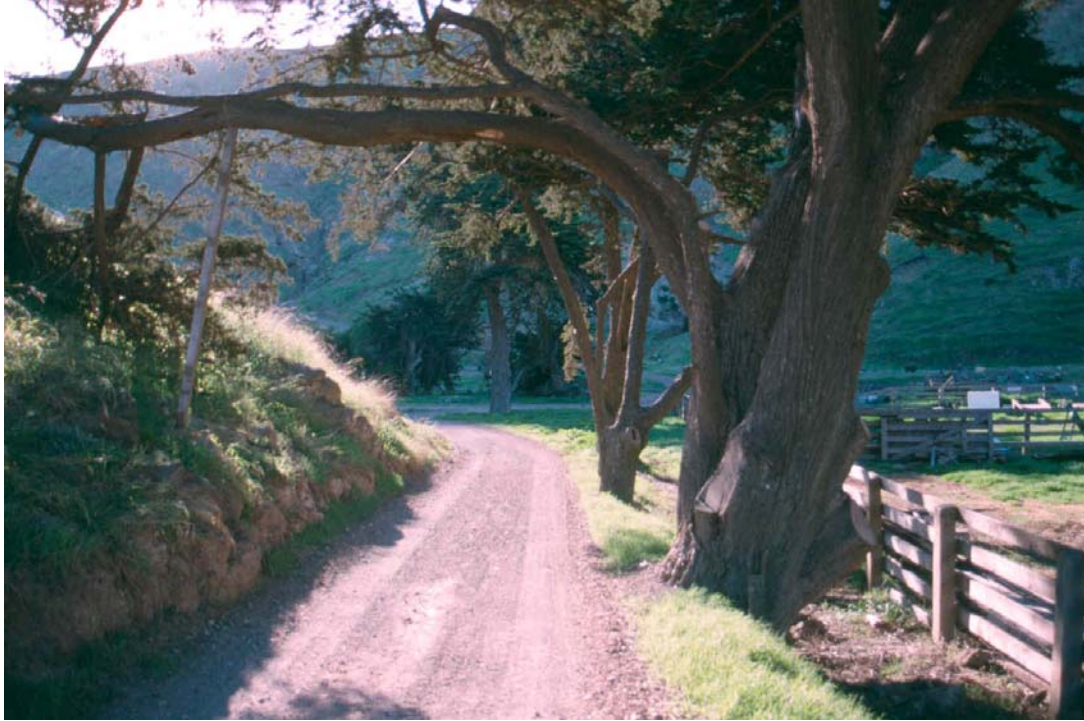
*Vegetation #1: Monterey cypress located along the Service Road, near the new corral. View of one of the hazard limbs at Caire-Gherini Ranch Historic District. (PGSO, CLI, CHIS-S-0009-2, 2003)*

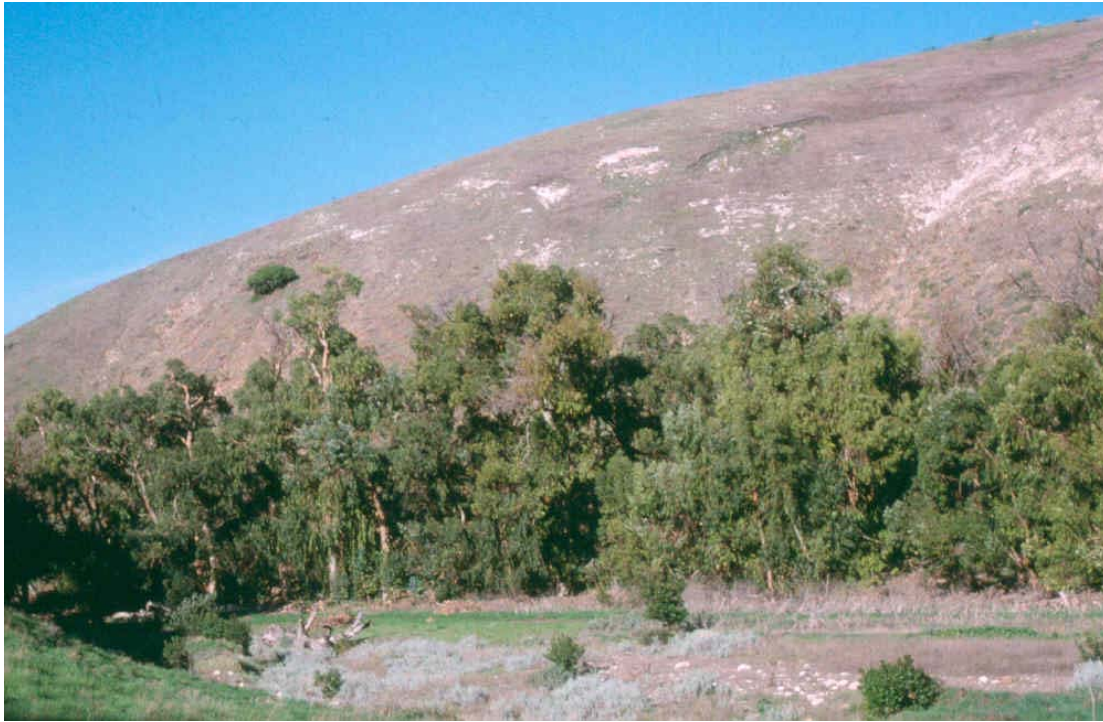
*Vegetation #2: View of one of the eucalyptus groves in Valley Field west of Scorpion Ranch. (PGSO, CLI, CHIS-S-0009-8, 2003)*

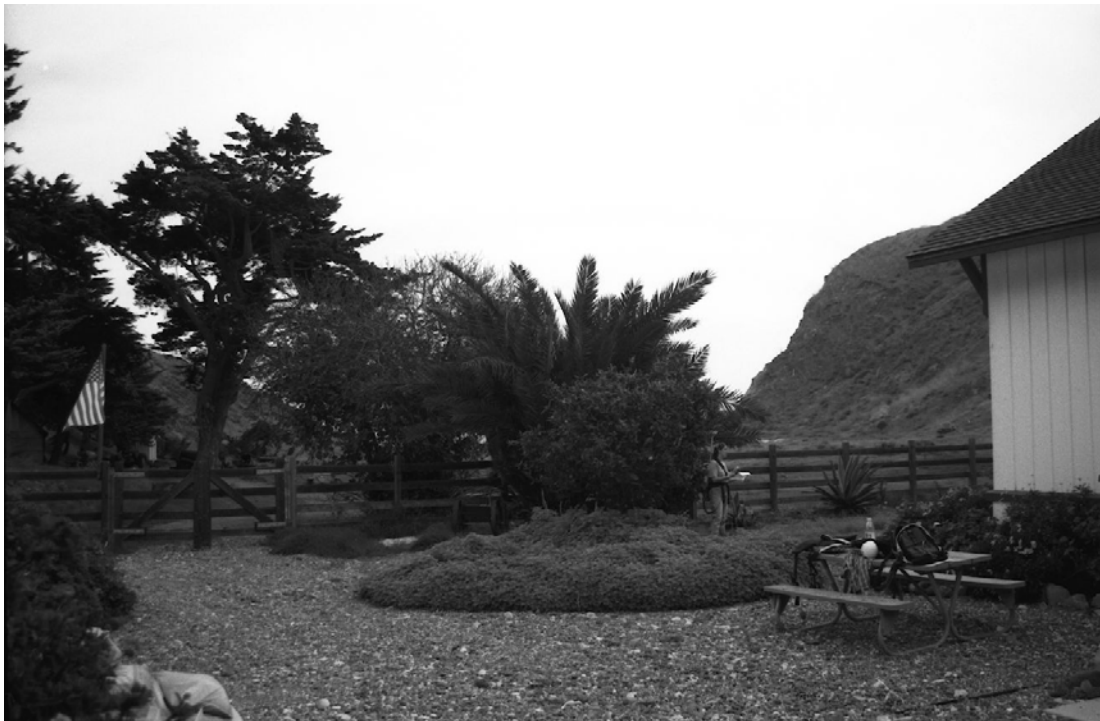
*Vegetation #3: View of the non-contributing tree and perennial massings at Scorpion Ranch next to the bunkhouse. (PGSO, CLI, CHIS-N-0013-19, 2003)*

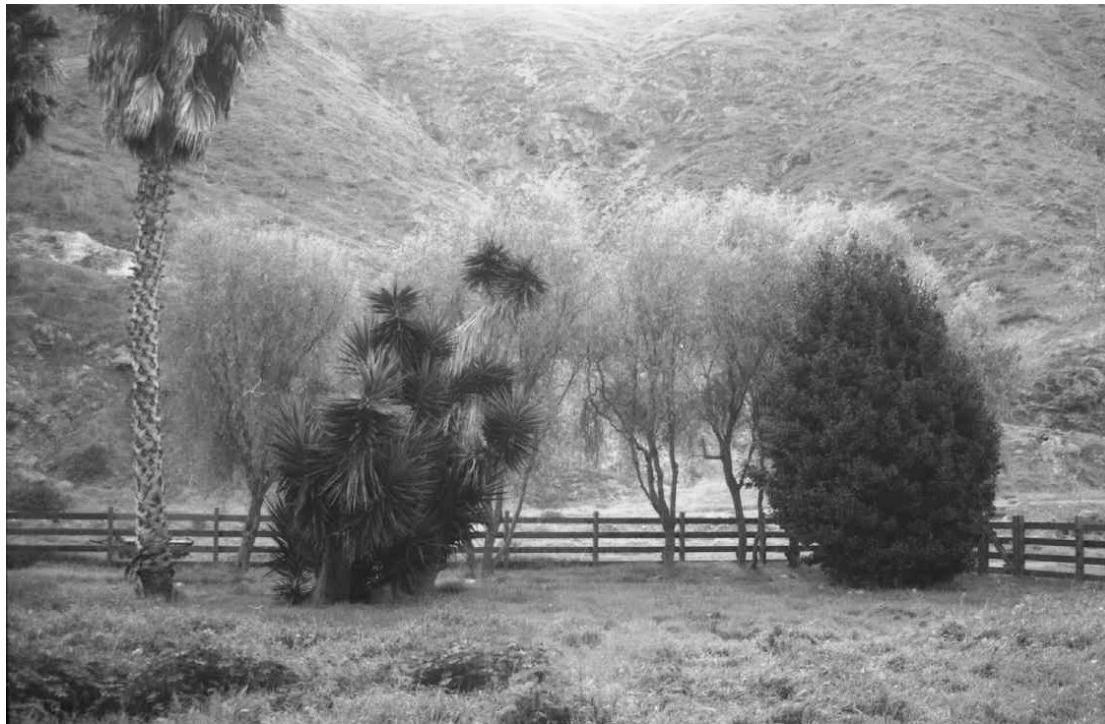
*Vegetation #4: View of the historic corkcreeper willow row at Scorpion Ranch. Note the modern fence surrounding the residential area. (PGSO, CLI, CHIS-N-0013-23, 2003)*

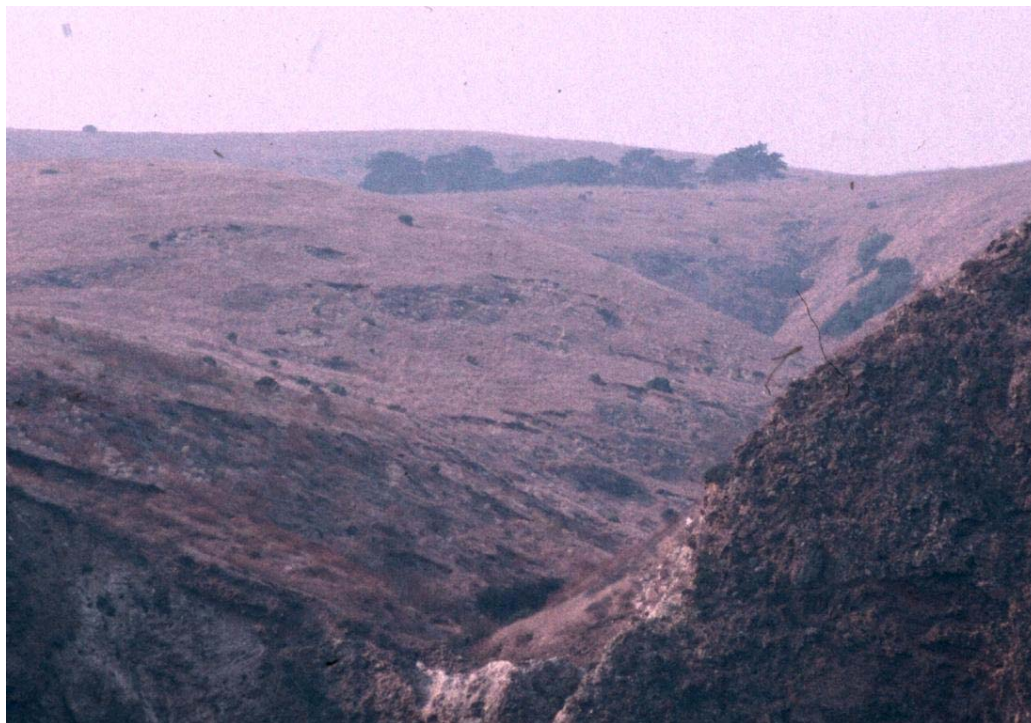
*Vegetation #5: View of Delphine's Grove while approving the Scorpion Anchorage. (PGSO, CLI, CHIS-S-00010-1, 2003)*

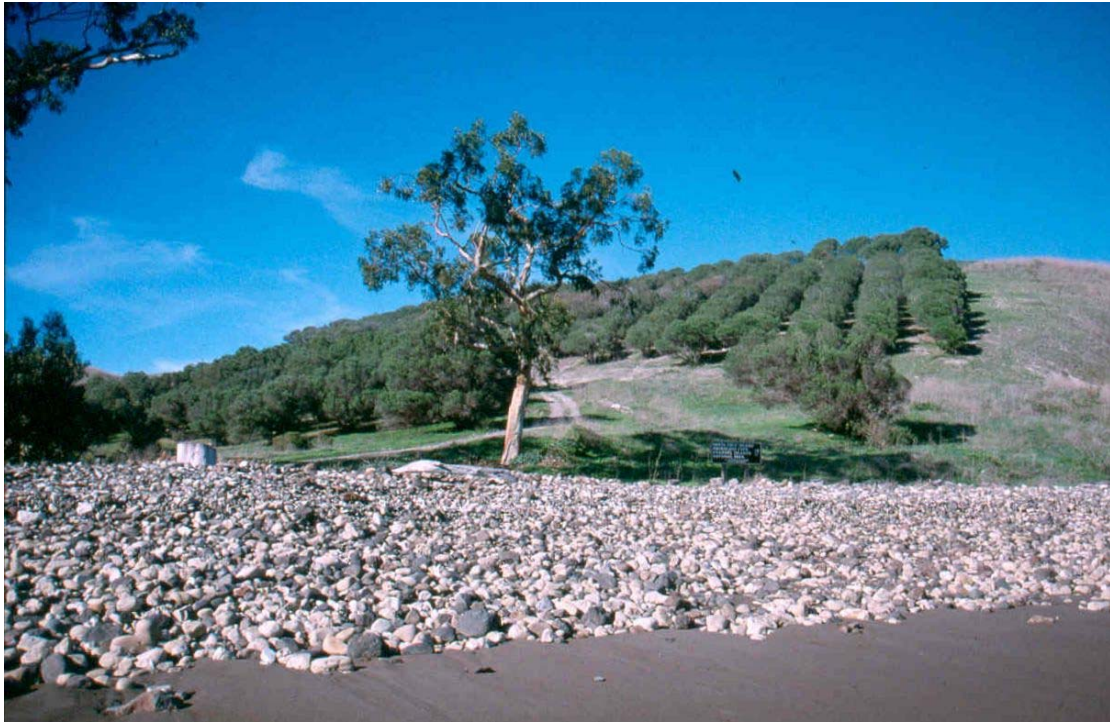
*Vegetation #6: View of two of the olive orchards at Smugglers Ranch from the beach. Smugglers Road divides the orchards in the center of the photo. (PGSO, CLI, CHIS-S-0007b-13, 2003)*

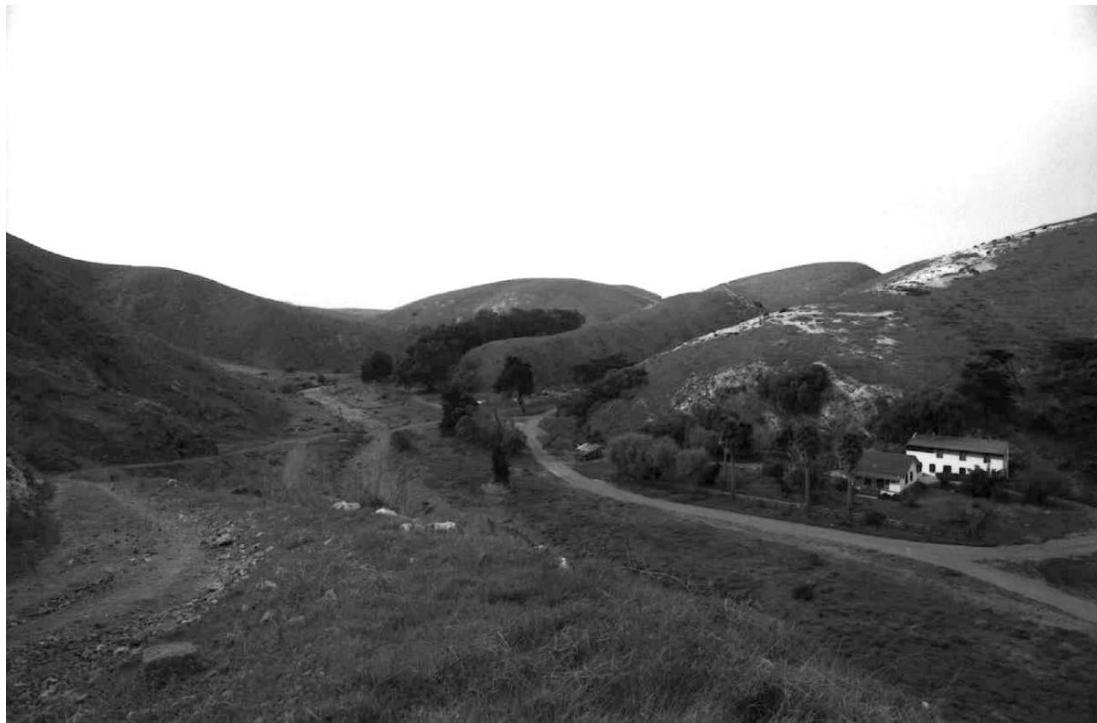
*Circulation #1: View of some of the branches of Scorpion Canyon Road. The intersection of Smugglers Road, Scorpion Canyon Road, and the Service Road is at the center of the photo. (PGSO, CLI, CHIS-N-0013-33, 2003)*

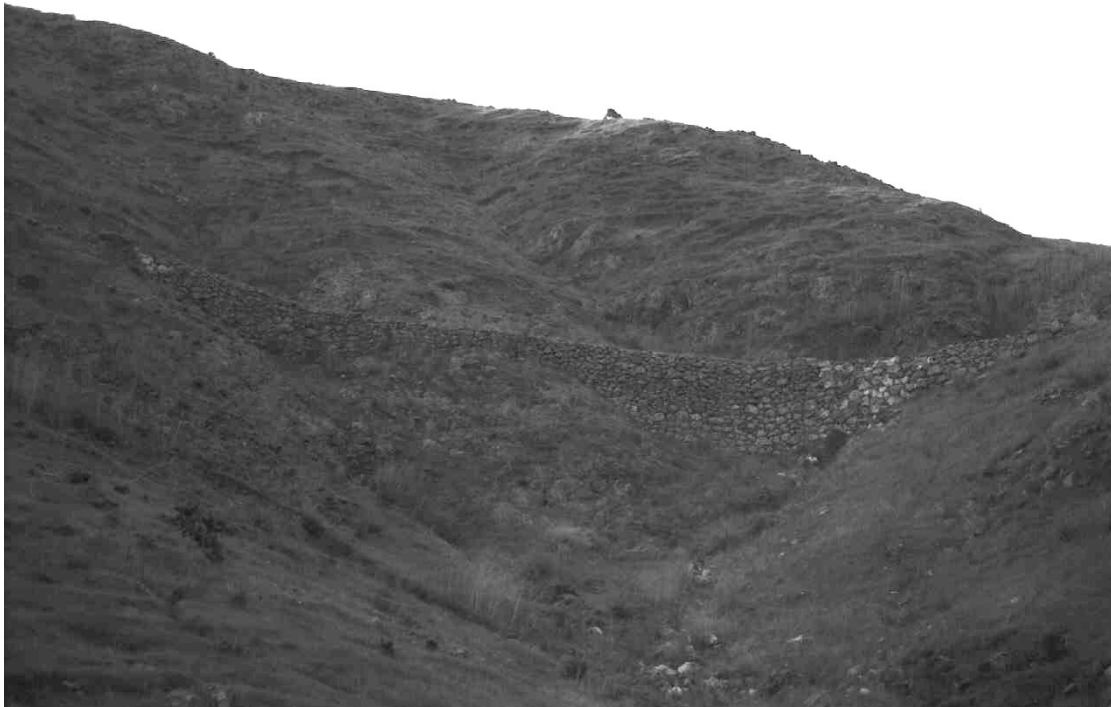
*Circulation #2: View of the rock work used in the initial ascent from Scorpion Canyon. (PGSO, CLI, CHIS-N-0013-5, 2003)*

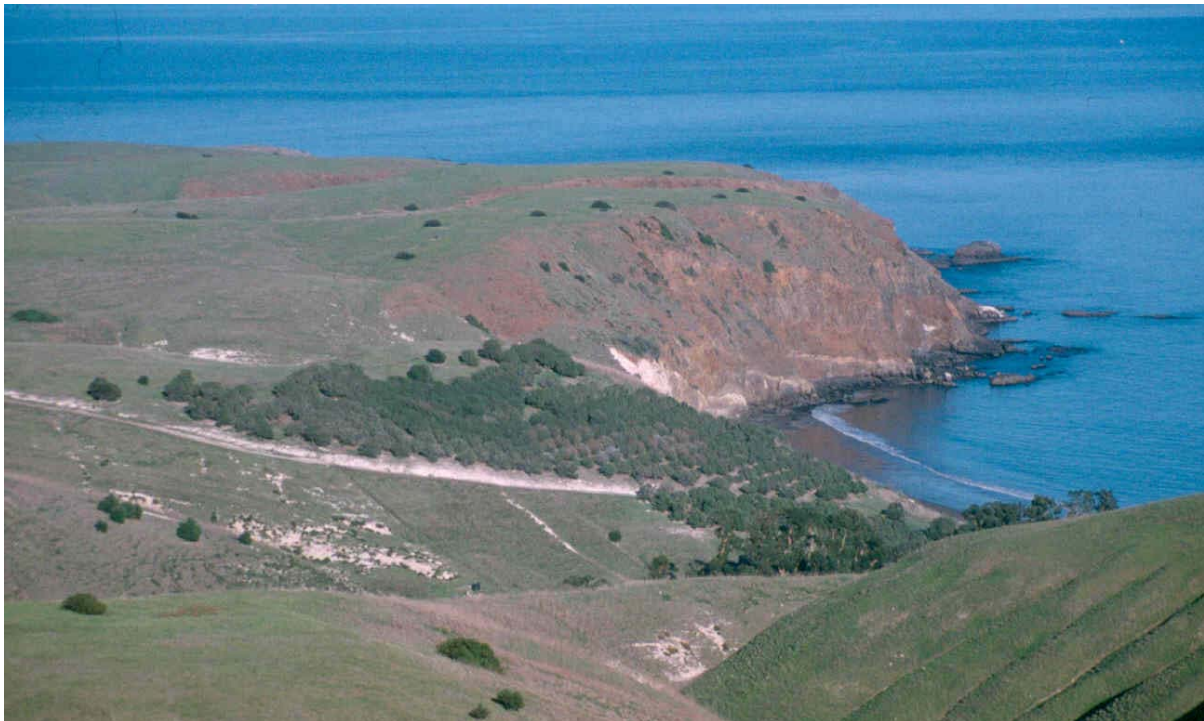
*Circulation #3: Smugglers Road divides the olive orchards before turning toward Smugglers Ranch. (PGSO, CLI, CHIS-S-0008-6, 2003)*

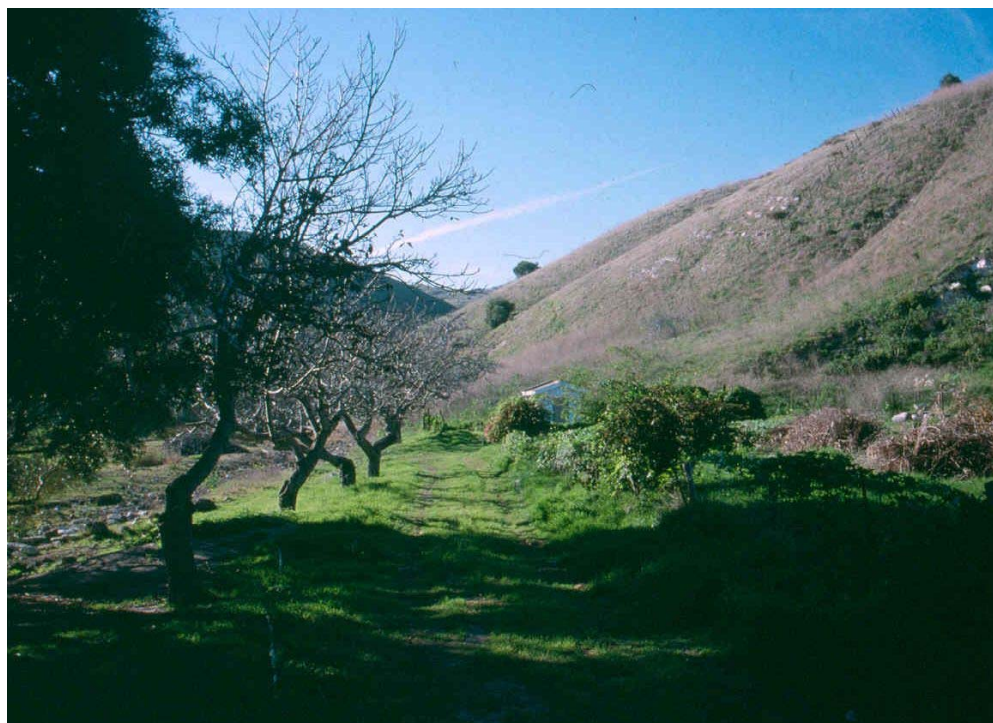
*Circulation #1: View of the Yellowbanks Trail at Smugglers Ranch. Walnut trees line the south side of the trail.  
(PGSO, CLI, CHIS-S-0007b-17, 2003)*

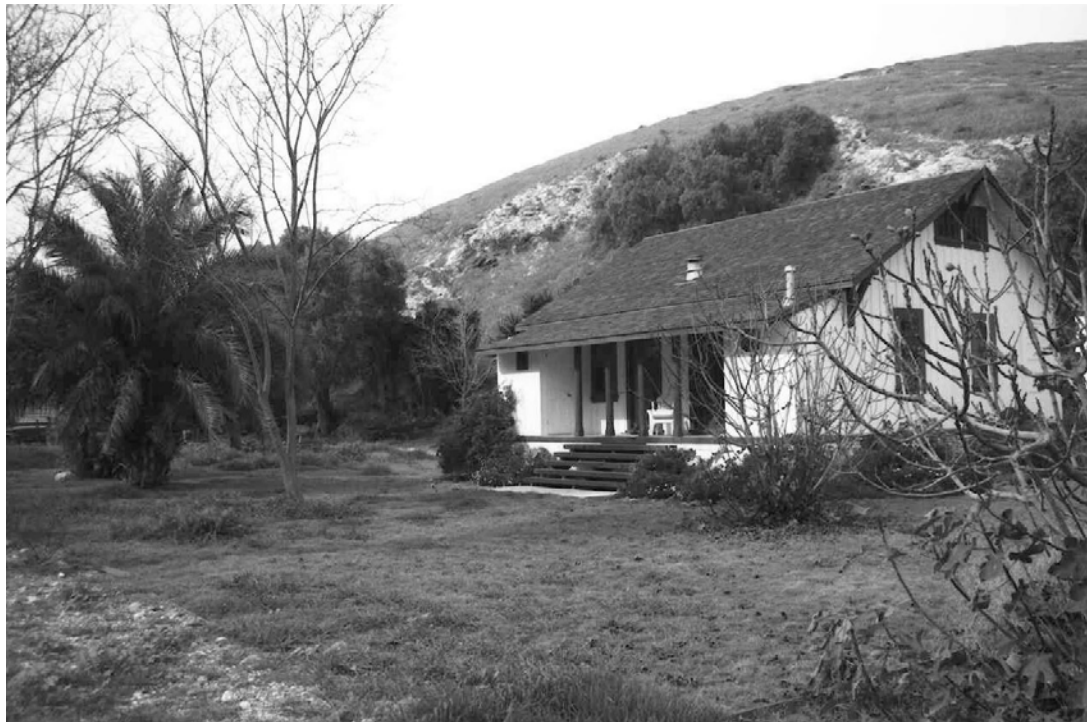
*Buildings and Structures #1: View of Scorpion bunkhouse. Much of the vegetation around the house post-dates the period of significance. (PGSO, CLI, CHIS-N-0013-26, 2003)*

The National Park Service regraded the stream channel following the flood in order to remove several feet of rocks and debris that obstructed the flow of water. Major work was done to restore the Scorpion bunkhouse. The bunkhouse was attached to a new, higher concrete foundation at the original location. Archeological investigation done at the time revealed the foundation of the original adobe building at Scorpion Ranch. The chicken coop, shed, and outhouse have also been stabilized since the flood.

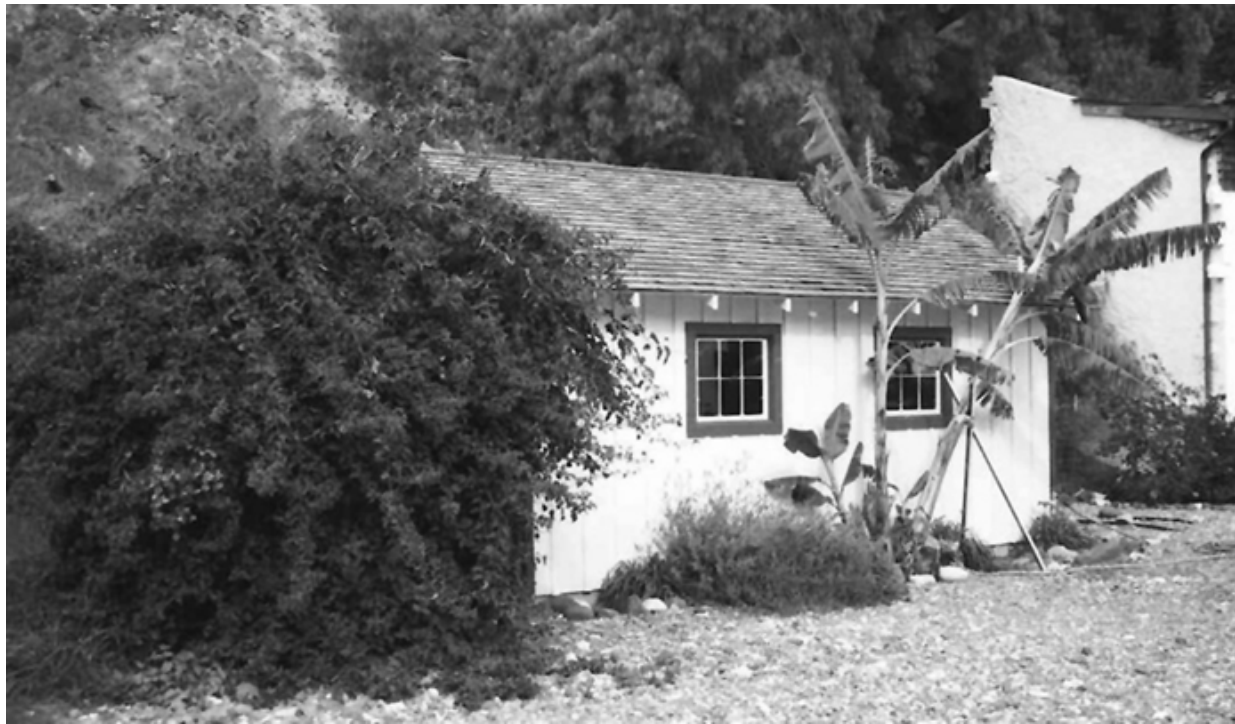
*Buildings and Structures #2: View of the kitchen at Scorpion Ranch. Non-contributing bougainvillea and banana has been planted on the south side of the building. Scorpion ranch house is on the far right. (PGSO, CLI, CHIS-N-0013-20, 2003)*

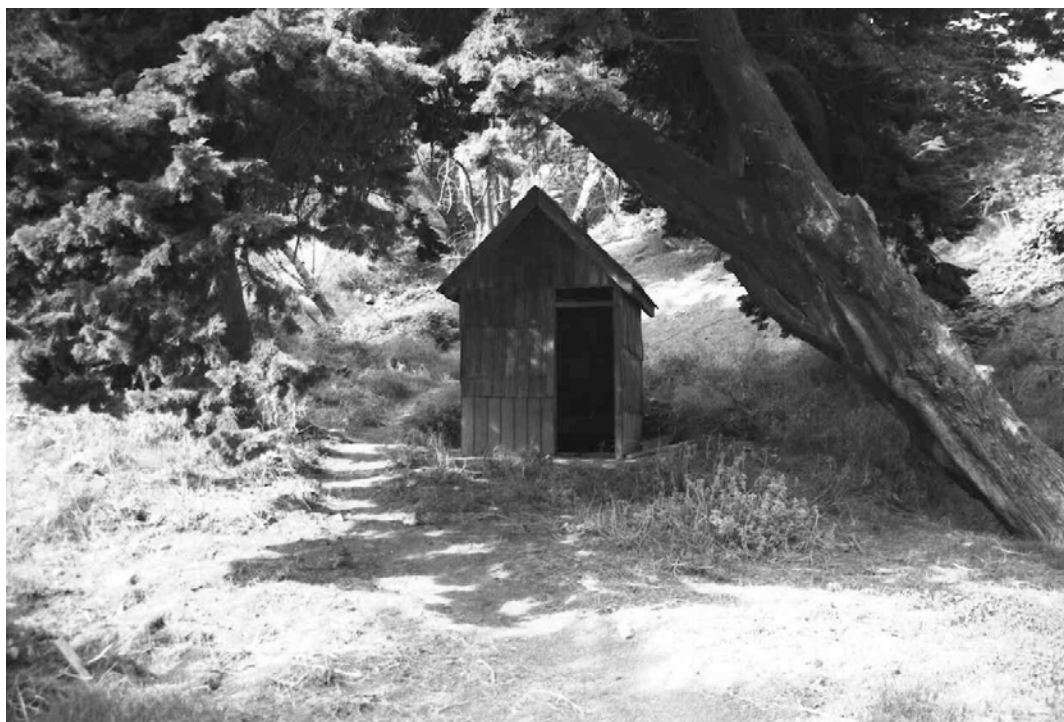
*Buildings and Structures #3: View of the outhouse at Scorpion Ranch. (PGSO, CLI, CHIS-N-0013-31, 2003)*

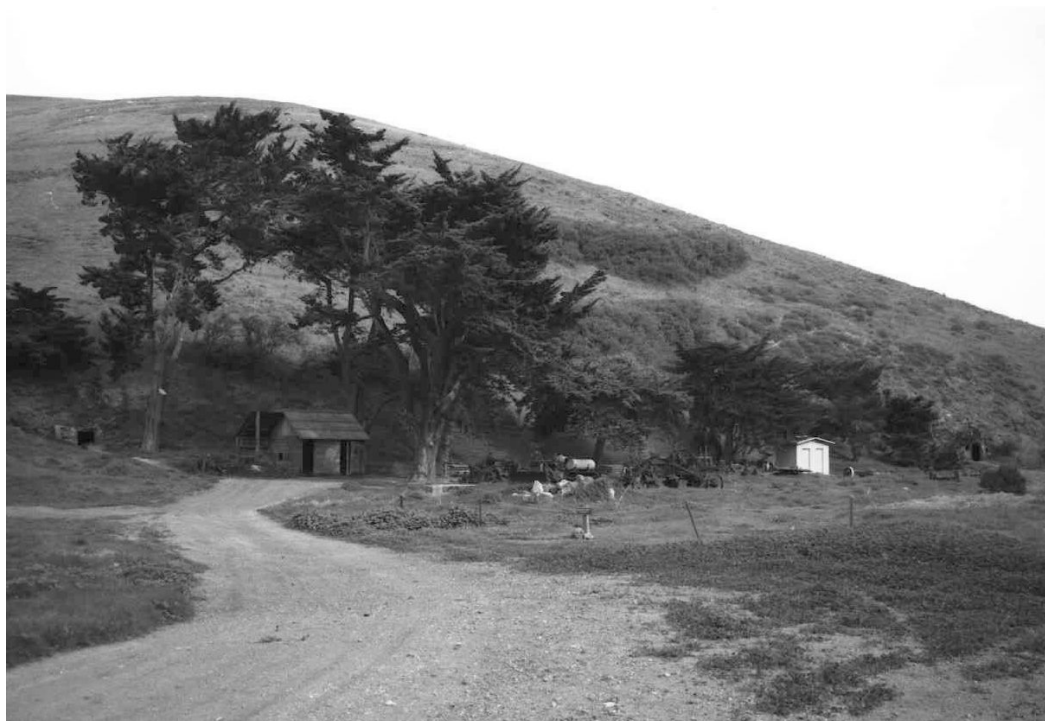
*Buildings and Structures #4: View of the shed. Note potato cave to the left and dairy cave on the far right. The white building is a modern NPS toilet. (PGSO, CLI, CHIS-N-0013-11, 2003)*

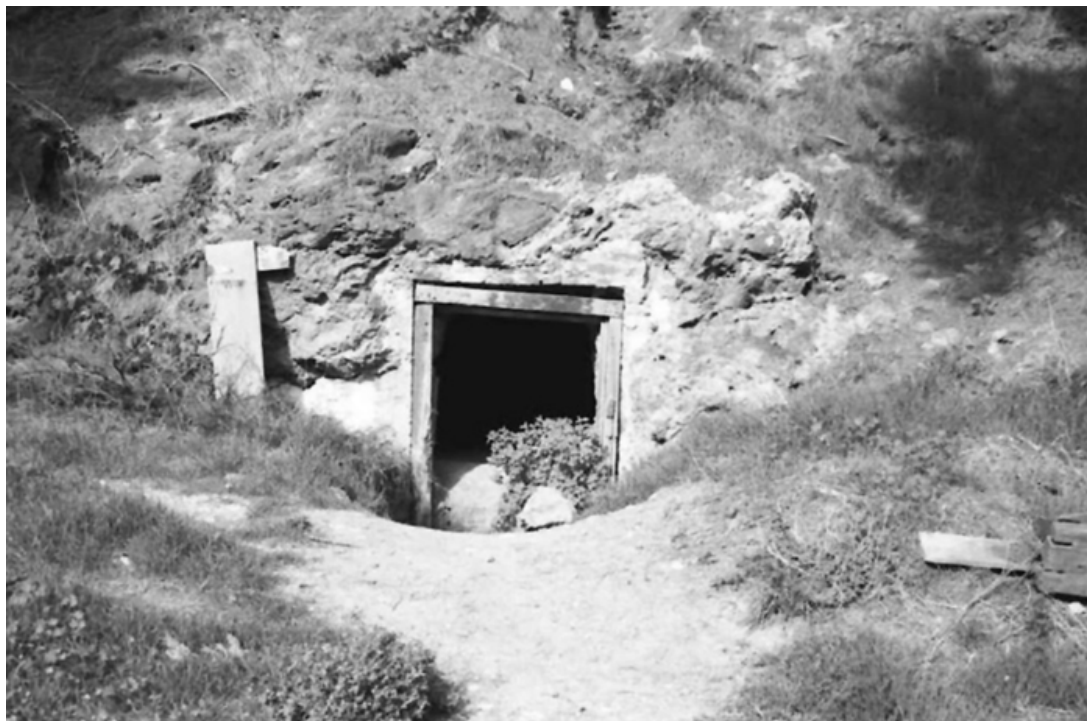
*Buildings and Structures #5: View of the damage to the potato cave at Scorpion Ranch from the flood of 1997. (PGSO, CLI, CHIS-N-0013-30, 2003)*

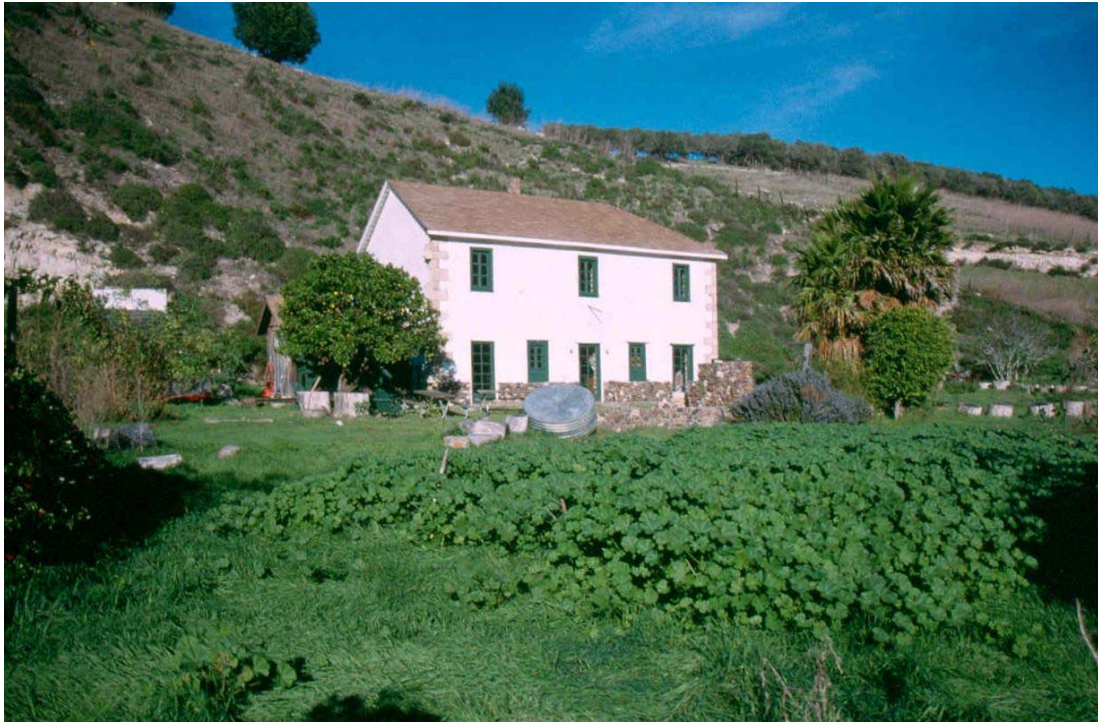
*Buildings and Structures #6: View of Smugglers ranch house. (PGSO, CLI, CHIS-S-0007b-18, 2003)*

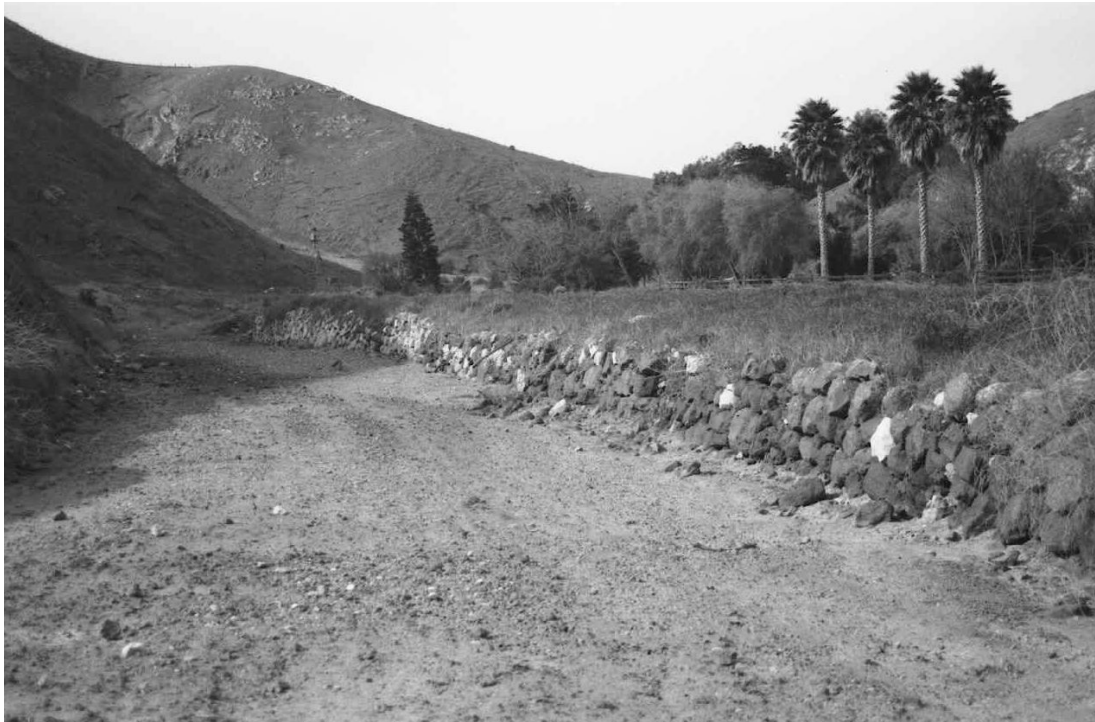
*Buildings and Structures #8: View of Scorpion Wash with a section of the retaining wall. The Norfolk Island Pine is near the center of the photo. (PGSO, CLI, CHIS-S-00013-6, 2003)*

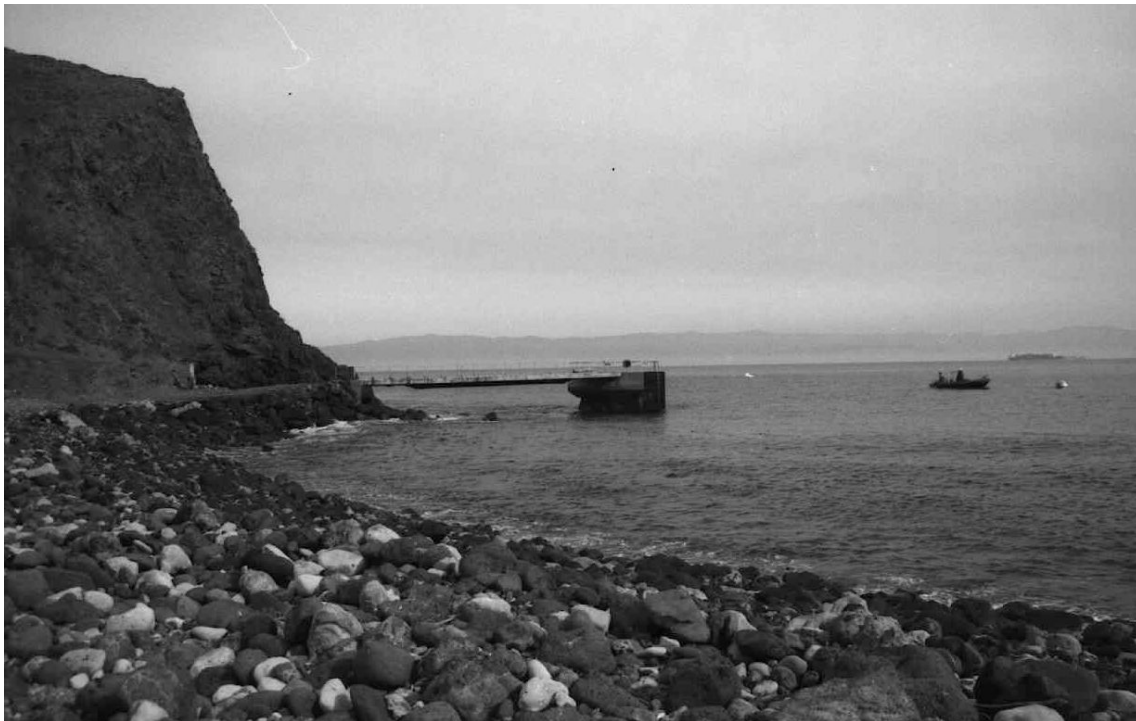
*Buildings and Structures #9: View of the modern pier in Scorpion Harbor. (PGSO, CLI, CHIS-N-0013-3, 2003)*

Constructed over the historic pier abutment built by the Gherinis in 1938, the modern pier structure, composed of steel, concrete, and wood, is a railroad car chassis laid on the old abutments in 2001 (see photo, Buildings and Structures #9). The boardwalk is over eighty feet long, ending in a square platform. The pier is lined with metal railing except where the ladders used to reach the boats are located.

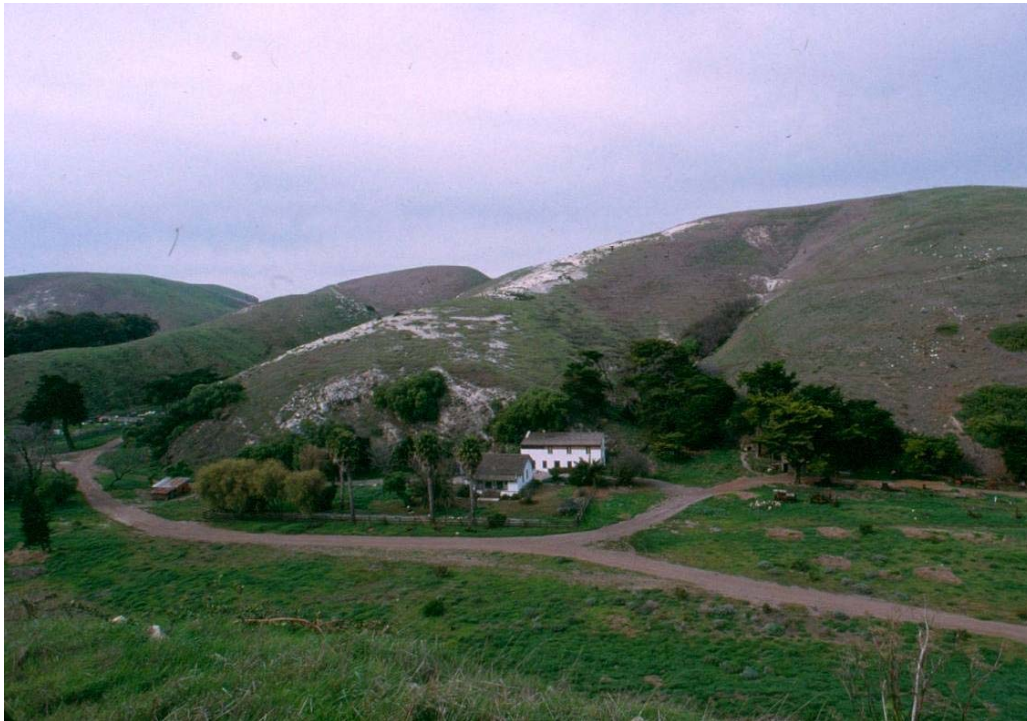
*Cluster Arrangement #1: Scorpion Ranch Cluster includes chicken coop on the left, bunkhouse and ranch house in the center, and shed on the right. (PGSO, CLI, CHIS-S-0007b-2, 2003)*

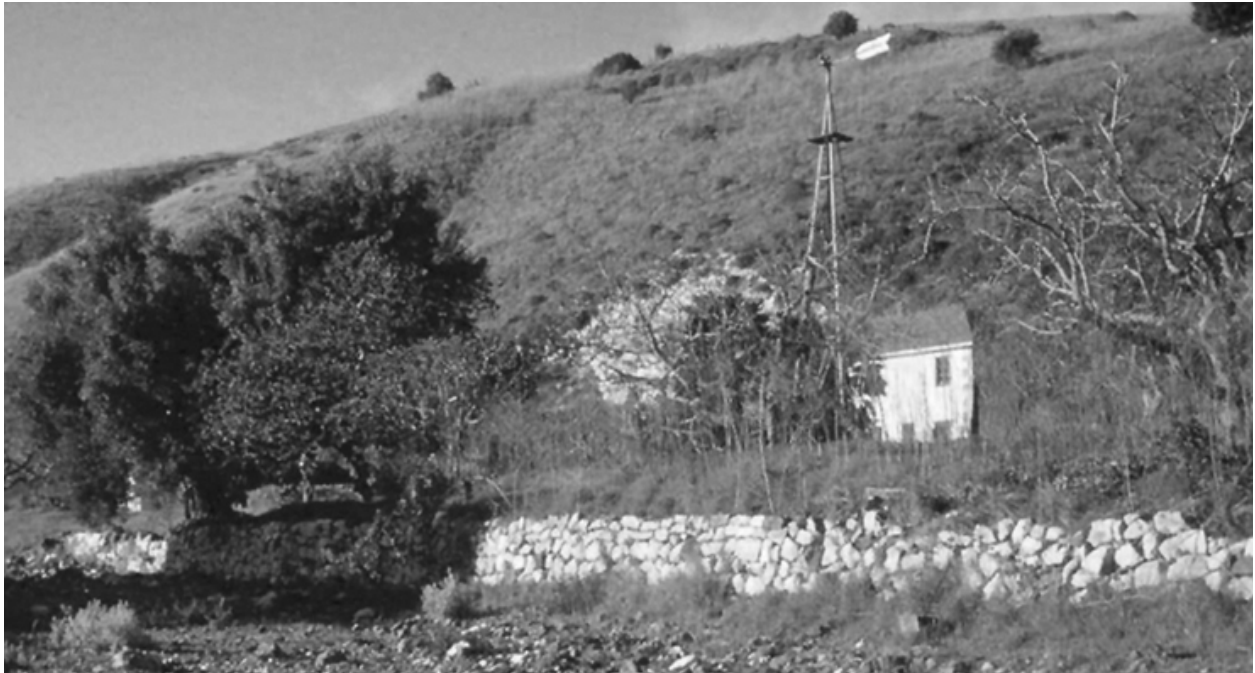
*Cluster Arrangement #2: Smugglers Ranch Cluster. (PGSO, CLI, CHIS-S-0007b-30, 2003)*
