National Park Service  
Cultural Landscapes Inventory  
2003

Caire-Gherini Ranch Historic District  
Channel Islands National Park

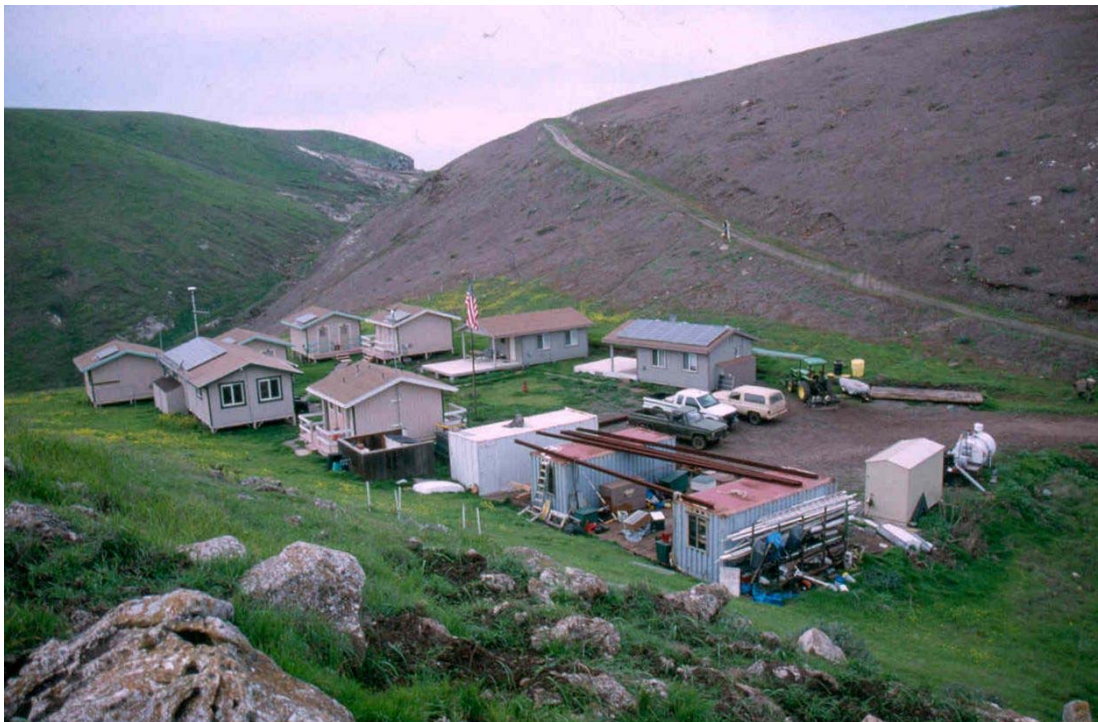
*Cluster Arrangement #3: NPS Area. (PGSO, CLI, CHIS-S-0007b-6, 2003)*

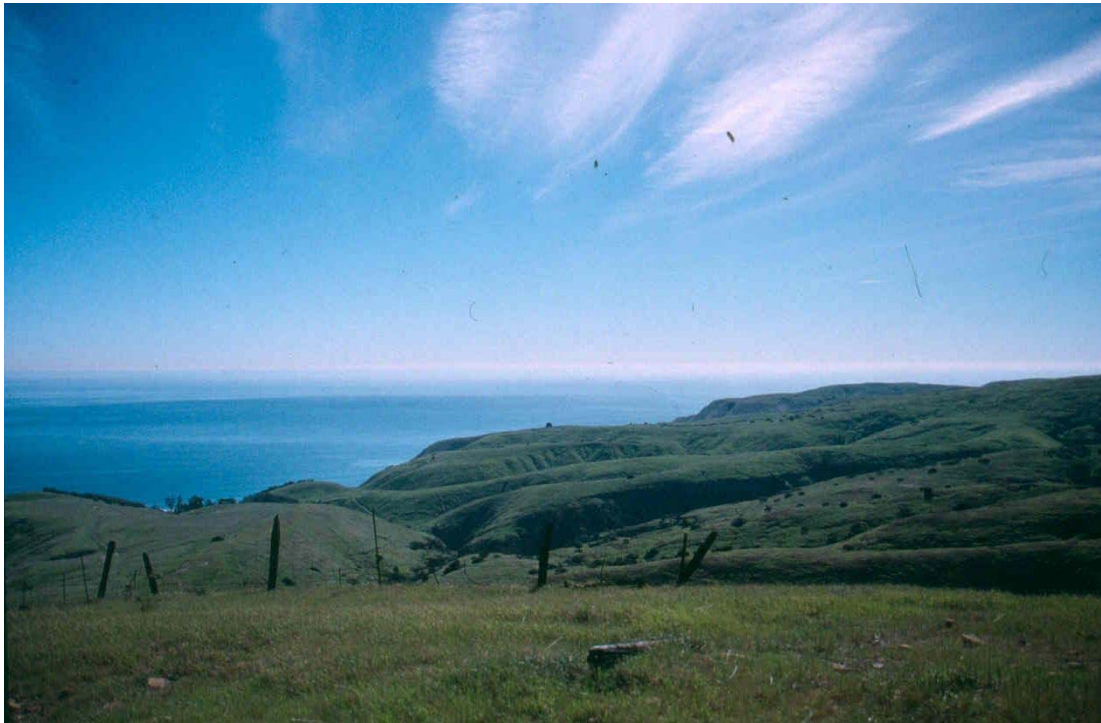
*Small Scale Features #1: A view of the fenceline looking out onto the Aguaje Pasture. (PGSO, CLI, CHIS-S-0008-3, 2003)*

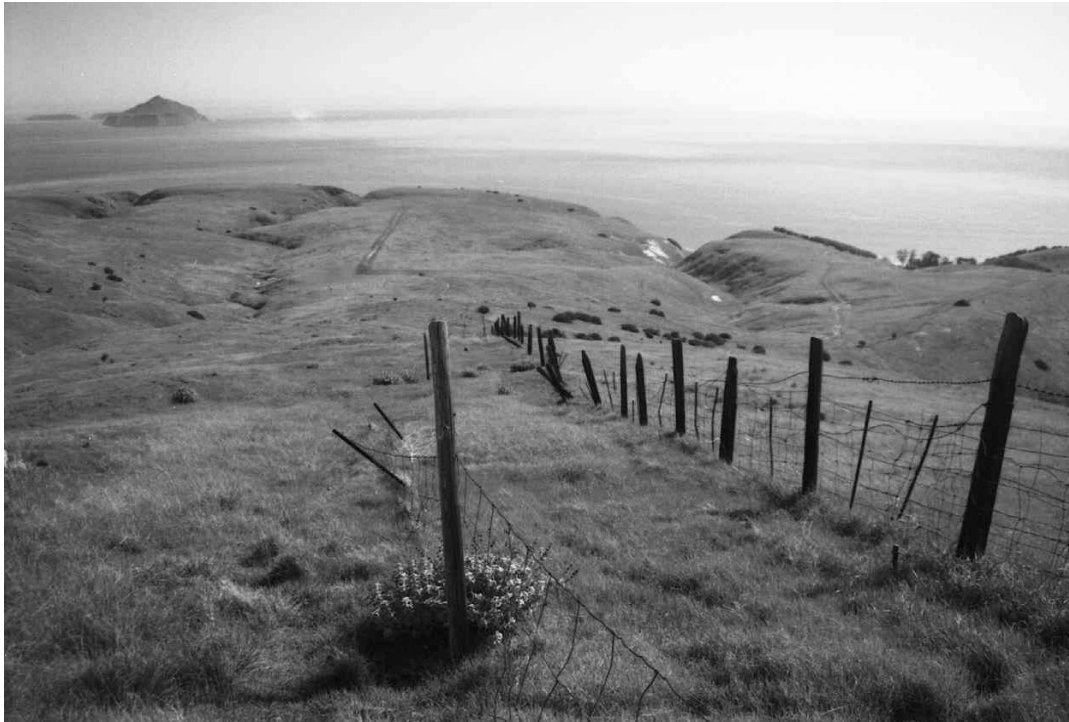
*Small Scale Features #2: Example of the "wings" found at Caire-Gherini Ranch Historic District. (PGSO, CLI, CHIS-N-0015-19, 2003)*

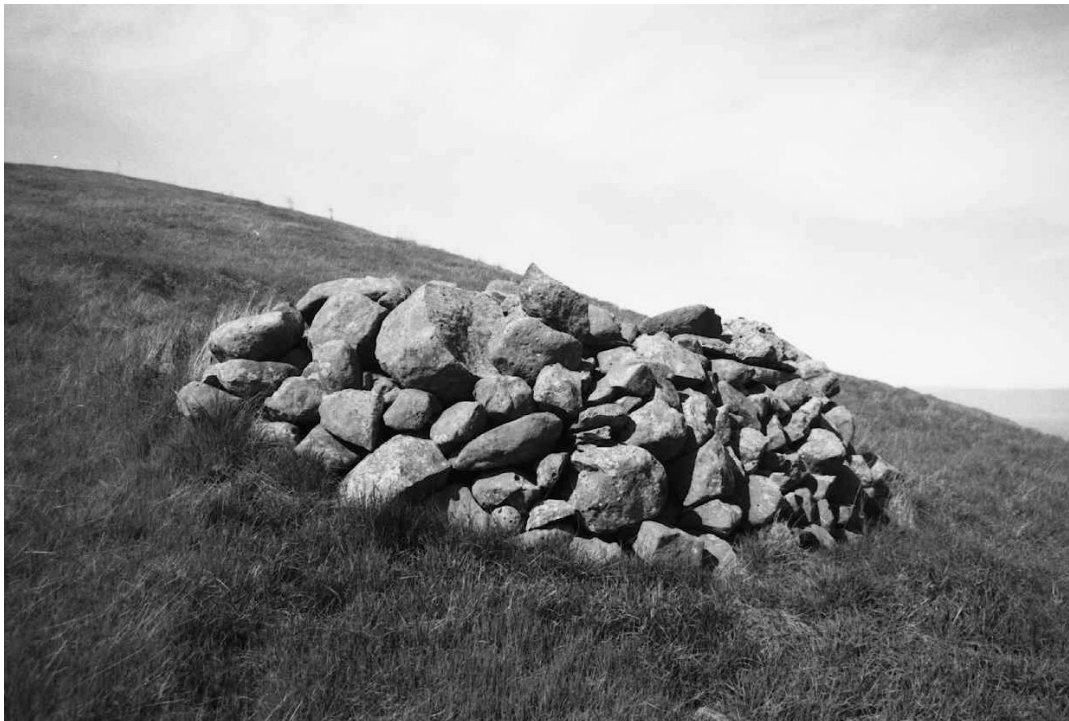
*Small Scale Features #3: Example of one of the eighty-six rock piles found at Caire-Gherini Ranch Historic District. (PGSO, CLI, CHIS-N-0015-20, 2003)*

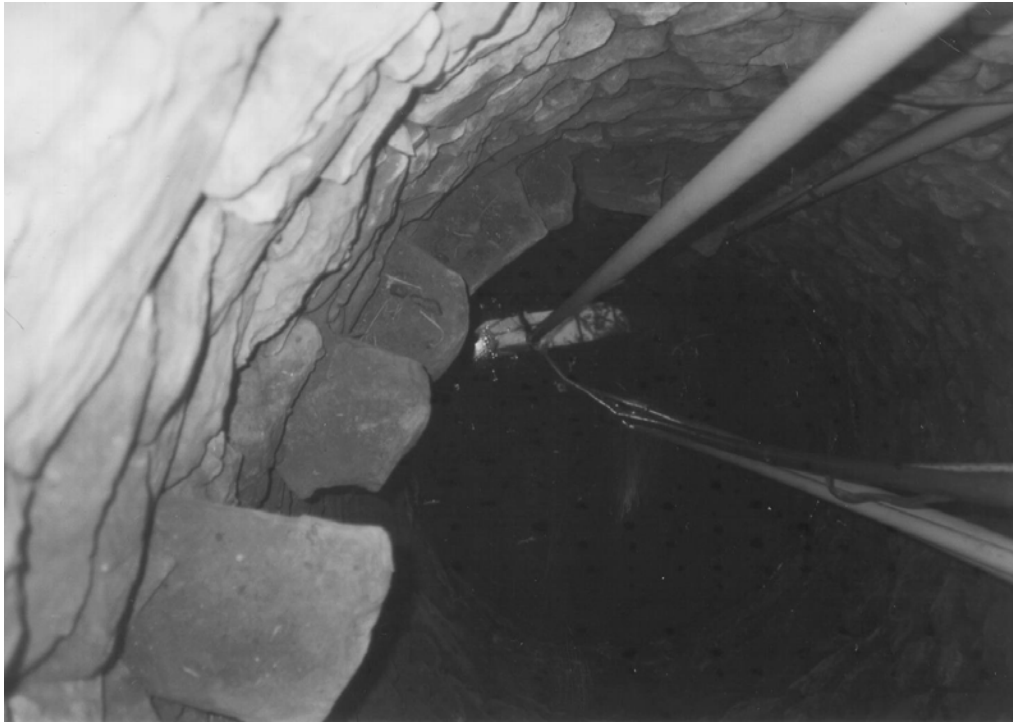
*Small Scale Features #4: View down the Smugglers Ranch well. Note the stone steps. (PGSO, LCS files, 1999)*

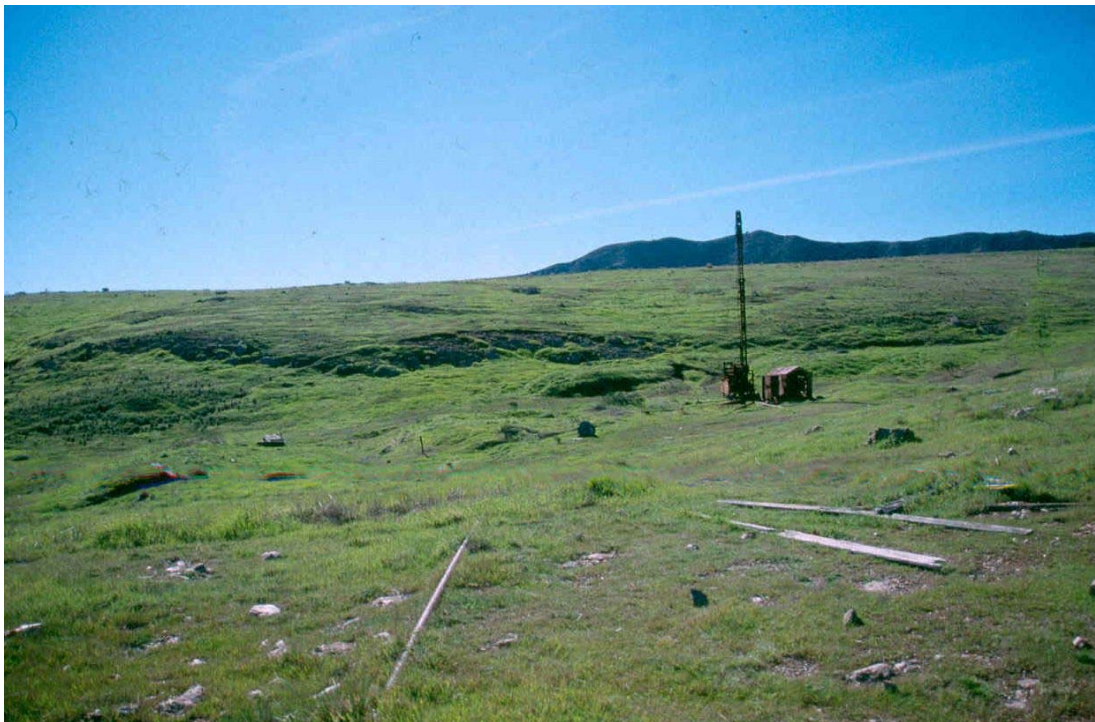
*Small Scale Features #5: View of the non-contributing oil well site and surrounding debris. (PGSO, CLI, CHIS-S-0008-1, 2003)*

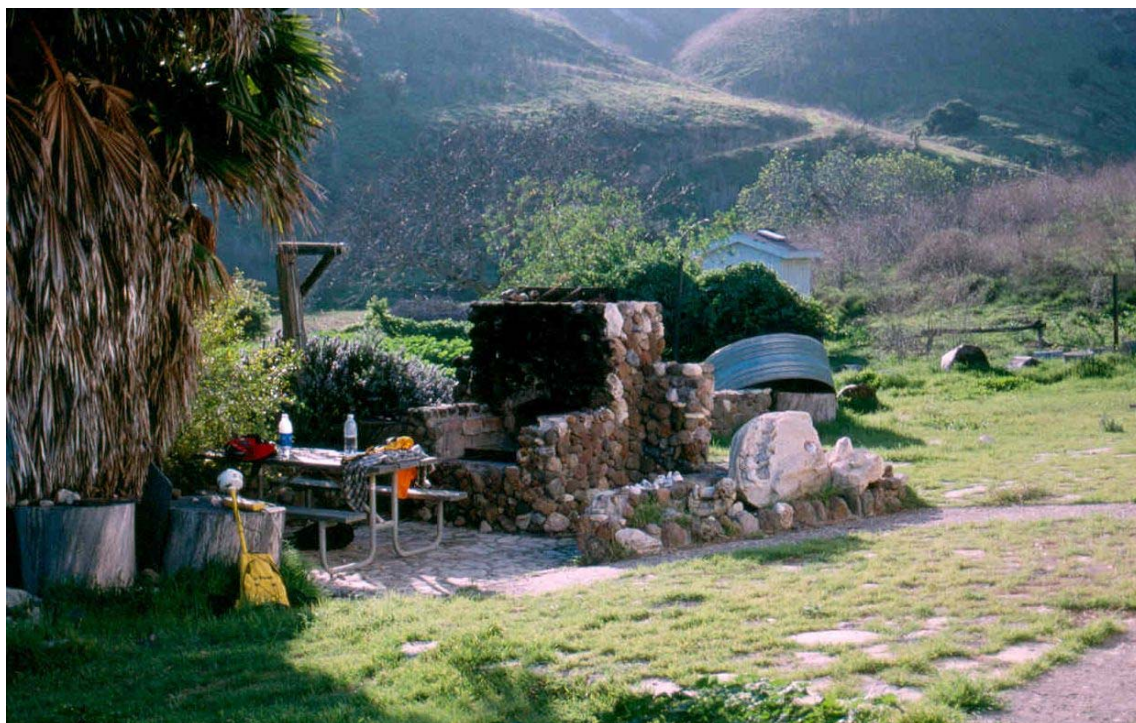
*Small Scale Features #6: View of the non-contributing barbeque pit and patio in front of the Smugglers ranch house. (PGSO, CLI, CHIS-S-0007b-23, 2003)*

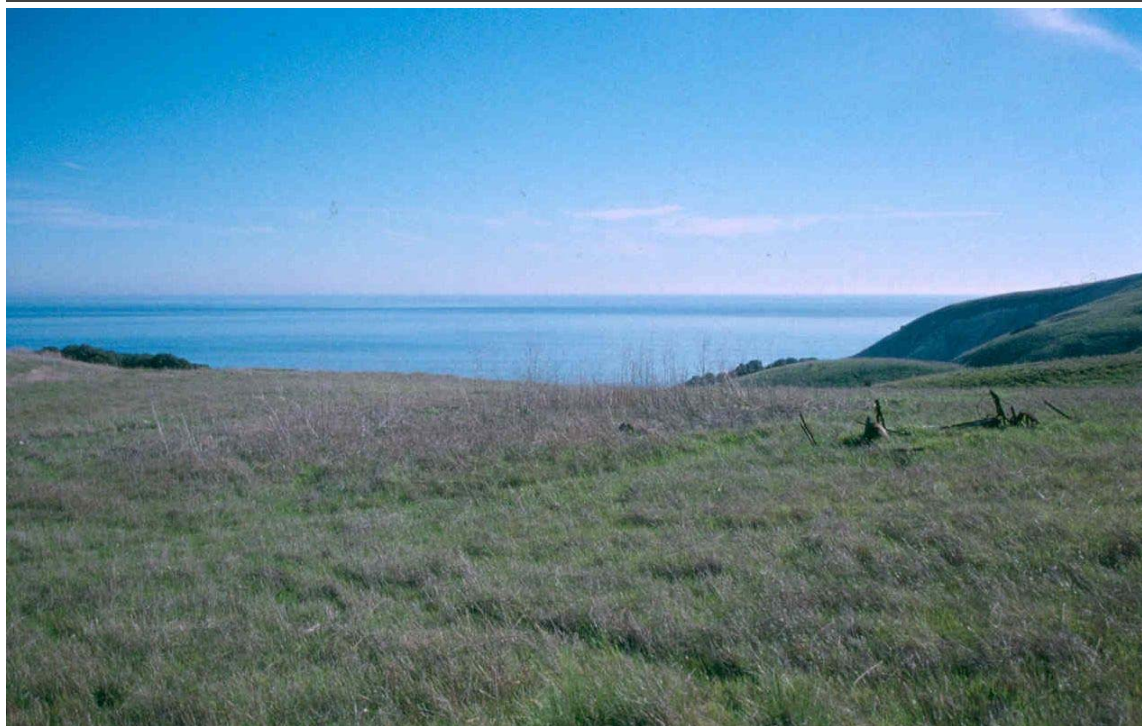
*Archeological Sites #1: All that remains of the sacateras (hay barns) at Caire-Gherini Ranch Historic District.  
(PGSO, CLI, CHIS-S-0008-5, 2003)*

There are ten hay barns (sacateras), two horse stable foundations, and sheep shearing shed ruins found around the island in the various fields and pastures (see photo, Archeological Sites #1). The dry-laid stone foundations can be found on relatively level areas throughout the east end. Barns were placed near the roads in Scorpion Field, Smugglers Field, Campo Grande, Buck Pasture, Wether Field, and Potato #1, and other fields. During the Caire era these fields were called Potrero Llano, Campo Maximo, Campo Toros, Campo Cruce, Potrero Vallata. However, many of the foundations have been damaged during the floods. The remaining foundations may provide additional information to the understanding of sheep ranching and grain production on the island. The foundations of the original adobe residence at Scorpion and likely subsurface remains of other earlier buildings at Scorpion could provide information about the earliest ranching settlement of the island. These archeological sites retain integrity and are a contributing characteristic of the landscape.
