National Park Service  
Cultural Landscapes Inventory  
2007

Buffalo Pasture/Prairie Uplands  
Chickasaw NRA - Travertine District

## **Inventory Unit Summary & Site Plan**

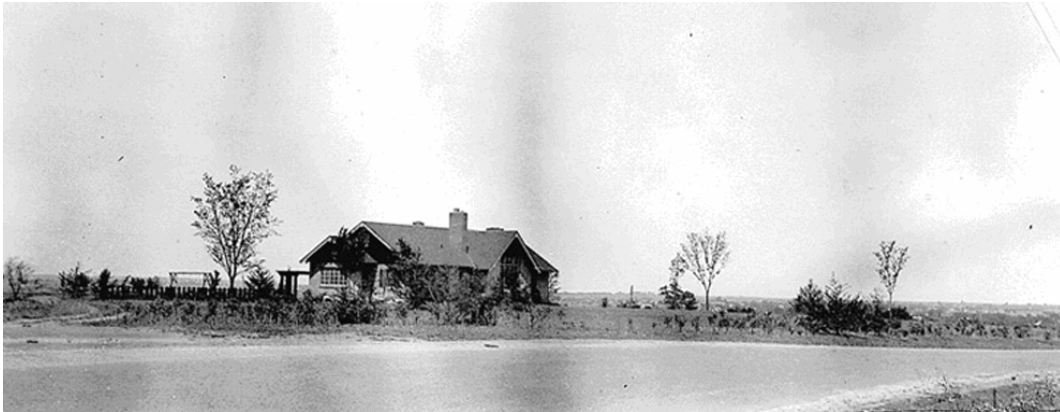
*Landscape implemented around the Superintendent's Residence, circa 1935.  
Note Buckhorn Road in foreground, and fence, arbor, and screening plantings.  
(CNRA archives, photograph date)*

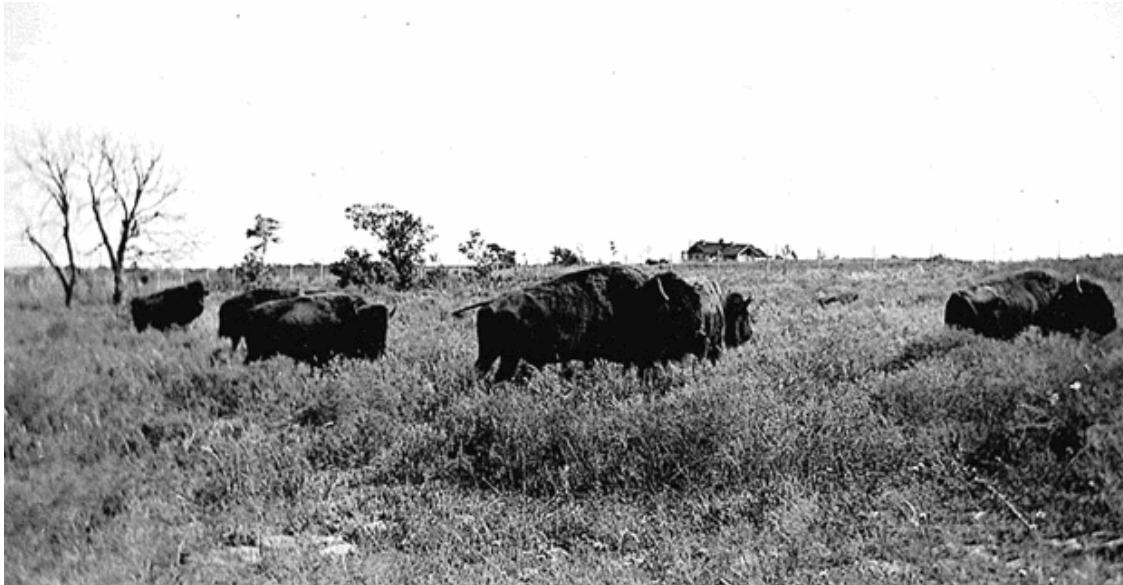
*Buffalo foraging in Buffalo Pasture, circa 1934. Note open aspect of the landscape and Superintendent's Residence in the distance to the southwest.  
(CNRA archives, photograph BF-1)*

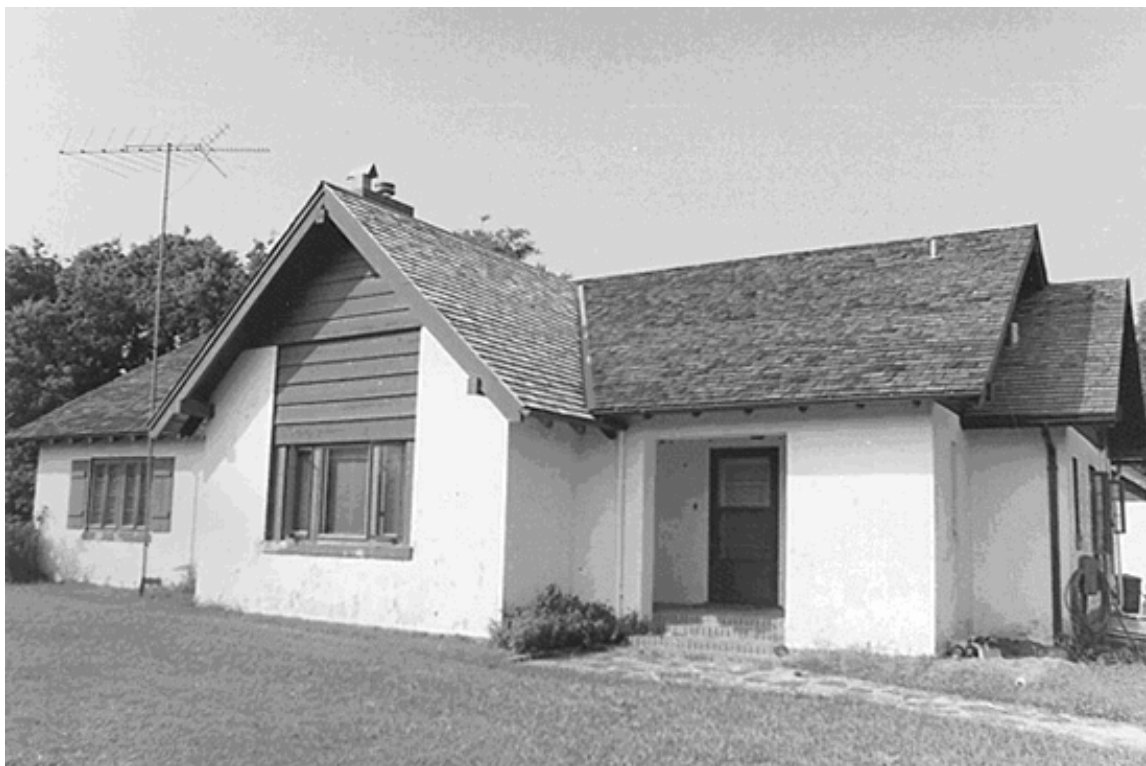
*Front façade of Superintendent's Residence, 1992.  
(CNRA archives, LCS photograph)*

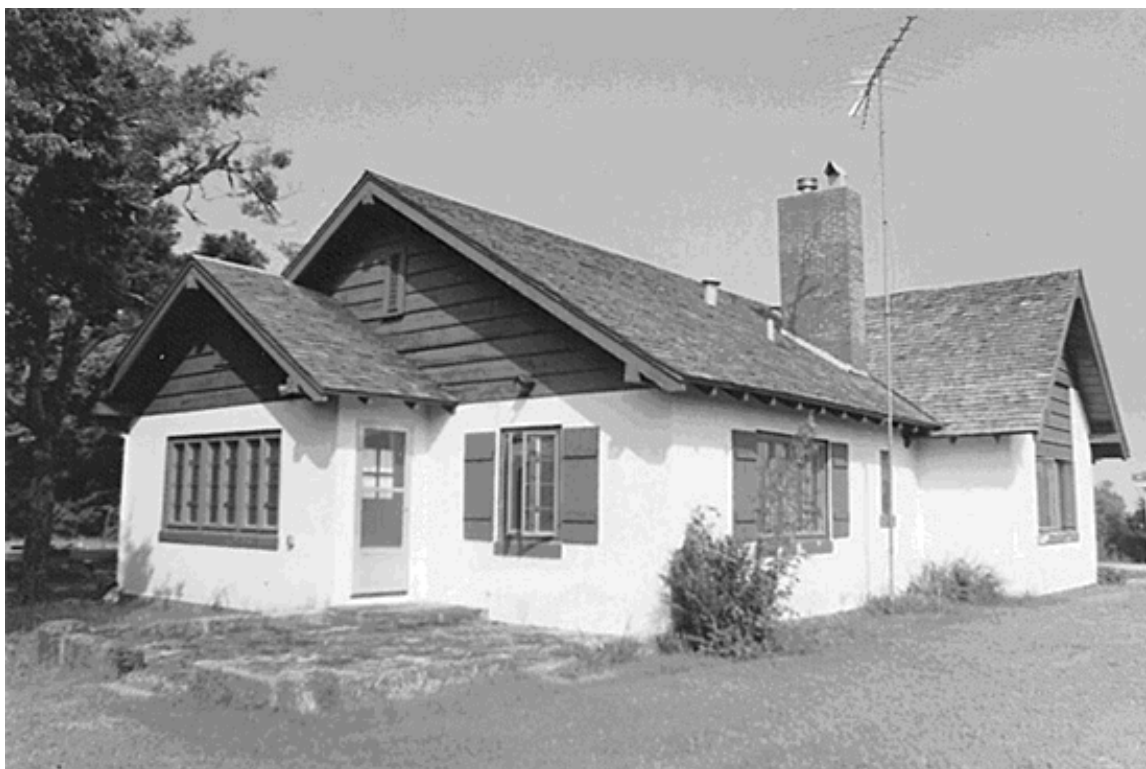
*Rear elevations, Superintendent's Residence, showing flagstone patio area, 1992.  
(CNRA archives, LCS photograph)*

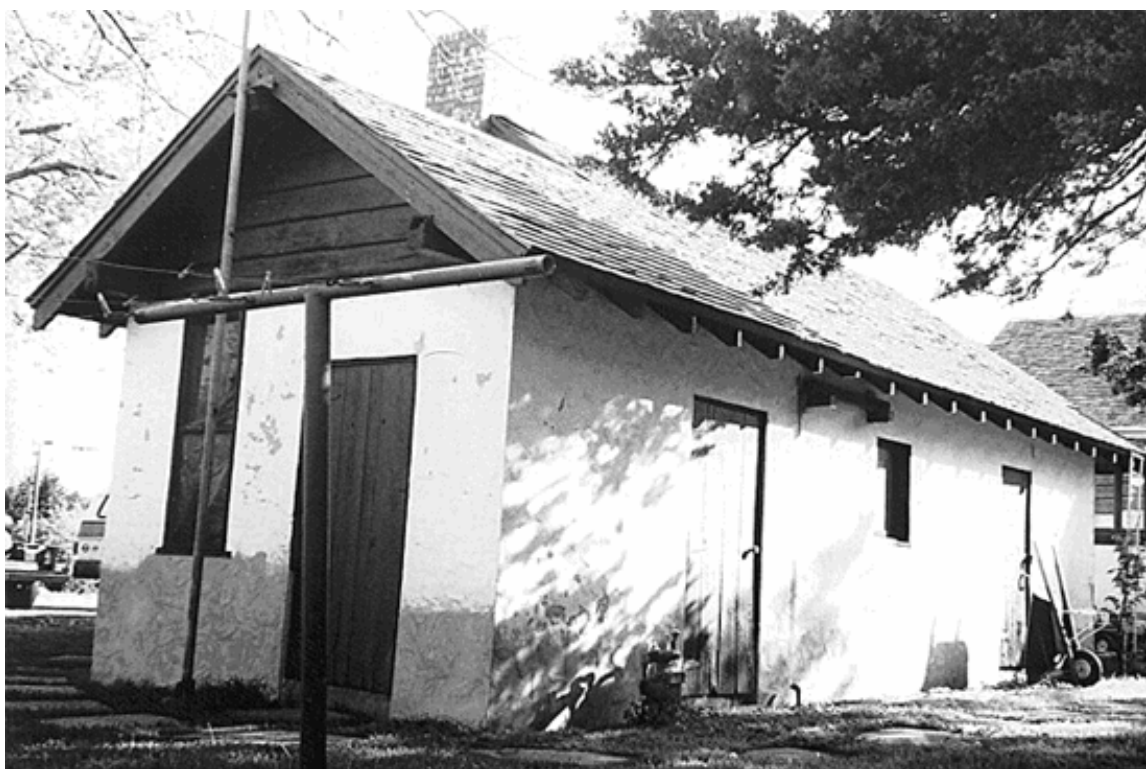
*Garage/ Washroom at Superintendent's Residence, 1993.  
(CNRA archives, LCS photograph)*

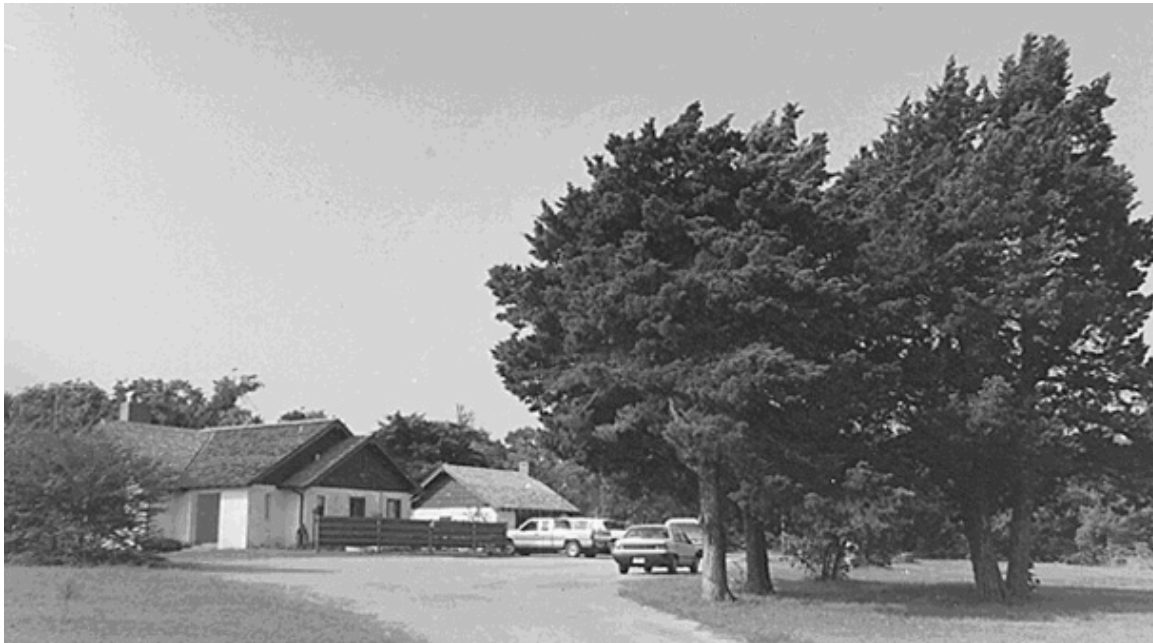
*Landscape around Superintendent's Residence, view from driveway, 1992.  
(CNRA archives, LCS photograph)*

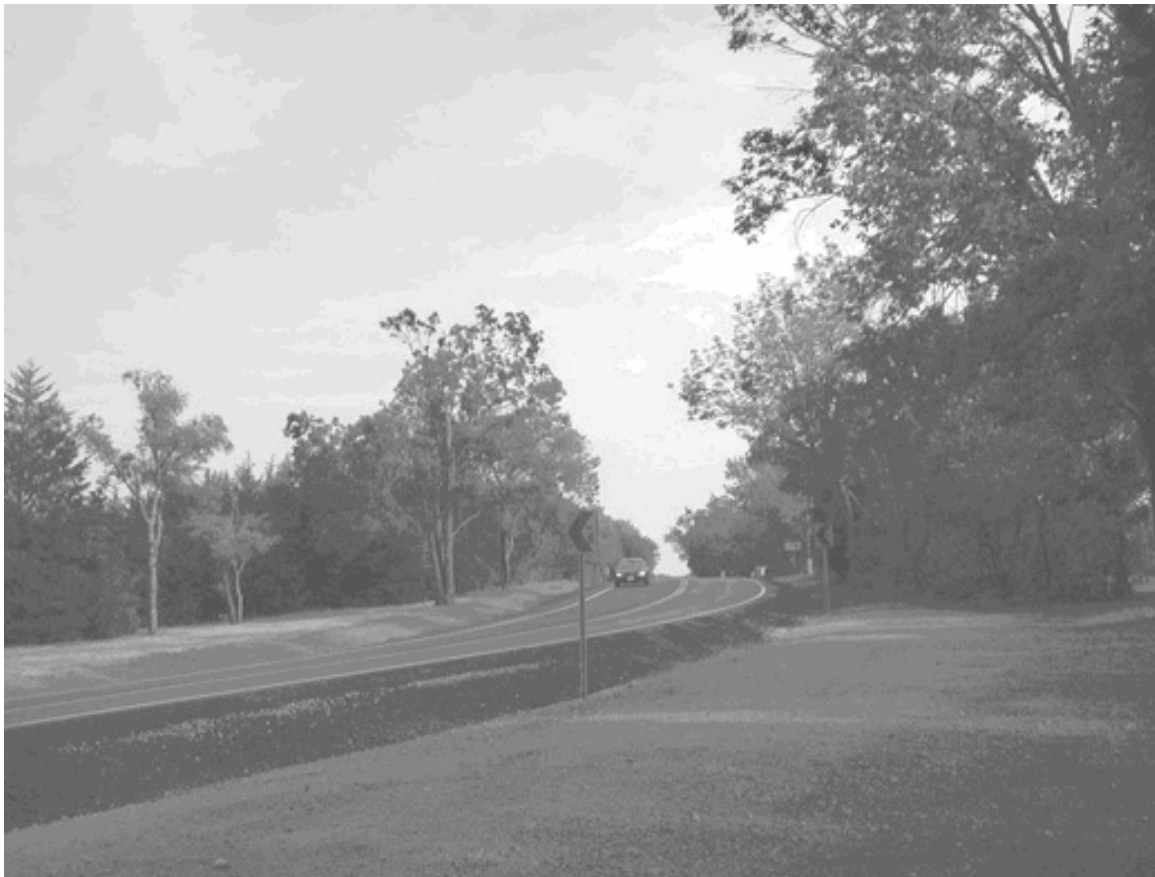
*Highway 177 after resurfacing, view south at curve near Buffalo Overlook, 2001.  
(Photograph by Iowa State University).*

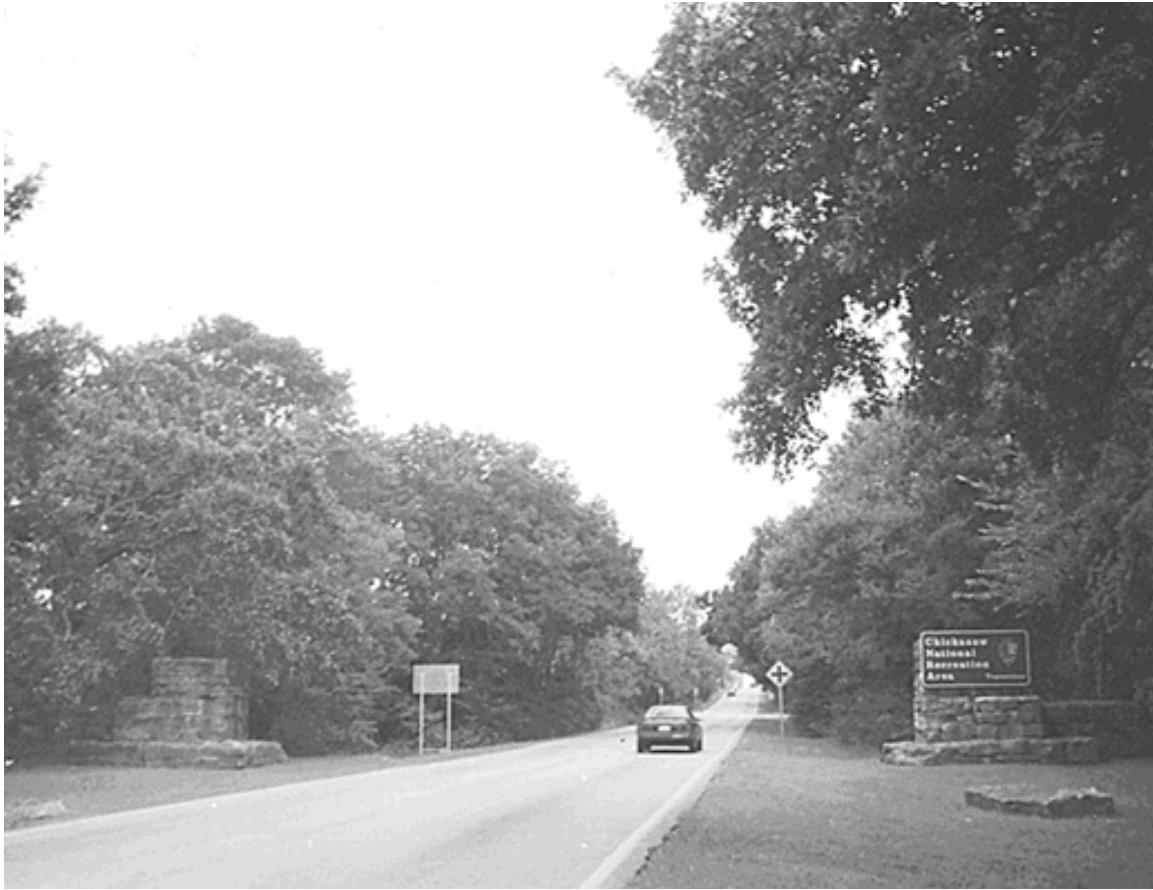
*View of entry piers at the park's south entrance along Highway #177, 1992.  
(CNRA archives, LCS photograph)*

Feature: South Entrance Piers  
Feature Identification Number: 120008  
Type of Feature Contribution: Contributing  
IDLCS Number: 62855  
LCS Structure Name: Highway 177 Entrance Piers South  
LCS Structure Number: HWY177.211
