National Park Service  
Cultural Landscapes Inventory

2010

Revised: 2/2025

Vanderbilt Mansion Formal Gardens  
Vanderbilt Mansion National Historic Site

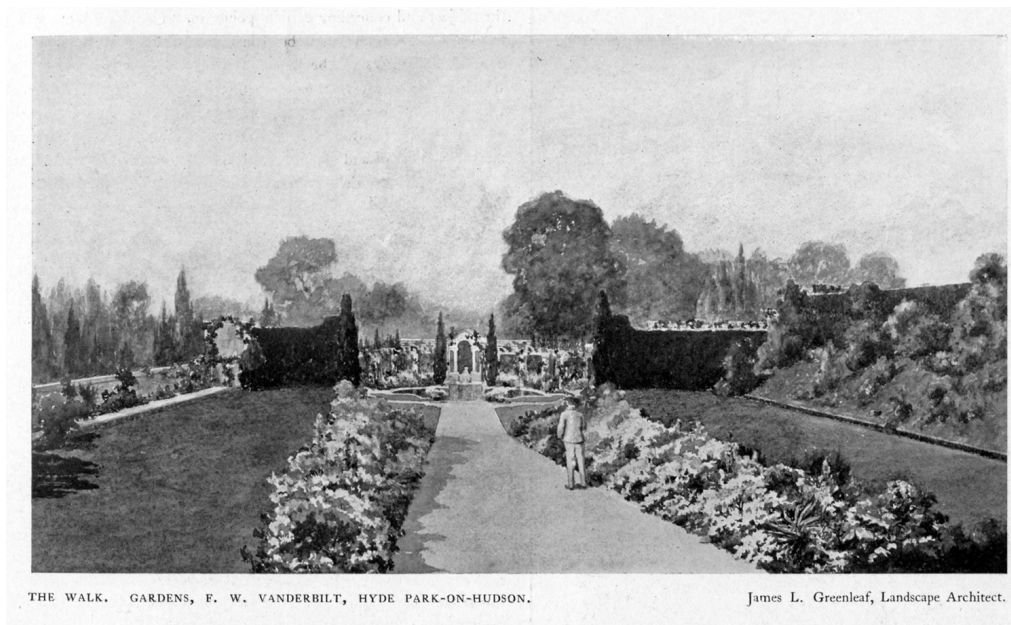
Figure 4. Watercolor of the upper perennial garden in 1903 shortly after completion of Greenleaf's design. The image shows a very open character with a perennial border and cedar hedge separating the two terraces.

Two watercolor illustrations done around the time of the completion of Greenleaf's design show the upper and lower perennial garden. In the upper perennial garden, the long central walk is flanked by two banked beds thickly planted with flowering perennials (Figure 4). On the west edge of the garden, the embankment appears to be planted with shrubs and groundcover or vines. The east edge of the garden also shows a number of small shrubs between the walkway and the garden wall. The upper and lower terraces are divided by the midway hedge, a tall formal hedge punctuated by columnar elements at the ends. The opening in the center of the hedge frames views of the reflecting pool and pergola, which is itself framed by two tall columnar cypresses (CLRFG 2010:34).

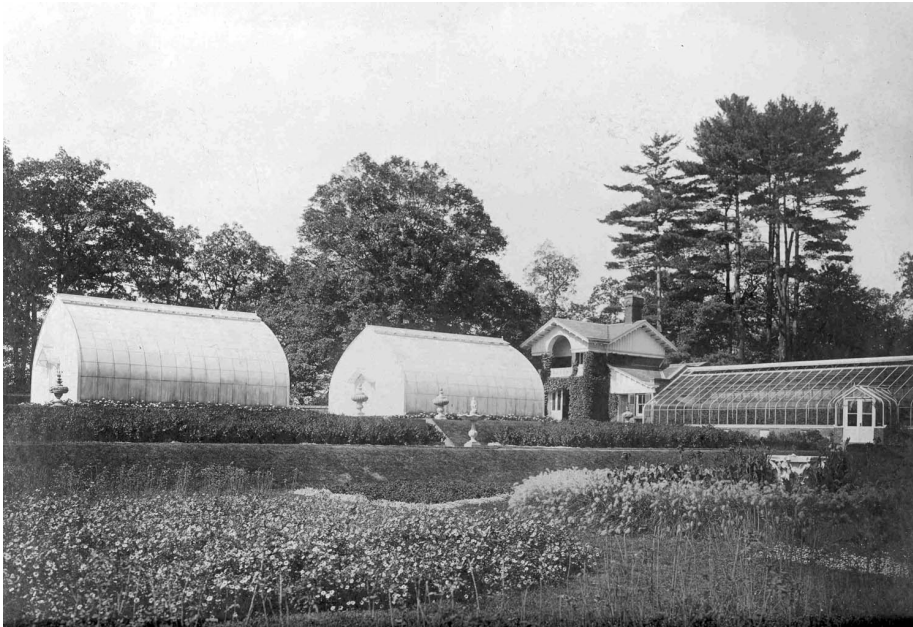
Figure 6. View looking northeast showing the upper annual garden in the foreground and the twin palm houses, tool house, and carnation house in the background, post 1908 (VAMA, no. V-104, Van Osdel Collection).

In 1905 plans were put forward by the Pierson-Sefton Company of Jersey City, New Jersey, who advertised themselves as horticultural builders and architects. The company proposed simple, twin palm houses intended to replace the more elaborate Langdon conservatory on the first terrace of the formal gardens (Figure 6). Two alternative schemes were developed as water color drawings. The palm houses were constructed in 1905, though slightly differently than the proposals. For the next three years, the palm houses were used in conjunction with the remaining four Langdon greenhouses at the southwest corner of the garden (CLRFG 2010:35).

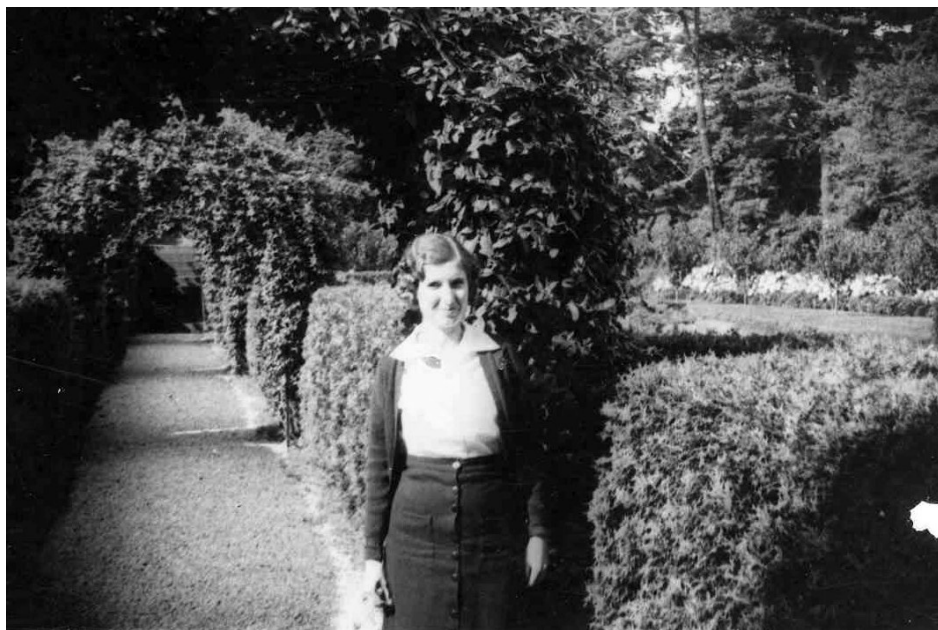
*Figure 9. View looking north showing Cridland's arborvitae hedge and wire trellis arches between the lower annual and lower perennial gardens, circa 1939 (VAMA, no. V-747, Lean Froats Collection).*

Cridland specified hedges to frame both sides of the walk and three wire trellis structures. The hedges were arranged in two straight rows but curved around each of the three wire vine support arches that were evenly spaced along the walk (Figure 9) (CLRFG 2010:42).

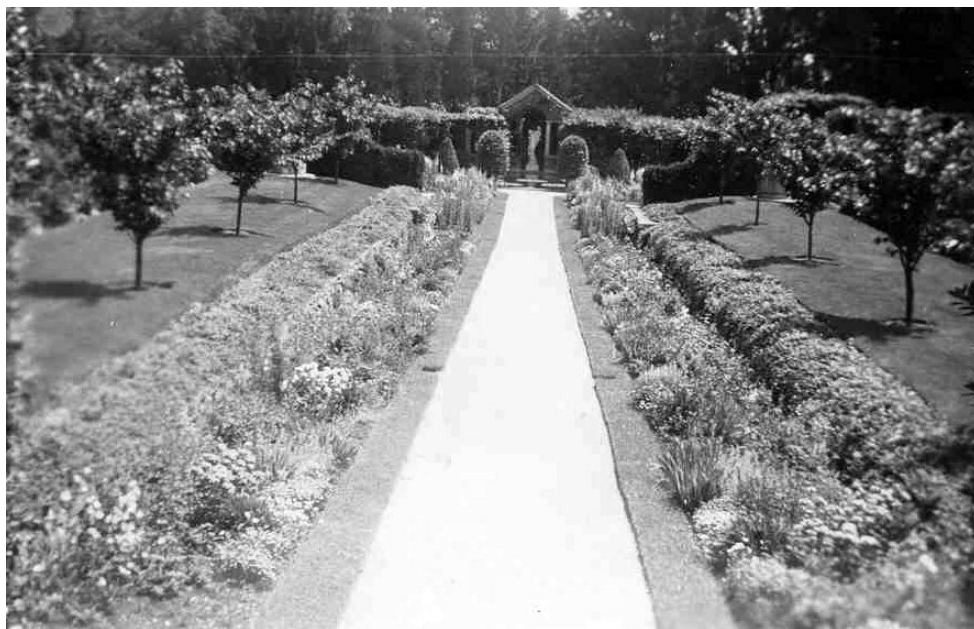
*Figure 10. View looking south showing the upper perennial garden as redesigned by Cridland with rows of flowering cherry trees, dry laid stone retaining walls and mixed perennial beds, 1930s (VAMA, V-111, Alex Knauss Collection).*

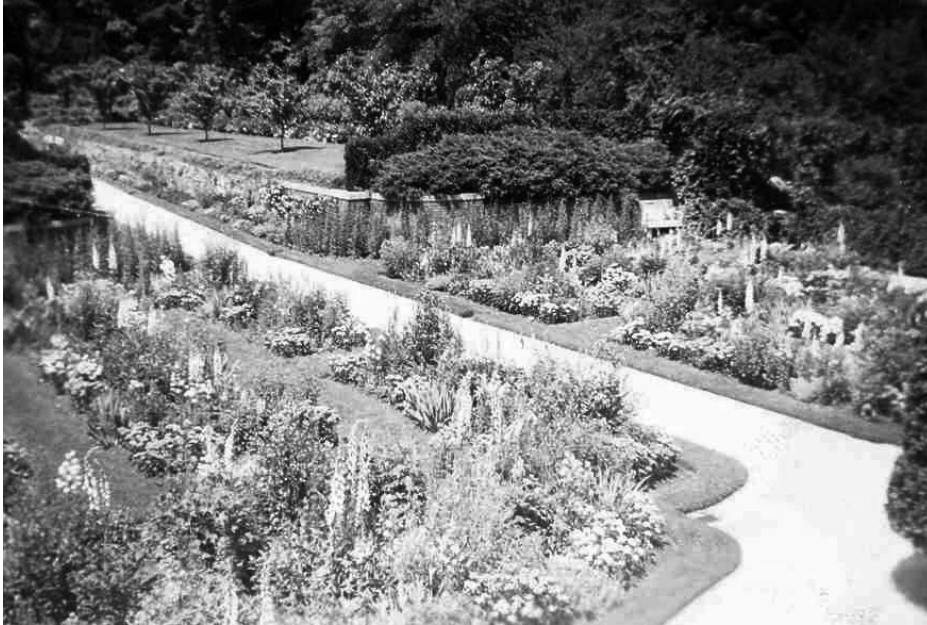
*Figure 11. View looking northeast showing the lower and upper perennial garden beds, circa 1930s. The arborvitae were removed from the lower beds and the cherry trees were planted above the upper beds around 1934 (VAMA, no. V-109, Alex Knauss Collection).*

Photographs taken between 1932 and 1935 by Alex Knauss show that the conical evergreens were removed by this time and beds of perennials in bloom appear with interior turf walks separating planted areas (Figure 11). *Digitalis* was placed sporadically throughout the beds punctuating the perennial masses. The juniper banks above the walls designed by Cridland in 1922 are also visible (Figure 12) (CLRFG 2010:44).

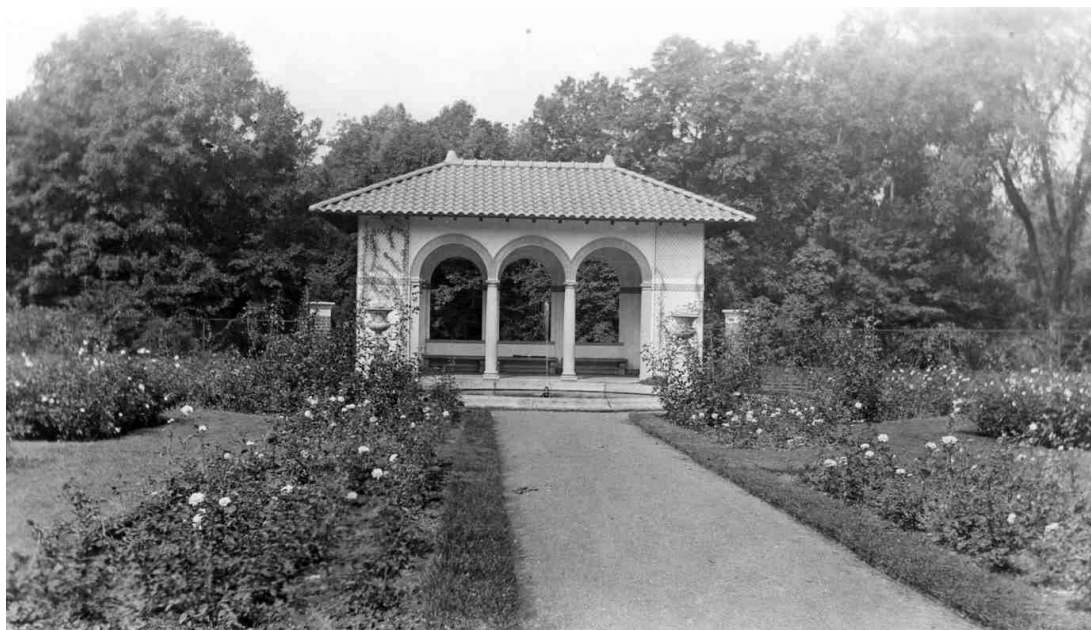
*Figure 13. View looking east showing the rose garden loggia flanked by ornamental vases with the frog fountain at center, circa 1922. Shrubs planted outside the perimeter fence are barely visible (VAMA, no. V-41, Alex Knauss Collection).*

Cridland prepared an undated plan entitled "Rose Garden Arrangement for F.W. Vanderbilt Esq." in about 1916. Cridland also designed and oversaw the construction of the rose garden loggia (Figure 13). Cridland organized the rose beds by color rather than by cultivars. Cridland specified assorted roses in the edge beds with climbers on the fence and white climbers at each brick pier. White roses are to be planted at the face of the upper brick wall between the two steps. The two upper parterres are shown in mirror image arrangements of pink, white, yellow and red roses around the edges. A note to these center beds states, "See plan from Wadley and Smyth for baby ramblers and bedding roses." No plan by Wadley and Smyth is in the park's collection. These baby rambler roses would have been full and short and were likely intended to fill in the bed below the standards. Six rose standards are also lined up on each side of the central steps at the upper level while climbing roses and assorted hybrid teas are shown at the base of the wall flanking the steps. At the lower level the parterres are also arranged in mirror image by color. Two central beds on each side are shown with five standards each and bear the same note regarding baby ramblers and bedding roses as the one above (CLRFG 2010:44-45).

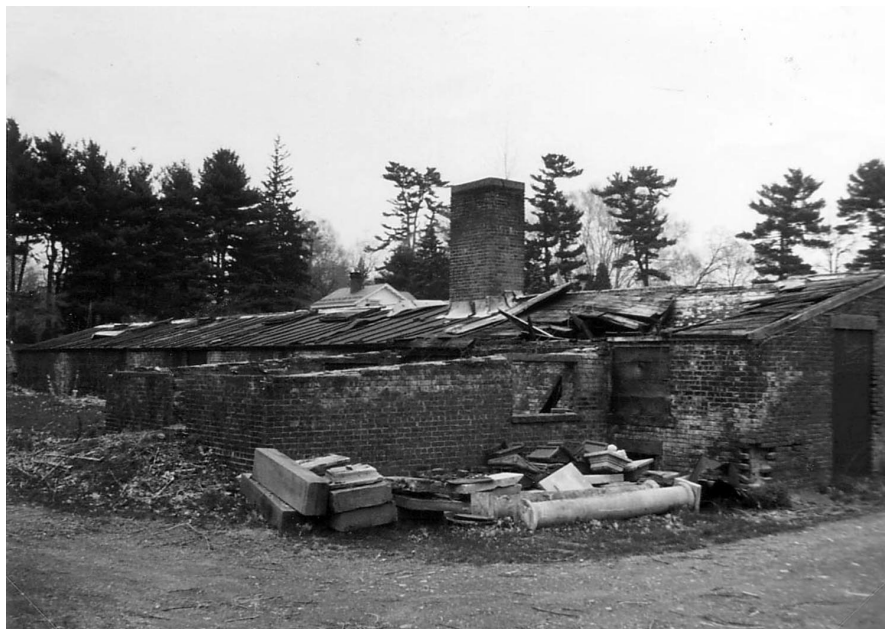
*Figure 14. View looking northeast showing the damaged Potting Shed with stockpiled elements including columns and bluestone steps, circa 1970s (VAMA, no. 71592).*

The gardens continued to suffer from insufficient resources and languished through the 1950s and 1960s (Figure 14). Efforts to stabilize the garden structures in the 1970s slowed the deterioration, but it wasn't until the 1980s with the establishment of the Frederick W. Vanderbilt Garden Association that marked improvement happened. Work began in earnest with the restoration of the pergolas, trellises, and walls. The Frederick W. Vanderbilt Garden Association was formally established in 1984 and continued to restore the gardens to their former elegance. This work continues to the present (CLRFG 2010:48).

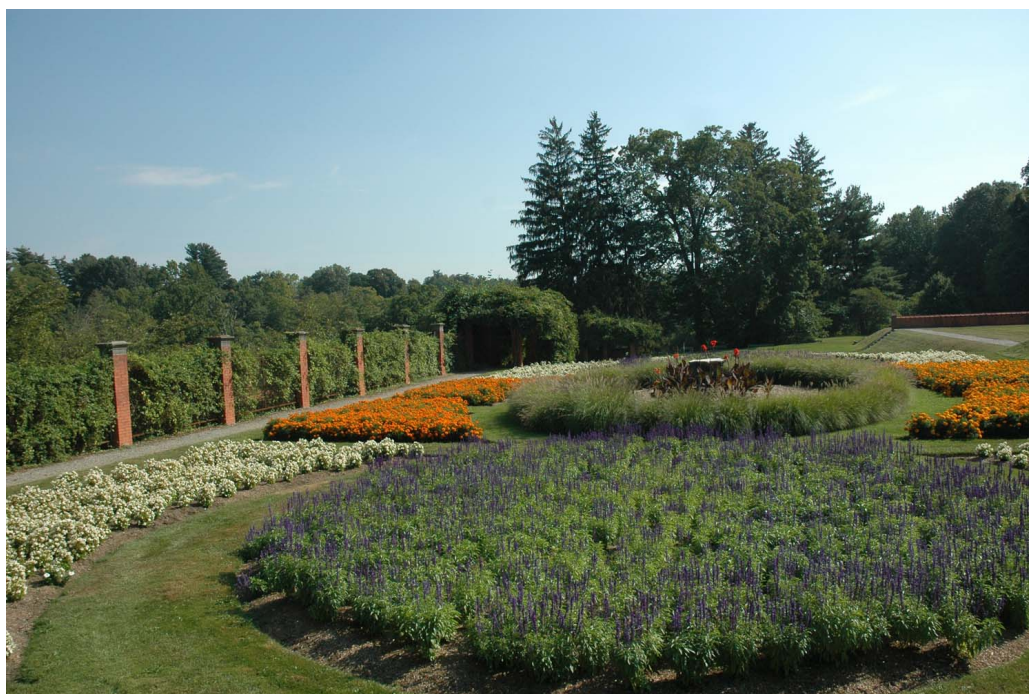
Figure 15. View south of the upper annual terrace beds. The path along the eastern side of the terrace is lined with brick pillars that support wire lattice panels and vines (OCLP, September 2008).

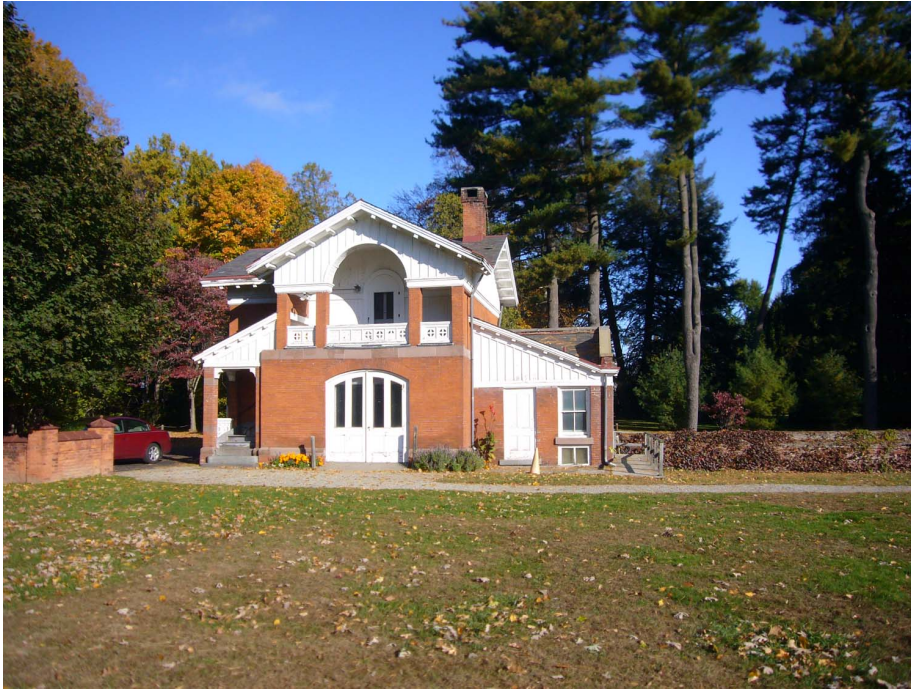
*Figure 16. View north of the Tool House, constructed in circa 1875, which is now used by the Frederick W. Vanderbilt Garden Association as its meeting and office space (OCLP, October 2008).*

The Tool House remains today a prominent element of the gardens (Figure 16). Architecturally, the Tool House has changed little since the historic period. The two-story brick building is currently being used by the Frederic W. Vanderbilt Garden Association as office, meeting space, and storage. The building was stabilized in 1974. Building access is by concrete ramp that leads to double doors on the ground level and by three bluestone steps that lead to the upper level. Some spalling is present in the bluestone, but overall the steps are in good condition (CLRFG 2010:168).

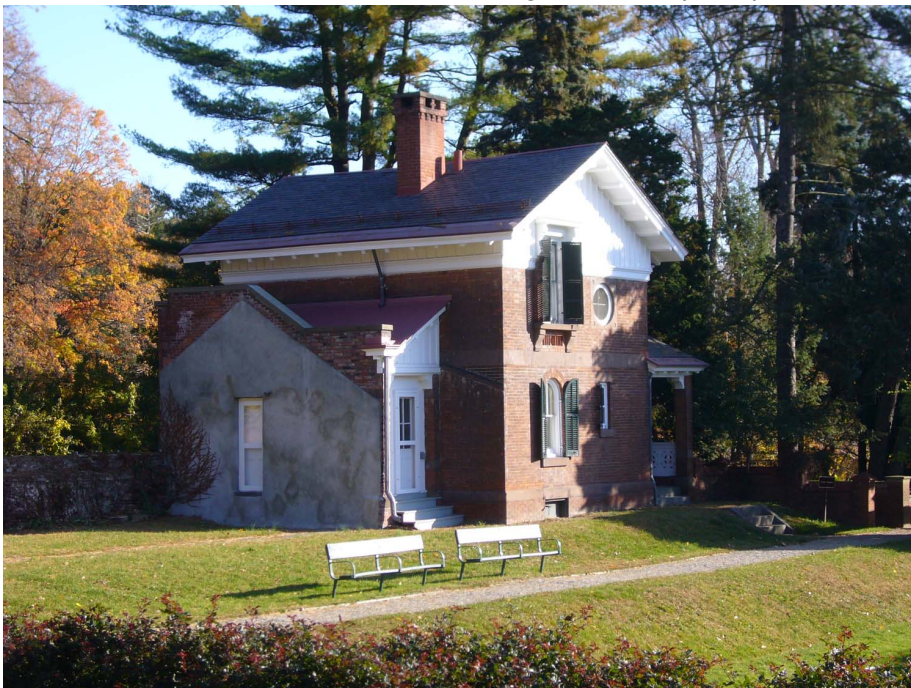
*Figure 17. View northeast of the Gardener's cottage, constructed in circa 1875, which now serves as a park staff residence (OCLP, October 2008).*

The Gardener's Cottage remains today with few alterations since the historic period (Figure 17). Notably, the wooden fence has been removed and the façade is no longer covered in vegetation. Today the Gardener's Cottage is used as park housing. The steps and landing at the entrance to the Gardeners Cottage entrance are in good condition (CLRFG 2010:169).

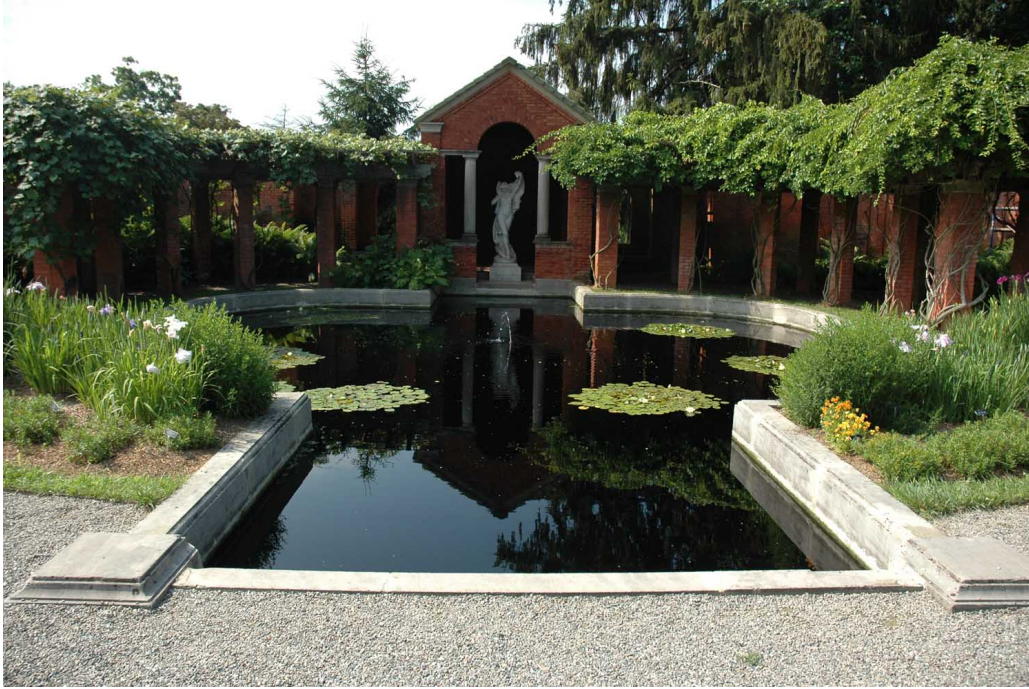
*Figure 18. View east of the pool and pavilion in the lower perennial garden. The pool contains water lilies and is flanked by beds containing iris and other perennials (OCLP, June 2008).*

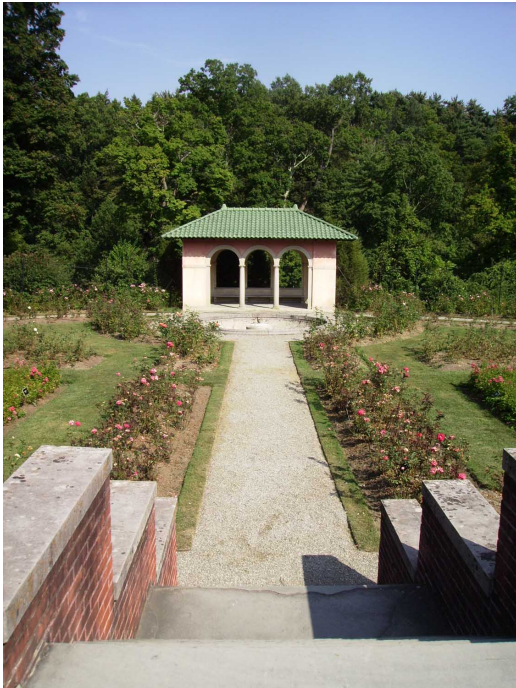
*Figure 19. View east of the loggia at eastern lower edge of the rose garden. A central walkway framed by rose beds leads to the now empty pool in front of the loggia (OCLP, September 2008).*

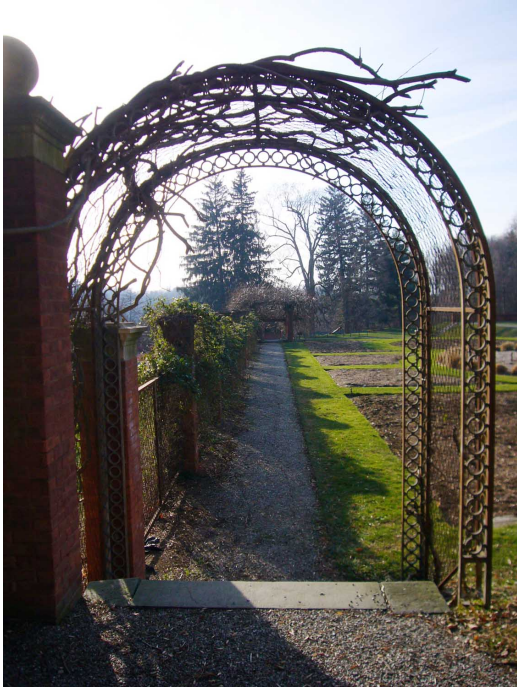
*Figure 20. View looking south showing the arched stair arbor and wire trellis fence along the upper annual terrace (OCLP, September 2008).*

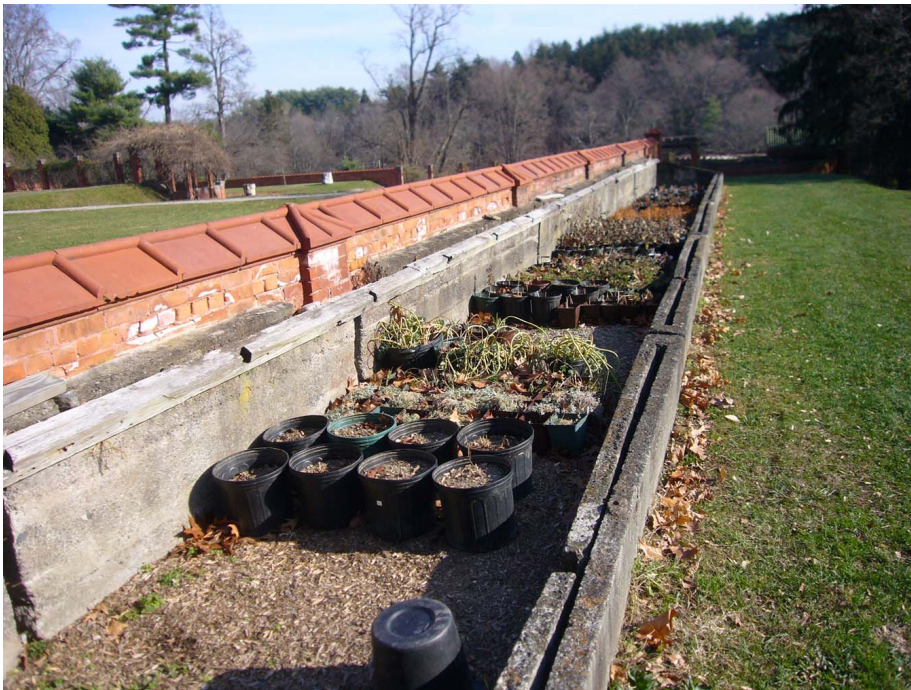
*Figure 21. View looking east showing the cold frames along the outer side of the south wall of the garden near the former greenhouse site. The cold frames are used by FWVGA for young plants (OCLP, June 2008).*

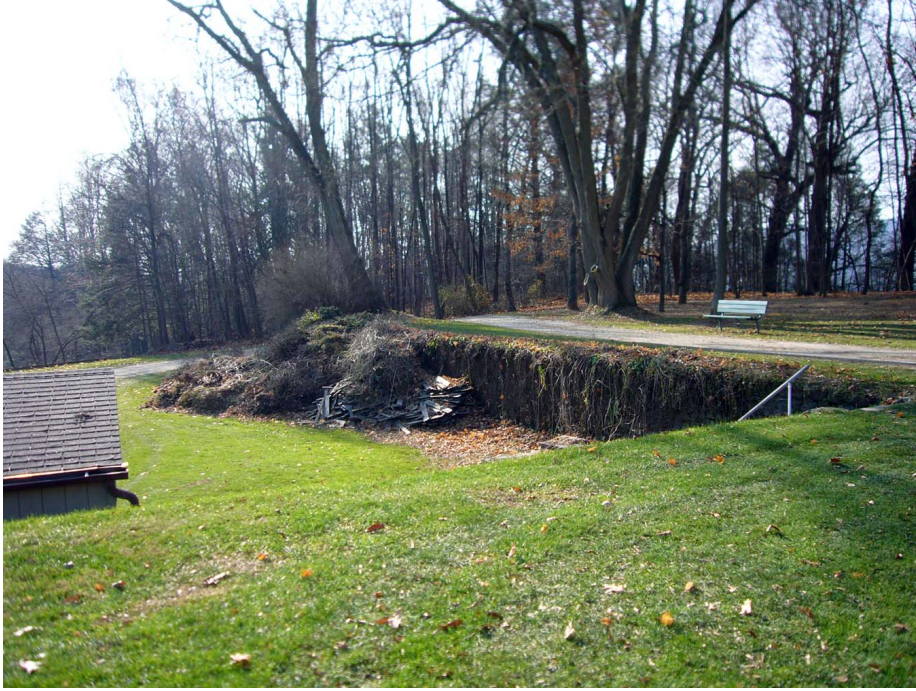
*Figure 22. View looking northwest showing the mortared stone retaining wall along the former cutting garden (OCLP, October 2009).*

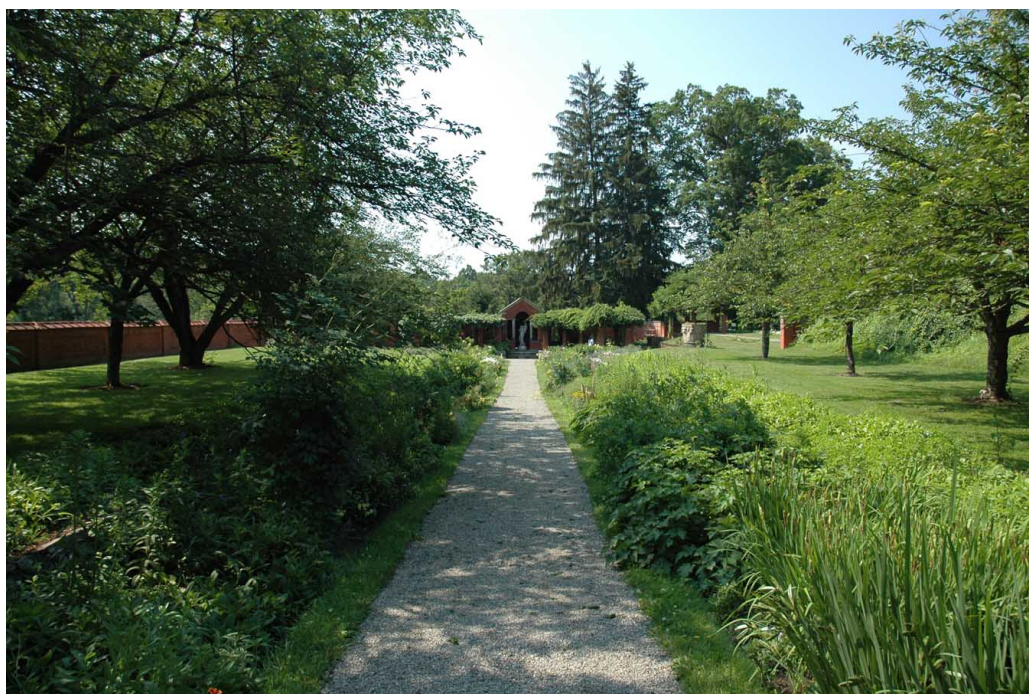
*Figure 23. View east of the upper perennial garden central walk framed by perennials and cherry trees. The perennials obscure dry laid field stone retaining walls (OCLP, June 2008).*

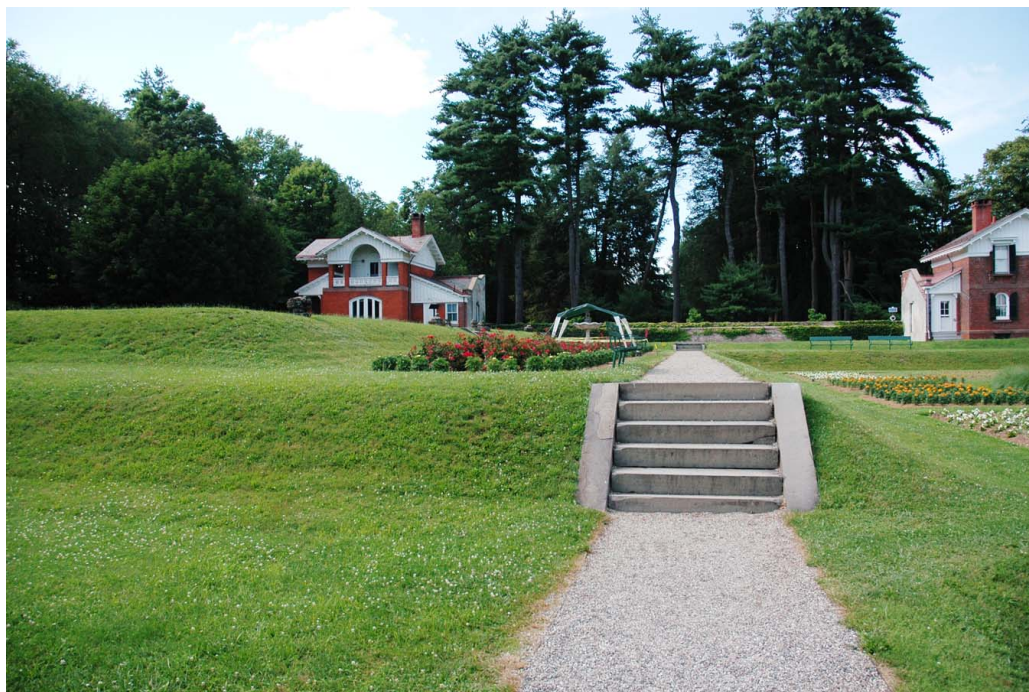
*Figure 24. View north of pea stone walkway and granite steps between the annual and fountain terraces. A tent that protects the boy dolphin fountain during the winter months has not yet been removed for the summer (OCLP, June 2008).*

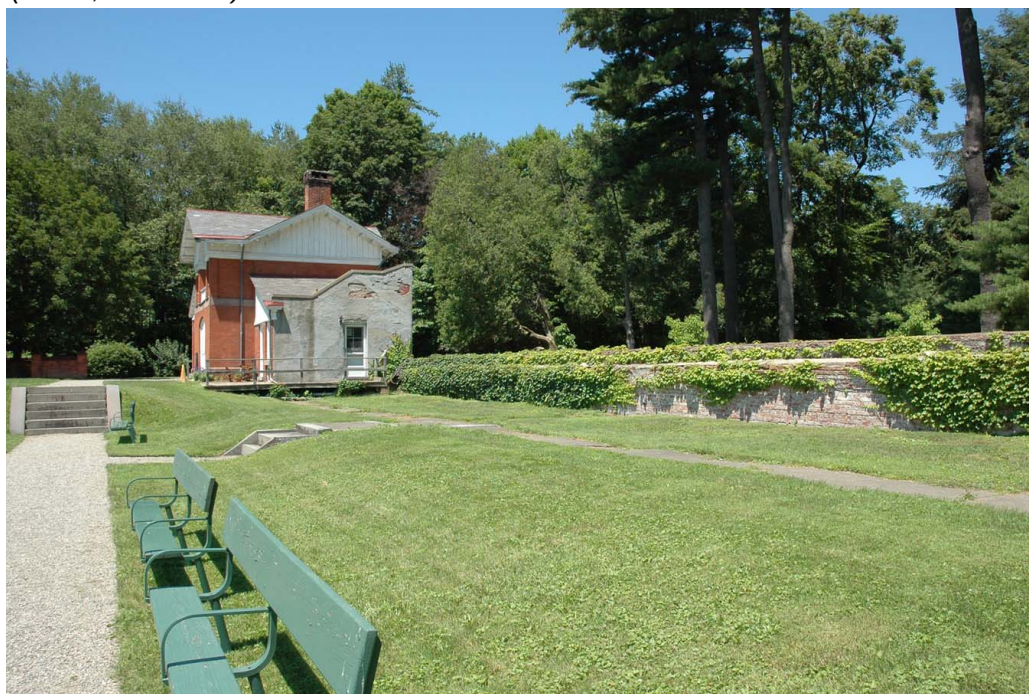
*Figure 25. View northeast of the Tool House and site of the former Carnation House. Three steps that formerly led into the center of the Carnation House are visible on the left (OCLP, June 2008).*

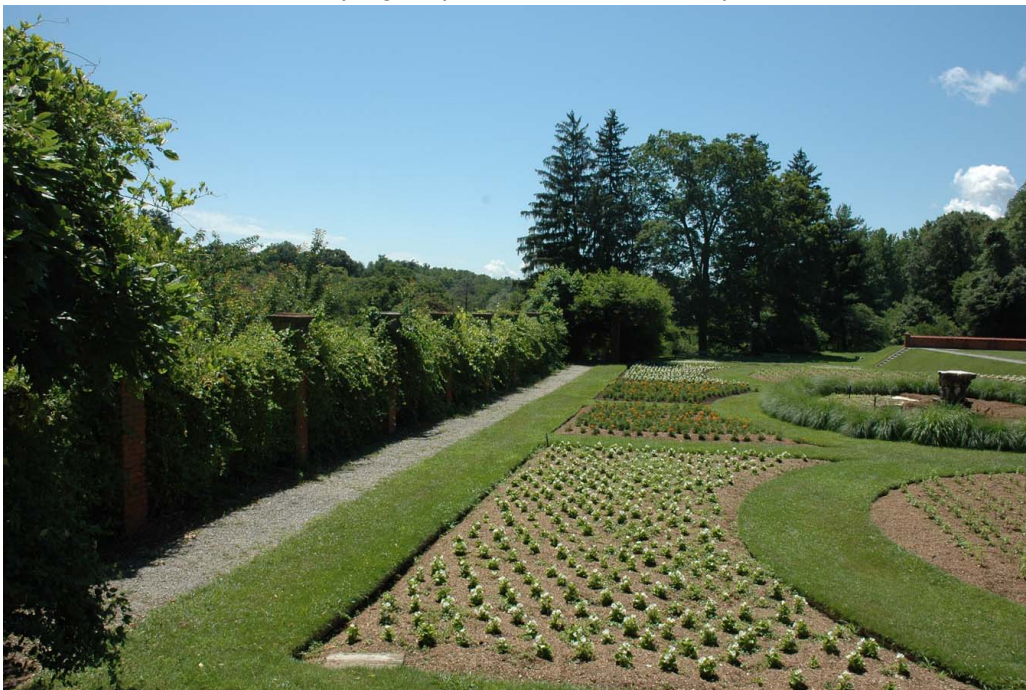
*Figure 27. View south of the upper annual terrace edged by a pea stone walkway and trellis structure. The trellis consists of brick piers with limestone capitals that support a wire lattice and vines (OCLP, June 2008).*

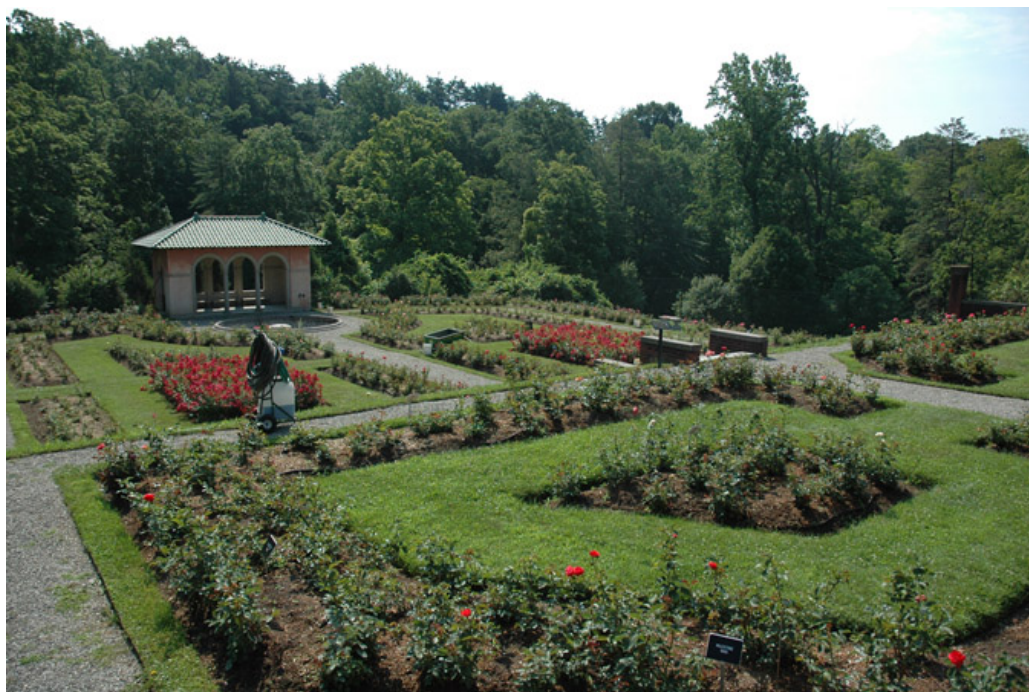
*Figure 28. View southeast of the rose garden and loggia (OCLP, June 2008).*

The F.W. Vanderbilt Garden Association currently maintains the rose garden with roses that differ in variety, form, and color. The layout does not conform to the symmetrical arrangement and large color blocks specified by Cridland (Figure 28) (CLRFG 2010:187).

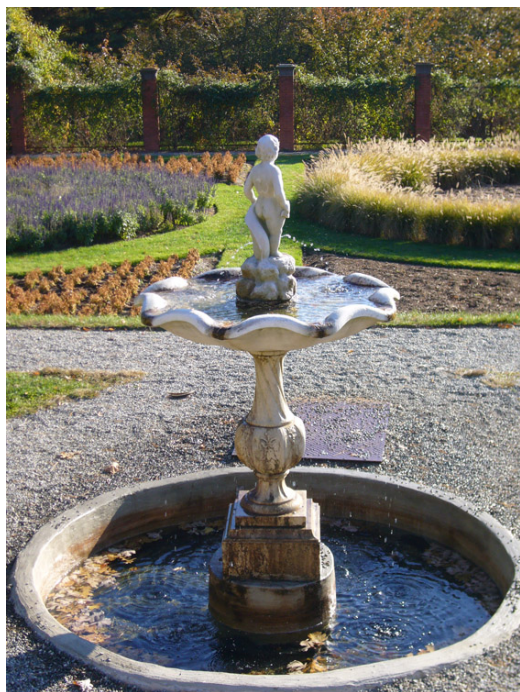
*Figure 29. View east of the brecciated stone Italian garden fountain (Upper Fountain) on the terrace overlooking the upper annual garden. (OCLP, October 2008).*

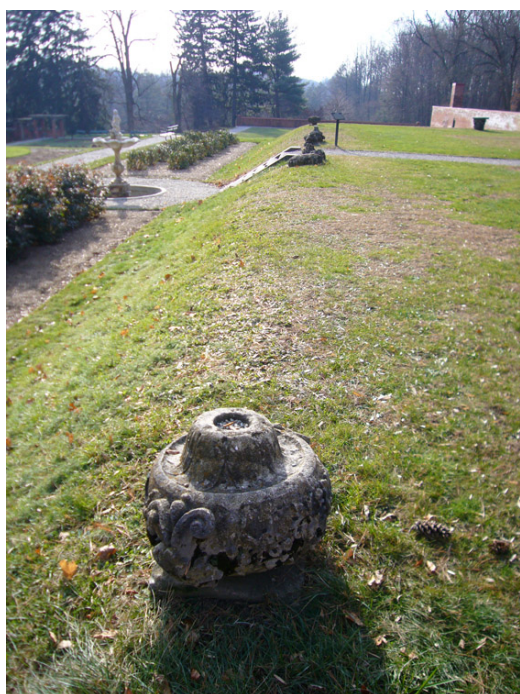
*Figure 30. View south of sandstone pieces that were once part of late nineteenth-century Baroque style vases. The objects line the eastern edge of the palm house terrace (OCLP, November 2008).*

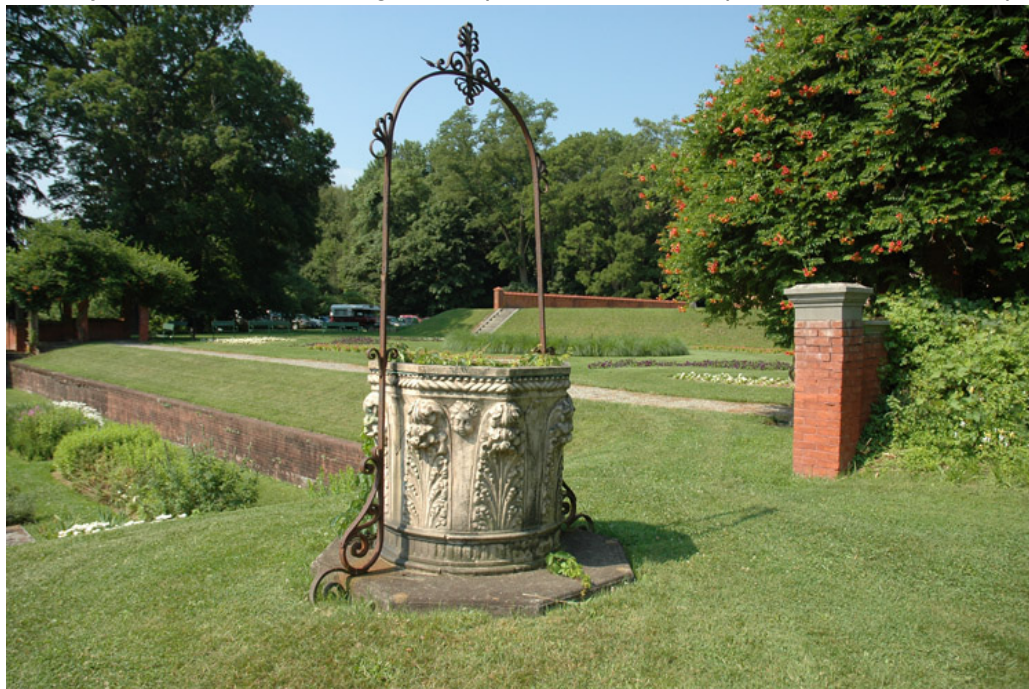
*Figure 31. View southwest of cast faux wellhead with decorative wrought iron overthrow. The bas relief contains unfurling acanthus fronds, masks, and heraldic shields. The wellhead is set on an octagonal concrete base (OCLP, June 2008).*

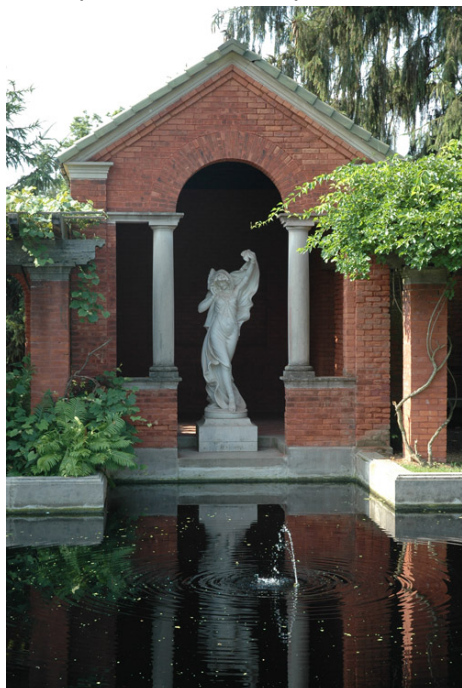
*Figure 32. View south of the Italian white marble sculpture of an Odalisque. The feather fan in her right hand was broken off by vandals (OCLP, June 2008).*

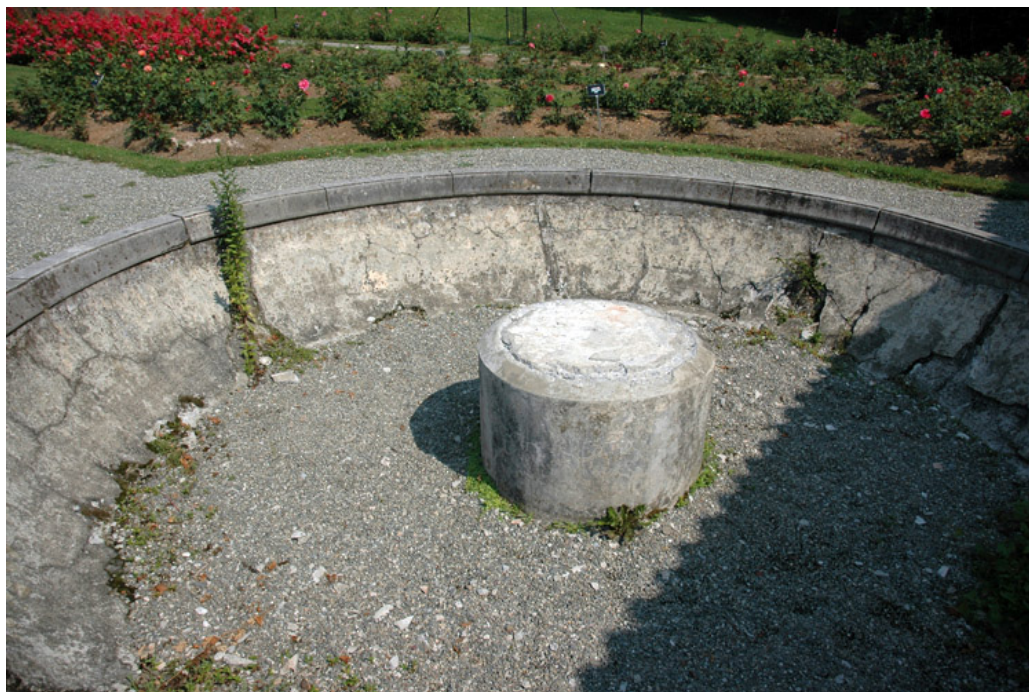
*Figure 33. The shell of the Orpheus fountain in the lower rose garden is cracked and in need of repair (OCLP, June 2008).*

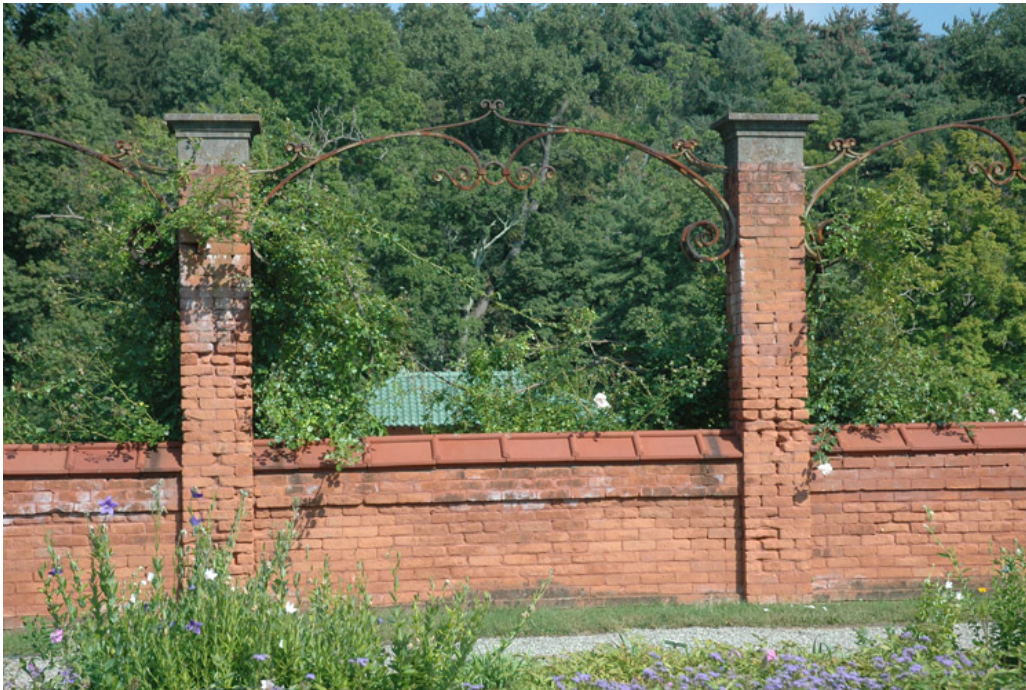
*Figure 34. View east of the brick piers and wire scrolls that frame the view of rose garden from the lower perennial garden (OCLP, September 2008).*

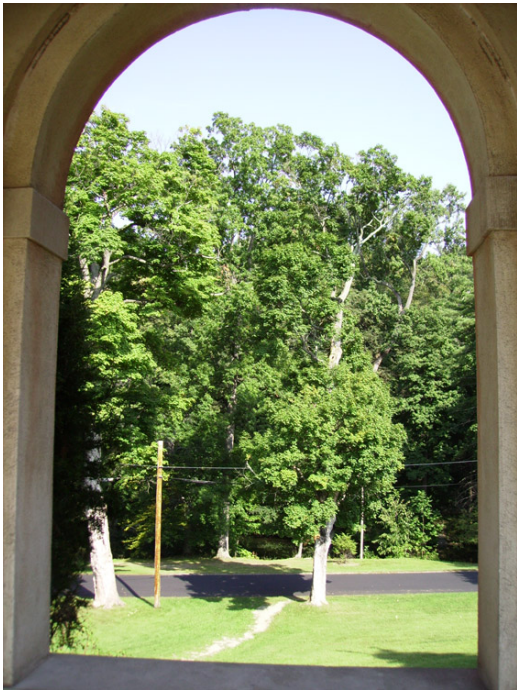
*Figure 35. View east from the arched window of the rose garden loggia. Note the narrow footpath that extends from the garden toward Crum Elbow Creek to the east across the road (OCLP, October 2008).*
