CENTRAL RAILROAD OF NEW JERSEY  
COMBINATION CAR No. 303  
HISTORIC STRUCTURE REPORT

Part I

NATIONAL PARK SERVICE  
Steamtown National Historic Site

Prepared by  
Mark L. Morgan

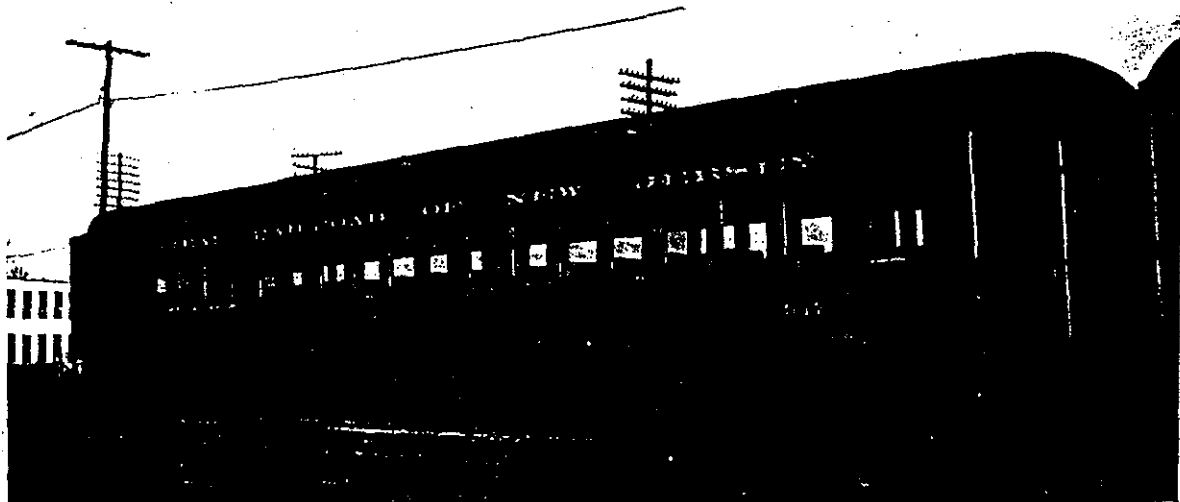
Fig. 15. Central Railroad of New Jersey suburban coach No. 947, in the railroad's second passenger paint scheme. Central Railroad of New Jersey photograph, collection of Willard Sturdevant.

Finally, photographic references indicate that the handrails were painted the body color (Fig.15).

This second scheme is the period chosen for the restoration of combination car No. 303.<sup>88</sup>
