## CULTURAL LANDSCAPE REPORT FOR BELLEFIELD

HOME OF FRANKLIN D. ROOSEVELT NATIONAL HISTORIC SITE

Prepared by  
Kirsten Holder, Historical Landscape Architect

Olmsted Center for Landscape Preservation  
National Park Service, Boston, Massachusetts, 2012

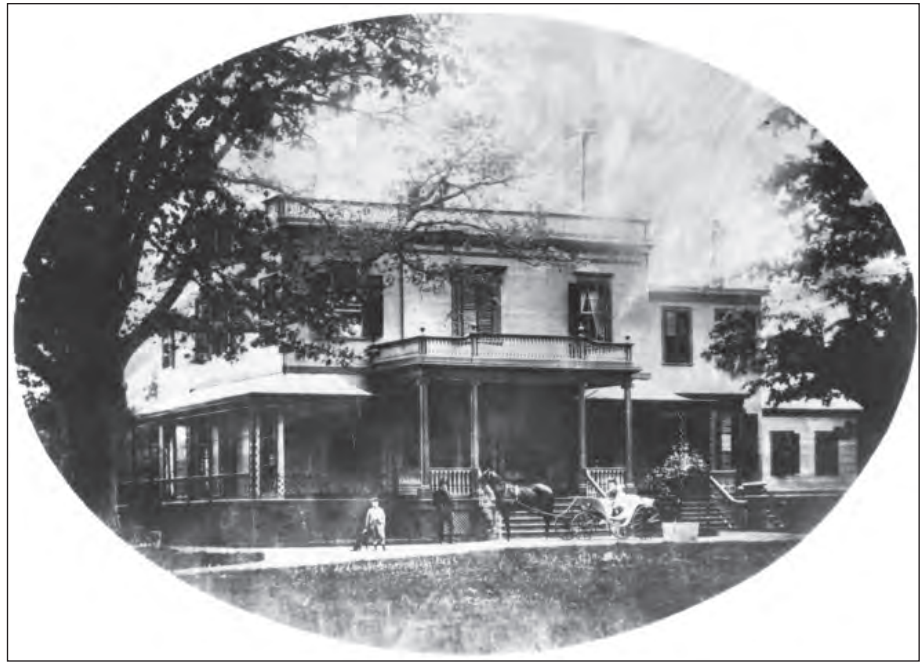
Figure 1.15. View looking northwest of the Bellefield house from the east lawn, c. 1900. The photo shows the renovation of the house from c. 1890 (Newbold-Morgan Collection, ROVA Archives).

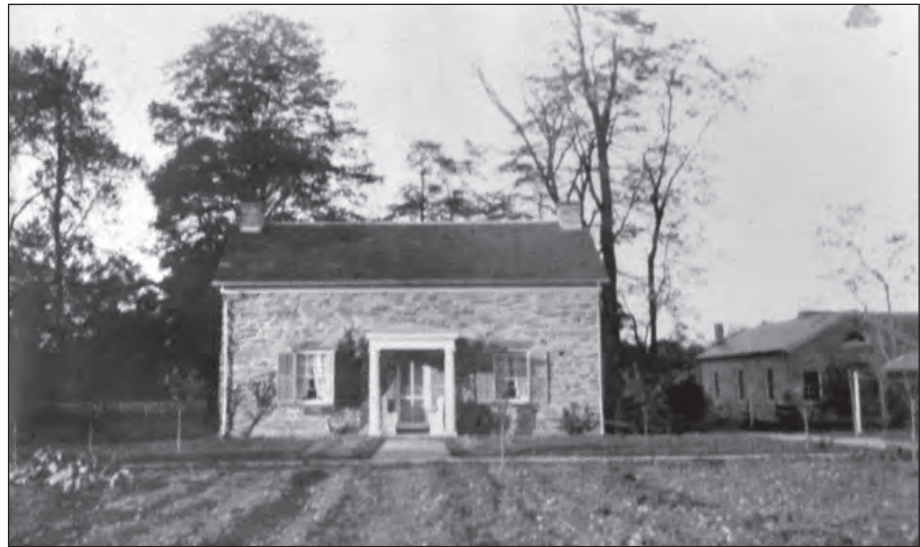
Figure 1.16. Stone house, 1907. View looking north at the stone house from the vegetable and flower garden. The gravel pathway and small orchard trees run between the garden and stone house. The old garage, built in 1905, appears in the far right of the photo (Newbold-Morgan Collection, ROVA Archives).

construction since it was built soon after the introduction of this popular building material for garages. The old garage contained one large room with a large door in the center. The Newbolds likely added a shed on the north face of the old garage around 1916.

The Newbolds once again commissioned Henry Meyers to build a second structure in the service area around 1905 to serve as the superintendent's quarters. The stone house, a one and a half story Colonial Revival building, was located south west of the old garage. The fieldstone walls of the stone house were constructed with stones collected from the nearby woods. The front door opened to the south onto the Newbold's flower and vegetable garden. It is possible that McKim, Mead & White designed the stone house; however, no plans exist for this building.<sup>81</sup>

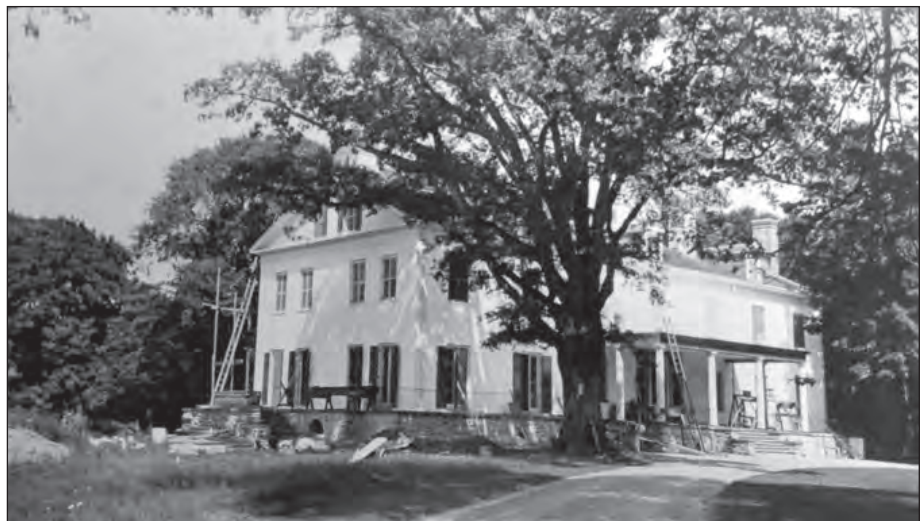
**Figure 1.22. Bellefield house during renovations, 1911. View looking northwest toward the house from the main entrance drive. The tree at the corner of the porch is a white oak (Newbold-Morgan Collection, ROVA Archives).**

In 1908 Newbold contacted Charles Follen McKim, of McKim, Mead & White to renovate and expand the Bellefield house. McKim, known to the Newbold family as Uncle Charles McKim, was a friend to the family.<sup>82</sup> Charles Follen McKim died in 1909, and his colleague, F.J. Adam produced architecture drawings for the first and second floor designs between 1909 and 1911 (Figures 1.20 and 1.21). The renovations transformed the house in the Colonial Revival style and included several changes to the interior of Bellefield such as an enlarged north wing, new bedrooms, a larger kitchen, a new cellar, and addition on the south of the house.<sup>83</sup> Two prior renovations had removed and altered the earlier porches, balustrades, window sash, and eaves brackets. The architects designed a new gable roof to replace the existing roof and to unify the additions with the existing house (Figure 1.22). A new porch over the east entrance and sleeping porch on the west elevation replaced the older Victorian porch. An existing wrought-iron porch on the west side of the house was retained. When the remodel was complete in 1911, Bellefield included twenty-nine rooms, five-and-a-half baths, and a cellar.

Newbold intended to keep the structure of the original Bellefield house intact since it was one of the oldest houses in the region; accordingly, the renovations added rooms to the north and south of the original structure in order to enlarge

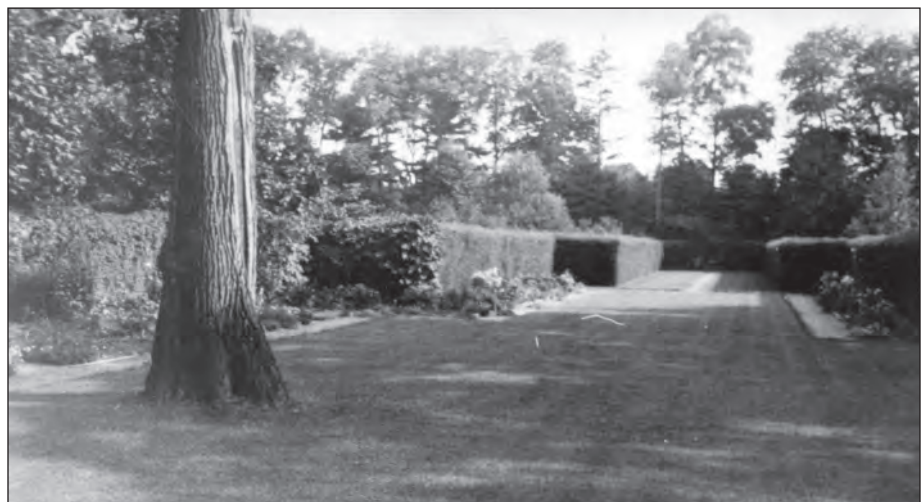
Figure 1.32. Walled garden, 1927. View looking south toward the end of the garden from near the porch. The elm tree (left) stands in the central lawn area, planting beds line the garden walks, and the hemlock hedge lines the southern half of the garden. Maple and pine trees follow the southern edge of the property boundary (Newbold-Morgan Collection, ROVA Archives).

Farrand laid out the garden so that the view from the porch or inside of the house toward the end of the garden was a forced perspective. This made the end of the garden, with sequentially smaller garden rooms extending south from the house, appear farther away (Figure 1.32). Farrand was sensitive to the existing trees at Bellefield and designed the walled garden around an existing elm tree that was one of the only asymmetric elements within the garden (Figure 1.33). The planting beds along the garden gravel walks and lawn area were filled with layers of profuse blooms with low vegetation spilling over the stone edging and

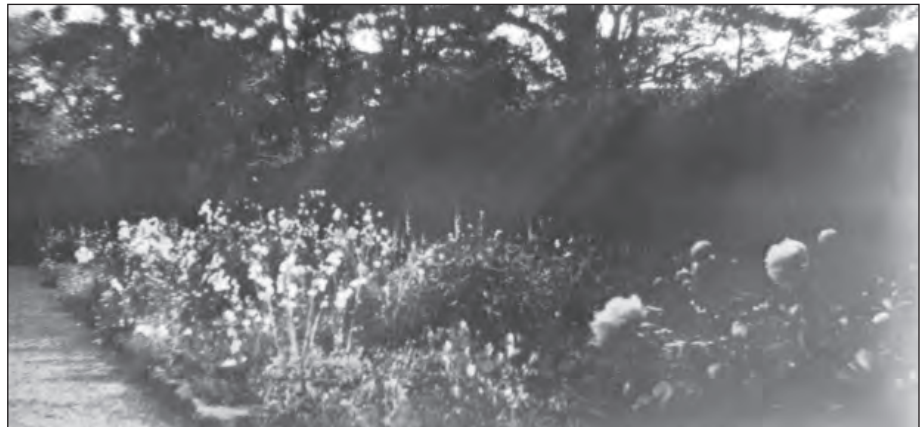
Figure 1.34. Walled garden planting bed, 1929. View looking southwest at the vegetation in the planting beds. Black locusts stand outside of the walled garden (Newbold-Morgan Collection, ROVA Archives).

some taller plants standing tall adjacent to the garden walls. Images of the family members in the garden show their use and appreciation of the garden (Figures 1.34, 1.35, and 1.36). The planting beds were defined by vertical stone edging. The garden was well-used by the Newbold family and well-maintained by household staff. Farrand's plans show an outline of a natural or wild garden beyond the walled garden area that incorporated several existing trees. The vegetation in this area likely served as a transition to the surrounding lawns and tree clusters and likely included several new flowering trees, which are evident in family images and aerials.<sup>91</sup>

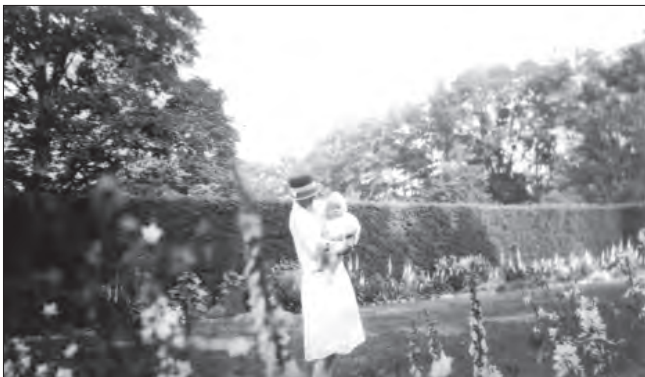
Figure 1.35. Walled garden planting beds, 1929. View looking southeast from inside of the garden toward a women and baby. Foxglove spires are visible in the foreground and along the hemlock hedge (Newbold-Morgan Collection, ROVA Archives).

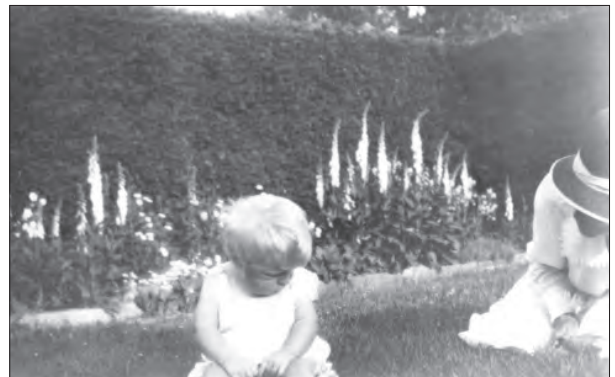
Figure 1.36. Walled garden stone edging, 1929. Child sitting on the central lawn with stone edging along the planting beds (Newbold-Morgan Collection, ROVA Archives).

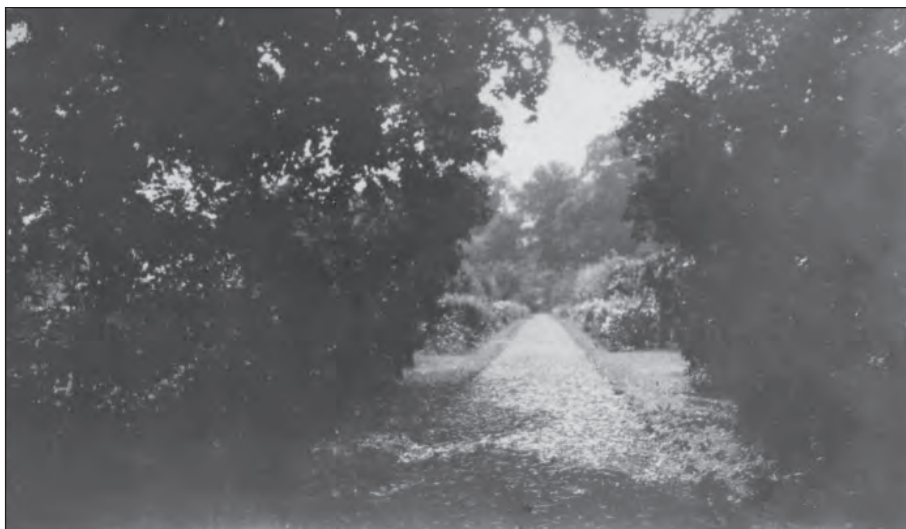
Figure 1.37. Gravel pathway, 1927. View looking west along the gravel pathway from the Bellefield house toward the stone house. The pathway is lined by vegetable and flower gardens, a rose garden, and grape arbor (Newbold-Morgan Collection, ROVA Archives).

West of the Bellefield house, Newbold planted several sugar maples (*Acer saccharum*) and fruit trees between the west entrance and the stone house, and along the gravel pathway (Figures 1.37, 1.38, and 1.39). The family and groundskeepers maintained grape arbors, flowering planting beds, fruit trees, and vegetable beds on both sides of the path. It is possible that Farrand helped the Newbolds conceptualize the design of the plantings in the planting beds west of the house, however no records of this garden exist today other than family photographs.<sup>92</sup> Newbold likely built two seven-by-thirteen-foot cold frames

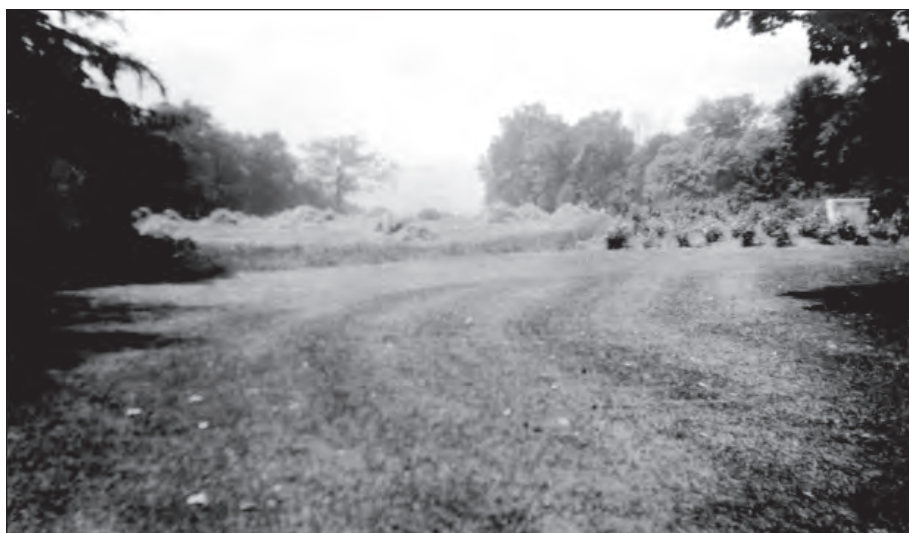
Figure 1.40. West lawn, rose garden, and hay field, 1929. View looking west from the mowed lawn toward the view over the Hudson River. A larch grows on the far left and the wellhead is on the right (Newbold-Morgan Collection, ROVA Archives).

South of the gravel pathway, Newbold installed a decorated wellhead around 1916 and planted several roses. He also continued to grow hay in the open fields to the west of the mowed lawn area and wellhead (Figure 1.40). The Newbold family did not have any buildings in this area and views extended toward the highlands on the west side of the river, across the wooded area below the house. This was the approximate location of the sanitary sewer, constructed by Newbold in 1902, that ran along the south boundary of the property through the parcel he purchased from Rogers in 1890. The sewer line joined the line from the Roosevelt house where it flowed untreated into a small creek southwest of the Roosevelt Estate.<sup>93</sup> Newbold likely buried horses and other animals in the far western area of the fields. Archeological surveys later uncovered bones and other debris in this general area.<sup>94</sup>

Beginning in the nineteenth century and extending to the twentieth century, Boorman, Newbold, and Morgan planted and sustained flower and vegetable gardens west of the Bellefield house on either side of the gravel pathway. Newbold maintained between two and three acres of vegetable gardens that included celery, cabbage, lettuce, onions, beans, peas, carrots, asparagus, strawberries, sweet peas, and string beans.<sup>39</sup> In addition, Newbold maintained a rose garden around the wellhead west of the house (see Figure 1.40).<sup>40</sup>

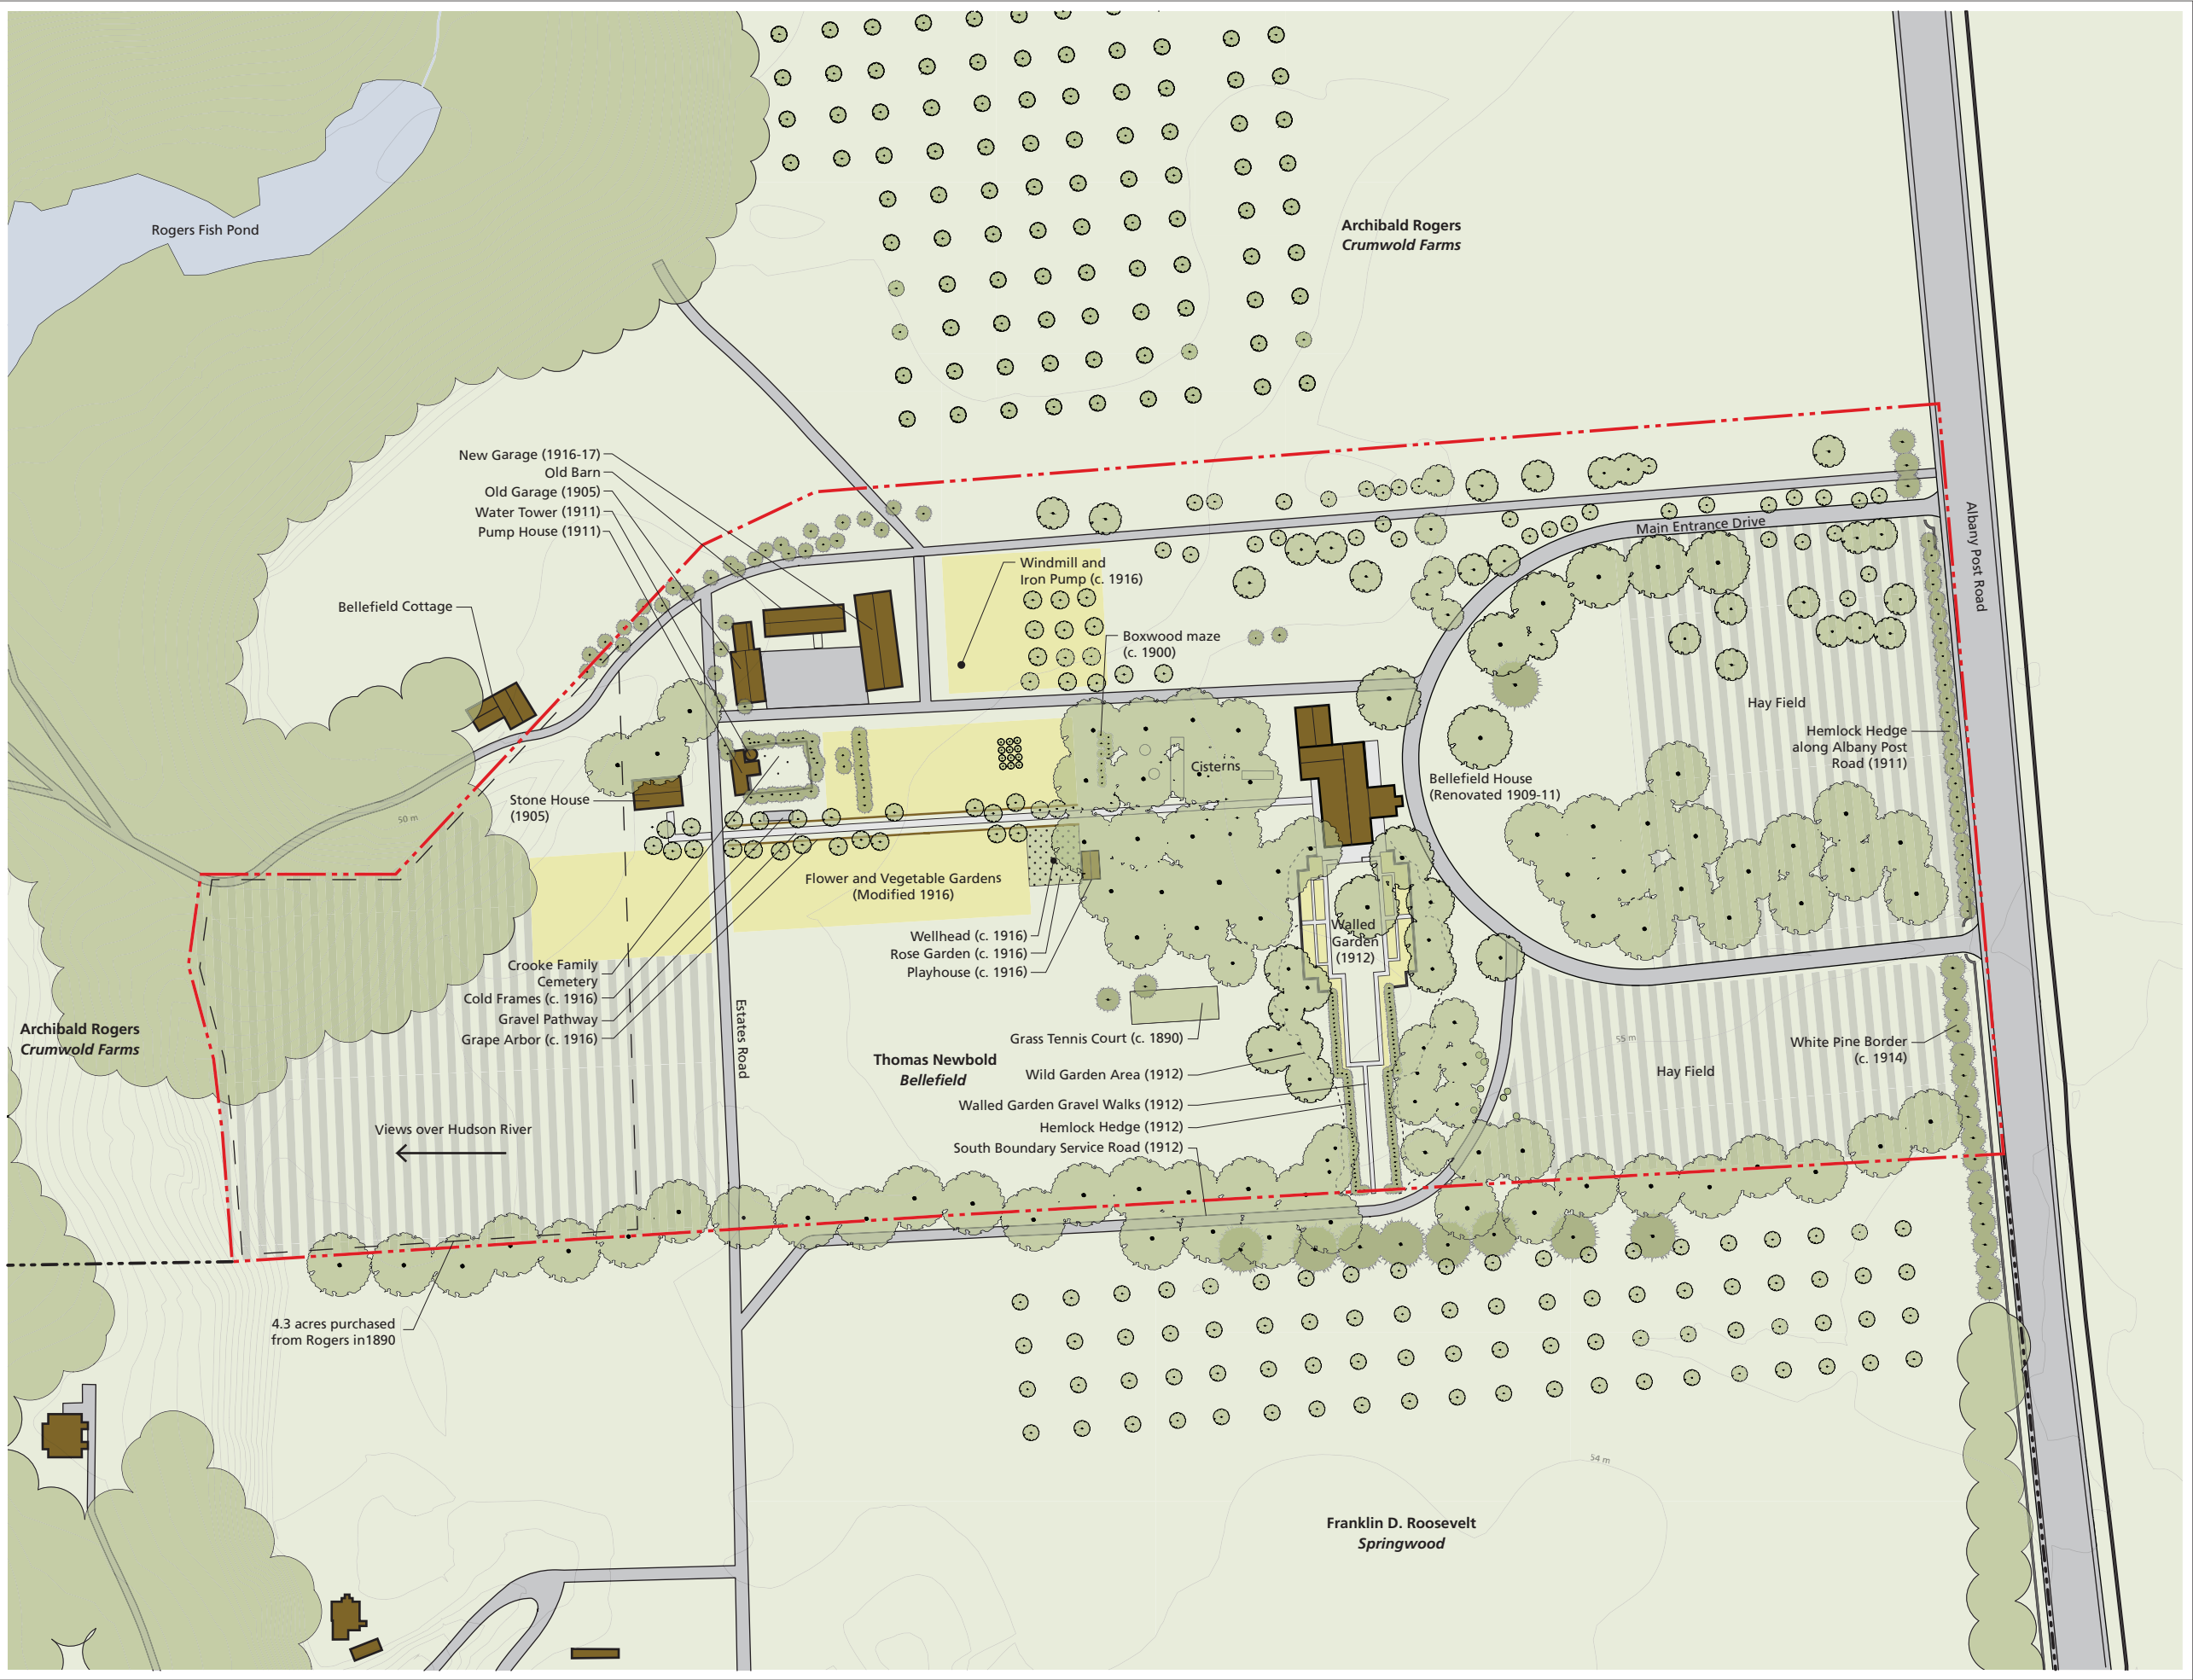
Drawing 1.5

In 1929, as illustrated in Drawings 1.5 and 1.6, the Bellefield landscape appeared as a small residential river estate, surrounded by agriculture fields to the north, east, and south and wooded areas to the west. During Thomas Newbold's tenure, the family expanded their property to include nearly three hundred acres of agricultural land east of Albany Post Road, and residential properties in Hyde Park village. To the north and west of Bellefield, Archibald Rogers owned Crumwold Farms and to the south, the Roosevelts owned Springwood.

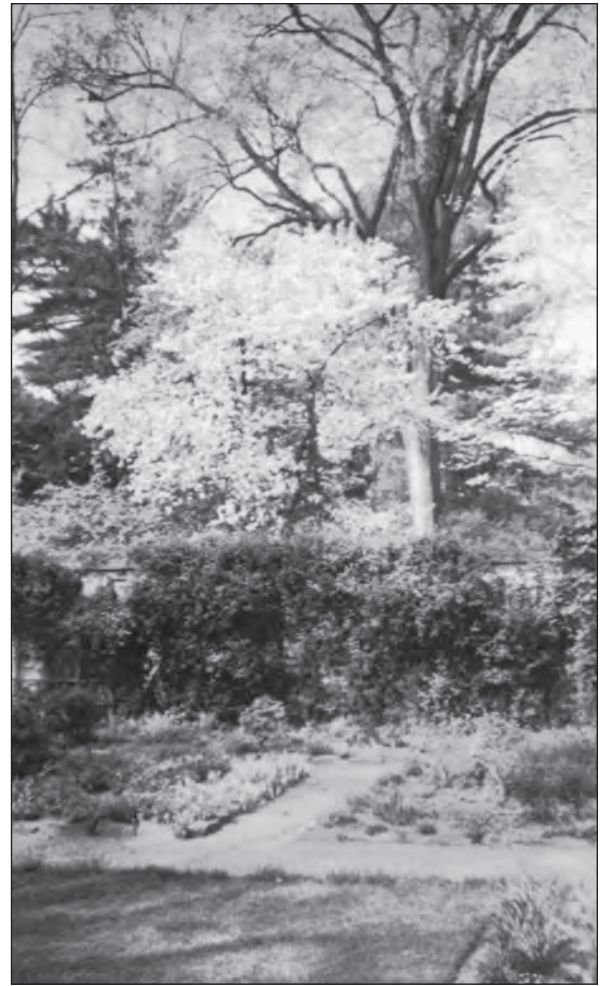
Figure 1.50. View looking southwest from the second floor of the Bellefield house toward the walled garden, c. 1935. Several flowering trees surround the garden, including crabapple or cherry and a dogwood, which likely grew within the wild garden (Newbold-Morgan Collection, ROVA Archives).

The planting beds contained a variety of flowering perennials and annuals that varied in height and texture were neatly trimmed, and spilled slightly over the stone edging. Vines grew along the chestnut and bamboo trellis that was attached to the stone walls (Figure 1.50). Outside of the walled garden, the informal arrangement of low shrubs and flowering trees may have been intended by Farrand as the wild garden. These trees matured and hung over the walled

existing trees and a stone pathway. Photos show that the Newbold walled garden at Bellefield contained drifts of daffodils and flowering trees outside of the walled garden (see Figures 1.50, 1.51, 1.52, and 1.65)

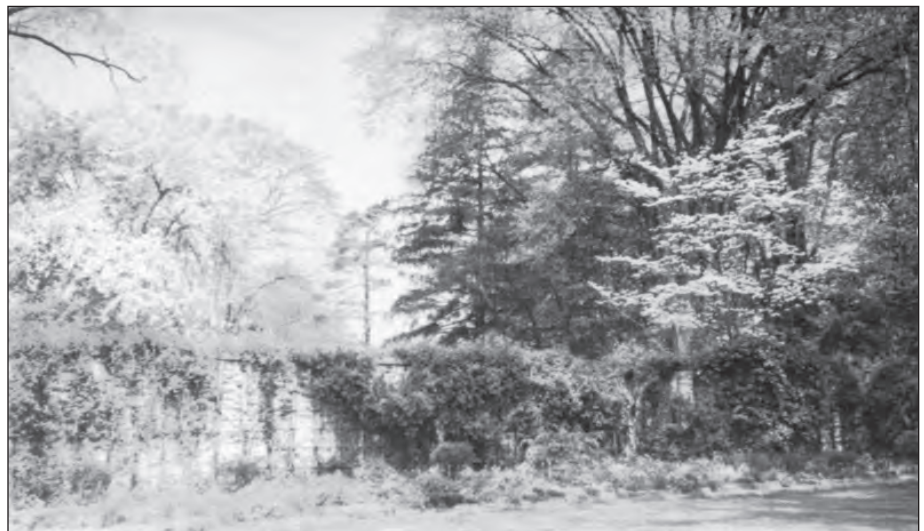
Figure 1.52. View looking southeast from inside of the Bellefield walled garden, c. 1937. The planting beds contain low vegetation and vines grow on the walls. A flowering dogwood grows outside of the garden walls (Newbold-Morgan Collection, ROVA Archives).

garden fieldstone walls (Figures 1.51 and 1.52). Randolph Traudt worked as a groundskeeper from 1926–56 where he was employed by the Newbolds and later the Morgans. Mr. Traudt recalled several trees east of the walled garden that included “a large oak tree by the garden wall, beautiful dogwood trees and lilacs, magnolia, and an oak tree.”<sup>103</sup>

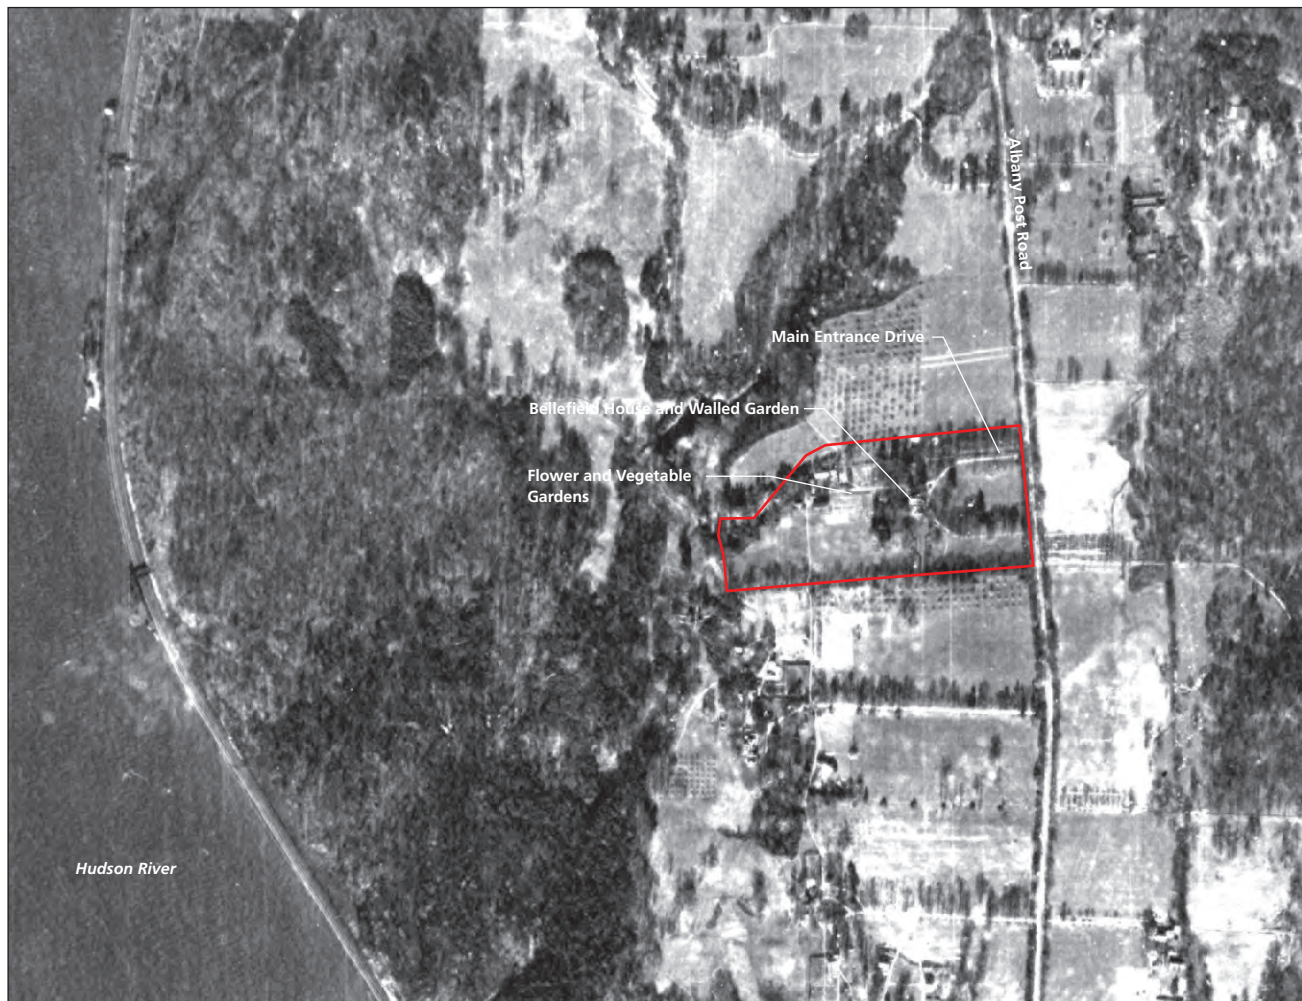
**Figure 1.53. Aerial photograph of Bellefield and Hudson River, 1936.** The aerial shows the undeveloped land along Albany Post Road and the main landscape features. Bellefield is outlined in red (ROVA Archives, annotated by OCLP).

Family photographs and aerials capture the appearance of the landscape surrounding the house from around 1935 to 1937. Large maple and pine trees stood along the southern property line and service road, south of the garden hedge. To the east, the manicured entrance drive remained as the formal entrance to the house. To the west, flower and vegetable gardens stood near the house with hay fields and the service area farther west. To the north, a driveway, lined on both sides by deciduous trees, ran between Albany Post Road and the service area. Beyond the Morgan’s property line, the Rogers maintained a large orchard in the late 1920s, 1930s, and 1940s (Figure 1.53).<sup>104</sup>

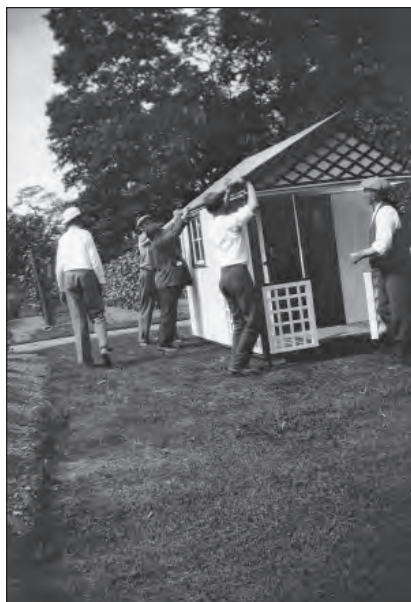
Figure 1.60. Cistern and cover within the west lawn, c. 1935. View looking south with the gravel walkway and plantings in the background. Thomas Newbold Morgan stand in front of the ornamental cistern cap in the west lawn (Newbold-Morgan Collection, ROVA Archives).

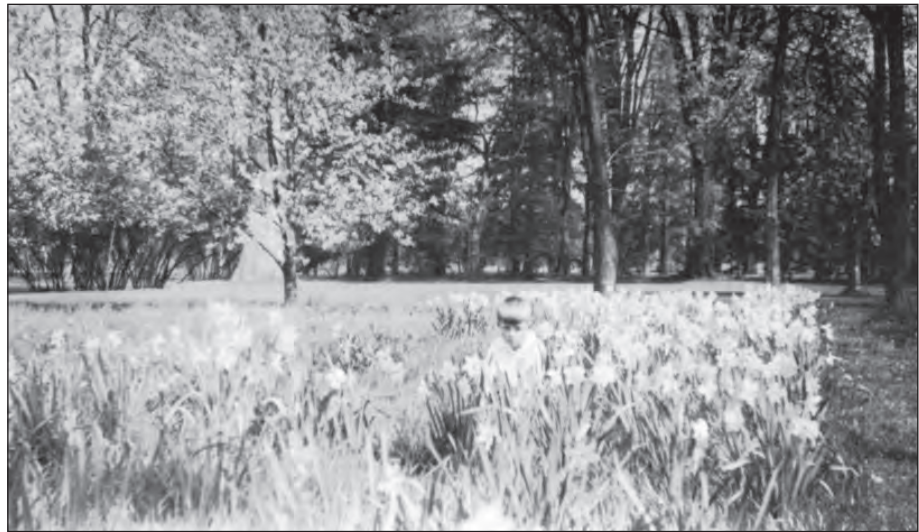
Figure 1.65. Daffodils and trees in the east lawn, c. 1937. View looking south toward the trees east of the walled garden. A Morgan child sits within the daffodils (Newbold-Morgan Collection, ROVA Archives).

lawn long in the spring and bulbs grew within groupings of flowering shrubs and deciduous trees (Figure 1.65).

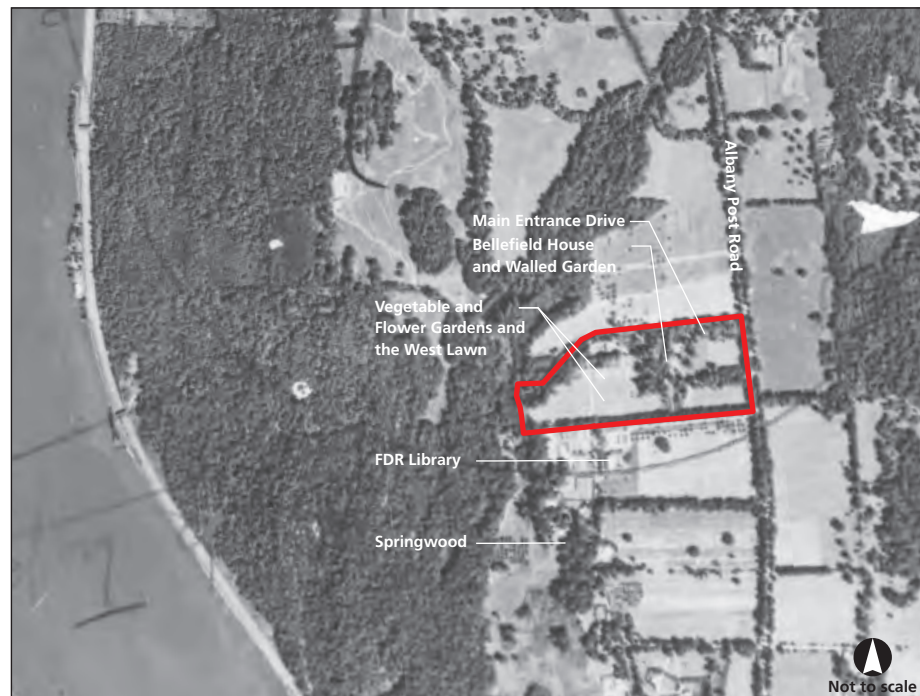
Figure 1.70. Bellefield aerial, 1945. The aerial shows the landscape features and undeveloped land within the Roosevelt Estate prior to construction of the Hyde Park Drive-In and commercial buildings. The Bellefield property is outlined in red (ROVA Archives, annotated by OCLP).

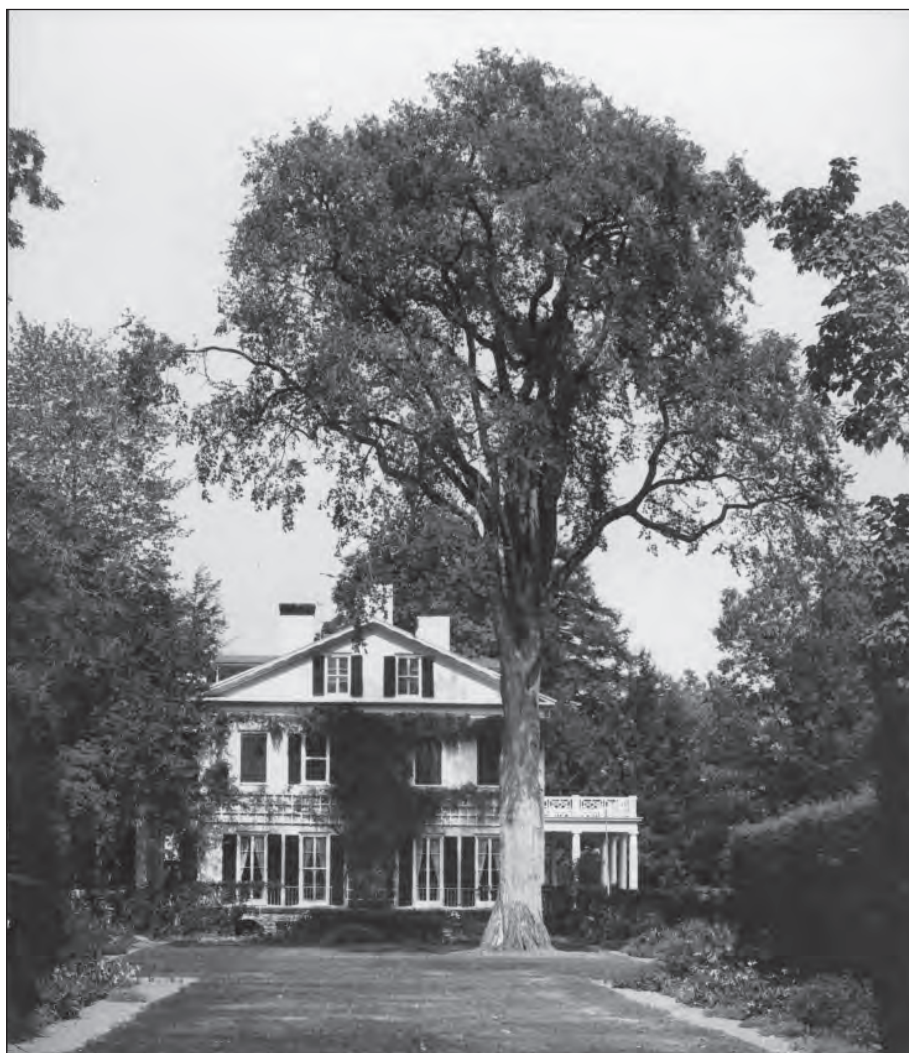
**Figure 1.77. Walled garden, 1964.** View looking north toward the Bellefield house from inside of the walled garden. The single American elm stands in the center of the lawn area. Planting beds are filled with lush vegetation along the gravel pathways. Grape vines grow on the trellis attached to the house (ROVA Archives).

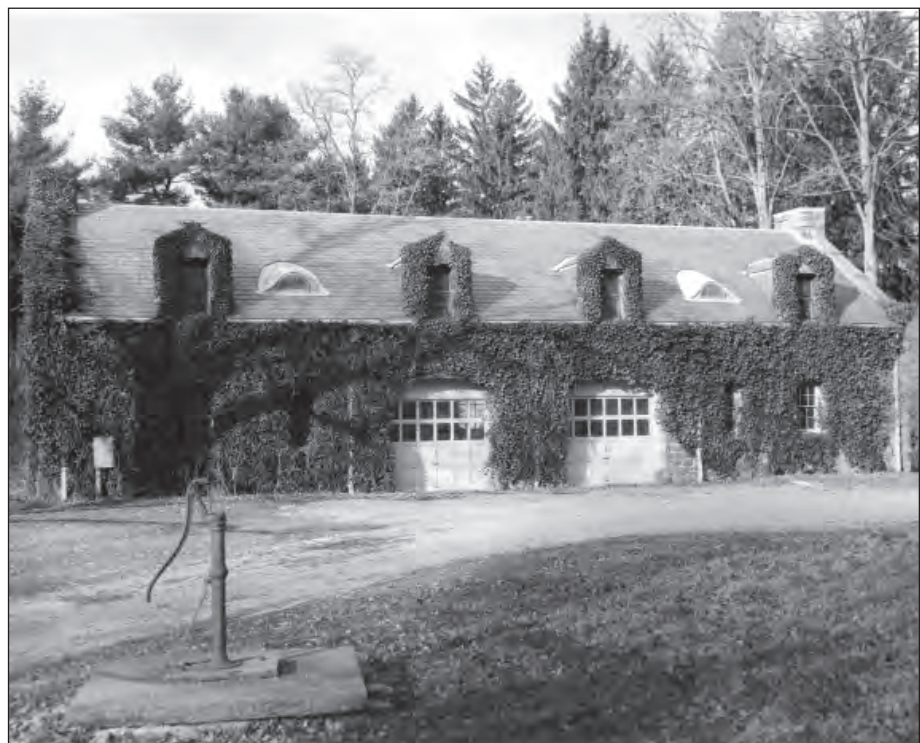
Figure 1.79. View looking west toward the new garage and driveway, 1975. The iron pump in the foreground marks the location of a windmill that pumped water from the well to the water tank (ROVA Archives, photo taken by Fred Van Tassell).

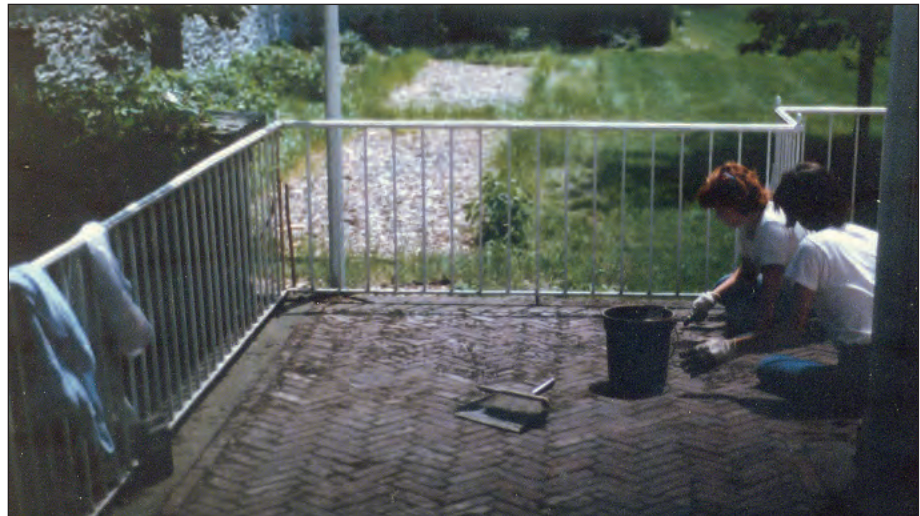
Figure 1.88. Youth Conservation Corps remove weeds, 1985. View looking south with the walled garden in the background. The planting beds are empty and grass grows over the gravel pathways. The young elm tree grows in the far right of the photo (ROVA staff, Henry Van Brookhoven).

garden areas including the walled garden, vegetable gardens, and the rose bed (Figure 1.88).

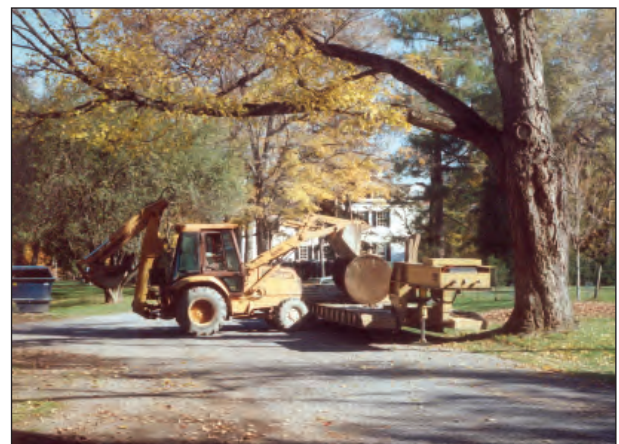
Figure 1.94. Work along service road, 1989. View looking east toward the house where a contractor removes the underground tank (ROVA staff, Henry Van Brookhoven).

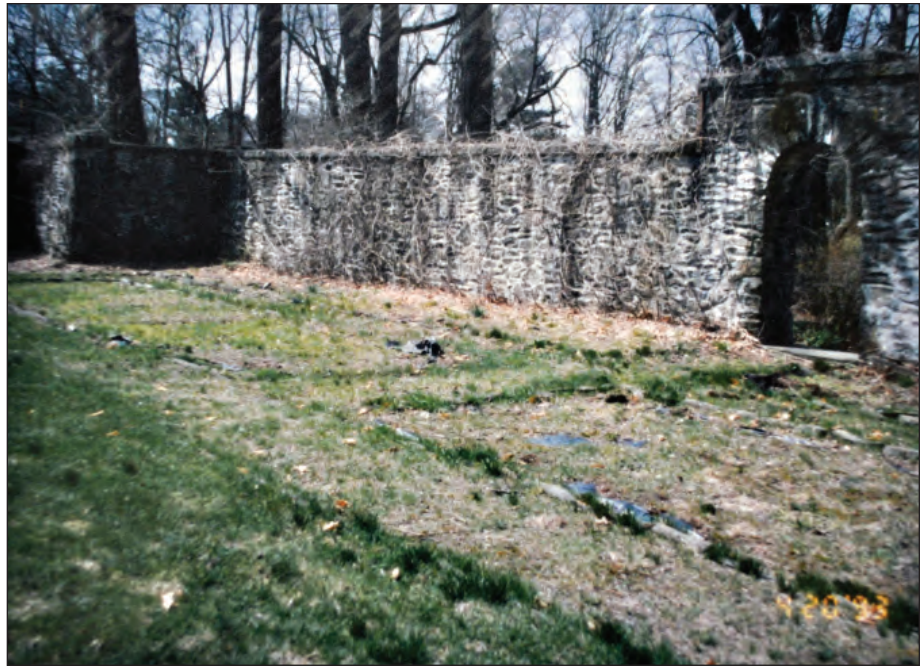
Figure 1.95. Walled garden planting beds, 1993. View looking northwest toward the stone wall and planting beds. The gravel pathways are covered in grass and the planting beds are covered with black plastic. The stone edging remains between the planting beds and walkways (Beatrix Farrand Garden Association).

The National Park Service staff did not have the fiscal resources, original planting plan drawings, or horticultural staff to rehabilitate or maintain the walled garden vegetation to the condition it displayed during Newbold and Morgan ownership. The walled garden contained structural remnants of the original garden, yet lacked lush annual and perennial plantings that once filled the interior beds. The garden fieldstone wall was in good condition, although staff had removed the bamboo and chestnut trellis on the stone wall and stored in the Bellefield house basement. Remnants of the gravel pathways and stone edging around the beds continued to delineate the lawn and planting beds (Figure 1.95). The hemlock hedge that surrounded the south end of the garden had matured into large rounded shrubs rather than a continuous vegetated wall after years of deer browsing and minimal maintenance. The park maintained canna lilies in the planting beds, which they also stored in the Bellefield house basement during the winter. In the early 1990s park staff laid black plastic over the planting beds in order to reduce the growth of weeds.<sup>132</sup>

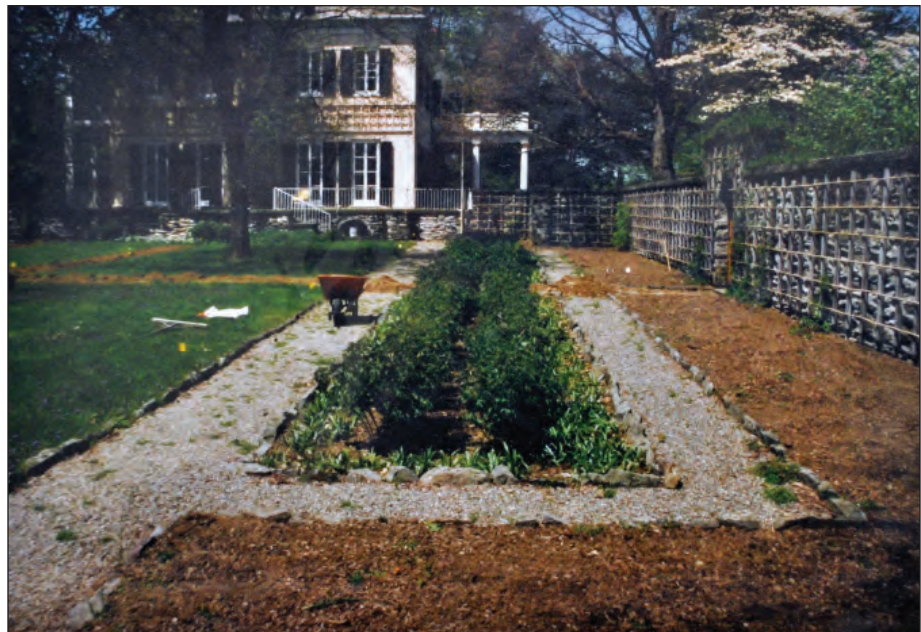
Figure 1.97. Spring planting, 1997. View looking north toward the house. The bamboo and chestnut trellis is attached to the fieldstone wall on the right (Beatrix Farrand Garden Association).

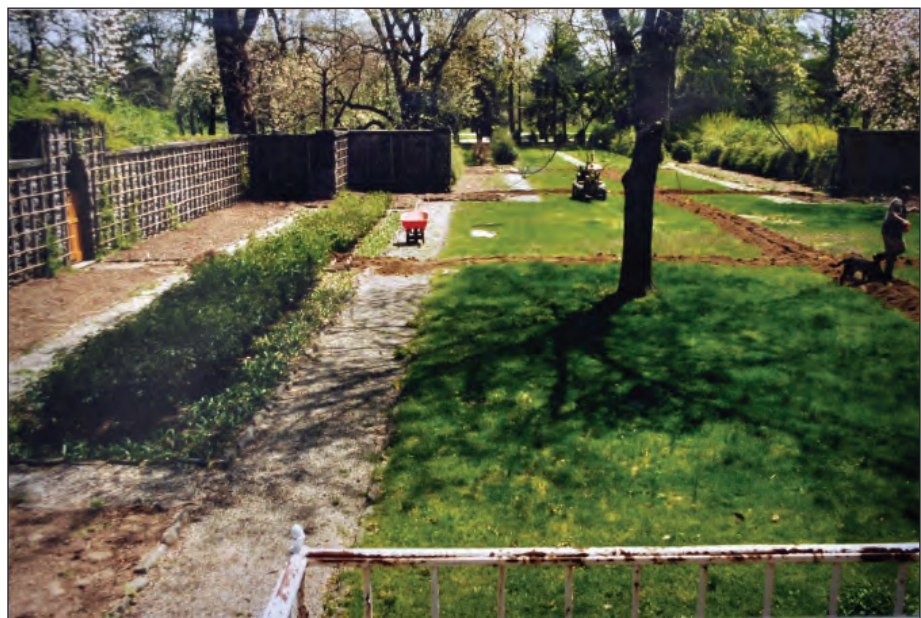
Figure 1.98. Spring planting, 1997. View looking south from the second story of the Bellefield house. The irrigation lines are laid out and the hedge is recently planted (Beatrix Farrand Garden Association).

In 1994 the Beatrix Farrand Garden Association worked with the National Park Service to remove the overgrown hemlock hedge and replant a single line of hemlocks that created a vertical wall similar to what existed in the Newbold era. They installed a new irrigation system for the interior of the walled garden, replenished the gravel walks and in some areas reset the stone edging. The park had saved and numbered the vertical chestnut slats that once attached to the interior of the stone walls, and volunteers were able to remount the slats in the original location and install new bamboo horizontal pieces. Park staff and volunteers replaced the east and west garden gates using Farrand's original design details for the fences as a guide.

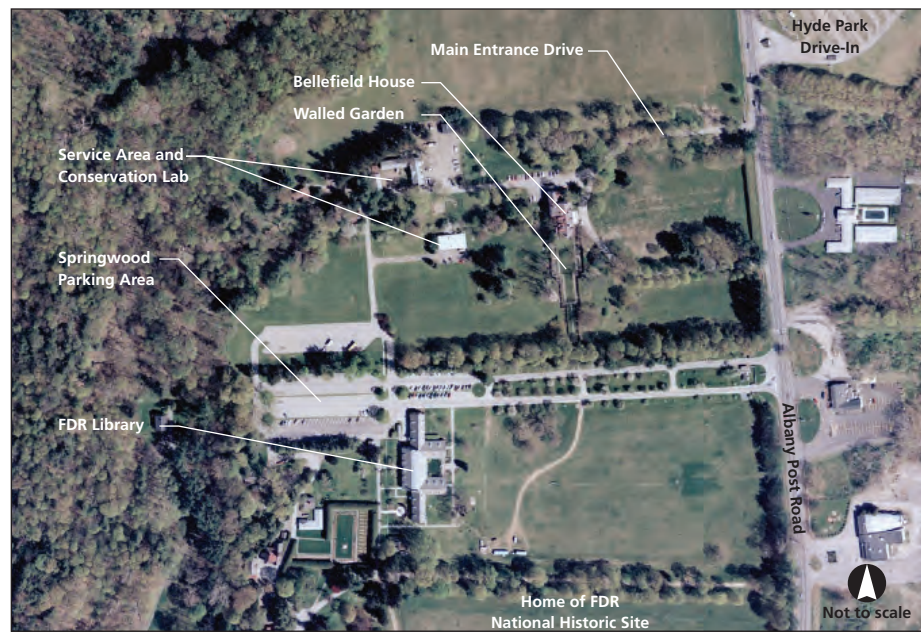
**Figure 1.104. Bellefield aerial, 2000.** The aerial shows the development along Albany Post Road, the structures on the Bellefield property, and the expanded visitor parking area (ROVA Archives).

Prior to construction of the Wallace Center, the National Park Service removed the parking area that was partially on Franklin D. Roosevelt's estate and partially on Bellefield (Figure 1.104). Construction of the new facility and parking area was completed in 2003, and the Wallace Center opened later that year. Around 2004, park staff laid a new layer of bituminous asphalt over the main entrance drive and staff parking area and removed a small planting area in the staff parking area. The

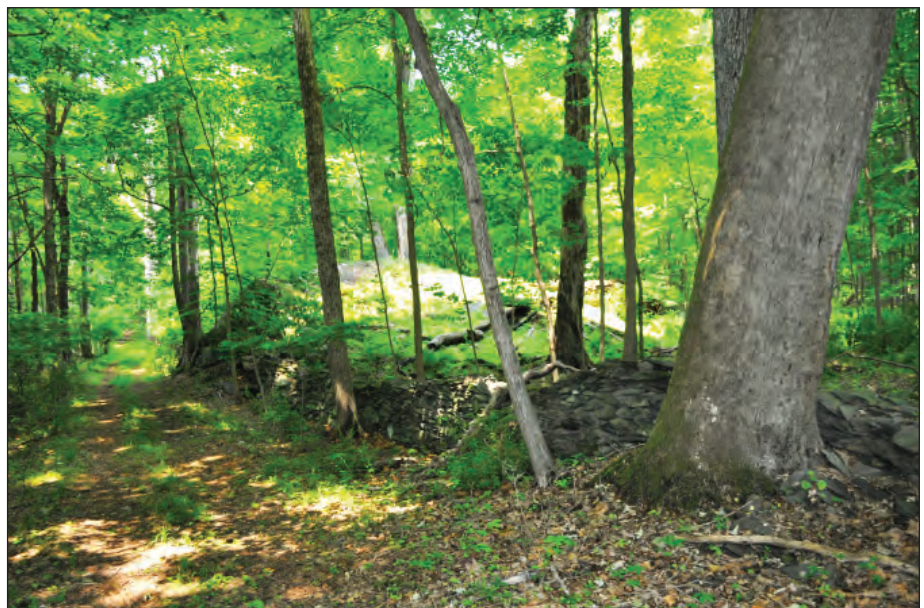
**Figure 2.2. Natural Systems and Topography.** View looking west on the stone cottage road with a stone retaining wall parallel to the road. The road is now used as a trail (OCLP 2011).

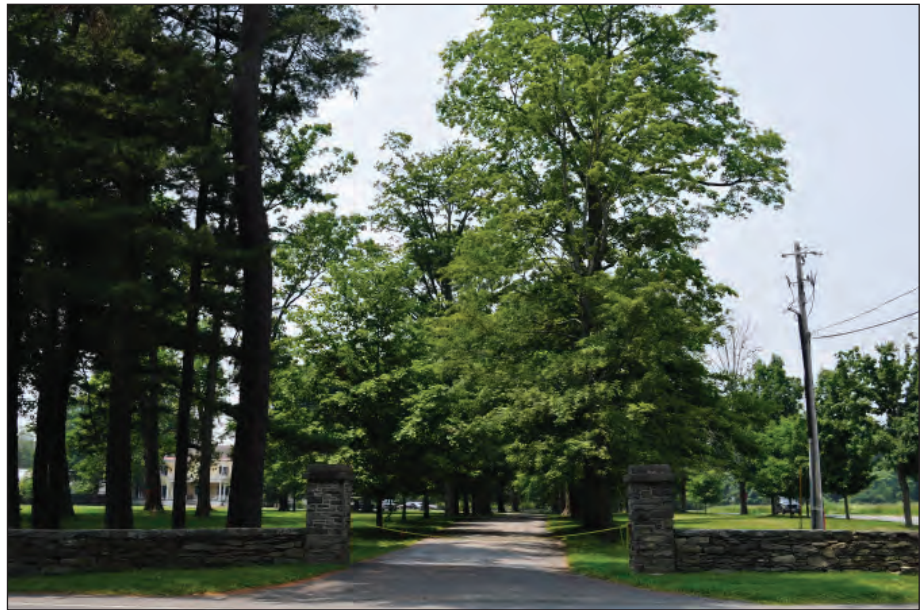
**Figure 2.10. Circulation.**  
View looking west from the southern leg of the main entrance drive. The drive serves as the exit road for park staff and volunteers (OCLP 2011).

Circulation consists of the spaces, features and surfaces that constitute the systems of movement in the landscape. A vehicular and pedestrian network connects Albany Post Road to the Bellefield house, Wallace Center, Springwood, Presidential Library and Museum, and surrounding trail network. FDR Drive, which is the primary vehicular entrance to the Wallace Center, Library, and Historic Site, follows the Scenic Hudson property line at the northern edge of the Bellefield property (Figure 2.8). The drive curves south before the cemetery and service area and ends at the bus turn around and entrance to the visitor parking area. The FDR Drive is the physical divide between the Bellefield house and grounds area and the cemetery and service area. The two-way bituminous concrete road is approximately twenty-six feet wide. South of FDR Drive and near the intersection to Albany Post Road, the Bellefield main entrance drive extends from Albany Post Road, to the Bellefield house and staff parking area, and back to the Albany Post Road. Prior to 1975 the eastern half of the stone cottage road, which ran between FDR Drive and the northern leg of the main entrance drive, was removed. The northern half of the main entrance drive is no longer open for vehicular use; however, it remains in use for pedestrians and serves a link for the Hyde Park Trail (Figure 2.9). Construction of a new crosswalk, trailhead, and parking area at the intersection of FDR Drive and Albany Post Road occurred in 2012, with additional parking and trail access on the east side of Albany Post Road. The south leg of the main entrance drive is a vehicular exit from the staff parking area (Figure 2.10).
