## CULTURAL LANDSCAPE REPORT FOR BELLEFIELD

HOME OF FRANKLIN D. ROOSEVELT NATIONAL HISTORIC SITE

Prepared by  
Kirsten Holder, Historical Landscape Architect

Olmsted Center for Landscape Preservation  
National Park Service, Boston, Massachusetts, 2012

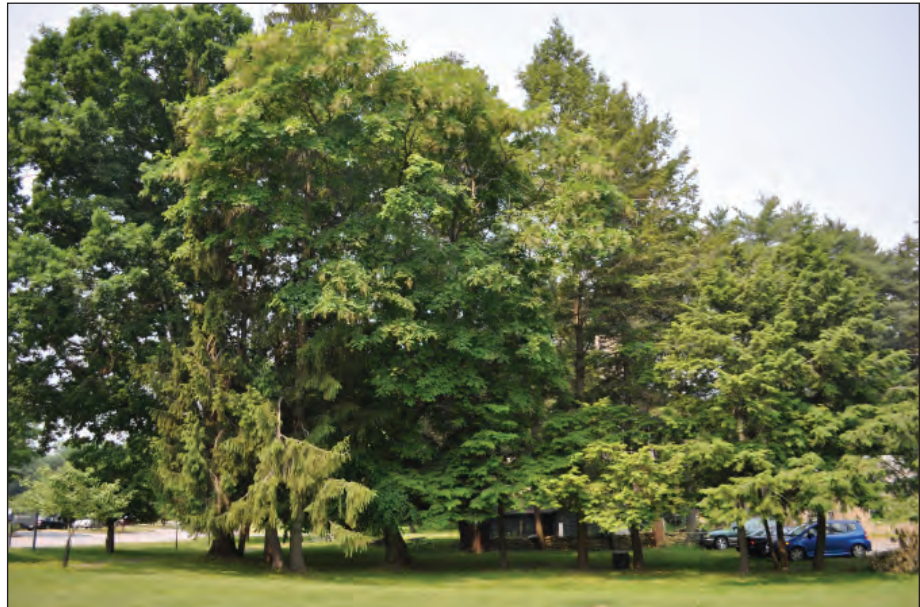
**Figure 2.12. Vegetation.**  
View looking west from FDR Drive. The hemlock hedge, now overgrown, surrounds the cemetery and the apple and pear trees line the west end of the gravel walkway (OCLP 2011).

South of the service area, a small orchard of apple trees (*Malus sp.*) line the west end of the gravel pathway. A dense grouping of Norway spruce (*Picea abies*) define the northern boundary of the service area and a cluster of eastern hemlocks line the southern and eastern walls of the cemetery (Figure 2.12). The Wallace Center parking area contains sugar maple, white ash (*Fraxinus americana*), and white pine.

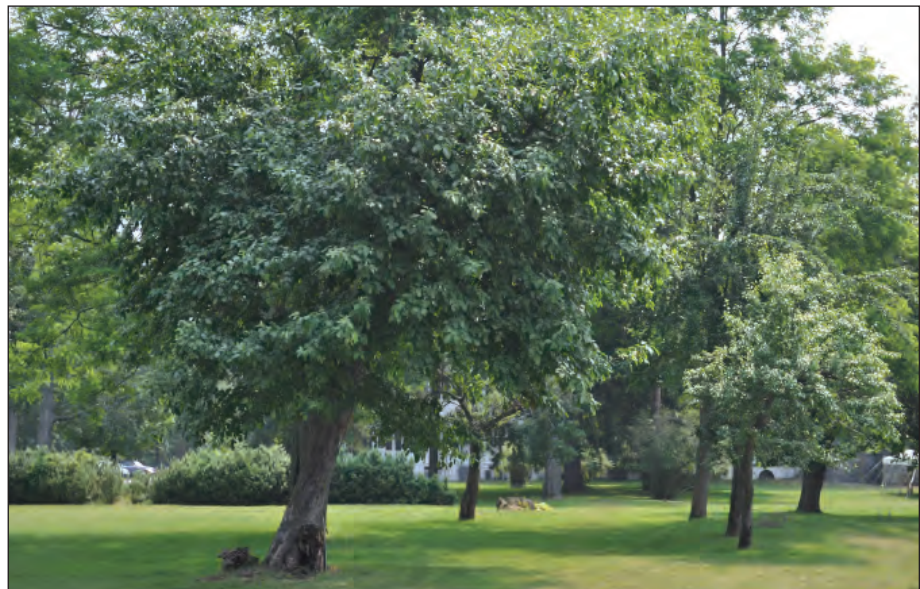
**Figure 2.13. Vegetation.**  
View looking east through the vegetation toward the Bellefield house. The canopy lines the remnants of the straight gravel pathway between the Bellefield house and the stone house (OCLP 2011).

Throughout the Newbold and early Morgan years, the fields and gardens west of the house included flower and vegetable beds, trellises, and hay fields. Today there are trees including sugar maple, mulberry (*Morus alba*), and Norway spruce and shrubs such as sweet mockorange (*Philadelphus coronarius*) along the gravel pathway and around the edge of these remnant garden areas (Figure 2.13 and Figure 2.14).

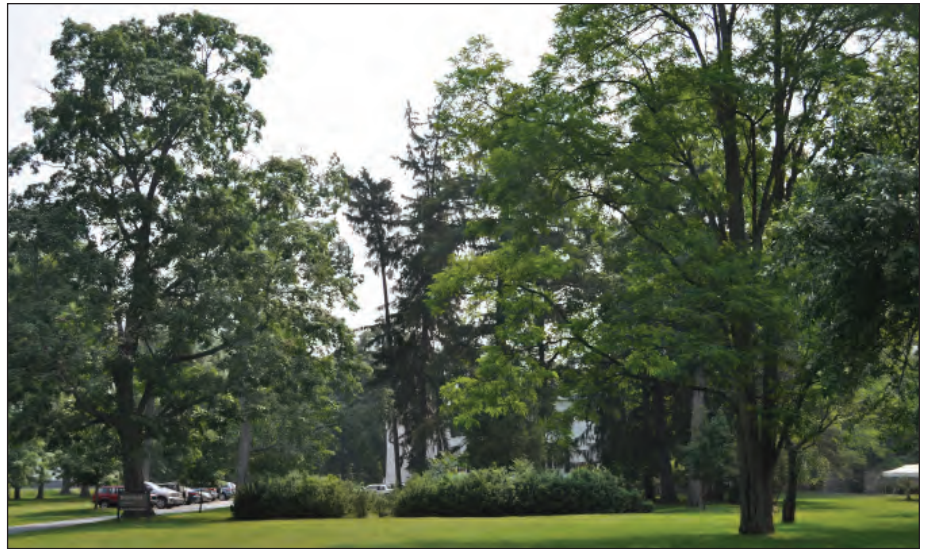
Figure 2.14. Vegetation. View looking east from FDR Drive. The low boxwood hedge is in the center of the image, trees line the staff parking area on the left side of the photo, with a variety of mulberries, Norway spruce, and sugar maples (OCLP 2011).

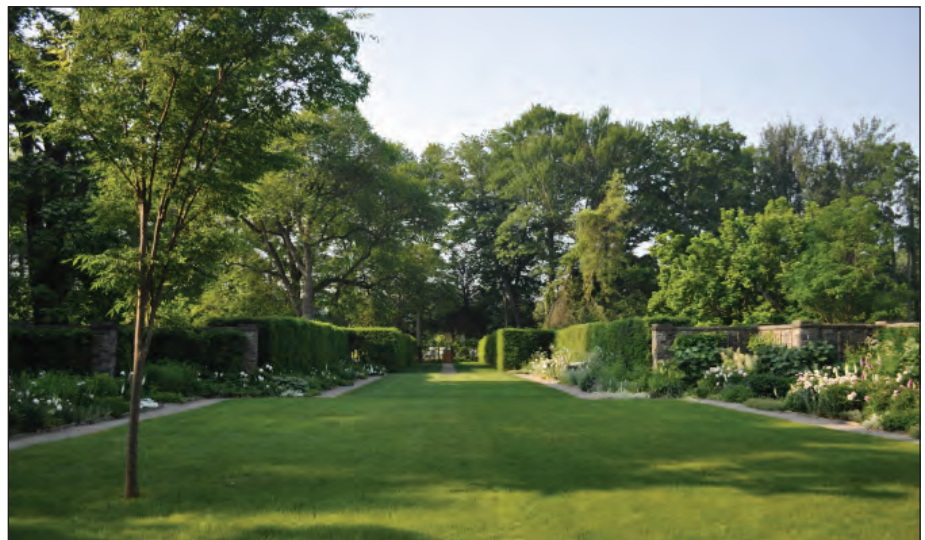
Figure 2.15. Vegetation. View looking south from the Bellefield house. The Chinese elm stands on the left side of the photo with planting beds and the hemlock hedge lining the edge of the garden. Black locusts, magnolias, dogwoods, and a Carolina silverbell line the exterior walls of the garden with white pines and sugar maples at the southern edge of the property (OCLP 2011).

The walled garden consists of a large expanse of lawn in the center, a single Chinese elm (*Ulmus parvifolia*) in the lawn, planting beds with a variety of perennials and annuals along the garden walks, vines attached to the fieldstone walls, and a hedge of eastern hemlocks around southern boundary (Figure 2.15). The planting beds are divided into four areas, each with a unique color theme. These schemes include: the cream, blush, and grey border; the white border; the pink border; and the purple and mauve border. Each bed contains a variety of perennial and annual species (Tables 1 and 2).

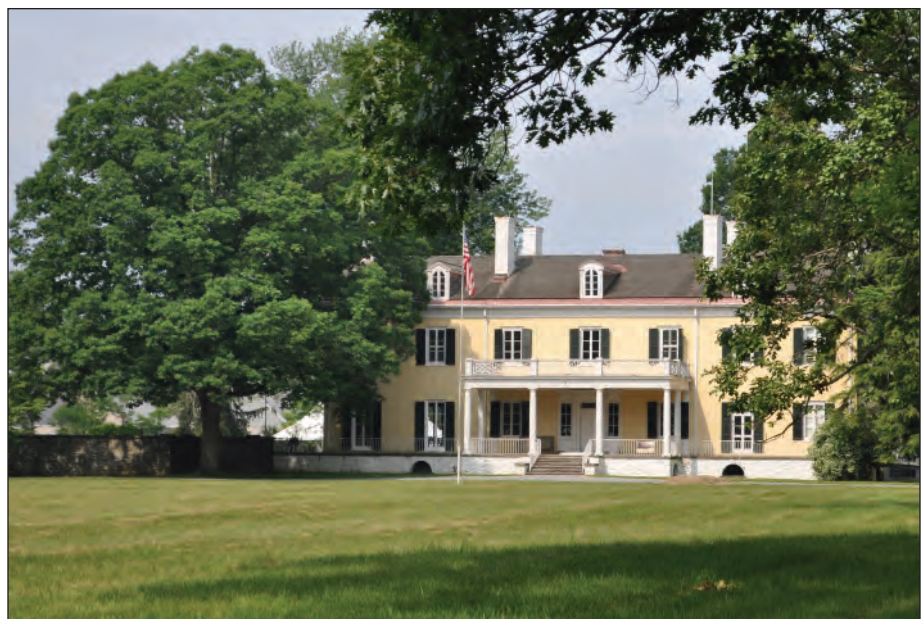
Figure 2.16. Buildings and Structures. View looking west toward the Federal-period Bellefield house with Colonial Revival alterations. The walled garden is visible at the left behind the mature oak tree. A flagpole stands in the lawn east of the main entrance drive (OCLP 2011).

The Bellefield house is a two-story Federal-period house with Colonial Revival alterations that is visible from Albany Post Road. The front lawn, walled garden, staff parking area, and main entrance drive surround the building. John Johnston constructed the sixteen-room house in 1795, and the building remains the core of the Bellefield house. The Boorman family, who resided at Bellefield from 1843–66, renovated the house by adding a cornice and veranda to the exterior in the Victorian style. Newbold made minor exterior alterations around 1895, 1905, and most significantly from 1909–11, when Thomas Newbold hired McKim, Mead

& White architectural firm and initiated the final remodel of the home in the Colonial Revival style, a state that is very similar to what exists today (Figure 2.16).

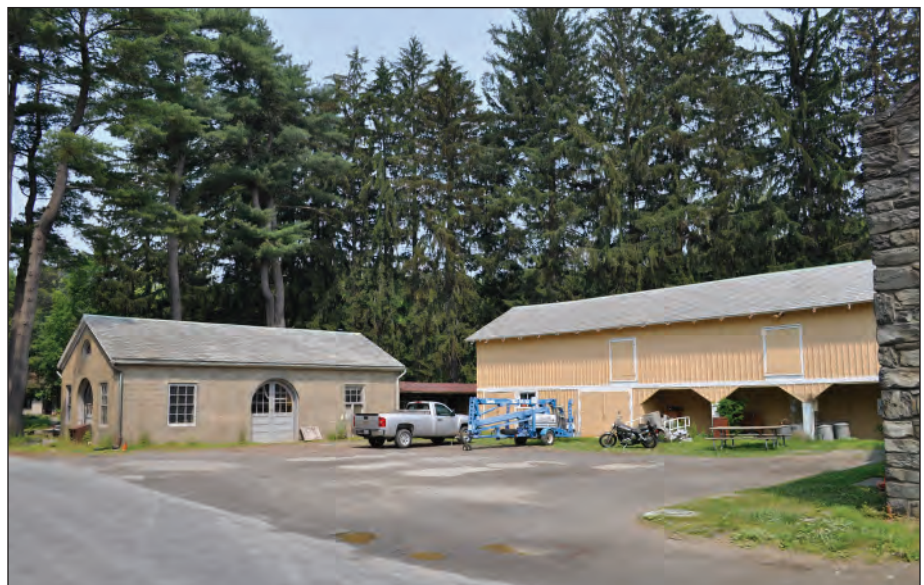
**Figure 2.17. Buildings and Structures.** View looking northwest toward the service area. The old garage (left), old barn (center), and new garage (right) surround the open service area (OCLP 2011).

The service area consists of several buildings and structures that were built by various landowners. Buildings in the service area contain park maintenance equipment and operations (Figure 2.17). The old barn, the oldest support building at Bellefield, was built by the Newbold family around 1800. The old barn has a slate gable roof with vertical board-and-batten siding. The old garage, located perpendicular to and west of the old barn, was built in 1905 by Thomas Newbold. The old garage is a gable-roof concrete-block building with three bays on each side with arched entrances on the middle bay. Southwest of the service area, the stone house was built around 1905 at the time of the Newbold's construction of the old garage. The stone house is a one-and-a-half story Colonial Revival building with random-coursed fieldstone walls and chimneys (Figure 2.18). The stone house serves as the residence for park staff. The front door faces south across from the Wallace Center parking area.

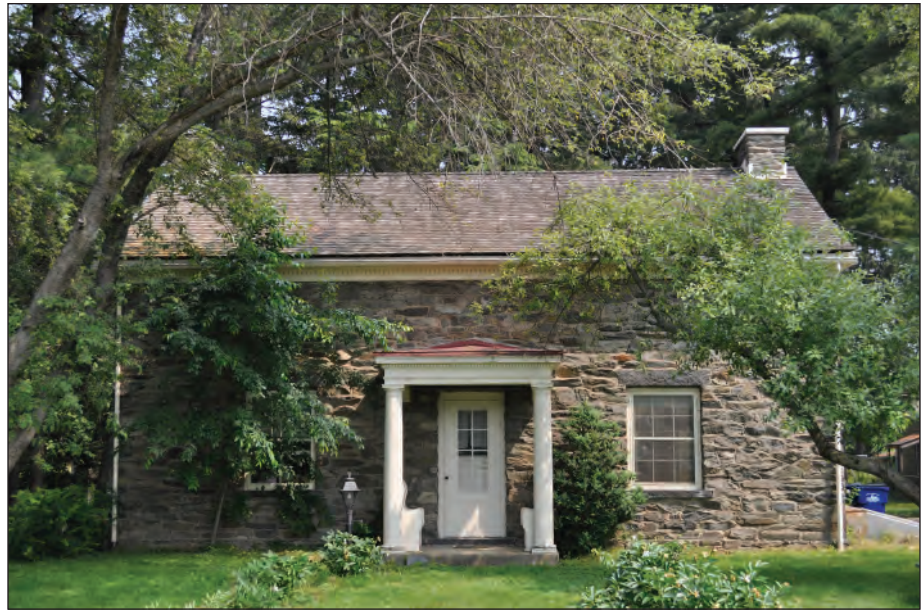
**Figure 2.18. Buildings and Structures.** View looking north toward the south facade of the stone house. This building is a residence for National Park Service staff (OCLP 2011).

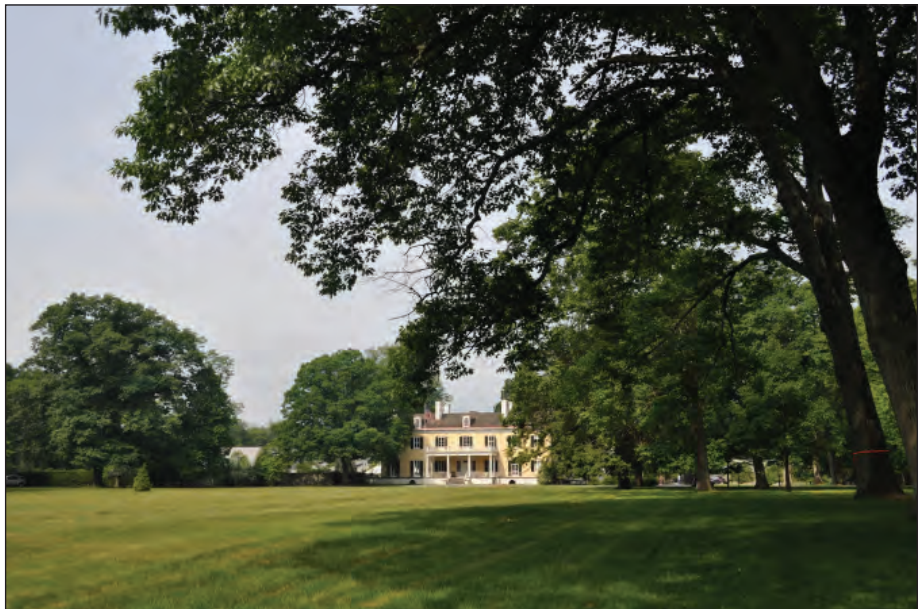
Figure 2.24. Views and Vistas. View looking east from the main entrance drive toward the Bellefield house with mature trees and a well-manicured lawn in the foreground (OCLP 2011).

Views are the expansive or panoramic prospect of a broad range of vision while vistas are the controlled prospect of a linear range of vision, deliberately contrived. The prospect of the Bellefield house is similar to what early travelers viewed from Albany Post Road and the main entrance drive. The replacement of a segment of the stone wall along Albany Post Road with the hemlock hedge changed the broad prospect to a discrete vista of the Bellefield house from the main entrance drive entrances (Figure 2.24). Views west from the Bellefield house include the Wallace

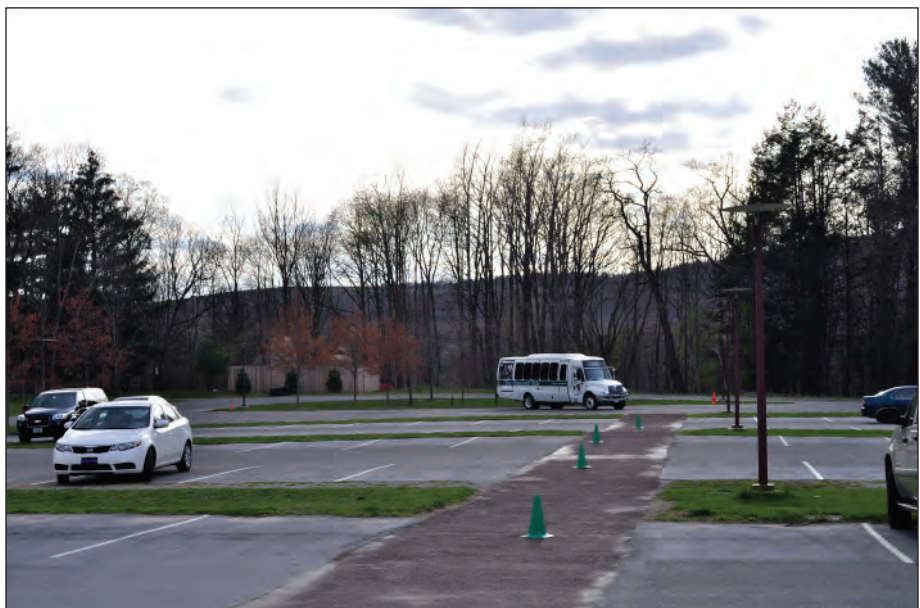
Figure 2.25. Views and Vistas. View looking west from the Wallace Center. Mature and volunteer trees block the view over the Hudson River (OCLP 2012).

Center and wooded lot in the Rogers Land, however, views toward the Hudson River are blocked by woods west of the Wallace Center parking area (Figure 2.25).

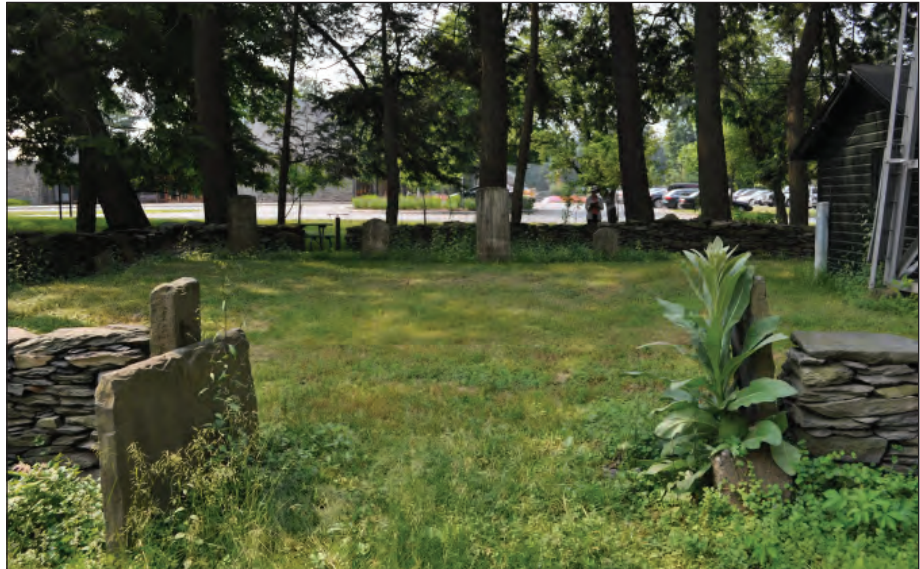
**Figure 2.27. Small-scale Features.** View looking east at the west lawn wellhead with the Bellefield house in the background. The Corinthian style wellhead was likely used to transfer water to the flower and vegetable gardens. Note the trees along the gravel pathway and the white event tent stakes in the background (OCLP 2011).

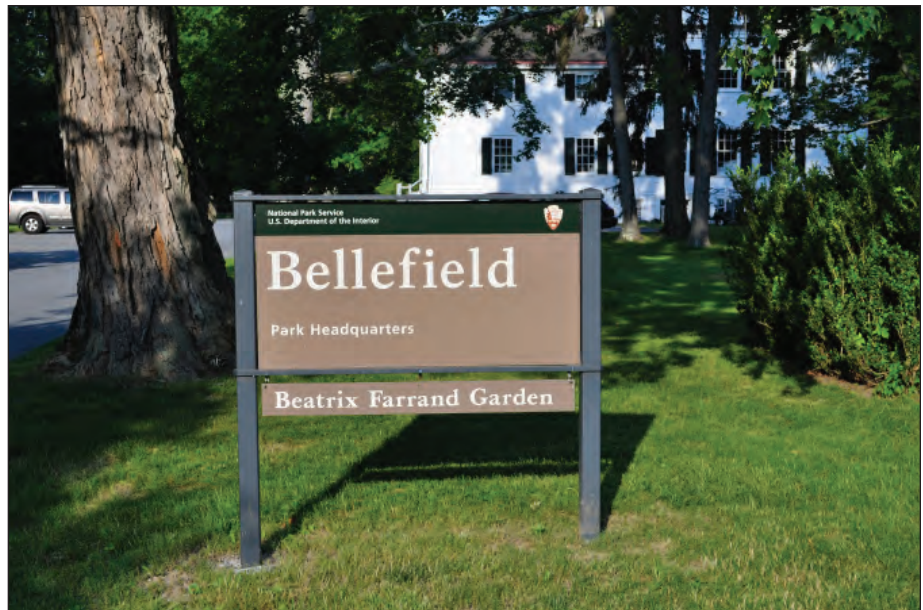
Figure 2.28. Small-scale Features. View looking east toward the Bellefield house and staff parking area. The headquarters sign includes a sign for the walled garden (OCLP 2011).

a new welcome sign line the low stone wall on both sides of the entrance. These features were installed in 2004 during the construction of FDR Drive. Wayfinding and welcome signs are scattered throughout the Bellefield property including near the Bellefield house and staff parking, in front of the new garage, near the Wallace Center Parking area entrance, near the walled garden, and at trail intersections (Figure 2.28).

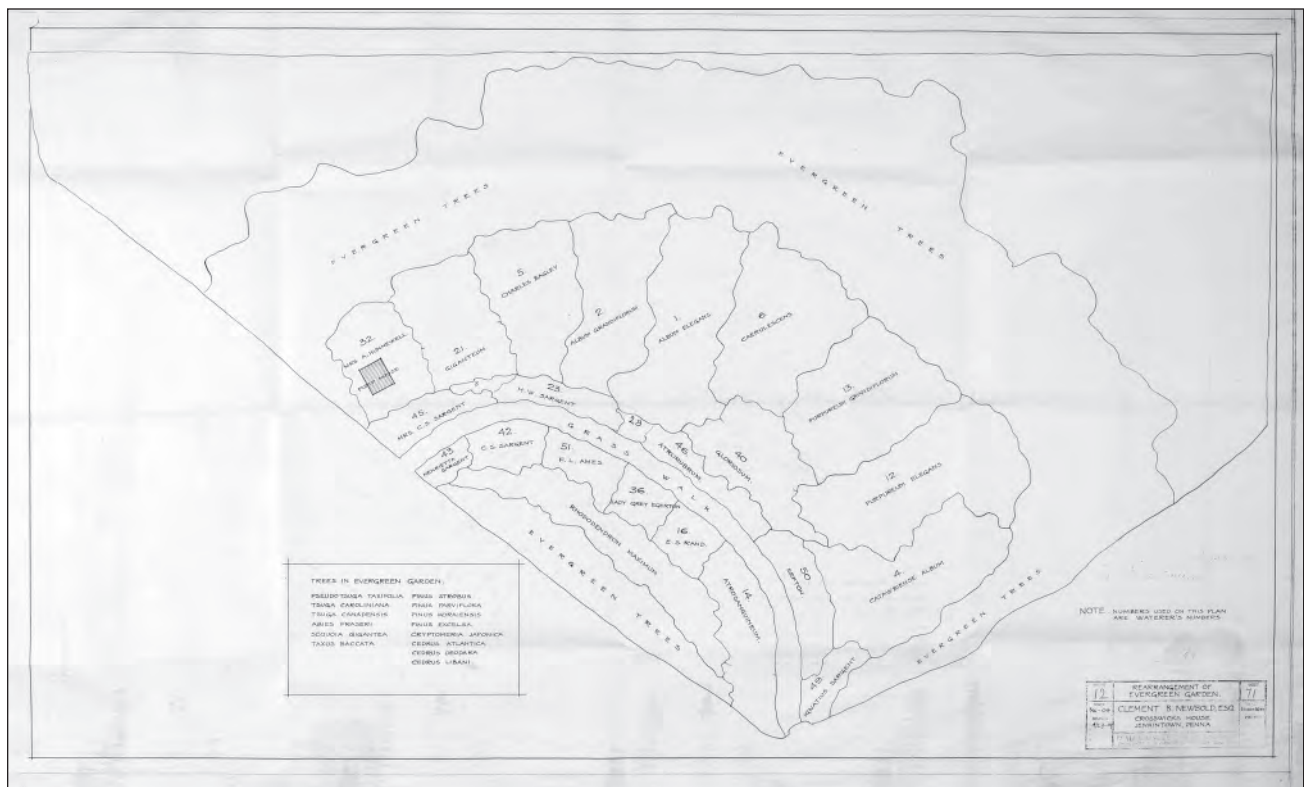
Figure 3.4. Clement B. Newbold garden, Jenkintown, PA, c.1904. The plan shows the evergreen garden with a grass walk, vegetation massings, and a tree legend (Beatrix Farrand Collection (1955-2), Environmental Design Archives, University of California, Berkeley).

Farrand designed a garden for her cousin, Clement B. Newbold, in Jenkintown, Pennsylvania, between 1891 and 1916 on a site that was near an abandoned quarry. The plans, most of which date from the early 1900s, include a plan of the garden and central sunken rose area surrounded by a stone and brick wall, an evergreen garden and grass walkway, and a rock garden (Figures 3.2 and 3.3). The design included a natural garden area with drifts of vegetation around a grass walk (Figures 3.4 and 3.5). Long axial views extended from the parterred flower gardens towards the surrounding landscape.

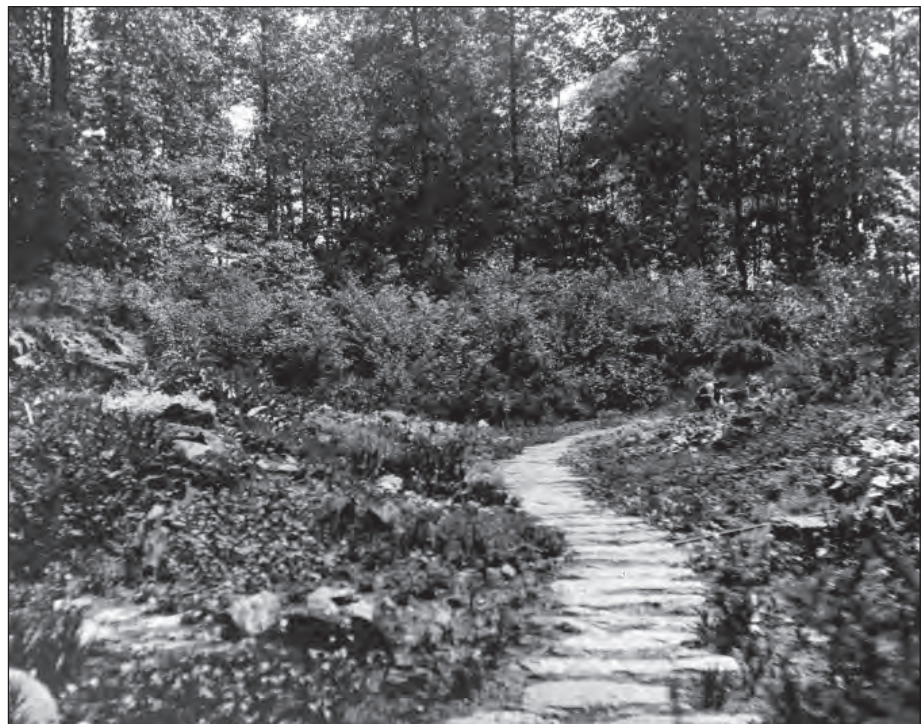
Figure 3.5. Clement B. Newbold garden, Jenkintown, PA, c. 1904. Photo labeled "Walk in Rock Garden" shows the stone walkway in the natural planting area (Beatrix Farrand Collection (1955-2), Environmental Design Archives, University of California, Berkeley).

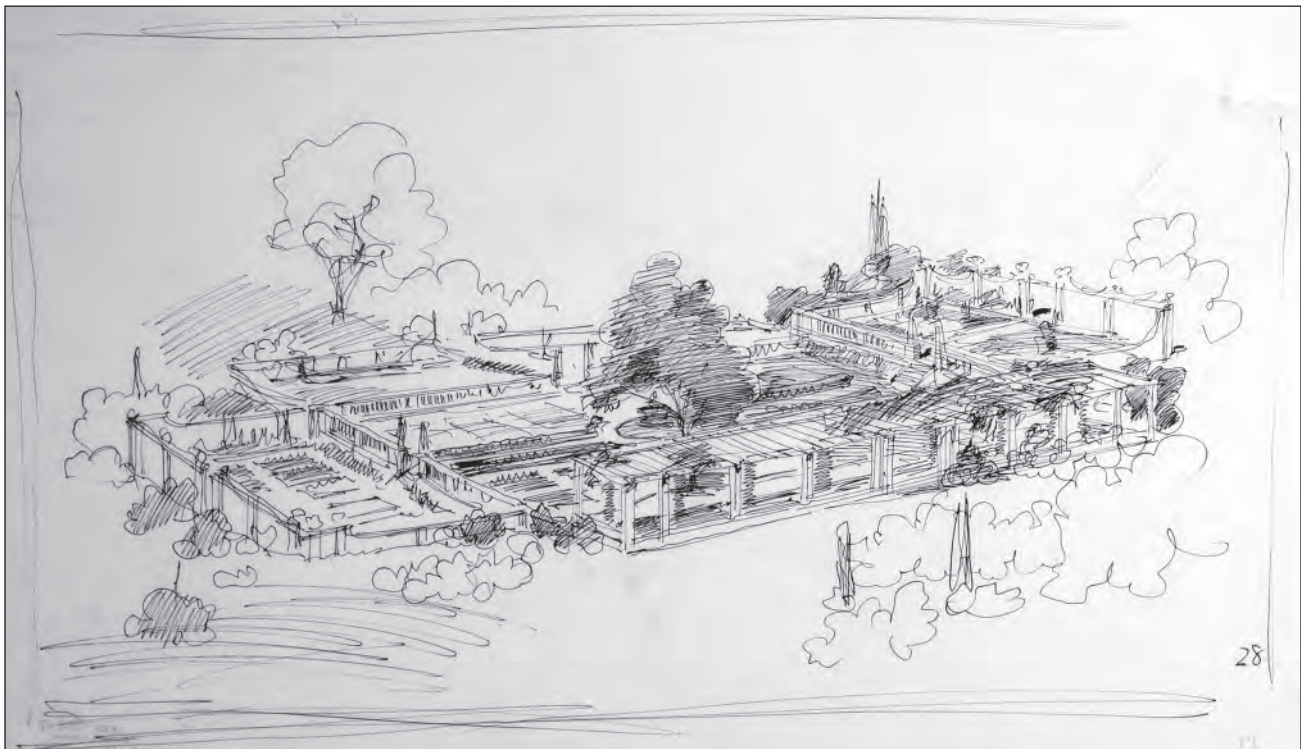
**Figure 3.11.** The Goelet garden, Glenmere, New York, c. 1912. The axon drawing shows the three terraces with linear pathways and planting beds. The terraces are surrounded by trees and shrubs (Beatrix Farrand Collection (1955-2), Environmental Design Archives, University of California, Berkeley).

Farrand designed the Goelet garden between 1912 and 1916. The walled rectangular design contained a rose garden, bulb and annual garden, central planting areas, and a pergola terrace surrounded by an exterior wall. She paid particular attention to detail when she drew the sketch for the fruit and flower baskets that sat on top of the garden walls. Surrounding the walled garden Farrand labeled “Double flowering cherries,” “Lombardy poplars,” “Lilacs,” and “Roses,” which were likely proposed vegetation to grow at the base of the garden walls. The ink sketch on trace shows the three garden terraces surrounded by drifts of trees and shrubs particularly around the lower garden entrance (Figure 3.11).

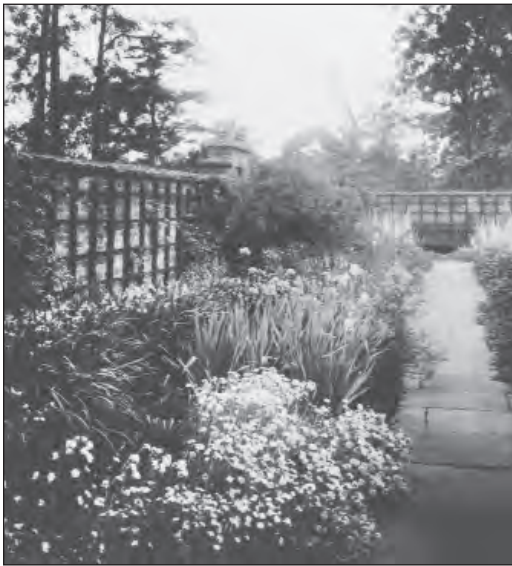
**Figure 3.14.** The Straight garden, Long Island, New York, c. 1918. (left) The photo shows a linear stone pathway and planting bed. The stone wall at left includes a wood trellis attached to the stone wall. Layers of plants fill the planting beds (Beatrix Farrand Collection (1955-2), Environmental Design Archives, University of California, Berkeley).

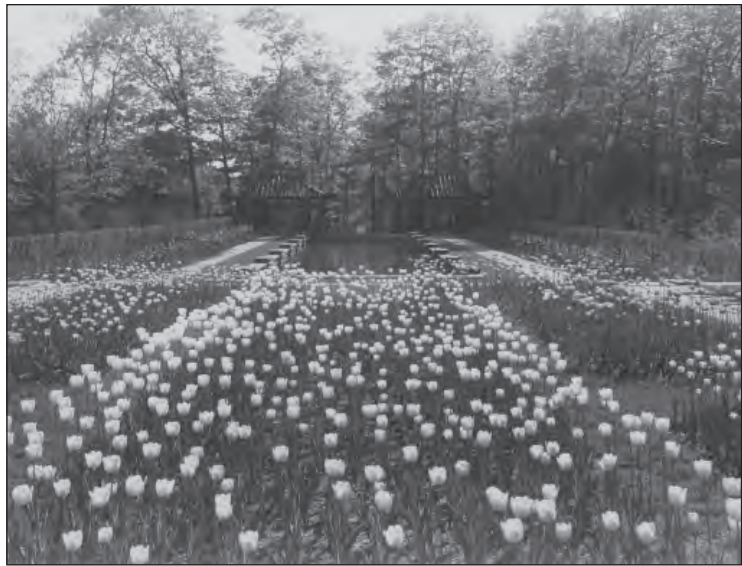
**Figure 3.15.** The Straight garden, Long Island, New York, c. 1918. (right) The photo shows the lawn with tulips, the pool in the background, and trees that line the outside of the garden walls (Beatrix Farrand Collection (1955-2), Environmental Design Archives, University of California, Berkeley).

pathway was lined by lush border planting beds that included layers of annuals and perennials. A wood trellis was attached to the interior of the wall where vines grew (Figure 3.14). Bulbs filled the interior lawn area next to the pool before a dense backdrop of trees that grew beyond the summer houses and outside of the garden walls (Figure 3.15)

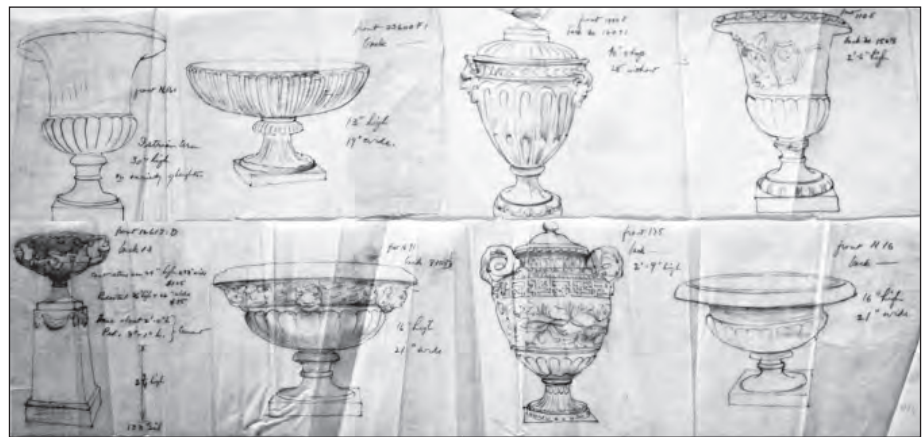
Figure 3.16. The Mann garden, Great Neck, New York, c. 1918. The sketches show several variations of an urn (Beatrix Farrand Collection (1955-2), Environmental Design Archives, University of California, Berkeley).

Farrand designed the Mann garden between 1918 and 1930. During that time she completed several planting plans and garden details including several urn details of various designs and heights that demonstrate her attention to detail (Figure 3.16). The garden included several elements including a knot garden, box garden, planting beds, linear plantings along a highway wall, and a lilac walk.

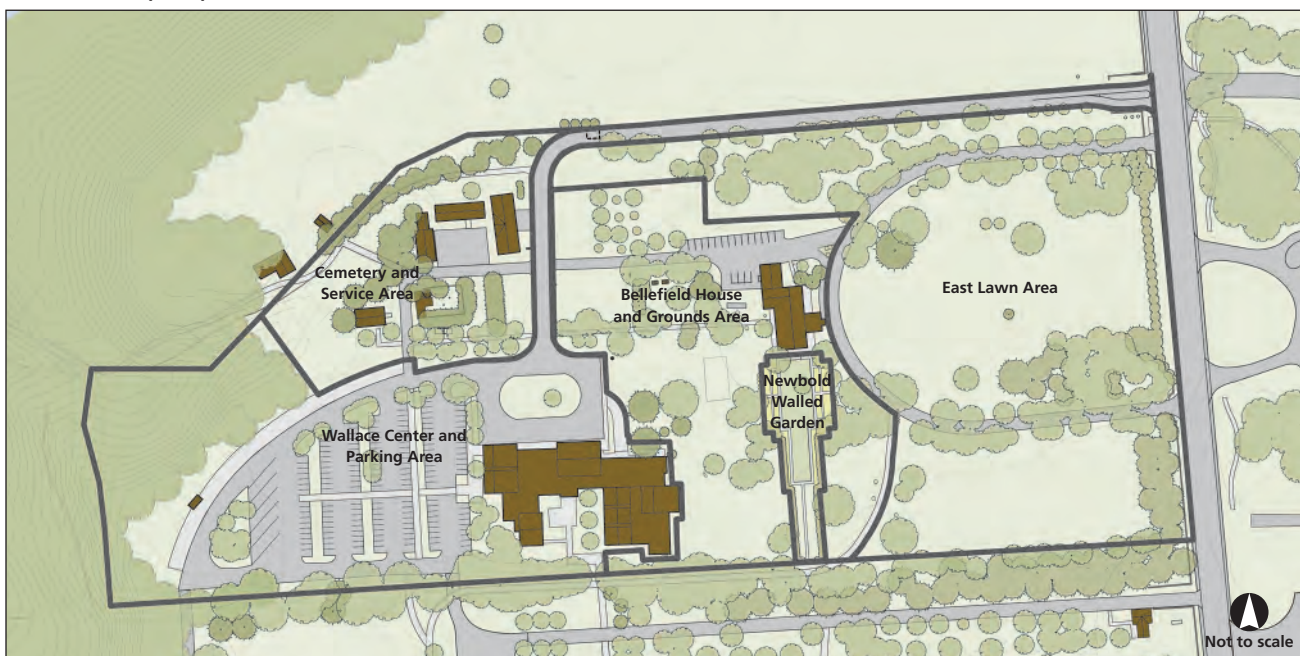
**Figure 3.20. Estate Organization.**  
The Bellefield property is divided into five areas (OCLP).

Spatial organization refers to the three-dimensional organization of physical forms and visual associations in a landscape, including the articulation of ground, vertical, and overhead planes that define and create spaces. For Bellefield, the historic spatial organization is relatively intact and includes five character areas defined by circulation, vegetation, and development (Figure 3.20). The East Lawn Area near Albany Post Road remains relatively unchanged with some modifications to circulation. The Bellefield House and Grounds Area remains the focal point of the property and is relatively unchanged with some circulation and vegetation alterations. Surrounded by the Bellefield House and Grounds Area, the Walled Garden extends south from the Bellefield house and remains enclosed by the fieldstone wall and hemlock hedge. West of the house and within the Cemetery and Service Area, the support structures, Crooke family cemetery, and stone house remain. For the purposes of this report, the Wallace Center and Parking Area are described as a separate sub area where the west field and lawn once grew.

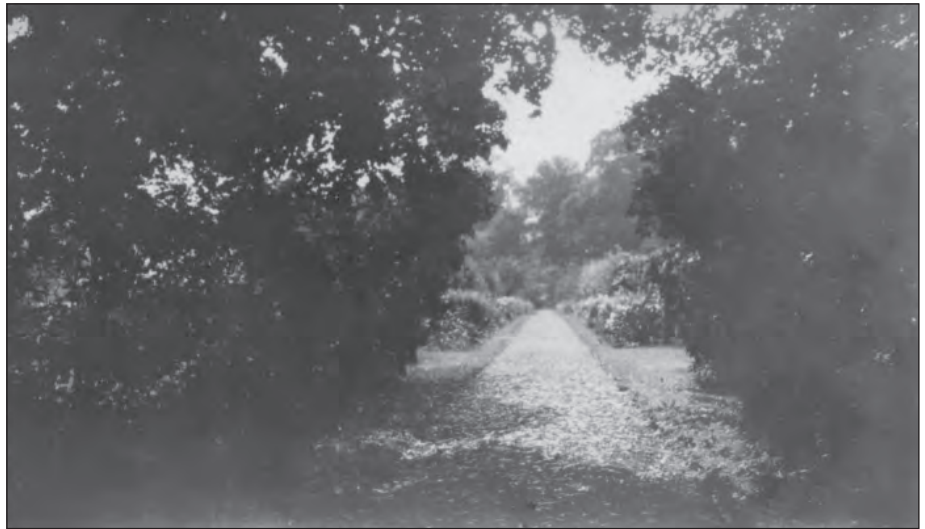
Figure 3.21. View west of the gravel pathway in 1927 from the back door of the Bellefield house. The gravel pathway may date to the mid 1800s and extends to the stone house with flower and vegetable gardens, a grape arbor, and fruit trees on both sides (Newbold-Morgan Collection, ROVA Archives).

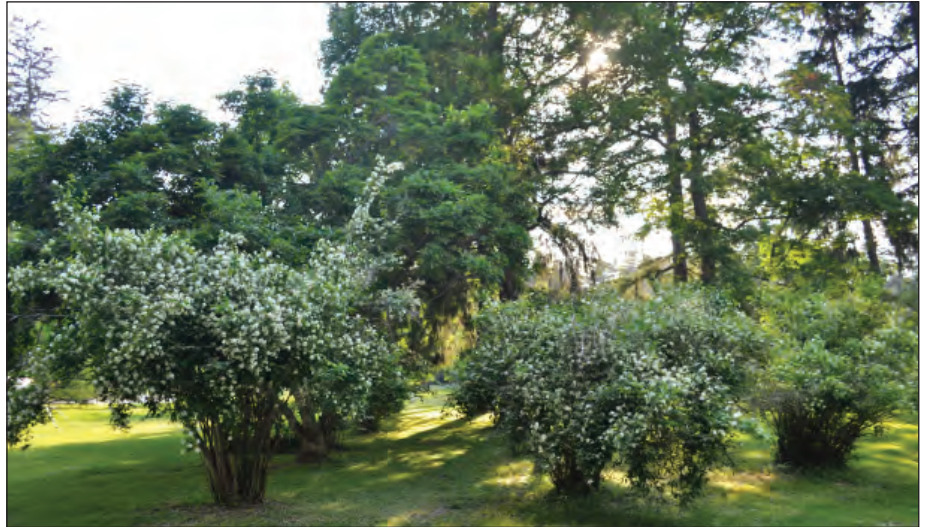
Figure 3.22. View looking west down the remnants of the gravel pathway, 2011. Sweet mockorange, pines, and maples cover portions of the pathway (OCLP 2011).

landscape. Although the condition of the gravel pathway has declined and FDR Drive built in 2003 bisects a portion of the pathway, the location and alignment remain intact. Segments of the gravel pathway may be intact beneath the lawn. The new eight foot wide pathway on the portion of the gravel pathway between FDR Drive and the stone house detracts from the historic character because the path is wider and the aggregate is coarser than during the historic period. Segments of the gravel pathway continue to illustrate the formal arrangement and location of the garden beds that once existed west of the house.

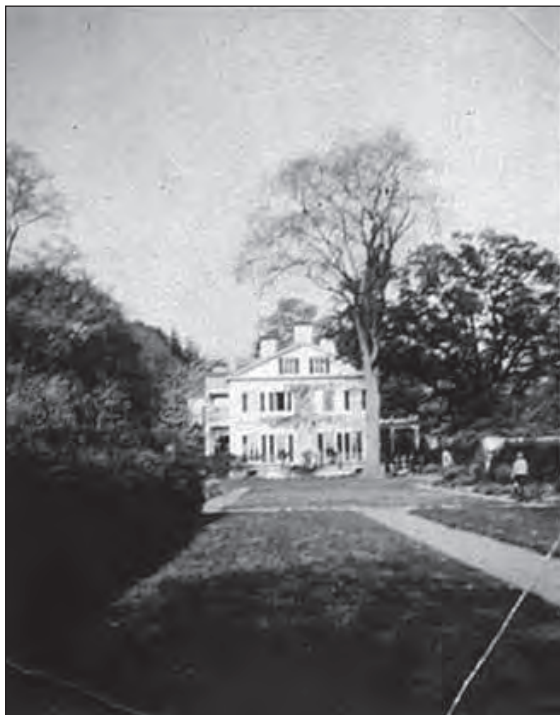
**Figure 3.23.** Walks in the walled garden, 1912. A 1930 photo looking north toward the house from the walled garden. Gravel walks line the central lawn panels and join in the center of the third garden room. The elm tree stands in front of the house and the oak tree stands outside of the garden wall (ROVA Archives).

in the third room. The lawn panels narrowed from forty-six feet wide near the house, to twenty-six feet wide in the middle, to two twelve foot wide panels at the southern end. This axial emphasis and the narrowing of the garden spaces created an elongating effect from the house (Figure 3.23).

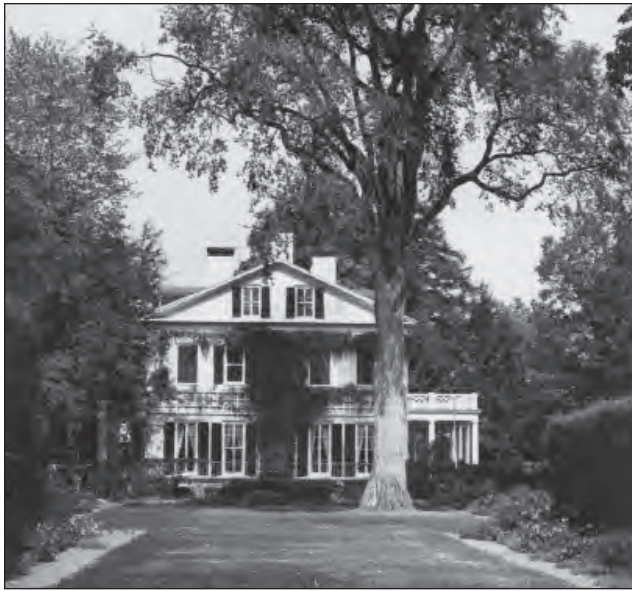
Figure 3.24. (left) Walks in the walled garden, 1912. A 1964 photo looking north toward the house from the walled garden. Gravel walks line the lawn with vegetation in the beds spilling onto the walks. The elm tree remains in front of the house and vines grow on the facade of the house (Newbold-Morgan Collection, ROVA Archives).

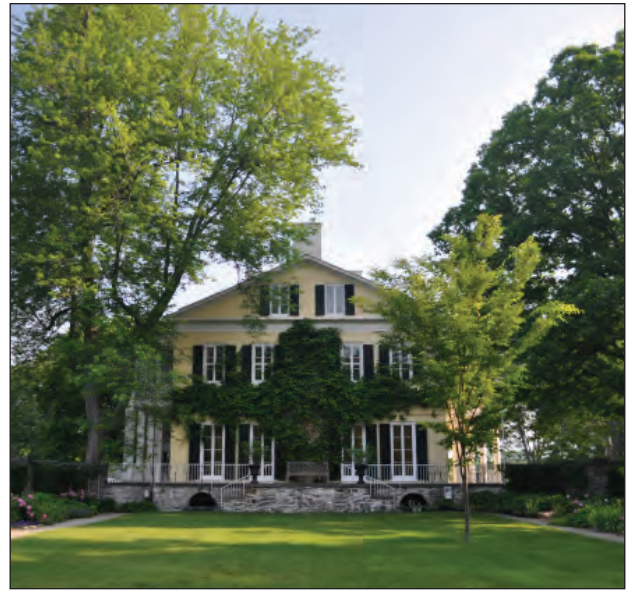
Figure 3.25. (right) A 2011 photo looking north toward the stone house. Gravel walks continue to line the lawn panels. Vines remain on the facade of the house, the young elm tree stands in front of the house, and a maple stands outside of the northwest corner of the garden (OCLP 2011).

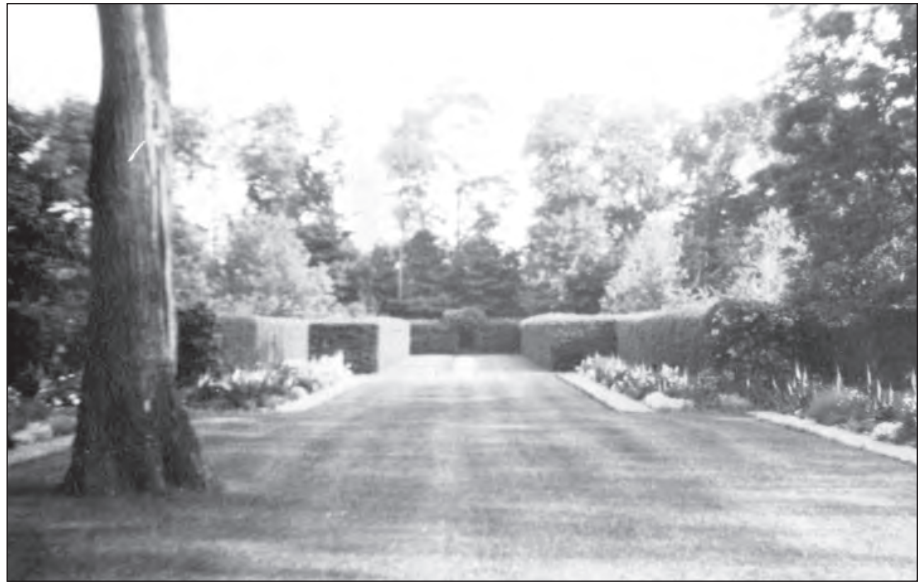
Figure 3.26. Walled garden in 1929. The elm tree stands on the left, walks line the lawn area, and the planting beds grow at the foot of the walls and hemlock hedge. Locusts, pines, and maple trees line the exterior of the walled garden (Newbold-Morgan Collection, ROVA Archives).

Beatrix Farrand designed the walled garden in 1912 and soon after the Newbolds and their gardeners installed the enclosed and finely manicured garden off the south porch of the Bellefield house. The walled garden extended south from the house toward the southern property boundary with a fieldstone wall and vertical hemlock hedge that arched over the southern entrance (see Figure 1.33). The large panel of grass lawn extended throughout the central portion of the three garden spaces and was kept short. The walks were bordered by several lush annual and perennial flower beds that grew at the base of the wall and hemlock enclosure (Figure 3.26).

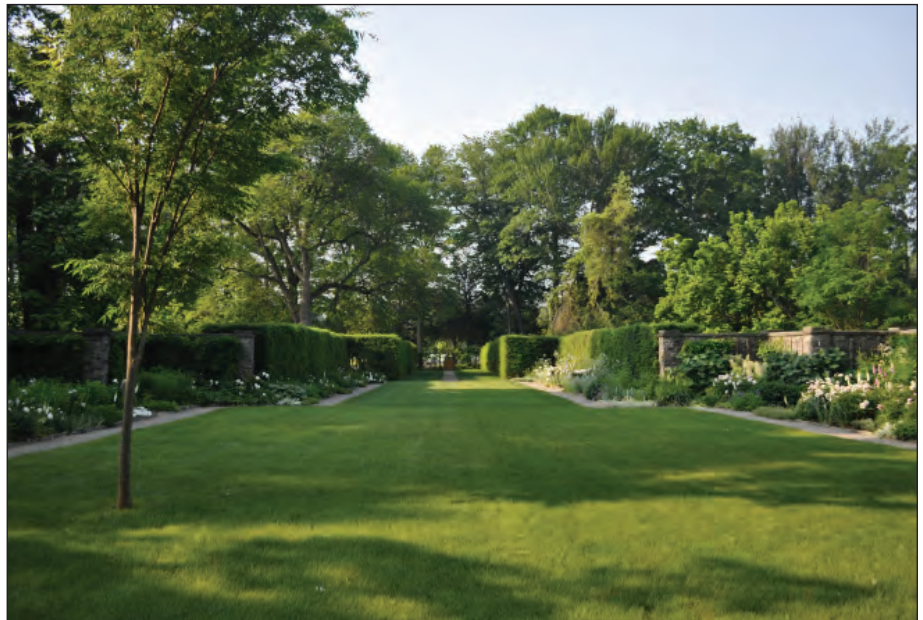
Figure 3.27. View looking south of the walled garden, 2011. A new elm tree stands on the left, the lawn area, walks, planting beds, walls, and hemlock hedge remain (OCLP 2011).

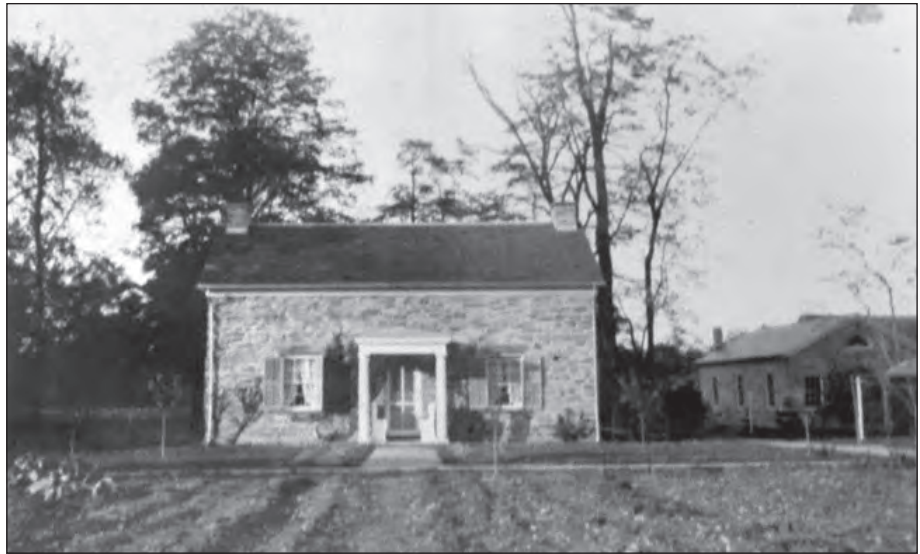
Figure 3.28. View looking north from the vegetable garden of the stone house in 1907, which was built in 1807. Young fruit trees line the gravel pathway in front of the house. The old garage stands in the far right behind the stone house (Newbold-Morgan Collection, ROVA Archives).

Newbold hired Henry Meyers in 1905 to build the one-story Colonial Revival style stone house south of the old barn and west of the Bellefield house. The house was thirty-nine feet wide by twenty-five feet deep and faced south across the west field. The house included an entrance porch with two Doric columns and two chimneys. It is possible that the stone house was designed by McKim, Mead & White, however, no documentation or plans exist for the stone house. Meyers likely collected the fieldstones from the Rogers Land to construct the house. It served as a residence for the Newbold and Morgan's site superintendents, including Charles Plog, from 1905 to the 1940 (Figure 3.28).

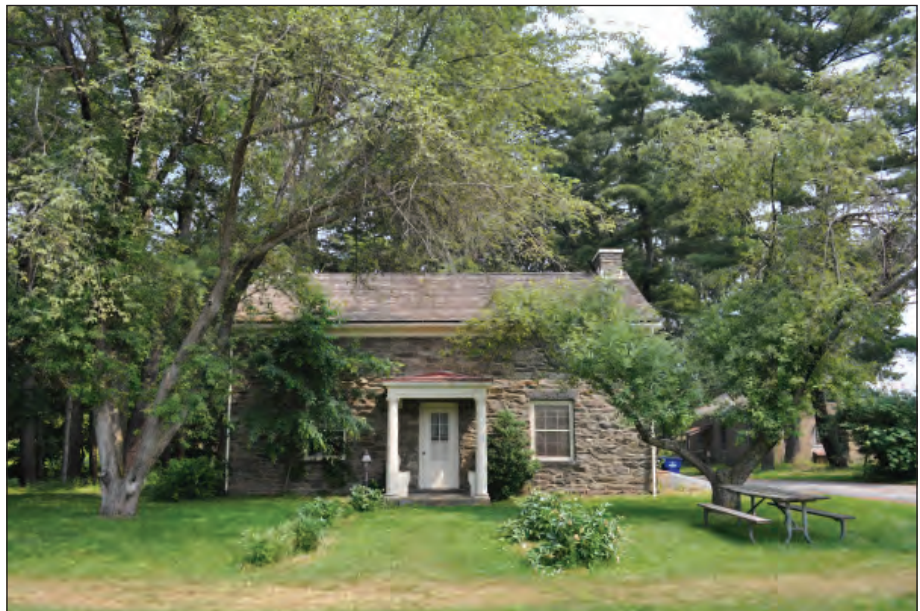
Figure 3.29. View looking north toward stone house, 2011. Two mature apple trees stand in front of the house. The old garage remains in the far right (OCLP 2011).

The stone house, built in 1905 and updated in 1975, contributes to the historic character of the Bellefield landscape. The stone house remains in good condition with minimal changes since the historic period (Figure 3.29).

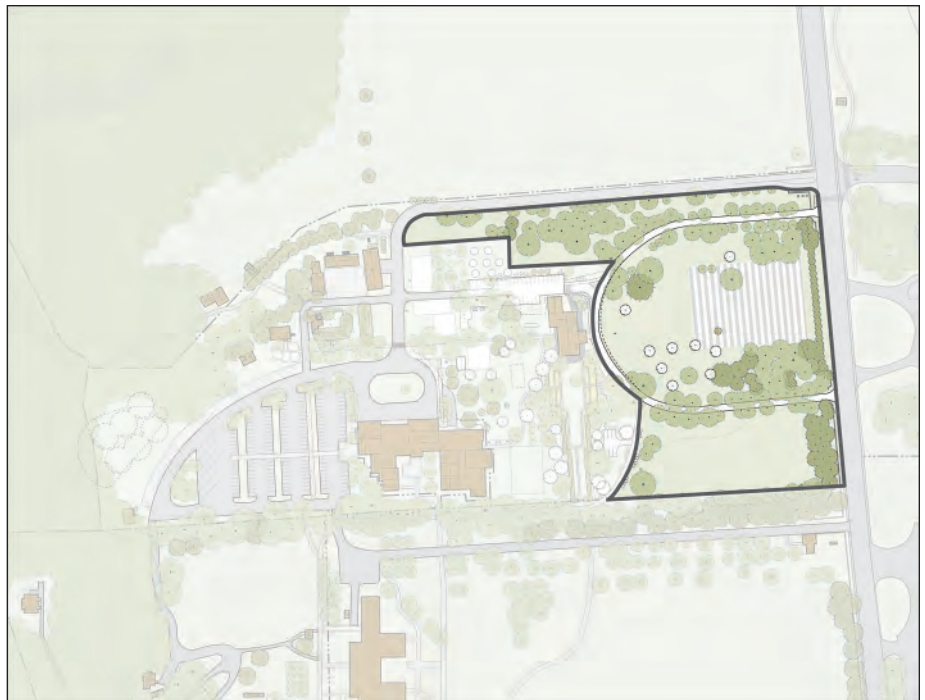
**Figure 4.2. East Lawn Area landscape treatment plan, 2012 (OCLP).**

Overall treatment objectives for the east lawn area are to retain and enhance the historic character of the east lawn, main entrance drive, and trees and shrubs between the Bellefield house and Albany Post Road. The main entrance drive dates to 1795 and for two centuries served as the main entrance to the house. Throughout the historic period the drive was lined mostly with deciduous trees and the east lawn included a few evergreen trees. The eastern edge was defined by the fieldstone wall along Albany Post Road, and later by the hemlock hedge and pine trees, and the western edge was defined by the Hyde Park Trail and main entrance drive (Figure 4.2).

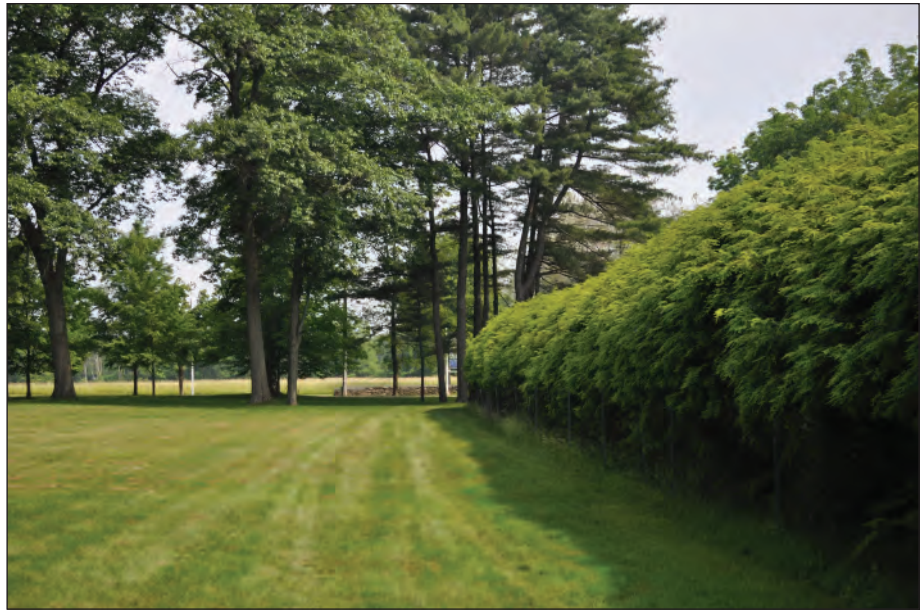
Figure 4.4. Mowed lawn, 2012.  
View looking north from the south  
leg of the main entrance drive. The  
east lawn does not currently reflect  
the historic character (OCLP).

To reestablish the character of the east lawn as it appeared at the end of the historic period, the eastern portion of the east lawn should be managed as a hay field. The hay could be harvested through an agricultural lease or cooperative agreement. The limits of the hay field should extend between the trees that line the north and south legs of the entrance road, it should start 10 feet west of the hemlock hedge to allow for maintenance access to the hedge, and extend west approximately 250 feet toward the house. The northern and southern extents of the hay field should correspond with the edge of the tree line. A second hay field should grow on the lawn area south of the main entrance drive southern leg. The hay fields should cover approximately two acres (Figures 4.4 and 4.5). If agricultural use is not feasible, allow the grasses on the east half to grow high and mow once, twice, or three times annually, which is the typical mowing frequency for hay. The mowing time and frequency is dependent on the amount of seasonal precipitation, quality of hay desired, and presences of nesting species within the area. Less frequent mowing will reduce regular maintenance needs for this area, reduce the use of power equipment, and enhance wildlife habitat. The hemlock hedge should be trimmed regularly to maintain its current upright form.

The half circle of lawn directly in front of the Bellefield house should be mowed regularly. Mow the field in a north-south direction to maintain a clean line between the field and the manicured lawn using Drawing 4.1 as a guide for the location of the edge of the lawn area.
