## CULTURAL LANDSCAPE REPORT FOR BELLEFIELD

HOME OF FRANKLIN D. ROOSEVELT NATIONAL HISTORIC SITE

Prepared by  
Kirsten Holder, Historical Landscape Architect

Olmsted Center for Landscape Preservation  
National Park Service, Boston, Massachusetts, 2012

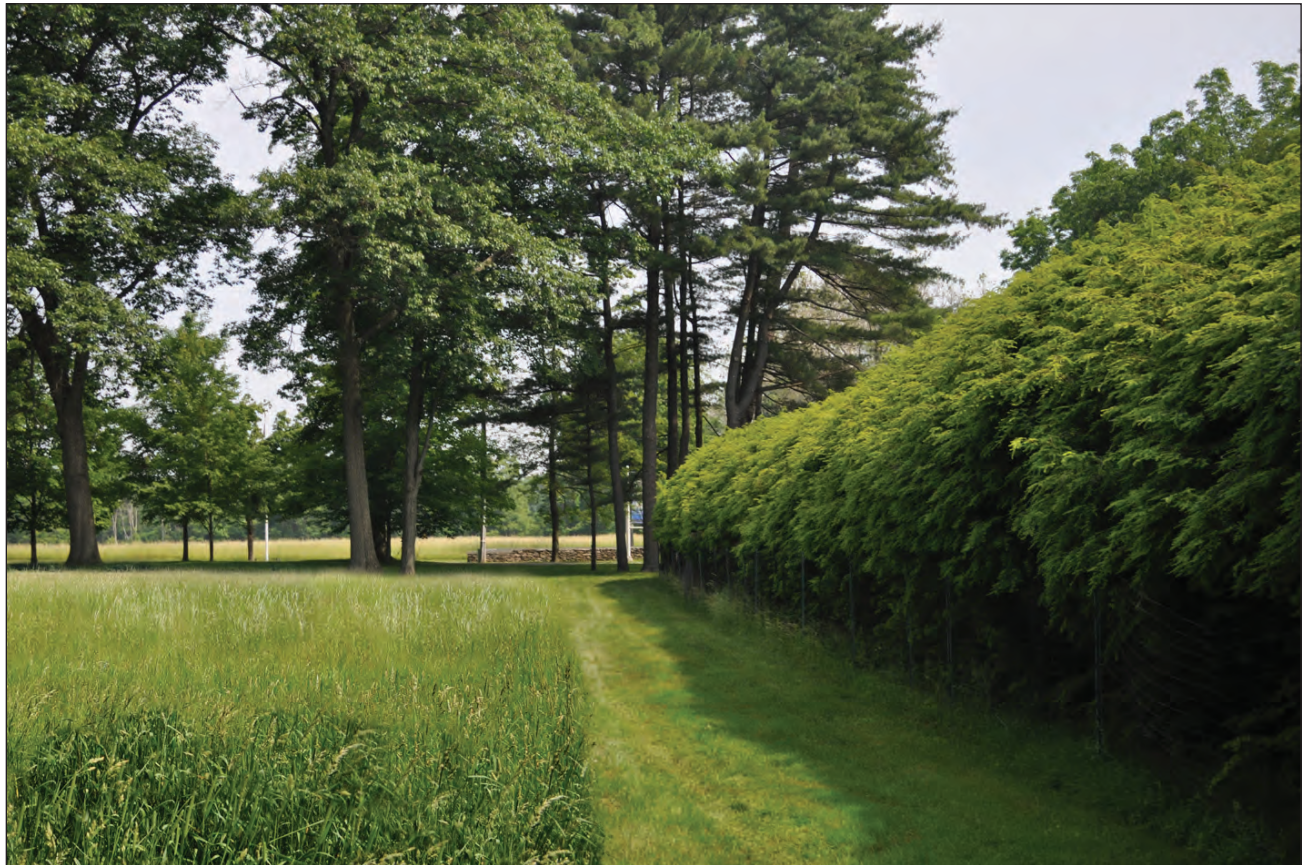
Figure 4.5. Reestablished hay field  
in the east lawn.  
Rendering shows a mow strip  
between the hay field and hemlock  
hedge (OCLP).

To reestablish the character of the east lawn as it appeared at the end of the historic period, the eastern portion of the east lawn should be managed as a hay field. The hay could be harvested through an agricultural lease or cooperative agreement. The limits of the hay field should extend between the trees that line the north and south legs of the entrance road, it should start 10 feet west of the hemlock hedge to allow for maintenance access to the hedge, and extend west approximately 250 feet toward the house. The northern and southern extents of the hay field should correspond with the edge of the tree line. A second hay field should grow on the lawn area south of the main entrance drive southern leg. The hay fields should cover approximately two acres (Figures 4.4 and 4.5). If agricultural use is not feasible, allow the grasses on the east half to grow high and mow once, twice, or three times annually, which is the typical mowing frequency for hay. The mowing time and frequency is dependent on the amount of seasonal precipitation, quality of hay desired, and presences of nesting species within the area. Less frequent mowing will reduce regular maintenance needs for this area, reduce the use of power equipment, and enhance wildlife habitat. The hemlock hedge should be trimmed regularly to maintain its current upright form.

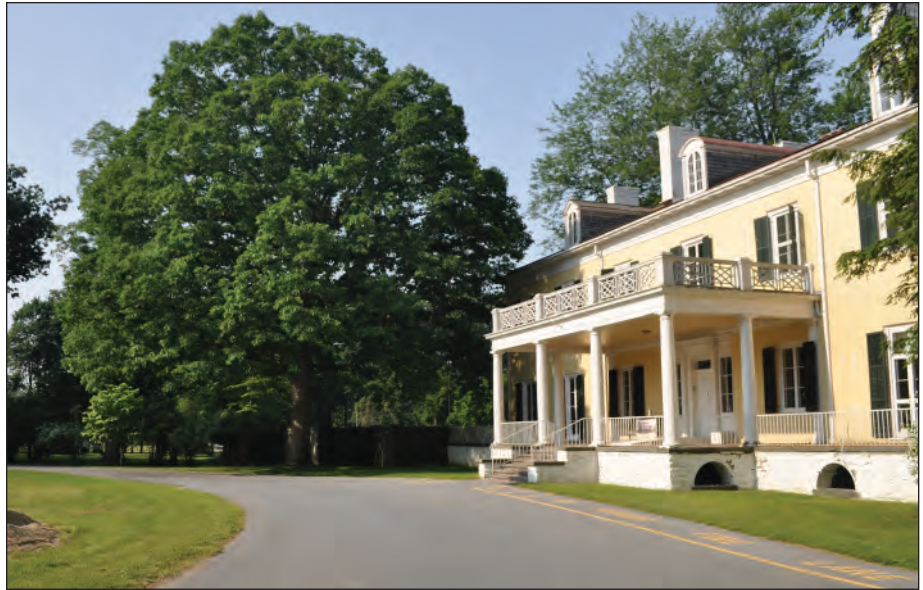
Figure 4.6. Main entrance drive, at the Bellefield house, 2012. View looking southwest toward the house and walled garden. The twenty-five foot wide drive area in front of the house does not currently reflect the historic character (OCLP).

To enhance the historic character of the Bellefield property and provide a compatible yet durable driving surface, the width of the main entrance drive should be reduced to fifteen feet. The bituminous concrete should be removed and replaced with a crushed aggregate surface. If the aggregate surface is not feasible due to maintenance concerns, consider bituminous concrete with a chip-seal. When resurfacing the drive, the bituminous concrete should be covered with a gray chip-seal the following year (Figures 4.6 and 4.7). The chip-seal should be installed with an asphalt (bitumen) or latex emulsion to bind the gravel to the road surface.<sup>17</sup>

To improve vehicular and pedestrian circulation, the area in front of the Bellefield house should be rehabilitated to improve pedestrian circulation and enhance the domestic character of the home. If possible, the current "no parking" lines painted on the main entrance drive should be removed with the new roadway and the park should place permanent "no parking" signs along the drive, particularly in front of the Bellefield house, to discourage visitors from parking on the drive. If the "no parking" paint lines remain a requirement for fire truck access, incorporate the pedestrian walkway in front of the house with the no parking lines. During park events, additional signage and park staff should direct visitors to park in designated overflow parking areas such as at the northwest edge of the Wallace Center parking area and across Albany Post Road on the Farm Lane trailhead. If these areas are full, the park should instruct visitors to park in the overflow parking areas between FDR Drive and the staff parking, near the orchard trees. EL-3 provides a related recommendation to improve the separation of vehicular and pedestrian circulation.

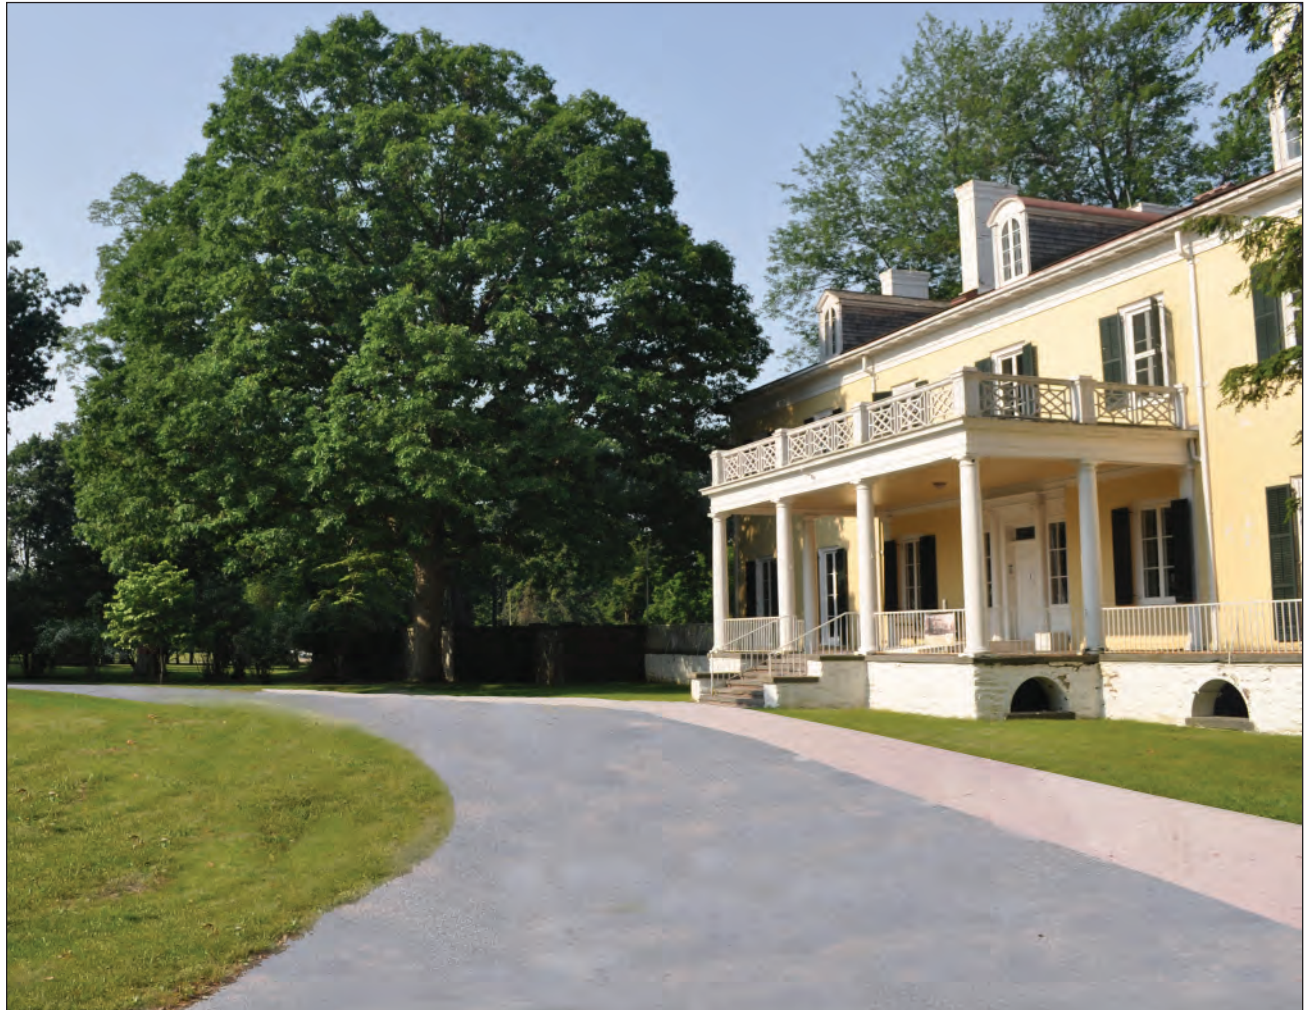
Figure 4.7. Main entrance drive and pedestrian walkway. Rendering shows a fifteen foot wide bituminous concrete drive with a chip-seal and a pedestrian walkway (OCLP).

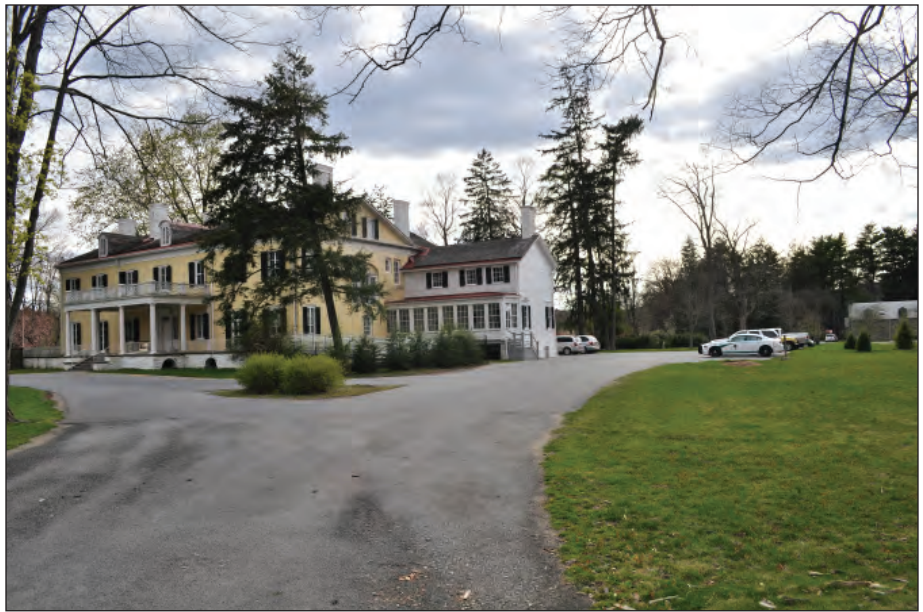
Figure 4.8. Main entrance drive and staff parking area, 2012. View looking southwest toward the parking area and service road. Pedestrians do not have a clear right of way (OCLP).

The Hyde Park Trail follows the northern portion of the main entrance drive and connects the Roosevelt Farm Lane trailhead to the Bellefield house. This portion of the road is paved in bituminous concrete with a chip seal and is closed to vehicular use. Pedestrians do not have a clearly defined route from the north leg of the main entrance drive to the front of the Bellefield house, the walled garden, or the Wallace Center. The pedestrian pathway currently meets the vehicular drive at the eastern exit of the staff parking area without any warning or signage. The drive in front of the Bellefield house is currently shared by pedestrians and vehicles.

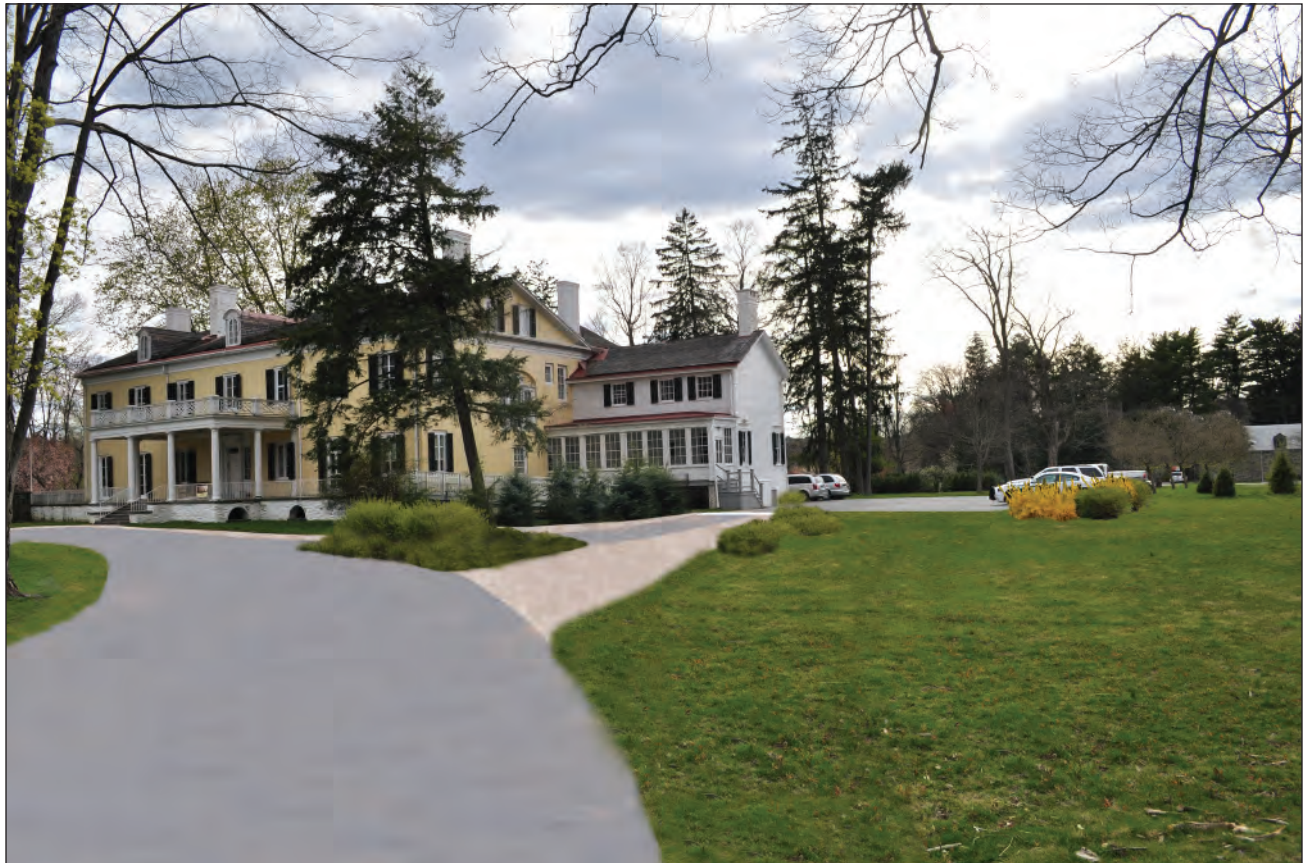
Figure 4.9. Main entrance drive and pedestrian walkway. Rendering shows a new pedestrian walkway, roadway surface, crosswalk, and vegetation around the staff parking area (OCLP).

To ensure pedestrian safety, a pedestrian walkway and that connects the northern leg of the main entrance drive to the Bellefield house, and to the east entrance of the walled garden should be installed (Drawings 4.2 and 4.3). This walkway should include a designated pedestrian route near the staff parking area and main entrance drive, a crosswalk across the eastern end of the staff parking area, and a connection to the universal access ramp on the north side of the Bellefield house. From the crosswalk, the walkway should include a connection to the front of the Bellefield house, and to the east entrance of the walled garden (Figures 4.8 and 4.9). The pedestrian walkway should be distinguishable from the vehicular drive by paving type, markings in the pavement, medallions on the trees or along the walkway, or signage. The trail should be constructed with bituminous concrete paving with a chip-seal, a stabilized aggregate with a binder, or stone paving. If possible, paint or install low markers within the pedestrian pathway to prohibit parking in front of the house in order to meet local fire codes. The park should work with the Hyde Park Fire Department to establish a walkway consistent with fire lane requirements. Keep wayfinding in front of the Bellefield house to a minimum to maintain the historic character of the front façade. If necessary, relocate vegetation in front of the ramp to install the pedestrian pathway and allow shrubs to grow into an upright hedge to screen the ramp. EL-2 provides a related recommendation to reestablish the width and character of the main entrance drive.

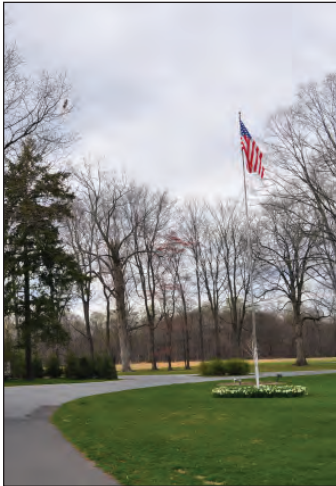
Figure 4.10. View north of the flagpole standing in the east lawn in front of the Bellefield house, 2012 (OCLP).

The National Park Service installed a flagpole that stands in front of the Bellefield house within the east lawn in 1976, after the historic period. In 2003 the park installed a second flagpole at the entrance to FDR Drive. The prominent location of the flagpole in front of the house and in the open lawn area detracts from the historic character of the property (Figure 4.10). To improve the historic character of the front of the Bellefield house, remove the flagpole in front of the house and restore the lawn. Retain the newer flagpole at the entrance to FDR Drive.

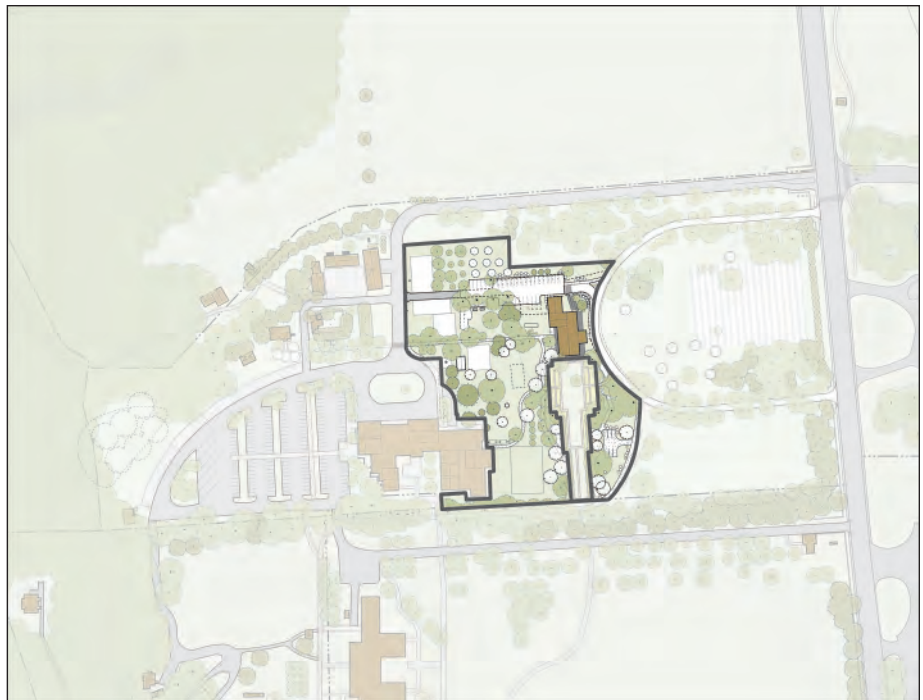
**Figure 4.11. Bellefield House and Grounds treatment area, 2012 (OCLP).**

Overall treatment objectives for the Bellefield house and grounds are to retain and enhance the historic character of the domestic landscape at Bellefield and reestablish portions of the wild garden, vegetable and flower gardens, and gravel pathway between the house and stone cottage. The Bellefield house and grounds historically included small-scale agriculture, orchards, play structures, a lawn tennis court, walled garden, and wild garden area. Currently, the area is edged by the Wallace Center and FDR Drive to the west, the cemetery and service area to the northwest, and the Hyde Park Trail and main entrance drive and east lawn to the east (Figure 4.11).

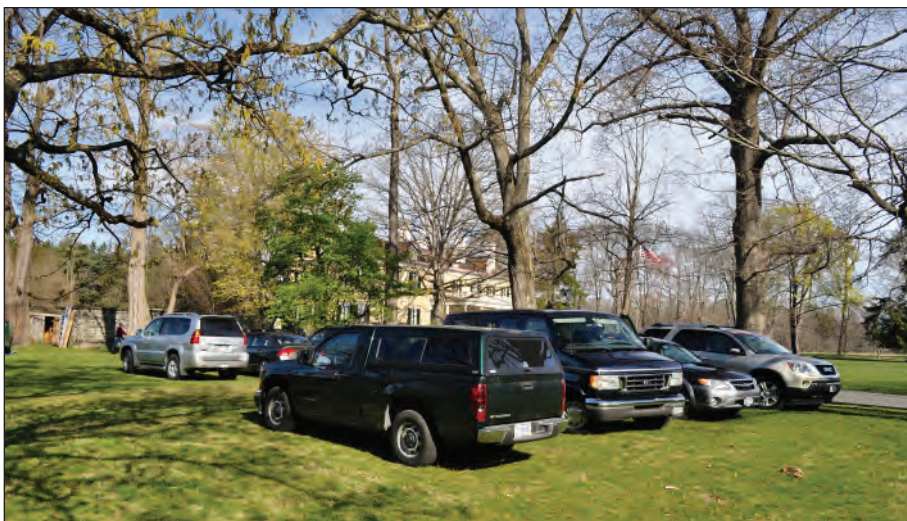
Figure 4.12. Volunteer parking at the walled garden, 2012.

View looking northwest toward the Hyde Park Trail right of way and the volunteer parking area (OCLP).

Volunteers from the Beatrix Farrand Garden Association park on the lawn east of the walled garden, near the Hyde Park trail, every Tuesday for their work day. Parked cars on the lawn are visible from Albany Post Road, the main entrance drive, and FDR Drive, and detract from the historic character of the house grounds and entrance area (Figure 4.12). Volunteers often transport gardening equipment and plants and require a place to park that is close to the walled garden.

To rehabilitate the wild garden and to facilitate garden maintenance, a small parking area east of the walled garden should be designated. This area should be concealed from the nearby roadways by the wild garden vegetation (Drawing 4.3). The turf parking areas should be stabilized using engineered aggregate topsoil mixture, fiber-reinforced turf systems, or cellular paving systems (Appendix B).<sup>18</sup> Selection of a stabilization system should take into consideration the existing site conditions, durability, maintenance, and the anticipated frequency and use of the proposed parking area. The parking area should include six to eight spaces and should be used as short term parking by volunteer and park maintenance staff.

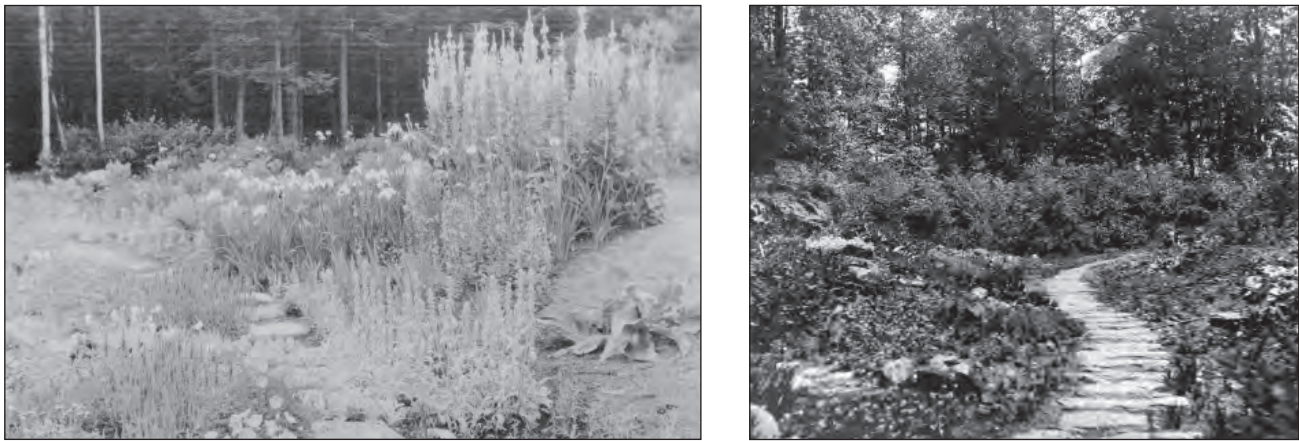
Figure 4.13. Natural planting areas and pathways. Photos from Clement B. Newbold garden in Jenkintown, Pennsylvania (left) and the Milliken garden in Northeast Harbor, Maine (right). (Beatrix Farrand Collection (1955-2), Environmental Design Archives, University of California, Berkeley).

The primary layout plan for Farrand's design of the walled garden includes an outline outside of the walled garden, which was likely the location of a wild garden. The plan labels some of the existing trees, however, no labels for a natural or wild garden exist on the plans (Figure 4.13). The wild garden was likely a feature at Bellefield during the historic period because Farrand frequently designed a wild garden with natural planting drifts as an area of transition between a walled garden to the surrounding landscape (Figure 4.14).<sup>19</sup> In addition, the Newbold family images from within the walled garden and aërials from the 1930–70s show more flowering trees and shrubs around the perimeter of the walled garden (Figure 4.15). Lastly, the *1995 Historic Plant Inventory* documented additional flowering trees and shrubs surrounding the walled garden than what exists today (Figure 4.16).

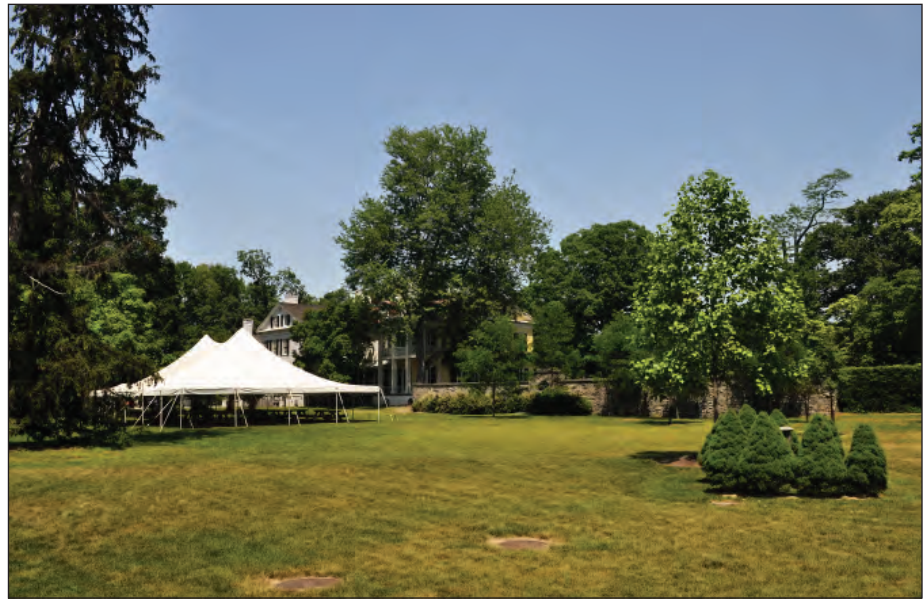
Figure 4.17. Bellefield house, west lawn, and walled garden, 2012. View looking northeast toward the house from the east exit of the Wallace Center. Lawn area does not reflect the historic character (OCLP).

vegetation should be laid out as layers of naturalistic drifts of mostly native plants (Figures 4.17 and 4.18).<sup>20</sup> Incorporate existing trees into the layout of the wild garden and plant trees, low shrubs, bulbs, and groundcover around existing trees where feasible. Do not plant trees within the boundary of the septic system. As no planting plans for the wild garden exist, a plant palette that follows Farrand's species selection along with species that grow in this region, provides guidance on specific species (Table 4.2). Plant species and layout of perennials and groundcover can be adjusted according to maintenance requirements.

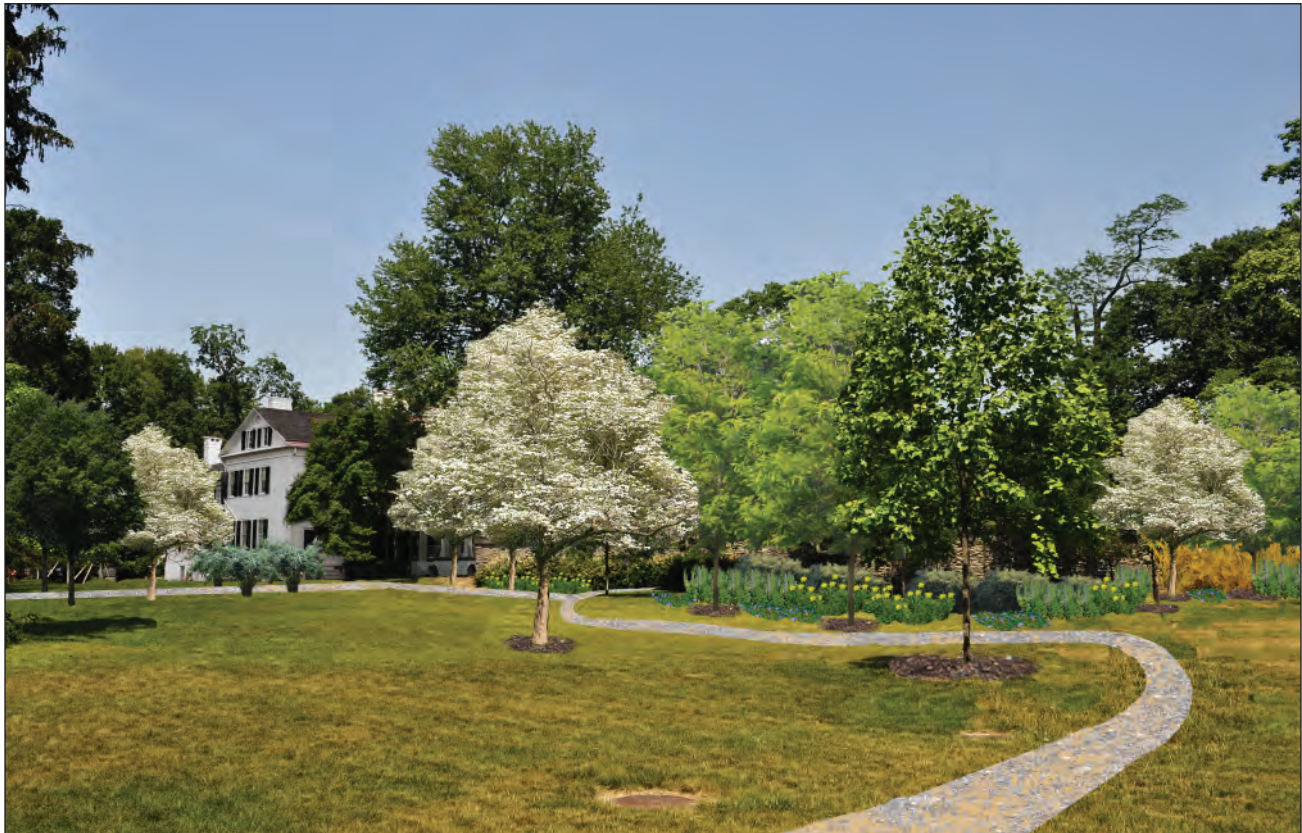
Figure 4.18. Bellefield house, walled and wild garden. Rendering shows a pedestrian walkway between the Wallace Center and the walled garden, through the new vegetation in the wild garden (OCLP).

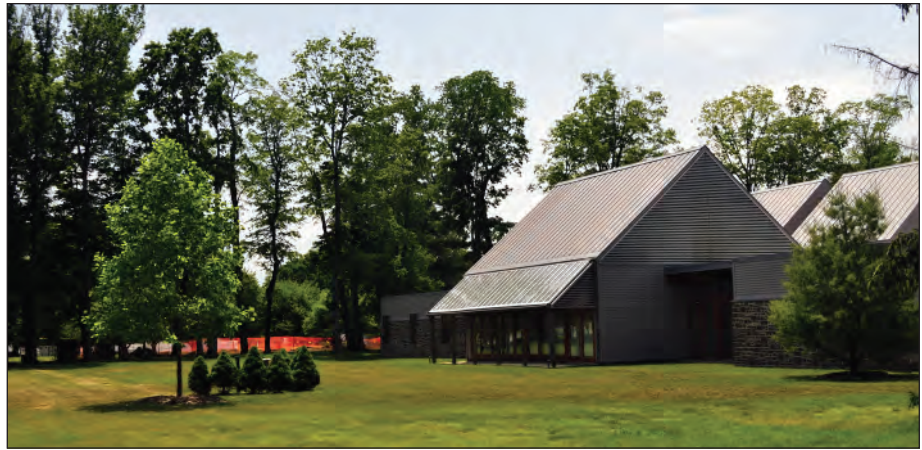
Figure 4.19. New plantings at septic system, 2012. View looking southwest toward the Wallace Center. The new tree and shrubs grow in front of the system control box (OCLP).

Seven *Picea glauca* ‘Conica’ or dwarf Alberta spruce, were planted in about 2004 following the construction of the Wallace Center and adjacent septic system. The spruce trees were planted to screen the septic system control box that stands adjacent to the septic system in the middle of the lawn (Figure 4.19). The trees are not in character with the vegetation on the Bellefield property and they detract from the historic character of the Bellefield grounds.

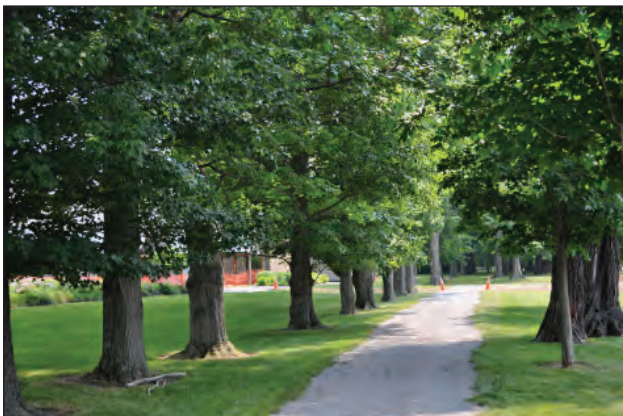
**Figure 4.20. View looking east from the Hyde Park Trail, 2012. The trail is defined by aggregate south of the Wallace Center (left) and is overgrown with turf near the walled garden (right) (OCLP).**

The Hyde Park Trail traverses the southern side of the Bellefield property. Much of the trail follows the south boundary service road, which the Newbold or Morgan family built during the historic period. Traveling west to east, the Hyde Park Trail links the south entrance of the Wallace Center to the south entrance of the walled garden, then the trail arcs north toward the main entrance drive. Grass has grown over the trail, which makes the alignment difficult to distinguish from the adjacent lawn area (Figure 4.20).

To enhance pedestrian circulation between the Wallace Center and the walled garden, the trail surface and route should be created. Rehabilitate the current south boundary service road to serve as an accessible ten foot wide pedestrian trail between the south entrance of the Wallace Center, the south entrance to the walled garden, and the main entrance drive. Remove existing organic matter and vegetation from the trail route. Where the route is uneven or muddy, install a stabilized aggregate with a binder or crushed stone that matches the color of other historic trails on the property (Appendix C). If the stabilized aggregate or crushed stone is not feasible, increase the number of trail markers and signs to clearly demarcate the route. Alternatively, remove the vegetation along the existing trail with an herbaceous herbicide to uncover the existing stone base. Cyclic removal of vegetation along the route by mechanical and or chemical methods will improve

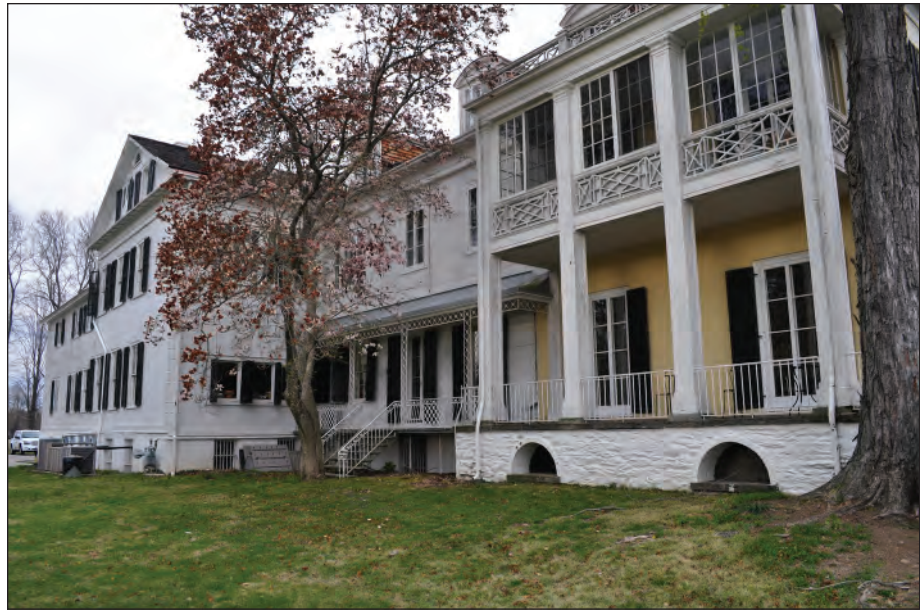
**Figure 4.21.** Remnant planting beds on west side of house, 2012. View looking northeast toward foundation of the house where two raised beds of plants likely grew (OCLP).

The flower and vegetable gardens, constructed by the Boormans and Newbolds in the nineteenth century and twentieth centuries, grew west of the Bellefield house in the latter half of the historic period. It is also likely that two garden beds were at the foot of the porch, along the Bellefield house (Figure 4.21). Newbold family photos show the care that went into maintaining the flower beds near the house and interviews with family members and staff describe the vegetable and fruits that grew further west.<sup>21</sup> The Newbolds planted flowering shrubs, annuals, and perennials (such as delphiniums, hollyhocks, iris, and phlox), which lined portions of the gravel pathway near the house (see Figure 1.38 and Figure 1.39). Vegetable garden beds were a key feature of the domestic landscape as the families grew most of their fruits and vegetables within these garden areas. In the early twentieth century the Newbolds grew several types of vegetables (such as celery, cabbage, lettuce, onions, beans, carrots, asparagus, peas and string beans), as well as fruits such as apples (MacIntosh, Northern Spy, and Baldwin varieties), grapes,

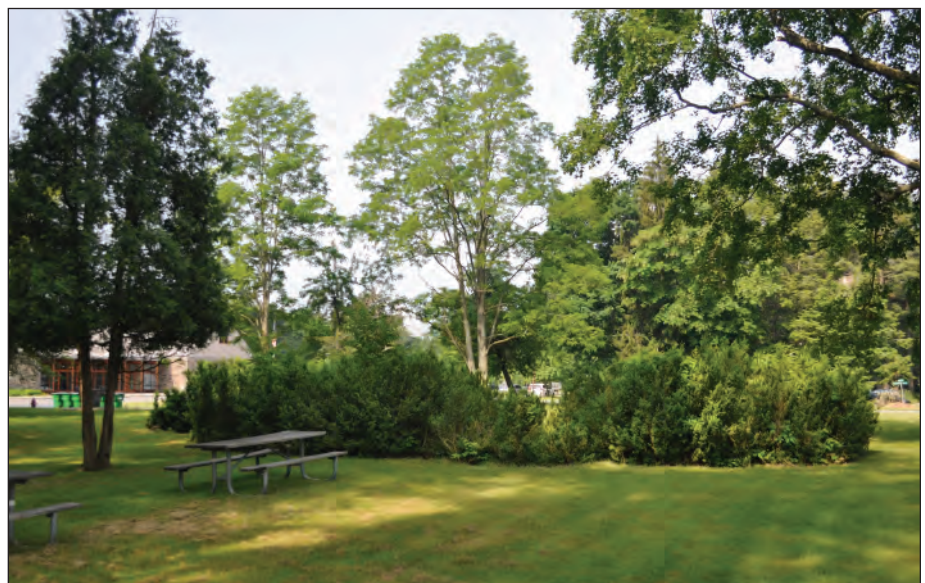
**Figure 4.22. Boxwood hedge, 2012.**  
View looking west toward the existing overgrown hedge that grows six to eight feet tall (OCLP).

The boxwood hedge, planted by the Newbolds in the early twentieth century, grows approximately 180 feet west of the Bellefield house in the open lawn area. The hedge contains three rows, with about fifteen boxwood shrubs, which stand about six to eight feet tall. During the historic period the Newbolds likely maintained the boxwood as a nursery, though Gerald Morgan recalled that the shrubs were in the shape of a maze.<sup>23</sup>

To enhance the character of the domestic landscape, the overgrown hedge should be rejuvenated or removed. The boxwood shrubs should grow in a linear alignment (Figure 4.22). Both the gardens at Adams National Historical Park in Quincy, Massachusetts and Hampton National Historic Site in Towson,

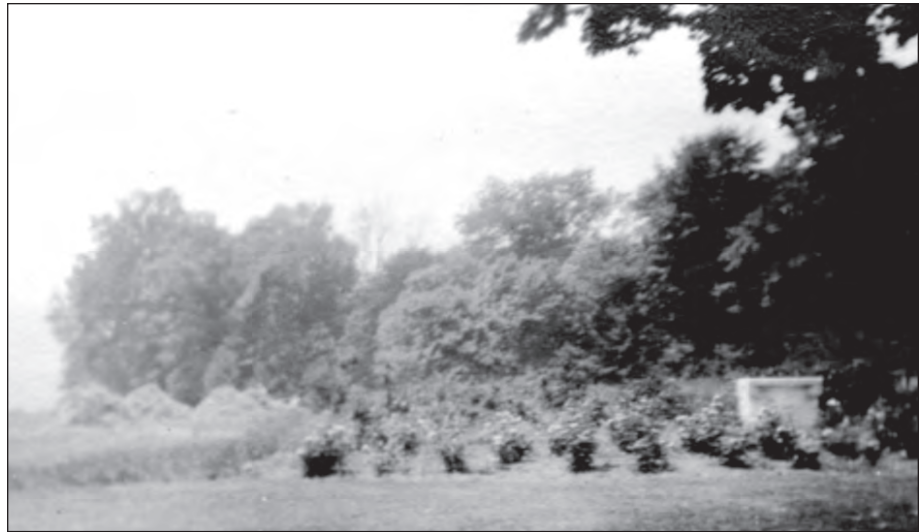
**Figure 4.23.** Roses around west lawn wellhead, 1929.  
View looking west to the west lawn wellhead and roses (Newbold-Morgan Collection, ROVA Archives).

The west lawn wellhead, installed in the early twentieth century by the Newbolds, remained through the end of the historic period within a bed of roses (Figure 4.23). The west lawn wellhead currently sits at the edge of the rectangular bus turn-around and no rose beds remain around the wellhead.

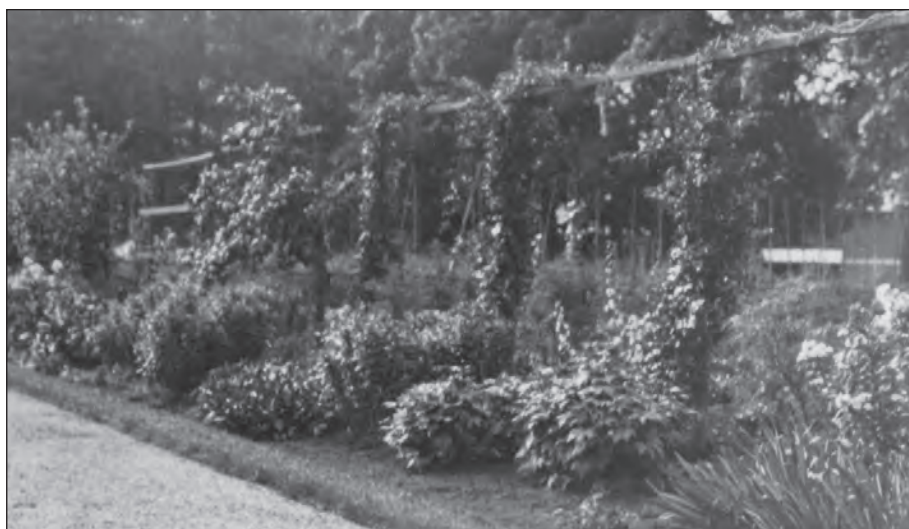
**Figure 4.24. Grape arbor, 1927.**  
View looking northwest toward the arbor and grape vines along the north side of the gravel pathway (Newbold-Morgan Collection, ROVA Archives).

The grape arbor, built in the early twentieth century by the Newbolds, ran parallel to the gravel pathway and supported grape vines.<sup>24</sup> The wood arbor stood approximately six to eight feet tall with four rows of linear slats with strings between the slats to support the vines (Figure 4.24). The grape arbor was removed sometime during the end of the Morgan ownership or beginning of National Park Service ownership.<sup>25</sup>

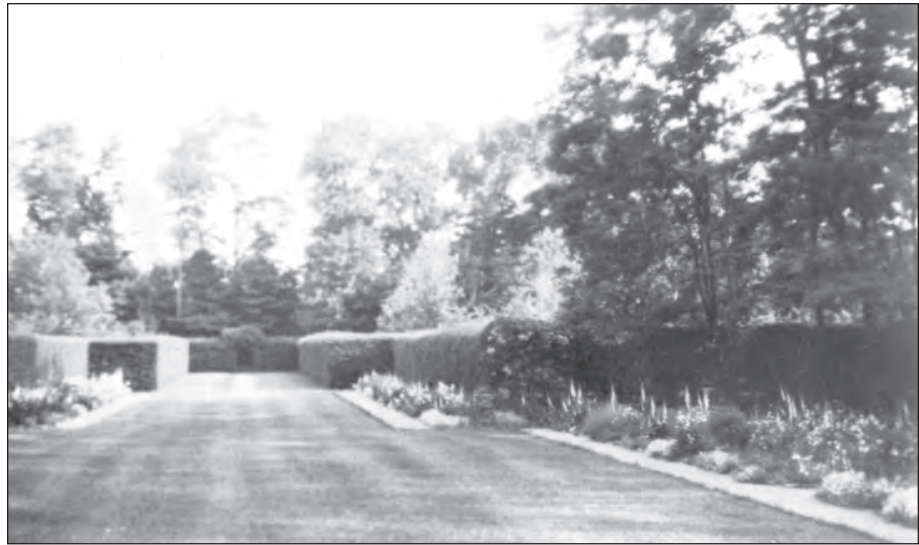
**Figure 4.26. Walled garden, 1929.**  
View looking south toward  
the end of the garden from the  
Bellefield house (Newbold-Morgan  
Collection, ROVA Archives).

The trees along the south property line of Bellefield include maple and pine trees that were planted in the nineteenth or early twentieth century under the direction of the Boorman and Newbold families (Figure 4.26). The border includes mature trees along the Bellefield south boundary service road. Several trees were recently removed.

To maintain the historic character of the walled garden, the lawn and vines within the walled garden should continue to be trimmed. The lawn should be weed free, even in character, and mown in a north to south direction as shown in historic photos (Figure 4.26). The vine on the south side of the Bellefield house should be cut back each year and pruned frequently to prevent visitors from walking on the base of the vines and to keep the vines from blocking the windows. Interpret the lawn and vines for school groups and visitors with historic family photos.

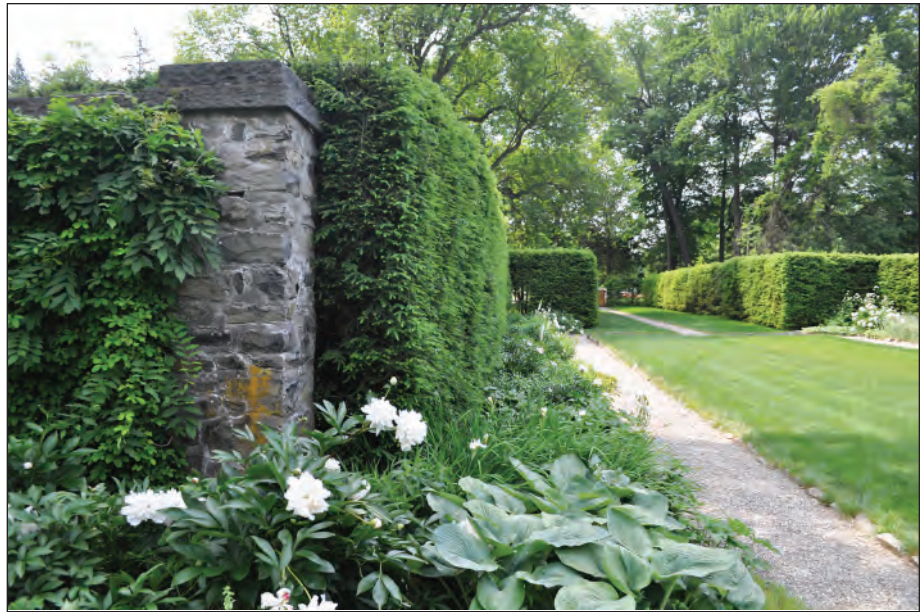
**Figure 4.28. Hemlock hedge, 2012.**  
View looking south toward the south gate of the walled garden. Note the hemlock hedge on the left grows beyond the fieldstone wall (OCLP).

The hemlock hedge, first planted under the direction of the Newbolds in 1912, runs along the southeast, south, and southwest edge of the walled garden. During the historic period, the hedge formed a garden wall that was continuous with the fieldstone wall along the east and west sides of the garden. The vertical hemlock hedge arched over the southern entrance to the walled garden (Figure 4.26). The National Park Service and the Beatrix Farrand Garden Association removed the overgrown hemlock hedge in 1994 and replanted the hedge with a single line

To enhance the historic character of the walled garden, the hemlock hedge should be maintained so that it is level with the fieldstone wall and the interior vertical face of the hedge should be trimmed so that it aligns with the face of the fieldstone wall (Figure 4.28). Train hedge to grow over the southern gate to the walled garden. As detailed in task BH-15, removal and replacement of the mature trees to the south of the walled garden will increase sunlight in this area, which will increase the density of the hedge.

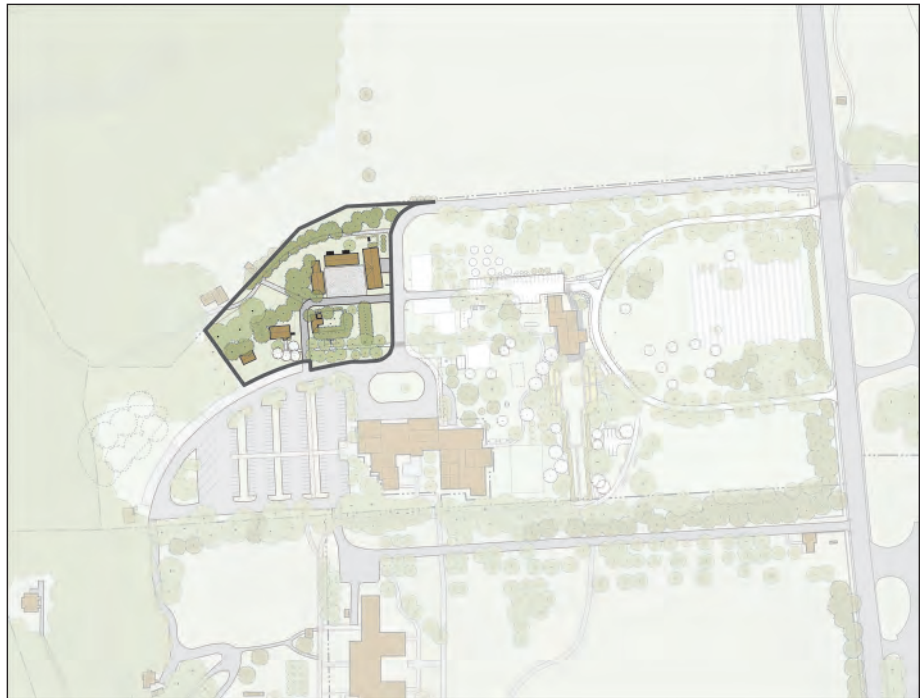
**Figure 4.29. Cemetery and Service Area treatment area, 2012 (OCLP).**

Overall treatment objectives for the cemetery and service area are to retain and enhance the historic character of the Crooke family cemetery, service buildings and structures, and vegetation. The cemetery and service area houses park maintenance equipment and staff and receives little public use. The character area was an extension of the Bellefield house and grounds until 2003 when FDR Drive separated the service area from the house grounds. The service area served as the support area for the Bellefield house throughout the historic period and contained small scale agriculture, water supply infrastructure, and staff housing. The western edge is defined by the tree border at the edge of the Bellefield property and FDR Drive to the east (Figure 4.29). The Wallace Center parking area abuts this character area to the south. If the National Park Service acquires the Scenic Hudson property, the Bellefield cottage and garage should be managed as part of the cemetery and service area.

The historic character of built features, vegetation, and circulation should be preserved, while accommodating park staff requirements, access to the trails in Rogers Land, and future access to the Scenic Hudson property. Interpretation could inform visitors and school groups about the history of the cemetery, the oldest constructed feature on the property, and the historic agricultural use of the property. The treatment tasks are shown on Drawing 4.1 and identified by the prefix CS.

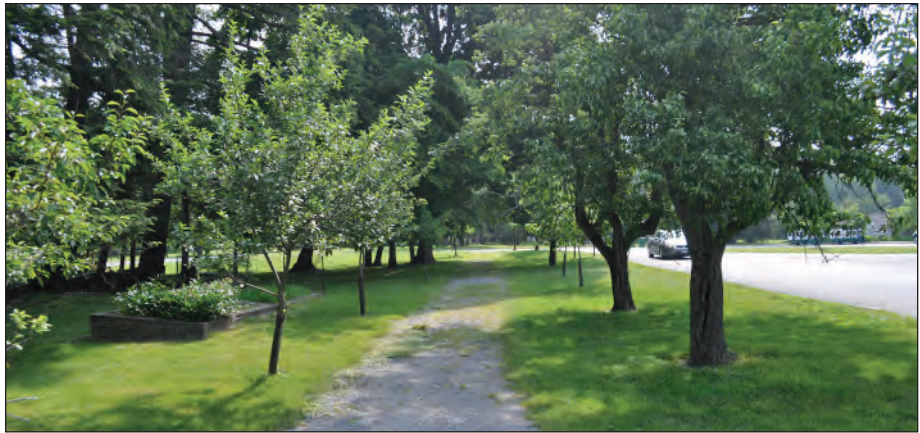
Figure 4.30. Gravel pathway, 2011.  
View looking east toward the  
Bellefield house (ROVA Archives).

#### **CS-1: Rehabilitate gravel pathway west of FDR Drive**

The gravel pathway, constructed in the late nineteenth century under the direction of the Boormans or Newbolds, ran from the back porch of the Bellefield house, to the entrance of the stone house, and ended near the tree border at the edge of Rogers Land. West of FDR Drive and within the cemetery and service area, an eight-foot wide coarse aggregate pathway currently runs between the orchard trees to the service area road, which used to be the estates road between Springwood, Bellefield, and the Red House (Figure 4.30). West of FDR Drive and in front of the stone house, the pathway is overgrown and little aggregate remains to mark the pathway. The pathway receives little public use as there are few public attractions or facilities in this area.

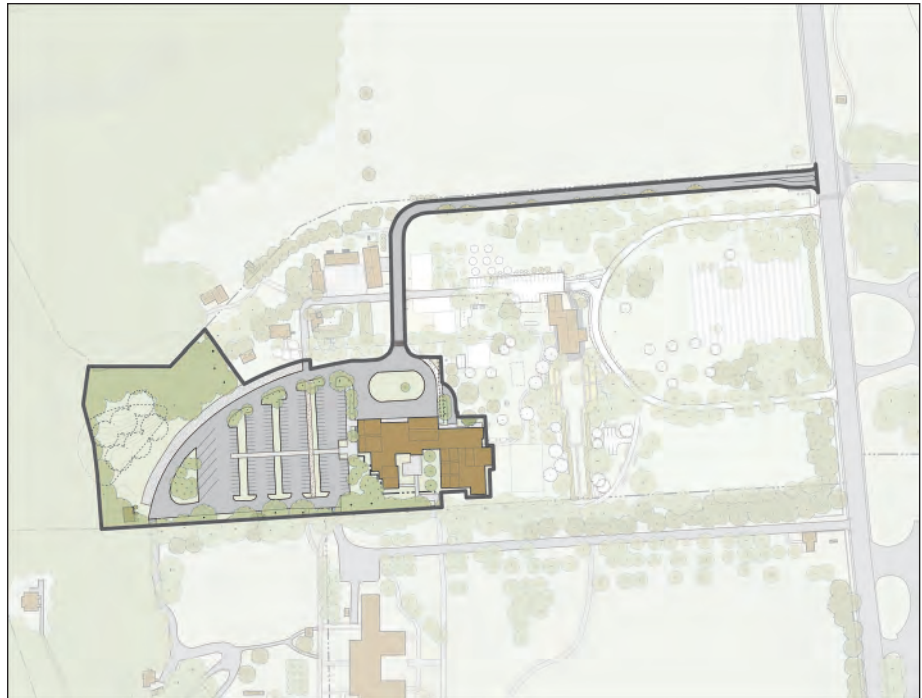
**Figure 4.31. Wallace Center and Parking Area treatment area, 2012 (OCLP).**

Overall treatment objectives for FDR Drive, Wallace Center, and parking area are to improve visitor experience and wayfinding, restore views to the west, and create safer pedestrian access. The area is defined by the Rogers Land to the west, the edge of the parking area to the north, the edge of the Wallace Center to the east, and FDR Drive (Figure 4.31). Little remains of the hay fields and gardens that grew on the site of the Wallace Center and parking area during the historic period—only the tree border and archeological sites associated with Camp Morgan. FDR Drive, Wallace Center, and parking area serve as the starting point for visitors going to the National Historic Site and Presidential Library. Views over the Hudson River toward the highlands on the west side of the river should be restored and the design of the bus turn around modified to improve safe pedestrian circulation between the Wallace Center and the Bellefield property. The treatment tasks are shown on Drawing 4.1 and identified by the prefix WC.

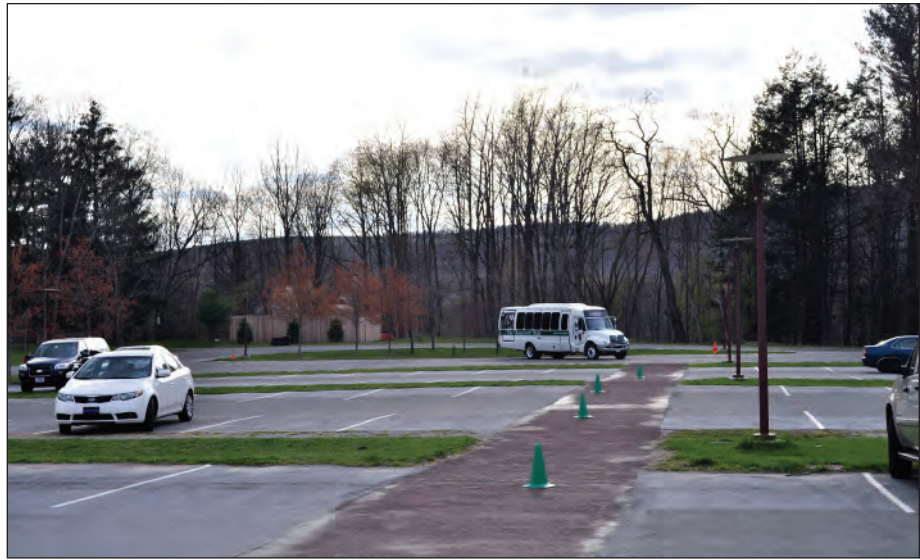
**Figure 4.32. View from the Wallace Center**  
View looking west toward the Hudson River (OCLP).

During the historic period, views from the western portion of the Bellefield property extended toward the Hudson River and the highlands on the west side of the Hudson. Current views are blocked by overgrown vegetation west of the Bellefield core (Figure 4.32).

To improve visitor's sense of arrival to an estate property along the Hudson River, views to the river and highlands should be reestablished so that visitors connect with the surrounding geographic landscape. To maximize the view and

preserve mature trees, thin the existing tree border at the west edge of the Wallace Center parking area by removing volunteer trees through a forest management plan. Maintain trees west of the existing HVAC unit and thin trees north of the unit toward the northwestern edge of the overflow parking within the Wallace Center parking area. Retain select healthy and mature trees that grew during the historic period. Prior to tree removal, the park should conduct a detailed viewshed analysis to determine the quantity and location of trees to be removed. In addition, identify and protect archeological features such as the stone dust deposit, Bellefield dump, horse burial, and Camp Morgan.<sup>29</sup>

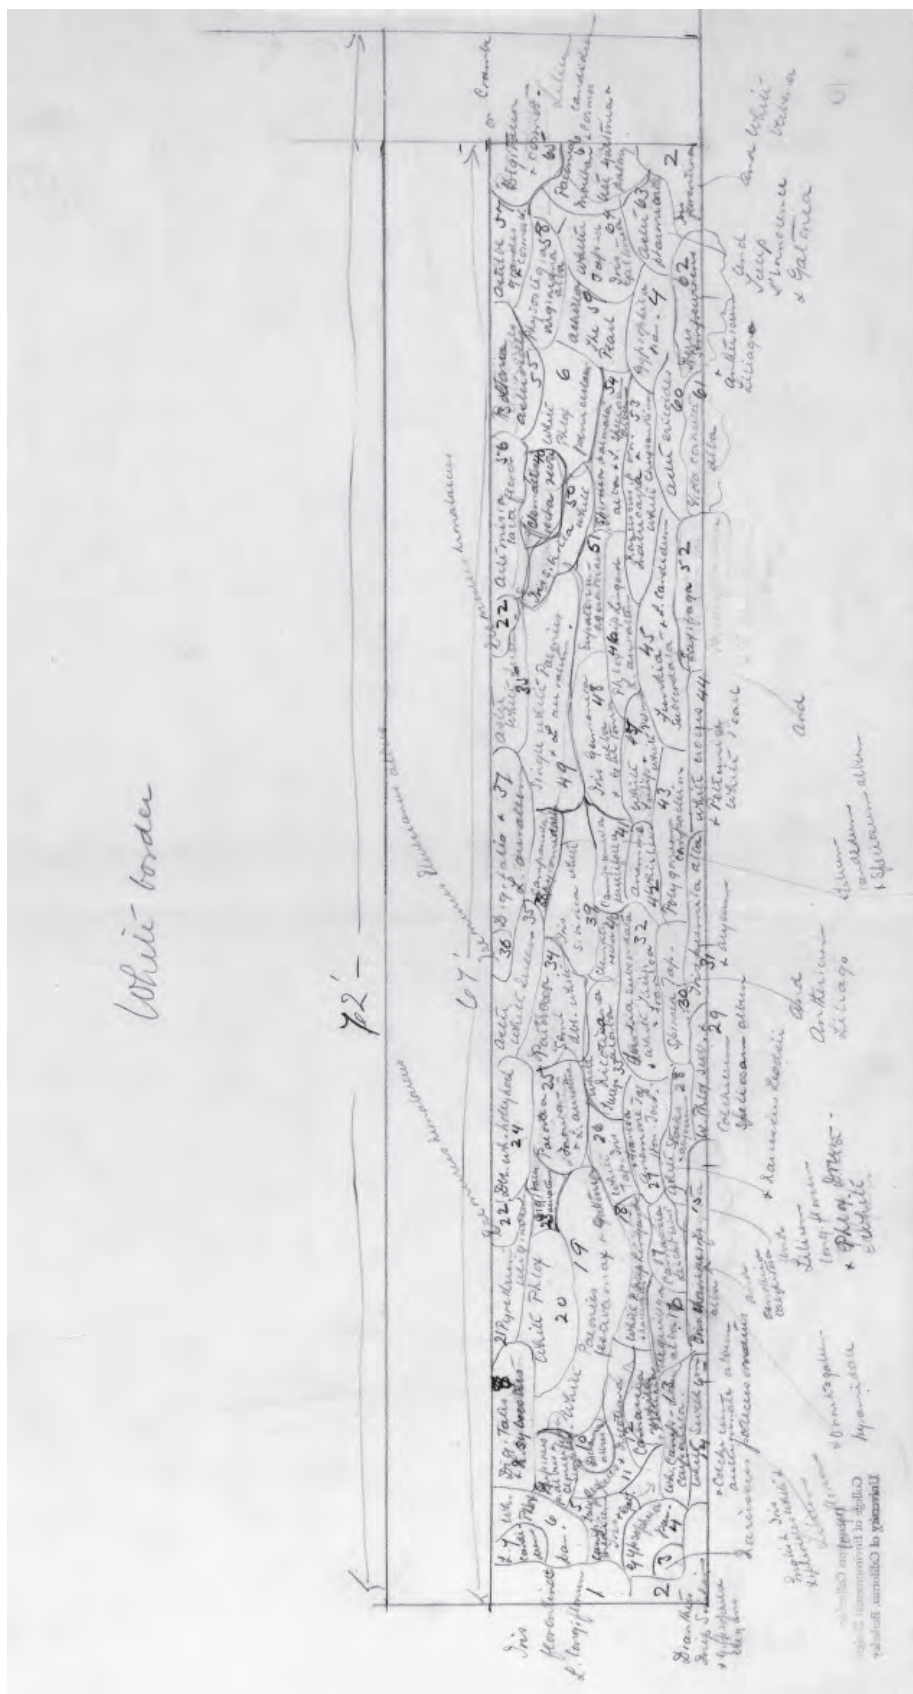
“White border” in the upper east terrace of the Read Garden, Harrison, New York, c. 1909 (Beatrix Farrand Collection (1955-2), Environmental Design Archives, University of California, Berkeley).
