# Inventory of Coastal Engineering Projects in Fort Raleigh National Historic Site

Natural Resource Technical Report NPS/NRSS/GRD/NRTR—2013/704

March 2013

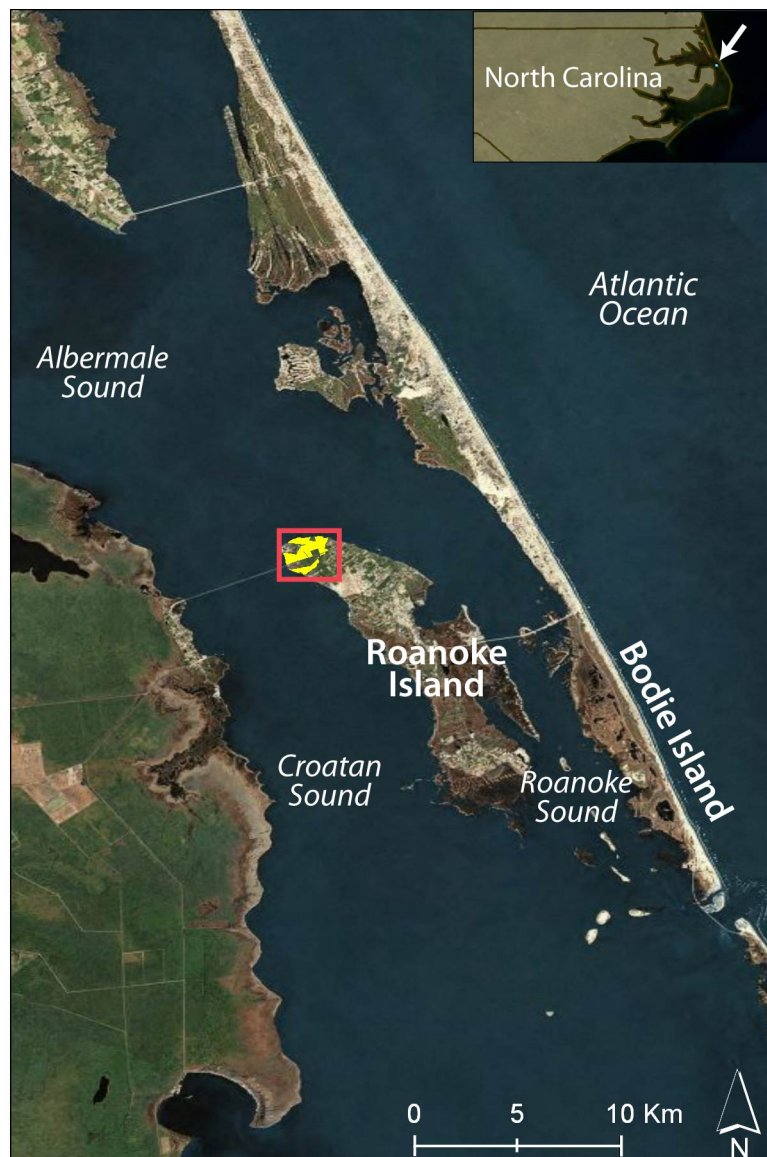
**Figure 2.** Regional map of Fort Raleigh National Historic Site (shown in yellow). Area in pink box is enlarged in Figure 3 (images from ESRI Bing Maps basemap layer 2012).

FORA occupies 1.4 km<sup>2</sup> (355 ac) (NPS 2011) on the northern end of Roanoke Island in the northeast region of North Carolina (Figure 2). Roanoke Island is situated between the coastal mainland of North Carolina and Bodie Island, a barrier island in the Outer Banks barrier island chain (Figure 2). FORA was established on April 5, 1941 to preserve the probable location of the first English colony in the United States and the history of the Native Americans, European Americans, and African Americans who have lived on Roanoke Island (NPS 2007a).

Croatan and Roanoke Sound are drowned tributaries that flowed northward to the paleo-Roanoke River (now Albermarle Sound) (Figure 2) and Roanoke Island is a remnant of the divide that separated these two tributaries (Riggs et al. 1992). In the Roanoke Island region, a thick sequence of Quaternary sediments (about 75 m [245 ft]) rest unconformably on the Pliocene Yorktown Formation (Brown et al. 1972, Mallinson et al. 2005). The upper 4 to 6 m (13 to 20 ft) of Quaternary sediments on Roanoke Island are late Pleistocene aged estuarine and barrier-island facies (Riggs et al. 1992). On top of the late Pleistocene sediments in the FORA region are several meters of Holocene aged estuarine sand deposits and sand dunes that thin southward (NPS 2007b).

FORA is at the juncture of Albermarle, Roanoke, and Croatan Sounds and faces a large fetch of open water to the north (Figure 2), making it exposed to storm waves and surges from both nor'easters and hurricanes (Dolan and Lins 1985). The sounds around FORA have low amplitude astronomical tides because only four inlets exist along the 300-kilometer (190 mi) long Outer Banks barrier island chain, limiting the influence of oceanic processes (Riggs and Ames 2003). Instead, the intensity and duration of the wind primarily determines the currents and water levels (Riggs and Ames 2003).

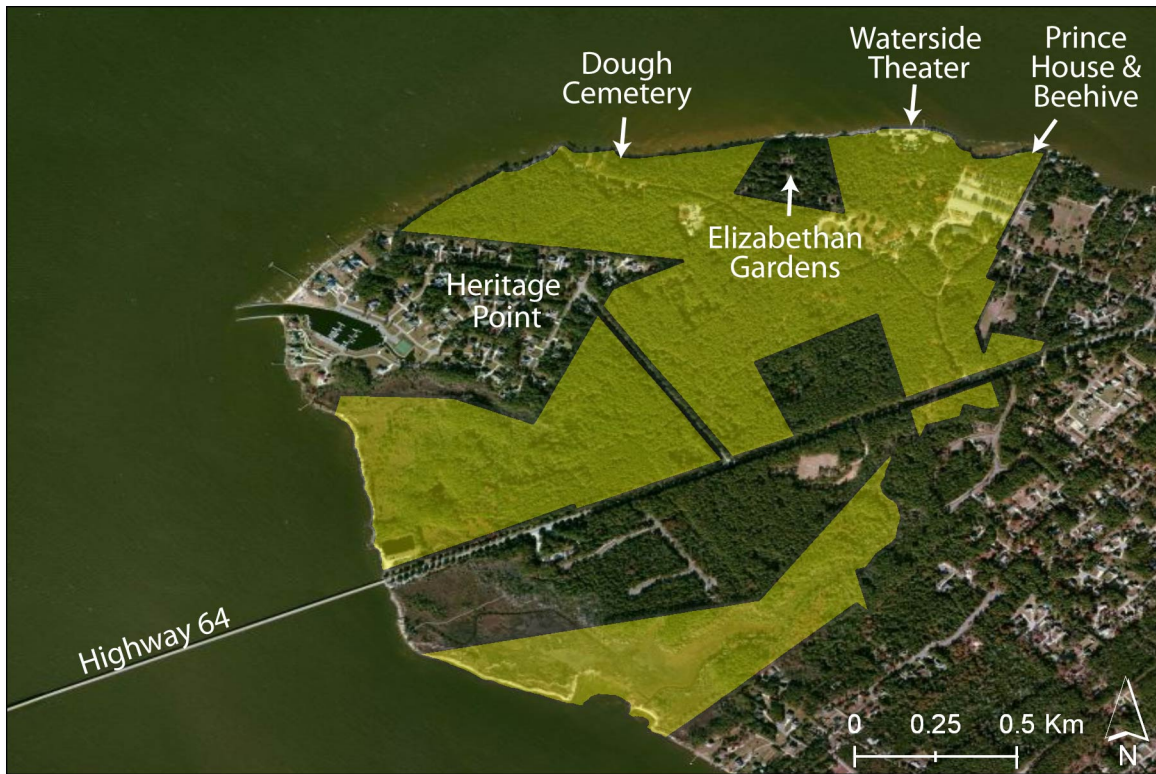
**Figure 3.** Map of Fort Raleigh National Historic Site and places mentioned in the report. Yellow shading shows the park property (image from ESRI Bing Maps basemap layer 2012).

Forty-six structures are on private or state property adjacent to the park and span over 2 km (1.2 mi) (Table 1). Roughly 43% of the shoreline contained within the greater extent of FORA, which spans from the Prince House to nearly 1 km (0.6 mi) south of the Highway 64 Bridge (Figure 3) and includes park, private, and state lands, is armored with coastal structures (Figure 1). A summary of all of the structures within and adjacent to FORA is presented in Appendix B.

produces the outdoor play *The Lost Colony* at the Waterside Theater (Figure 3). To the west of the theater is the Elizabethan Gardens (Figure 3), which is owned by the RIHA and leased to The Garden Club of North Carolina. Heritage Point is a private residential area that is surrounded by parkland on the northwest tip of Roanoke Island (Figure 3).

Erosion currently threatens culturally significant sites and related infrastructure at FORA and planning is underway to develop emergency stabilization actions (Eshleman and York 2011). Shoreline erosion has already caused the Prince House and Beehive buildings (Figure 3) to be condemned and has required the exhibits at a day-use area next to the Highway 64 Bridge to be moved (NPS 2011).

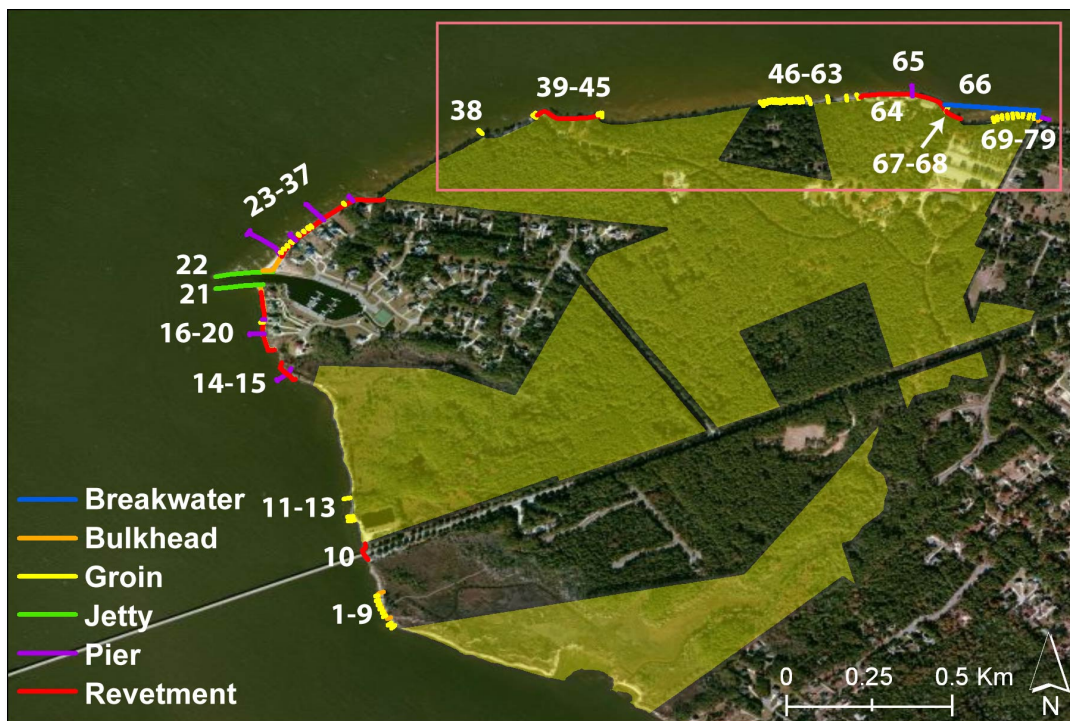
**Figure 4.** Structure map for FORA. Yellow shading shows the park property. Area in pink box is enlarged in Figure 5 (image from ESRI Bing Maps basemap layer 2012).

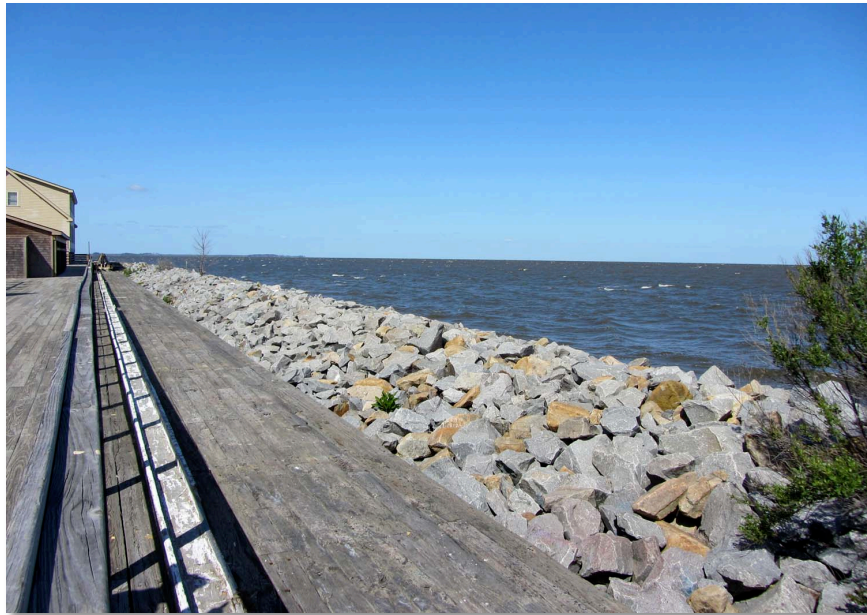
Binkley and Davis (2003) also note that beginning in 1949 the park constructed four groins of salvaged material from a local bridge demolition project along the northern Roanoke Sound shoreline, but the location and fate of these groins is unknown. In 1980 the NPS built a 242-meter (794 ft) long granite revetment in front of the theatre to stabilize the shoreline (#64 Figures 4, 5 & 6) (Binkley and Davis 2003).

**Figure 6.** Revetment (#64 Figure 5) fronting the Waterside Theater. View is to the west (image by Kate Dallas).

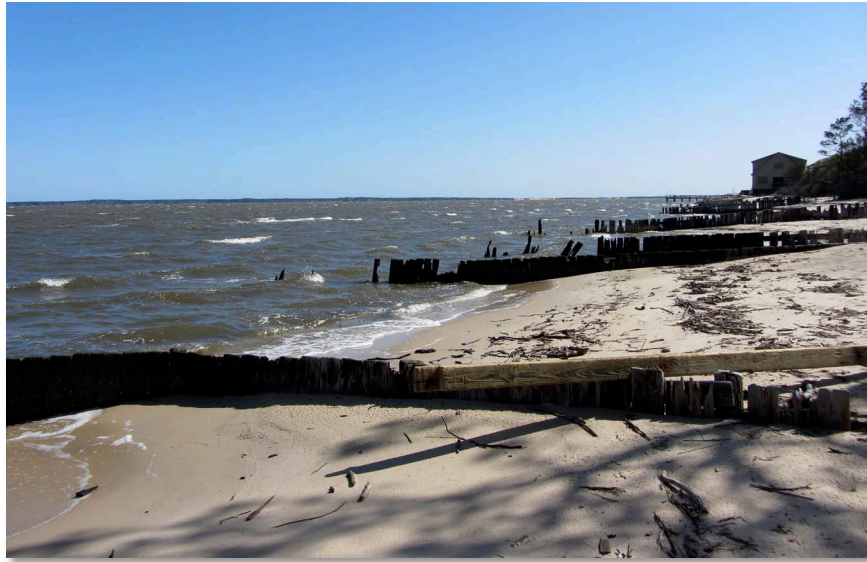
To the west of the theater are 18 wooden groins, which were built in the early 1950s (#46–63 Figures 5 & 7) (Dolan and Bosserman 1972). The groin field has been successful at trapping sand, with about 9 m (30 ft) of shoreline progradation observed between 1950 and 1970 (Dolan and Bosserman 1972). A breakwater was also built concurrently with the groins in the early 1950s (Dolan and Bosserman 1972), but no longer remains and details of its history are unknown. Eshleman and York (2011) report that park maintenance staff noted a sill offshore from the theater, which may be the same structure referred to as a breakwater by Dolan and Bosserman (1972).

**Figure 7.** Wooden groins to the west of the Waterside Theater (#60–63 Figure 5). View is to the east (image by Kate Dallas).

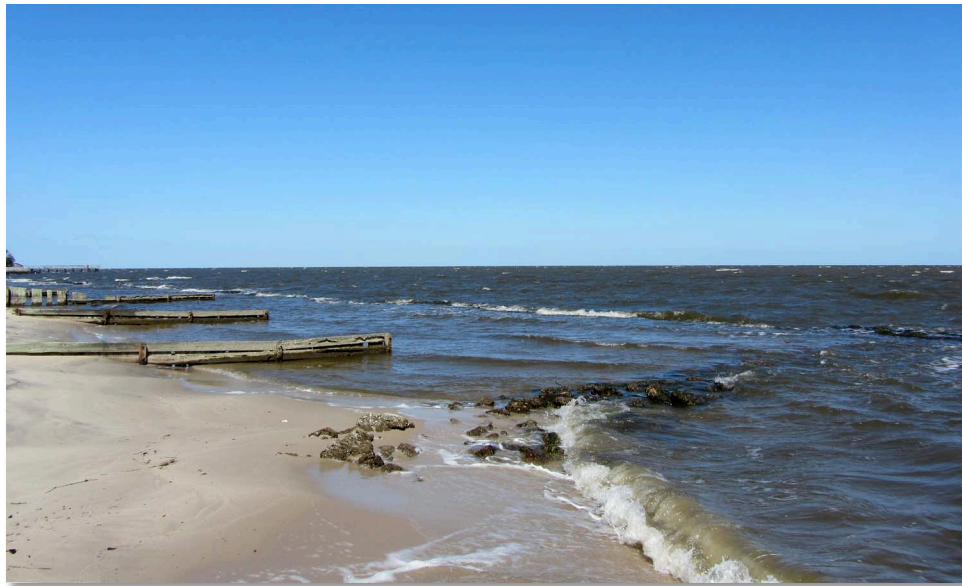
East of the theater is a submerged breakwater, rock revetment, ten wooden groins, and a small wooden bulkhead and pier in front of a private residence (#66–79 Figure 5). Eshleman and York (2011) reported that the original breakwater was built with sand bags in the 1960s, while Klingelhofer (2008) documents that a concrete breakwater was installed in the 1950s. The 42-meter (138 ft) long rock revetment was constructed in the 1970s (Klingelhofer 2008). It is unknown when the wooden groins were built, but historic Google Earth images show that all of the groins were built before 2002 (#67–77 Figure 5 & Figure 8).

**Figure 8.** Wooden groins (#74–77 Figure 5) and submerged breakwater (#66 Figure 5) to the east of the theater. View is to the northwest (image by Kate Dallas).

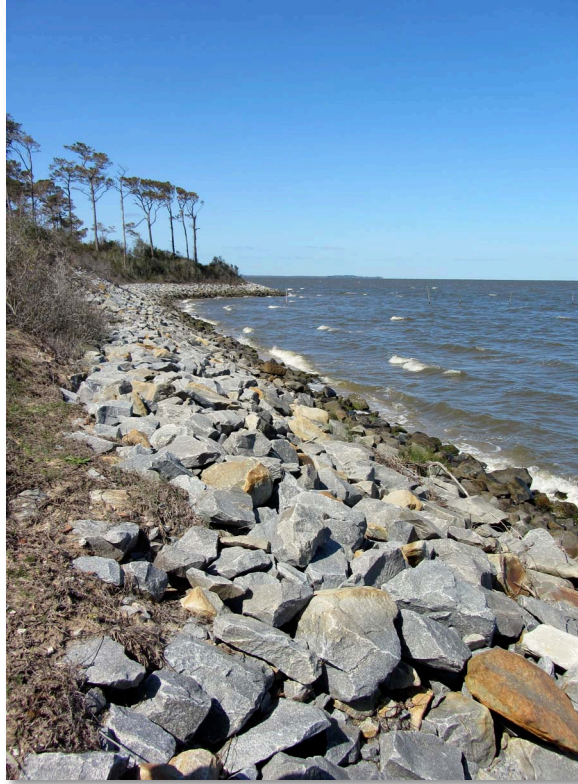
In response to rapid erosion, the NPS installed a 168 meter-long (551 ft) granite block revetment in 1980 (#42 Figure 5 & Figure 9) (Binkley and Davis 2003). Three wooden groins exist on both the eastern and western end of the revetment, but nothing could be found on their history (#39–41, 43–45 Figure 5). Severe erosion is now occurring at the eastern end of the revetment, which could threaten the cemetery. FORA staff are communicating with the descendents of the Dough family regarding the possibility of relocating the cemetery (Eshleman and York 2011).

**Figure 9.** Revetment fronting the Dough Cemetery (#42 Figure 5). View is to the west (image by Kate Dallas).

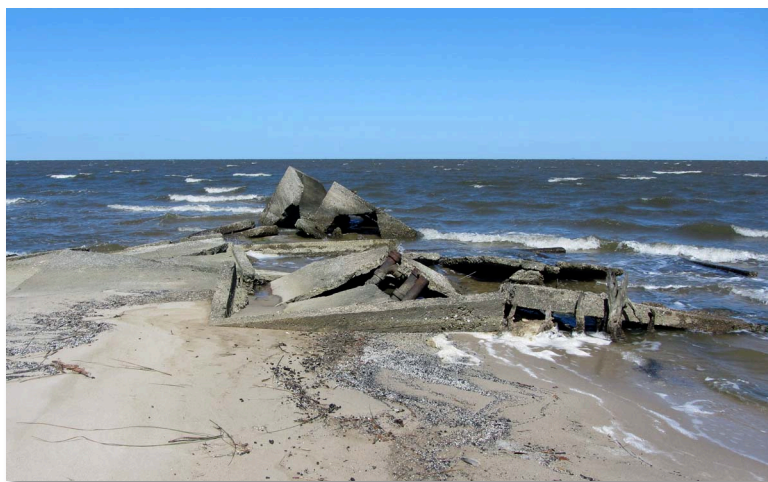
To the west of Dough Cemetery is a concrete septic tank and metal pipes exposed on the beach (Figure 10). This debris is the only remaining feature from the 1938 Civilian Conservation Corps Camp Wirth Site and acts as a groin, trapping sediment (#38 Figure 5) (Eshleman and York 2011).

**Figure 10.** Debris from the 1938 Civilian Conservation Corps Camp Wirth Site (#38 Figure 5) (image by Kate Dallas).

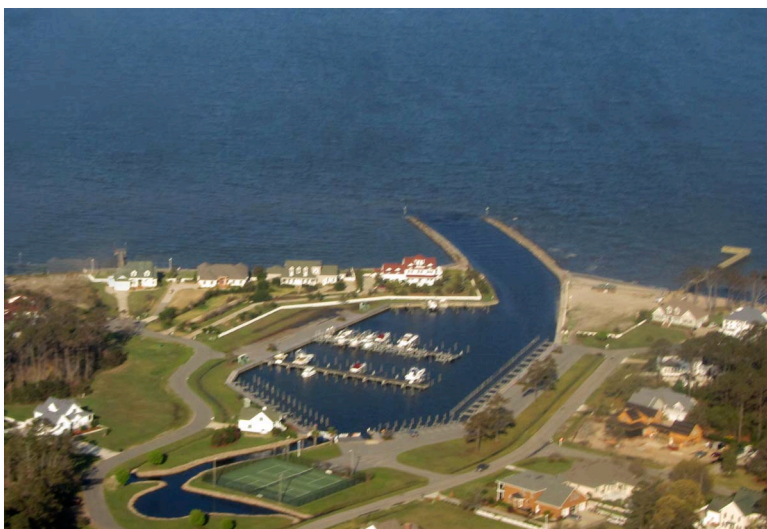
The Heritage Point Community is a private residential area and marina on the northwest tip of Roanoke Island (Figure 11). The area was developed in the 1990s and includes a highly altered shoreline consisting of bulkheads, revetments, piers, groins, and jetties (#14–37 Figure 4). The two rock jetties (#21–22 Figure 4) were built in 1991 and were extended in 1998 (Terry McGuiness, Heritage Point Home Owners Association President, phone, 10-24-12). Historic images from Google Earth provide a rough timeline for the installation of the other coastal structures.

**Figure 11.** Heritage Point residential area and marina. View is to the northwest (image by Kate Dallas).

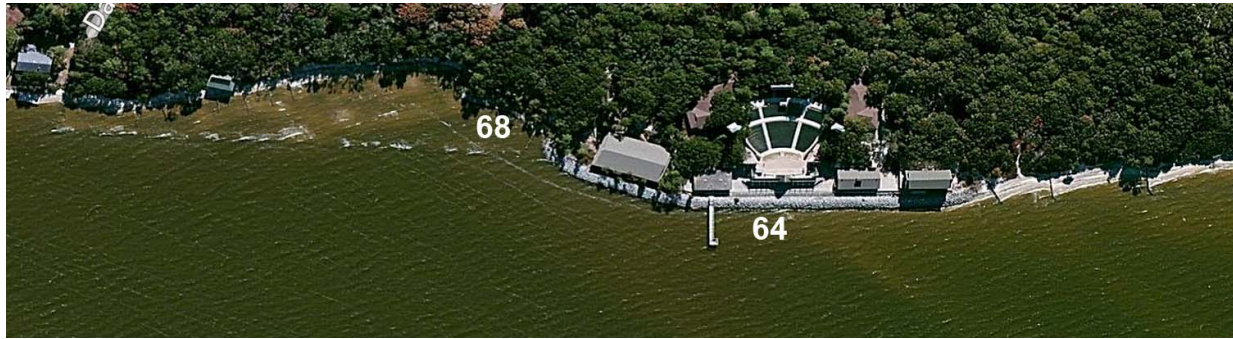
Revetments in front of the theater (#64 & 68 Figure 13) have fixed the location of the shoreline, preventing an estimated 30 m (100 ft) of shoreline loss since 1980. These structures have also likely cut off an important sediment supply to downdrift areas. Erosion at the eastern end of the

**Figure 13.** Shoreline in the vicinity of the Waterside Theater. View is to the south (image from Bing Maps 2012).

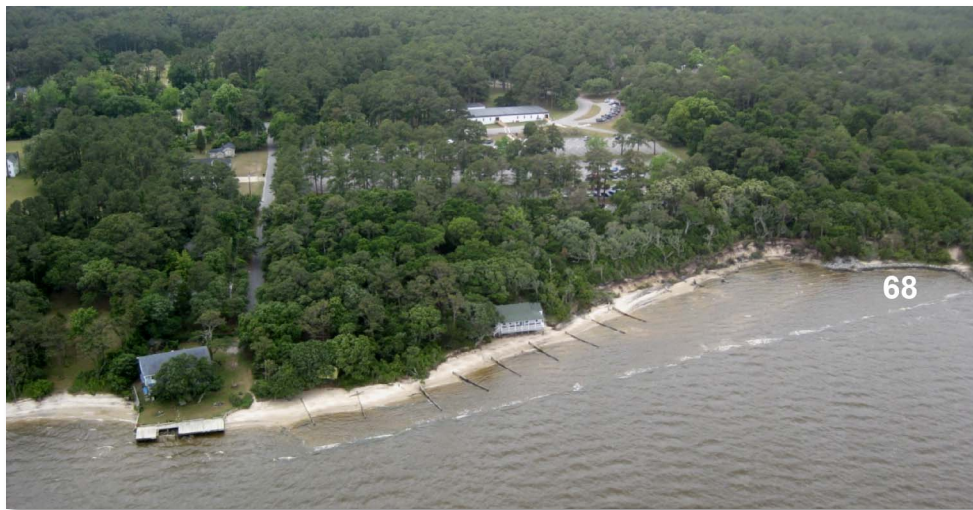
shorter revetment (structure #68) has become quite pronounced within the last few decades (Figure 14).

**Figure 14.** The shoreline east of the Waterside Theater includes a wooden groin field, submerged breakwater and revetment. View is to the southwest (image from Eshleman and York 2011).

Klingelhofer (2008) found that the shoreline in the Prince House vicinity (east of revetment #68) has experienced erosion on the order of  $-1.25 \text{ m/yr}$  ( $-4.1 \text{ ft/yr}$ ) over the last 25 years. Even with the construction of a groin field and submerged breakwater, erosion is still occurring, likely due to deflected currents and limited sediment supply (Klingelhofer 2008). Eshleman and York (2011) report that erosion in front of the Prince House and Waterside Theater parking area is a major concern for park maintenance staff. An additional impact of continued erosion includes decreased habitat for local species such as the mound-lily yucca and the Carolina water snake, both of which are native to the area and considered to be threatened (Eshleman and York 2011).

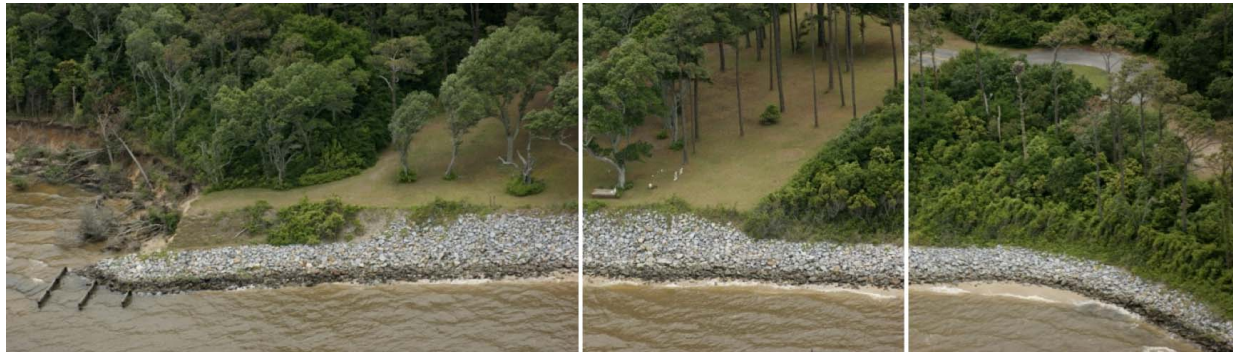
The Dough Cemetery revetment (#42 Figures 5, 9 & 15), built in 1980, extends 168 m (551 ft) along the bluffs of the northern boundary of the park. The cemetery's shoreline is exposed to high wave energy, with fetch distances of up to 56 km (35 mi) (Riggs and Ames 2003). The long-term (1851–1970) shoreline change rate in this area is approximately  $-2.4$  to  $-2.7 \text{ m/yr}$  ( $-8$  to

**Figure 15.** Rock revetment and groins in front of the Dough Cemetery (#42 Figure 5). View is to the south (images from Eshleman and York 2011).

Since construction of the revetment in 1980, the backshore has been held in place preventing an estimated 80 m (260 ft) of additional shoreline erosion. The armoring of the shoreline has likely limited sediment supply to downdrift beaches and caused accelerated erosion to the east of the revetment (Figure 15).

Applying these simple empirical relationships to the Dough Cemetery revetment, which is 168-meters (551 ft) long and causes impacts similar to those of a vertical seawall, results in inland erosion of about 17 m (56 ft) and an alongshore extent of erosion of 118 m (387 ft). These simple estimates are relatively close to the observed erosion east of the revetment.
