FINAL REPORT

SAMPLING, TESTING AND ANALYSIS OF THE  
ANTHROPOGENICALLY ALTERED PORTIONS OF THE TSHIREGE  
MEMBER OF THE BANDELIER TUFF, BANDELIER NATIONAL  
MONUMENT

November 2011  
Nancy J. McMillan, Frank Ramos, Annie Riggins, and April Smith  
New Mexico State University  
[nmcmilla@nmsu.edu](mailto:nmcmilla@nmsu.edu), 575-646-5000

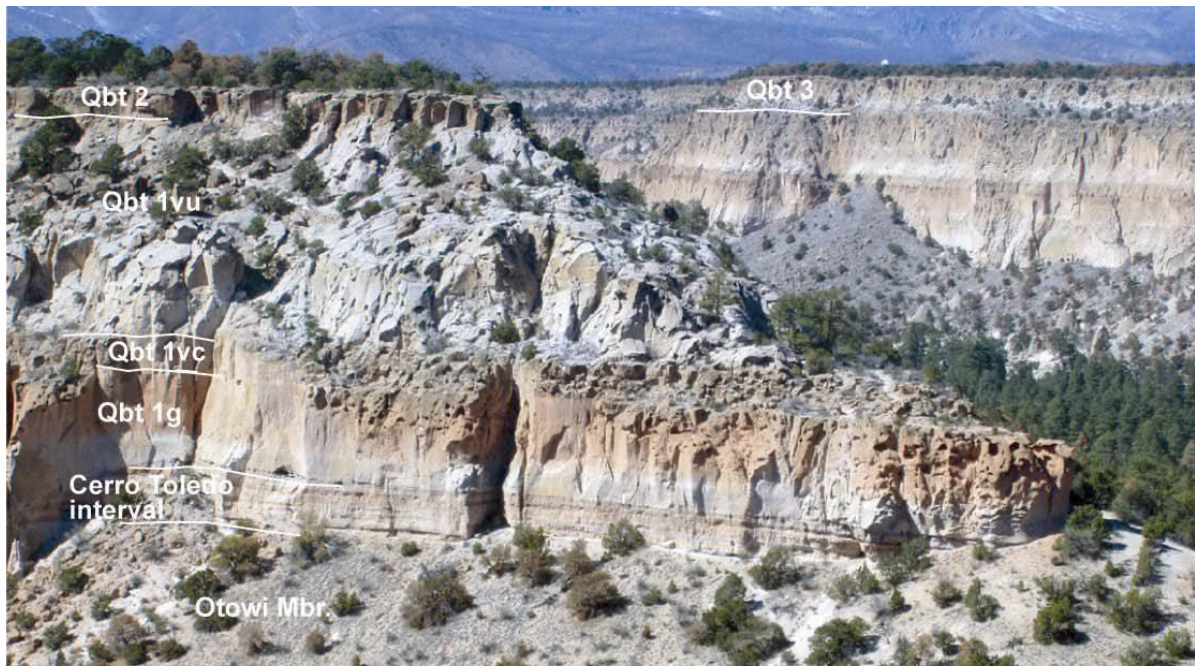
FIGURE 1. VOLCANIC STRATIGRAPHY OF THE BANDELIER TUFF IN THE JEMEZ MOUNTAINS, FROM VIERRA AND SCHMIDT (2008). THE OTOWI MEMBER, LARGELY COVERED WITH TALUS IN THIS PHOTO, WAS ERUPTED DURING THE FIRST COLLAPSE OF THE VALLES CALDERA. TUFFS IN THE CERRO TOLEDO INTERVAL ERUPTED FROM INTERMITTENT ACTIVITY OF THE CERRO TOLEDO CALDERA. MOST OF THE EXPOSED TUFF IN THE PHOTO COMPRISES THE TSHIREGE MEMBER OF THE BANDELIER TUFF, ERUPTED FROM THE SECOND COLLAPSE OF THE VALLES CALDERA.

Frijoles Canyon, in Bandelier National Monument, was incised into the Bandelier Tuff after the eruption of the Tshirege member at 1.22 Ma. Cavates were excavated in the lower, non-welded section of the Tshirege member (unit Qbt 1g in Fig. 1). The top of the Otowi member is exposed under the A-group cavates; volcanic rocks associated with the Cerro Toledo tuff were not observed in Frijoles Canyon. All samples in this study were taken from unit Qbt 1g.

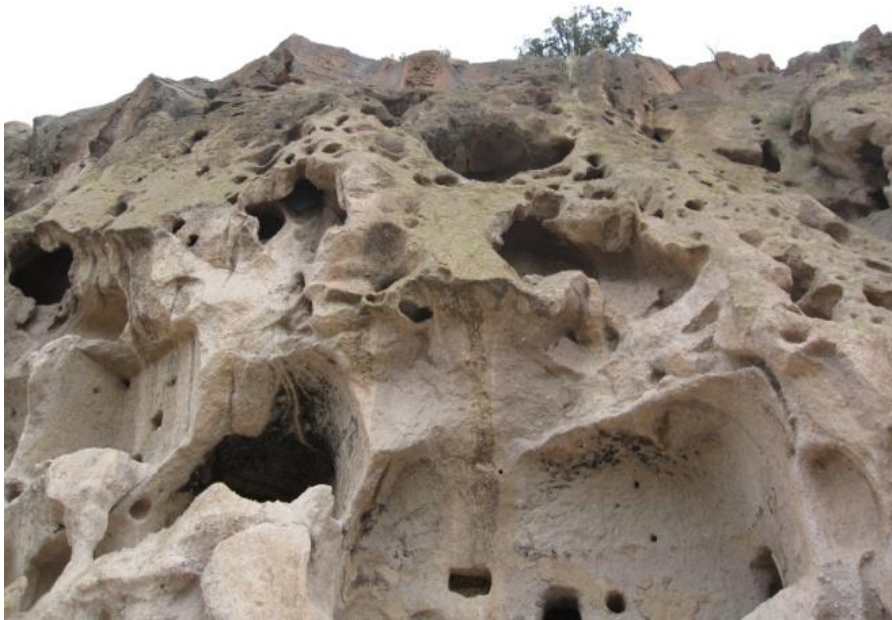
FIGURE 2. VAPOR PHASE CRYSTALLIZATION SURFACE AT LONG HOUSE.

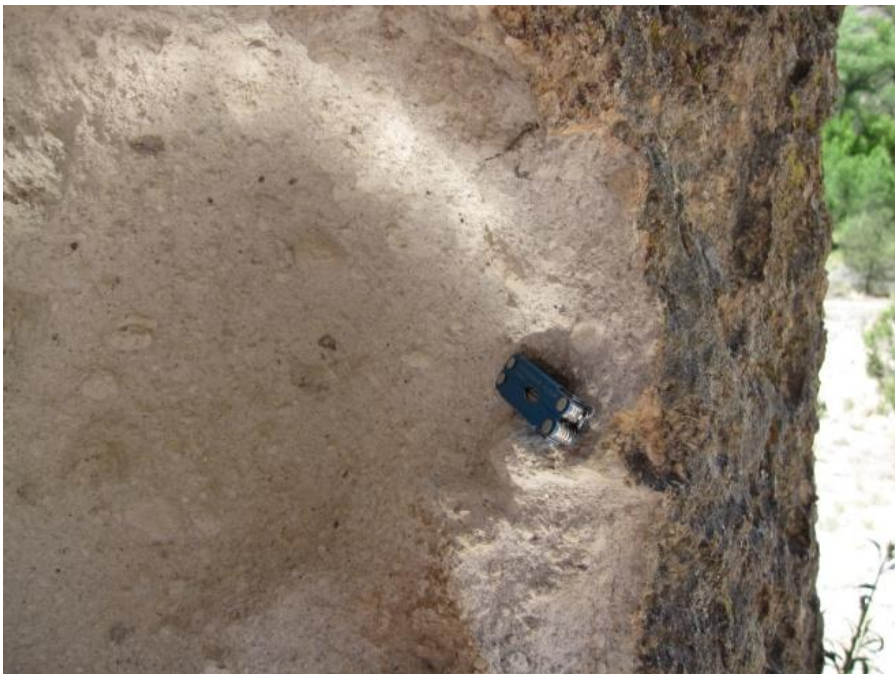
FIGURE 3. CLOSE UP OF CROSS-SECTION OF VAPOR-PHASE CRYSTALLIZATION ZONE. LEATHERMAN IS 6.5 CM LONG.

Vapor-phase crystallization, the second process, occurs along fractures and other zones of fluid flow as magmatic gases precipitate cristobalite (a high-temperature polymorph of quartz) as the tuff cools (Reneau, 2000; Crowe et al., 1978; Broxton et al., 1995). The cristobalite coats pumice, ash, and crystal faces and cements them together. Broxton et al. (1995) report that the upper part of the Tshirege has been devitrified by vapor-phase crystallization, resulting in a very durable rock that is resistant to erosion. Devitrification (crystallization of the glass in the tuff) has not occurred in Bandelier National Monument to any noticeable extent. In Frijoles Canyon, the vapor phase crystallization occurred along cooling fractures rather than throughout the unit (Figs. 2-4). Only the outer few centimeters of the tuff have been cemented together (Fig. 3), forming the “case-hardened” surface defined by Broxton et al. (1995).

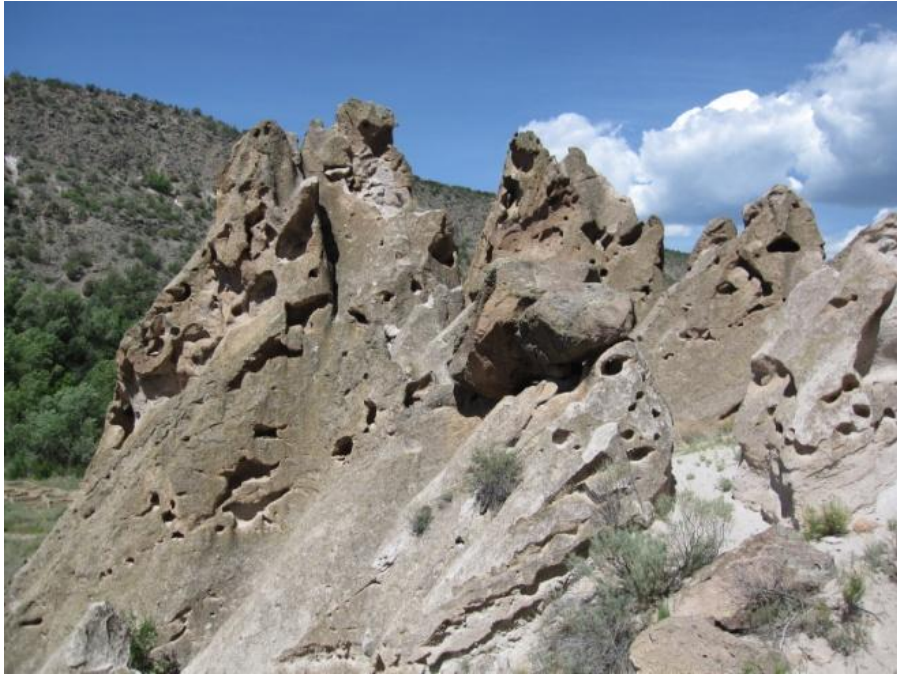
FIGURE 4. VAPOR-PHASE CRYSTALLIZATION ALONG CONICAL GAS-ESCAPE FRACTURES.

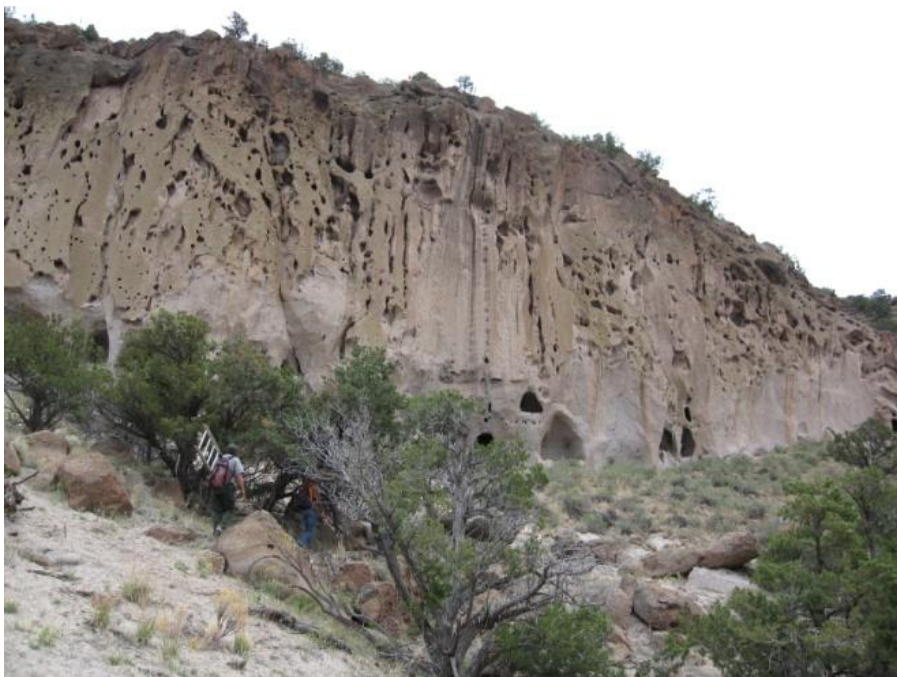
FIGURE 5. VERTICAL CLIFF FACES AT GROUP M.

If the Tshirege Member had not been strengthened by vapor-phase crystallization, Frijoles Canyon would not have vertical cliff faces (Fig. 5). Instead, the tuff would have eroded away rapidly, leaving a broad valley in contrast to the steep canyon that exists. The vertical cliff faces

that characterize Frijoles Canyon represent surfaces that were made more resistant to erosion by vapor-phase crystallization along cooling fractures (Reneau, 2000; Crowe et al., 1978).

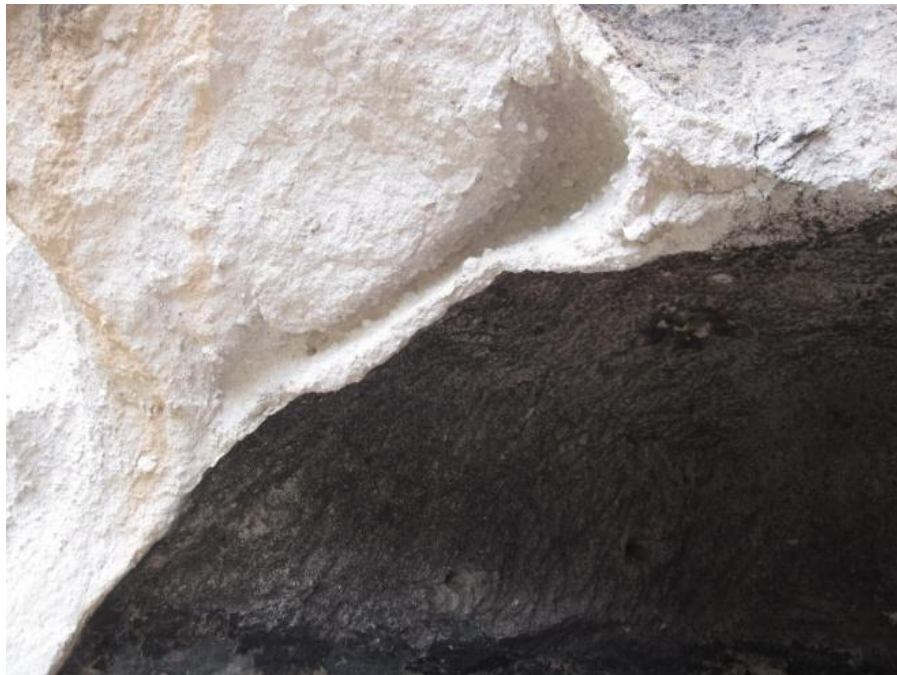
FIGURE 6. SAGGING OF SOOTED CEILING AT A-GROUP.

One of the features of interest in this work was the collapsing ceilings that had been coated with a layer of soot (Fig. 6). We collected several samples that had fallen completely off the cavates.

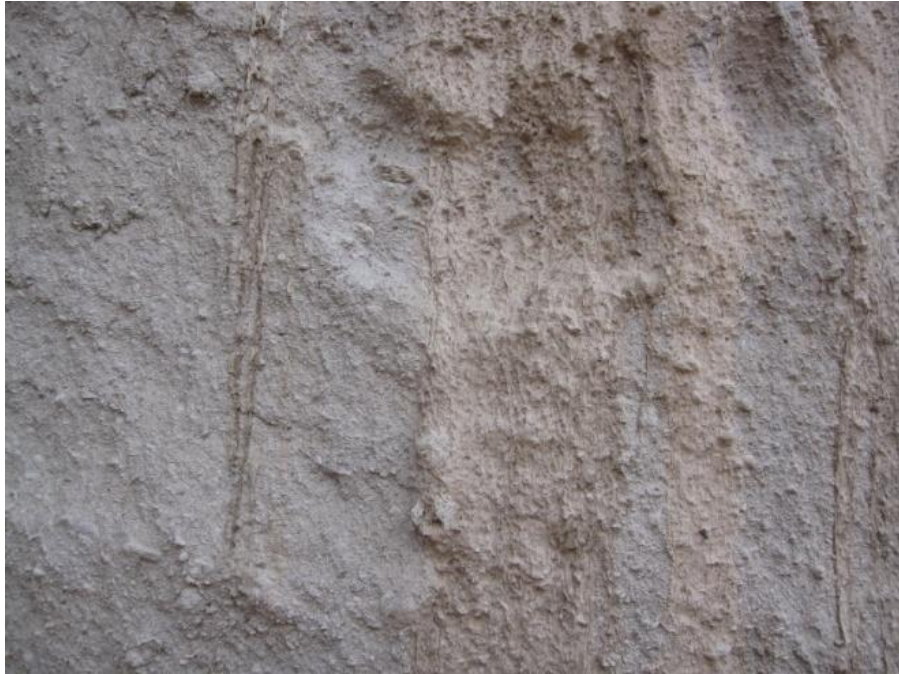
FIGURE 7. CLAY-COATED SURFACE AT GROUP M.

Run-off from the mesa top over the cliff surface deposits a vertical layer of clay on the tuff. When the clay hardens in the sun, it forms a resistant coat that strengthens the surface (Fig. 7). These clay coats are not as wide-spread as the VPC surfaces, but may play an important role in preserving the cliff face.

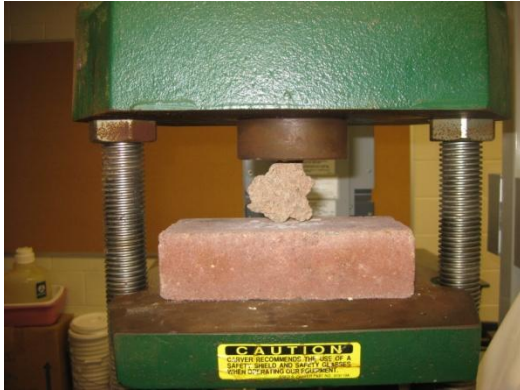
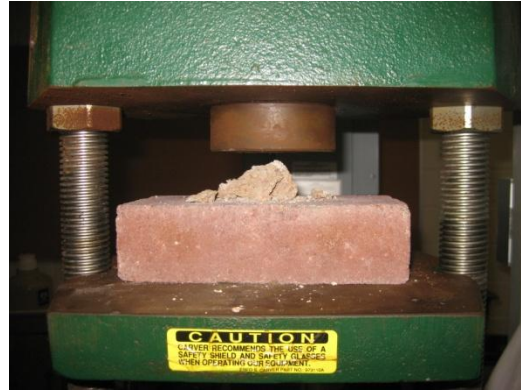
After Compression

The surfaces with the highest compressive strengths are VPC and VPC with lichen, which are also the most durable surfaces. Sample size may play a role in compressive strength since that largest VPC and VPC with lichen samples had the highest failure pressures.

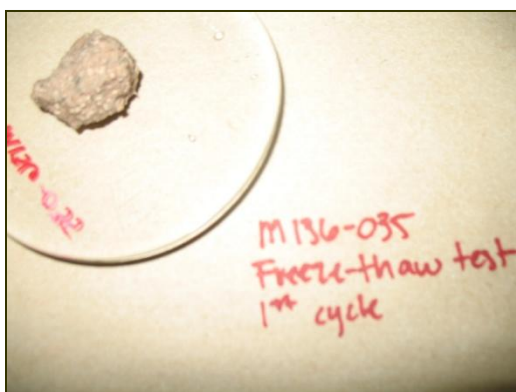
Sample M136-035 after immersion in  $\text{xxH}_2\text{O}$  for the first cycle.

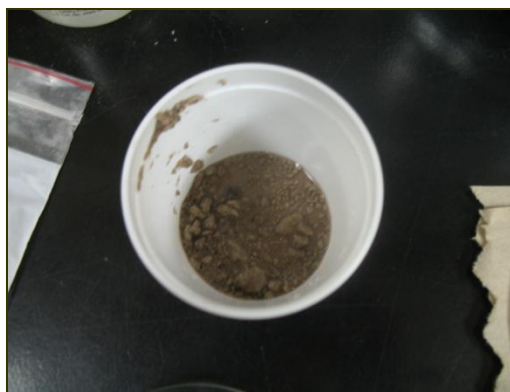
Material lost from sample M136-035 during immersion in  $\text{xxH}_2\text{O}$  for the first cycle.

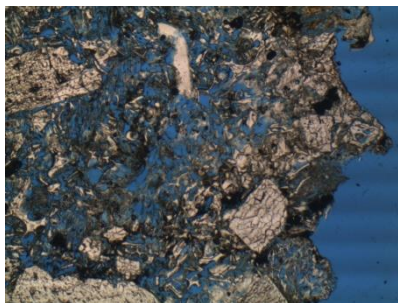
The sample of the Lichen covered surface also has small variation in porosity between the surface and interior. The surface is slightly less porous than the interior. The pumice in this sample varies in porosity. Some of the pumice in the rock had the "Smashed" appended where as others had more open pore spaces. The porosity observed in this sample strongly resembled unaltered tuff.
