# Inventory of Coastal Engineering Projects in Golden Gate National Recreation Area

Natural Resource Technical Report NPS/NRSS/GRD/NRTR—2013/734

May 2013

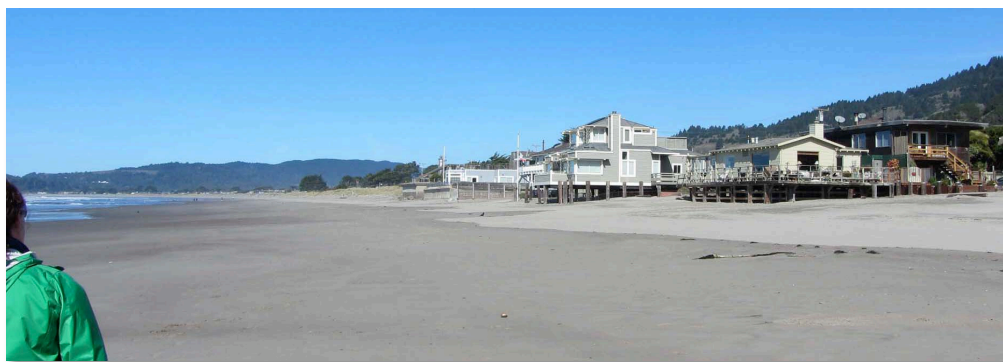
**Figure 3.** Stinson Beach with homes built on stilts on the back beach. View is to the northwest (image by Kate Dallas).

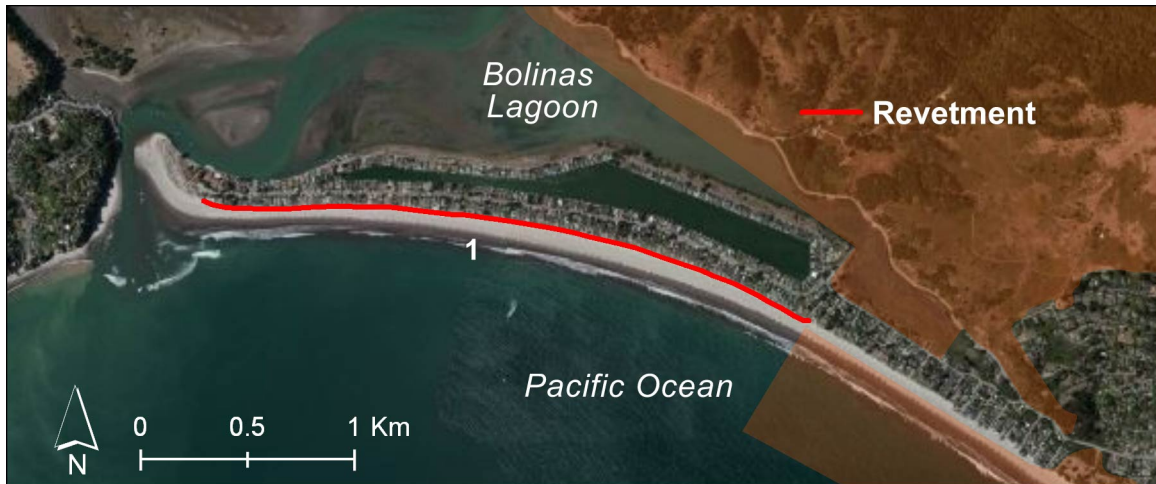
**Figure 5.** Stinson Beach structure map. Orange shading shows park property (image from ESRI Bing Maps basemap layer 2012).

Following the damage or destruction of over 65 homes in the winter of 1982, a 7.5-kilometer (4.7 mi) long revetment was built along the beach just to the north of GOGA (#1 Figure 5) at a cost that exceeded \$525,000 (in 2005 dollars) (Savoy et al. 2005). Since the early 1990s the NPS has maintained the dunes along the southern section of the beach (within GOGA) periodically to store sand that has blown into the parking lot (NPS 2009).

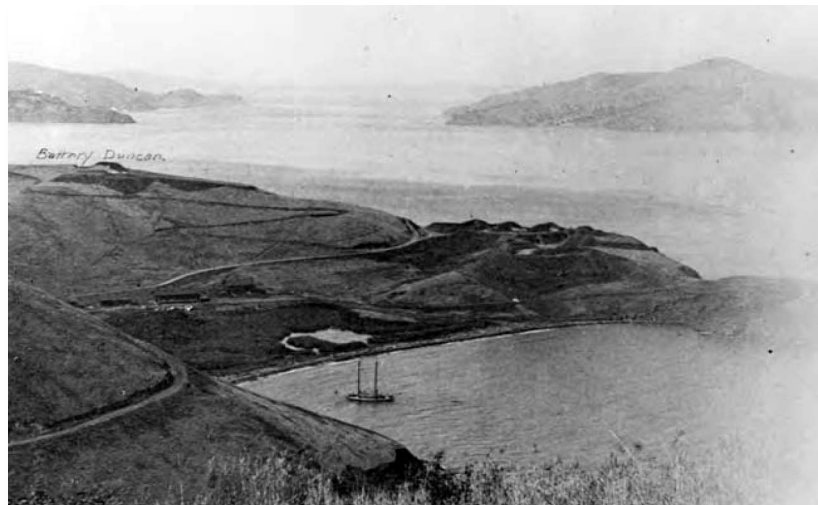
**Figure 6.** Horseshoe Cove circa 1905 (from NPS no date a).

Fort Baker is a historic army post located on the north side of the Golden Gate Bridge on Horseshoe Cove. Prior to construction of the fort, the natural harbor had a curving sand beach and brackish marshlands (Figure 6). Fort Baker was built between 1902 and 1910 to provide housing for the soldiers manning the seacoast defense batteries. Requiring more space for the fort, the U.S. Army Corps of Engineers (USACE) filled 28,330 m<sup>2</sup> (7 ac) of marshland in 1903 with 61,160 m<sup>3</sup> (80,000 yd<sup>3</sup>) of sediment (NPS no date a, NPS 2004).

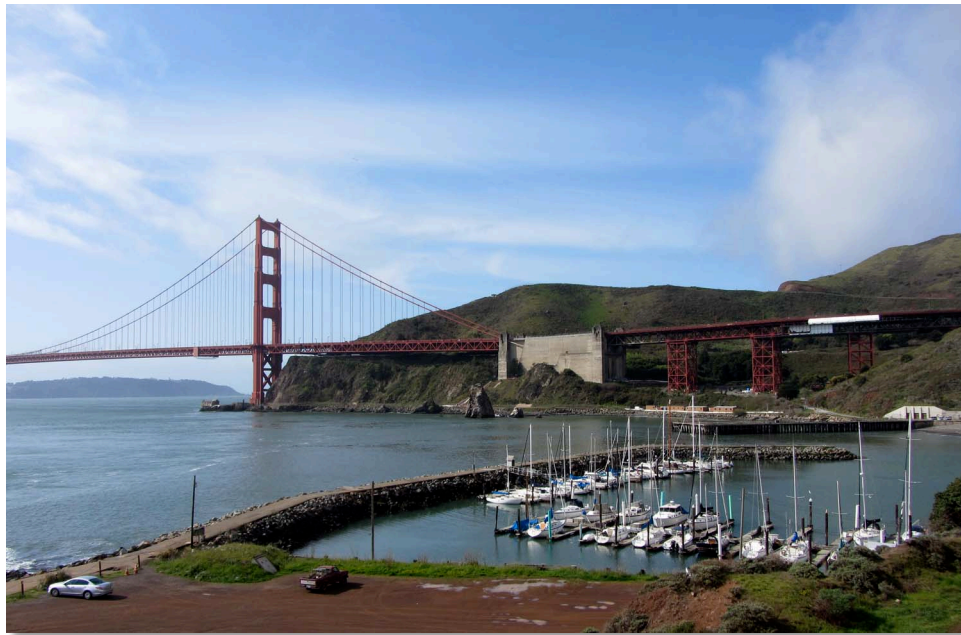
**Figure 9.** The Satterlee Breakwater and the Ft. Baker wharf (right middle) (#6 & #17 Figure 7) in front of the Golden Gate Bridge. View is to the southwest (image by Kate Dallas).

Two rock breakwaters provide shelter within the cove. The Moore Breakwater (#7 Figure 7) was constructed between 1937 and 1945 and was widened by the U.S. Coast Guard in the 1990s (NPS 2005a). The 237-meter (778 ft) long Satterlee Breakwater (#17 Figure 7 & Figure 9) was built in 1943 by the Army, and was improved and repaired from 1951 to 1984 (NPS 2004).

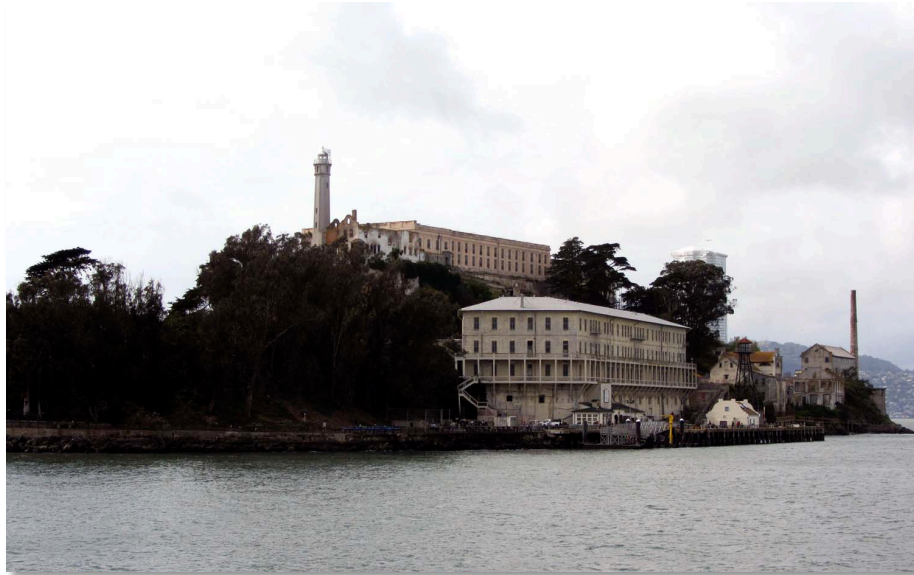
**Figure 10.** Alcatraz Island viewed from the southeast end of the island. The southern seawall and revetment (#24–25 Figure 11) are visible on the left and the ferry pier (#23 Figure 11) is in the middle right of the image (image by Kate Dallas).

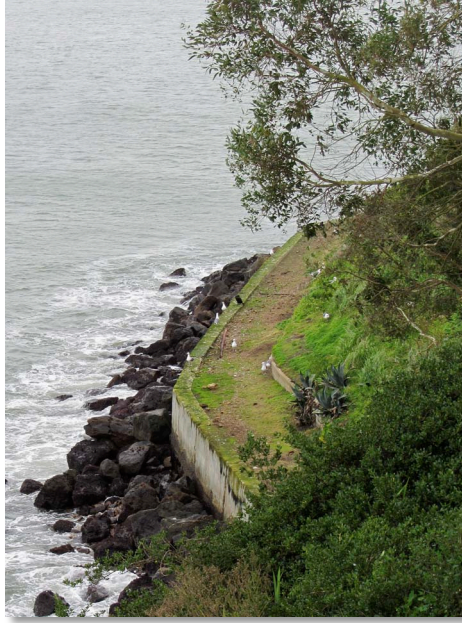
**Figure 12.** Northeast seawall and revetment on Alcatraz Island (#21–22 Figure 11) (image by Kate Dallas).

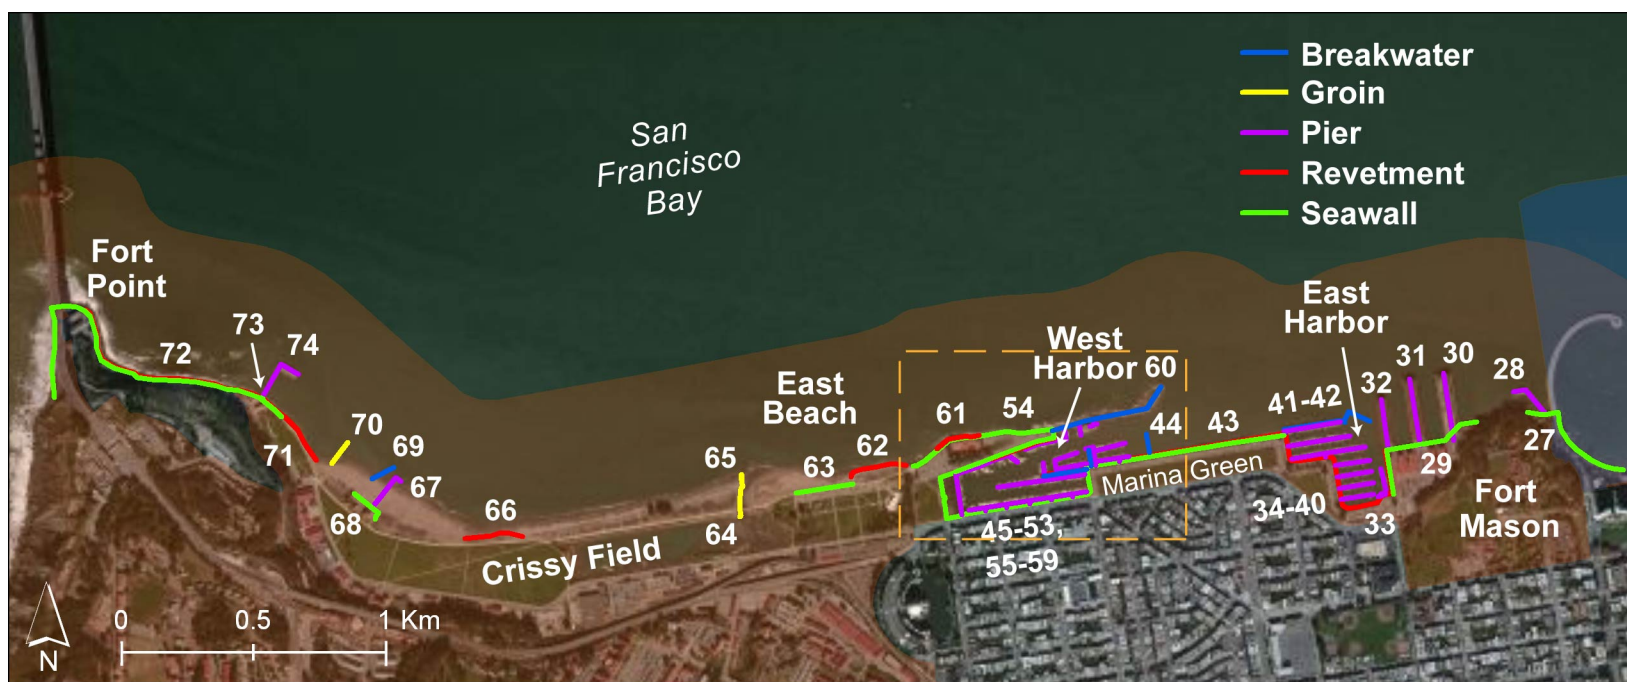
**Figure 13.** San Francisco structure map. Area in orange box is enlarged in Figure 16. Orange shading shows GOGA property and blue shading shows the boundary of the San Francisco Maritime National Historical Park (image from ESRI Bing Maps basemap layer 2012).

Circa 2000, 1,910 m<sup>3</sup> (2,500 yd<sup>3</sup>) of sand was placed on East Beach (Figure 13) (Porter 2003). A low, roughly 170 m (558 ft) long seawall was built under the sand using concrete highway barriers in December 2000 (#64 Figure 13) (Porter 2003). The seawall fronts a low, concrete seat wall that was built in 1998 or 1999 as a place for visitors to sit (Figure 20A). A rock revetment is also present on the east end of the beach (#63 Figure 13), but its installation date is unknown.

The timber breakwater to the north of the pier (#70 Figure 13) was built in 1938 to provide shelter to the Coast Guard operations (NPS 2006a). Northward of the breakwater is a concrete ramp (labeled as a groin, #71 Figure 13) that is usually buried in the beach. The seaplane ramp was built in 1921 by the Army and connected the bayshore with the aircraft hangers at Crissy Field (Haller 1994). This section of beach has experienced a significant increase in width in recent years, with shoreline accretion of +8.4 m/yr (+28 ft/yr) measured between 1993 and 2000 (Erikson et al. in review).

The concrete Crissy Field Fishing Pier, also known as Torpedo Wharf, is 115-meters (377 ft) long with an L-shape that is 60 m (197 ft) long (#73 Figure 13). Bishop (2012) documents that a pier has existed in this location since 1854. Torpedo Wharf was constructed in 1907–1910 at a cost of \$6,782 and was originally used to load submarine mines (Thompson 1997, Bishop 2012). In 1943 the wharf was rebuilt of reinforced concrete (Bishop 2012).

The Fort Point Seawall extends for nearly 1,120 m (3,670 ft) from southwest of the fort to past Torpedo Wharf (#74 Figure 13 & Figure 21). The seawall was built in stages between 1861 and 1933 and has been repaired numerous times (Table 4). From roughly 1861 to 1869 a 610 m (2,000 ft) long granite seawall, called the DeRussy Seawall, was completed around the tip of Fort Point at a cost of \$400,000 (Martini no date, Bearss 1973, Bishop 2012). A second seawall, named after Major Elliot, was built adjacent to the DeRussy Seawall and extended the seawall an additional 183 m (600 ft) to the east.

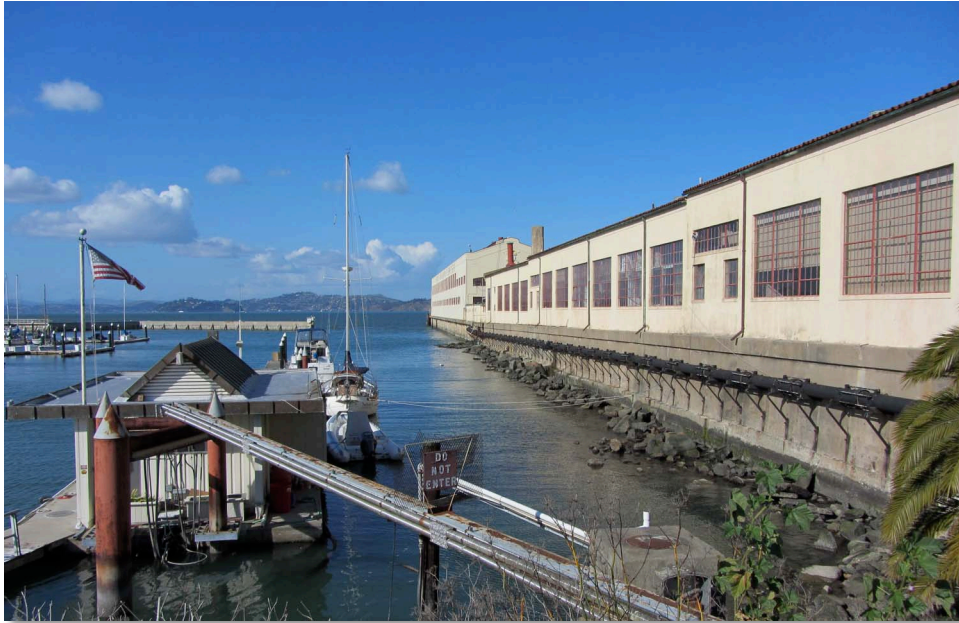
**Figure 14.** Fort Mason's Pier 1, seawall, and revetment (#29, 32, 33 Figure 13). Piers and a breakwater (middle left) in the San Francisco Marina's East Harbor are also visible (#35, 40, 41 Figure 13). View is to the north (image by Kate Dallas).

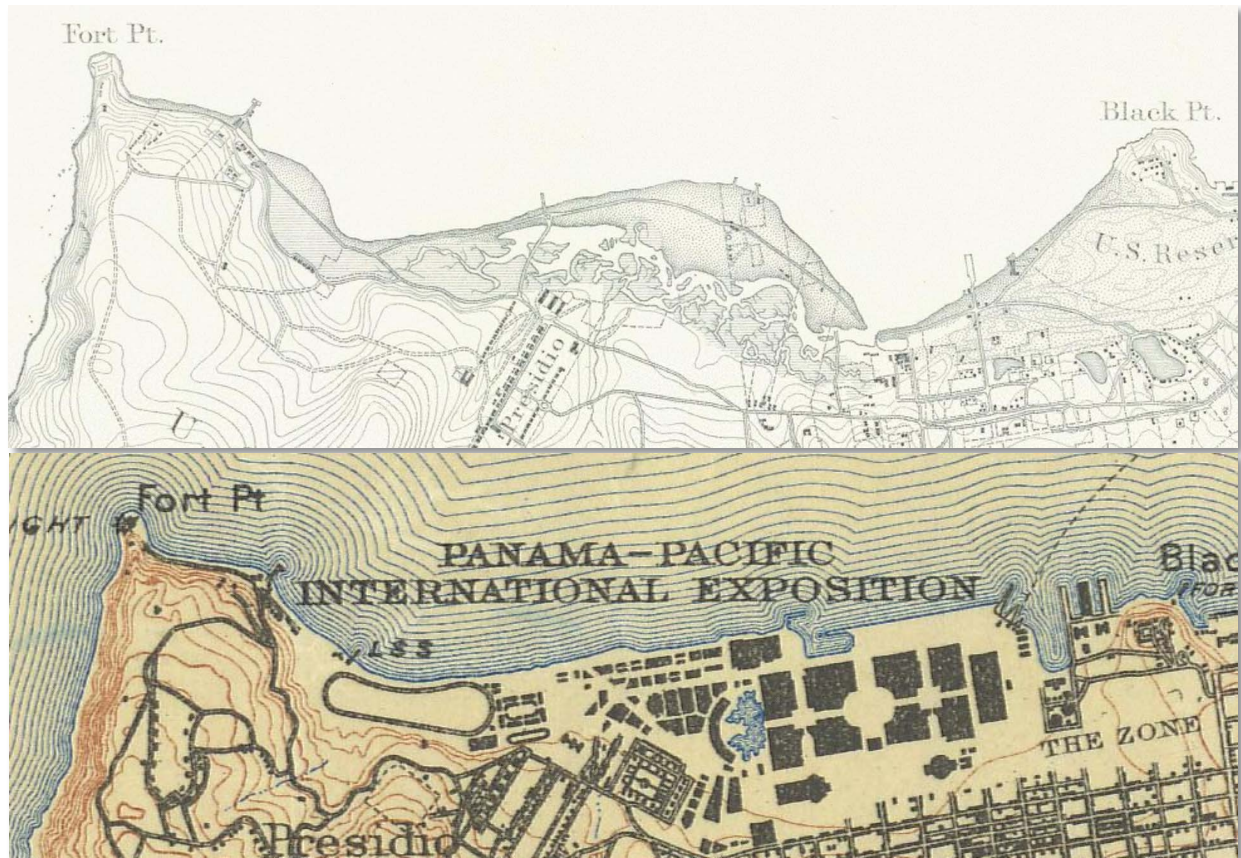
**Figure 15.** Comparison of nautical charts of the northern San Francisco shoreline in 1869 (top) and 1915 (bottom) illustrate the significant filling that occurred during this time period (from U.S. Coast Survey (1869) and U.S. Geological Survey (1915)).

Historically, the northern San Francisco coast had an irregular, marshy shoreline and a shallow bay called Marina Cove (Figure 15) (Bonilla 1991). Filling occurred along the northern San Francisco shoreline between 1869 and 1917, primarily in 1912 in preparation for the 1915 Panama-Pacific International Exposition that celebrated the completion of the Panama Canal (Figure 15) (Bonilla 1991). Fill placed from 1869 to 1906 likely included beach sands and debris from the 1906 earthquake and fire (Bonilla 1991). To accommodate the exposition, 0.7 km<sup>2</sup> (184 ac) were filled in 1912 with 1.3 million m<sup>3</sup> (1.7 million yd<sup>3</sup>) of fill (70% sand and 30% mud) mined from Presidio Shoal at a cost of \$302,000 (Markwart 1915).

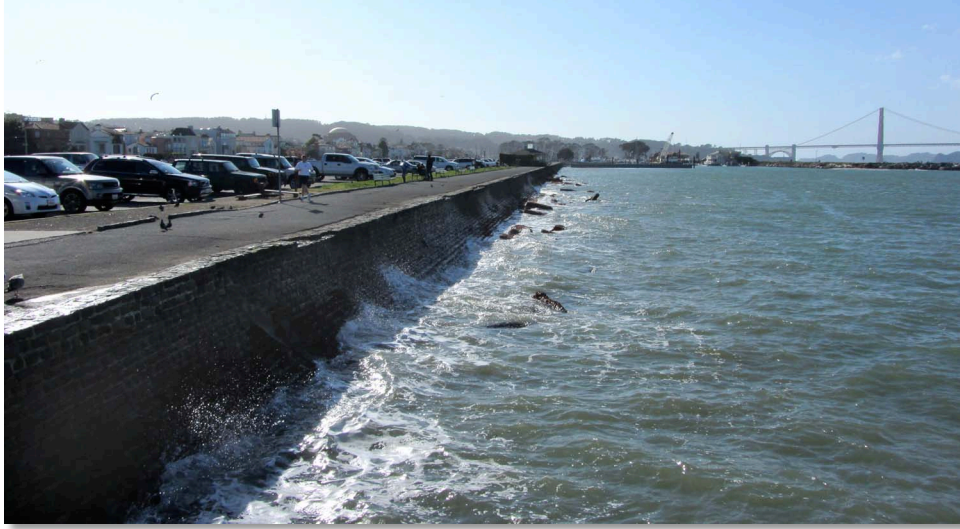
**Figure 16.** James Fair Seawall along the Marina Green (#43 Figure 13). View is to the southwest (image by Kate Dallas).

The James Fair Seawall was completed in 1894 to contain the newly placed fill by dumping rock from a railroad trestle (Bonilla 1991). The rock seawall was ultimately replaced with a concrete seawall (#43 Figure 13 & Figure 16) that was constructed in phases until 1938. The seawall was extended an additional 335 m (1,100 ft) to the west of Scott Street in 1934 by WPA laborers (Treadwell & Rollo 1997, SFPD 2007). The 1934 addition is commonly referred to as the Marina Boulevard Seawall and is composed of concrete with a basalt rock facing. Today the Fair & Marina Boulevard Seawalls extend seamlessly for 1,890 m (4,230 ft) from the East Harbor to the St. Francis Spit (Figures 13 & 17).

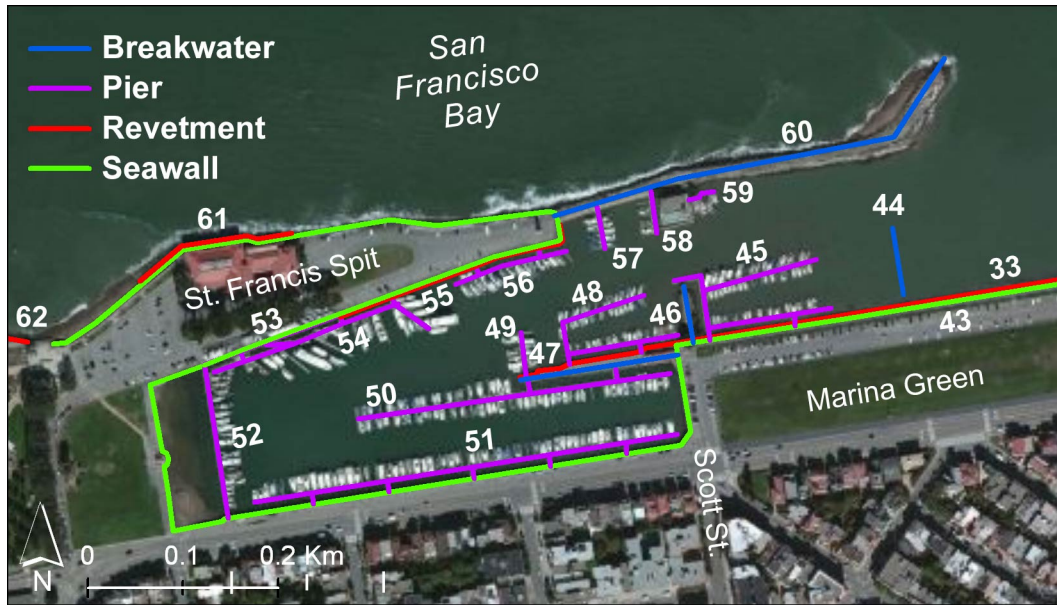
**Figure 17.** West Harbor structure map (image from ESRI Bing Maps basemap layer 2012).

The St. Francis Spit (Figure 17) was filled during the early 1900s through the 1930s (SFPD 2007). A seawall surrounds the spit (#53 Figure 17 & Figure 18) and was likely constructed near the end of filling in the 1930s. The spit was extended in 1958 by the Recreation and Park Department with construction of the 335-meter (1,100 ft) long rubble breakwater (#60 Figure 17 & Figure 18), changing the location of the harbor entrance (SFPD 2007). The Scott St. mole (labeled as a breakwater, #46 Figure 17), is a remnant of the pre-1958 breakwater that served as part of the earlier entrance channel. A 138-meter (453 ft) long rock revetment was built in front of the St. Francis Yacht Club building circa 1940 and was recently repaired (#61 Figure 17) (Frank Filice, SFDPW, email, 2-22-13).

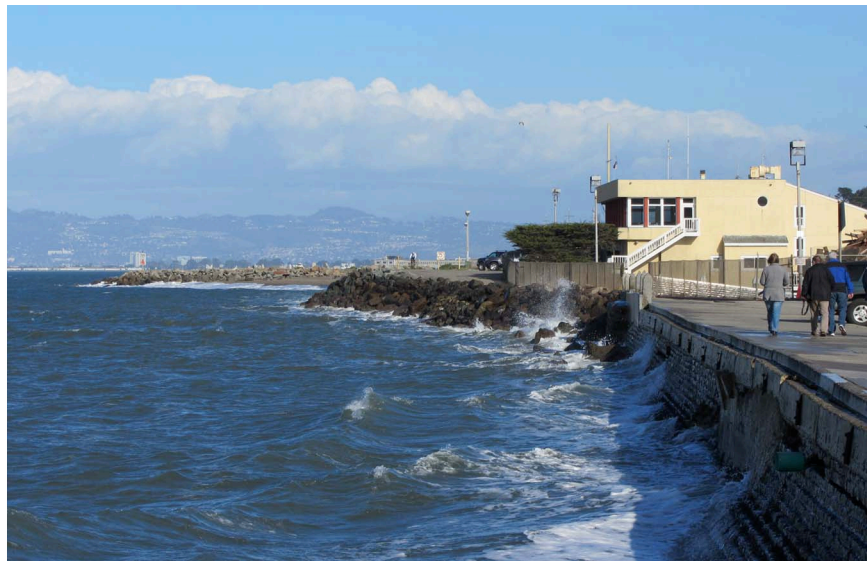
**Figure 18.** St. Francis Spit seawall and rubble breakwater (#53, 60 Figure 17). View is to the east (image by Kate Dallas).

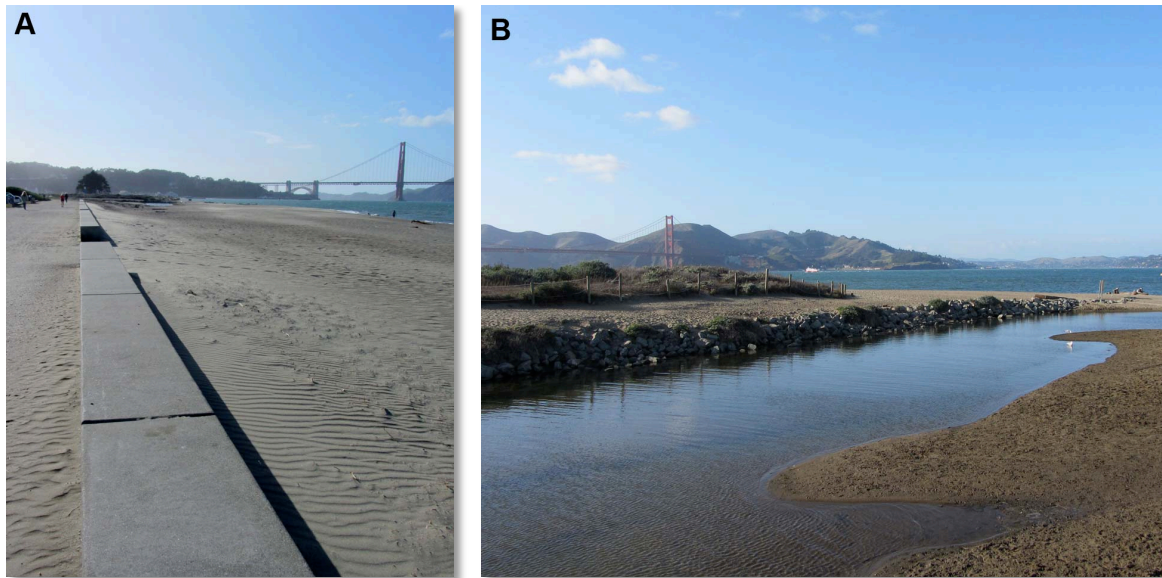
**Figure 20.** Crissy Field's (A) seat wall and location of buried (i.e. non-visible) concrete seawall and (B) rock groin (#64–65 Figure 13) (images by Kate Dallas).

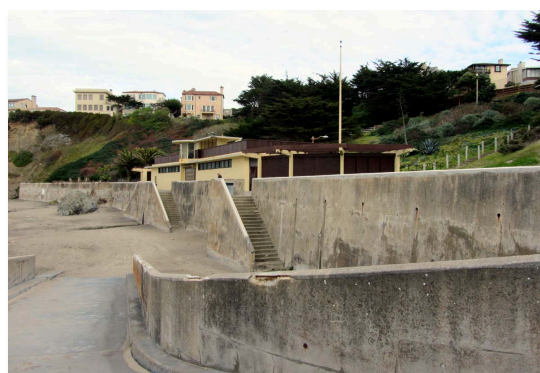
**Figure 23.** China Beach seawall (#76 Figure 24) (image by Kate Dallas).

The very southern end of Baker Beach has a low, concrete seawall that protects a sloping hillside with private homes (#75 Figure 24). At China Beach, a tall concrete seawall constructed circa 1951 armors nearly the entire beach (Figure 23 & #76 Figure 24).

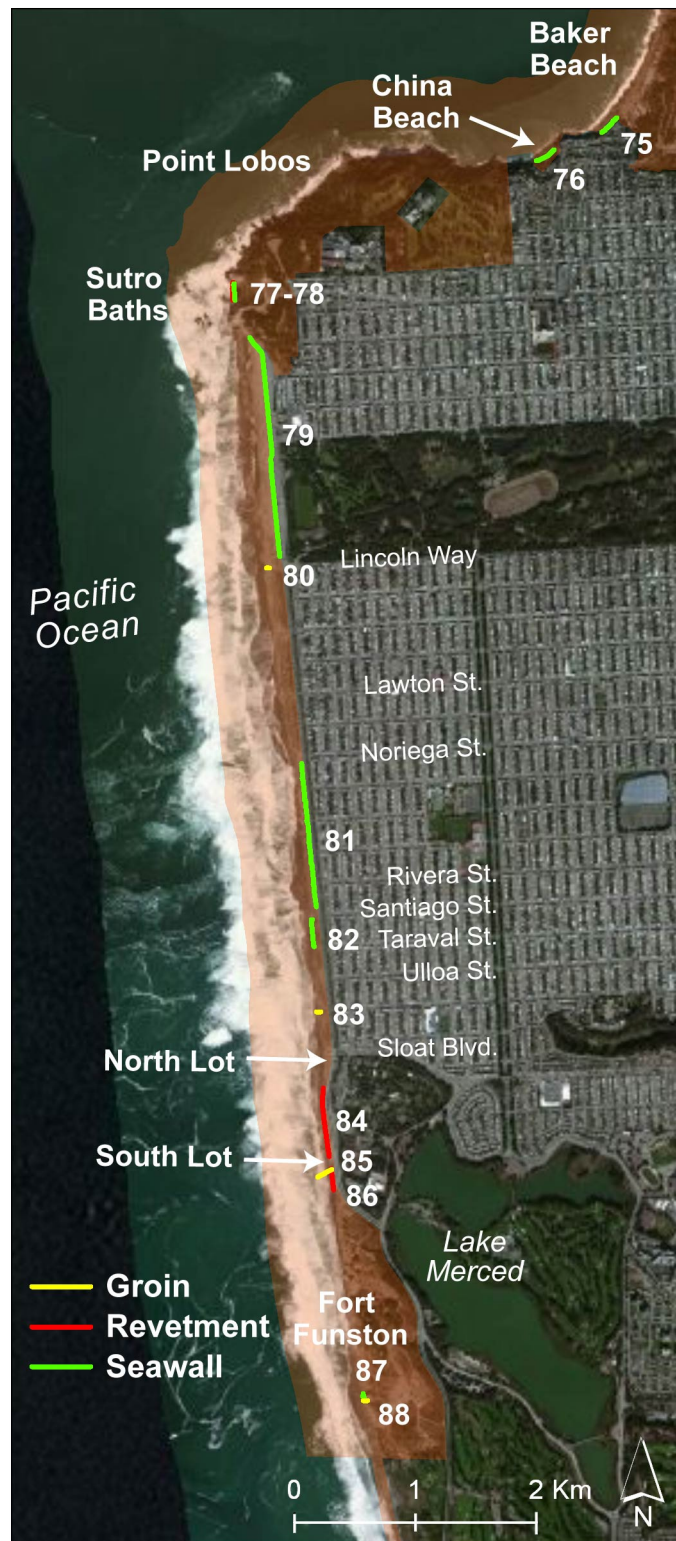
**Figure 24.** Baker, China, and Ocean Beach structure map. Orange shading shows park property. Groin #85, the Southwest Ocean Outfall pipe, extends 7.2 km (4.5 mi) offshore (not shown) and Groin #88, the Vista Grande Outfall, extends 762 m (2,500 ft) offshore (not shown) (image from ESRI Bing Maps basemap layer 2012).

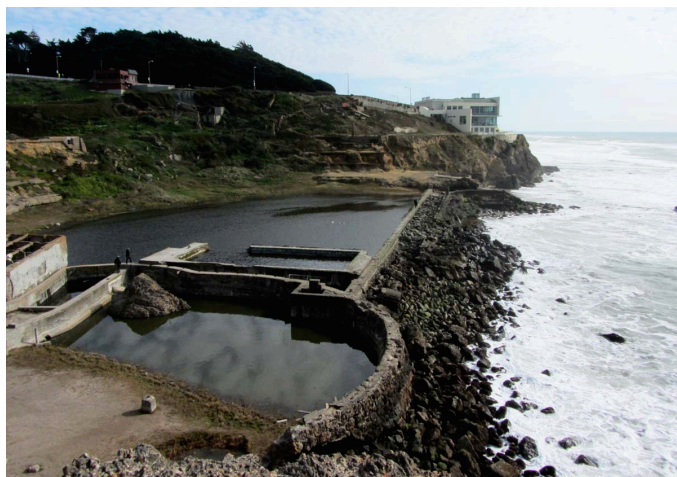
**Figure 25.** Sutro Baths' ruins with its concrete and rock seawall and revetment (#77–78 Figure 24). View is to the south (image by Kate Dallas).

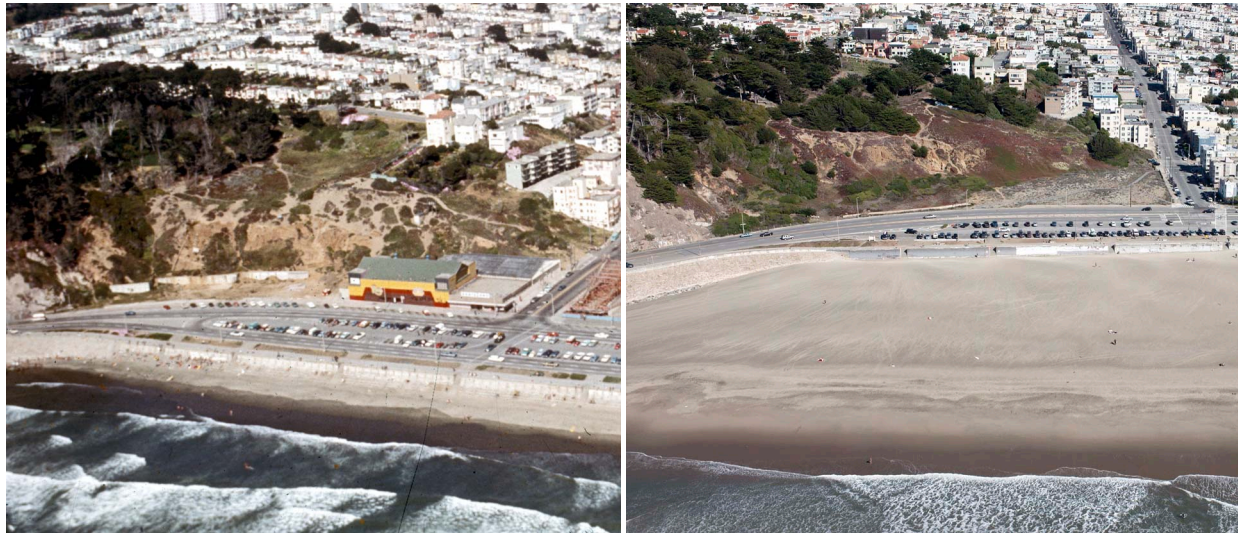
**Figure 26.** Oblique aerial imagery of northern Ocean Beach and the O'Shaughnessey Seawall (#79 Figure 24) in 1972 (left) and 2009 (right) illustrates the significant progradation that has occurred on the northern section of the beach (from Adelman and Adelman 2012).

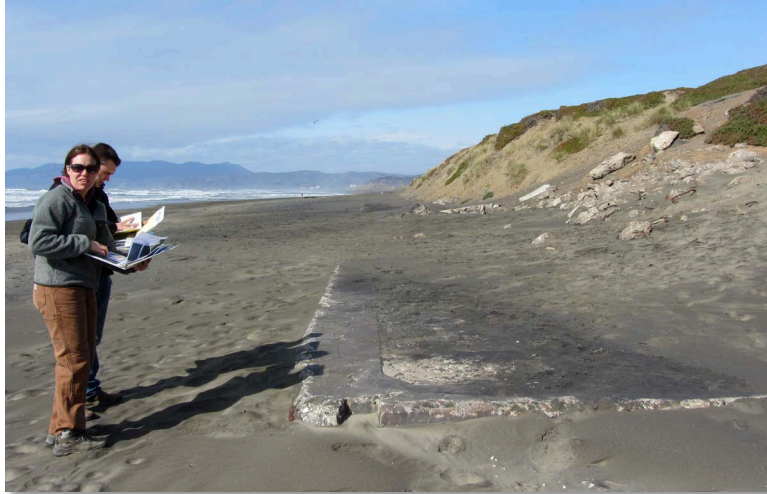
**Figure 27.** Jodi Eshleman and Mike Berry at the buried Taraval Seawall (#82 Figure 24). Concrete rubble is also visible on the dune face. View is to the north (image by Kate Dallas).

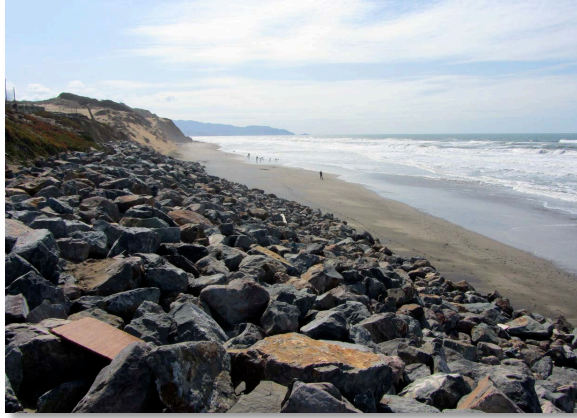
**Figure 28.** Revetment at southern Ocean Beach installed in 2010 (#86 Figure 24). View is to the south towards Fort Funston (image by Kate Dallas).

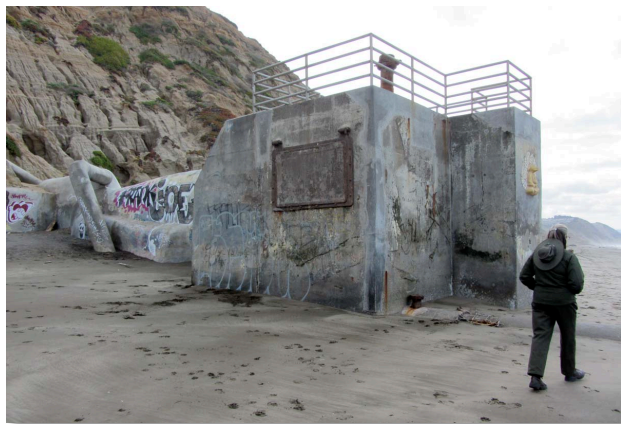
**Figure 30.** Vista Grande Outfall at Fort Funston (#88 Figure 24). View is to the south (image by Kate Dallas).

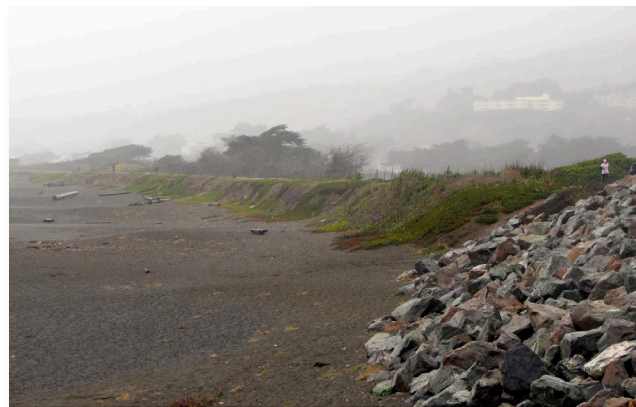
**Figure 32.** Levee and revetment at Mori Point/Sharp Park (#93–94 Figure 31). View is to the northeast (image by Kate Dallas).

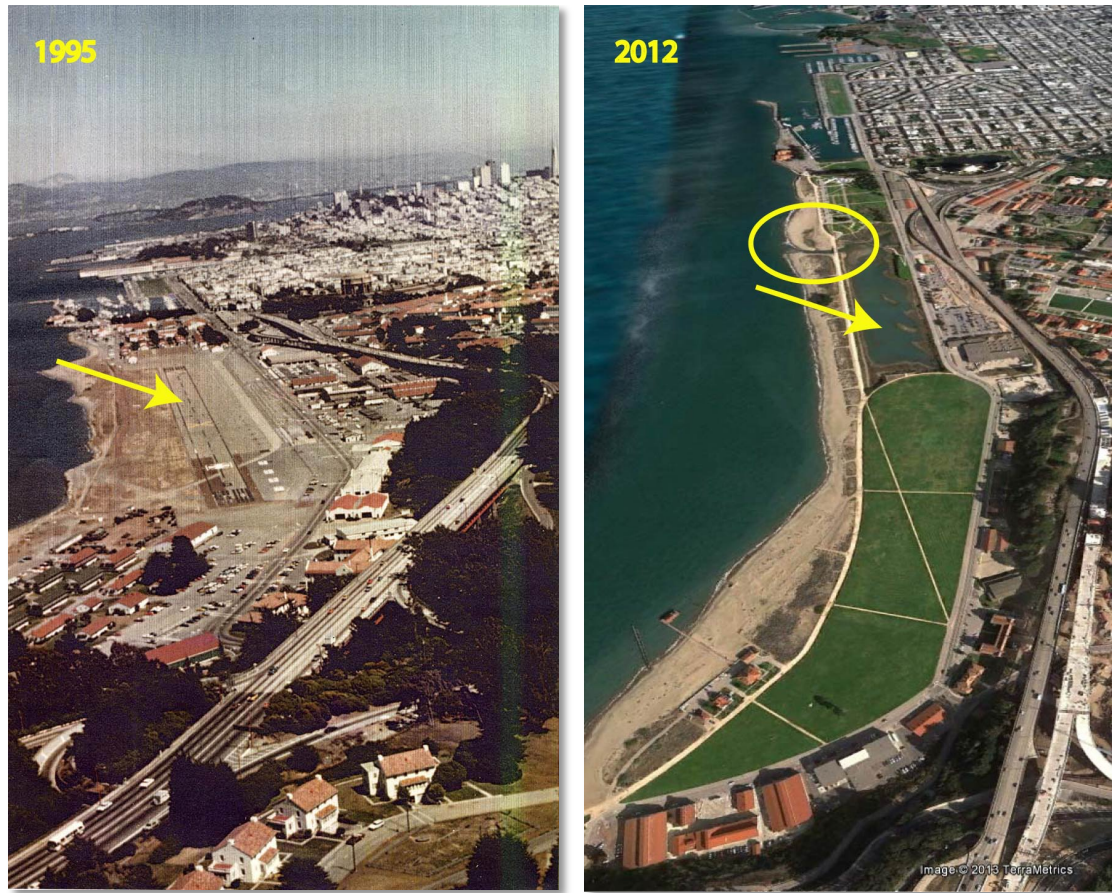
**Figure 37.** Aerial images of Crissy Field before (1995) and after (2012) the 1998–1999 restoration project. Arrow represents location of restored marshlands, circle indicates area of the restored tidal outlet (from NPS 2013b & Google Earth 2012).

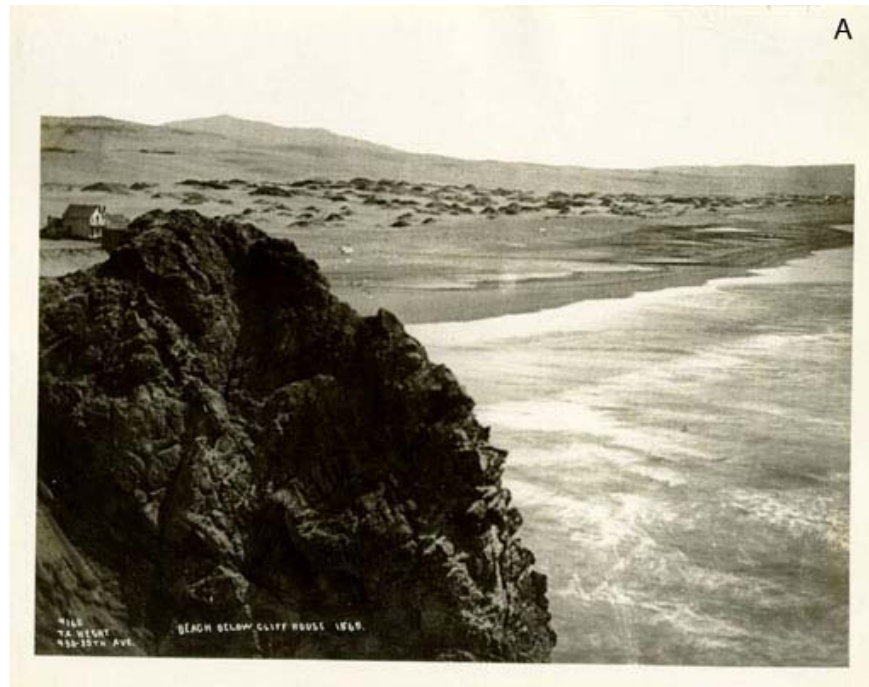
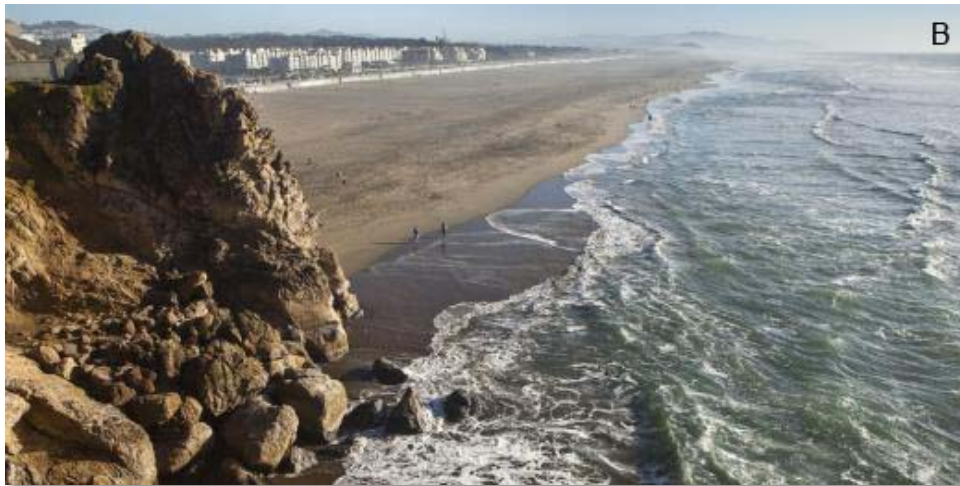
**Figure 38.** Comparison of Northern Ocean Beach in (A) 1865 and (B) 2012 illustrates the extensive residential development, construction of the O'Shaughnessey Seawall, and progradation of the shoreline due to artificial fill and natural processes (top image from the San Francisco Library 2012, photo AAB-9721, bottom image from SPUR 2012).

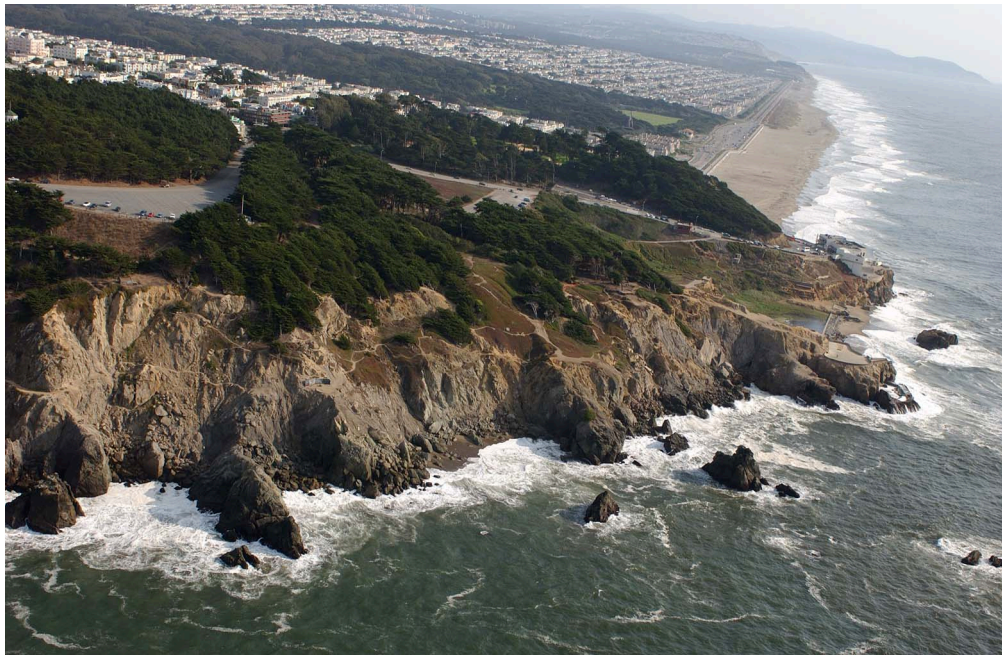
**Figure 40.** A 2002 oblique aerial image of Point Lobos and northern Ocean Beach shows how the headlands of Point Lobos act as a littoral barrier. View is to the southeast (from Adelman and Adelman 2012).

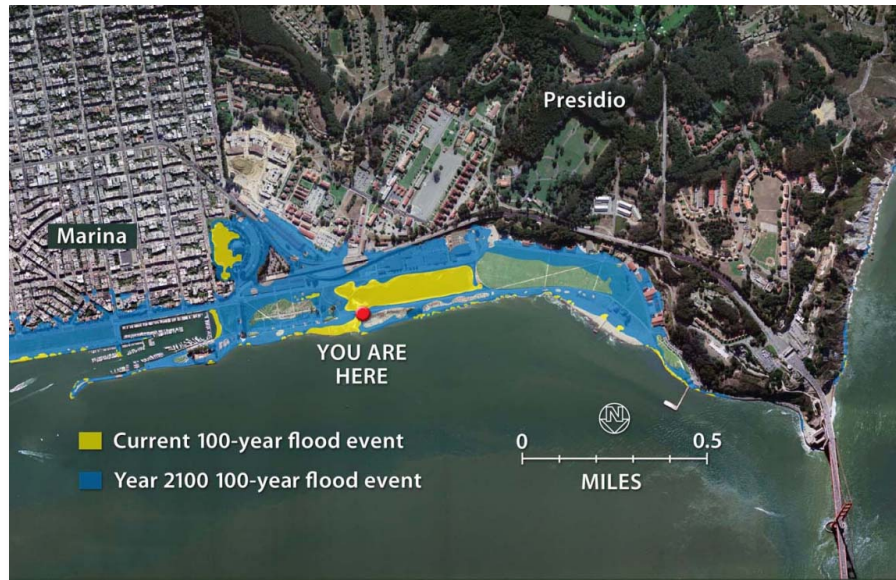
**Figure 42.** Map showing Crissy Field's increased vulnerability to flooding given a 1.4 m (4.6 ft) rise in sea level (from NPS 2013c).
