# PARK PRACTICE

## Increasing the Odds for Accurate Restoration

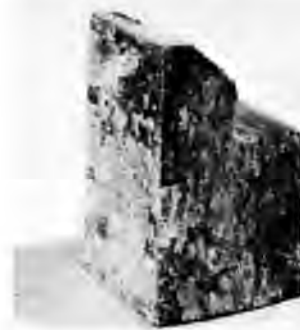
*This small dentil was found between a floor joist and the wall in Independence Hall where it fell during a remodeling in 1815-16. The 51 mm x 32 mm fragment yielded clues to the size of the original room cornice and contained all paint colors applied to the woodwork.*

Small, seemingly insignificant pieces may prove to be of great value. The restoration crew working in the Assembly Room of Independence Hall in Philadelphia found a dentil from the original cornice of the room where it had fallen between a joist and the wall. The cornice had been removed in a

massive remodeling in 1815. This little fragment, about half the size of a cigarette package, gave us, by proportion, the size of the complete cornice and all paint layers from the original construction until 1815. It could have been easily overlooked.

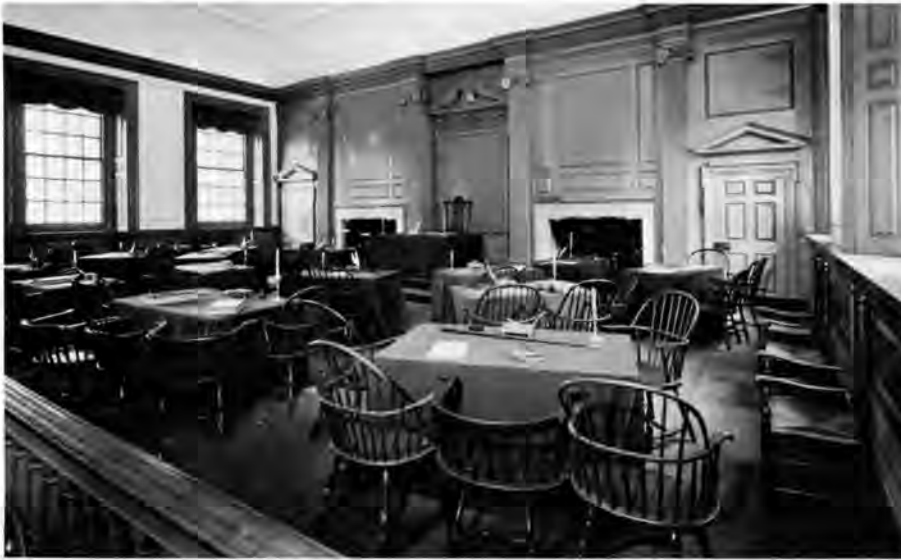
*The Assembly Room in Independence Hall, Philadelphia, as restored. Reused and derelict materials found under later alterations proved vital in the restoration of this room where the Declaration of Independence was signed.*

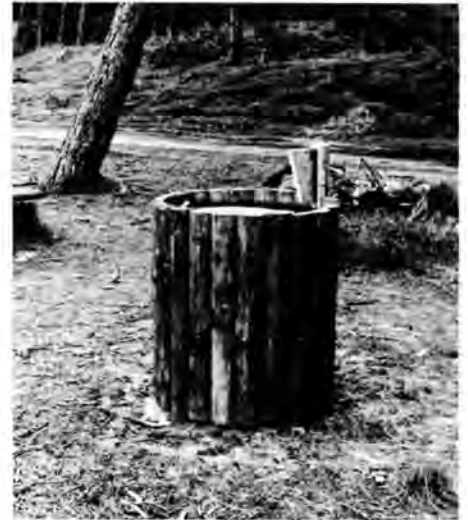
A simple block of wood with one face cut at an angle is all that is needed to make certain the hinged lid of this rubbish bin can never be left open. The idea and photo comes to us from Dr. E. C. M. Roderkerk, former Director of Kennemerduinen National Park, The Netherlands.

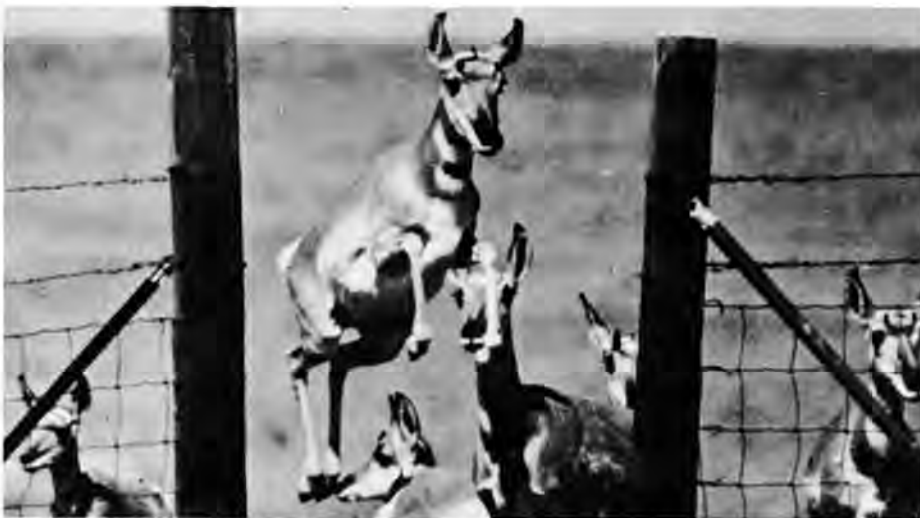
*Antelope leap through a break in a cattle fence known as an "antelope pass." A grating over a shallow pit 1 1/2 metres wide and 2 metres across (the leaping distance) made of pipe, steel bars or wooden poles on 15 cm spacings impedes cattle from crossing the break. This idea, which has been studied and tested in the western USA for many years, may have applications in parks or reserve areas where movement of wild ungulates is impeded by fences erected to control cattle or sheep. Details are available from the Bureau of Land Management, US Department of the Interior, Washington, D. C. 20240. U.S.A.*

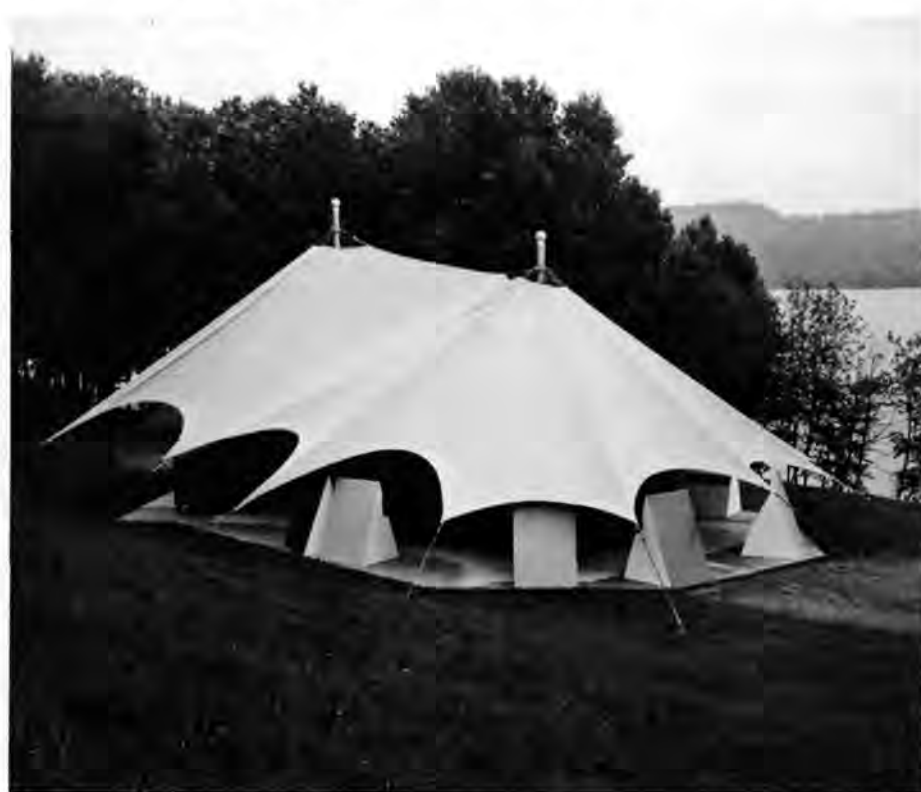
The pavilion is built on a concrete base of irregular shape with maximum dimensions of 72 by 40 ft. (21.94 m × 12.19 m). Well anchored in this base are the posts that support the canvas roof as well as the wind-screens of the audio-visual show room. Although the main part of the pavilion is rather small in size (25' × 15' or 7.62 m × 4.57 m), it offers an excellent area for exhibits. The display windows have a total exhibit space of 432 cu. ft. (12.23 cubic meters) and the walls measure approx. 350 sq. ft. (32.5 square meters). Inside the pavilion, there is multifunctional space: a booth for the projection equipment, access to the display windows, and miscellaneous storage.—René Rivard, Parks Canada

A pavilion housing a history exhibit was built last year at the national historic site of Fort Temiscamingue, Ville-Marie, Quebec. It was designed with the following original features: the exhibits do not fill the inside of the pavilion, but are arranged on the perimeter where visitors face the natural outside view. This feature results in savings in construction and operating costs, as well as maximum utilization of the pavilion's inner space, improved handling of visitors, and a better presentation of the exhibits. Built of wood and covered with a canvas tent during the summer season, this pavilion also has space for audio-visual presentations for groups of 20-30 persons. It is suitable for all kinds of sites and parks that do not require or cannot support large structures such as a museum or an information center.

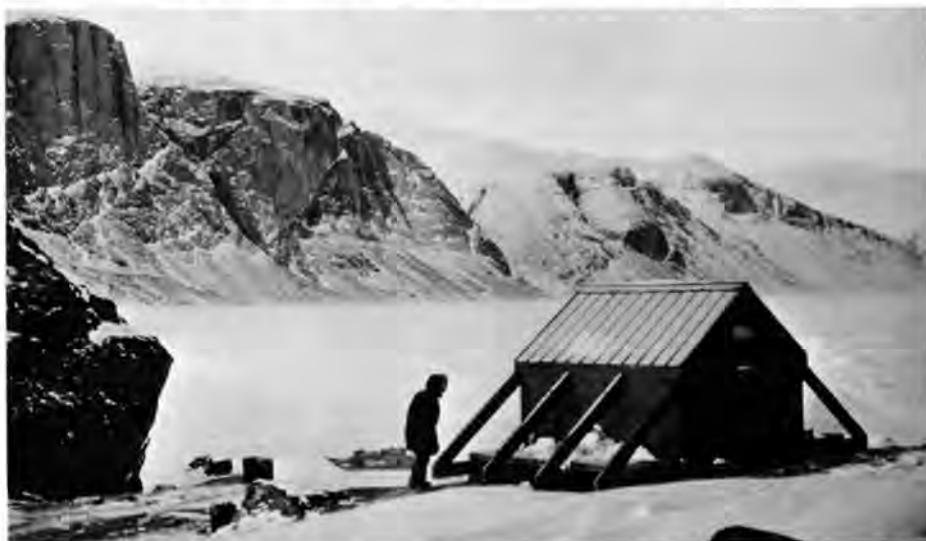
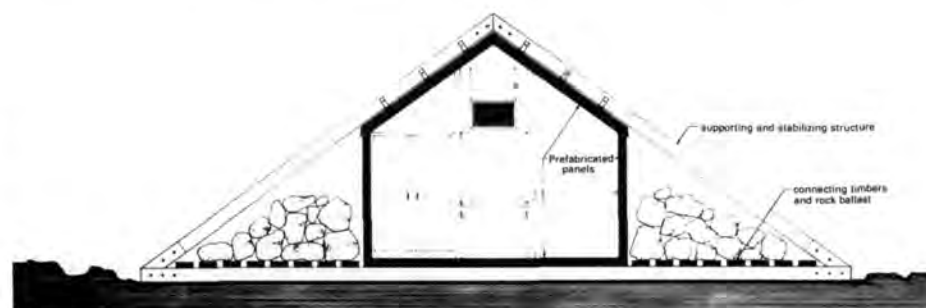
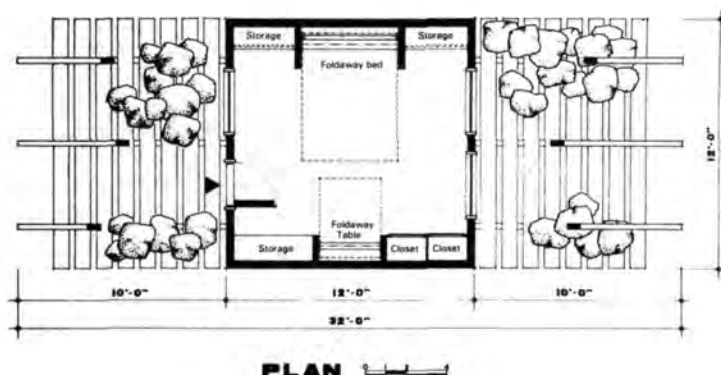
The photo and drawings give a clear idea of the construction principle of these shelters. Note that in this example the basic

frame consists of 4 triangular support structures of timber measuring  $3'' \times 8''$  (76 mm  $\times$  203 mm) in cross section. Prefabricated plywood panels with a core of solid insulating material are attached to this structure to form the floor, the side walls, and the two-sided sloping roof.

The outer horizontal members of the triangular support structure are bridged over with beams on which heavy rocks can be piled to anchor the shelter in place. It is set up directly on ground surface. All components are prefabricated and may be assembled or disassembled easily.
