National Park Service  
Cultural Landscapes Inventory  
2002

Buck Springs Overlook  
Blue Ridge Parkway - Pisgah District

The Buck Springs Overlook is a twenty-nine acre component landscape that is located at Milepost 407.6 on the Blue Ridge Parkway. The component landscape is a developed overlook area that has vehicular parking, trailhead access, a view of Mount Pisgah to the north as well as a view of the southern mountains and the Pink Beds to the south. One building exists within the component landscape - a springhouse that dates from the Vanderbilt period of significance. Several stone retaining walls and stone steps remain within the landscape that date to this time as well. Other developments within the landscape boundary date to the 1960s when the overlook was developed as part of the completion of the Blue Ridge Parkway through the vicinity.

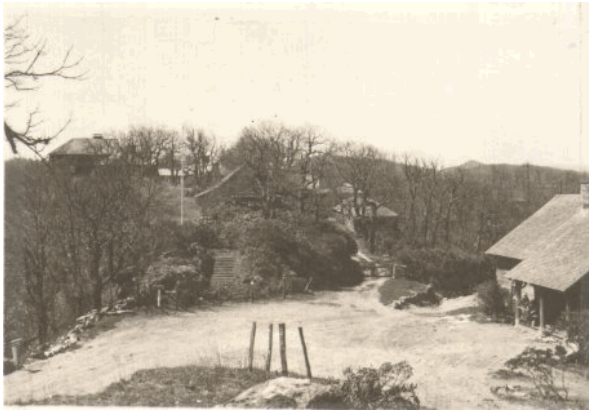
*Figure 5: Buck Spring Lodge developed area (date unknown). Area in left foreground is the present day Buck Springs Overlook (NPS).*

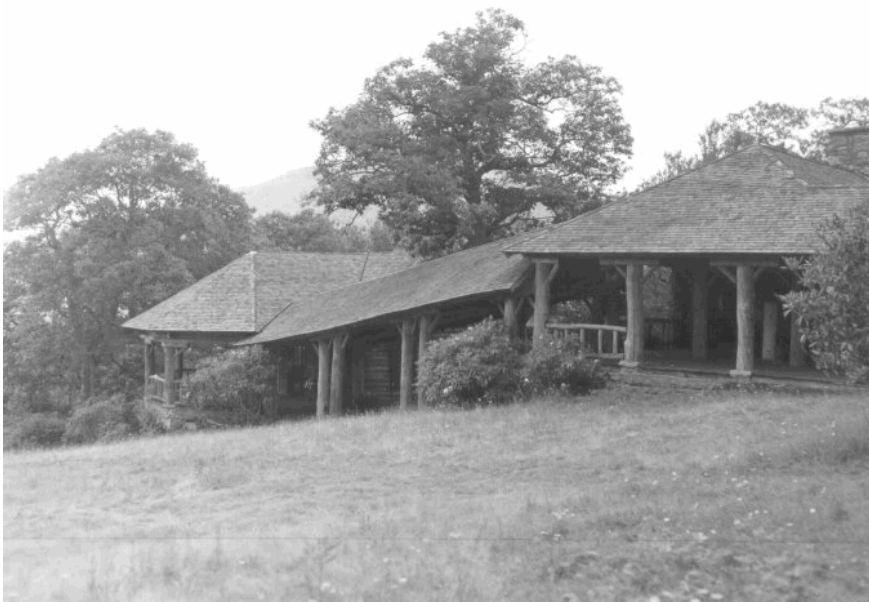
*Figure 7: View of dining area and arcade to sleeping area with cleared grassed area in foreground, date unknown (NPS).*

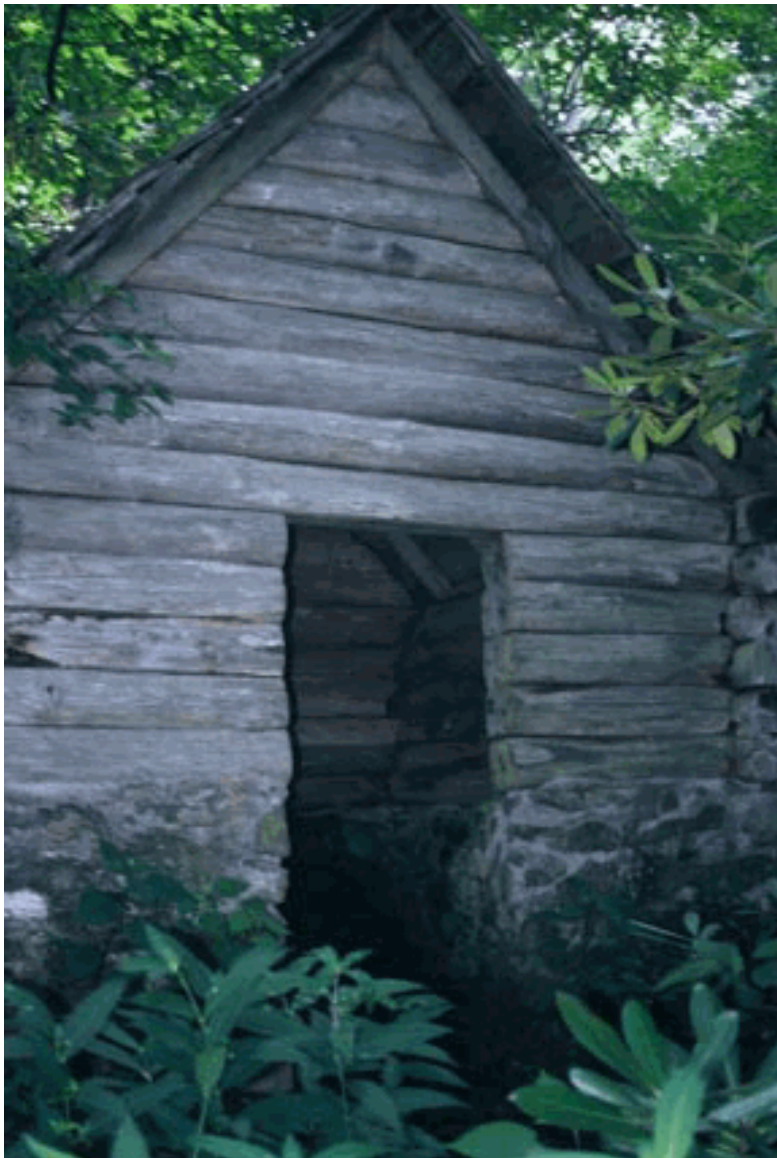
*Figure 8: 2002 view of the front facade of the springhouse (NPS).*

One stone springhouse and several stone walls date to the Vanderbilt period of significance. The ca. 1896 springhouse is located northwest of where the main lodge once stood. Its stone foundation and notched log walls are typical of vernacular farmstead springhouses from this time period. The extant ca. 1896 stone walls were constructed as retaining walls since the lodge complex was constructed on a sloping site.

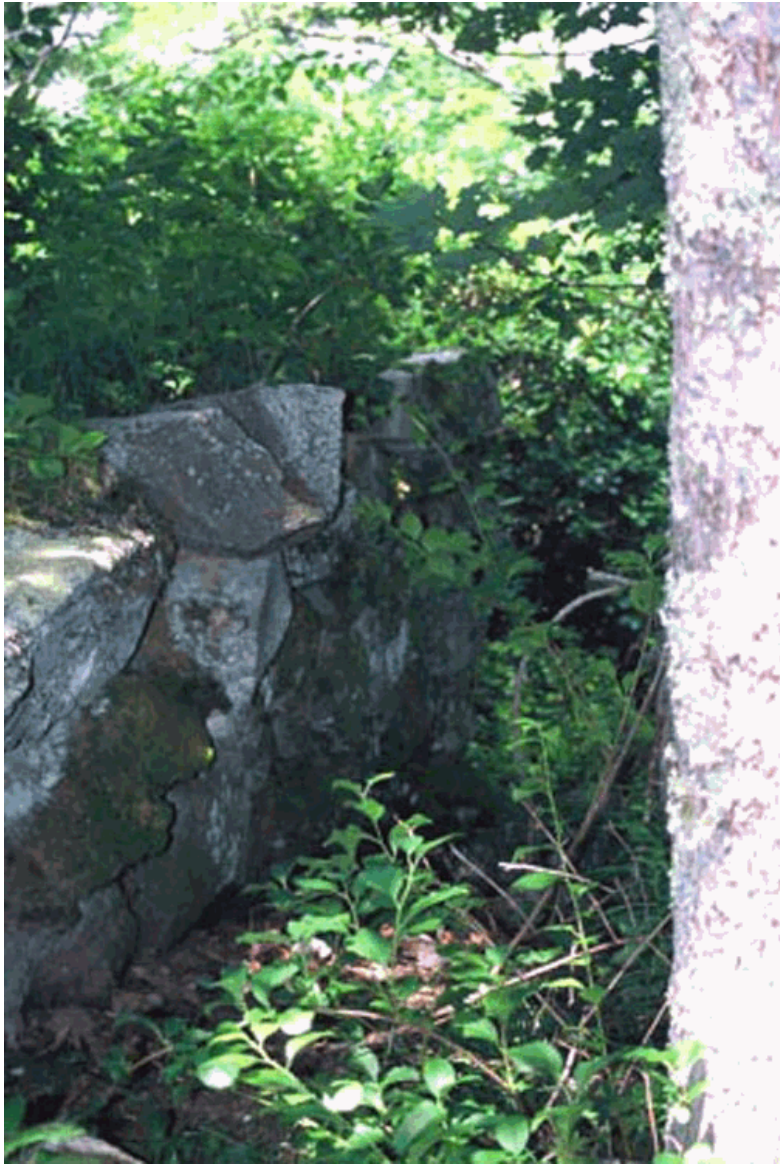
*Figure 9: Portion of a stone wall that dates to the Vanderbilt era. These walls are now currently obscured by dense vegetation (NPS).*

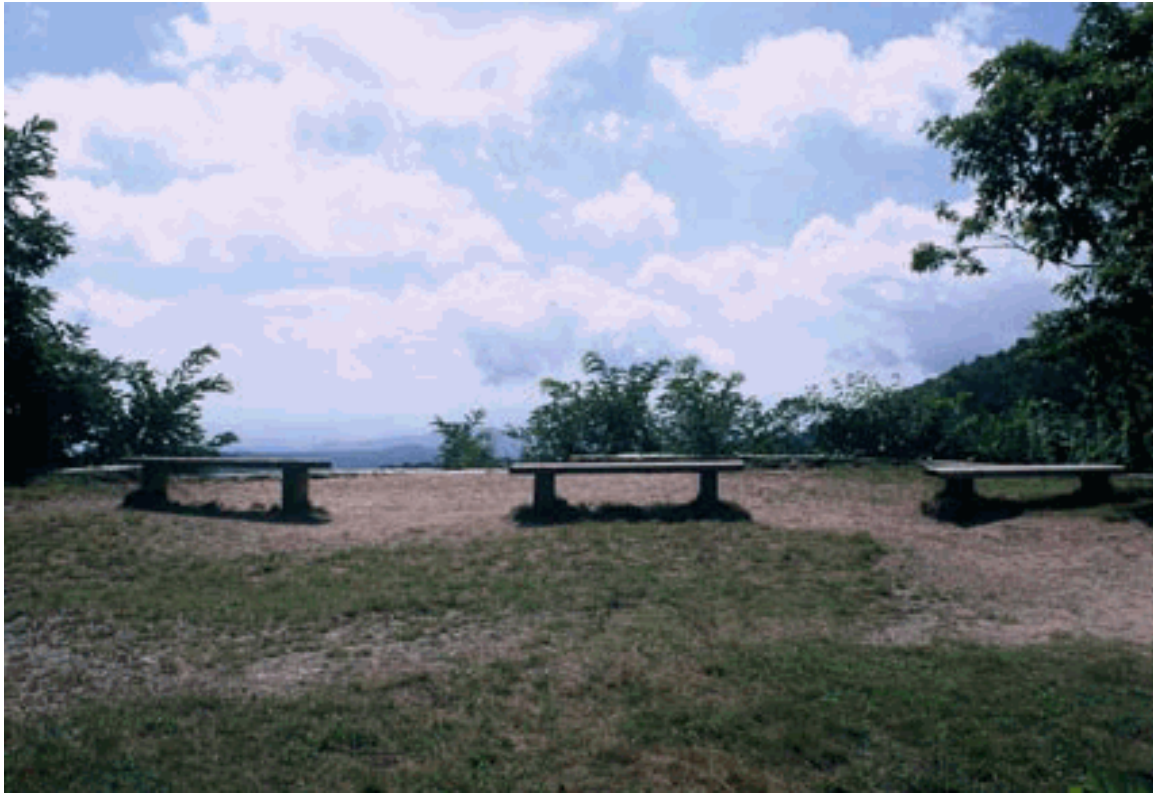
*Figure 17: Stone benches at Pink Beds overlook area (NPS).*

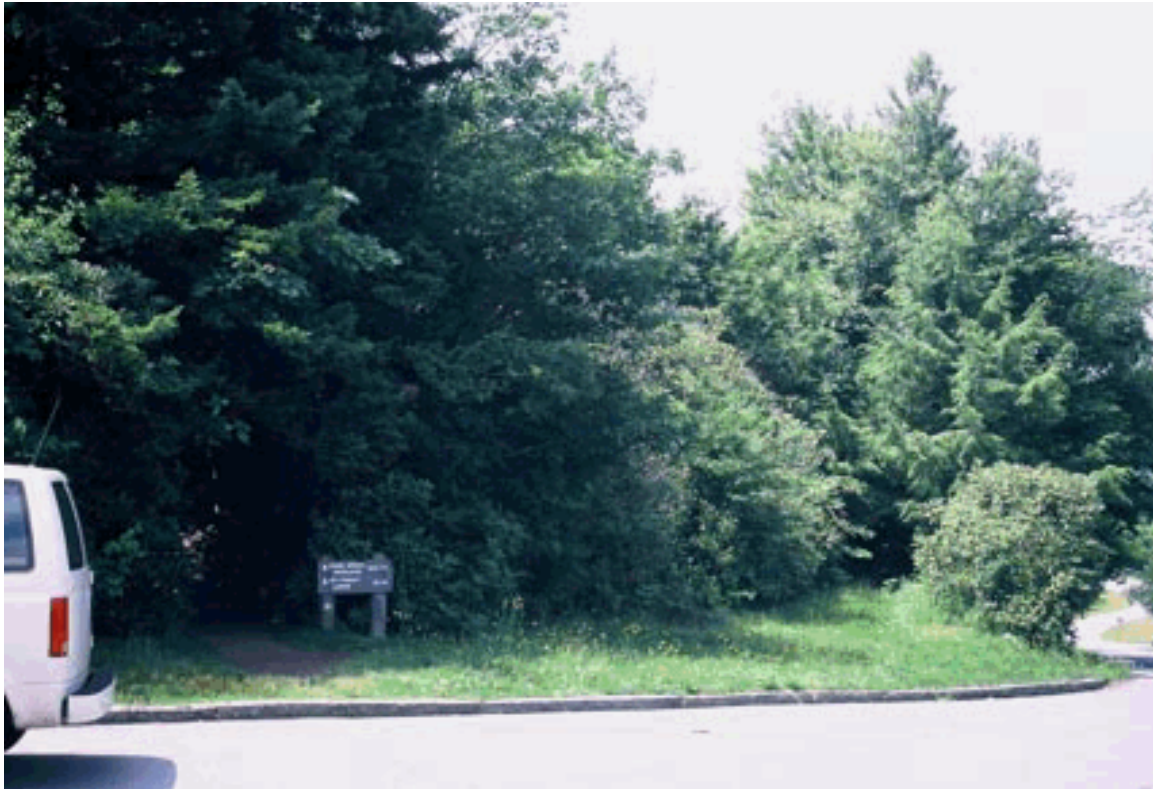
*Figure 17: View of pedestrian trailhead and vehicular access road. Note former Buck Spring Lodge road trace just right of center (NPS).*

These circulation improvements were completed in the 1960s and have changed little since their initial construction. Integrity in terms of location, setting, design, materials, feeling, and association for NPS-era circulation improvements is retained.
