# Rincon Creek Monsoon Event 31 July 2006

Saguaro National Park  
Tucson, Arizona

By: Bruce "Chuck" Perger  
October 2008

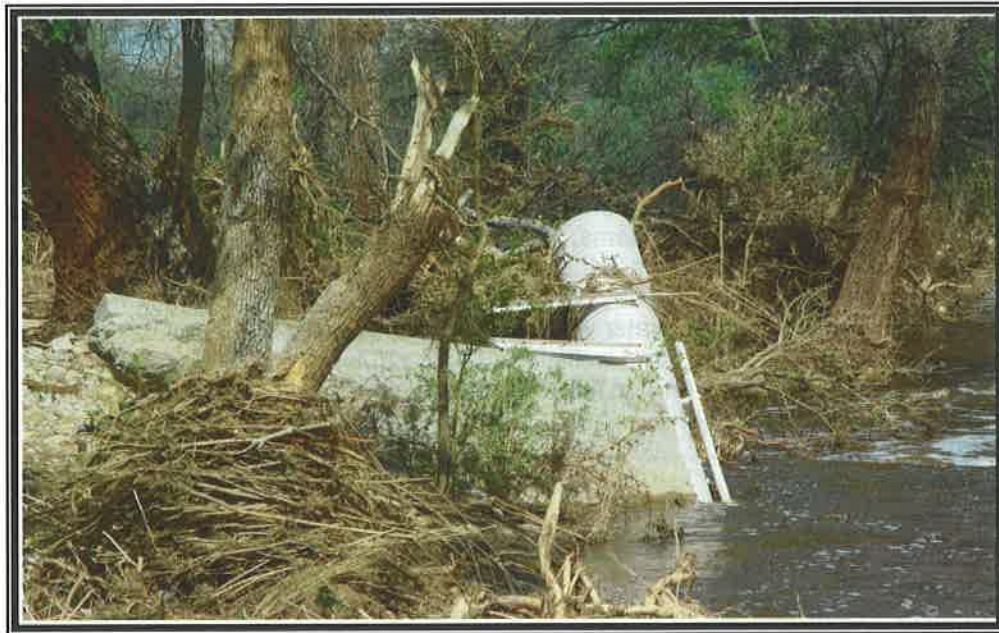
USGS gage, having stood intact for 53 years, yielded to the flow of 31 July.

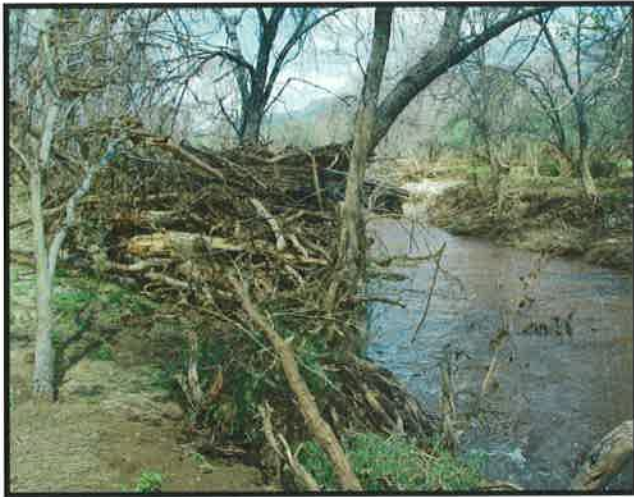
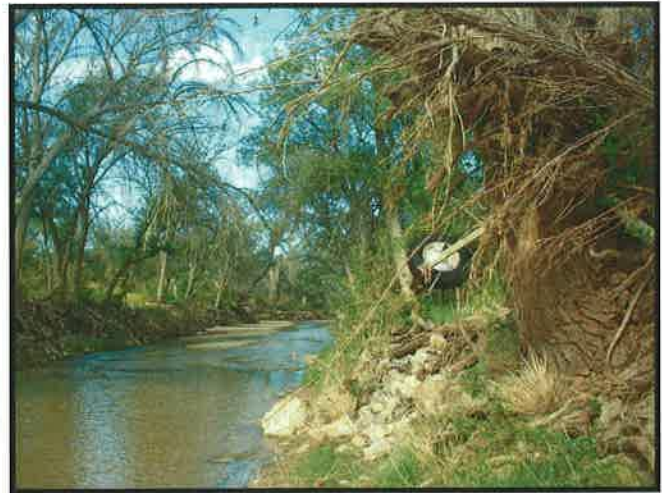
**Figure 1. Considerable natural debris was washed through the watershed, including a large assortment of household and ranch items, vehicles, tools, sheds, etc.**

In the early morning hours of 31 July 2006 a flood event occurred on Rincon Creek that was larger than any recorded in the past 53 years and may have qualified as a "100-year event."<sup>1</sup> Considerable damage was sustained by the creek and its floodplain as a result of very high flows, with attendant debris and sediment (Figure 1).

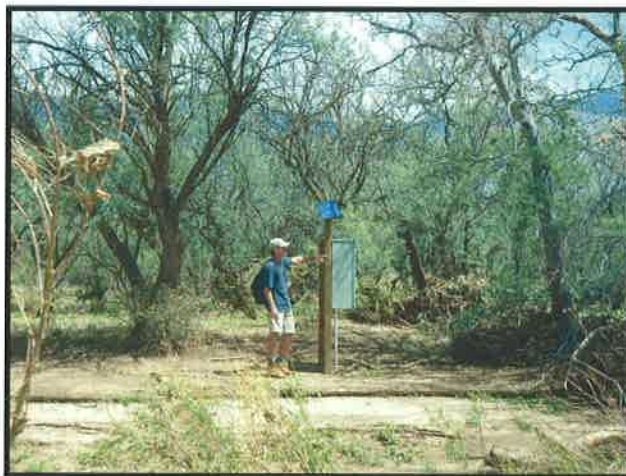
The data logger control box at Transect 1 was very nearly totally submerged by the flood water (Figure 4). The instrumentation was installed in hermetically sealed boxes so there was no water intrusion into the electronics.<sup>5</sup> The data logger recorded the event at Transect 1 before, during, and after the flood and provided the best record of the event.

**Figure 4. Data logger was nearly submerged.  
Water was 14.4 ft above channel bottom at this point.**

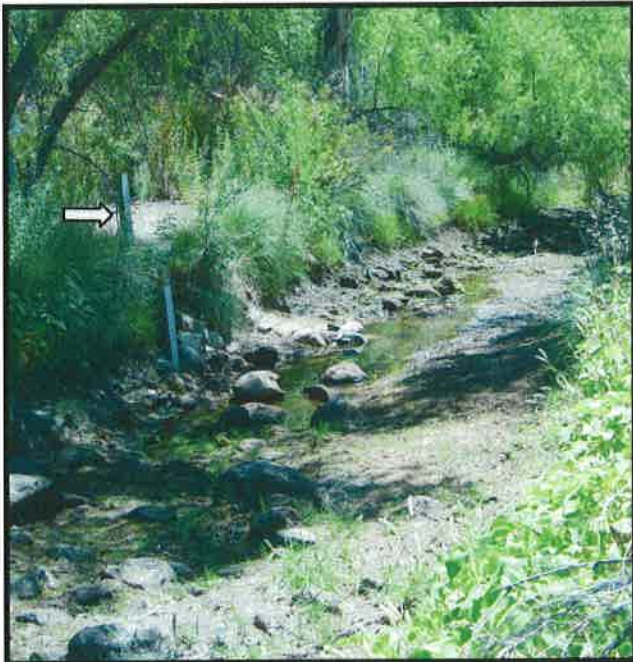
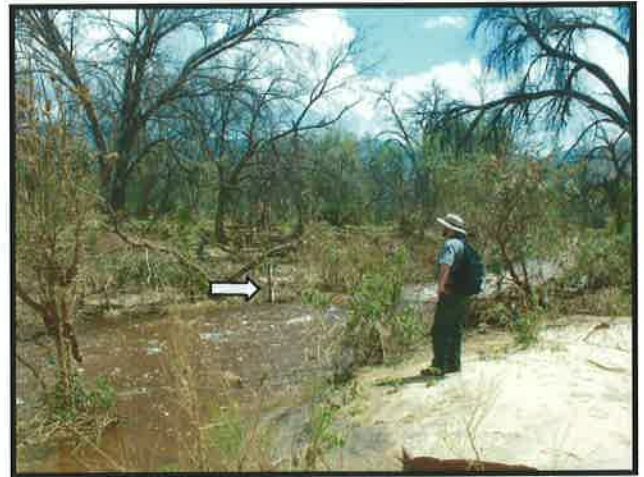
Transect 1 (Pool A) looking upstream before ...

and after flood. Channel width changed little at this point but much vegetation was swept away and there was considerable erosion and sediment deposition on the south bank. Flow is estimated to be about 130 cfs at this time.

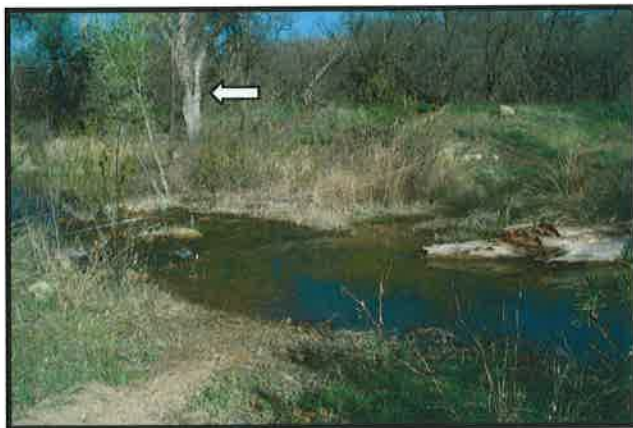
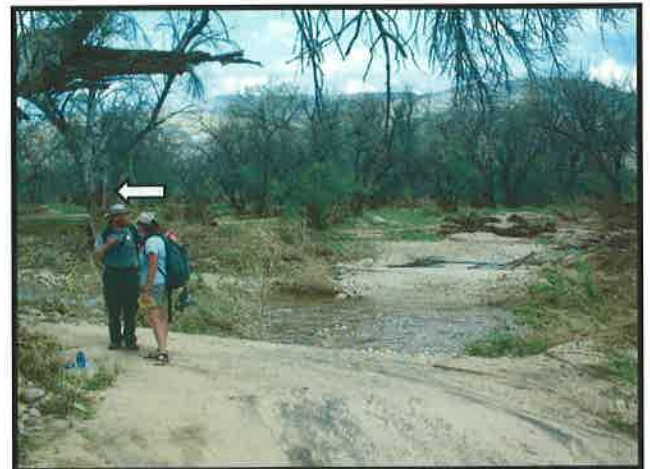
Transect 3 before ...

and after. Sediment in foreground is 2-3 ft deep, and road on far bank is no longer passable due to severe erosion and debris accumulation.

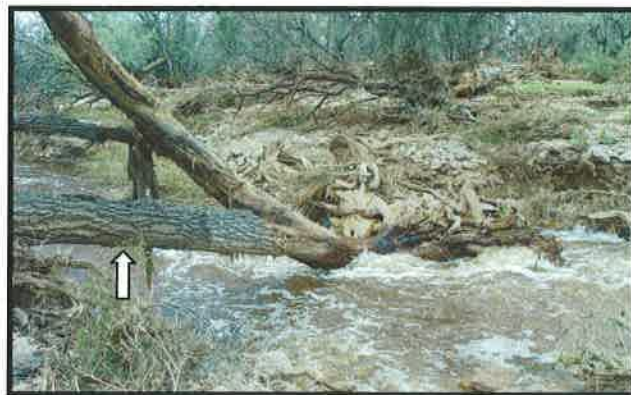
Transect 2 before ...

and after. Topography of this pool was the most seriously altered. When the large tree fell a second channel was eroded behind it, more than doubling the channel width

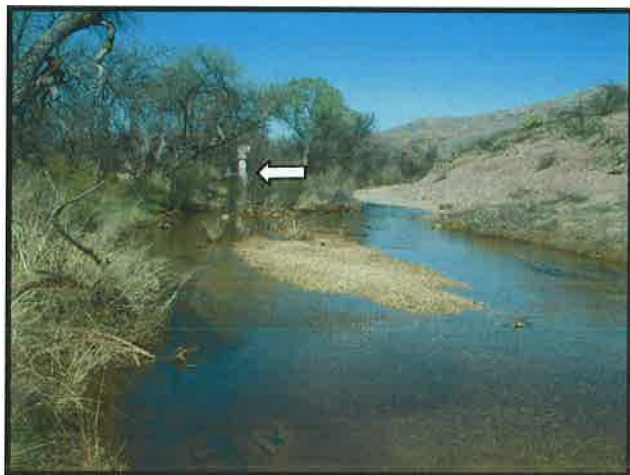
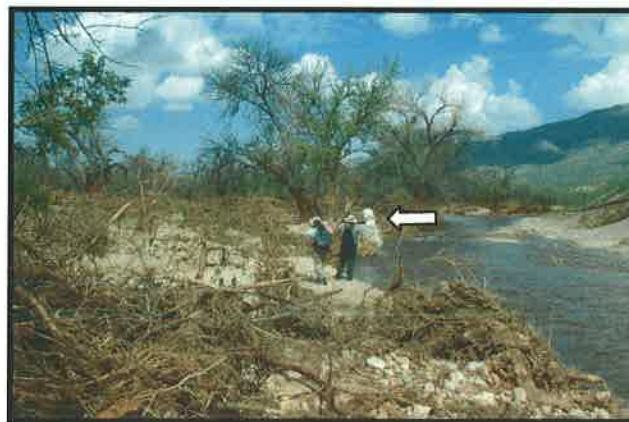
USGS gage before ...

and after. This portion of the survey area showed the most pronounced erosion and vegetation loss.

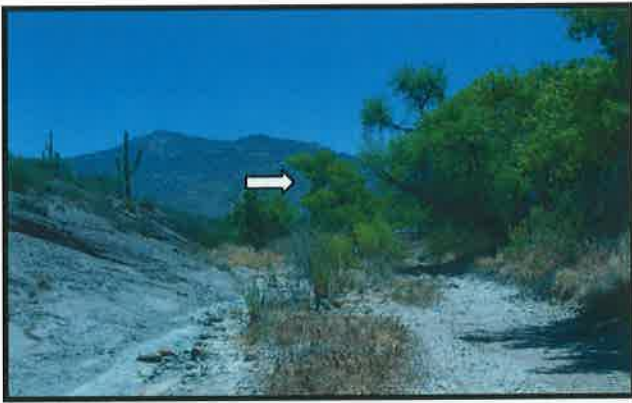
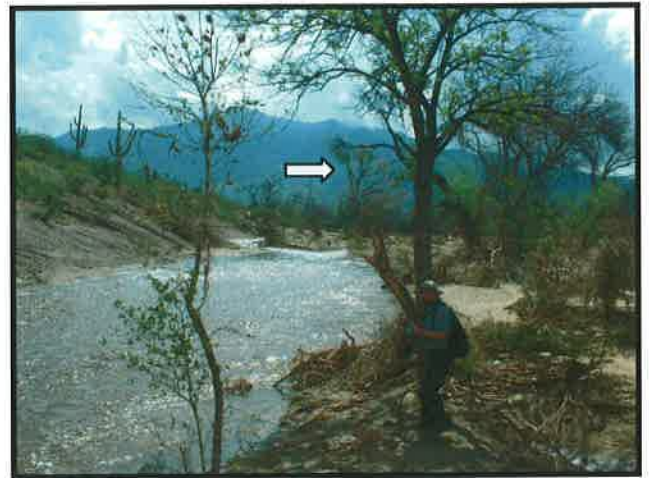
View upstream from Transect 6 before ...

and after. A new, larger channel can be seen upstream on the left.

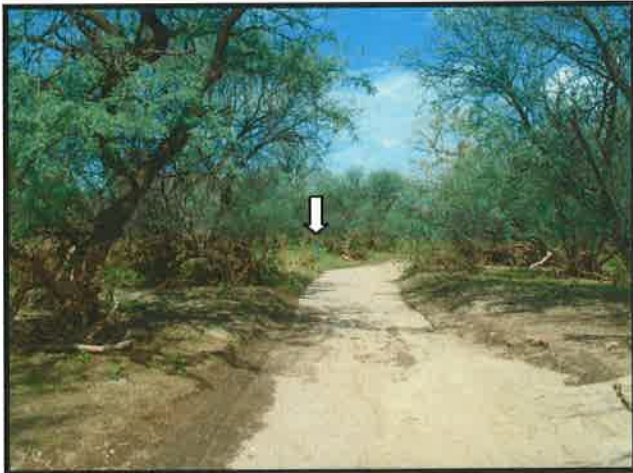
RC-5 looking West along access road. Well was topped (note high water mark on vegetation).

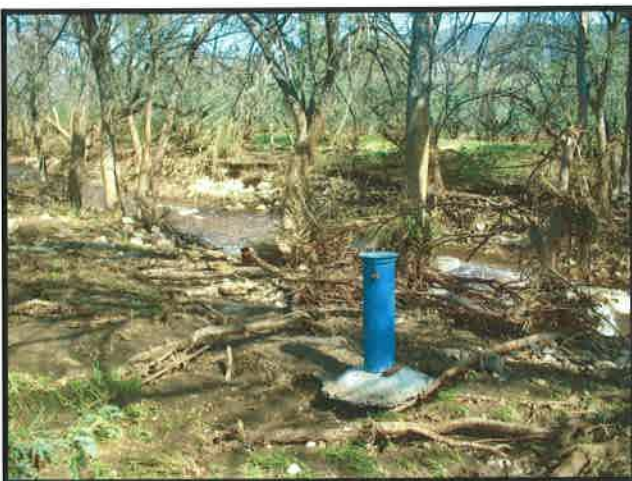
RC-4 was also topped (note high water mark on vegetation).

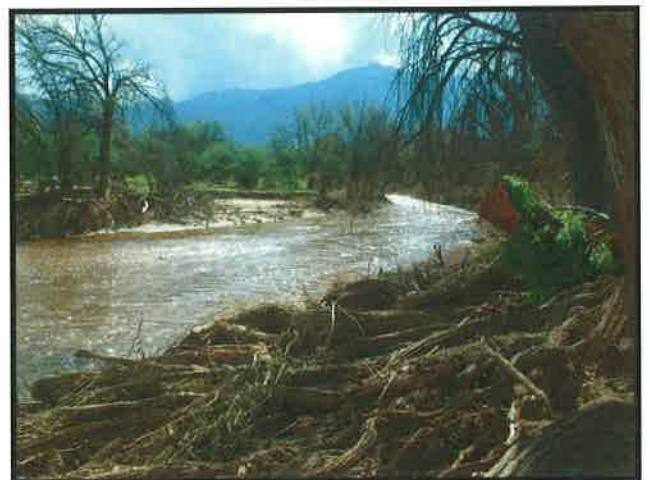
View looking upstream at large tributary showing erosion and channel widening.

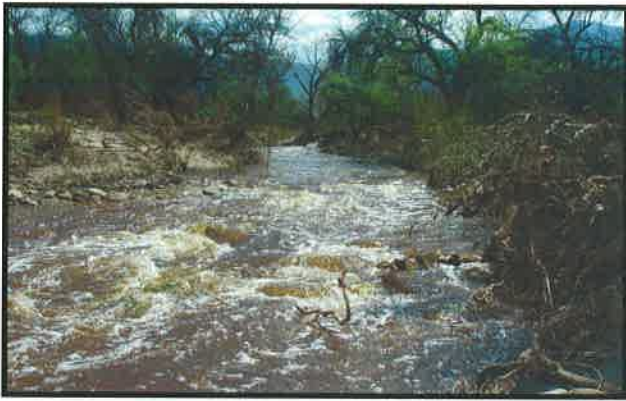
View upstream from Transect 3. Channel has more than doubled in width and vegetation has been swept away, allowing Transect 2 to be clearly seen.

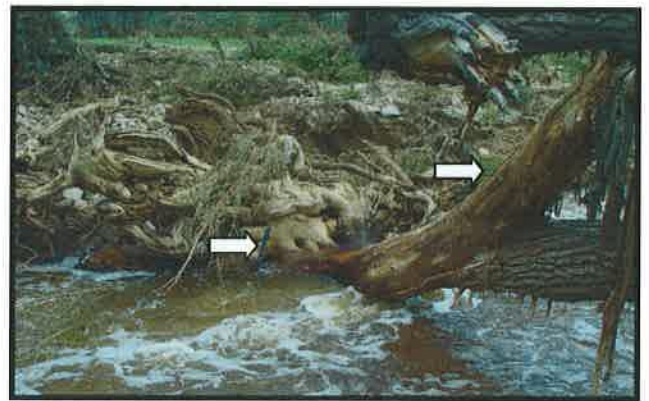
Transect 2. Only remnants of the staff gage and crest gage support structures remain.

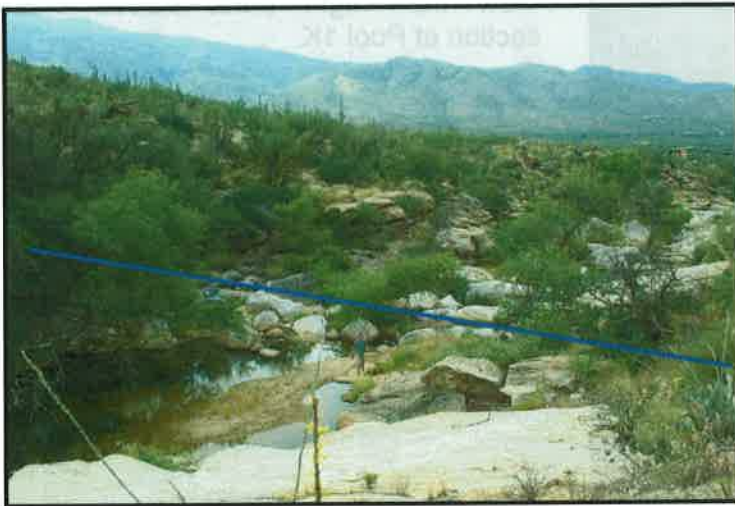
Cross section (high water line) at Pool 1K. View downstream. Note figure in center for scale. Large cobbles/boulders and thick vegetation are present on both banks outside the channel, and were submerged in the high flow.

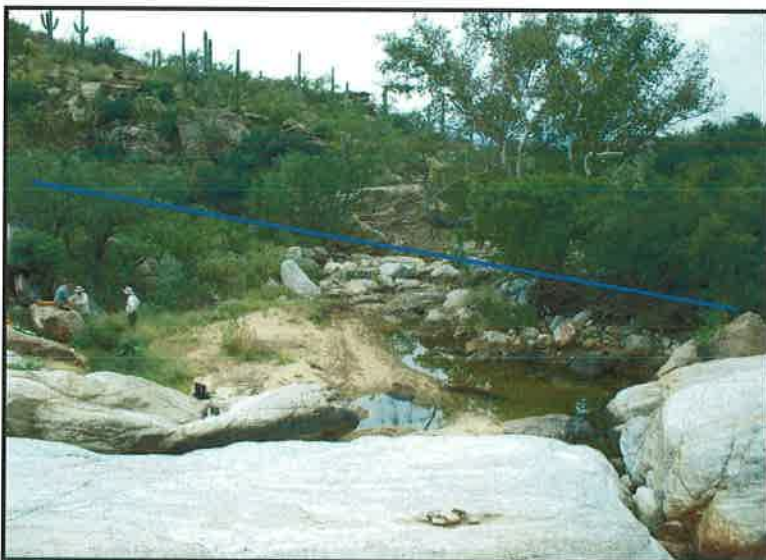
Cross section (high water line) at Pool 2A. View downstream. Note figures for scale. As with Pool 1K, boulders and thick vegetation are present outside the channel and were submerged in the high flow.
