# **Middle Rincon Creek**

## **Water Requirements for Bottomland Vegetation of Middle Rincon Creek and Potential Threats to Water Availability**

**A Study in Support of an Application for Permit to Appropriate Public Water of Arizona, Instream Flow Maintenance, Middle Reach of Rincon Creek, Saguaro National Park**

August 3, 2008

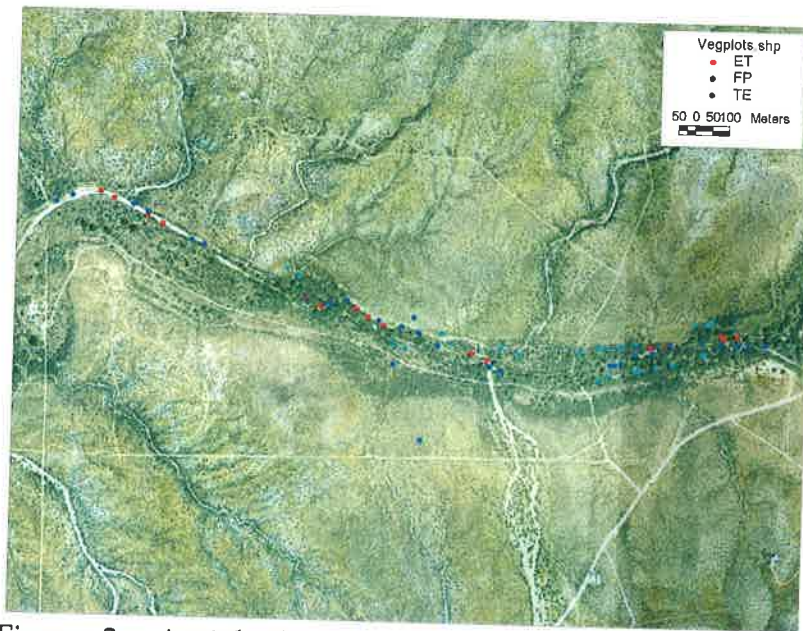
Figure 2. Aerial photograph of middle Rincon Creek showing distribution vegetation plots on terrace and floodplain surfaces.

Ultimately, 18 – 2 x 50 m plots were established on terrace surfaces, and 27 vegetation plots were established on floodplain surfaces, which were expanded to include the aforementioned transition zone. Vegetation data were collected during April and June 2004. The greater number of plots used to quantify middle Rincon Creek's floodplain plant community is due to this community's greater patchiness which, in turn, is due to the higher dynamics associated with this surface relative to terrace surfaces that are inundated much less frequently.

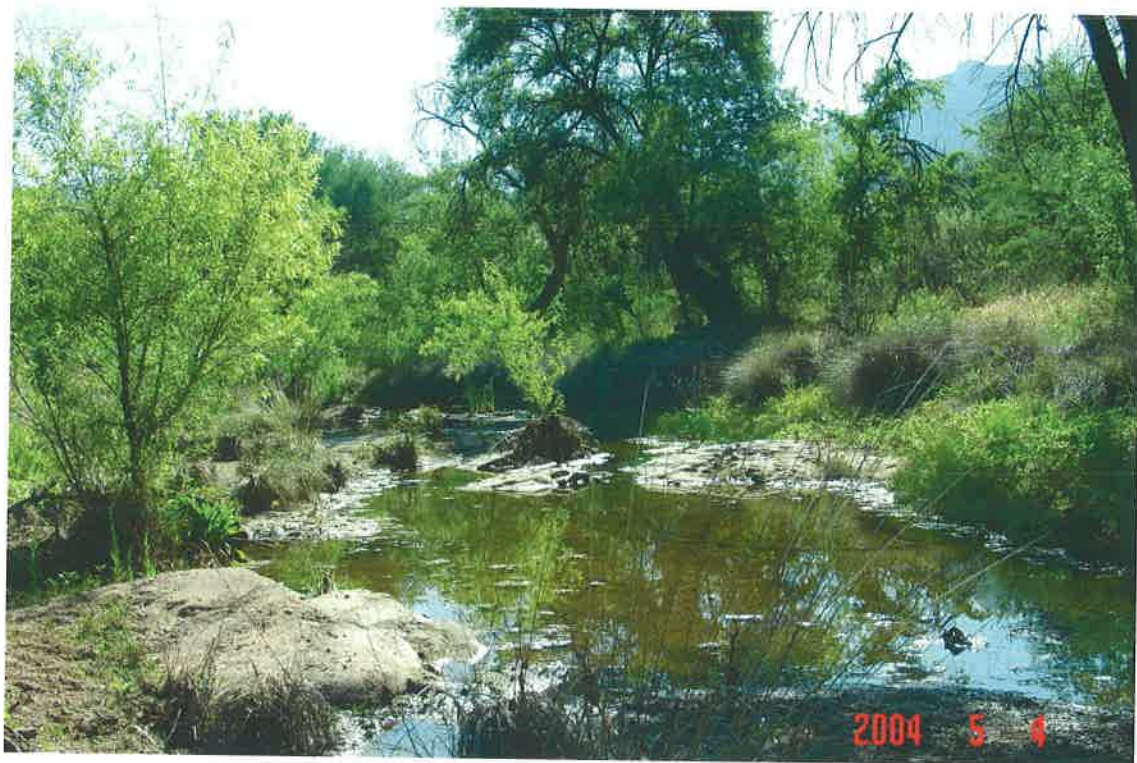
Figure 9. Photograph of upper half of the middle Rincon Creek study reach showing some channel incision with young riparian trees (like the Arizona ash on channel left) dominating floodplain surfaces close to the channel.
