National Park Service  
Cultural Landscapes Inventory  
2012

Rush Historic District  
Buffalo National River

## Inventory Unit Summary & Site Plan

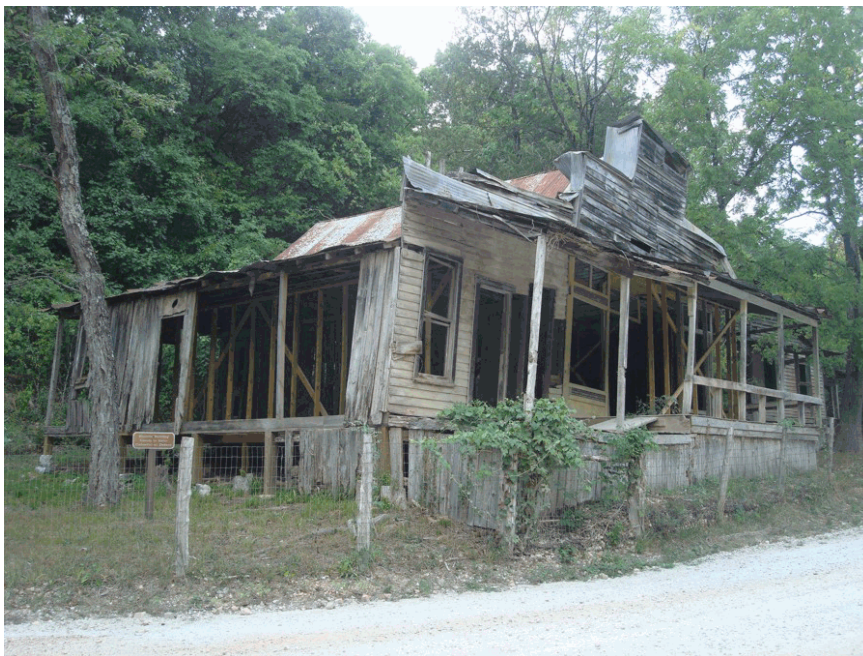
*Taylor-Medley General Store (Jackson/NPS 2012)*

The condition assessment made for the district in summer 2012 is fair. Components of the broad cultural landscape are intact, and four aspects of integrity exist. Over the years, however, neglect and drastic human intervention (particularly arson) have resulted in the serious loss of much of the district's built fabric, and a site such as the Taylor-Medley General Store has required additional stabilization.

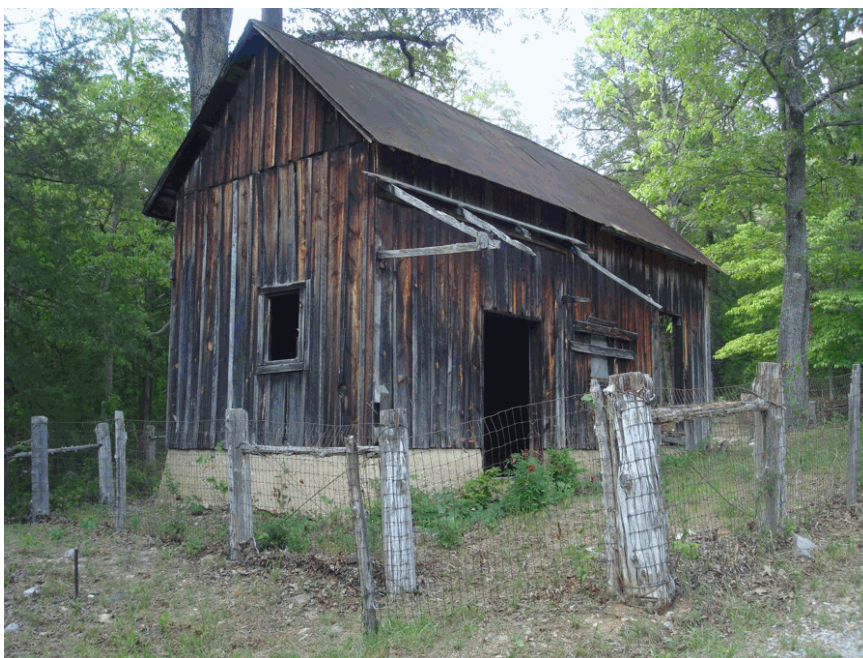
The Rush Blacksmith Shop, constructed in 1925, is a one-story, side-gabled building clad in vertical board-and-batten siding. It sits on a poured concrete foundation, and its roof is covered by corrugated metal.

*Rush Blacksmith Shop (Jackson/NPS 2012)*

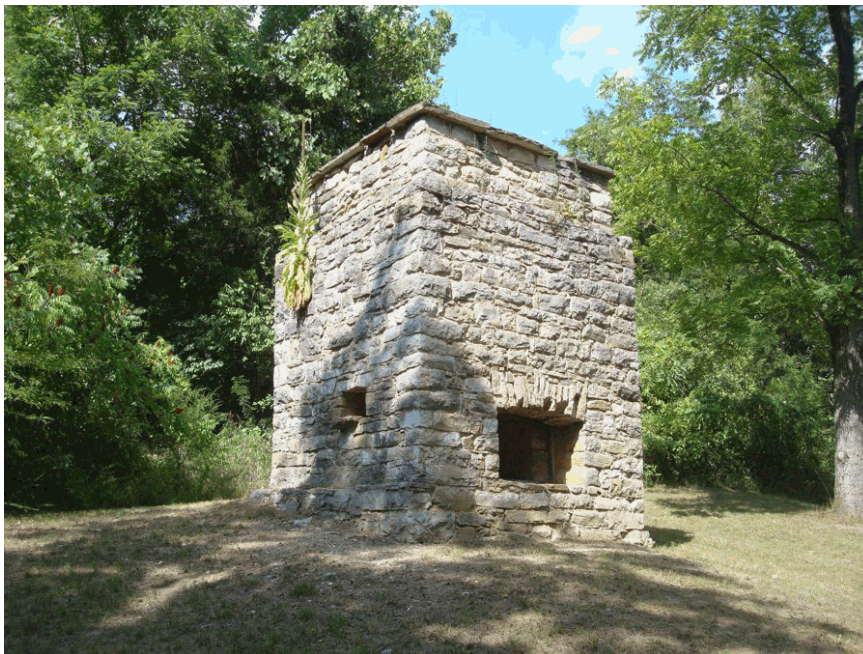
The Rush Smelter, constructed in 1886, is a massive mortared stone masonry structure, measuring eleven feet wide on all sides and fifteen feet tall. A large front opening reveals the central burning chamber.

*Rush smelter (Jackson/NPS 2012)*

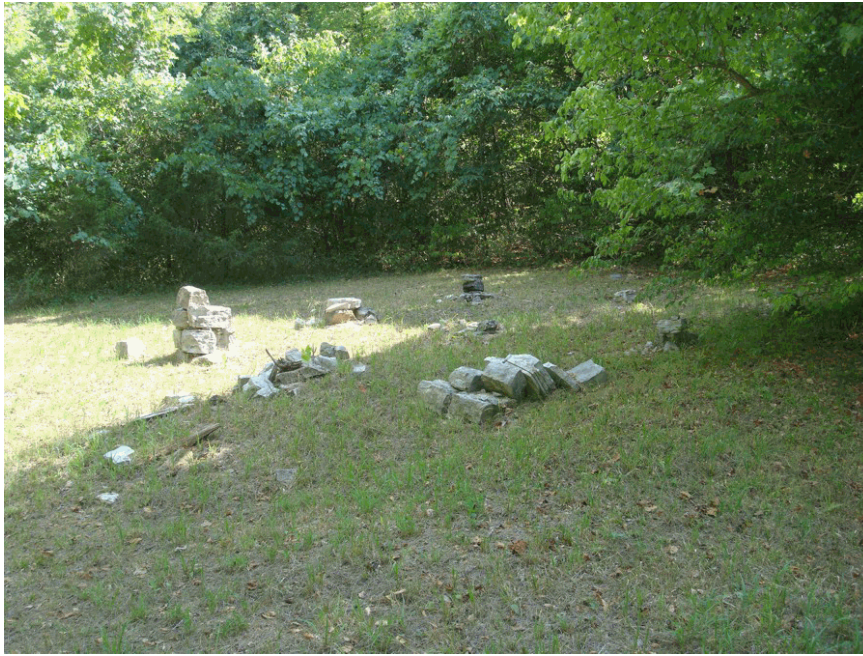
The remains of the Brantley House (built in 1899) are its stone foundation piers that once supported the wood-frame residence.

*Stone foundation of Brantley House, destroyed by arson in 1999 (Jackson/NPS 2012)*

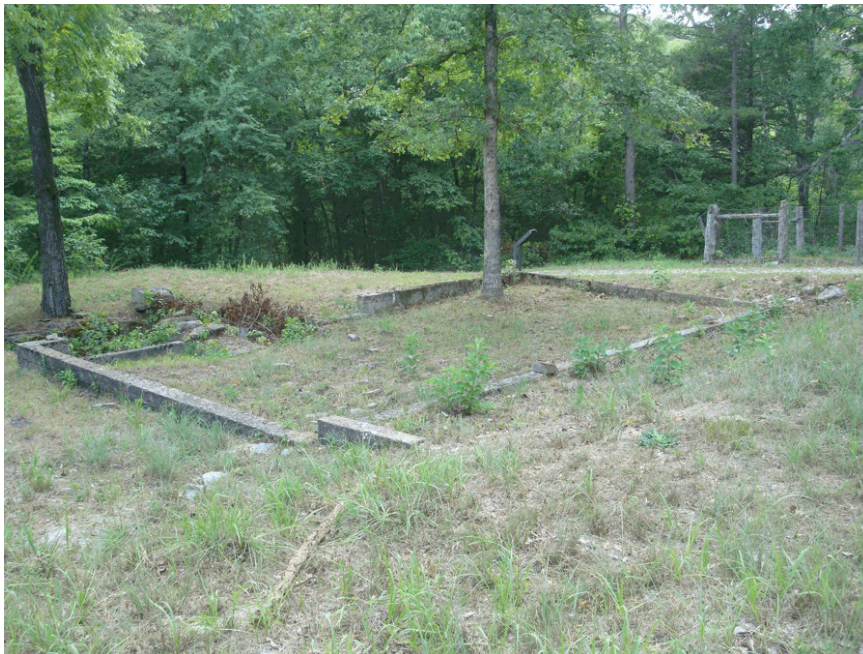
The Chase & Mulholland Store (built in 1895) exists as a poured concrete foundation, standing to approximately eight inches above grade, that rings a depression with dry-laid rock walls, perhaps a storage cellar.

*Foundation ruin to the Chase & Mulholland Store (Jackson/NPS 2012)*

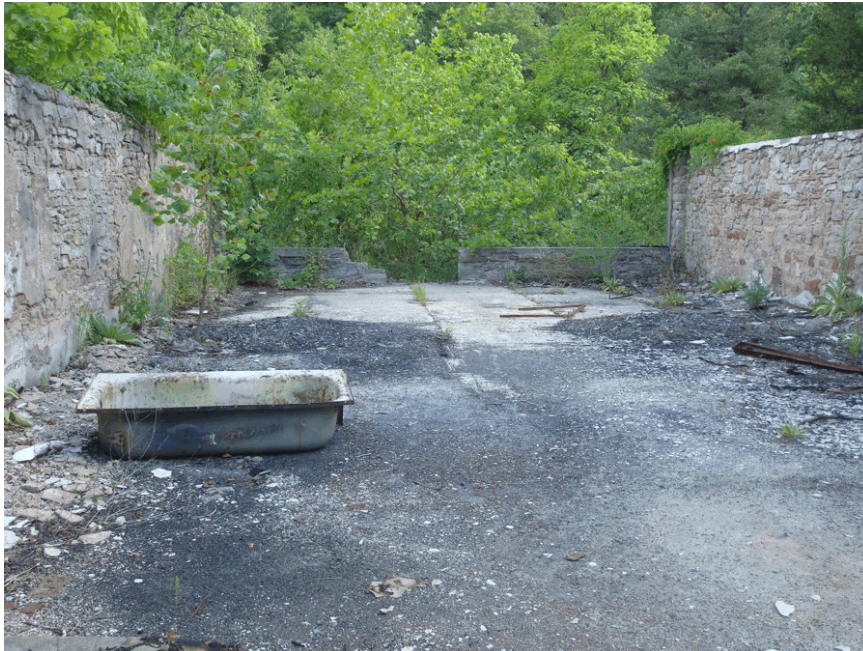
*Remaining ashlar walls of Hicks General Store, destroyed by arson in 2004 (Jackson/NPS 2012)*

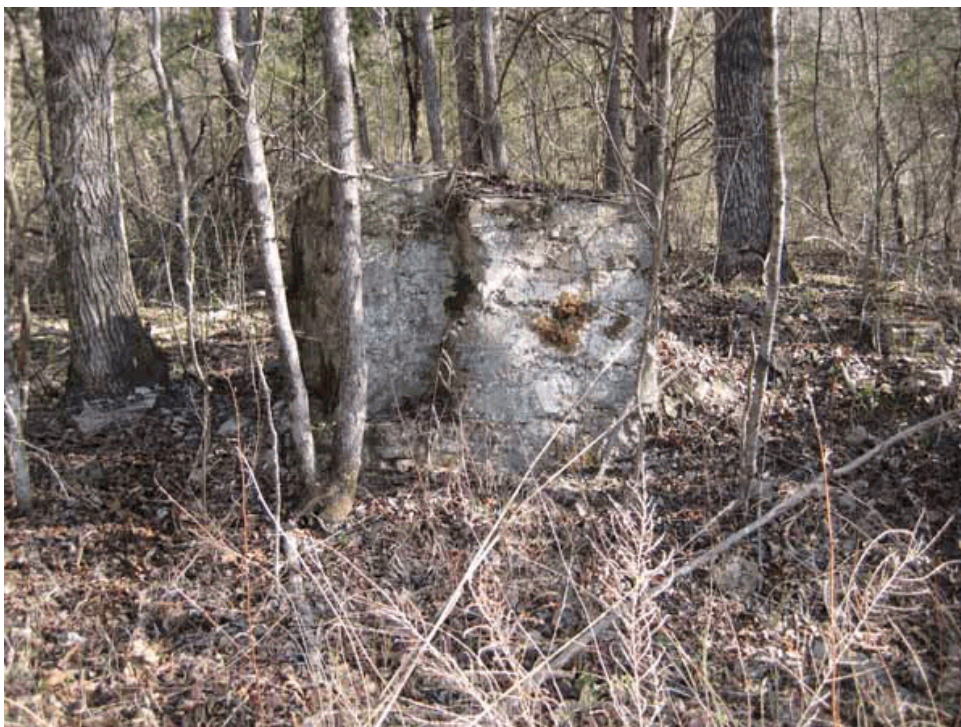
*Concrete corner of McIntosh Hotel, one of the few remnants of this structure that burned in the 1930s (NPS 3/2011)*

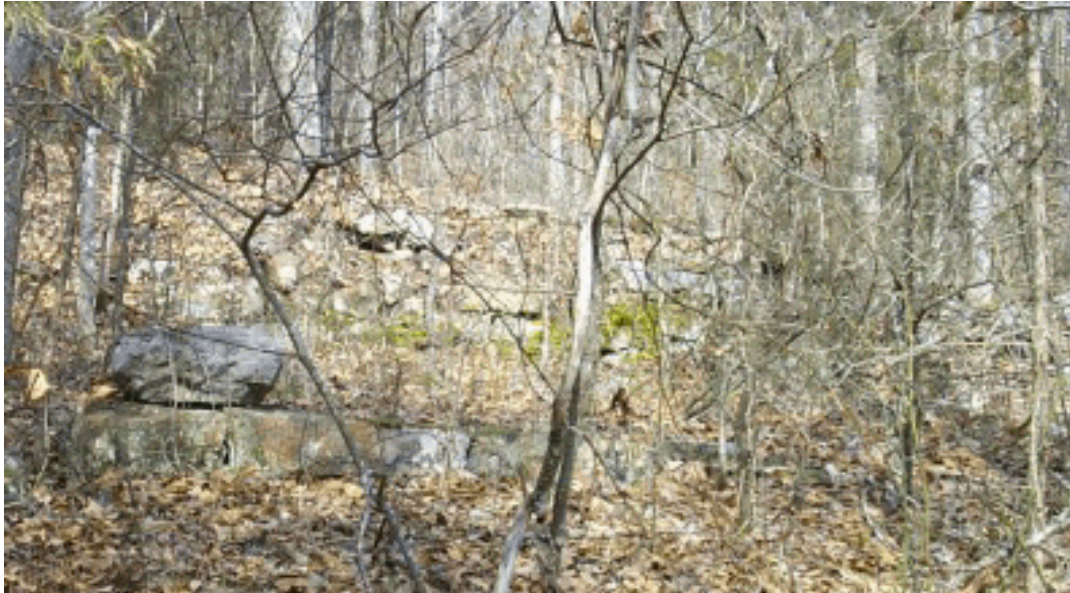
The ruins of the McIntosh Livery Stable (built in 1900) exist as a dry-masonry stone foundation footprint; the Morning Star Barn is now a scatter of foundation stones.

*Dry masonry stone foundation belonging to McIntosh livery stable (NPS 2/2005)*

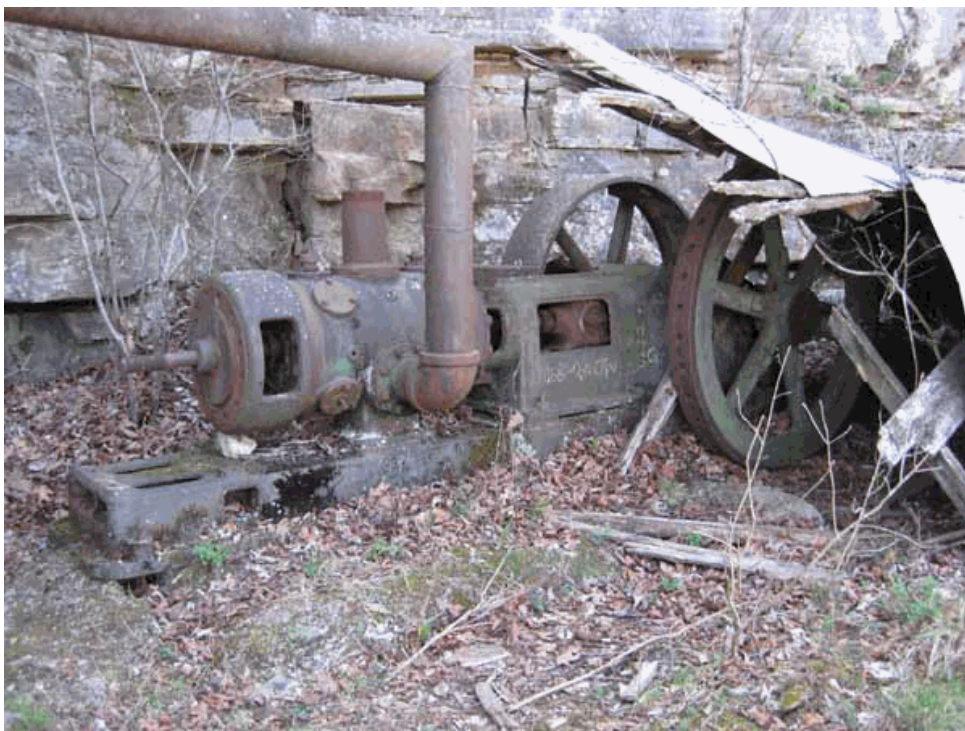
*Remnants of air compressor and its shed at Monte Cristo Mine (NPS 3/2011)*

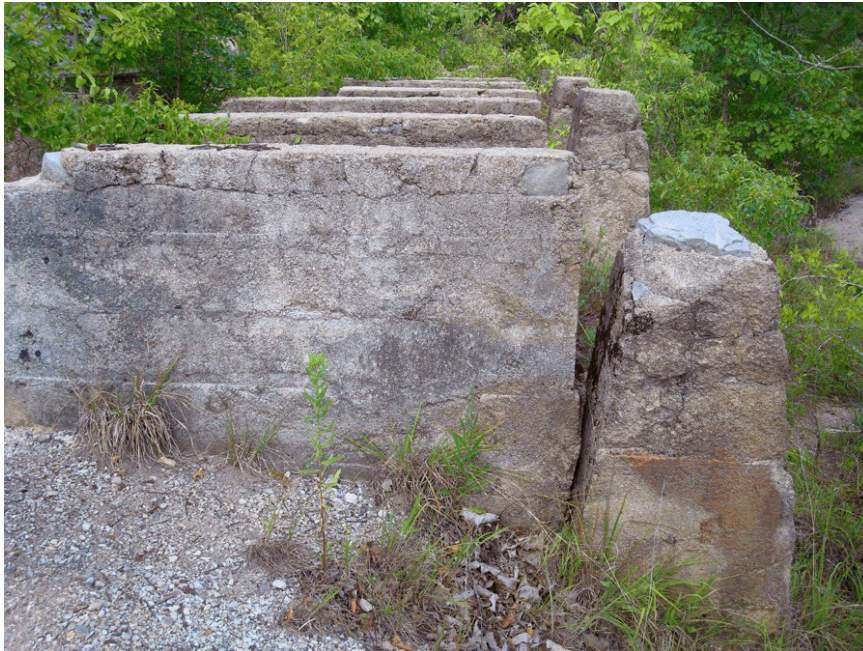
*Series of concrete piers belonging to Morning Star Mill (Jackson/NPS 2012)*

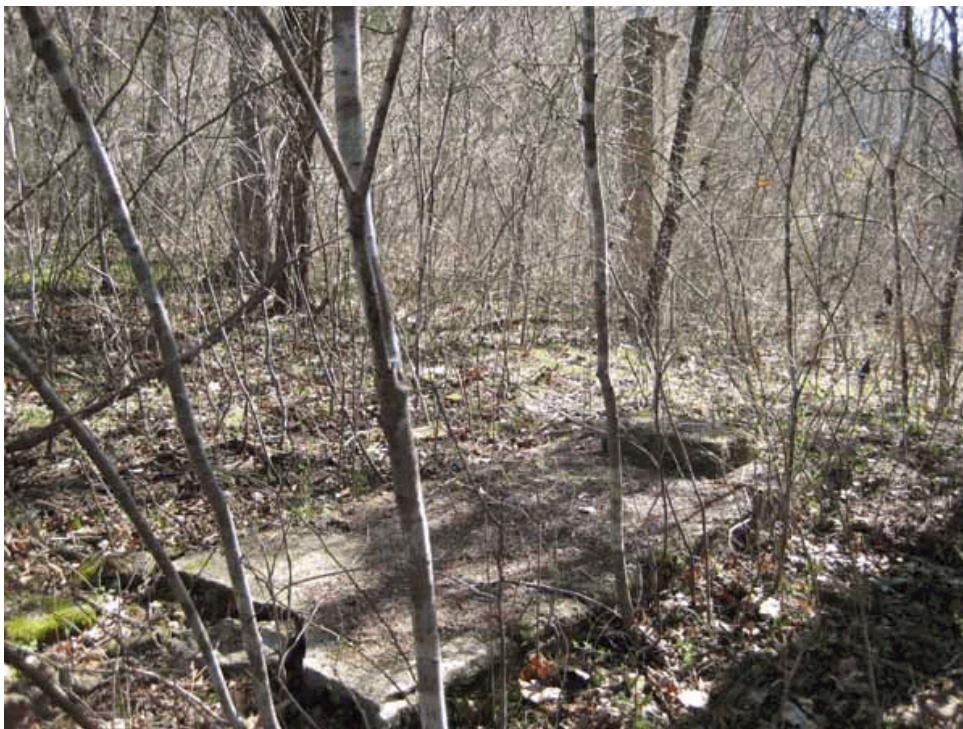
*Remnant concrete pad foundation, sidewalk, and brick chimney belonging to manager's house at Morning Star Mill (NPS 3/2011)*

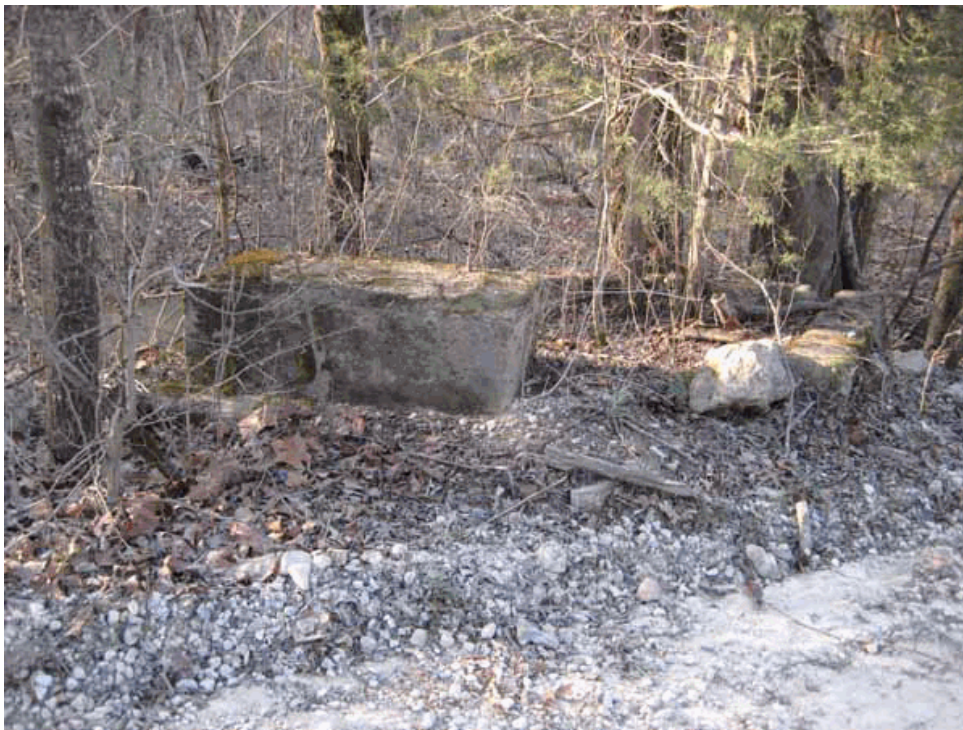
The pumphouse at the Morning Star Mine (built between 1890 and 1920) is a poured concrete foundation that rises two to three feet, ringing two concrete piers.

*Remnant concrete foundation to Morning Star Pumphouse (NPS 3/2011)*

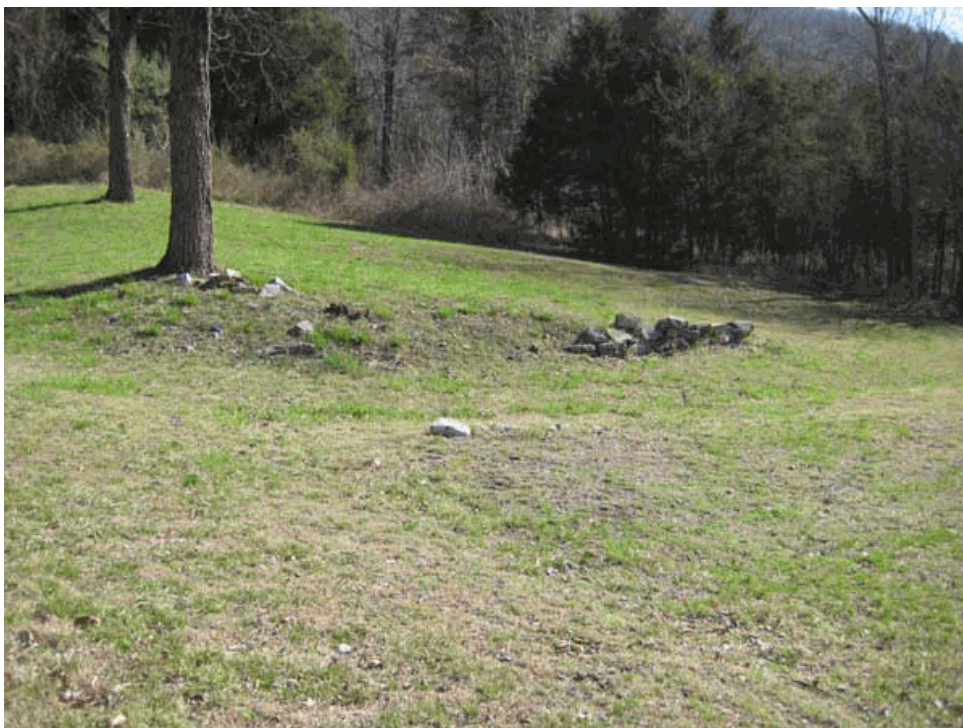
*Foundation stones belonging to Morning Star Barn, destroyed by arson (NPS 3/2011)*

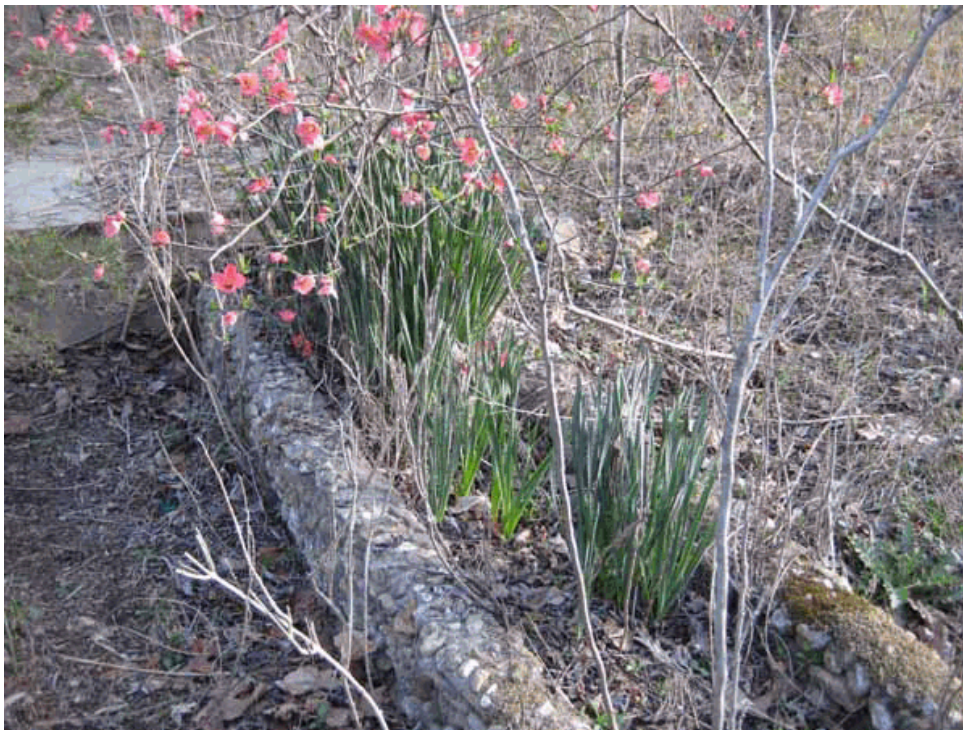
A retaining wall of mortared cobblestone and ashlar extends over three hundred feet around the foundation remnant of the Hicks Hotel. It includes two sets of stairs, and each is flanked by a pair of columns. Low mortared cobblestone flowerbeds are found near the foundation of hotel, including two elongated rectangular beds that edge the main walkway.

*Mortared cobblestone flowerbeds leading to the remnants of the Hicks Hotel (NPS 3/2011)*

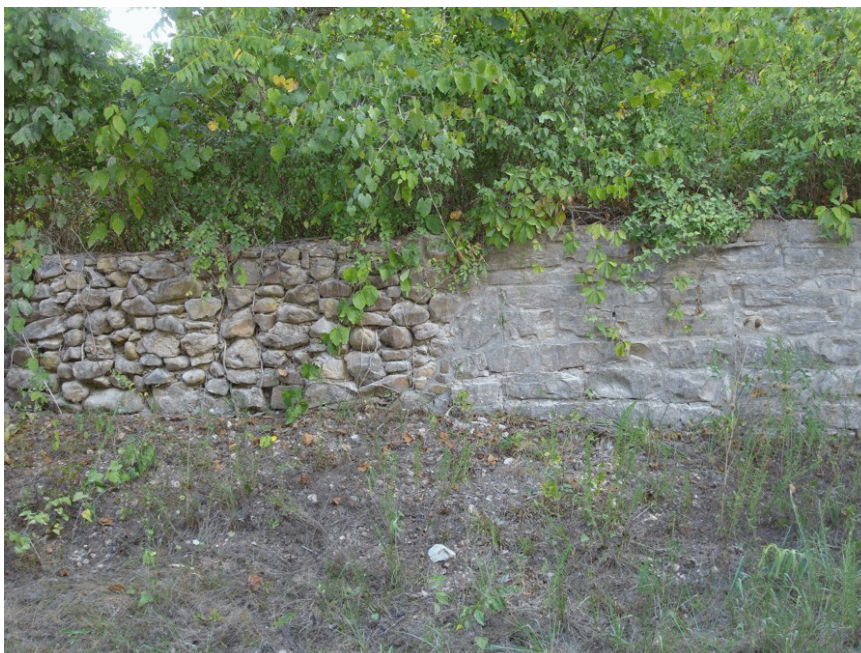
*Two masonry campaigns visible on Hicks Wall (Jackson/NPS 2012)*

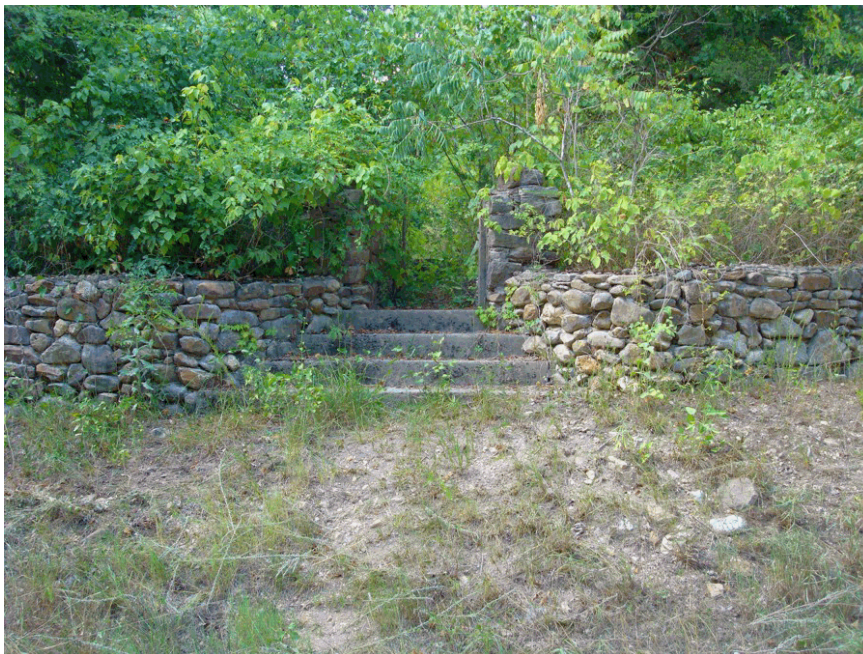
*Steps and pillars on Hicks wall (Jackson/NPS 2012)*

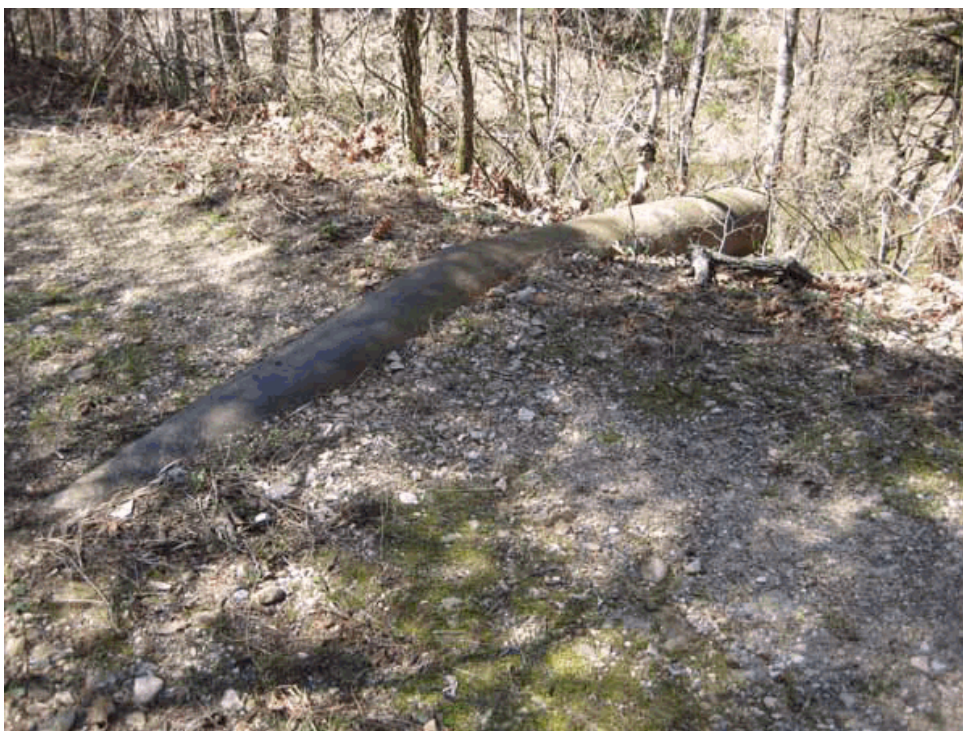
Other small-scale features relate directly to mining works, including an iron pipe that extends from the Monte Cristo mine, as well as small mines and exploratory diggings found throughout the landscape.

*Steel piping at Monte Cristo Mine site (NPS 3/2011)*

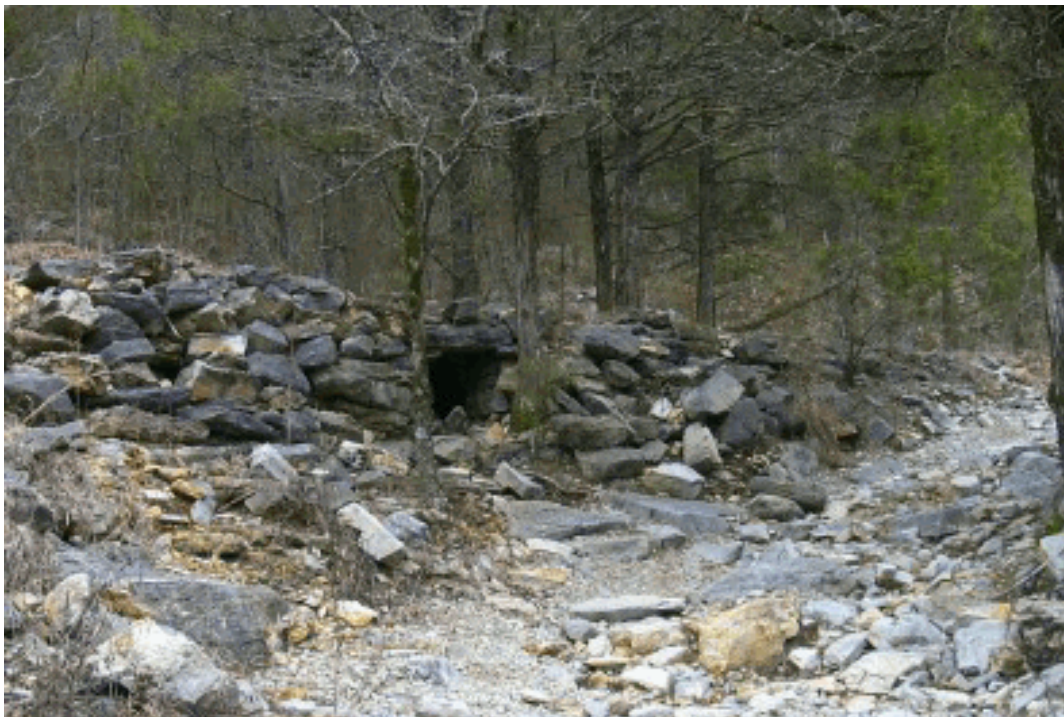
*Stone retaining wall and culvert along Morning Star Roadbed (NPS 2/2005)*
