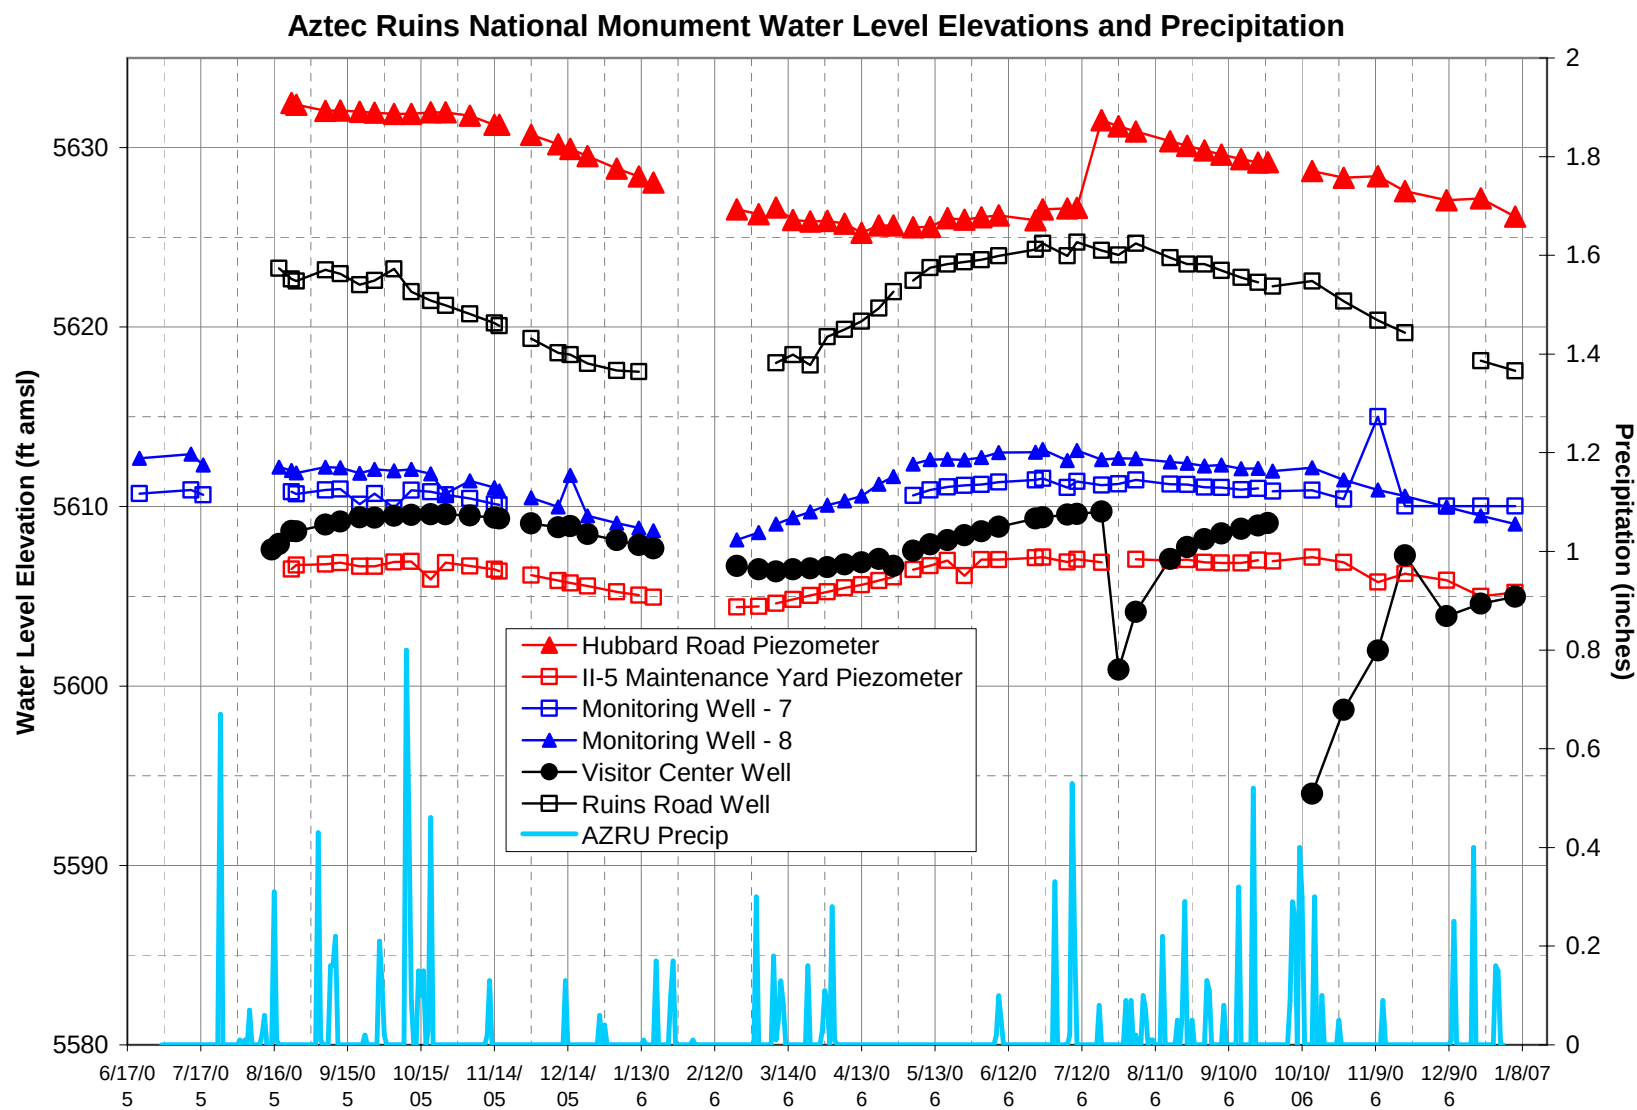
Figure 1. Water level elevations and precipitation at Aztec Ruins National Monument, June 2005 to January 2007.

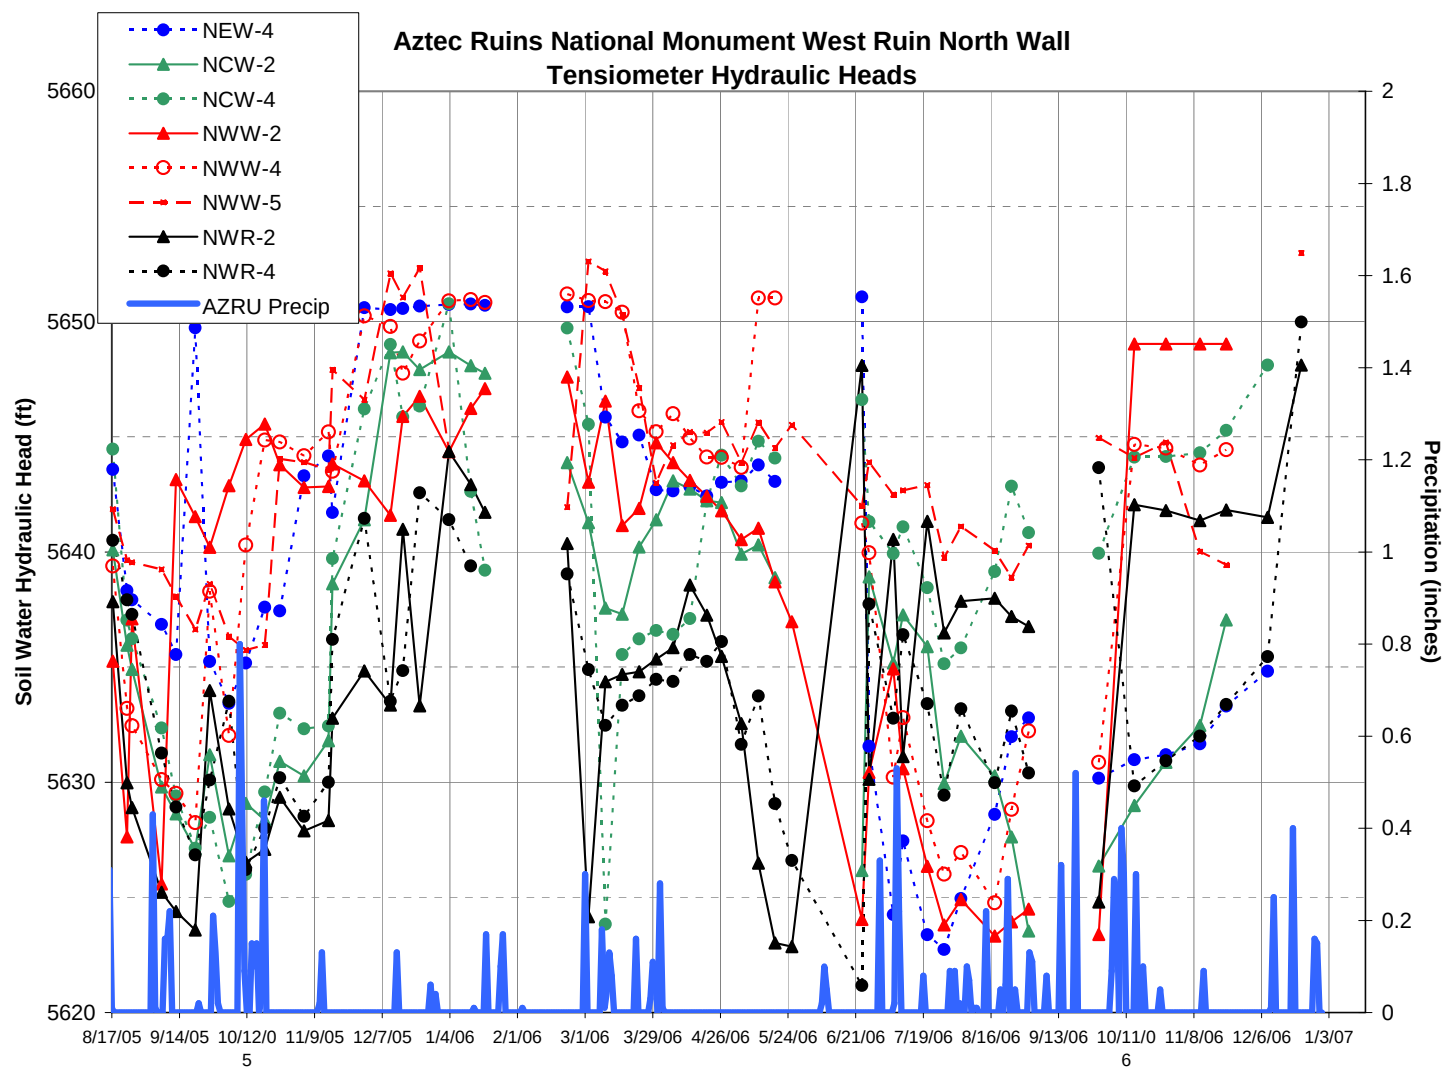
Figure 2. Soil water hydraulic heads measured at North Wall sensors and precipitation.

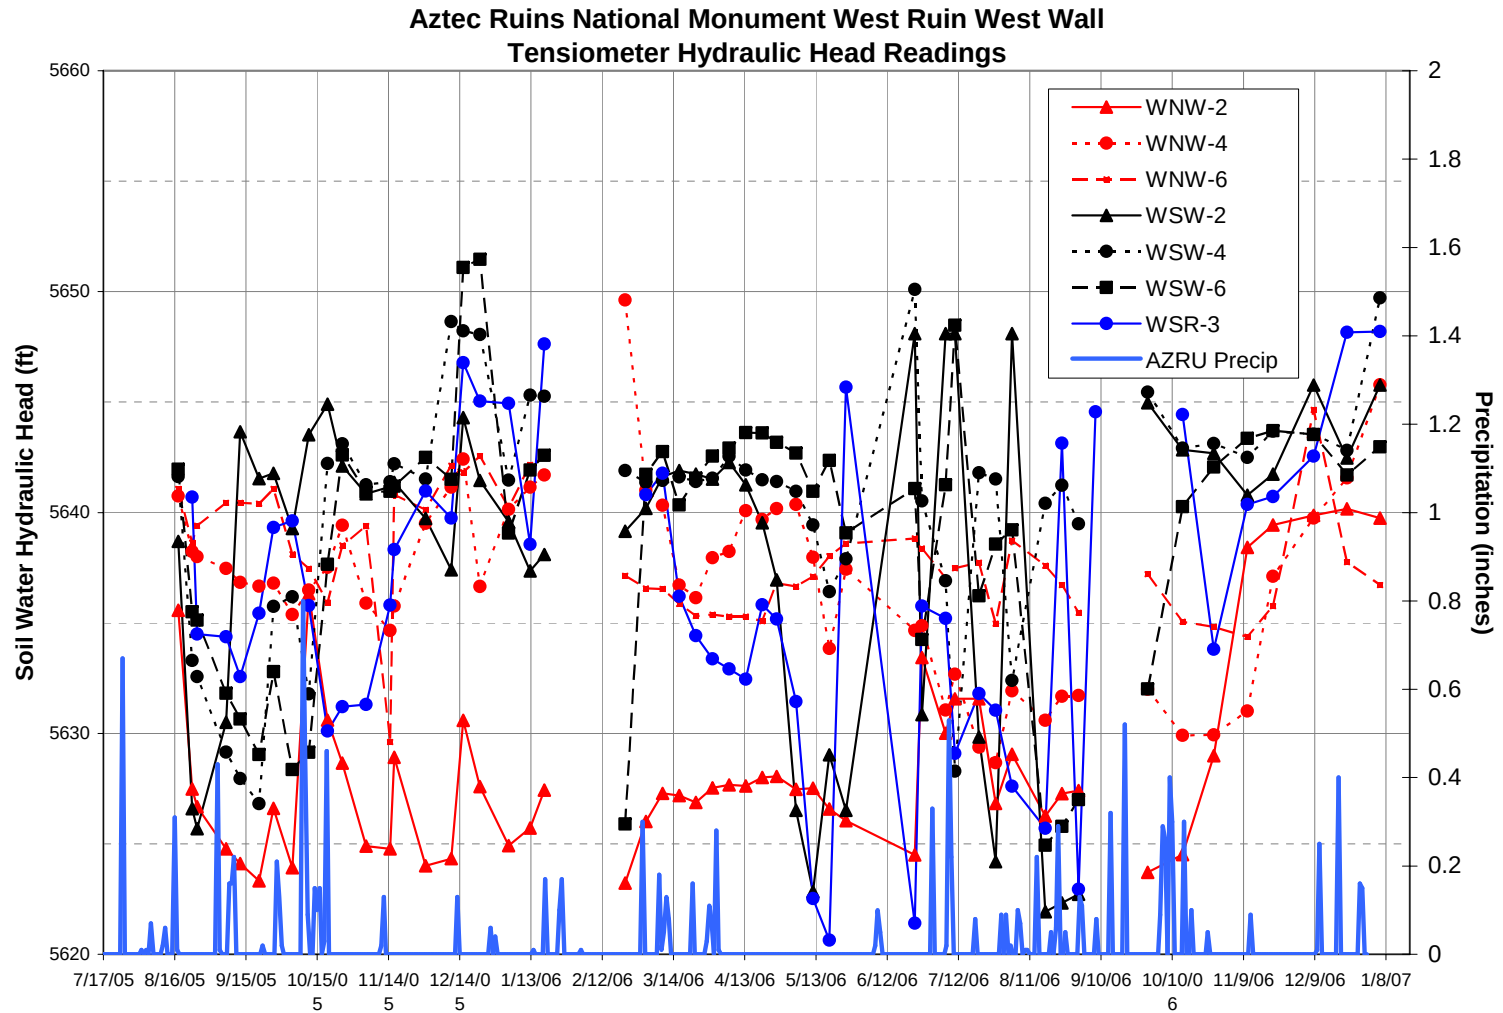
Figure 3. Soil water hydraulic heads measured at West Wall sensors and precipitation.

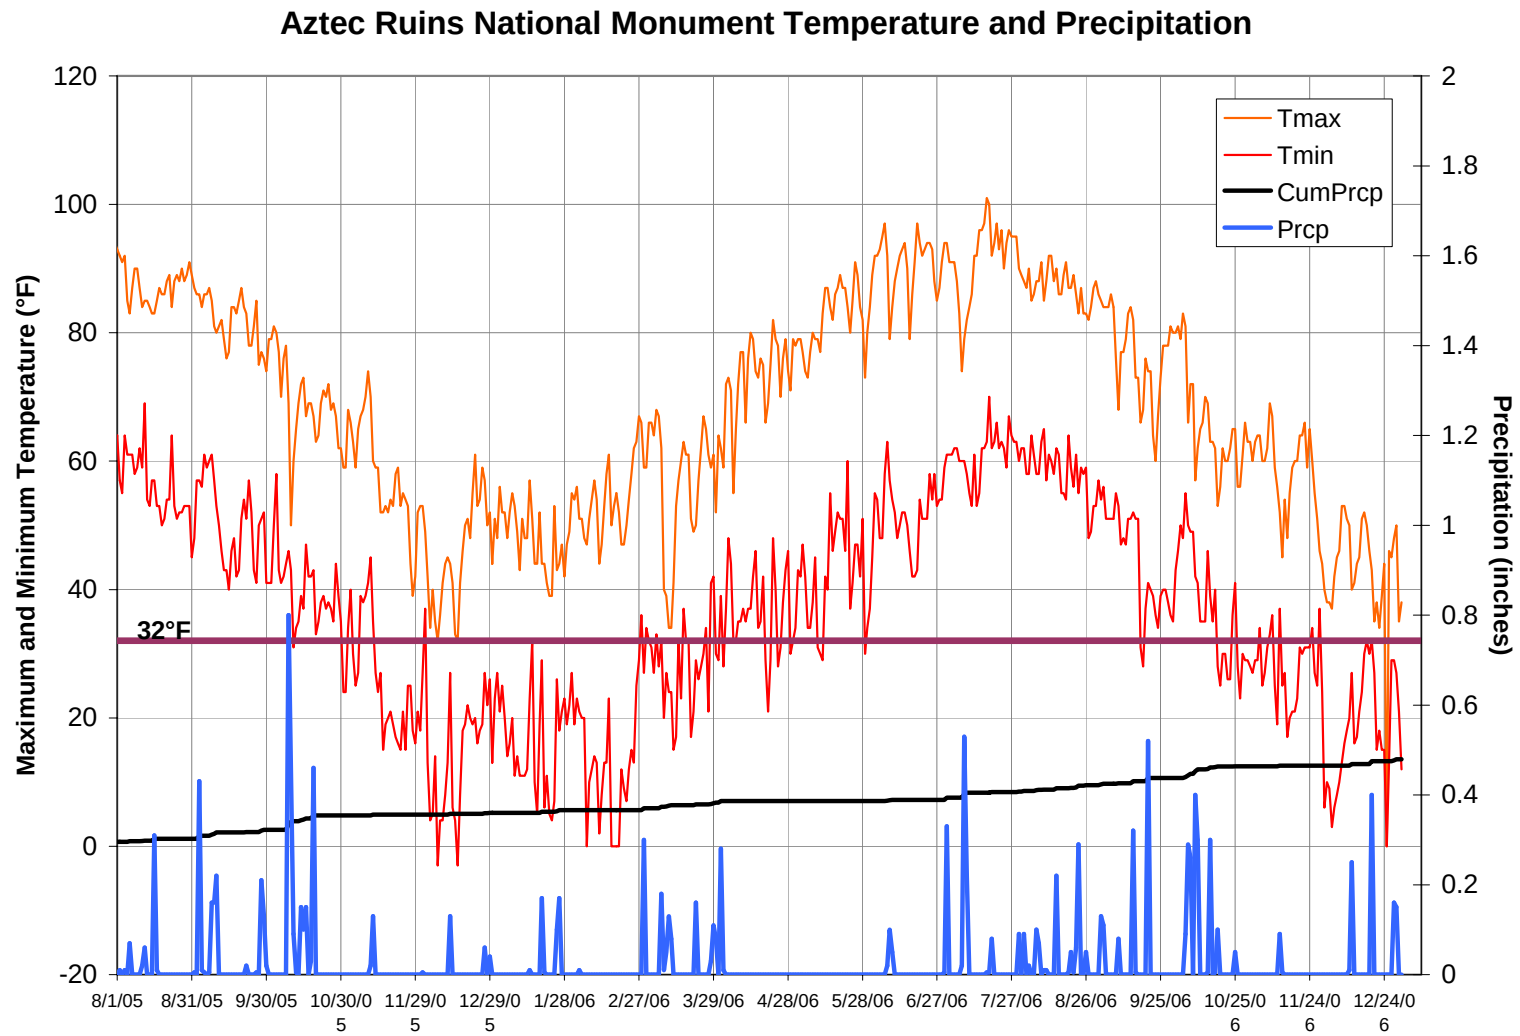
**Figure 4. Precipitation, cumulative precipitation, maximum and minimum temperatures recorded at Aztec Ruins National Monument during project.**

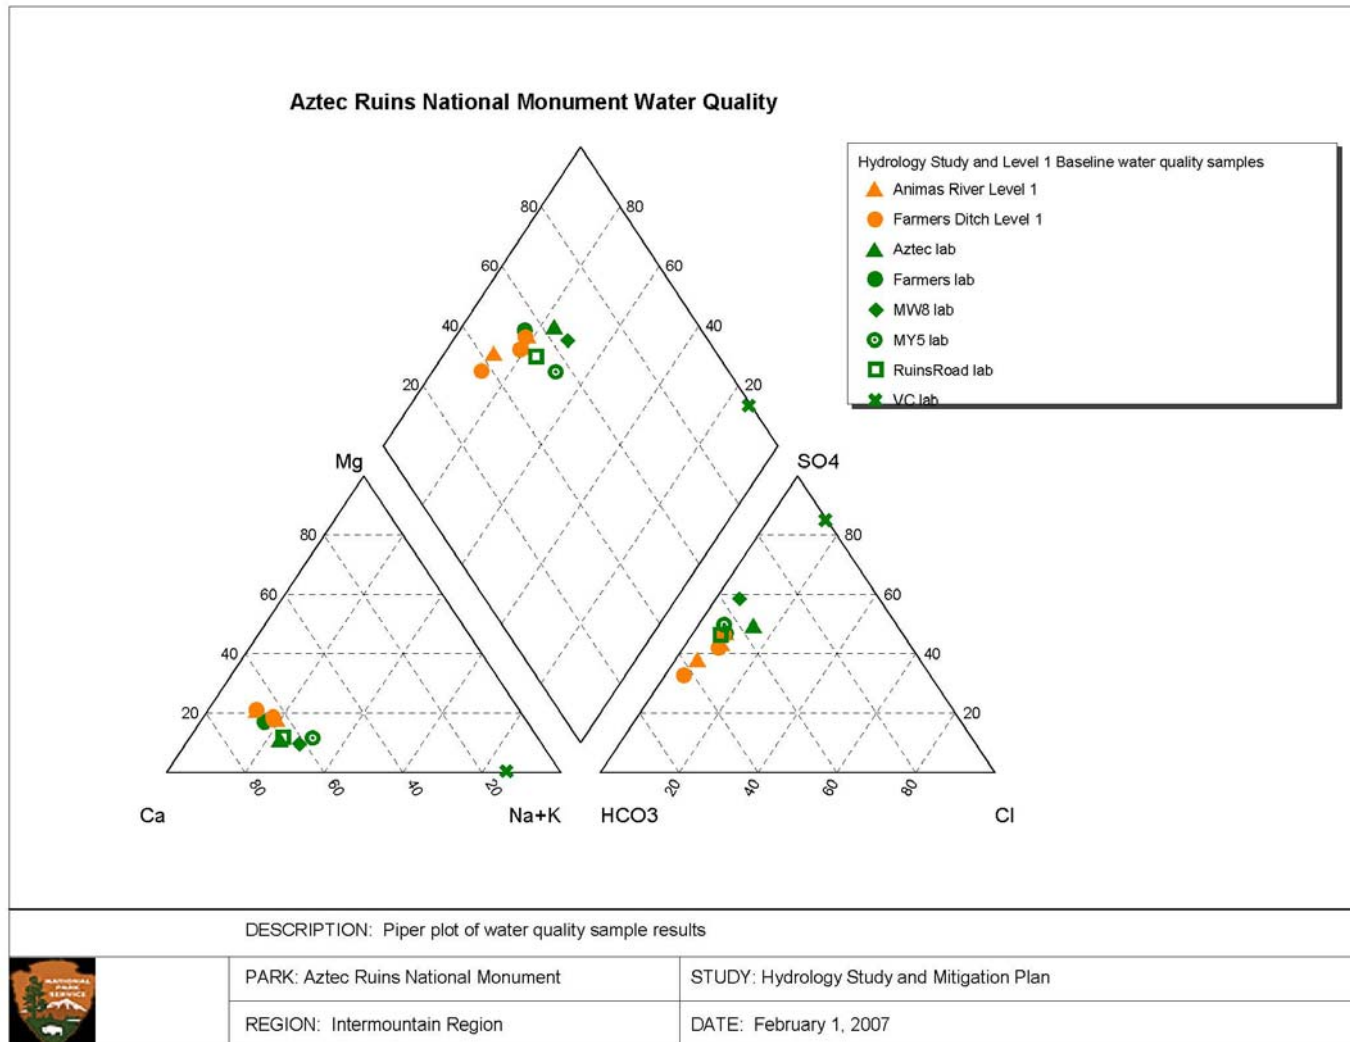
Figure 5. Piper plot of water quality samples from Aztec Ruins National Monument.

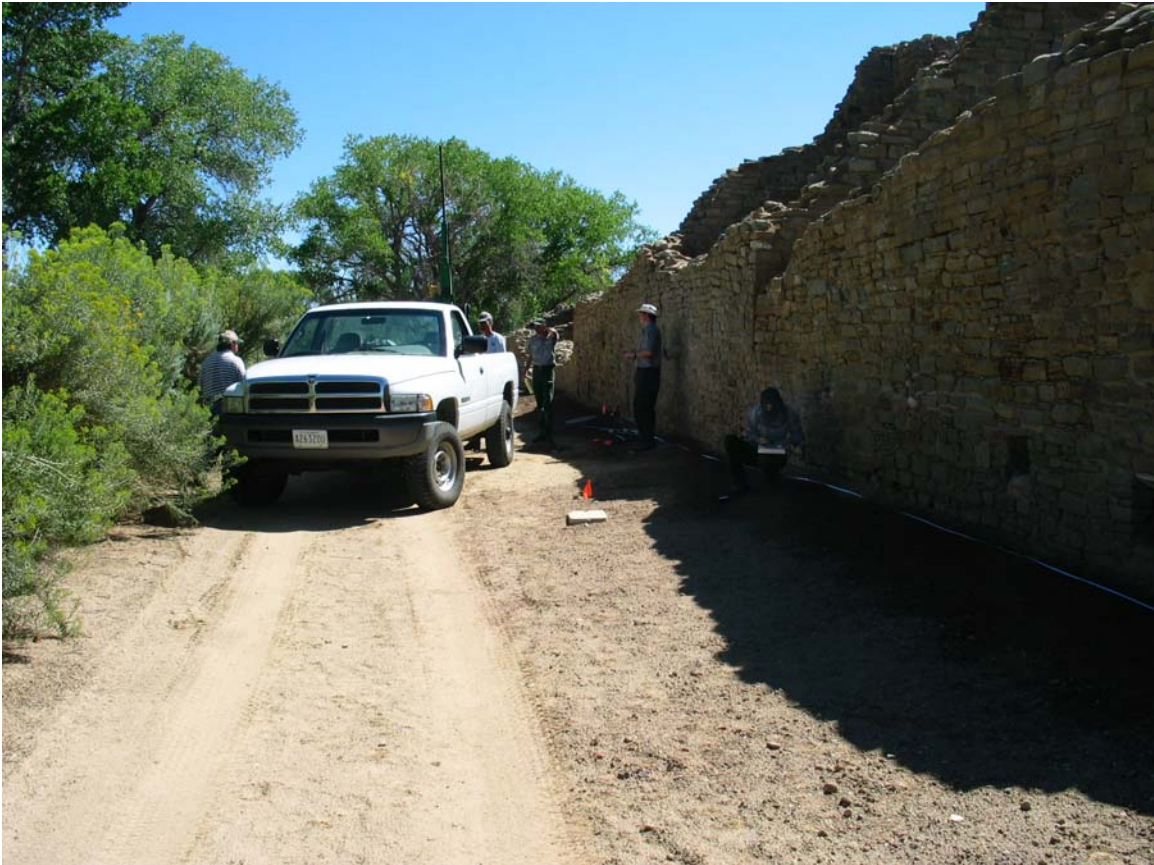
**Photograph 1. Installation of hydrologic monitoring instrumentation (August 2005).**

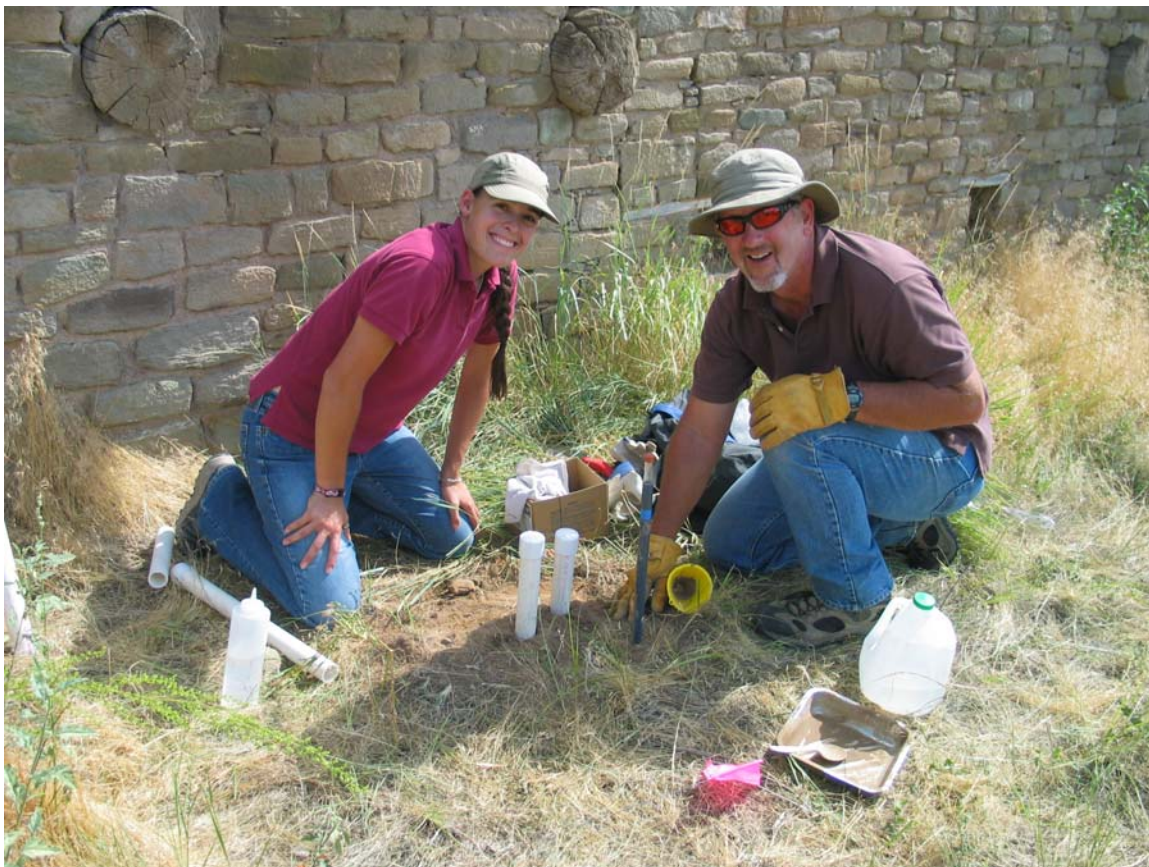
**Photograph 2. Installation of soil monitoring sensors (August 2005).**

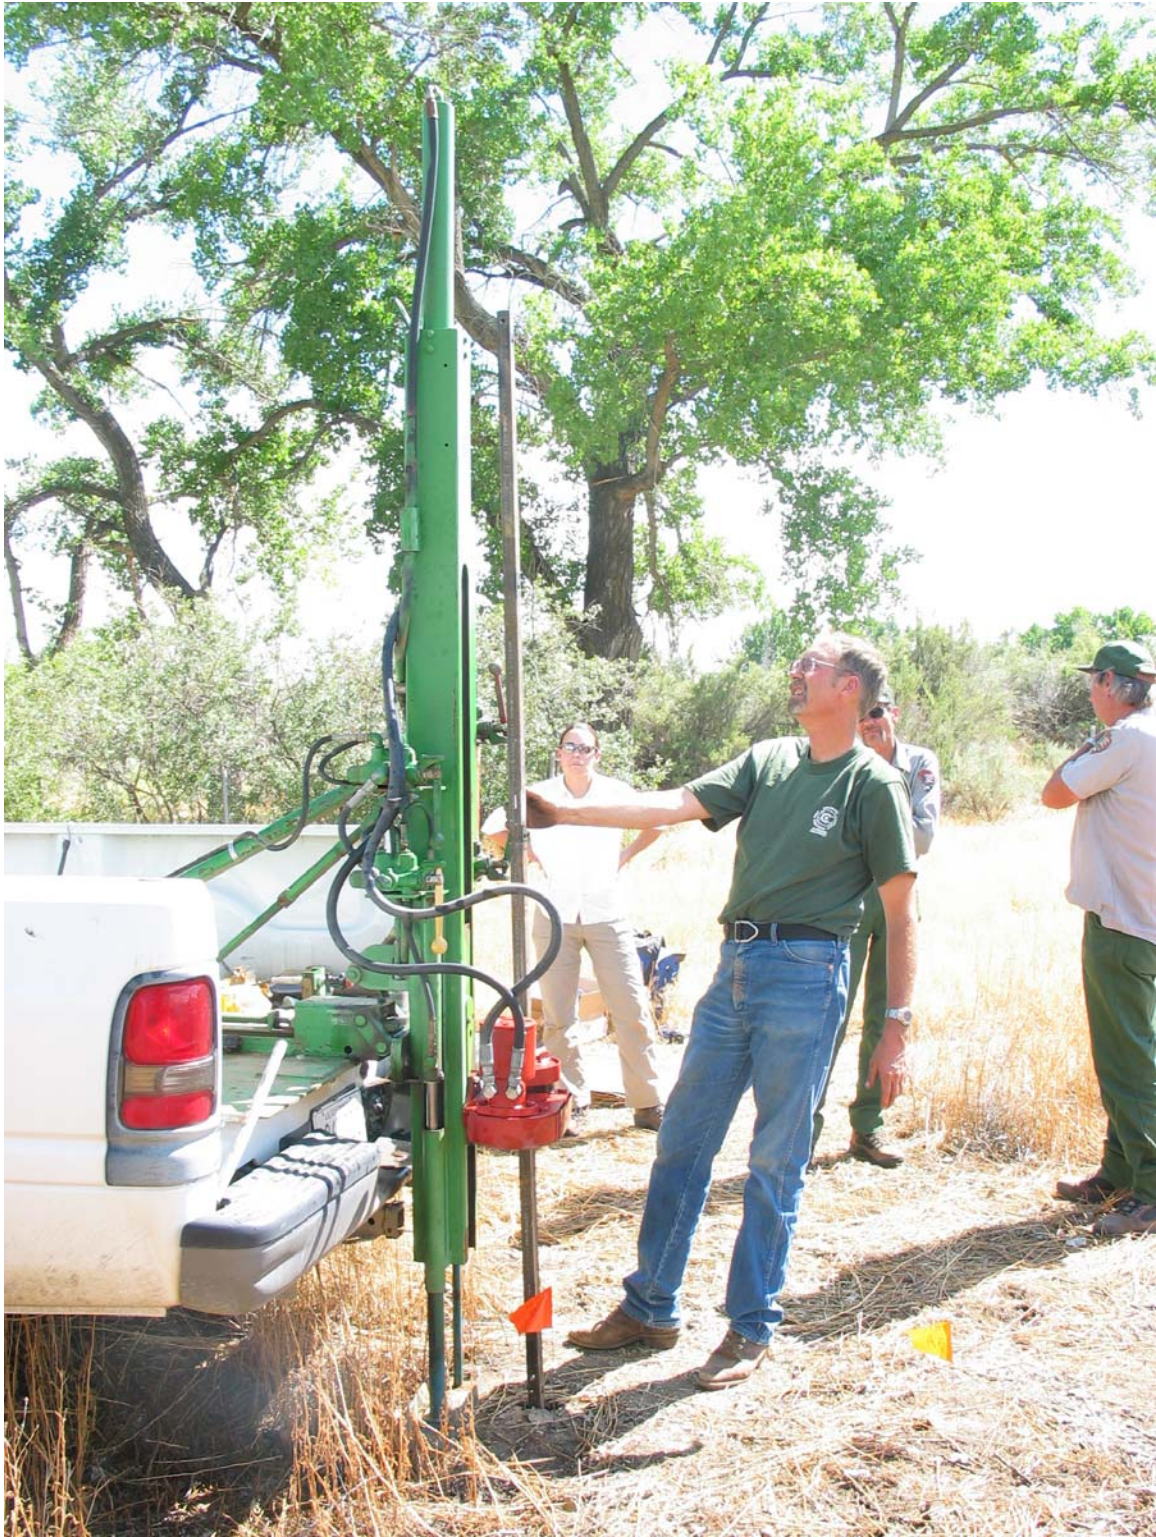
**Photograph 3. Soil boring apparatus and NRCS personnel (August 2005).**

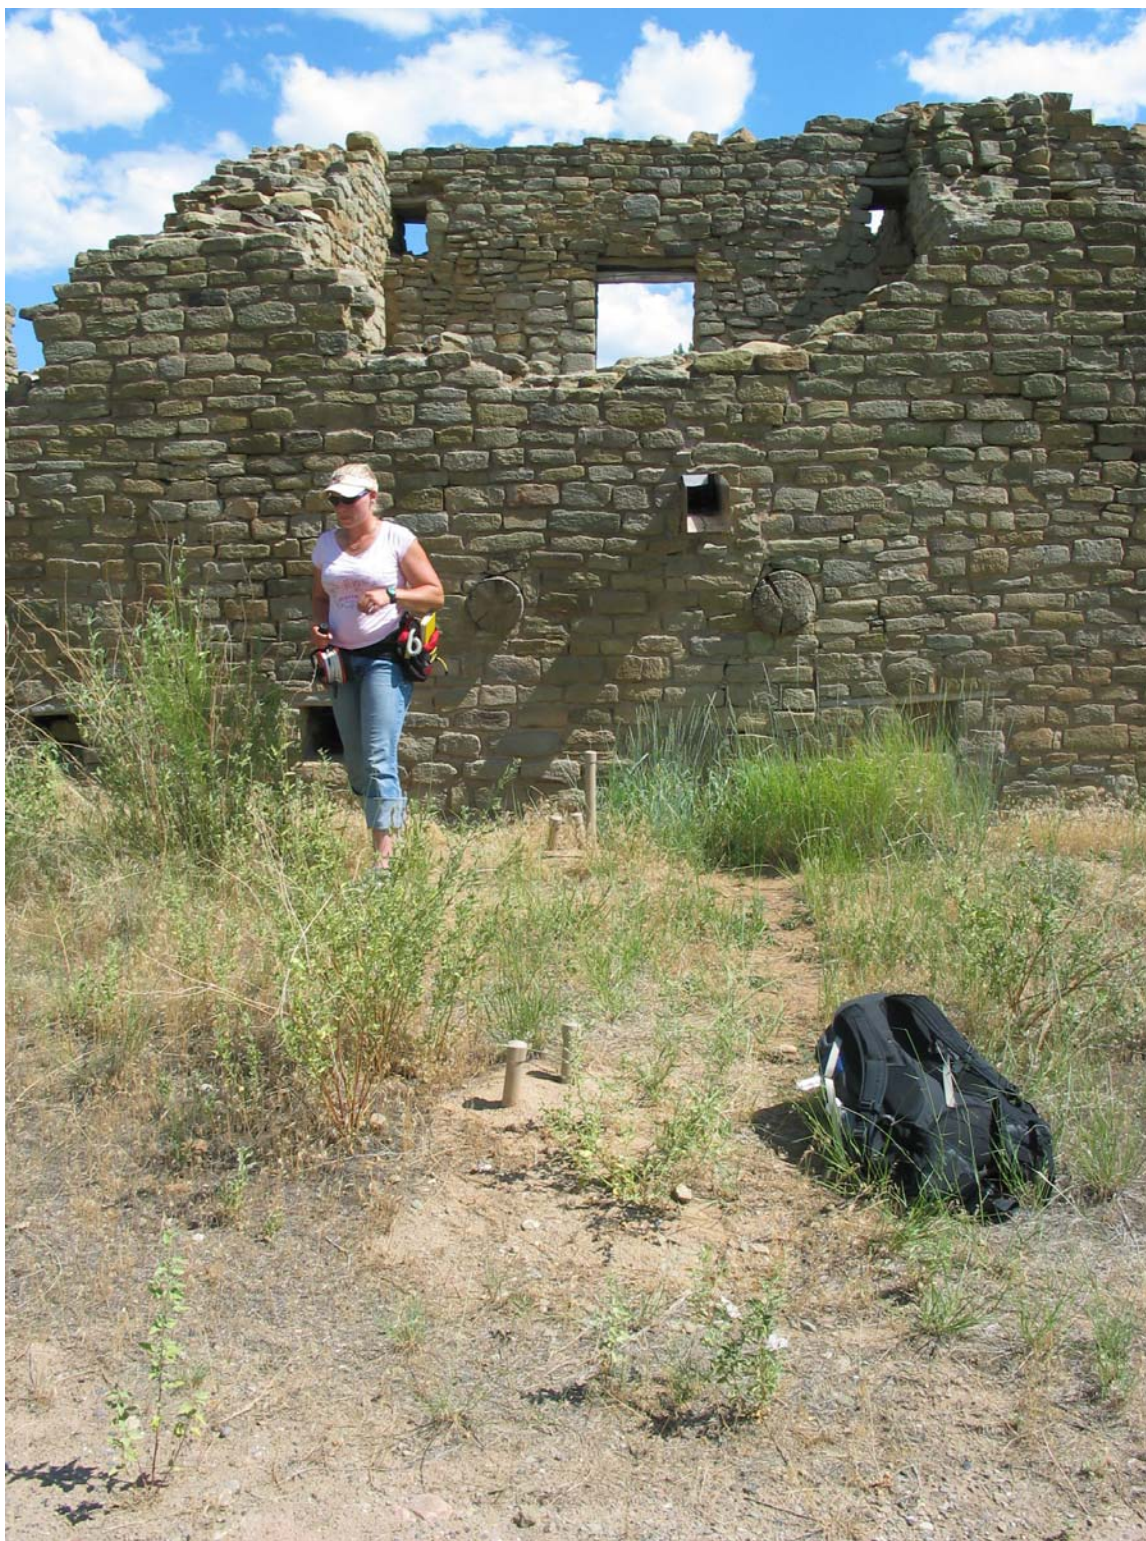
**Photograph 5. Soil water pressure monitoring (July 2006).**

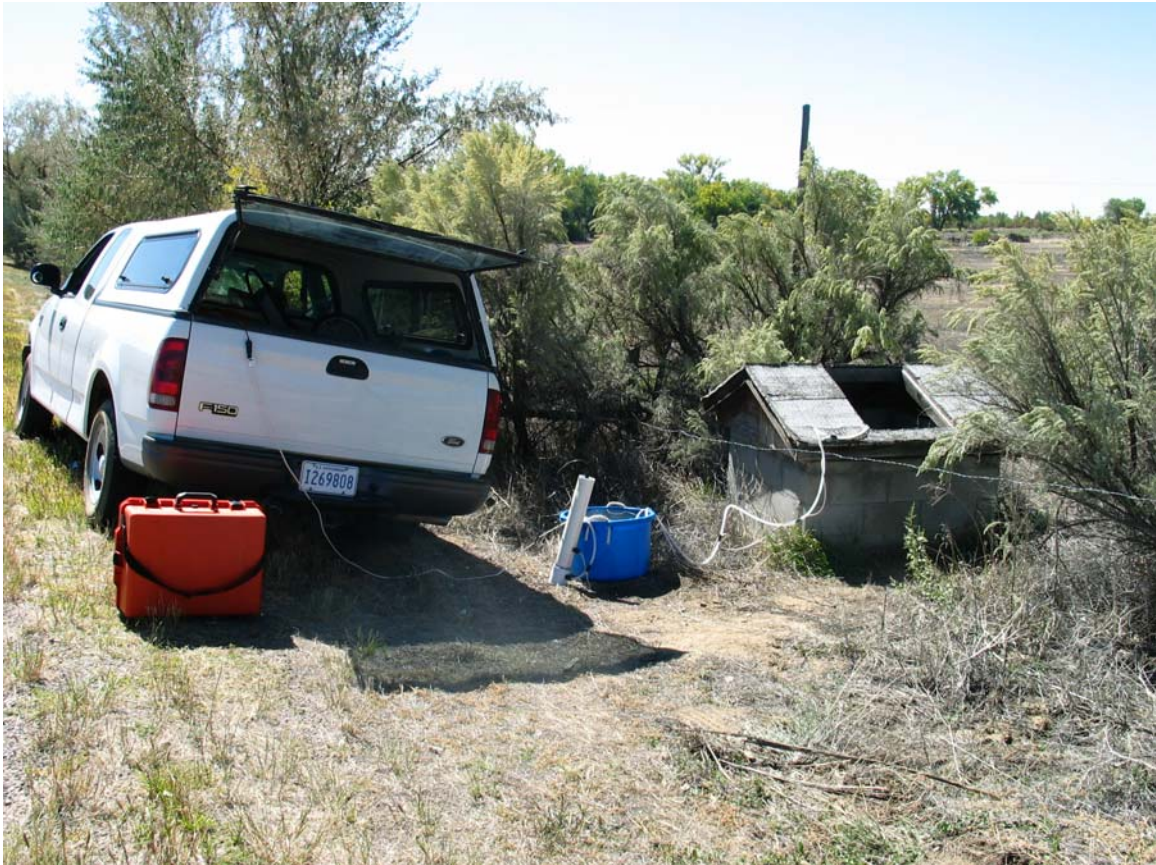
**Photograph 7. Water quality sampling at Ruins Road well (September 2006).**

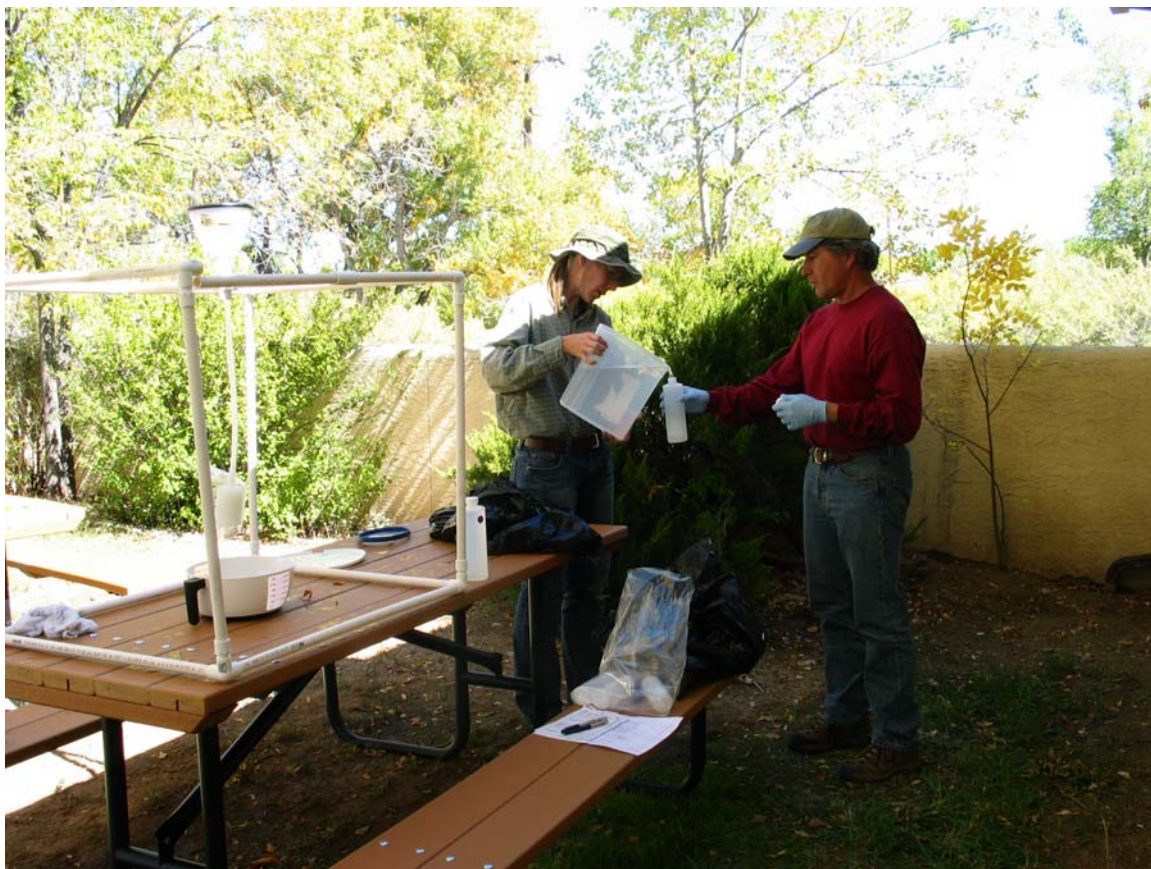
**Photograph 8. Processing water samples for transfer to laboratory for analysis (September 2006).**
