**Evaluation of Environmental Impact  
Related to Proposed Beach Restoration  
at Caneel Bay Resort, St. Thomas, U.S.V.I.**

11 October, 1996

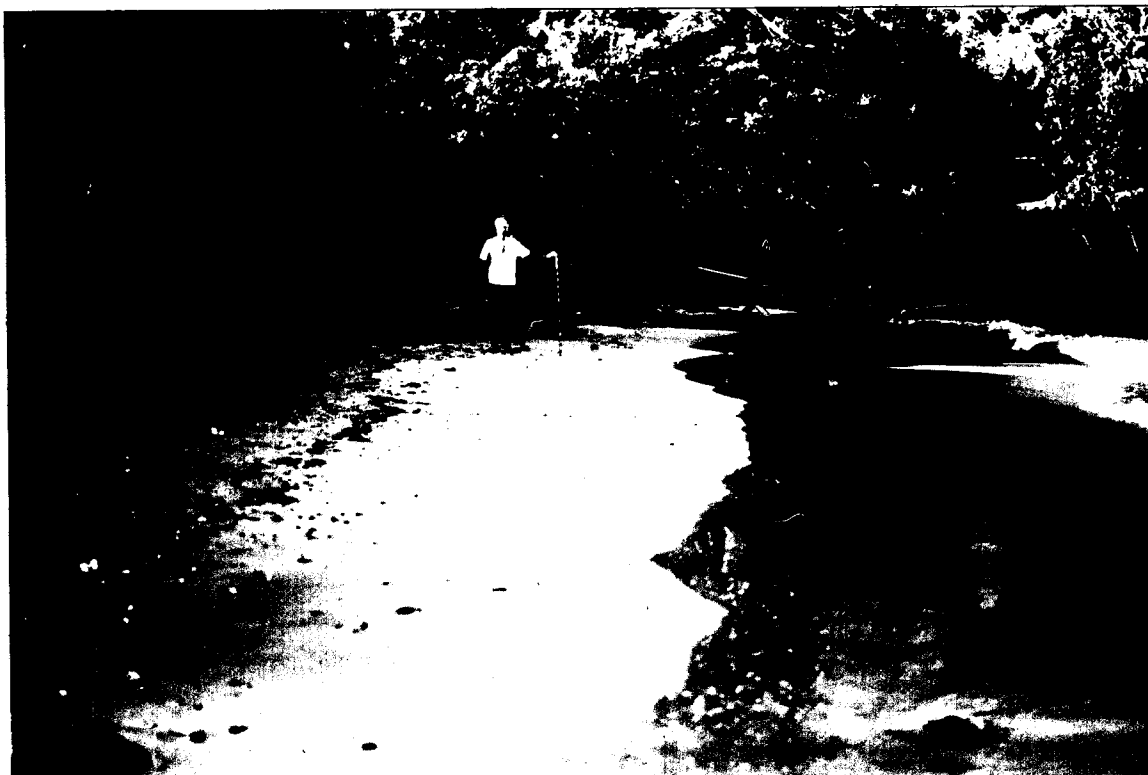
Seven profiles were run to determine the character of the beaches and the extent of the erosion (Fig. 1). Along profiles LC-1 (Little Caneel Beach: Fig. 2) and C-1 (Caneel Bay: Fig. 3, 4), erosion is slight. Approximately 30-45 cm (1.0-1.5 ft) of sand would be needed along the upper beach to cover exposed roots and to reduce wave reflection off the rocks along Little Caneel Beach. None of the sand would be placed in the water. Similarly, at Paradise Beach (Fig. 5) and southern Scott Beach (Figs. 6-9) only a thin veneer of sand would be needed to cover exposed roots.

**Figure 2.** A (top). View looking south along Little Caneel Beach. The person is standing on profile LC-1. Note the exposed rocks at the left. The proposed plan will add just enough sand to cover these, thereby reducing wave reflection. B. Profile LC-1 on 8 October, 1996. The dashed line and stippled pattern show the extent of the sand to be added. See Figure 1 for profile location.

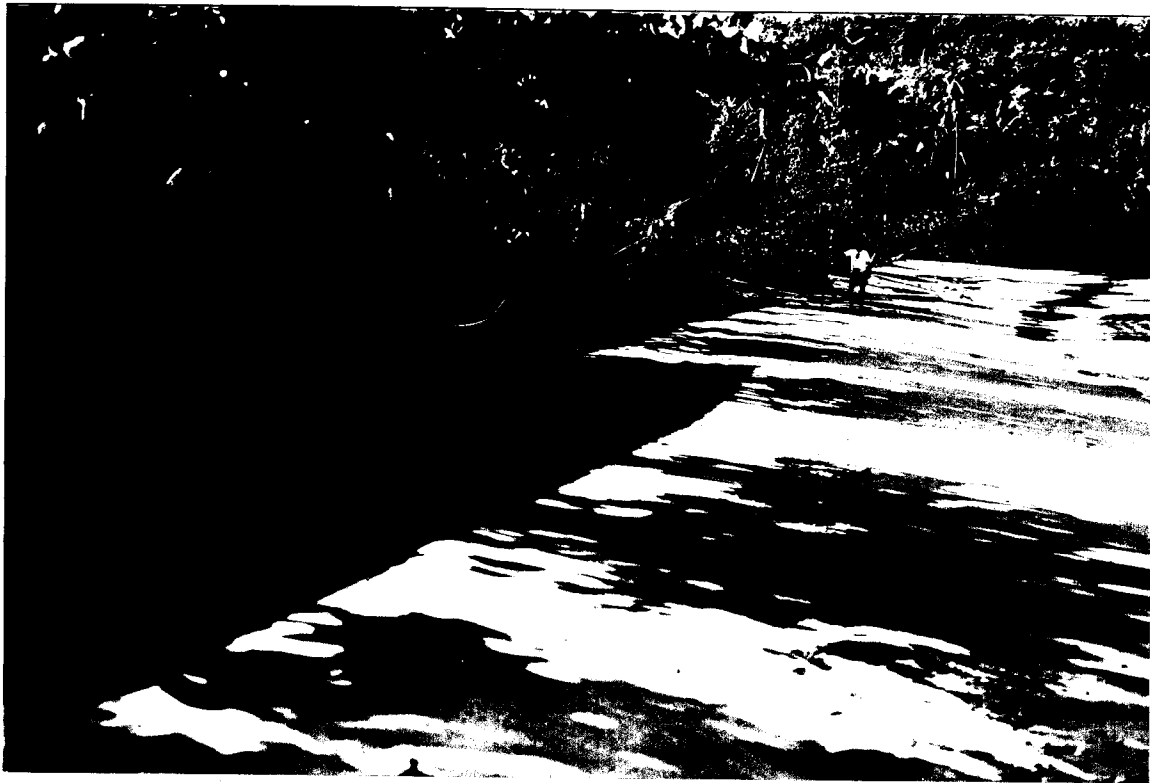
**Figure 3.** **A** (top). View looking south along Caneel Beach. The person is standing on profile C-1. Note the exposed roots at the left. The proposed plan will add just enough sand to cover these roots (ca 45 cm/1.5 ft). **B.** Profile C-1 on 8 October, 1996. The dashed line and stippled pattern show the extent of the sand to be added. See Figure 1 for profile location.

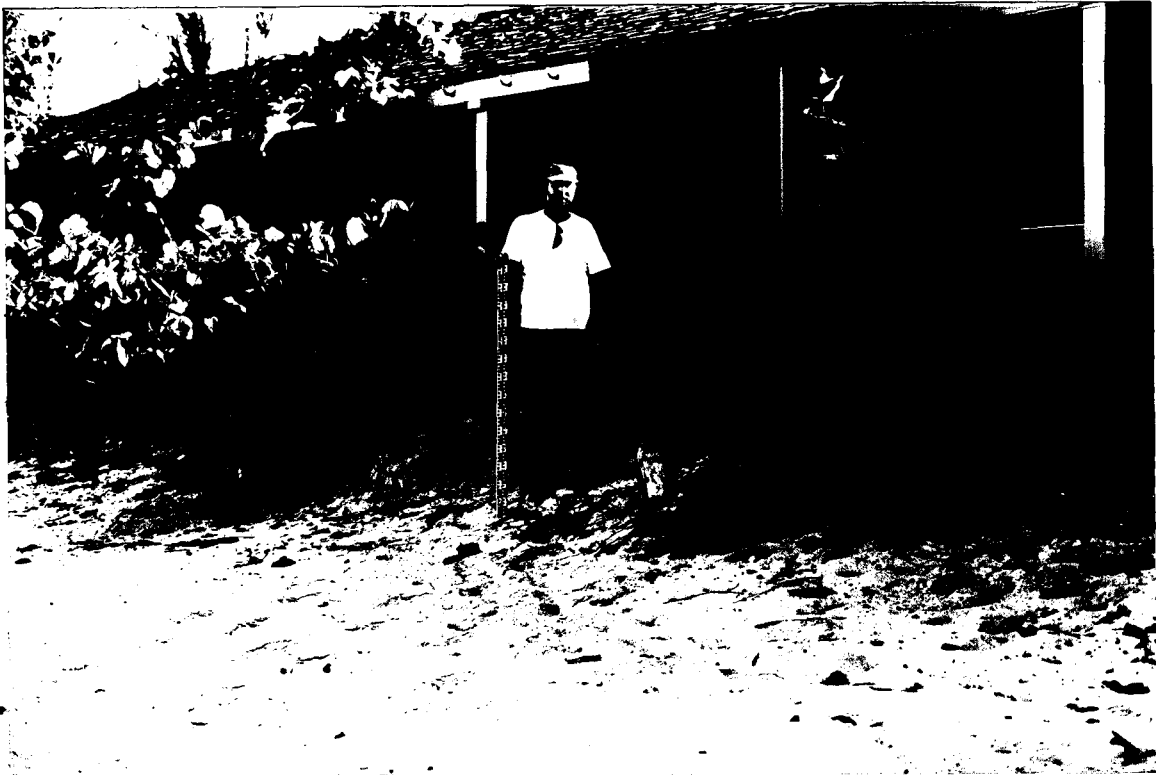
**Figure 4.** Closer view of the exposed roots along profile C-1. The proposed sand would be added only to the extent that it would be needed to cover and protect these roots.

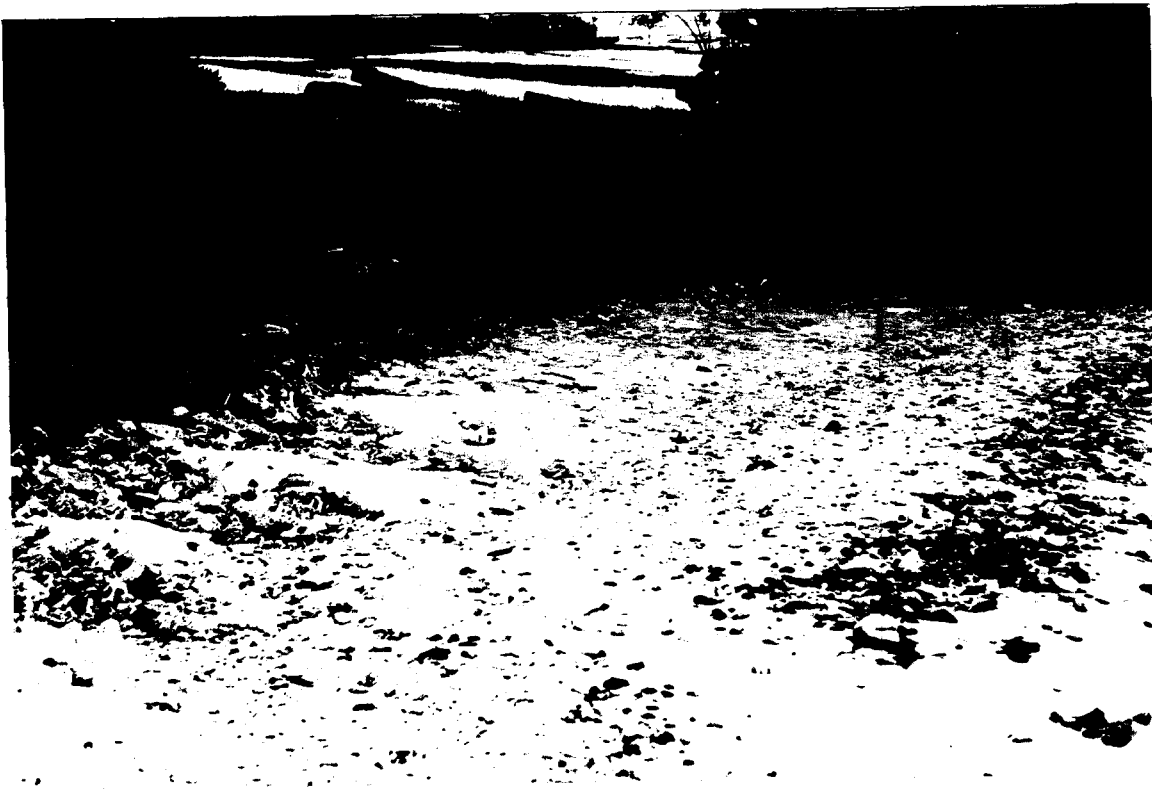
**Figure 5.** A (top). Exposed roots near profile P-1. The proposed plan will add just enough sand to cover these (ca 45 cm/1.5 ft). B. Profile C-1 on 8 October, 1996. The stippled pattern shows the extent of the sand to be added. See Figure 1 for profile location.

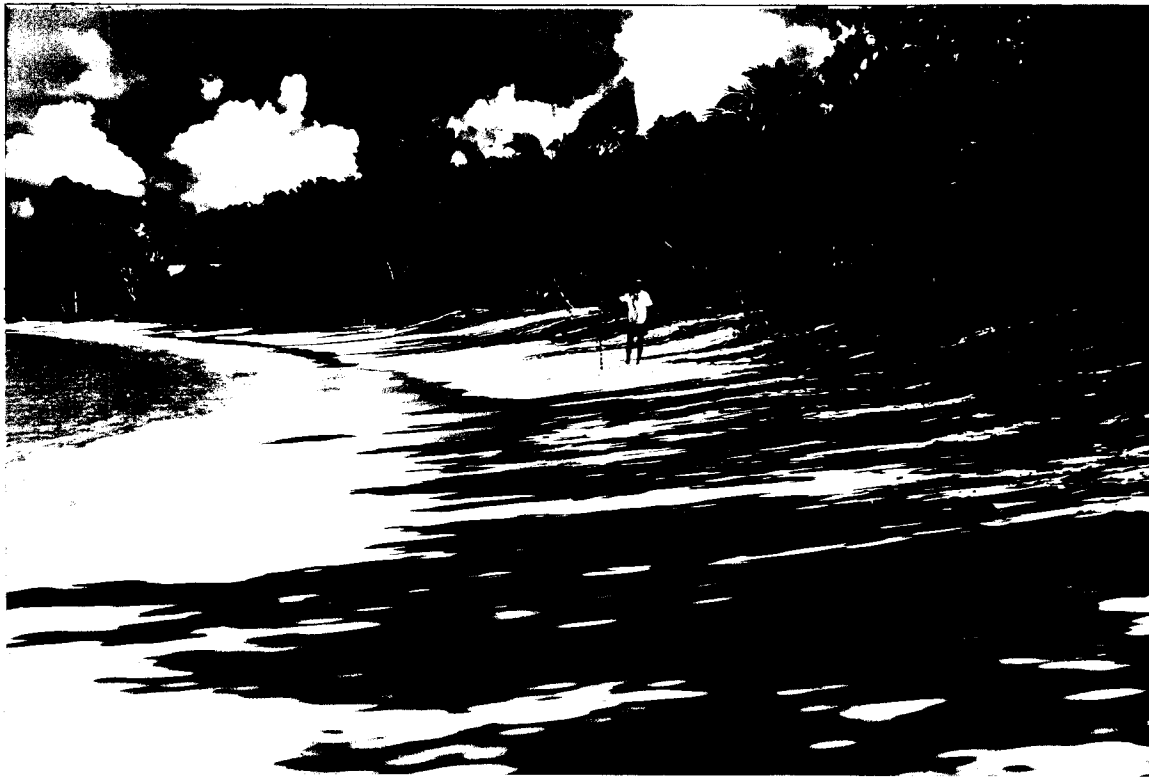
**Figure 8.** A (top) View looking north along southern Scott Beach. The person is on the profile. B. Profile S-1 on 8 October, 1996. The stippled pattern shows the extent of the sand to be added. See Figure 1 for profile location.

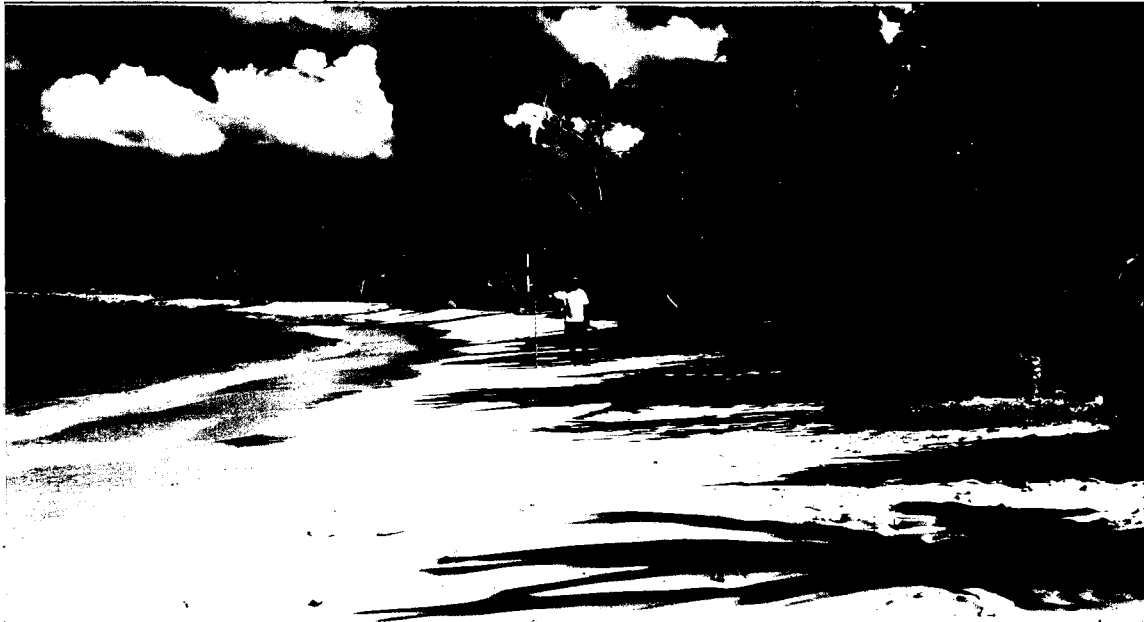
**Figure 9.** A (top) View looking north along northern Scott Beach. The person is on the profile. Note the seawall to the right. Sand needs to be added behind the wall to backfill areas eroded by wave action. A thin veneer of sand would also be added to cover the base of the wall. B. Profile S-2 on 8 October, 1996. The stippled pattern shows the extent of the sand to be added. See Figure 1 for profile location.

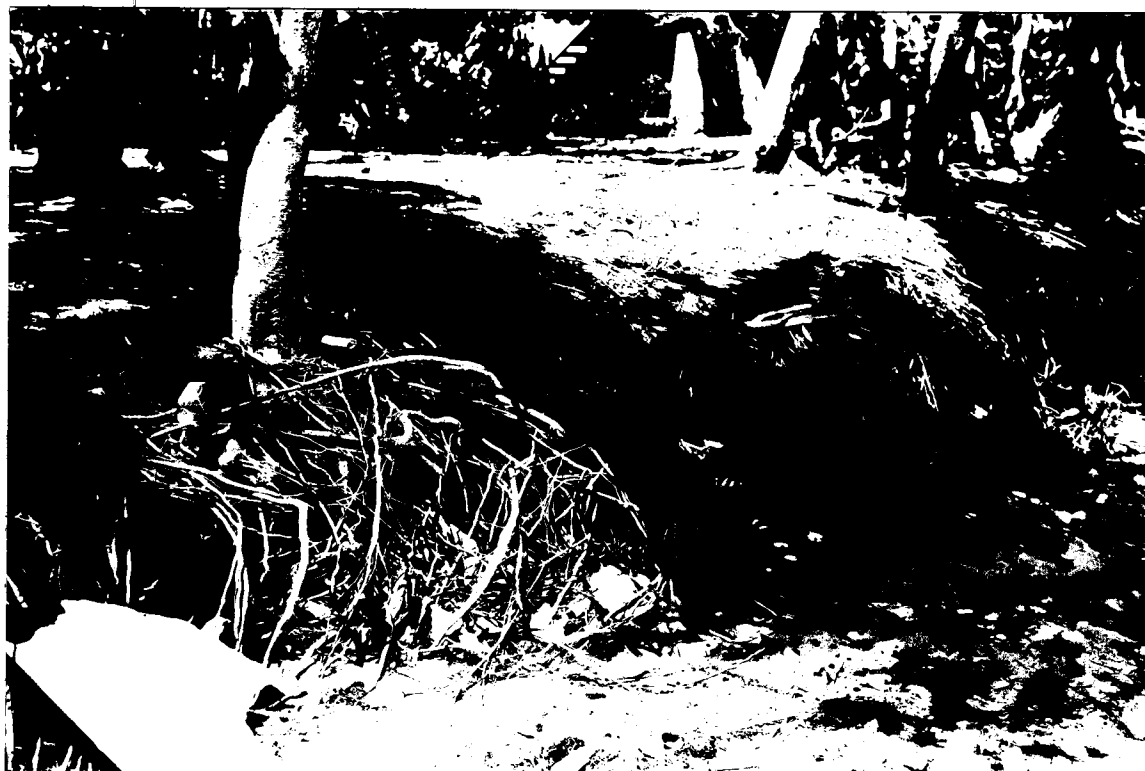
At Hawksnest Bay (Fig. 11), roots have been exposed by erosion and will probably not be covered by natural sand replenishment. A three-part remediation plan is recommended. First, sand should be added to cover the exposed roots. Second, a series of wooden steps should be

**Figure 11.** Photo of exposed roots in Hawksnest Bay. It is recommended that this problem be remedied by adding sand and building wooden steps along high-traffic areas to reduce damage to vegetation. This plan would be combined with an aggressive re-vegetation program along the upper beach.

added to restrict foot traffic to designated pathways in high-traffic areas (there are 7 walkways at present). Third, grasses and vines should be planted along the landward edge of the new beach to help hold sand during the next storm season. The wooden steps would help to protect both new and existing vegetation. The steps should be built in a way that does not require extensive footings (i.e., they should be sacrificial in the event of severe storms; perhaps they could even be taken in before storms).

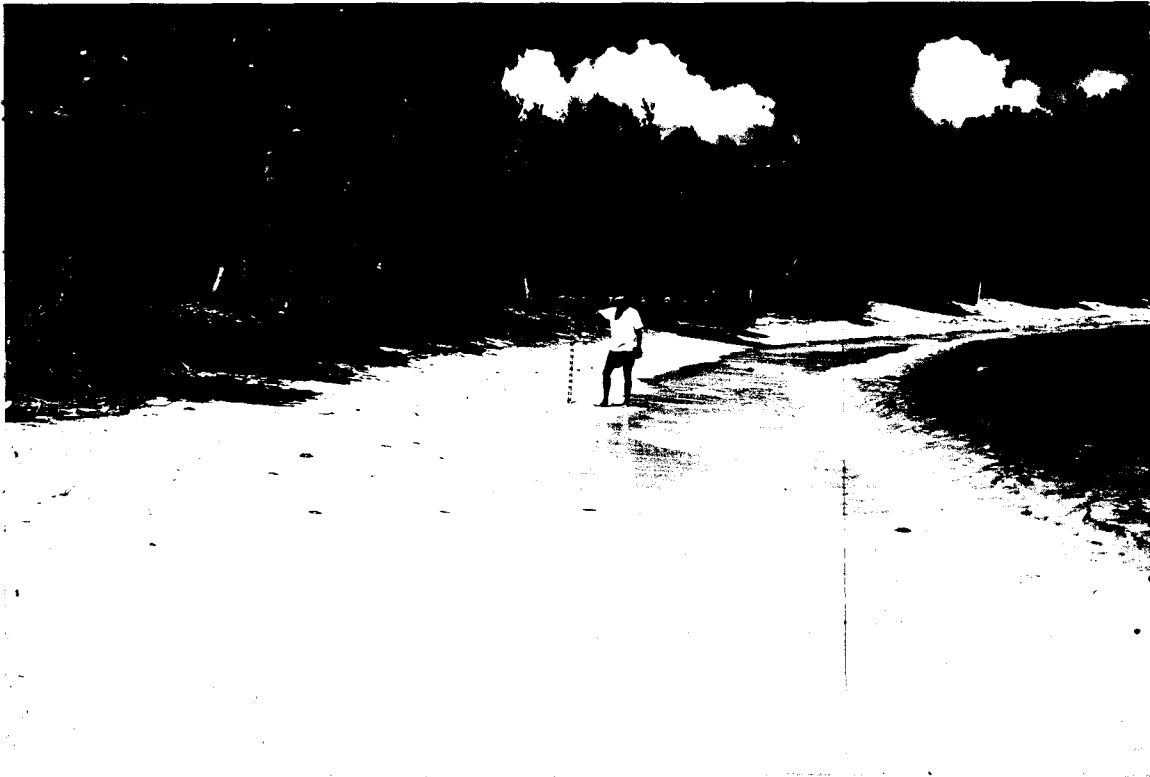
**Figure 12.** A (top) View looking north along Hawksnest Beach. The person is on the profile. Note the exposed roots all along the beach. We recommend that sand be added to cover the roots. As a follow-up, wooden steps should be added along high-traffic areas to reduce damage to vegetation. In addition, new vegetation needs to be added. B. Profile H-1 on 8 October, 1996. The stippled pattern shows the extent of the sand to be added. See Figure 1 for profile location.

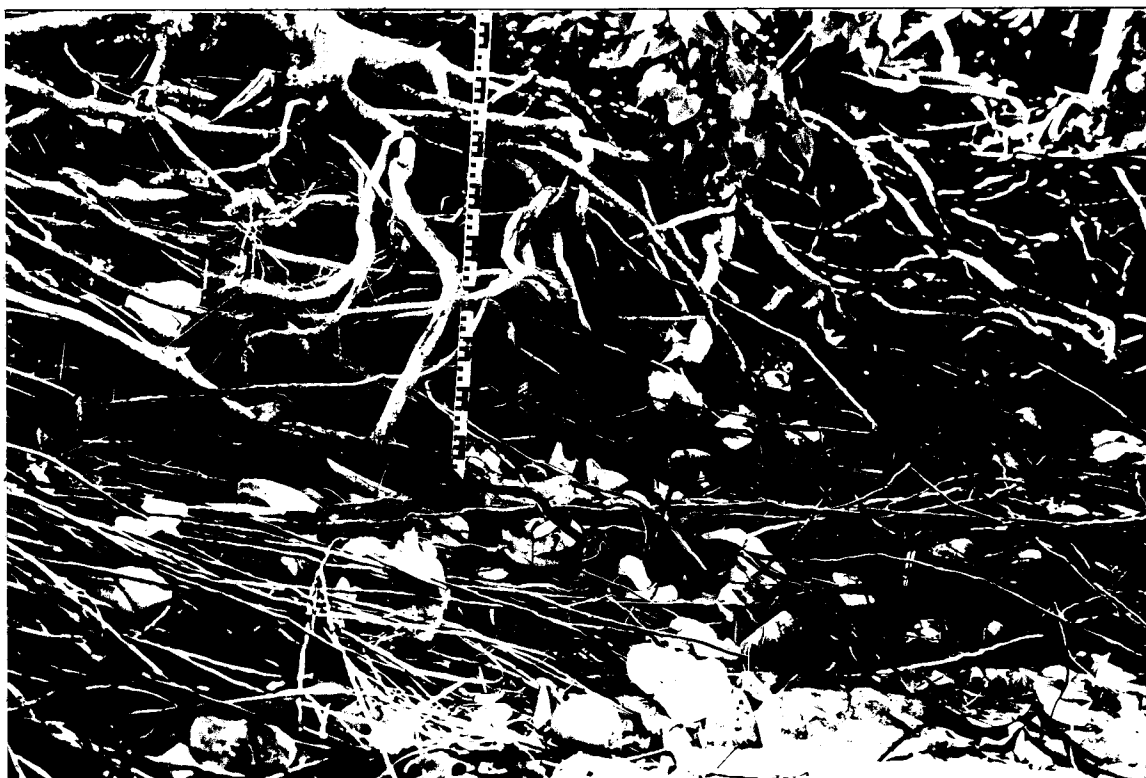
The root structure at Turtle Beach is similarly exposed (Fig 13). In addition, several palm trees are toppling over as their roots are undermined (Fig. 14). Reorientation of their trunks infer that this problem has existed at least once in the past (i.e., note the two changes in growth direction shown in Figure 15).

The history of this beach and its impact on man-made structures is not obvious. Clearly erosion has been widespread on this beach in the past. The roots in Figure 13 are colored near their bases and white near the top. The position of the color change is interpreted as the elevation of the beach before the 1996 hurricane season. The concrete walkway to the beach is footed well below the level of the color change in the roots. To further complicate the picture, the base of this walkway is below the present sand level (Fig. 14: note man standing in hole dug to the base of the steps).

**Figure 13.** Close-up view of the exposed roots along Turtle Beach. Note the change in color from top to bottom. The redder roots were probably exposed in the 1996 hurricane season.

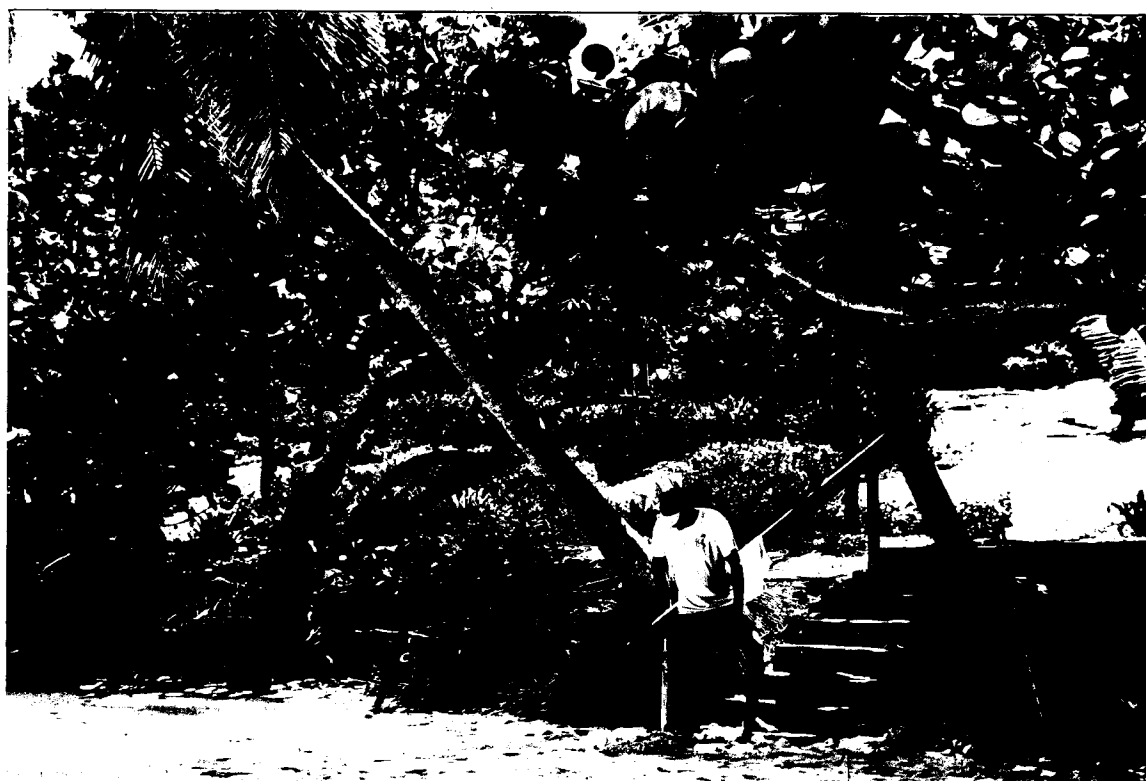
**Figure 14.** View of the landward edge of profile T-1. The person is standing in a hole that was dug to determine the level of the lowermost step (below the present sand level). Note the toppling palms all along the shoreline.

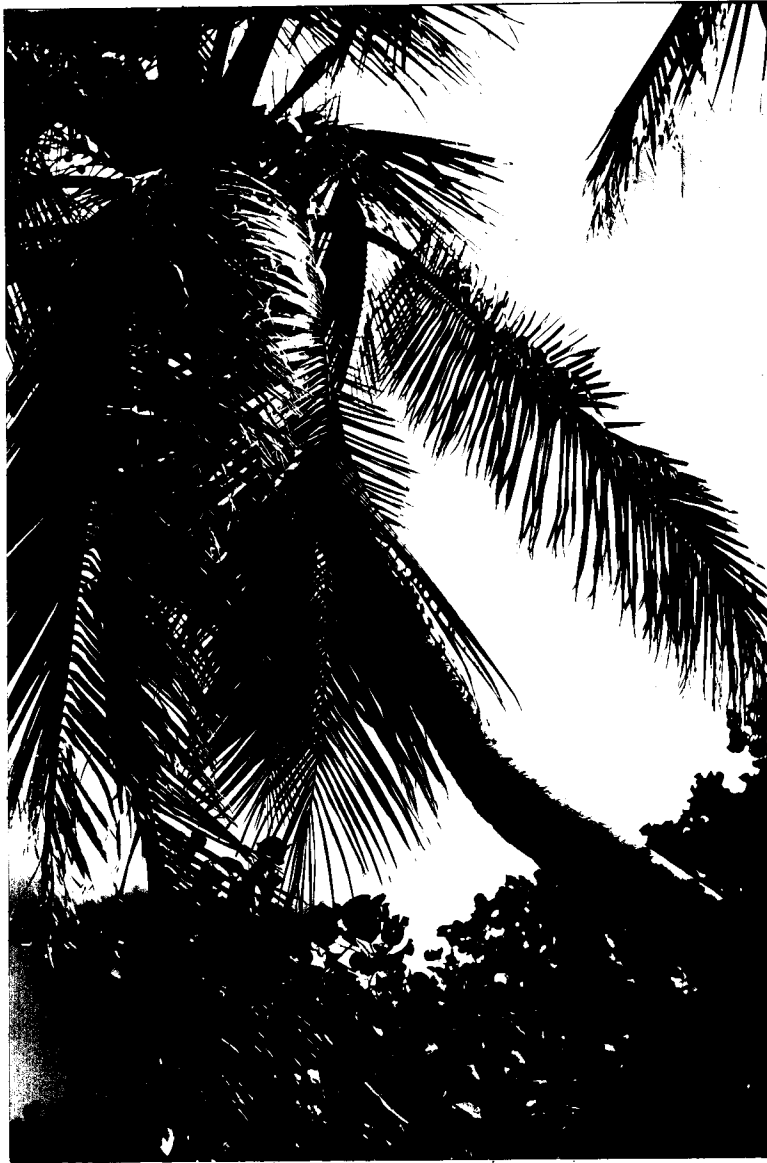
**Figure 15.** Palm tree near profile T-1. Note that the orientation of the trunk has changed several times, presumably related to shifts in the orientation of the tree as it was undercut by successive storms.

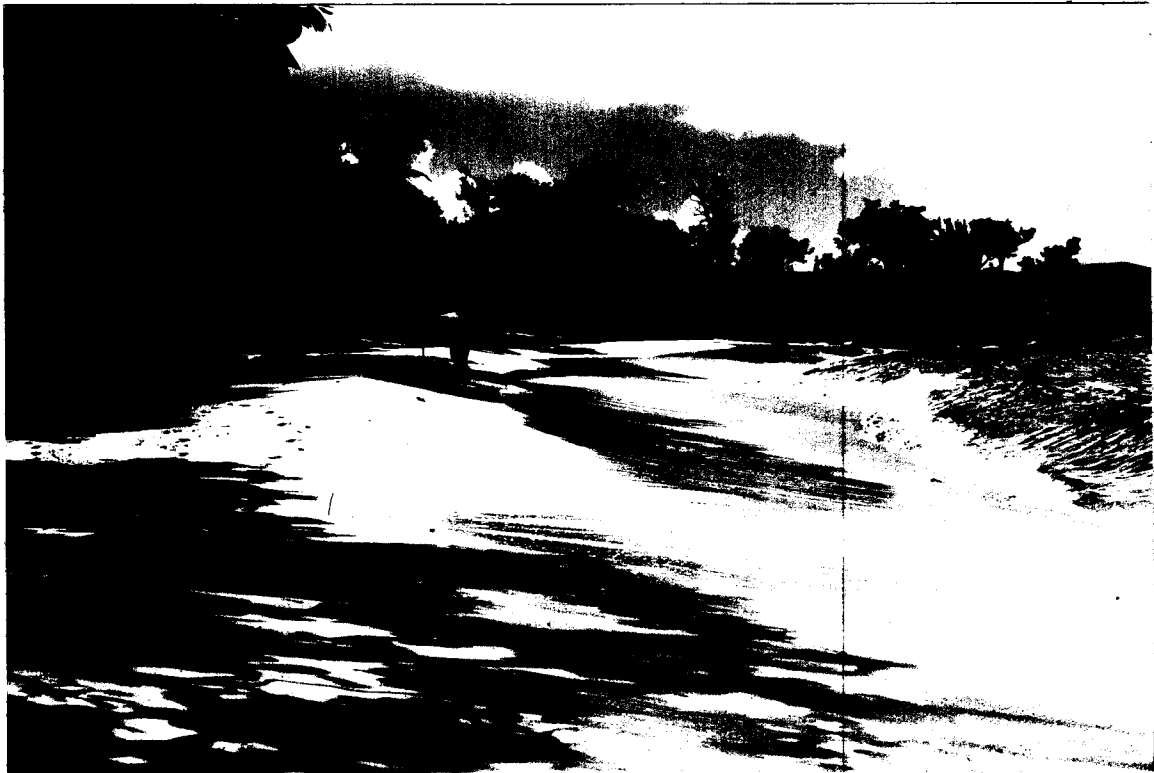
**Figure 16.** A (top) View looking north along Turtle Beach. The person is on the profile. Note the exposed roots all along the beach. We recommend that naturally occurring sand be moved up from the lower beach to cover the roots. By lowering the existing beach slope to cover the exposed roots, beach stability would be increased and new sand would be encouraged to come ashore. B. Profile across Turtle Beach. The stippled pattern shows the extent to which existing sand would be moved to the upper beach. See Figure 1 for profile location.

An important factor in choosing a remediation strategy for this beach is its rapid natural recovery. At present, a broad expanse of loosely packed sand likely reflects newly added sediment (Fig. 16). In some areas, the beach is oversteepened, again inferring rapid recovery. Based on these factors, plus the high ambient wave energy at this site, it is recommended that any remediation plan use natural sand that already exists on the beach.

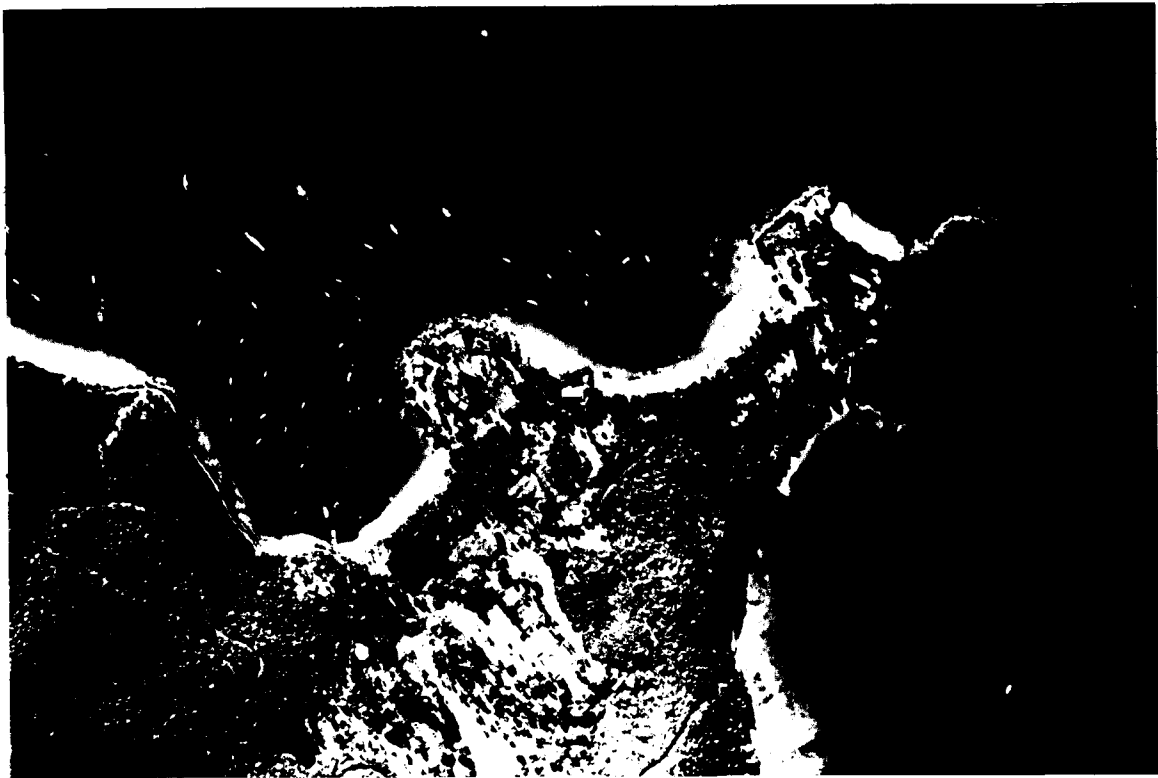
**Figure 17.** Vertical aerial photograph of the site taken by the National Ocean Survey in 1983. North is roughly to the upper right; refer to Figure 1 for locations of specific sites discussed in the text. Reefs are confined to thin fringes around major headlands. In Caneel Bay (upper left), a narrow and largely depauperate pavement extends around the northern point. The dark area in the center of the bay is probably sea grass that no longer exists today. In Scott Bay (upper center), a triangular section of depauperate pavement fronts the northern third of the bay and extends around the point outside Turtle Bay. The dark area north of Turtle Bay (upper right) is largely a barren pavement except for its seawardmost limits. This feature extends around the point and into northern Hawksnest Bay (lower right). The area described as "South Hawksnest" is the narrow, fringing pavement on the point just south of the hotel units (the point in the center of the Hawksnest Bay shoreline in this view). Descriptions from each area are included in the body of the text below. Refer to Figures 1 and 18 for locations and environmental interpretations of this photograph.

Figures 17 and 18 summarize the nearshore benthic communities that existed offshore of Caneel Bay Resort in 1983. The information in Figure 18 is derived from ground-truth surveys done by the College of the Virgin Islands and the National Park Service (Beets, *et al.*, 1986). The environments have been simplified to include only sand, submerged bedrock, reef pavement and grass beds. Table 1 summarizes the observed invertebrate populations and provides very limited data on fishes.

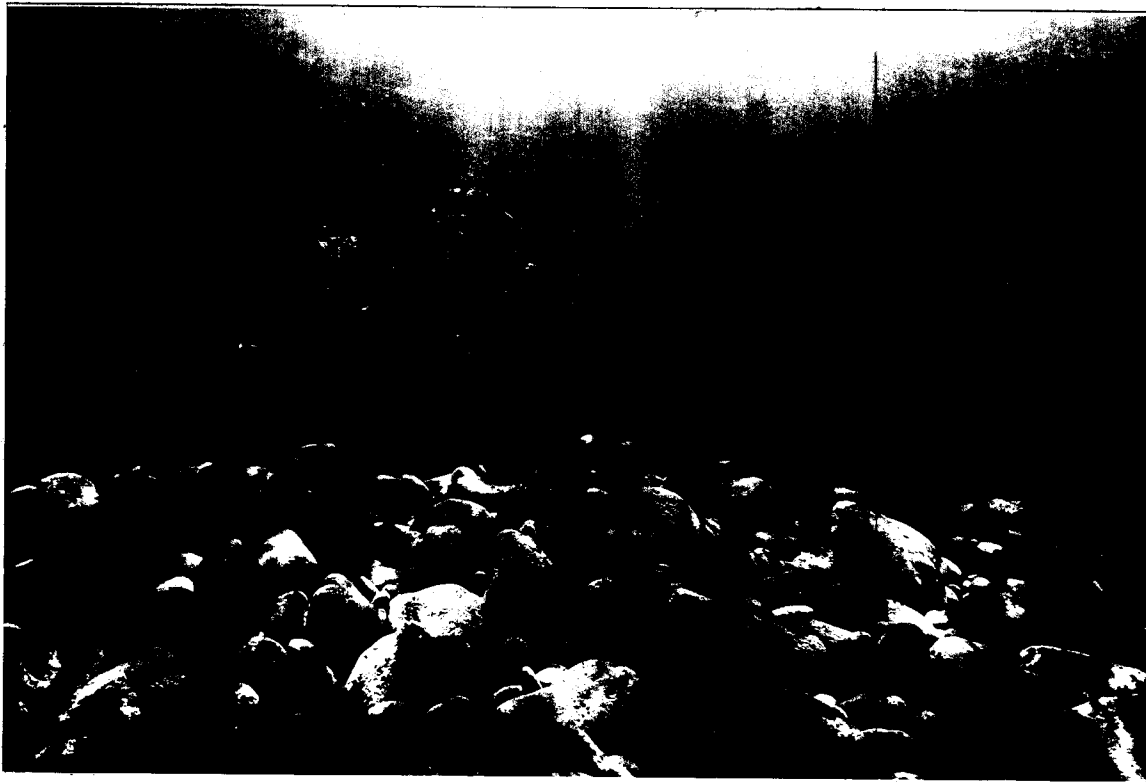
**Figure 25.** Photo of cobbles and small boulders that are mobile only during episodes of higher wave action.

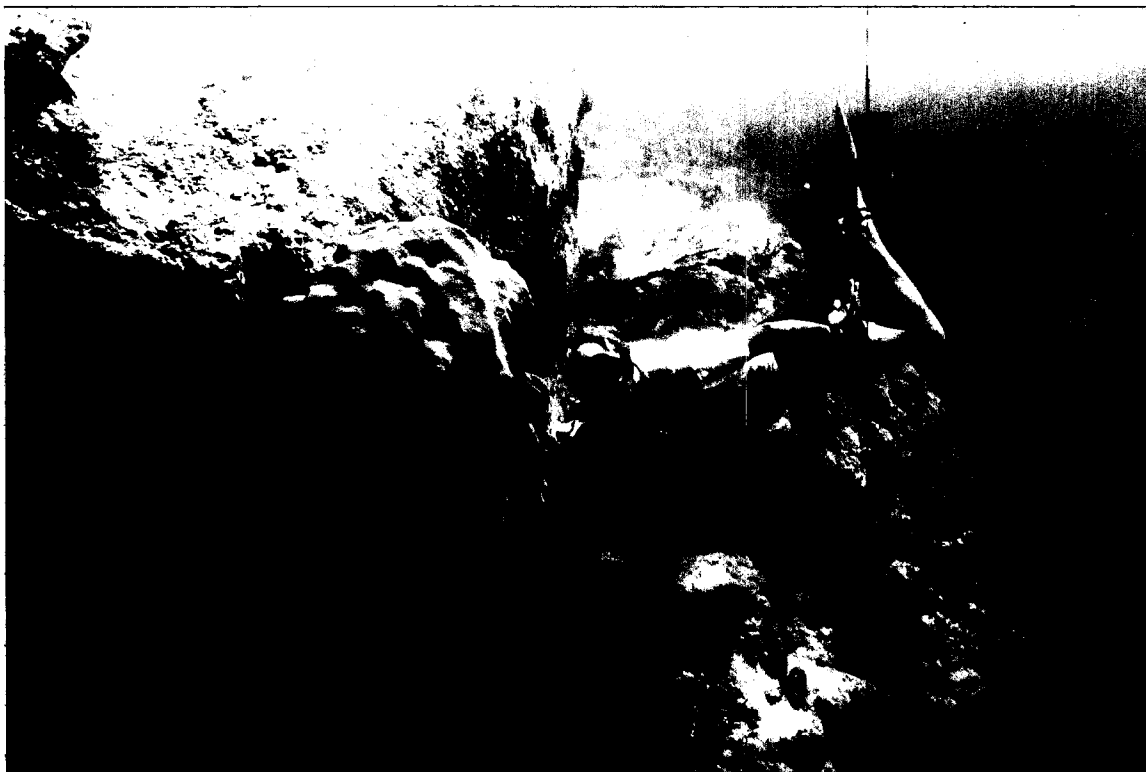
**Turtle Bay** - Reef organisms are confined to the outer reaches of Turtle Bay. Near the tip of the eastern point, larger colonies of *Montastrea franksi* (Fig. 26) plus smaller and widely scattered *Acropora palmata* (Fig. 27) were found. Midway along the eastern point, moderate-sized colonies of sediment-tolerant *Montastrea annularis* also occur, along with several species of gorgonians, widely scattered *Acropora cervicornis* and *Millepora* sp. (Fig. 28). Other corals include *Dendrogyra cylindrus*, a few scattered colonies of *Diploria* spp. and *Porites astreoides*.

**Figure 26.** A large colony of *Montastrea franksi* near the outer limits of Turtle Bay. Larger corals such as this occur well away from the beach and in a vigorous wave climate.

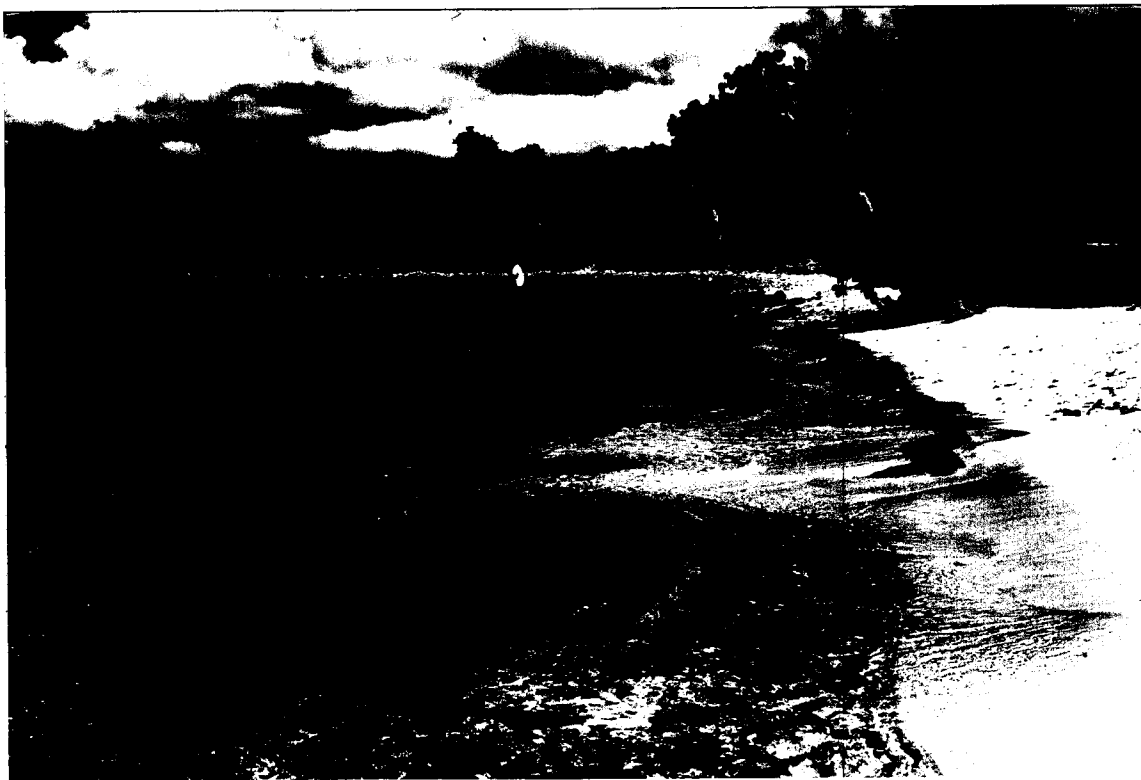
Along the shoreline north of the seawall, an outcrop of beachrock protects the beach (Fig. 31). This feature is covered with small and scattered colonies of *Diploria clivosa* (max size = 30 cm), *Millepora* sp. and *Siderastrea* sp. along with several small sea fans and widespread *Dictyota*. This community reflects frequent disturbance.

**Figure 31.** Beachrock exposed along the northern end of Scott Bay. The submarine pavement described in the text is located along the point in the background.
