United States Department of the Interior  
NATIONAL PARK SERVICE  
Intermountain Region Hydrologist  
7660 East Broadway Blvd. # 303  
Tucson, Arizona 85710  
September 30, 2011

**Subject:** Report on adequacy of new water supply well and recommendations for water supply at Coronado National Memorial

This report was developed in response to a technical assistance request for evaluation of the adequacy of a new water supply well, CORO-WSW-2, at Coronado National Memorial to supply 100-percent of park water requirements. At some point during the post-debris flow discussions about rehabilitation of roads and damaged channel in Montezuma Canyon, the idea of abandoning Headquarters Well, the original water supply well in Montezuma Canyon, was proposed. Since it was not known if CORO-WSW-2 would be a suitable sole source for park water supplies, a technical assistance request, shown in Appendix A, was submitted to the Intermountain Region Natural Resources technical assistance call for FY2011.

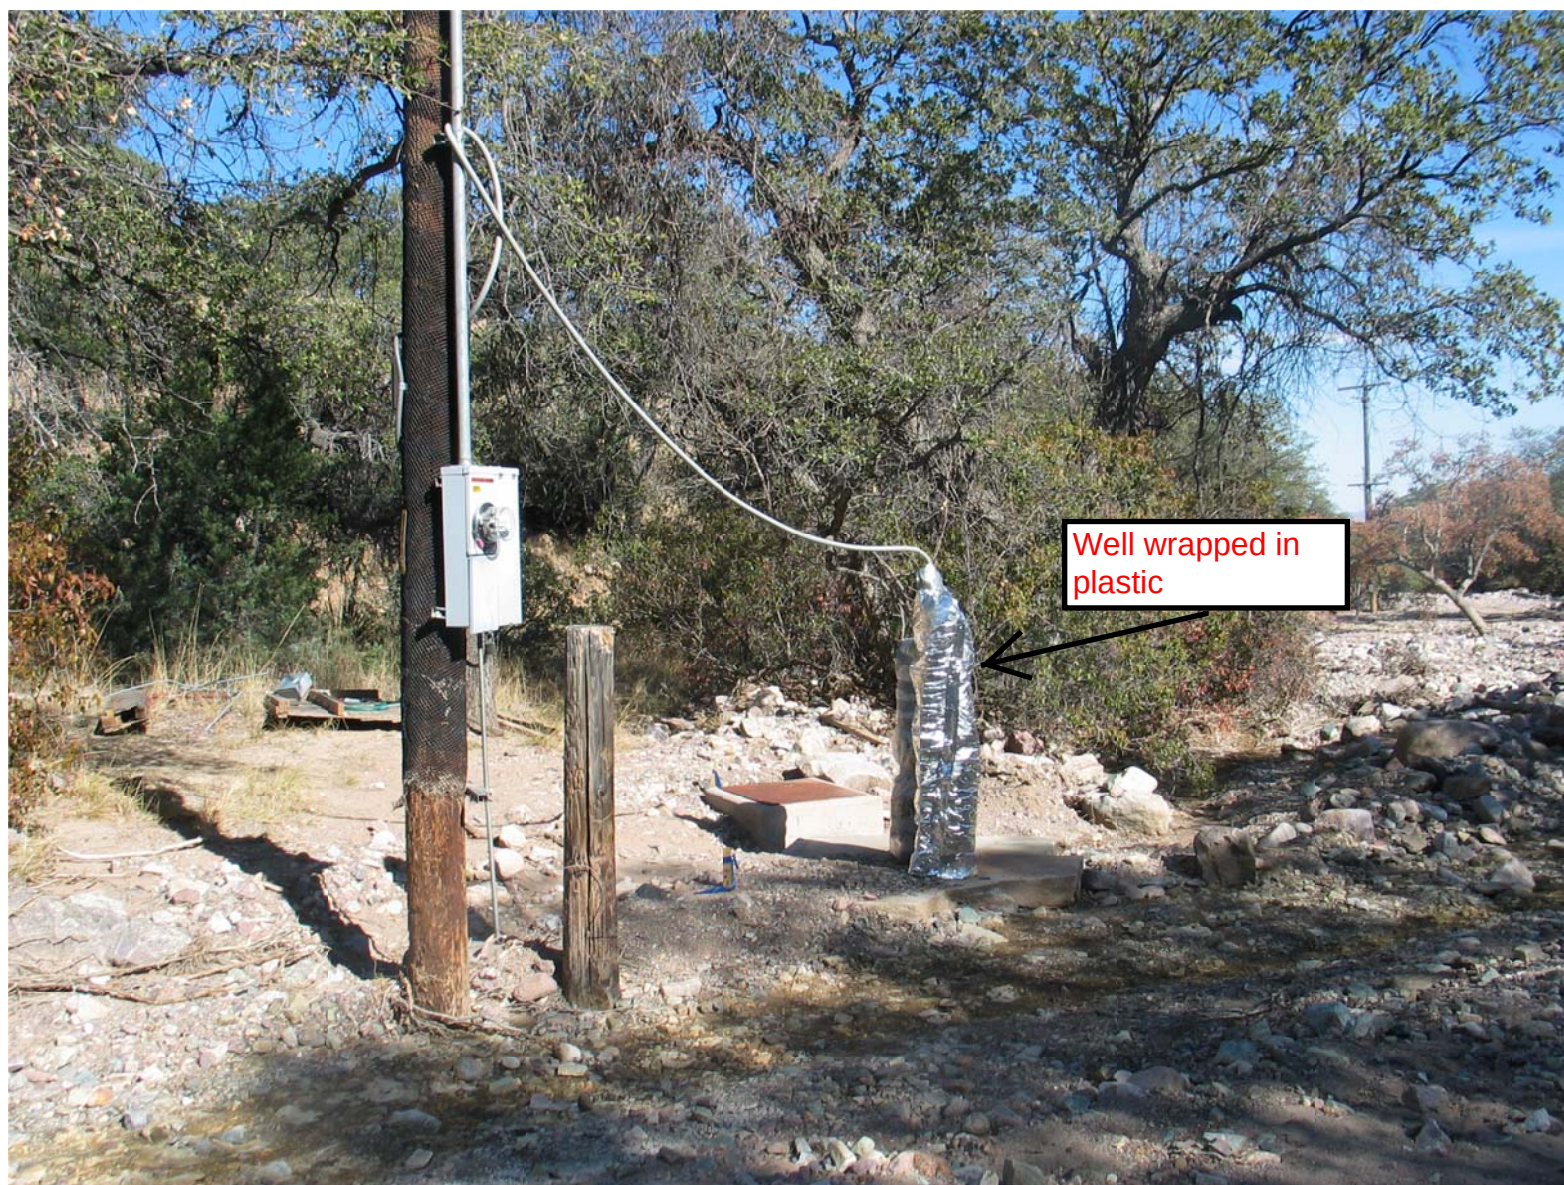
Figure 2. Headquarters Well following the July 2006 debris flow event.

Following the destruction of the existing park chlorination system and well building by debris flow in late July 2006, only the well and a nearby utility pole remained intact (Figure 2). In 2007, a replacement chlorination building was constructed adjacent to an existing 50,000-gallon water storage tank on the southern flanks of Montezuma Peak, above Montezuma Canyon at about 5,425 ft elevation. In September 2008, a new well designated CORO-WSW-2 (ADWR 55-909747) was constructed adjacent to the new chlorination building. The location of the new well is shown in Figure 1, and a photograph of the well is shown in Figure 3. The water tank and chlorination building are immediately uphill of the new well. Approximately 750 feet updrainage from the well, two springs and an inclined mine shaft known as Headquarters mine (93-025) are shown on Figure 1. Another mine, #93-026, is located nearby but not shown. Abandoned mine assessments for these two mining features are included as Appendix D (Karst Solutions, 2009a,b). Both of these features have been gated to prevent entry, but the documented presence of arsenopyrite seepage from the mine openings and flow of highly mineralized discharge from nearby springs, pictured in Figure 4, has not been addressed (Linda Dansby, 4/21/2011, email communication). The proximity of seepage from the abandoned mine features and the ore body may be a potential concern for water quality in the well. When the well was monitored on 2/17/2011, there was a distinct sewage-like sulfur smell coming from inside the casing that was not noticed on previous site visits.

Well wrapped in plastic

The NCD report does not implicate the existing wellhead in Montezuma Canyon as interfering with the recommended channel design and maintenance plan, and does not recommend abandonment of the well. The report does mention the vulnerability of the wellhead to future sediment movement in Montezuma Canyon. The presence of utility poles directly upstream of the wellhead is believed to have helped protect the wellhead from damage during the debris flow event. If these utilities are moved, it is recommended that the base of the poles be left in place to provide protection as long as the well remains. A better solution may be to install a protective bulkhead in the channel upstream of the well to deflect flood debris from the well.

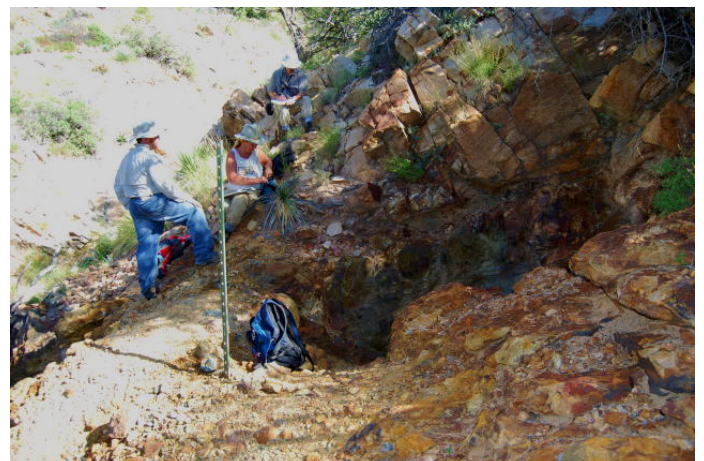
**Figure 4. Collar of inclined shaft. High sulfide ore in foreground on mine dump.**

Describe: *The acidic condition of oxidizing sulfides at the collar preclude use of mild steel for a closure. Crusts of native sulfur were noted on oxidizing sulfides of the tunnel walls. The sulfuric acid produced when the wall rock becomes wet will attack anything but stainless steel.*

**Description of shaft/stope condition:** *The inclined shaft slopes northward roughly parallel to the creek bed. The shaft is dug in a sulfide replacement body at the edge of a crystalline marble bed. The sulfides are largely oxidized creating leaving pockets of limonite which upon drying is sloughing into the shaft. This is creating some natural voids in the walls. Natural sulfur creates a crust in patches on the walls. The shaft has a strong sulfur odor. Some un-oxidized sulfide minerals are exposed on the waste pile, in particular arsenopyrite.*

*The recommendation is for a PUF closure and backfilling. This will prevent animals and humans from coming in direct contact with the water. The mine dump should be considered for additional remediation outside the scope of this contract. Routine monitoring of the well water for arsenic and other toxic metals should be undertaken if it is not being done.*

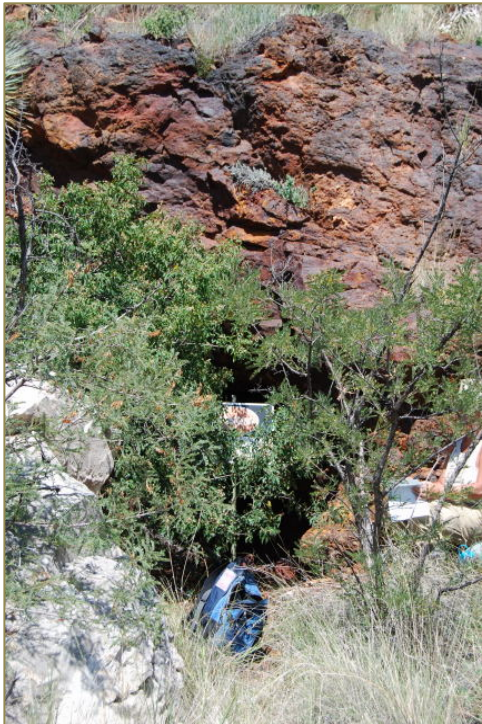
**Figure 1. Portal at base of red oxidized gossan. Marble exposed, white rock, lower left**

**Description of shaft/stope condition:** *The adit is in a massive sulfide replacement body on the border between quartzite and crystalline marble. This ore body is similar to that of 93-025 with the exception that the waste rock is not near a stream. The adit slopes downward and left to a small residual pool. Animals may use this as a water source during drought, if it persists. The portal is solid and will support a bat gate.*

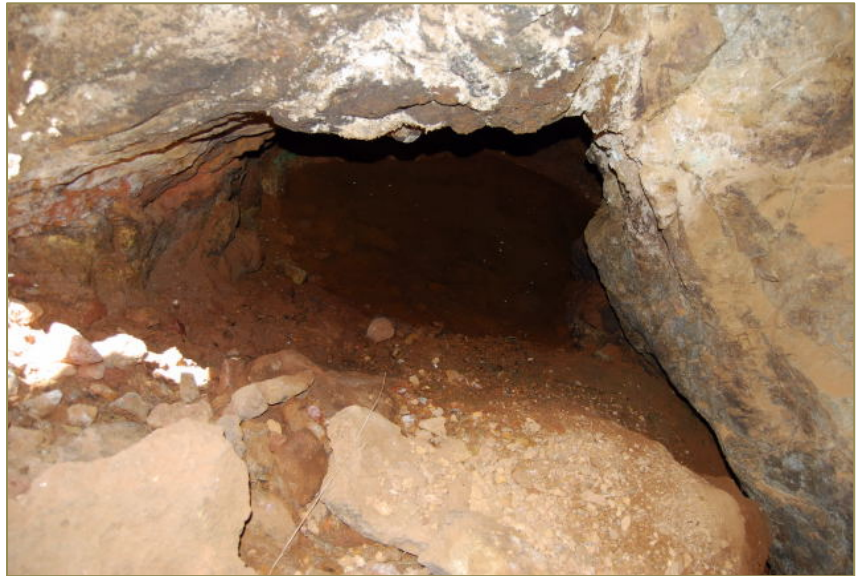
**Figure 2. Small pool at bottom of tunnel.**

Notes: *A pool of water at the bottom of the shaft may be used by wildlife. This probably contains a high concentration of arsenic and other toxic metals. A single macrotus was found roosting just inside the adit and took flight as the team approached. While the pool may contain metal contaminants, humans and larger animals can be kept away with a bat gate, which will preserve roosting habitat.*
