# **PARK SCIENCE**

## **A RESOURCE MANAGEMENT BULLETIN**

# Seismic Research Protects Significant Ruins At Chaco Culture National Historical Park

By Ken King and Keith A. Yarborough

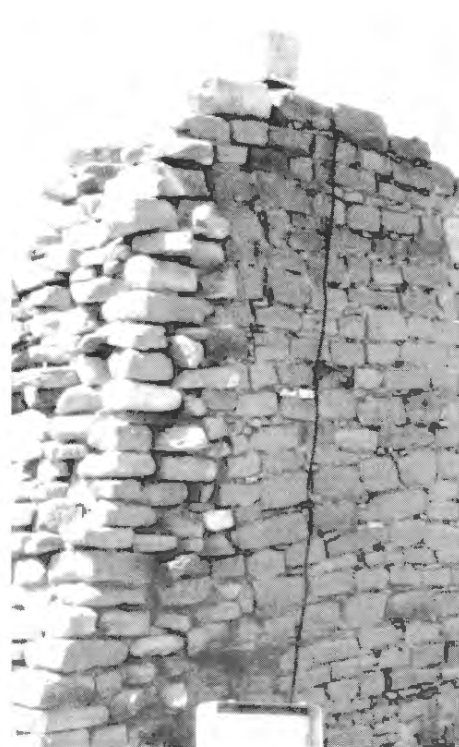
*Seismometer mounted on a typical Chaco wall is employed to determine the wall's vibrational response to energy inputs.*

Therefore, the different modes of wall vibrations, as well as the fundamental period and higher harmonics and wall damping were measured by placing a seismometer at the top and bottom of selected test walls

at Chaco to observe how they shake, as a function of wall height, for a standard energy input. The three modes of wall vibration observed were:

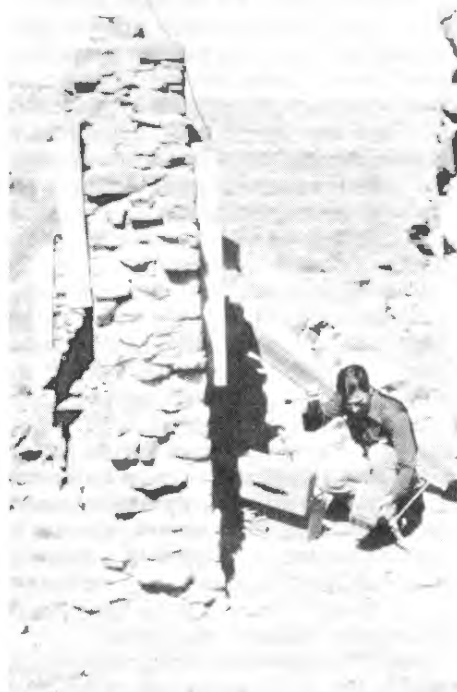
*Propping and bracing of a wall at Casa Chiquita after the wall's response to energy inputs. Ken King checks the new readings.*

Accordingly, certain of the ruins' walls were braced and supported during the road construction. This was done to alter their frequencies of response vibration – i.e., to “detune” them with respect to the ground motion vibrational frequencies – and **not** to support them. However, this has to be done carefully so that the **altered** response frequencies of the bracing and of the wall are not “tuned” to some other input source. This would be an “out of the frying pan, into the fire” change. For example, the back wall of Pueblo Bonito has been braced for many years. The large main brace has a natural frequency of 13.8 Hz, and a damping value of 6.8 percent. The wall itself has a natural frequency of 2.8 Hz, so the two are decoupled as well as being detuned with respect to the various energy source inputs.
