# Reclamation of Abandoned Mines At New River Gorge, Gauley River, and Bluestone

By Carol A. Pollio

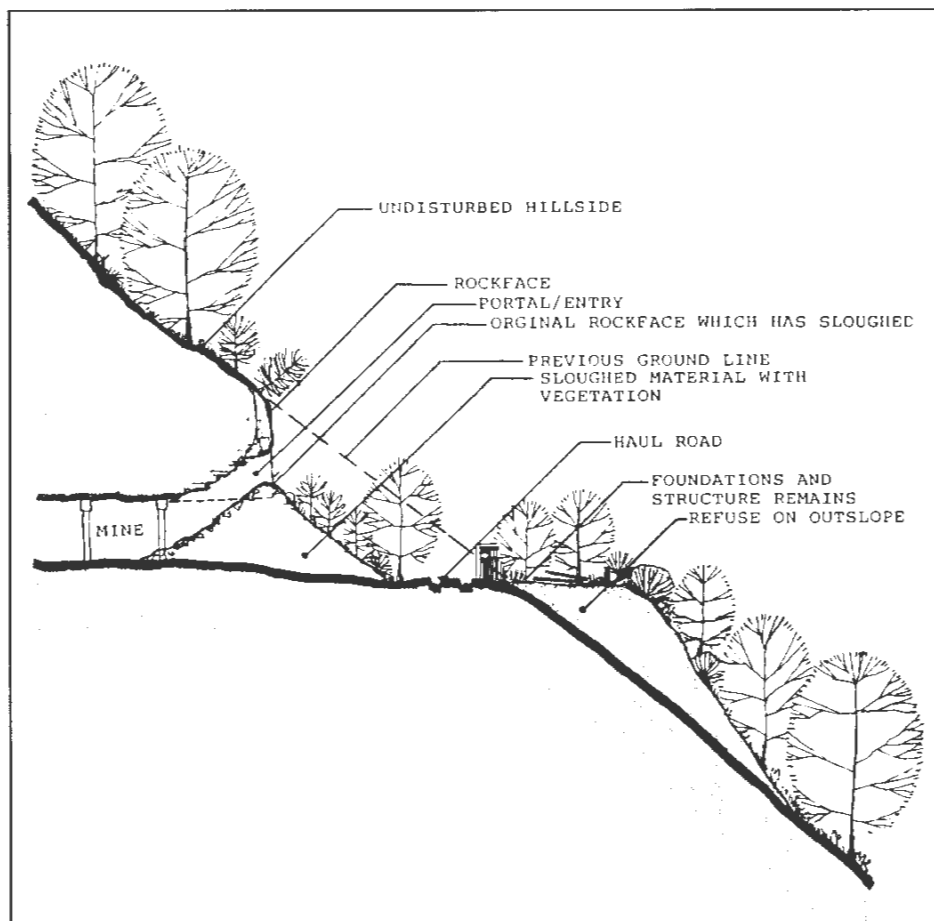
Diagram 1. Typical Abandoned Deep Mine Site

Because of the geologic formation of coal seams in this part of West Virginia, coal was primarily "deep mined." (Diagram 1). Deep mine portals present serious hazards to visitors, including the danger of roof falls (loose, falling rock), the presence of poisonous and explosive gases (methane), and deep pools of water. In addition, numerous partially collapsed buildings and unstable walls, conveyors, rail lines, bridges, hazardous equipment, and debris are associated with deep mines. Specific environmental problems that go with underground mines include mine drainage, subsidence of mine voids (creating sink-holes), and unvegetated, eroding mounds of waste materials and coal refuse.

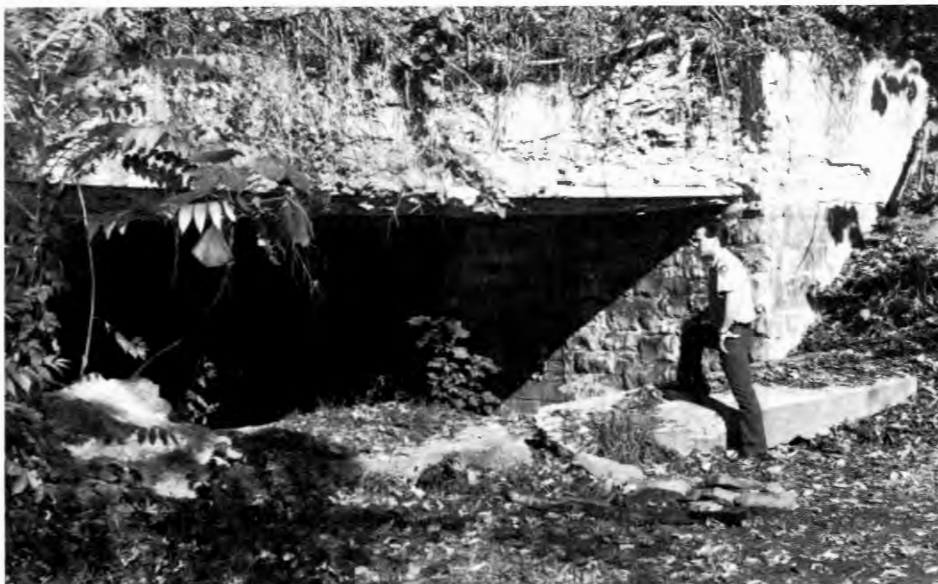
Resource Management Ranger Robert Sullivan looks into the main portal at the Ames Mine, scheduled to be reclaimed this year. Photo by Robert Sullivan.

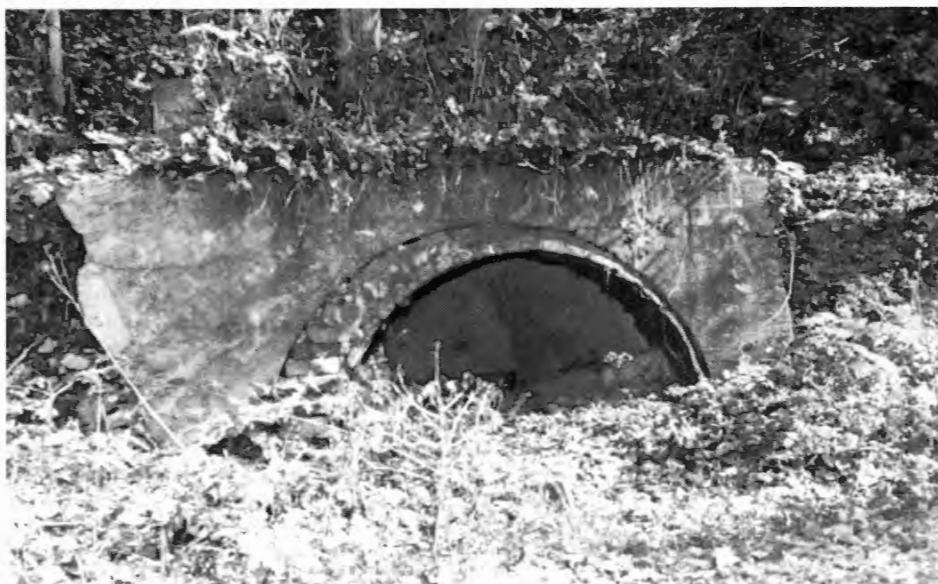
Open portal at Ames Mine. Photo by Robert Sullivan.

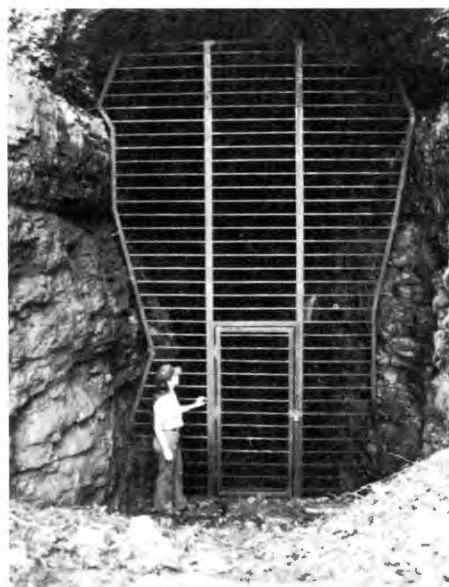
**Natural Resource Specialist Margaret Weesner** looks at a "bat gate" installed at the now reclaimed Kaymoor Mine. Photo by Margaret Weesner.

The second type of closure consisted of steel bars anchored in surrounding rock – wide enough for bat access yet narrow enough to exclude people. The T&E survey had indicated the presence of bats (*Pipistrellus subflavus* Eastern pipistrelles, *Myotis lucifugus* Little brown bats, and *Epescicus fuscus* Big brown bats) in

several mine openings that were a top reclamation priority. The study also identified portals that represented good potential habitat for federally endangered species, such as the Indiana bat (*Myotis sodalis*) and Virginia big-eared bat (*Plecotus townsendii virginianus*). Each of these steel closures, known as "bat gates," was custom made to fit individual mine openings securely.

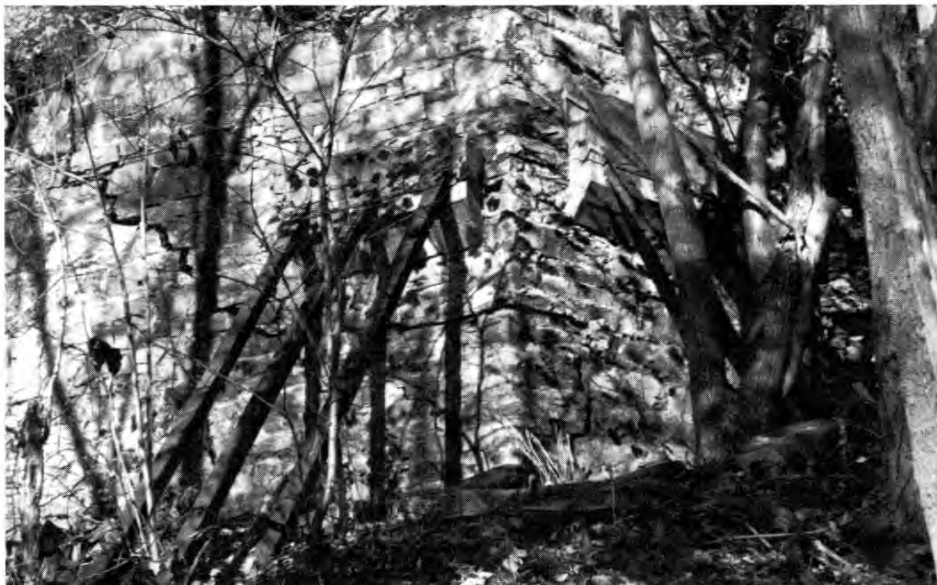
**Deteriorating stone wall** from the Ames Mine site. Photo by Robert Sullivan.

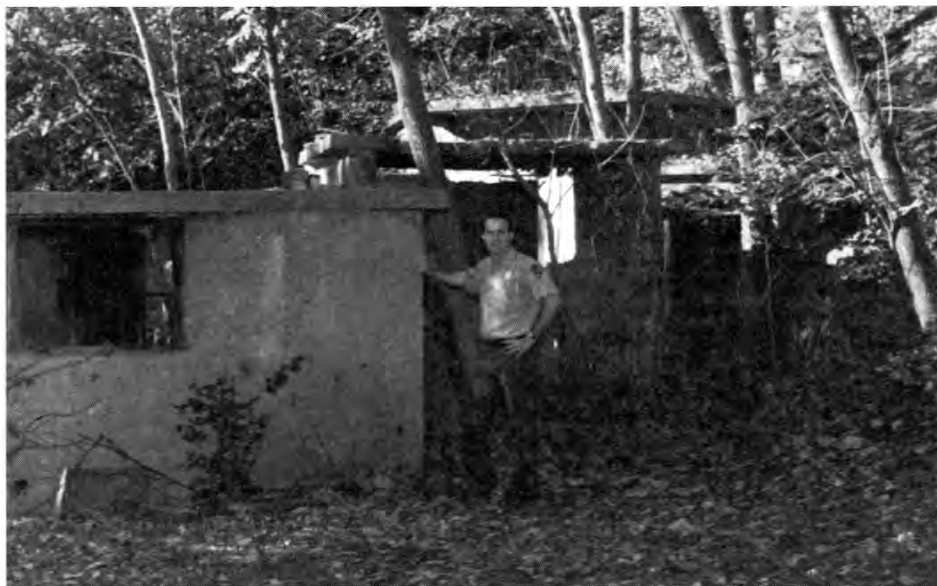
**Deteriorating structure** hides a large, 6' x 10' open portal. Photo by Robert Sullivan.
