## THE RECONSTRUCTION OF KENILWORTH MARSH THE LAST TIDAL MARSH IN WASHINGTON, D.C.

A PARTNERSHIP WITH THE U.S. ARMY CORPS OF ENGINEERS, AND OTHER AGENCIES,  
LEADS TO RESTORING A REGIONALLY IMPORTANT WETLAND

By STEPHEN W. SYPHAX AND RICHARD  
S. HAMMERSCHLAG

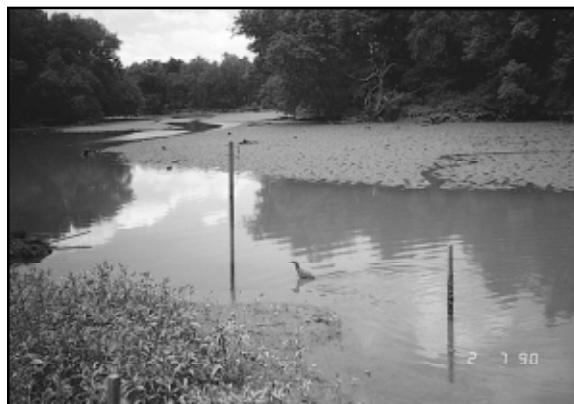
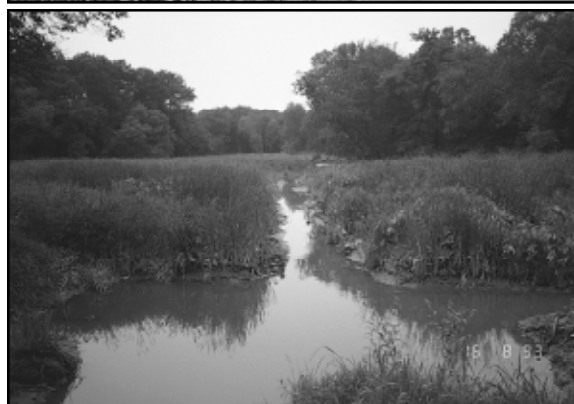
*Before (top) and after (bottom) reconstruction of mass fill area #1 at Kenilworth Marsh. A tidal gut, or channel, was also installed in the restoration effort and shows in the bottom image of the completed marsh.*

Following planting, an 8-inch hydraulic dredge barge with a 10-foot wide cutter head, known as a Versi-Dredge Model 308, re-created tidal channels in the two mass fill areas. The channels had been staked previously and were not planted. The new channels were cut approximately 3 feet deep and 10 feet wide and their locations approximated those of the original tidal channels. The sediment cut out of the channel was used to raise the remaining low areas (bottom photograph, front page).

covered with dense plant growth averaging several feet in height (bottom photograph, front page and figure 5, page 17). This may be attributable to several factors: the surrounding berms and islands protected the vegetation from fetch, volunteer plants established themselves prevalently, the newly deposited sediments provided dissolved oxygen and nutrients, sediment levels were near and just above the high tide elevation, wildlife feeding was limited, we planted native species, and we timed planting to coincide with optimal growing conditions.
