### **Flood Assessment in Shenandoah**

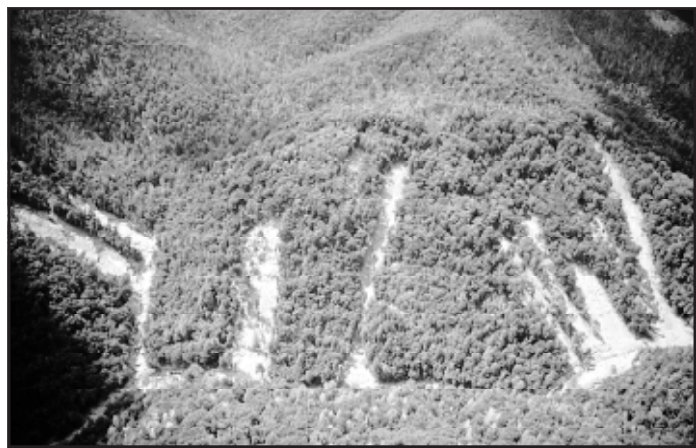
*Days of relentless rainfall caused landslides in Shenandoah National Park, Virginia, including these 2-5 acre (0.8-2.0 hectare) slides in the Moormans River drainage. While flood impacts were considerable throughout the park and region, the rare natural event provides scientists the opportunity to study geologic processes and ecological recovery.*

mended that the park restrict or discourage use of former trails or roads with undercut banks and “toe” areas at the base of

the most unstable debris flows. The team strongly recommended against stabilization of debris slopes. Trail or road rebuilding, if done at all, should wait until after next winter to allow some settling, continued slumping, and rockfall to occur. Some trail rerouting to more stable slopes was also recommended.
