# ASSESSING THE CONDITION OF RIPARIAN-WETLAND AREAS

BY GARY ROSENLIB, JOEL WAGNER, AND BILL JACKSON

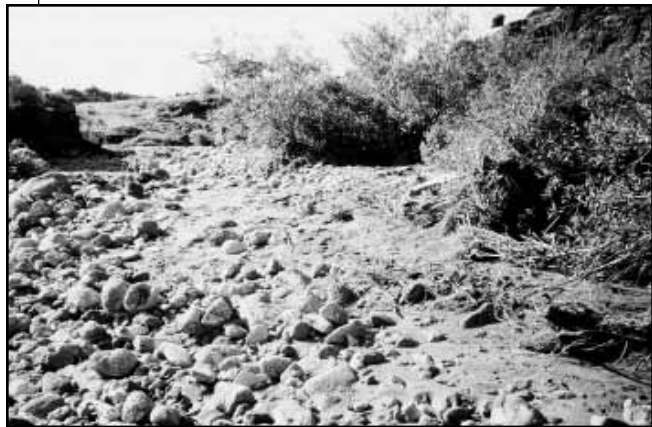
This segment of Windmill Canyon (figure 2, page 24) is grazed by horses but not cattle. The establishment of willow provides the capability to dissipate some stream energies and trap sediment that aids in floodplain development and improves floodwater retention. However, in spite of the presence of some attributes of functionality, this segment was rated as "functional-at risk" because certain vegetative and hydrologic attributes make it susceptible to degradation. For example, herbaceous bank cover is completely lacking, thus making the bank more susceptible to erosion and lateral cutting. The trans-

port of large quantities of bed and suspended sediment loads to the segment from unprotected upper watersheds also prevents this stream segment from obtaining full proper functionality.

Figure 2. Windmill Canyon (Channel Islands) is a functional-at risk stream. Vegetative bank cover is lacking, but the presence of willows allows for some ability to dissipate stream energies.

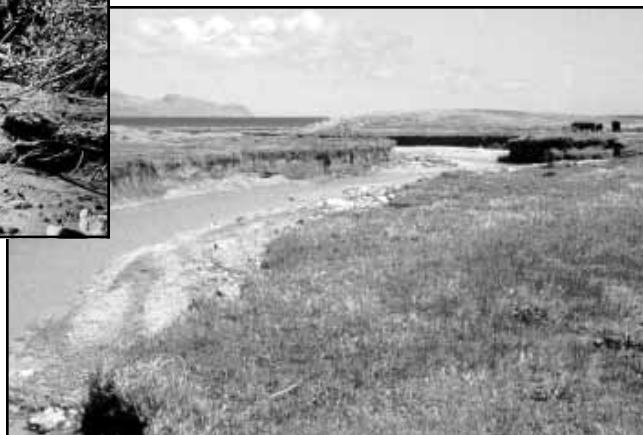
Old Ranch Canyon (figure 3), subject to continuous year-long cattle grazing, is a “nonfunctional” riparian-wetland area. Neither adequate vegetation nor appropriate landform is present to dissipate stream energies associated with high flows. During floods, the stream channel migrates, erosion continues, sediment is not filtered, water quality is altered, and floodwater retention and groundwater recharge are limited. The channel is not providing ponding or channel characteristics that provide habitat conditions necessary for enhancing biodiversity.

Figure 3. Old Ranch Canyon (Channel Islands) is a nonfunctional riparian-wetland area. It has neither adequate vegetation nor appropriate landform to dissipate stream energies.

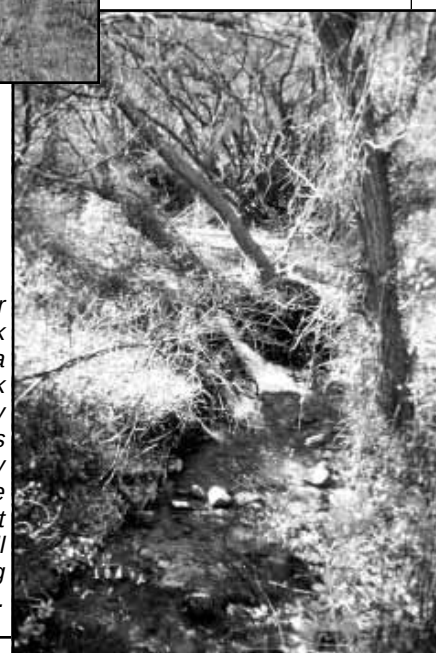
Karst geology, hydrology, and diversion by humans are important features that dictate the “functional-at risk” rating for this riparian reach. Prior to diversion, upper Snake Creek lost almost all of its flow to the karstic aquifer that underlies downstream portions of the creek. In order to

“harvest” additional water from the drainage, local irrigators constructed a pipeline to divert water from upper Snake Creek, bypass the karst area, and then release it to lower Snake Creek for transport to their land. The diversion has most likely impacted the lower reach by increasing flood flows in a channel that had evolved in response to smaller flows. Figure 4 shows one of several headcuts observed in lower Snake Creek that,

though temporarily stabilized by woody debris, could continue cutting in response to large flows. The headcuts are lowering the base level of the channel by 2-3 feet in some areas. As a result, woody and herbaceous riparian-wetland vegetation in these segments are in a downward trend.

Figure 4. Lower Snake Creek (Great Basin) is a functional-at risk stream. Woody debris has temporarily stabilized the stream, but erosion is still possible during large flows.
