## Cooperative watershed restoration in Whiskeytown National Recreation Area

Innovative partnership provides a model for restoration of a scarred landscape

By JOHN McCULLAH AND GRETCHEN RING

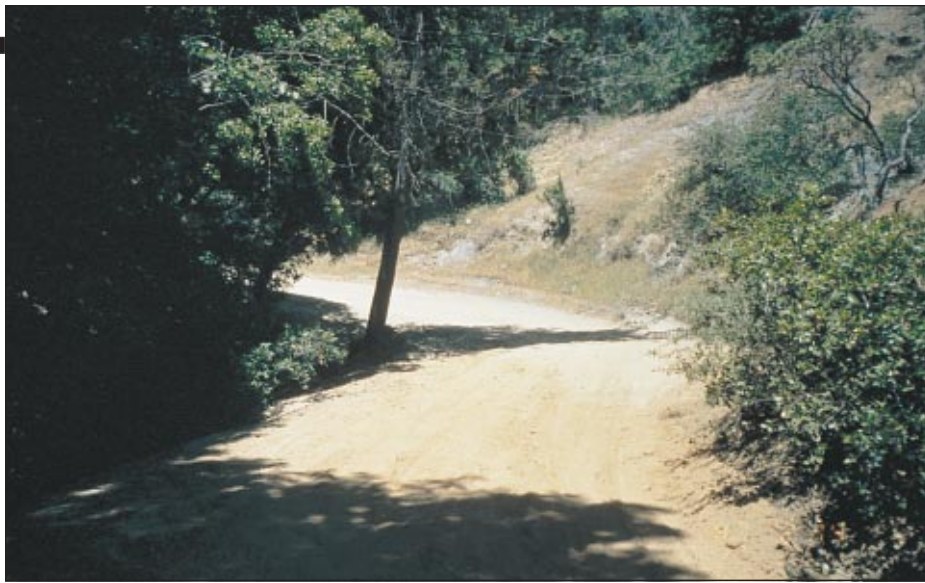
*Fig. 1. Old logging roads, such as this one in Whiskeytown National Recreation Area (California), are the primary source of sediment that washes into rivers and streams, degrading habitat for salmon and steelhead trout. To address the problem, the park and Shasta College teamed up to deploy innovative treatments for the restoration of watersheds and habitat recovery. This road was "outsloped" to reduce erosion and sedimentation.*

In many steep, forested watersheds old logging roads (fig. 1) are the primary source of the sediment that degrades rivers and streams. Roads cause erosion and greatly increase the potential for slope failure during large and episodic storm events. Roads alter the natural drainage patterns, and steeply cut slopes intercept subsurface flows, converting them to surface runoff. Drainage ditches and berms concentrate flows in channels, efficiently delivering sediment to streams. Most importantly, roads are frequently constructed by placing fill material in drainage channels. That fill becomes part of the drainage system and, given enough time, has a high probability of ending up in rivers and streams. Clearly, watershed restoration strategies are needed to deal specifically with road-related erosion and sedimentation.

<sup>1</sup>In hilly terrain, roads typically slope inward toward the hill where a ditch and culvert system drains runoff. As culverts and ditches become plugged, runoff concentrates, drains across the road, and creates gullies. Outsloping reverses drainage to the downhill side of the road. Fill is excavated and placed into the uphill cut, resulting in a 2-5-degree slope to the downhill side. Water runs off without forming gullies and subsequent erosion and sedimentation.

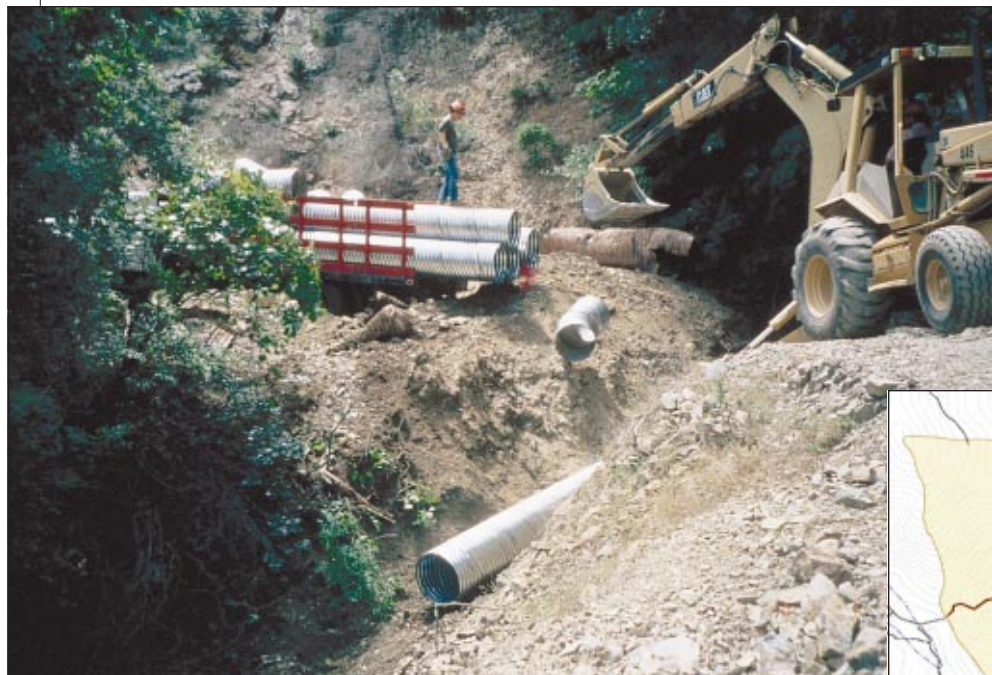
Fig. 2 (left). Heavy equipment is used to treat the drainage problems posed by the old logging roads. Here, a culvert is installed to restore natural drainage patterns and reduce erosion of the fill.

These physical treatments frequently include the use of heavy equipment such as hydraulic excavators (fig. 2) and bulldozers to repair and restore the drainage patterns that existed before roads were built. A new axiom is emerging among watershed restorers: for cost-effective road restoration, employ the same type and size of

1. Reconstructed approximately 2,000 m (1.2 mi) of the Peltier Valley Road using outsloped road design
2. Excavated rolling dips at each of the 23 swale and stream crossings
3. Replaced or installed seven appropriately sized and redesigned culvert crossings to reduce erosion
4. Treated all disturbed soil by seeding with native grasses and mulching

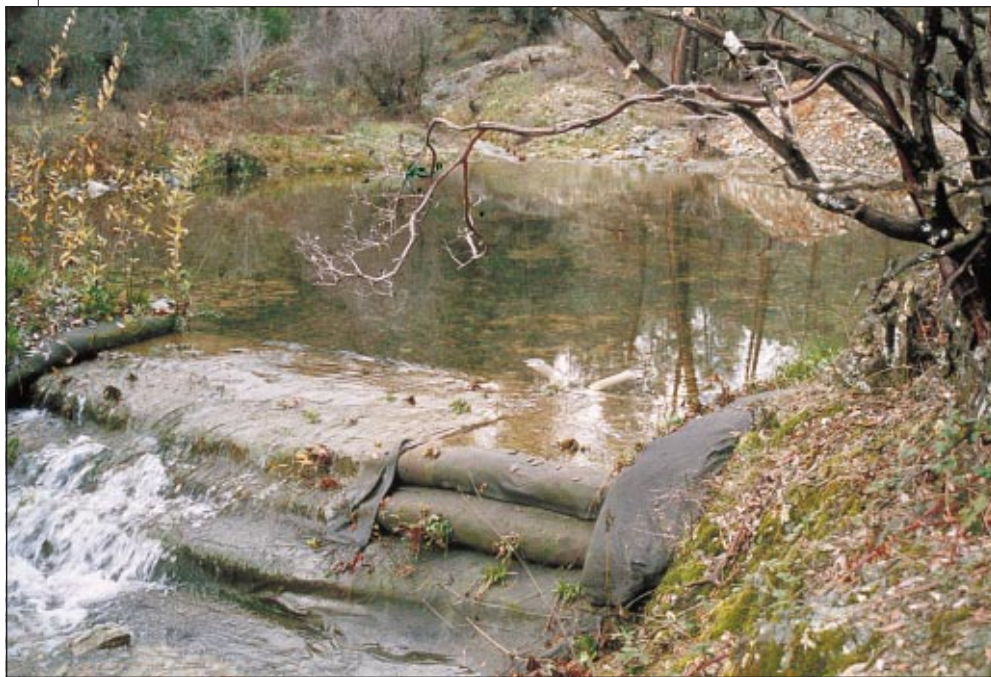
Fig. 4. A sediment pond was constructed within the lower reaches of the watershed to monitor erosion before and after restoration work. After three years, it will be removed and the stream restored to its natural course.

Using remnants of an old logging road as an embankment, the students designed and constructed a sediment pond in the lower reaches of the watershed. The pond is used to monitor and measure sediment production before and after treatment. The drainages of both the Peltier Valley Road and Logging Camp Road converge at the location chosen for the sediment pond. The pond has an expected life of three years after which it and the old road will be removed and the stream returned to its natural course.

The pond weir was constructed with layers of continuous berm (fig. 4) stacked in a triangular shape. MBW, Inc., donated the use of their Continuous Berm Machine and demonstrated its use. This machine can encapsulate soil, sand, or rock in filter fabric to make a berm that is 0.4 m high by 0.3 m wide (~1.3 ft x 1.0 ft). In this situation the berm was filled with existing channel material; no nonnative sediment was introduced to the stream. The berms conform tightly to the stream bottom because they are very heavy with a density of 1,600 kg/m<sup>3</sup> (2,691 lb/yd<sup>3</sup>). The berms can be

stacked much steeper than the angle of repose without slumping, and they can be used as spillway weirs without stream erosion because of the support provided by the fabric (Ellis 1997). The continuous berms were reinforced by driving willow stakes through the fabric.

The sediment pond has performed well. The weir has been through a number of rainstorms and it has been subjected to a variety of flows. The vegetation around the pond is well established. The willows planted within the berms have achieved heights of over 2 m (6.6 ft) and are rooting both inside and below the berms.
