### **Interagency cleanup of a former Army camp at Oxon Run**

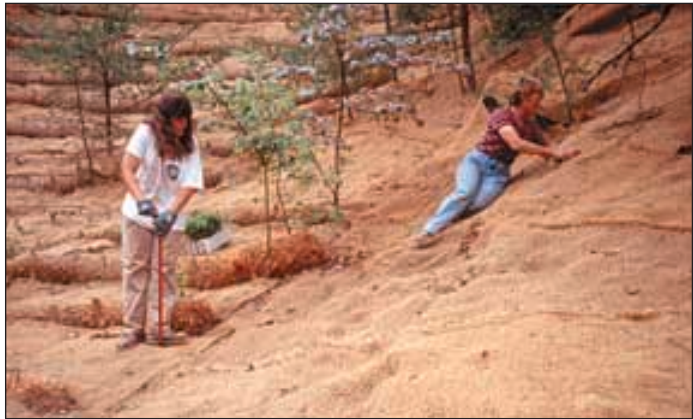
*Figure 1. The site at Oxon Run was stabilized with coconut "bio-logs" and matting.*

One ongoing 1999-2000 restoration project involves an approximately 0.5-ha (1-acre) former rifle range with substantial lead-contaminated soils left from years of target practice. Bullet casings wash down slope where they are easily collected by local children, creating a primary public safety problem. Standard EPA mitigation procedures for this steep, eroded hillside would involve trucking away tons of contaminated soil, which would threaten rare plant communities. However, the EPA analysis found that the lead was tightly bound to the soil with little migration through groundwater to the adjacent creek and sensitive wetlands. It supported the NPS decisions to stabilize and revegetate the eroding area despite the proposed COE engineering solution of cement and stone terraces. A cap of coconut “bio-logs” and matting sculpted to fit tightly over the site’s topography holds down imported topsoil and cov-

ers the bullet casings (figure 1). The local rain of seeds from the surrounding native communities will contribute to the natural revegetation and stabilization of the area. In order to assist establishment of the vegetation and its ability to outcompete and shade out possible exotic species, the Natural Resource Conservation Service is growing and installing site-collected cool and warm season grasses.
