# Dune Restoration at Fort Matanzas

By Brian Peters

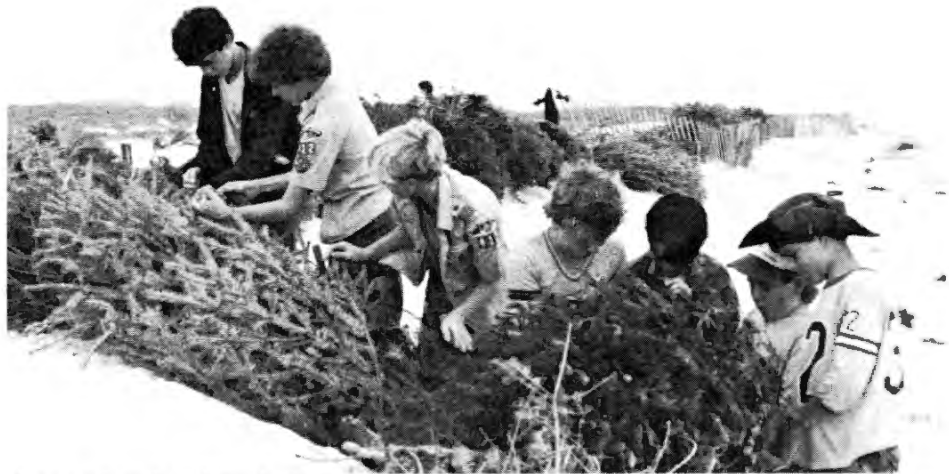
***Many hands make light work.*** The vegetation planting work was done by YCC volunteers in cooperation with USDA Soil Conservation Service.

To make the dune system self-sustaining, sea oats (*Uniola paniculata*) were obtained from the USDA Soil Conservation Service and planted by a local 4-H group; 500 plants in April of 1983 and 1984, 1000 plants in April of 1985. Plants on the windward side of the dunes became windblown and died when their roots were exposed. The remainder of the plants were successful, estimated at 90 percent survival. Sand fence protected the plantings and was well worth the cost, since one destructive incident can cancel out many hours of hard work.
