## Ochopee Prairie and Turner River Watershed Restoration

### Mitigation for Construction of Facilities on US41 (Tamiami Trail)

### Big Cypress National Preserve

## Progress Report, 2001

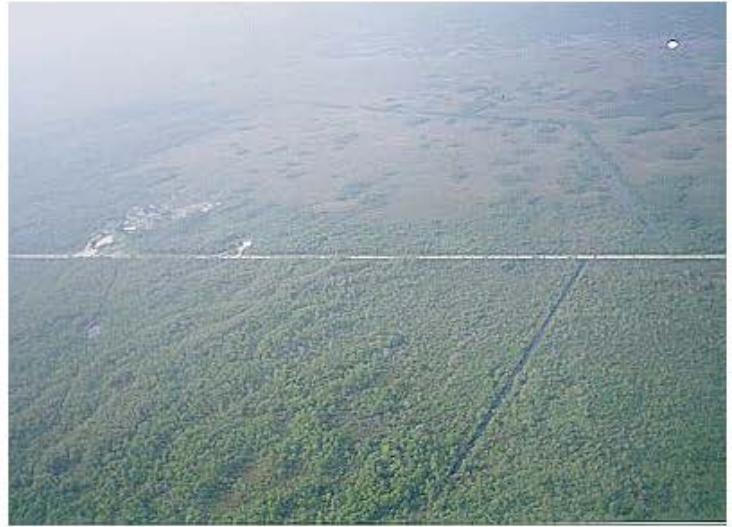
Photograph 1. Shot looking south at the northern and southern irrigation canals. The northern canal is in the foreground.

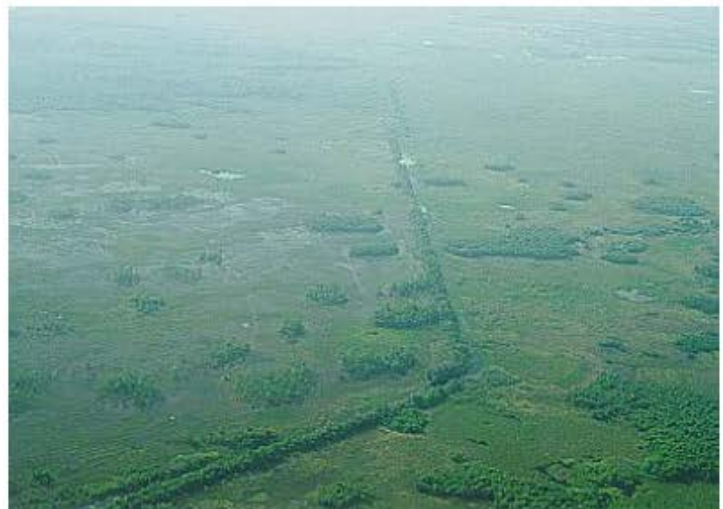
Photograph 2. Shot looking southwest at the bend in the southern irrigation canal. The berm switches sides at the bend.

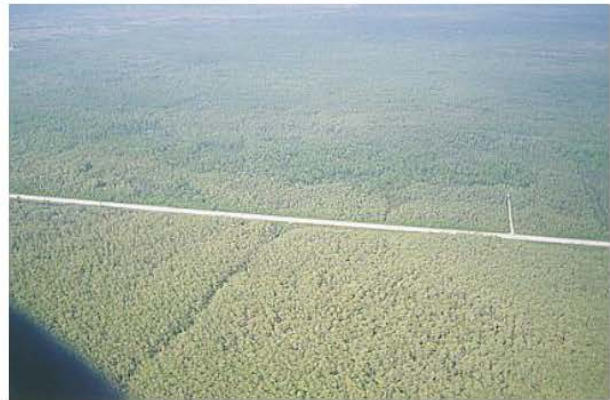
Photograph 1. Aerial view of Turner River Road, looking west. Spur roads are beneath the canopy.

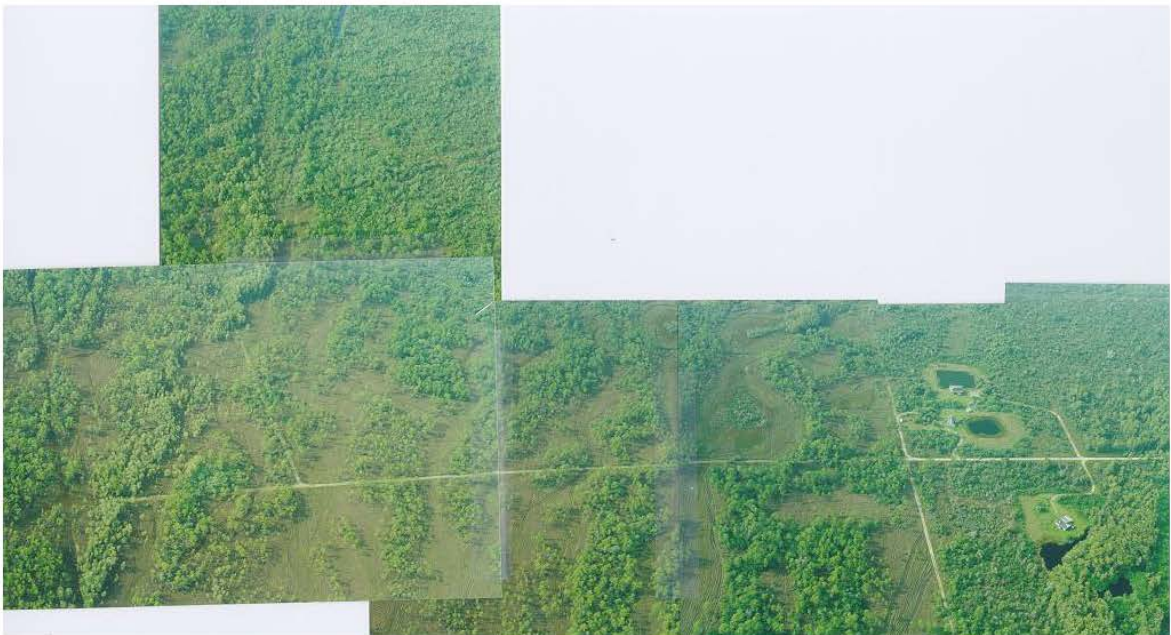
Photograph 2. Aerial view of non-residential east end of Bass Lake Estates, looking south. All elevated roads to the left of the borrow pits will be removed under this project.

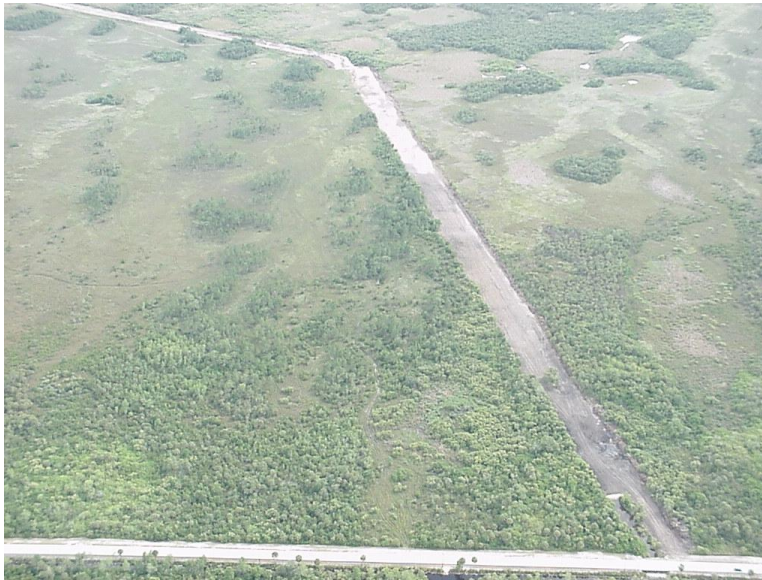
Former drainage canal immediately after filling with adjacent spoil and grading to surrounding ground levels. US41 is in the immediate foreground and the former canal and spoil bank extended south (reach 2) and then southwest (reach 3). Brazilian pepper formerly dominated the areas adjacent to the canal.

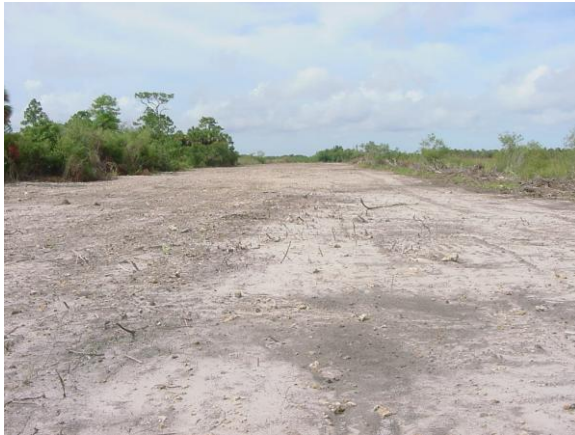
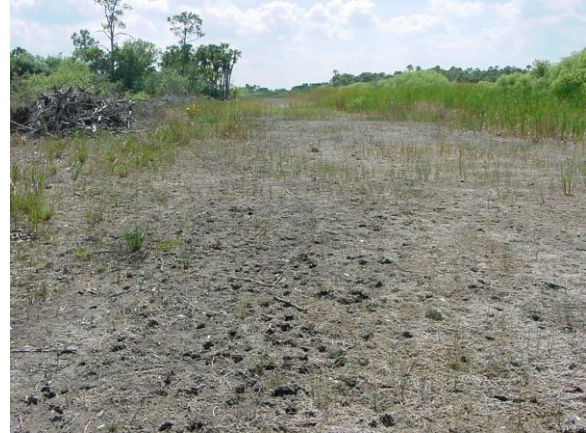
Former drainage canal immediately after filling with adjacent spoil and grading to surrounding ground levels. This area is ca. 1 km south of US41, looking north, immediately after topographic restoration (left), and less than one year after topographic restoration (right). Wetland graminoids are becoming established on the exposed soil after the wet season inundation; willows and occasional wax myrtles have undergone robust growth in the areas adjacent to the restoration (right).

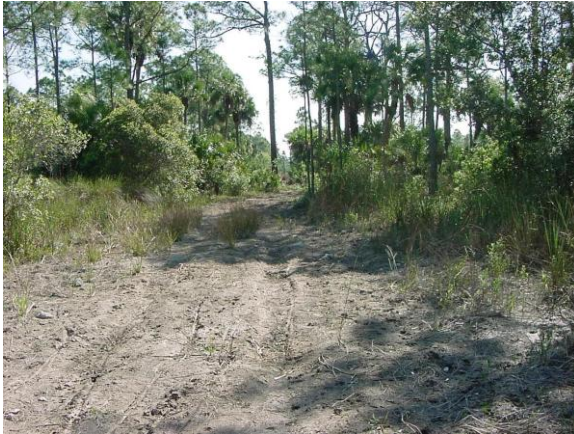
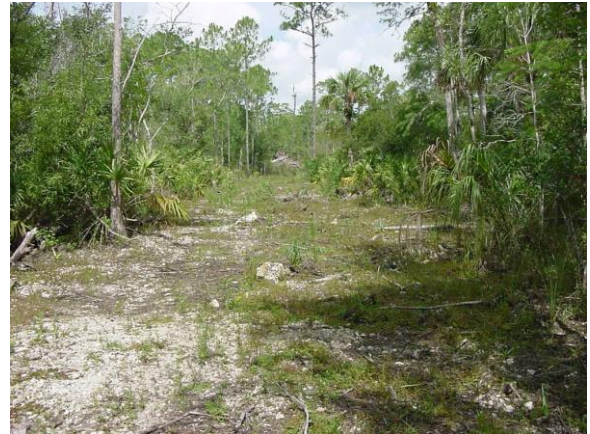
Bass Lake Estates area, Fill Removal and Restoration: southern east-to-west road. Former road from which fill has been removed (left); former road after ca. 1.5 yr. recovery (right).

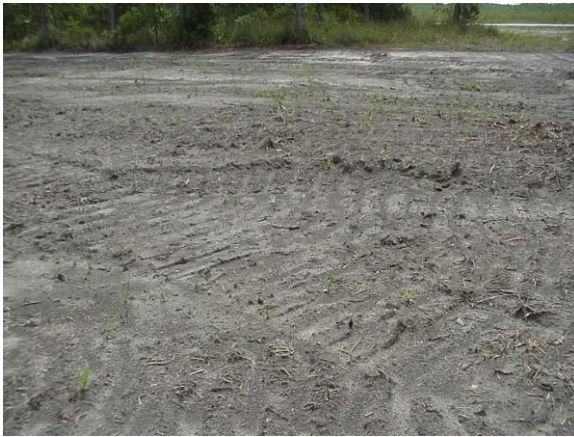
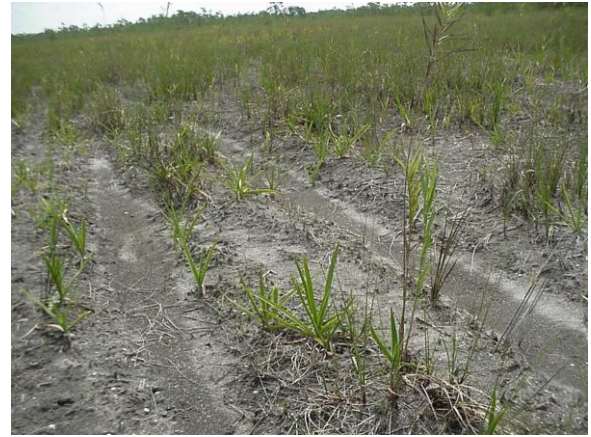
Restoration sites southeast of Concho Billy Trail (May 2001). One site (left) was prepared by leveling wheel ruts without mixing the surface soils with deeper substrates; another area (right) was left with no surface preparation. Both will be left to allow natural establishment, recruitment, and succession of plants. Plant cover and diversity will be monitored in each area.

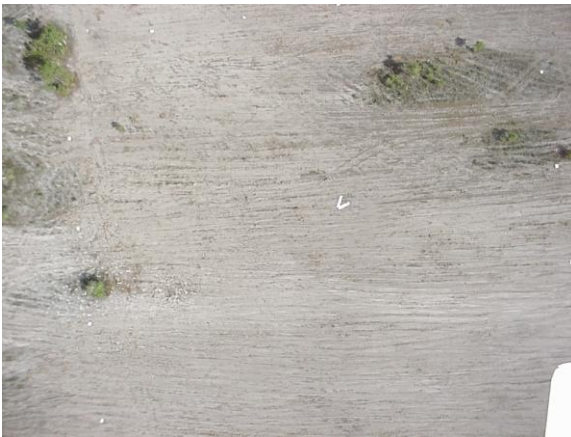
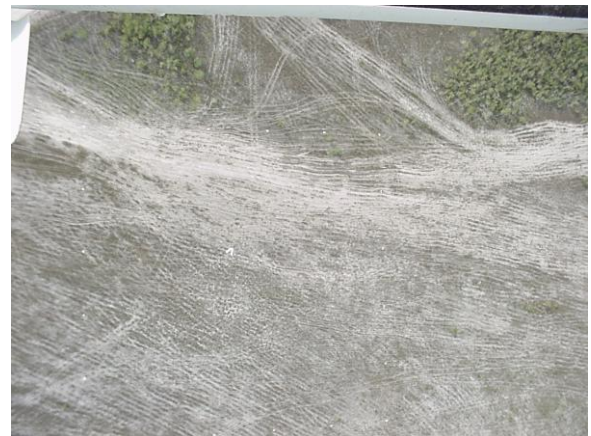
Restoration sites southeast of Concho Billy Trail (May 2001). Aerial aspects of the restoration site with substrate prepared by leveling wheel ruts (left), and the restoration site with no substrate restoration (right). Each of these sites is identified for photo-documentation so that subsequent photos of each area can be made to compare growth of plants and succession.
