# Upper Columbia Basin Network Integrated Water Quality Annual Report 2012

*City of Rocks National Reserve (CIRO)*

*Castle Rocks State Park (CRSP)*

Natural Resource Technical Report NPS/UCBN/NRTR—2013/807

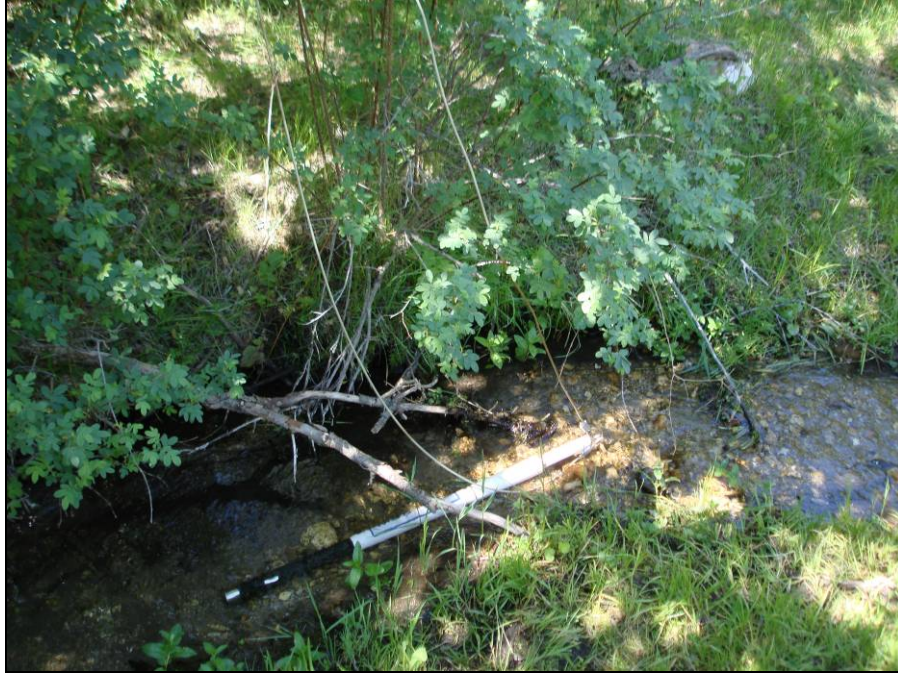
**Figure 2.** North Circle Creek water quality monitoring station #01, approximately 15 m upstream from the intersection of Stripe Rock trail with North Fork Circle Creek trail.

Continuous water quality monitors (Hydrolabs) were deployed in North, South and Main Circle Creeks in locations that provided adequate water depth and surface flow in mid June. Monitoring locations are noted in Figures 2-7, and Appendix A. These locations were the same as in 2009. The macroinvertebrate sample reaches along North, South and Circle Creeks coincide with the stream channel characteristics and riparian condition monitoring reaches (see Appendix C for GPS waypoints).

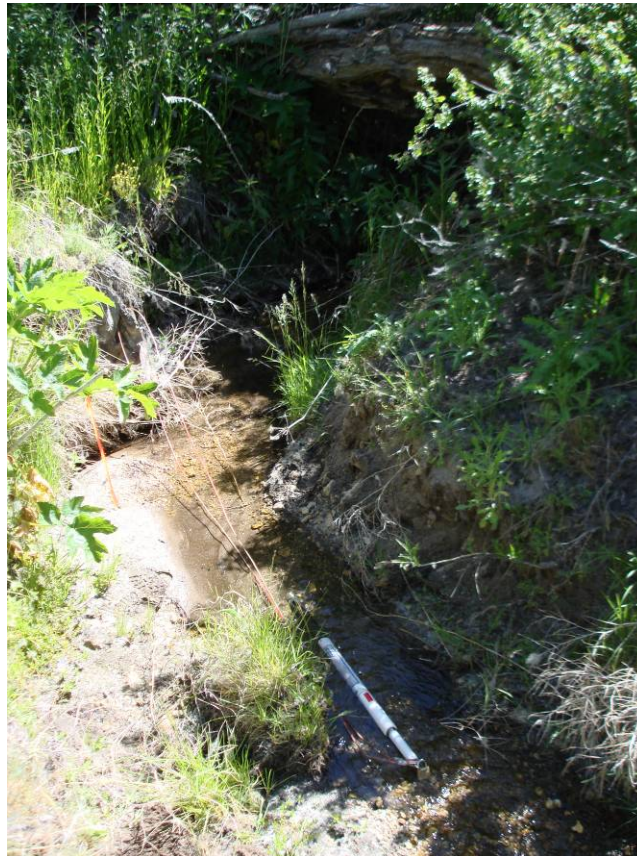
**Figure 3.** South Circle Creek water quality monitoring station #01, approximately 15 m downstream of Box Top trail.

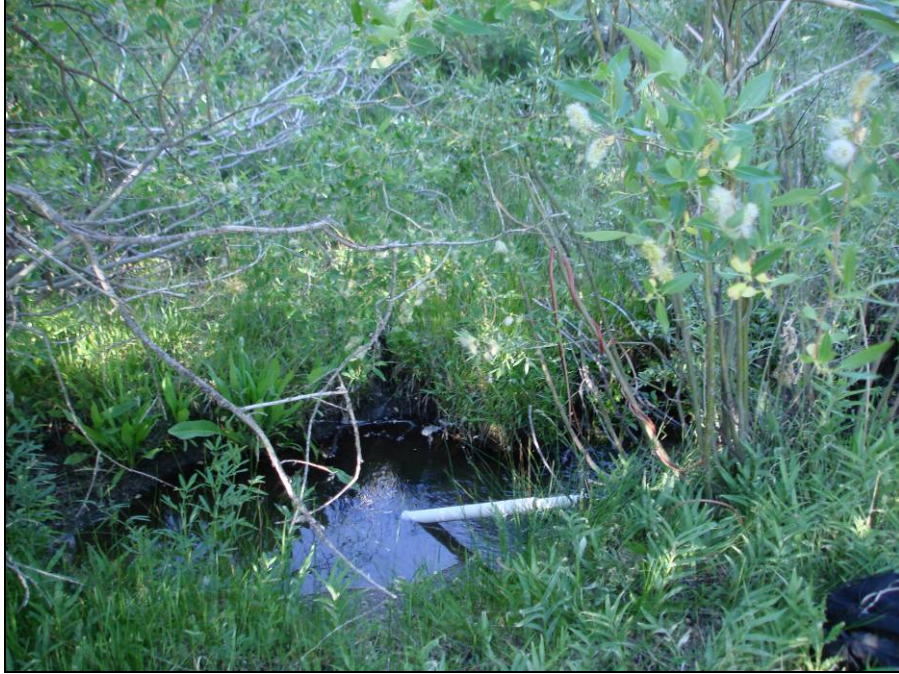
**Figure 4.** Main Circle Creek water quality monitoring station #01, approximately 150 m downstream of City of Rocks road.

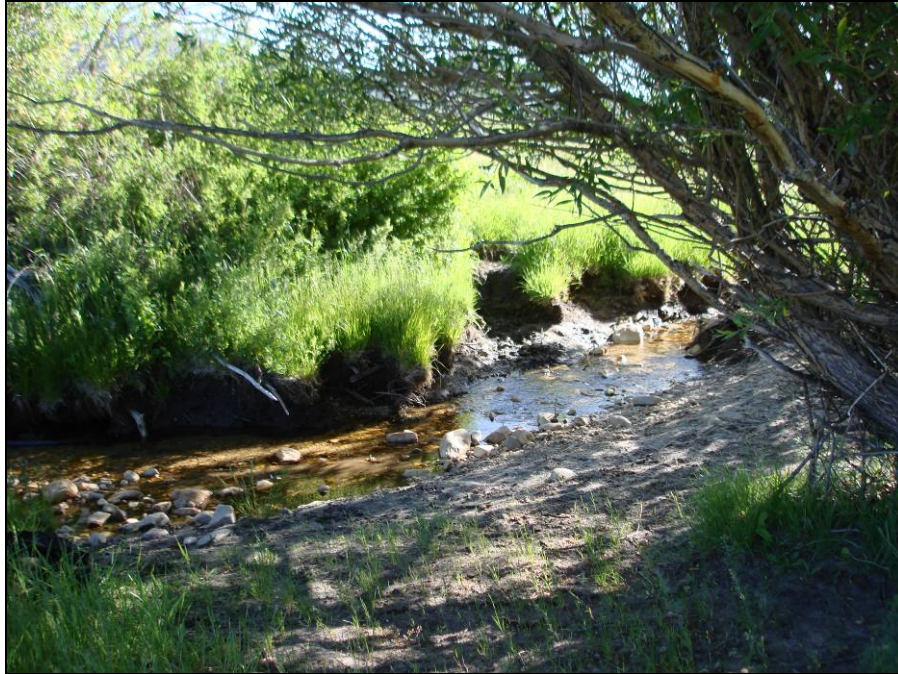
**Figure 8.** Almo Creek looking East towards water quality monitoring station #01.

The Hydrolab was deployed in Almo Creek in a location that provided adequate water depth and surface flow in mid June. The monitoring location is noted in Figures 8 and 9, and Appendix A. The location was the same as in 2009. The macroinvertebrate sample reaches along Almo Creek coincide with the stream channel characteristics and riparian condition monitoring reaches (see Appendix C for GPS waypoints).

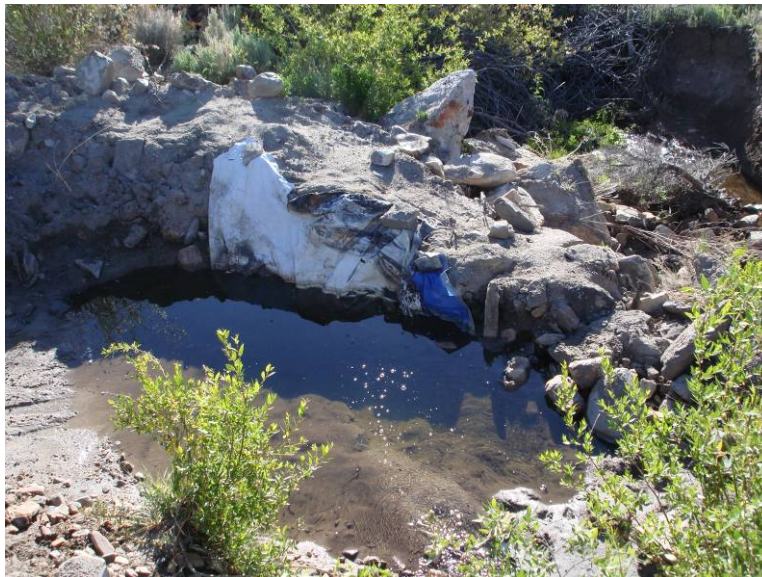
**Figure 21.** Looking downstream at pool constructed just downstream of City of Rocks road on Circle Creek.

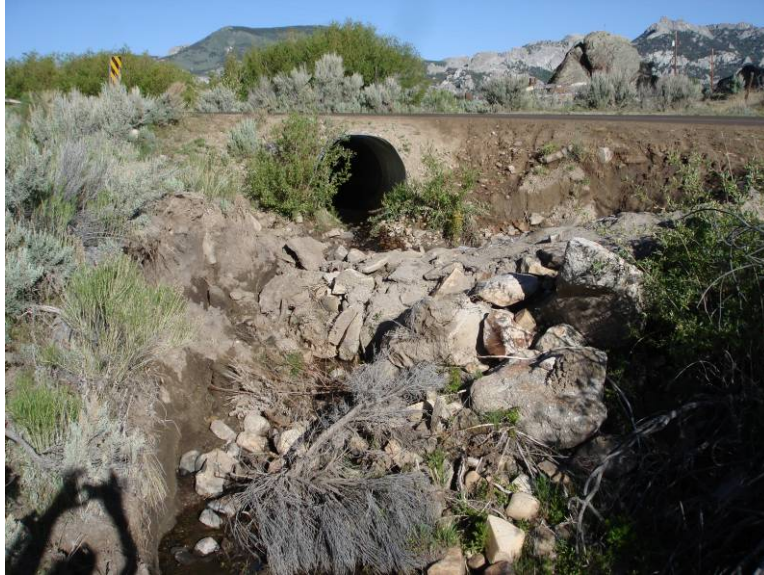
**Figure 22.** Looking upstream at pool constructed just downstream of City of Rocks road on Circle Creek.
