Wetland Processes and Restoration Opportunities in the Rodeo Lagoon Watershed,  
Golden Gate National Recreation Area, Marin County, California

A professional report submitted in partial satisfaction of the  
requirements for the degree of

Master of Landscape Architecture  
in

UNIVERSITY OF CALIFORNIA, BERKELEY

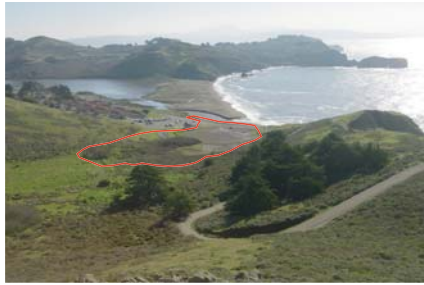
## Phasing:

- ① - Re-occupy abandoned roads with interpretive history and habitat trail  
 - Re-establish crossing of West Fork under abandoned road  
 - Remove culvert  
 - Excavate 4 to 5 feet on west side of valley  
 - Remove fill from dirt parking area and excavate to the current existing water table
- ② - Replace culvert outfall on beach with free-span bridge  
 - construct transitional dune zone between Rodeo Lagoon, Rodeo Beach, and freshwater wetland

Finally, I have developed a conceptual restoration plan and site design for the Rodeo Beach Parking Lot at the end of Mitchell Road. The design calls for removal of road fill and dirt associated with US Army activities during the early 1940's, and replacement with wet meadow, sand dunes, and transitional lagoon fringe habitat. Fort Cronkhite construction documents (Meyer Construction Company, 1941) indicate that approximately 3 acres was converted in this location for the establishment of a 'gun and tractor' area. The proposed restoration plan, as described in Chapter 6, outlines an approach by which the area can be converted back to wetland conditions, while maintaining recreational access to coastal and historical areas.

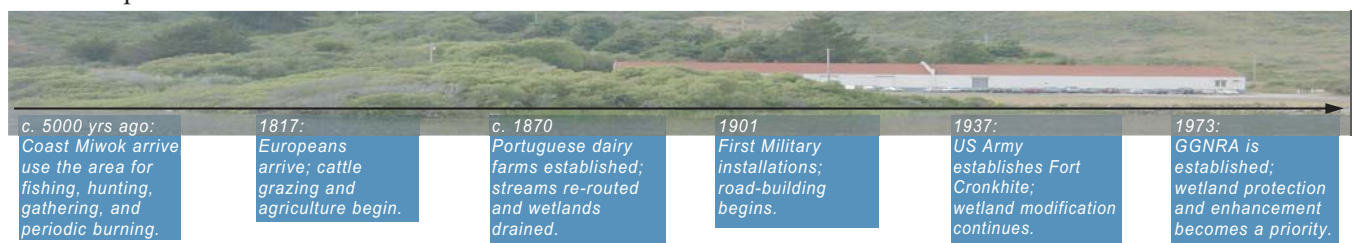
**Figure 5. Human history**

Today, this area remains much as it did during the Army's occupation. Although some roads have been removed or overgrown, many remain for fire control access, and as trails for mountain biking, hiking, and equestrian use. Most of the historic army buildings and associated parking facilities are still in place; many built over former wetlands (Darren Fong, personal communication, 2003), and are used as offices for government agencies and non-profit park partners. Rodeo Beach is currently the most popular recreational site in the Marin Headlands area, accounting for about 12 to 13 percent of visitors to the area (Nelson and Nygaard, 2002). Figure 5 is a summary of the major human influences and changes that have taken place here.

Perhaps the most significant impact to the lagoon during this time was the construction of a weir, or low dam, across the upper portion of the lagoon. The primary purpose of the weir was to store freshwater flows from the upper watershed for drinking and/or irrigation, but the pond was also stocked with trout for recreational purposes (Darren Fong, pers. comm., 2004). The weir effectively cut off brackish water from the upper lagoon area, and removed significant areas of rare transitional habitat between the brackish lagoon and upland vegetation, and created a small basin to trap the increasing volume of sediment being delivered from the watershed.

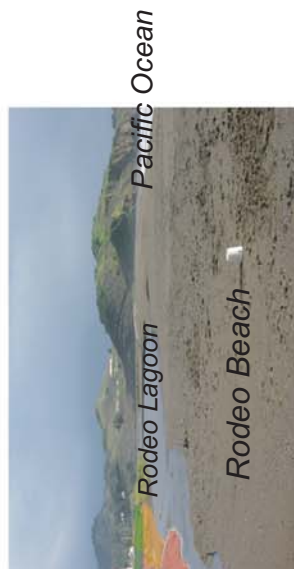
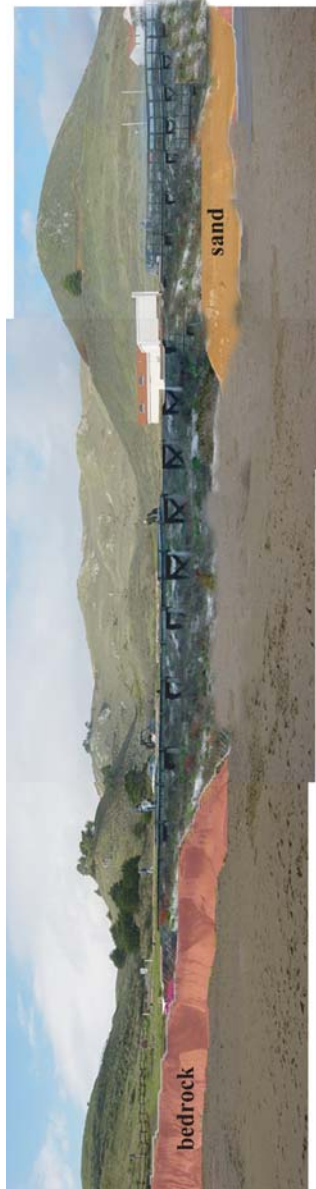
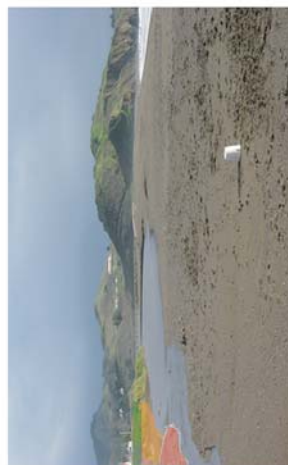
### Existing: double culvert in fill

### Proposed: remove fill, construct bridge, restore wetland-dune-lagoon transition

**Figure 16. Schematic cross-section B-B'.** The view from Rodeo Beach makes it easy to discern the depth and extent of artificial fill. Removal of fill and replacement with a footbridge would allow for a more continuous transition zone between the brackish emergent wetlands of Rodeo Lagoon's fringe, dunes, and the upland freshwater wet meadows and riparian trees.

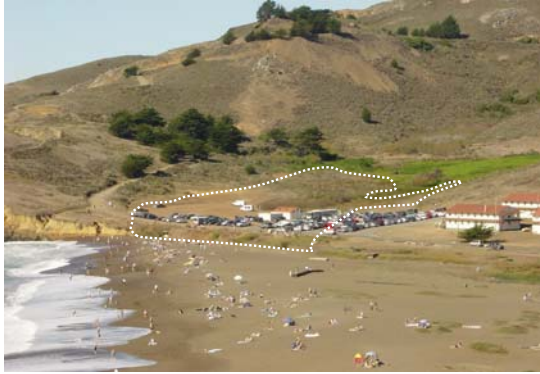
Surfer Parking Lot (former gun and tractor park)

Pre-Contact: Spring-fed slope wetlands (upslope) transitioned into sand dunes and colluvial wetlands

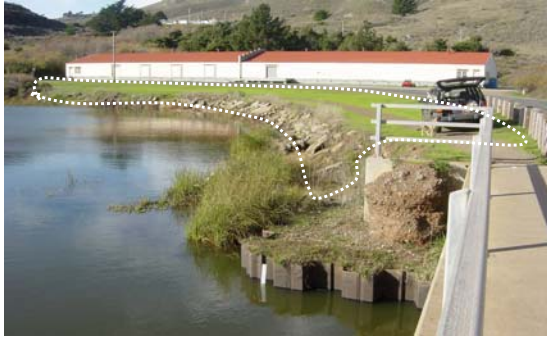
Area of fill across from Building T1111

Pre-Contact: Lagoon Fringe wetland

is possible that the area across from Building T1111 contains hazardous material, and would need to be tested prior to removal.

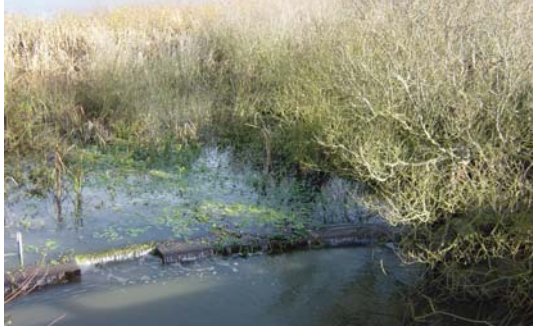
Rodeo Lagoon weir

Pre-Contact: Coastal lagoon transitioning to wet meadow and willow marsh

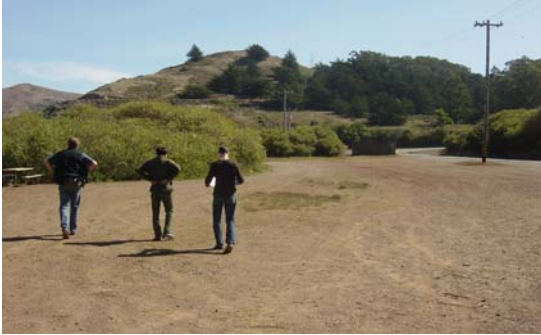
Rodeo Lake Picnic Area

Pre-Contact: Narrow lagoon Fringe wetland at base of hillslope

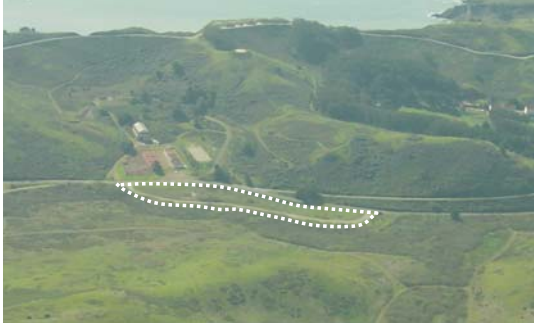
Smith Rd, Rifle Range, Capehart housing

Pre-Contact: wet meadows and floodplain wetlands with discontinuous channels

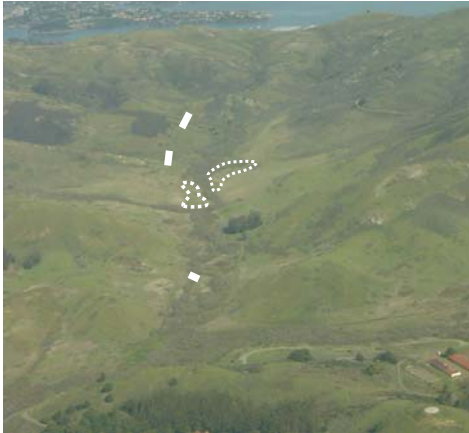
Shellmound Tributary; Upper Gerbode Valley

Pre-Contact: wet meadows and floodplain wetlands with discontinuous channels

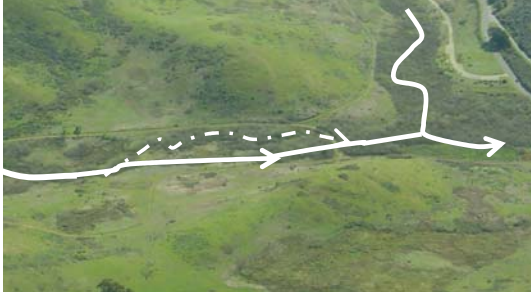
Gerbode Creek bypass channel

Pre-Contact: meandering channel in alluvial floodplain
