# Inventory of Spring Ecosystems at Bitter Lake National Wildlife Refuge, New Mexico

## *Physical and Biological Characteristics*

Natural Resource Technical Report NPS/CHDN/NRTR—2013/817

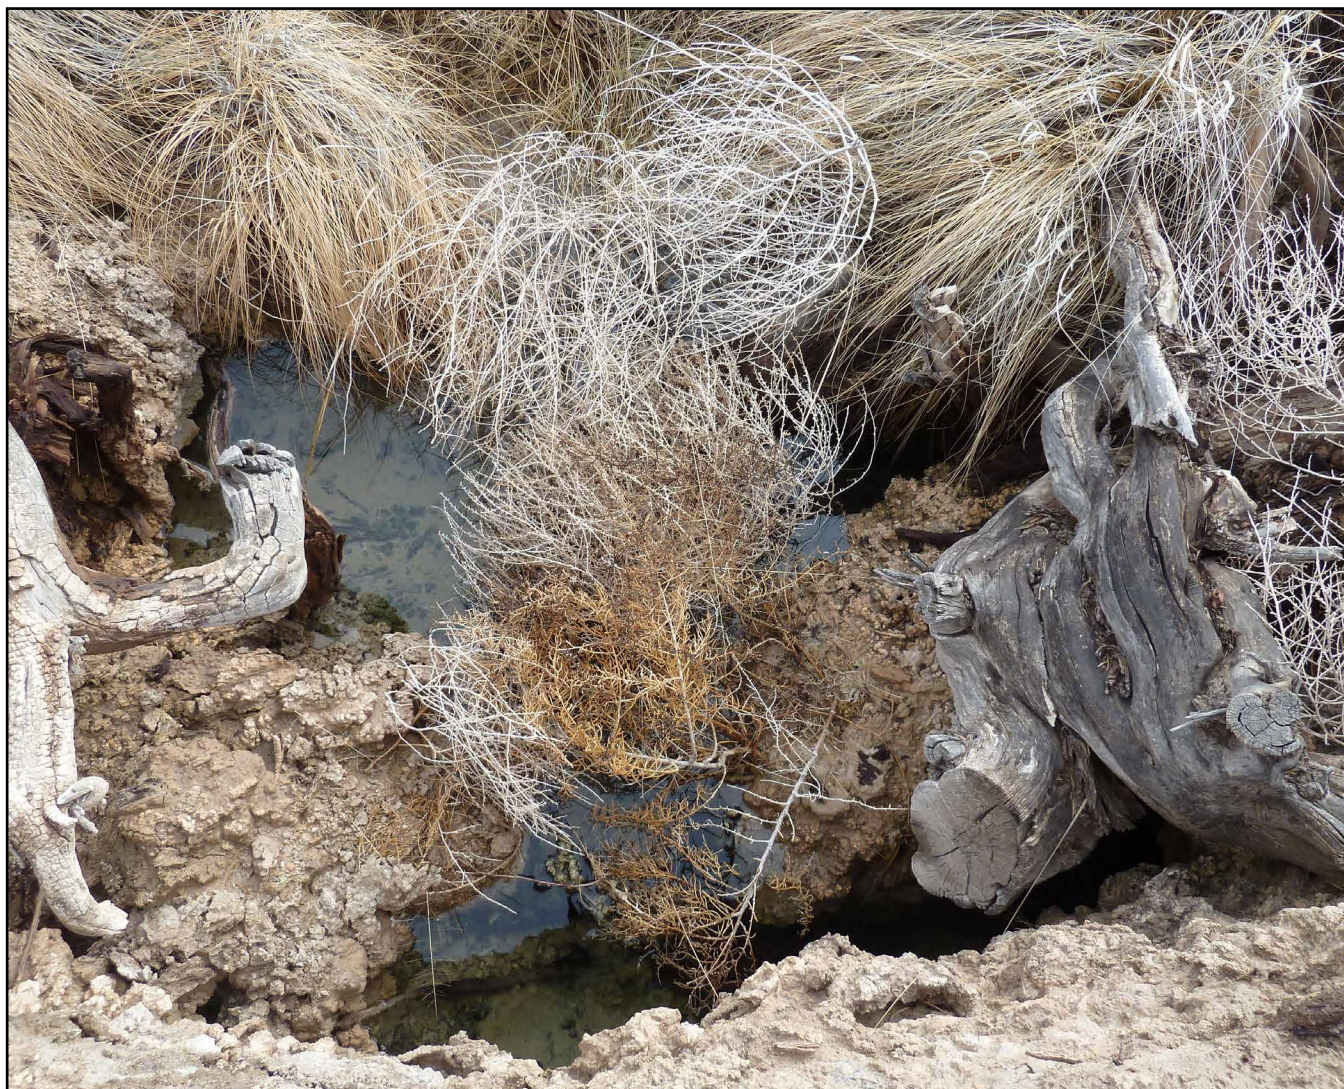
Sago Spring, Bitter Lake National Wildlife Refuge  
Photograph: NPS

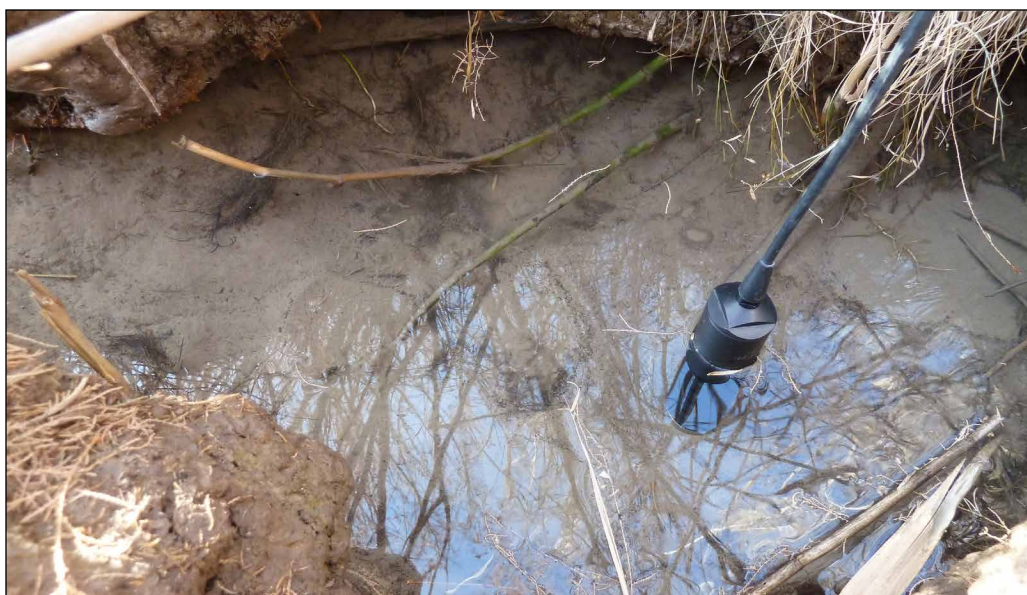
Hondo River with a water quality probe.

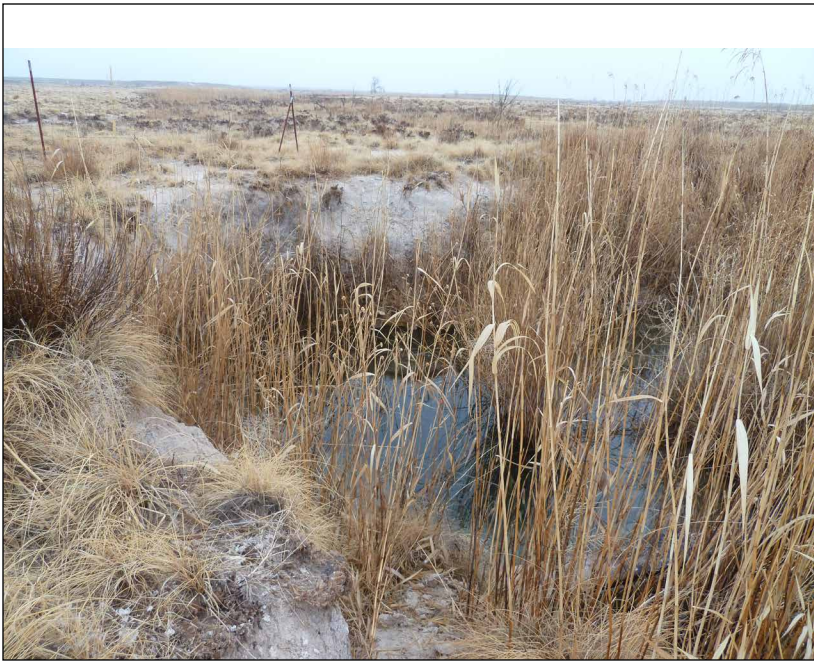
**Lost River Spring.**

**Lost River Spring** begins as a 1 x 0.5 m vertical vent at what is now the start of Lost River. The brook splits near the vent and flows approximately 20 m before joining Bitter Creek. Water in the spring brook is about 2 m wide and 20 cm deep. The substrate is composed entirely of fines. The banks are densely vegetated (100% cover) with Pecos sunflower and phragmites. Uplands are dominated by alkalai sacaton with large open spaces between plants with (gypsum?) precipitate. Other plant species present include Pecos sunflower, saltgrass, and sea lavender (*Limonium limbatum*); non-native Russian thistle was also present.

Water is clear and has a sulfur odor. Pecos gambusia and endangered spring snails are of concern for future monitoring (in addition to Pecos sunflower), but timing of sampling may sufficiently mitigate impacts. Area has gypsum in bedrock and soil.
