# Inventory of Arivaca Cienega at Buenos Aires National Wildlife Refuge, Arizona

## *Physical and Biological Characteristics*

Natural Resource Technical Report NPS/CHDN/NRTR—2013/818

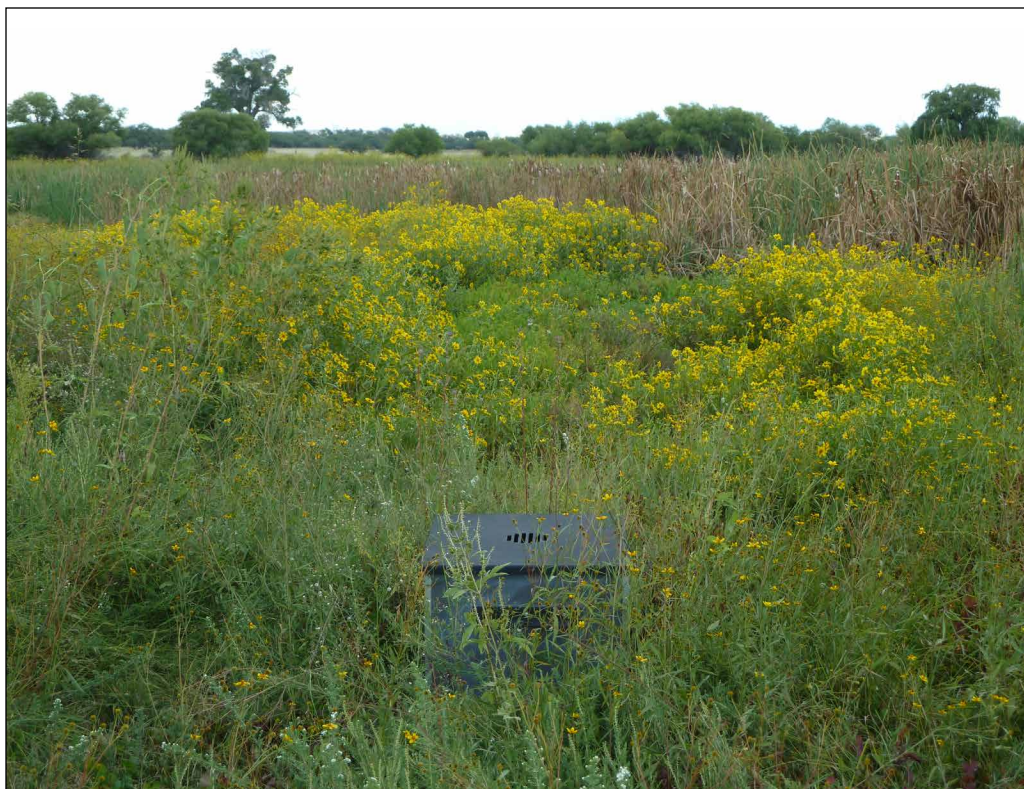
**Figure 3. Willow Pond and spring box.**

The Willow Pond area consists of a 50-m spring brook with flow controlled by a spring box (Figure 3), leading into a pond that was dry at the time of sampling. The center of the pond was filled with cattails and dotted smartweed (*Polygonum punctatum*). Willows (*Salix goodingii*) are located along the perimeter of the pond. More intensive vegetation and habitat studies were conducted on the spring brook. Riparian vegetation along the spring brook (defined as consisting primarily of facultative or obligate wetland plants) extended more than 20 m beyond the wetted edge of the brook. Moving out from the bank perpendicularly, dominant species in the first 5 m consisted of cuman ragweed (*A. psilostachya*), Johnson grass (a non-native), and a golden eye (*Vigiera* sp.). Beyond 5 m, cuman ragweed was still common, with large buttercup (*Ranunculus macranthus*) and Apache beggarticks (*Bidens feruifolia*).

As part of the more detailed survey conducted at Willow Pond, point intercepts were measured along the thalweg of the spring brook from the spring box toward Willow Pond at 1-m increments for 30 m to identify different canopy layers. At each point, either large buttercup or cutleaf waterparsnip (*Berula erectua*) was in the first (shortest) canopy layer, except for meters 24-25, which had cattails. A second canopy layer consisted of either large buttercup or cutleaf waterparsnip, except for presence of *Eleocharis* sp. from meter 10-12. Other species encountered at low densities include floating marsh pennywort (*Hydrocotyle ranunculoides*) and dotted smartweed.

Habitat within the spring brook is fairly uniform. Average wetted width of the channel is 1.7 m (range 0.70-2.6 m) and average water depth is 5 cm (range 1-17 cm). Wetted width of the channel generally decreased with distance from the spring box. There are no overhanging banks. The channel is covered consistently with fine substrates and detritus. Detritus is about 5 cm deep on average (range 0-30 cm) and is deeper closer to the spring box (up to 30

cm deep). Beyond 6 m downstream, detritus is rarely more than 5 cm deep. Emergent plants are found all along the spring brook. Cover ranges from 0 to 100%, however, more than half of the measurements had cover greater than 90%. Only three of fifteen measurements had cover less than 30%.
