# Inventory of Spring Ecosystems at San Andres National Wildlife Refuge, New Mexico

## *Physical and Biological Characteristics*

Natural Resource Technical Report NPS/CHDN/NRTR—2013/820

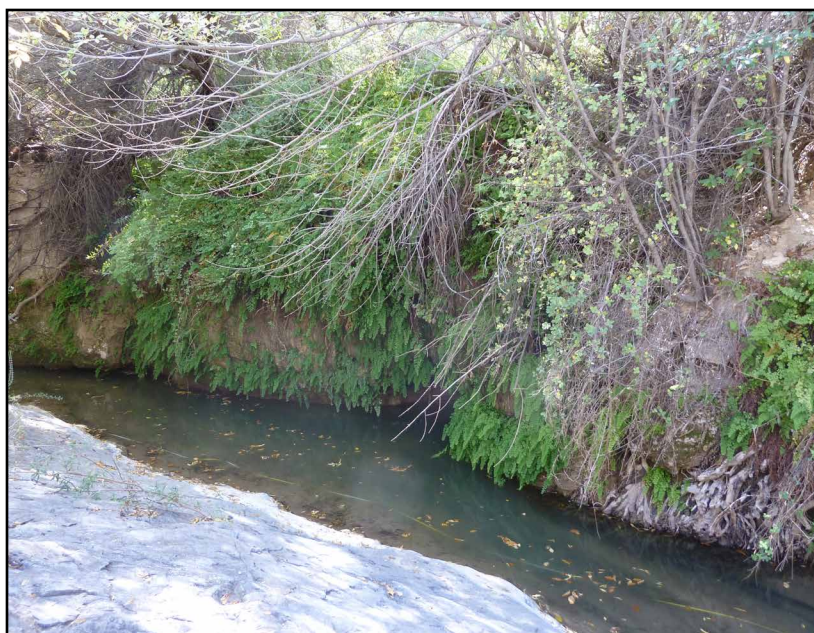
**Upper Ash Spring with maidenhair fern growing along the adjacent bank.**

Dominant riparian vegetation species at **Upper Ash Spring** included maidenhair fern (*Adiantum capillus-veneris*), equisetum, and goldenrod (*Solidago* sp.) in the area within 5 m of the spring. Between 5 and 15 m out from the spring, riparian vegetation species included maidenhair fern, equisetum, and velvet ash (*Fraxinus velutina*). Beyond 15 m away from the spring, maidenhair fern,

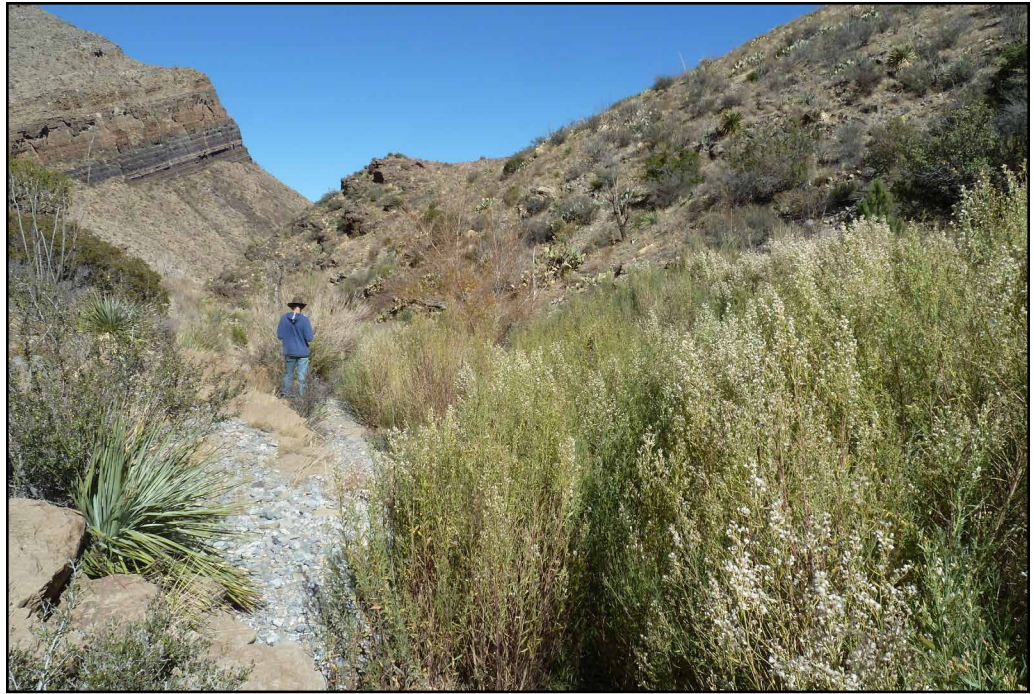
**West Little San  
Nicholas Spring,  
showing dominance  
of baccharis.**

At **West Little San Nicholas Spring**, the dominant riparian vegetation species included baccharis, California loosestrife (*Lythrum californicum*), and the non-native beardless rabbitsfoot grass within 5 m of the spring. Between 5 and 15 m, the same species were present, with the addition of *Juncus* sp. Between 15-30 m, baccharis was present, as was California loosestrife and western umbrella sedge (*Fuierena simplex*). Within 5 m from the spring, dominant upland species was skeleton goldeneye (*Viguiera stenoloba*), sideoats grama (*Bouteloua curtipendula*), and barberry (*Berberis* sp.) on the left side of the spring and sideoats grama on the right. Five to 15 m out from the spring, dominant upland species included acacia, skeleton goldeneye, and sideoats grama on the left and skeleton goldeneye and alderleaf mountain mahogany on the right. Fifteen to
