# Inventory of Spring Ecosystems at Sevilleta National Wildlife Refuge, New Mexico

## *Physical and Biological Characteristics*

Natural Resource Technical Report NPS/CHDN/NRTR—2013/822

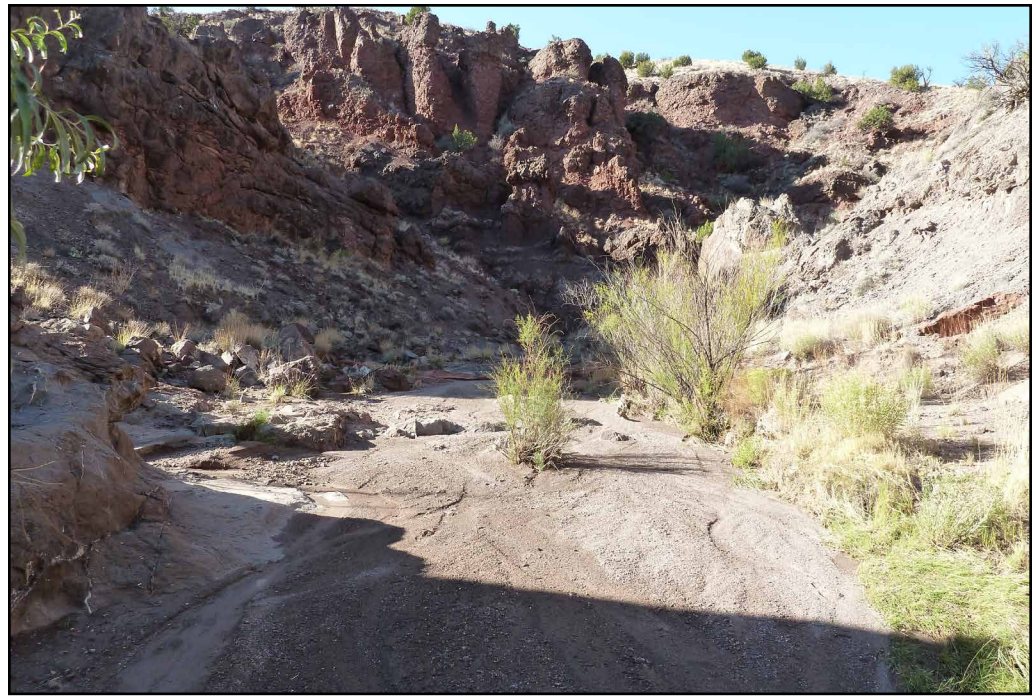
Dry channel at  
Canyon del Ojito.

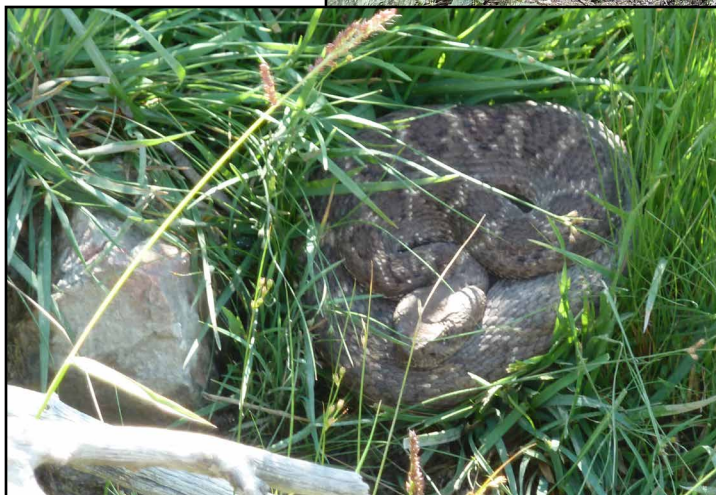
**Four Springs tanks (right)  
and Western diamondback  
rattlesnake found on site  
(below, inset).**

tank at San Lorenzo Spring 2, and a pipe diversion and an open trough/tank at Four Spring. Ninety percent of Sevilleta NWR springs are undisturbed or are slightly disturbed by roads (Table 4). Similarly, ninety-four percent of springs in the area are undisturbed or slightly disturbed relative to roads (Figure 2). Cibola Spring is moderately impacted by roads, meaning that a road or OHV trail is present, but located on the
