National Park Service  
Cultural Landscapes Inventory

Blow-Me-Down Farm  
Saint-Gaudens National Historic Site

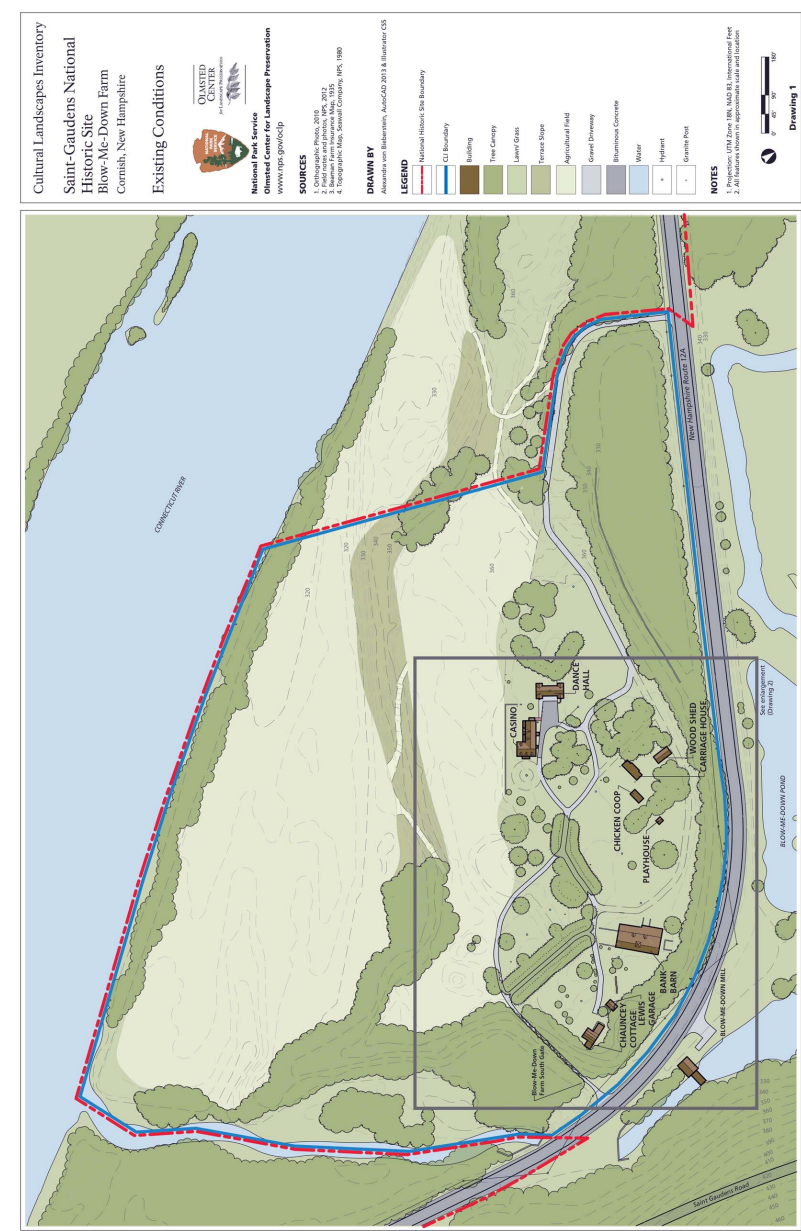
Site plan 1 of 2 for the Blow-Me-Down Farm. (Olmsted Center for Landscape Preservation—hereafter OCLP--2013)

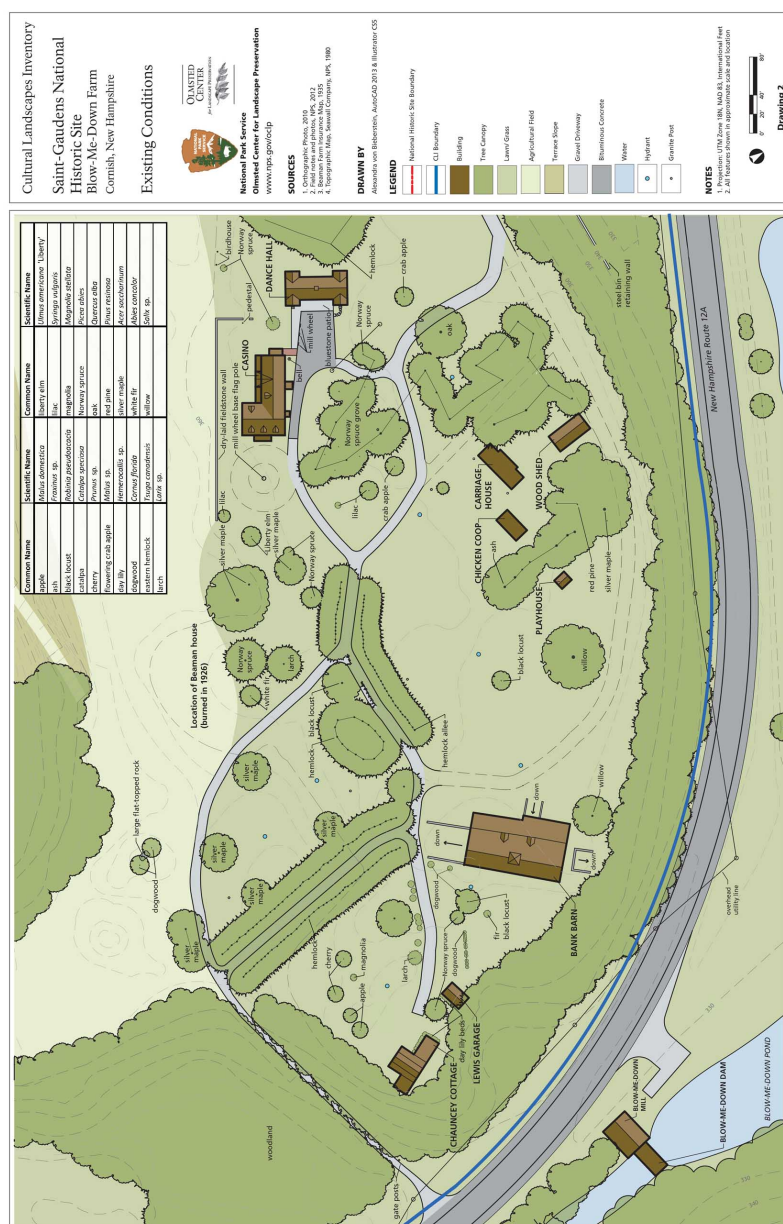
*Site plan 2 of 2 for the Blow-Me-Down Farm. (OCLP, 2013)*

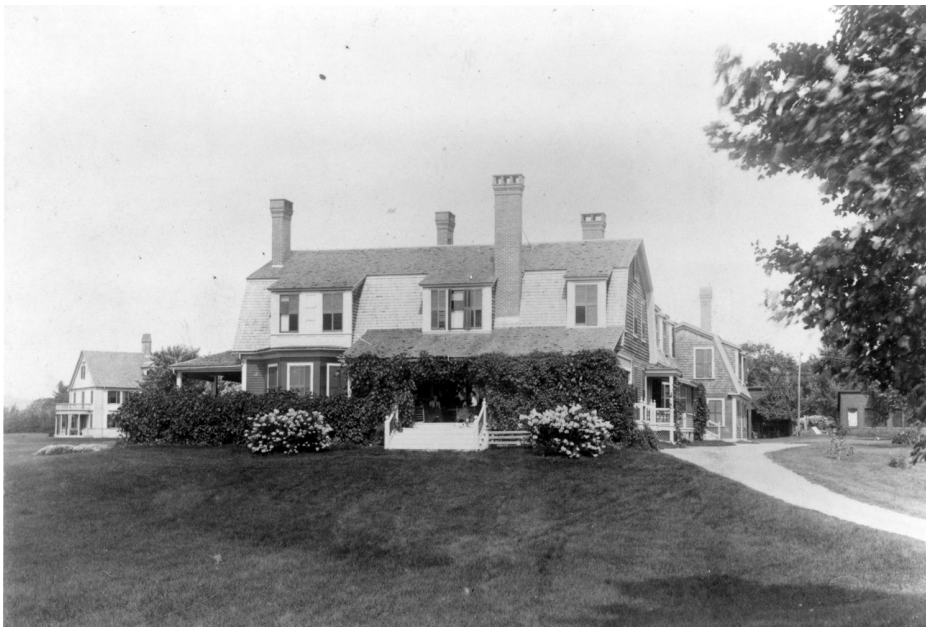
Figure 4. View looking north at the south side of the Blow-Me-Down cottage, 1888-1892, and the lawns/meadows and plantings. In the background at image right is a chicken house, and at image left is the 1888 casino. (SAGA, 3065w-tif633640012663143904)

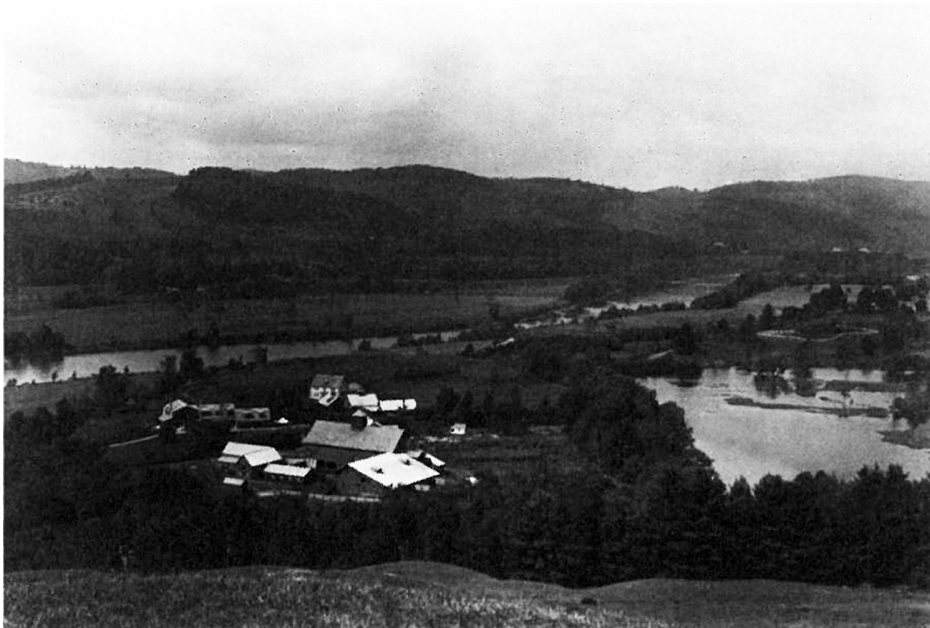
*Figure 5. View looking west at the farm from Dingleton Hill, c.1891, showing the large bank barn (with the cupola) and surrounding buildings. Blow-Me-Down cottage is at image left and Blow-Me-Down pond is at right. (SAGA, #1349, Dryfhout 2000:78)*

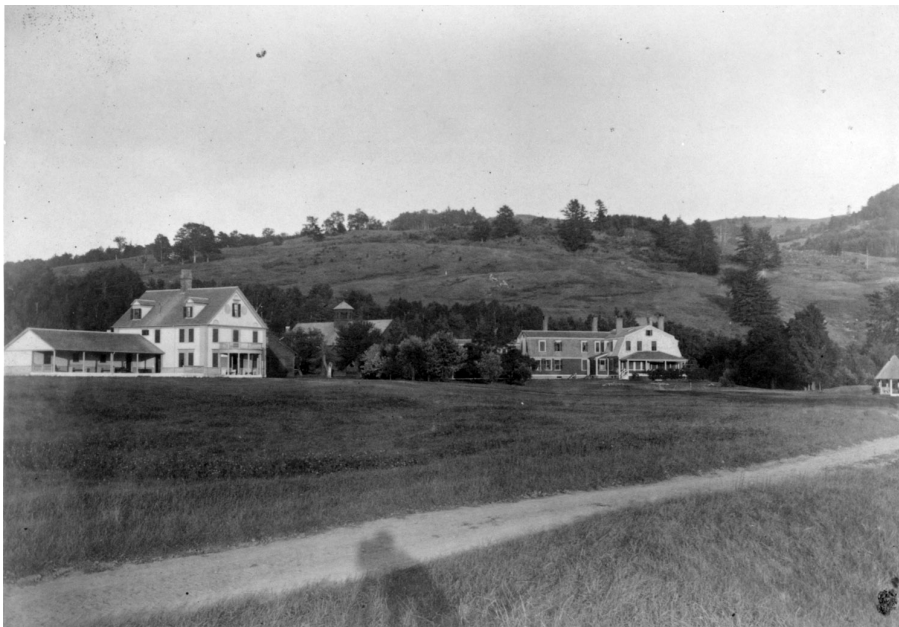
*Figure 6. View looking east at the Blow-Me-Down Farm, 1888-1892. From left to right is the casino and attached ell, bank barn (with cupola), Blow-Me-Down cottage, and the gazebo. (SAGA,3065bb-tif633640654610660640)*

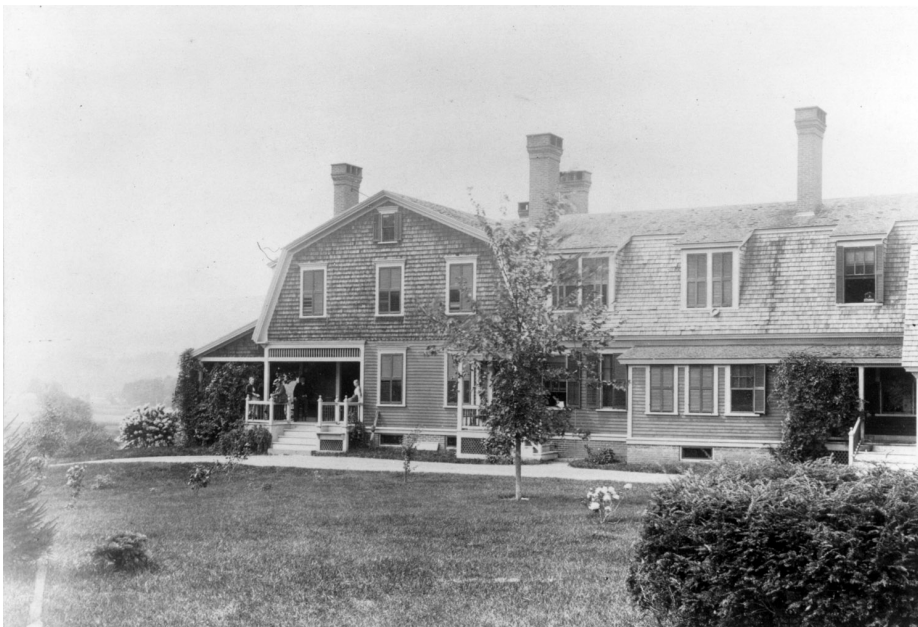
*Figure 8. View looking west at the east side of the Blow-Me-Down cottage, before 1892. Trees and shrubs dot the lawns/meadows, and vines shade the porches. Note the gravel driveway along the building. (SAGA, 3065y-tif633640014133100134)*

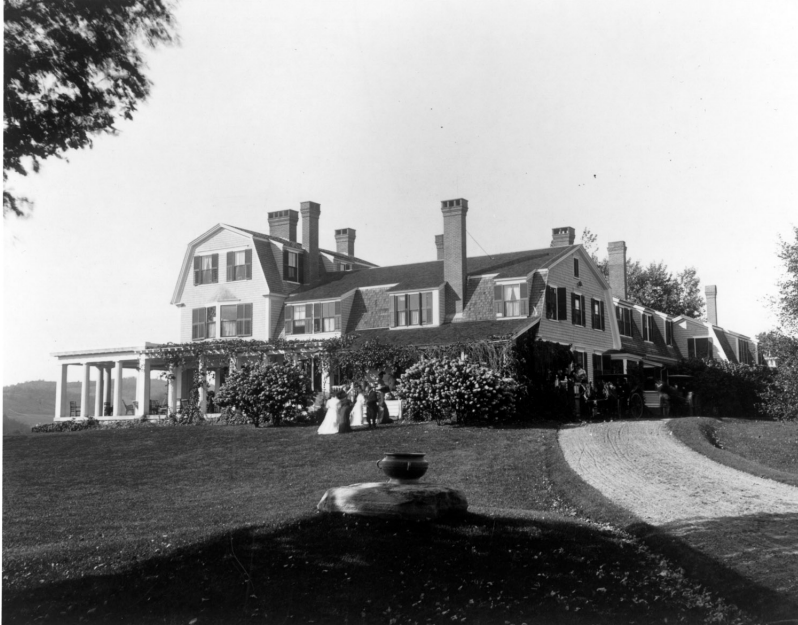
*Figure 11. View looking northwest at the Blow-Me-Down cottage in c.1909, showing the addition and piazza that was added in 1892. A driveway passes through a manicured lawn/meadow and by an urn atop a flat rock. (SAGA, 3065k-tif633639998840573892)*

To accommodate more guests at the farm, Beaman added an addition and a columned piazza to the southwest portion of the Blow-Me-Down cottage in 1892 (Figures 11 and 12). That same year, Beaman hired Ernest English from Windsor to work with R.T. Lozier of the Edison Electric Company in New York to install a dynamo for the production of electric lighting. Beaman also built a house for his friend and fellow Harvard alum Elihu Chauncey—called the Chauncey Cottage—between 1890

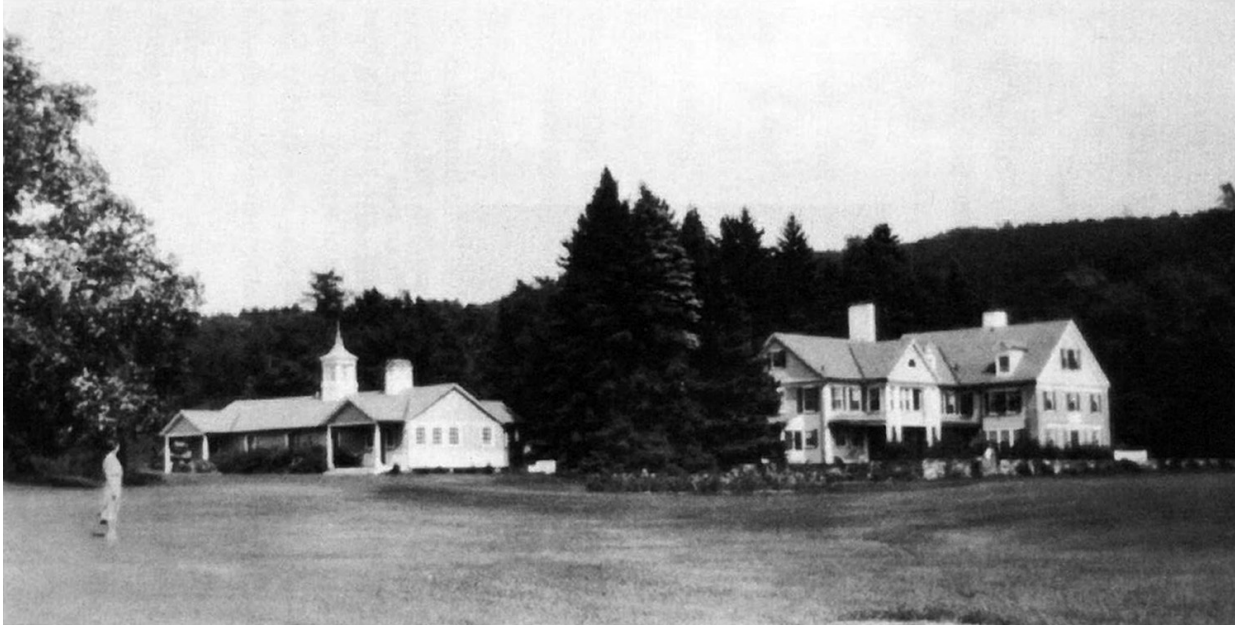
Figure 15. View looking east in 1928-1929 at the dance hall (image left) and the casino after it was remodeled and enlarged into a residence. Note the stone retaining wall on the south side of the casino. (SAGA, Davis Collection, from Dryfhout 2000:83)

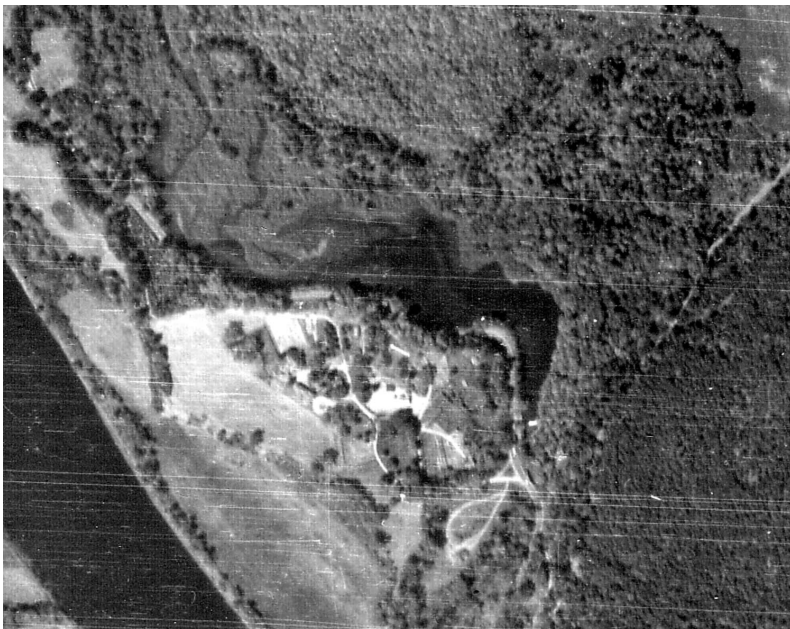
Figure 16. Aerial photograph from 1952 showing the Blow-Me-Down Farm. The Blow-Me-Down pond is at image center and the Connecticut River is at image left. (SAGA files)

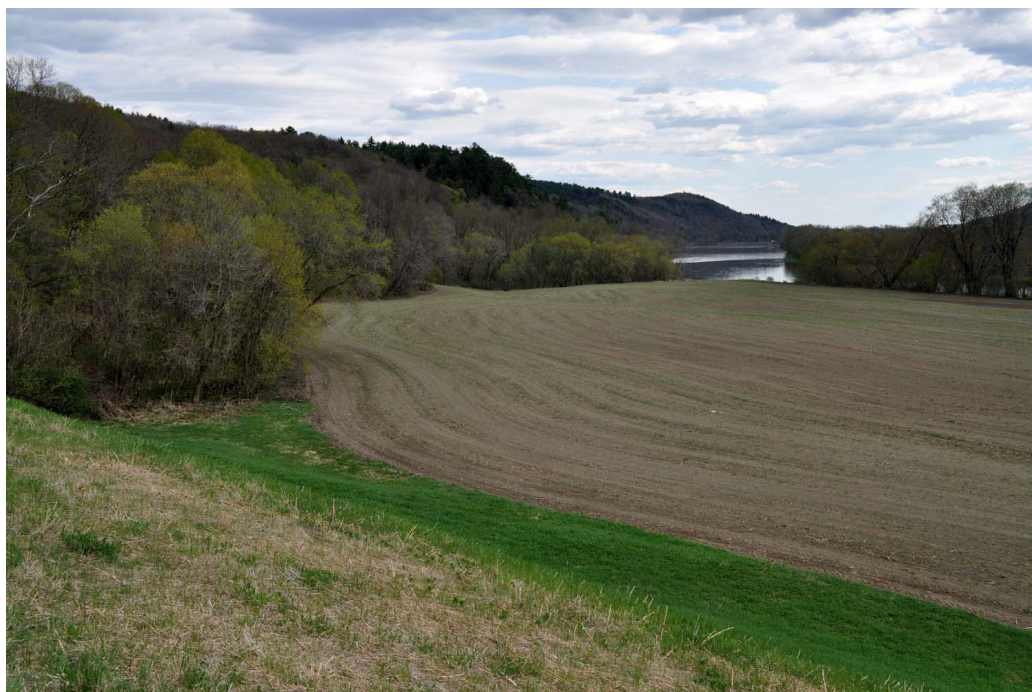
*Figure 17. View looking southeast at part of the agricultural field at Blow-Me-Down Farm. The Connecticut River is in the distance. (Olmsted Center for Landscape Preservation--hereafter OCLP--#DSC-0180, May 2012)*

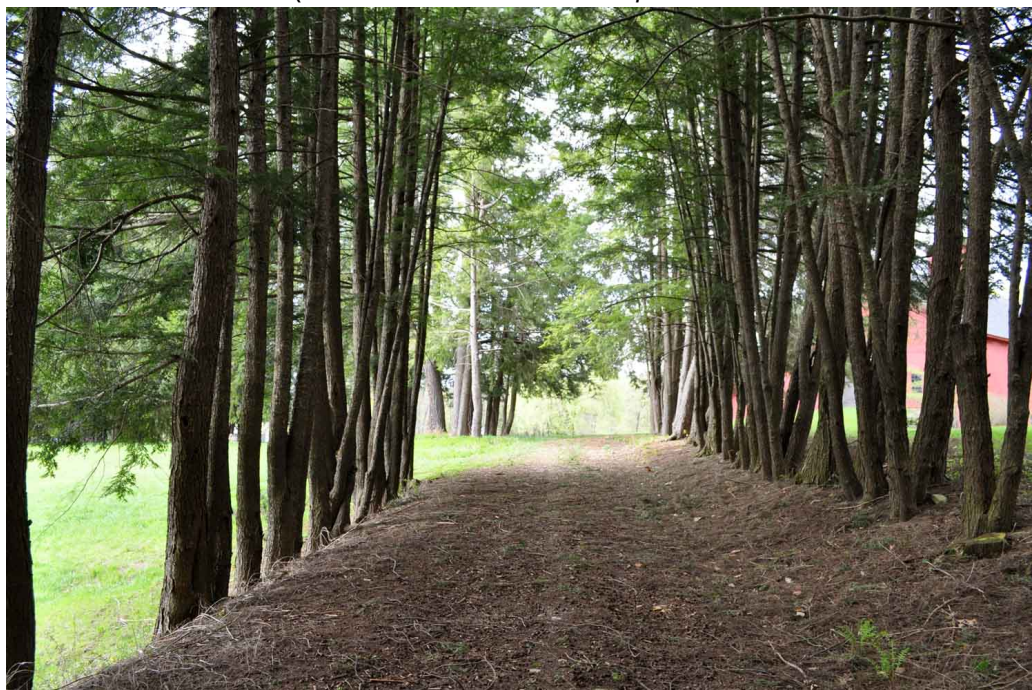
*Figure 18. View looking north at the historic hedge allée on the driveway leading to the bank barn, seen behind the trees at image right. (OCLP, #DSC-7771, May 2013)*

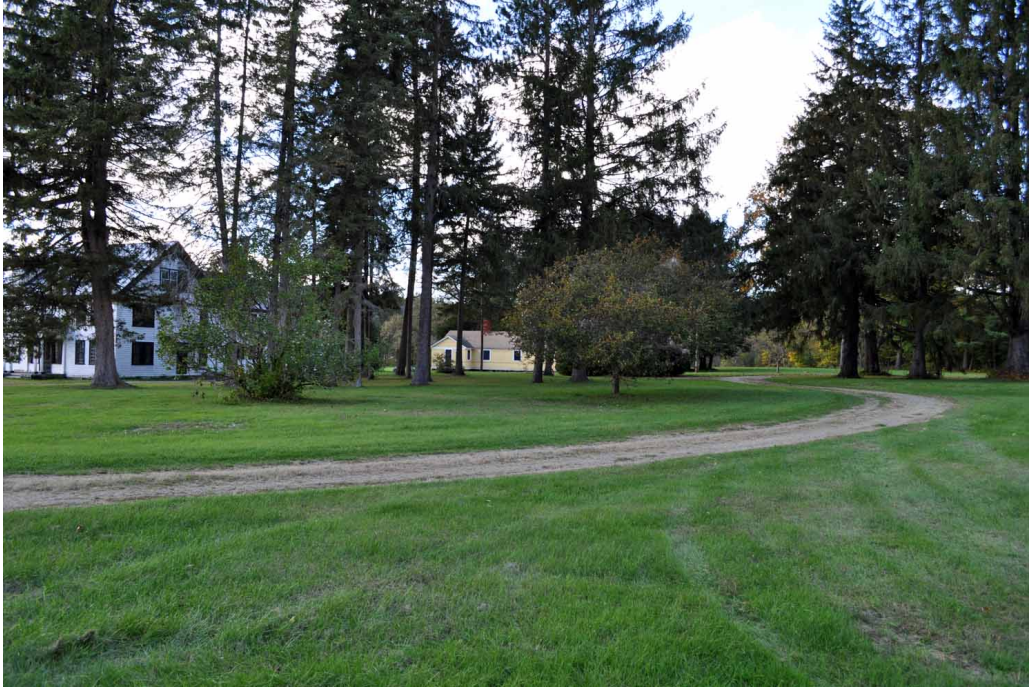
*Figure 19. View looking west at the lawns and one of the driveways within the developed core of the farm. The casino (image left) and dance hall (center) are visible in the background. (OCLP, #DCS-6480, October 2012)*

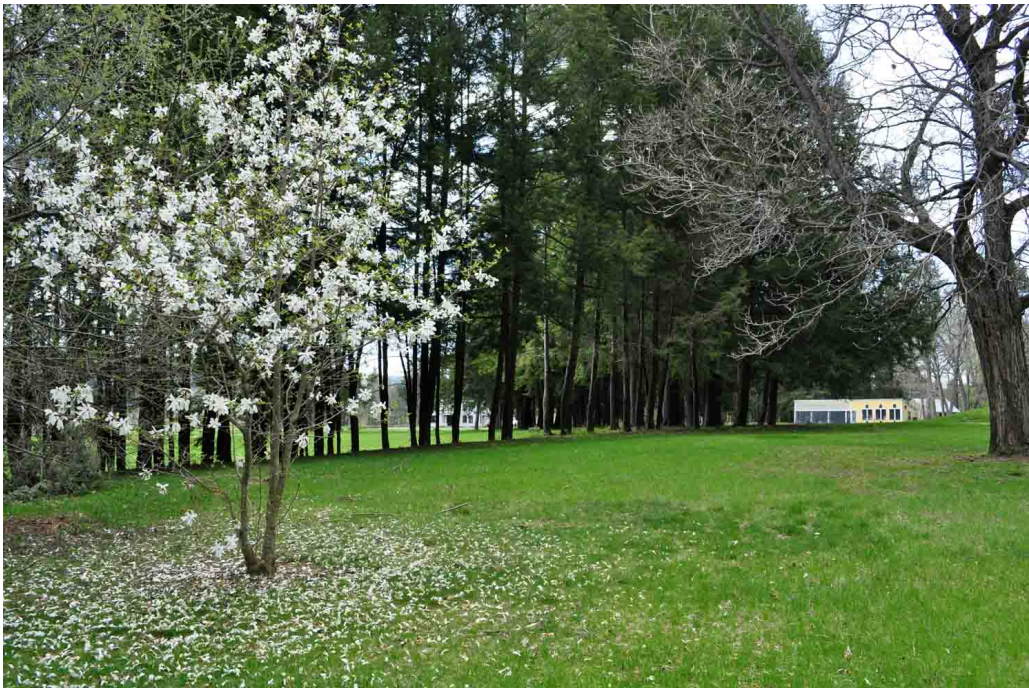
*Figure 20. View looking west at the lawns, specimen trees, and allée. In the distance are the casino (image center), and carriage house and chicken house (right). (OCLP, #DCS-7767, May 2013)*

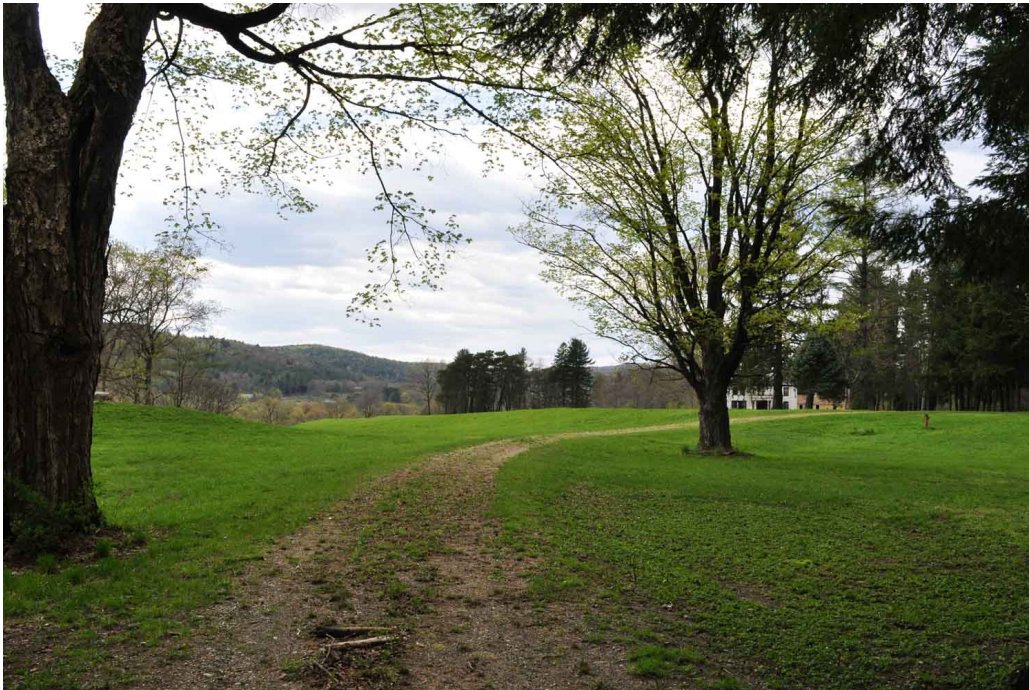
*Figure 21. View looking west at the part of the driveway that one passed by the Blow-Me-Down cottage, destroyed by fire in 1926. At image far left is the flat rock that was a pedestal for the urn seen in Figure 11. (OCLP, #DSC-7772, May 2013)*

The driveways developed during the historic period were not altered significantly after 1950 and are still extant. Both ends of the system still terminate at SR 12A and continue to loop through the eastern portion of the property to access the extant buildings, but the eastern historic entrance is no longer used due to poor sight lines along the highway. The ends of the driveway system are forested, while other sections pass through open lawns or under canopies of trees. Allées of historic hemlock also still line some of the driveways. Presently, the majority of the driveway system features earthen/gravel surfaces that are not as defined as they were historically. Less used drives, such as the circular drop-off area at the casino and several of the eastern loops, have transitioned mostly to grass. Unsurfaced farm lanes also still exist and are still used to access the fields along the river (Figure 21, see Figure 19).

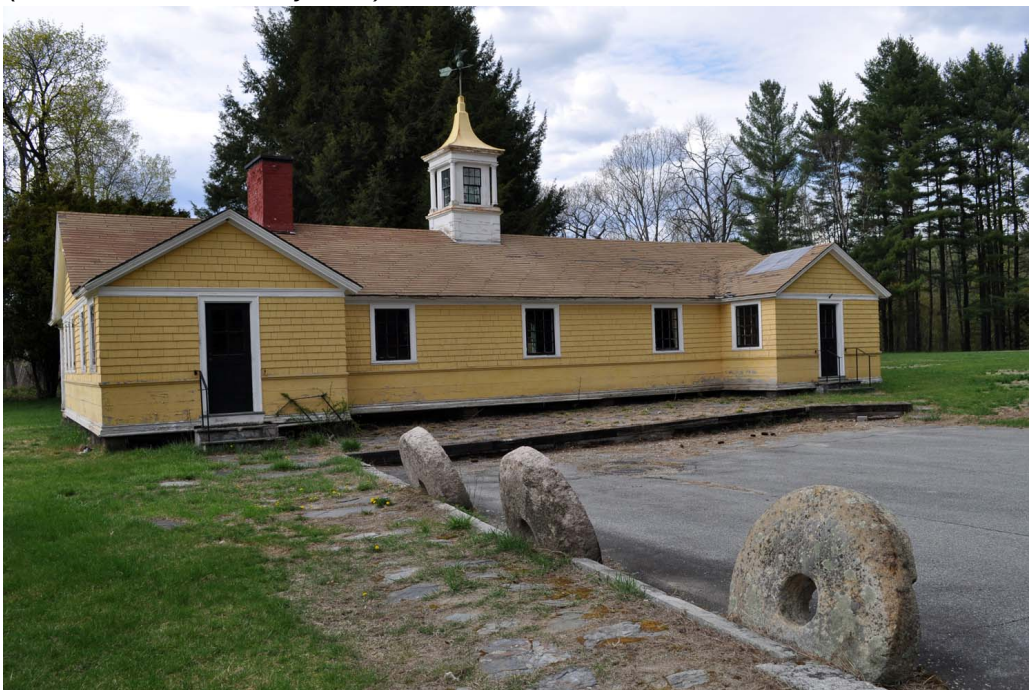
*Figure 22. View looking northwest at the dance hall. Three mill wheels are embedded in the parking lot. A stone patio connects to a stone walk that leads to the casino. (OCLP, #DSC-7731, June 2013)*

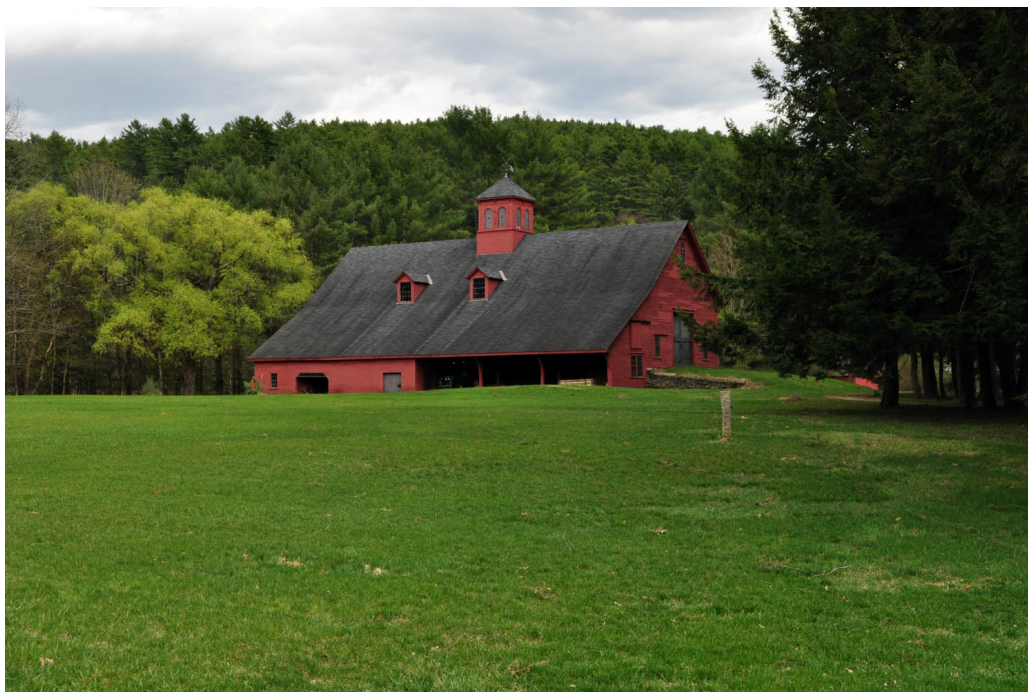
*Figure 23. View looking east at the bank barn, completed in 1884. A portion of the hemlock allée and a granite post are visible at image right. (OCLP, #DSC-7772, June 2013)*

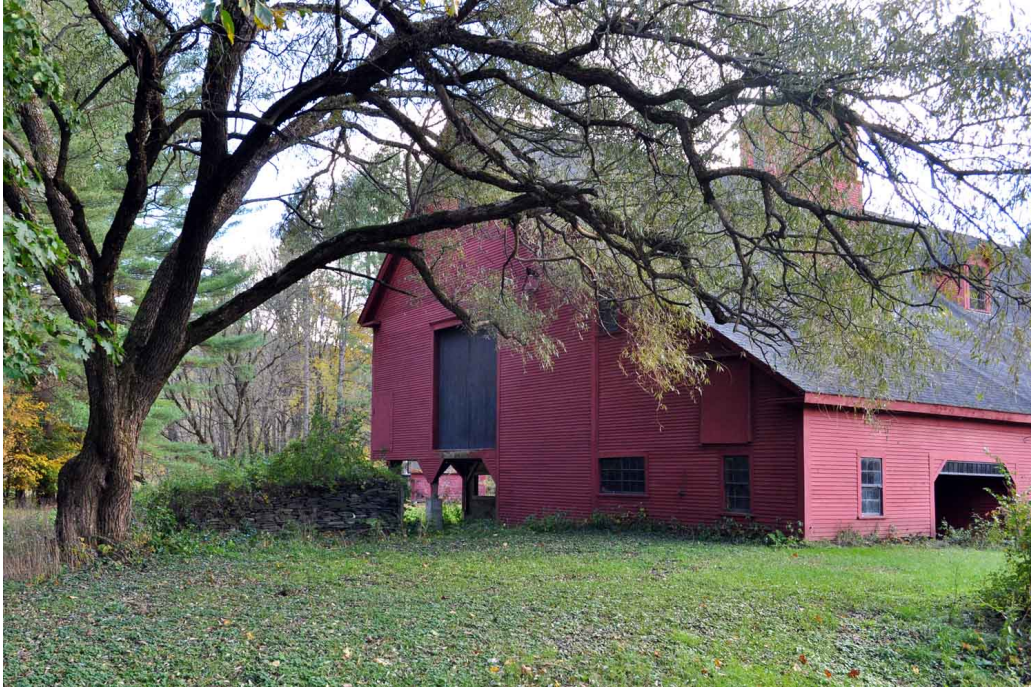
Figure 24. View looking south at the bank barn and the remains of a dry-laid stone ramp next to a large willow tree. (OCLP, #DSC-0156, June 2013)

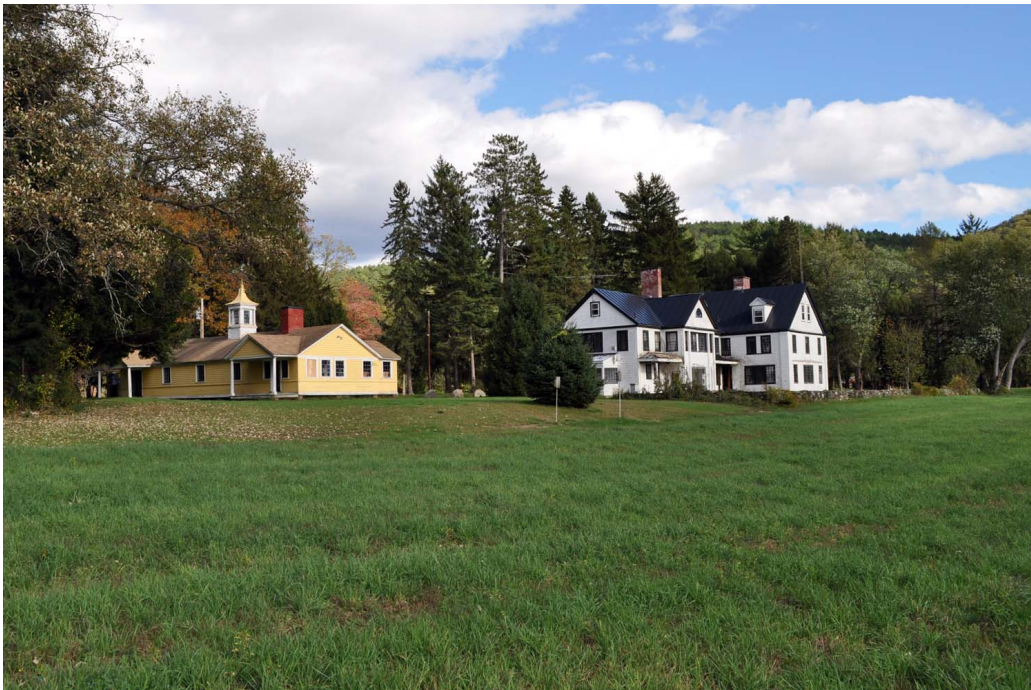
Figure 25. View looking east at the 1927-1929 dance hall (image left) and the 1888/1927 casino. The viewpoint of this photograph is similar to Figure 15. (OCLP, #DSC-0753, June 2013)

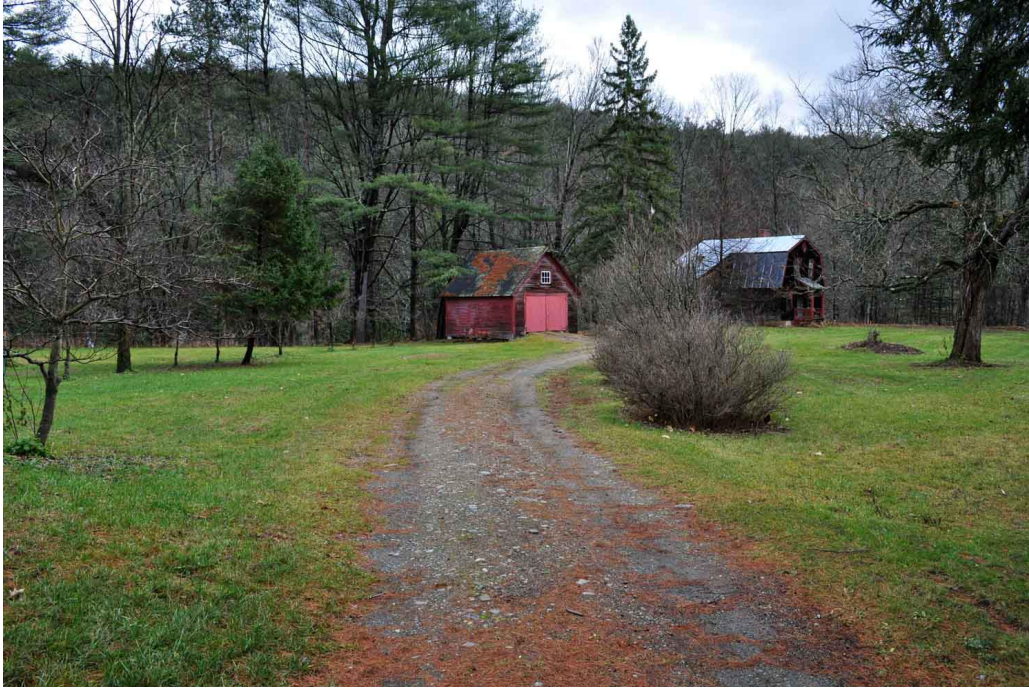
*Figure 26. View looking east at the Lewis garage (image center) and the Chauncey cottage. (OCLP, #DSC-6818, November 2012)*

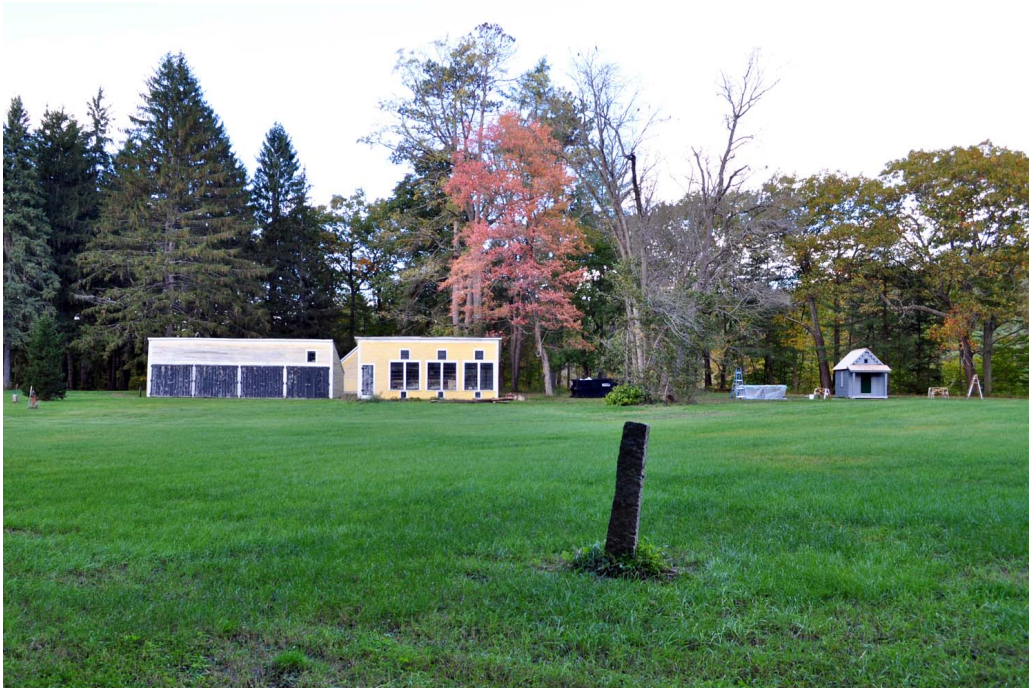
*Figure 27. View looking north across the lawn toward the carriage house (image left), chicken coop, and playhouse. A granite fence post is in the foreground. (OCLP, #DSC-0164, June 2013)*

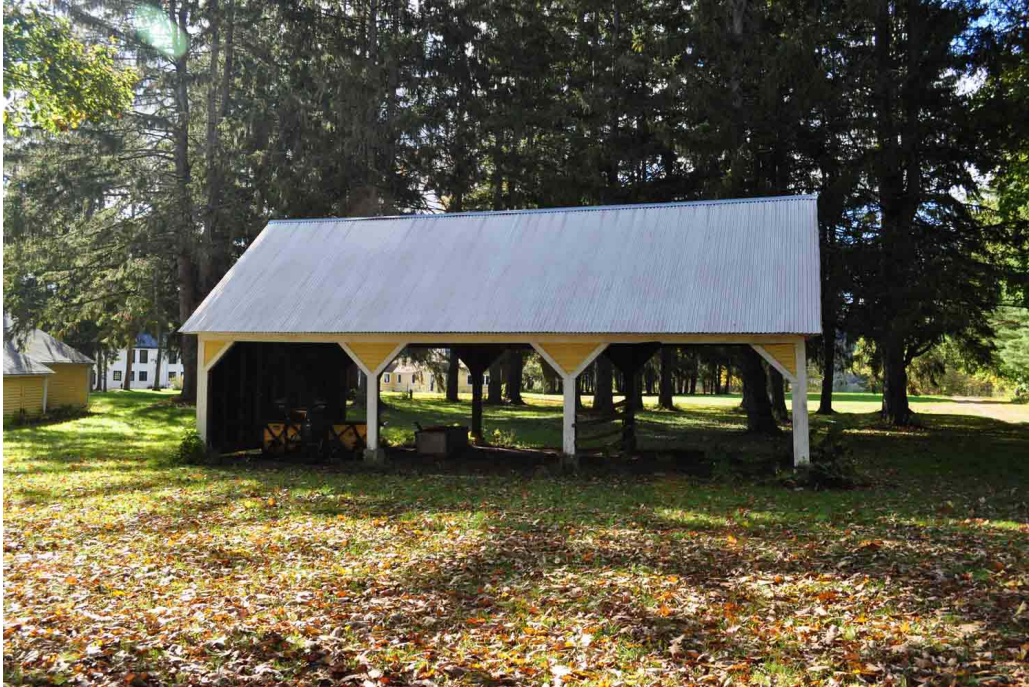
Figure 28. View looking west at the wood shed. The back of the carriage house is at image left, and the casino and dance hall are in the distance. (OCLP, #DSC-0144, October 2011)

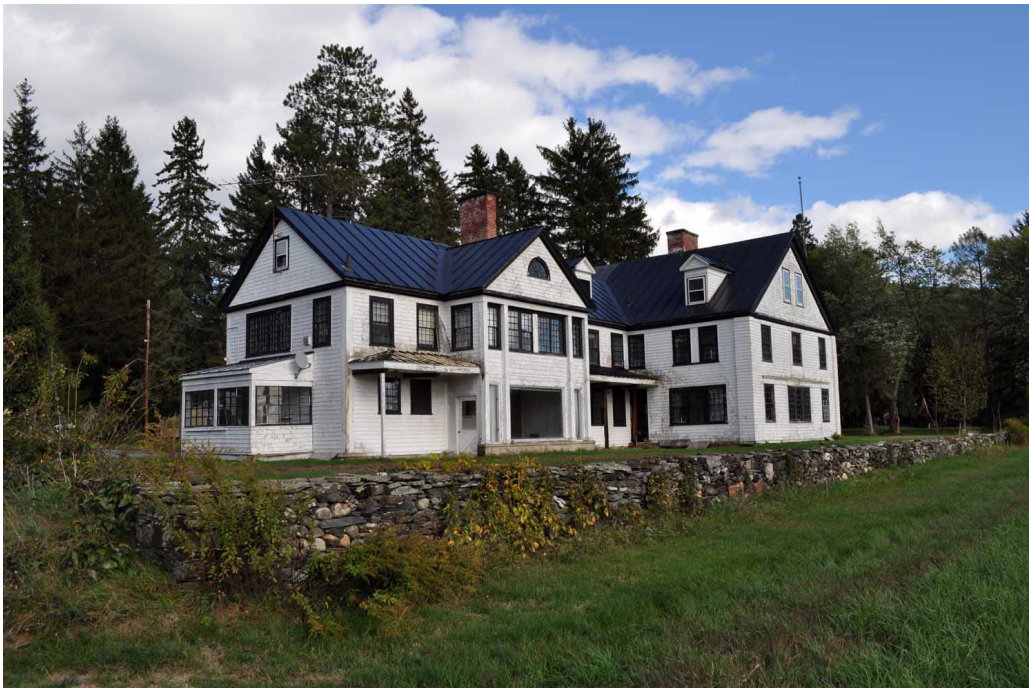
Figure 29. View looking east at the L-shaped stone wall on the south side of the casino. The top of the flagpole that stands in the middle of the driveway turnaround on the east side of the casino is visible at image right. (OCLP, #DSC-0756, October 2012)

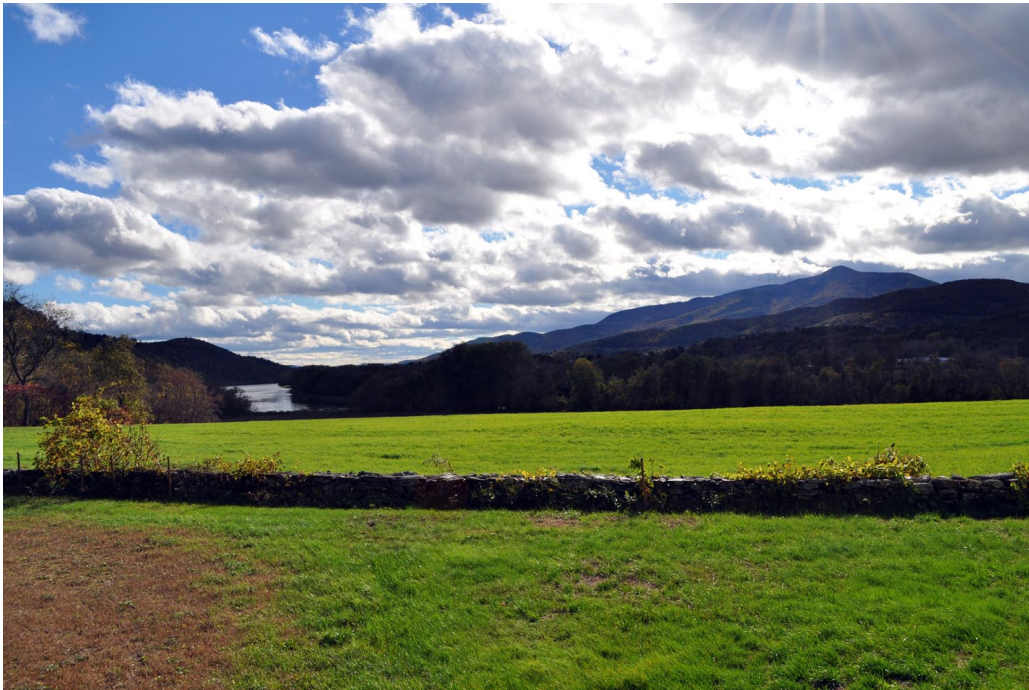
*Figure 30. View looking south across lawns and fields to the Connecticut River valley and Mount Ascutney, from the turnaround next to the casino. (OCLP, #DSC-0780, June 2013)*

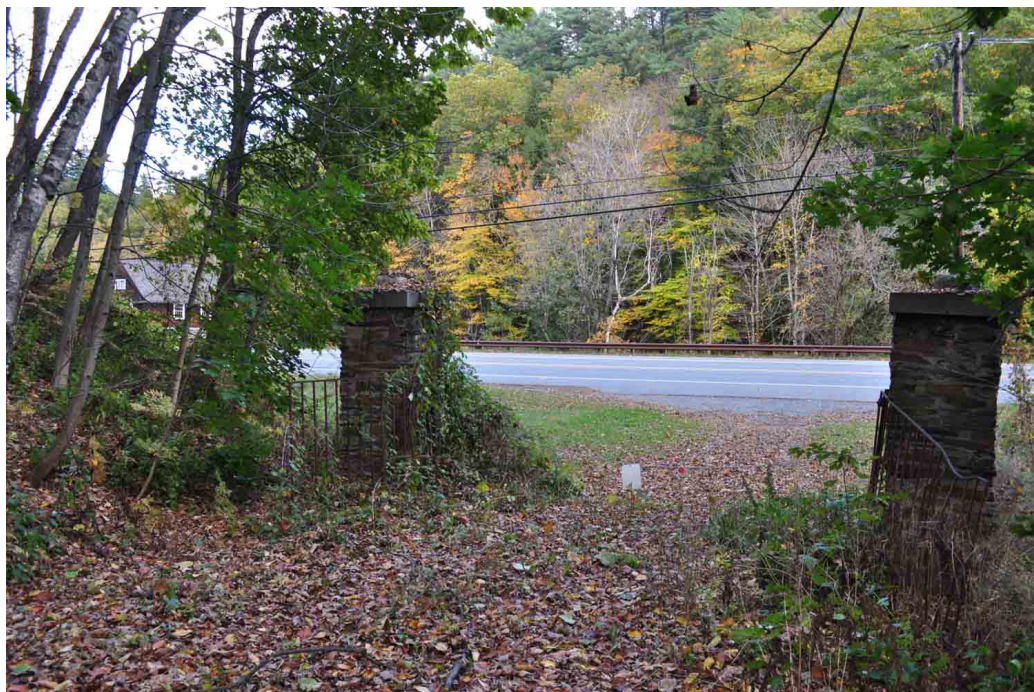
*Figure 31. View looking east at the south gate at Blow-Me-Down Farm, erected in 1898. One of two entrances to the farm, it is no longer open to the public. Blow-Me-Down Mill is in the background. (OCLP, #DSC-0183, October 2011)*
