National Park Service  
Cultural Landscapes Inventory  
2012

## Hoh Developed Area Historic District

### Olympic National Park

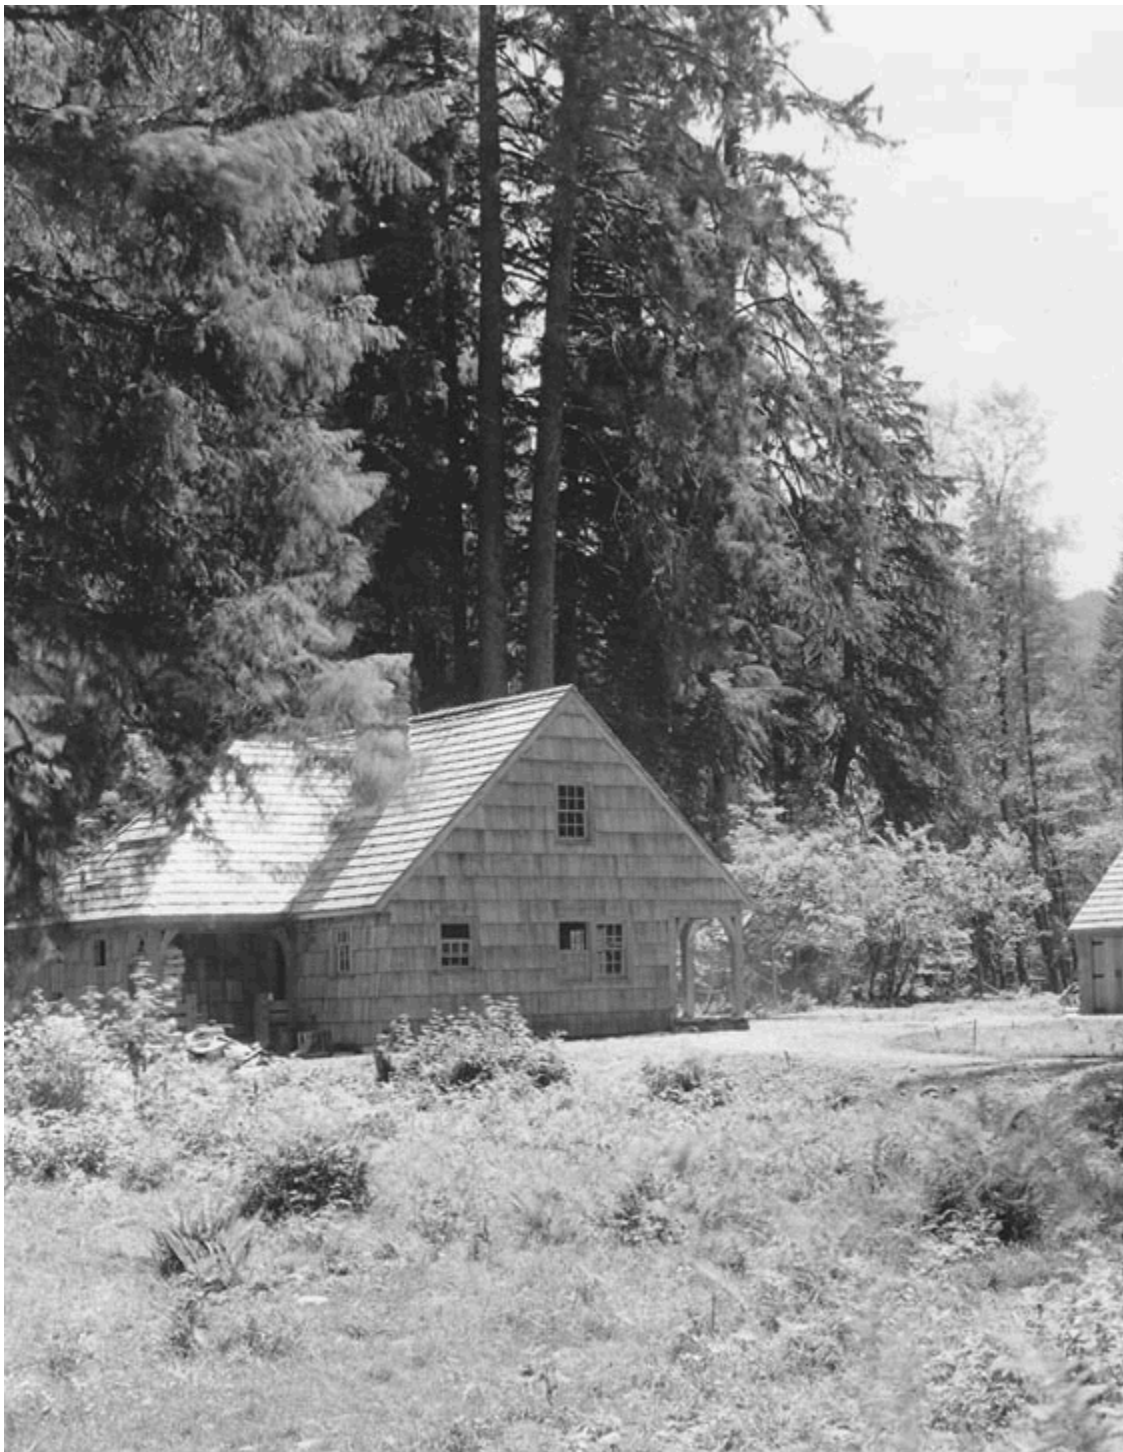
*U.S. Forest Service Jackson Ranger Station, 1937. Buildings from left to right are the bunkhouse, the garage/woodshed, and the residence. (OLYM Archives)*

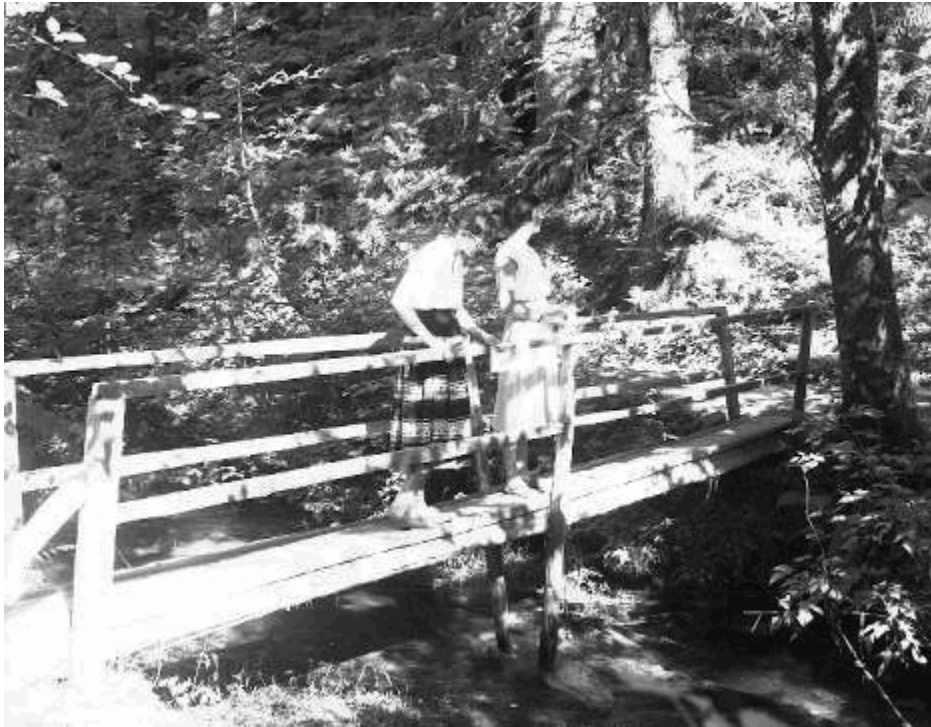
*Historic photo of a foot bridge along the Spruce Nature Trail. (OLYM Archives)*

The Spruce Nature Trail was completed in August of 1962. Historically, this 6,450-foot trail included four rustic footbridges and traversed the rain forest edge while also skirting the Hoh River through open forests of alder trees. Due to flooding in 2003, minor alterations occurred on an eastern portion of the trail along Taft Creek. All four footbridges along the Spruce Nature Trail have been replaced with more modern style bridges since 2009.

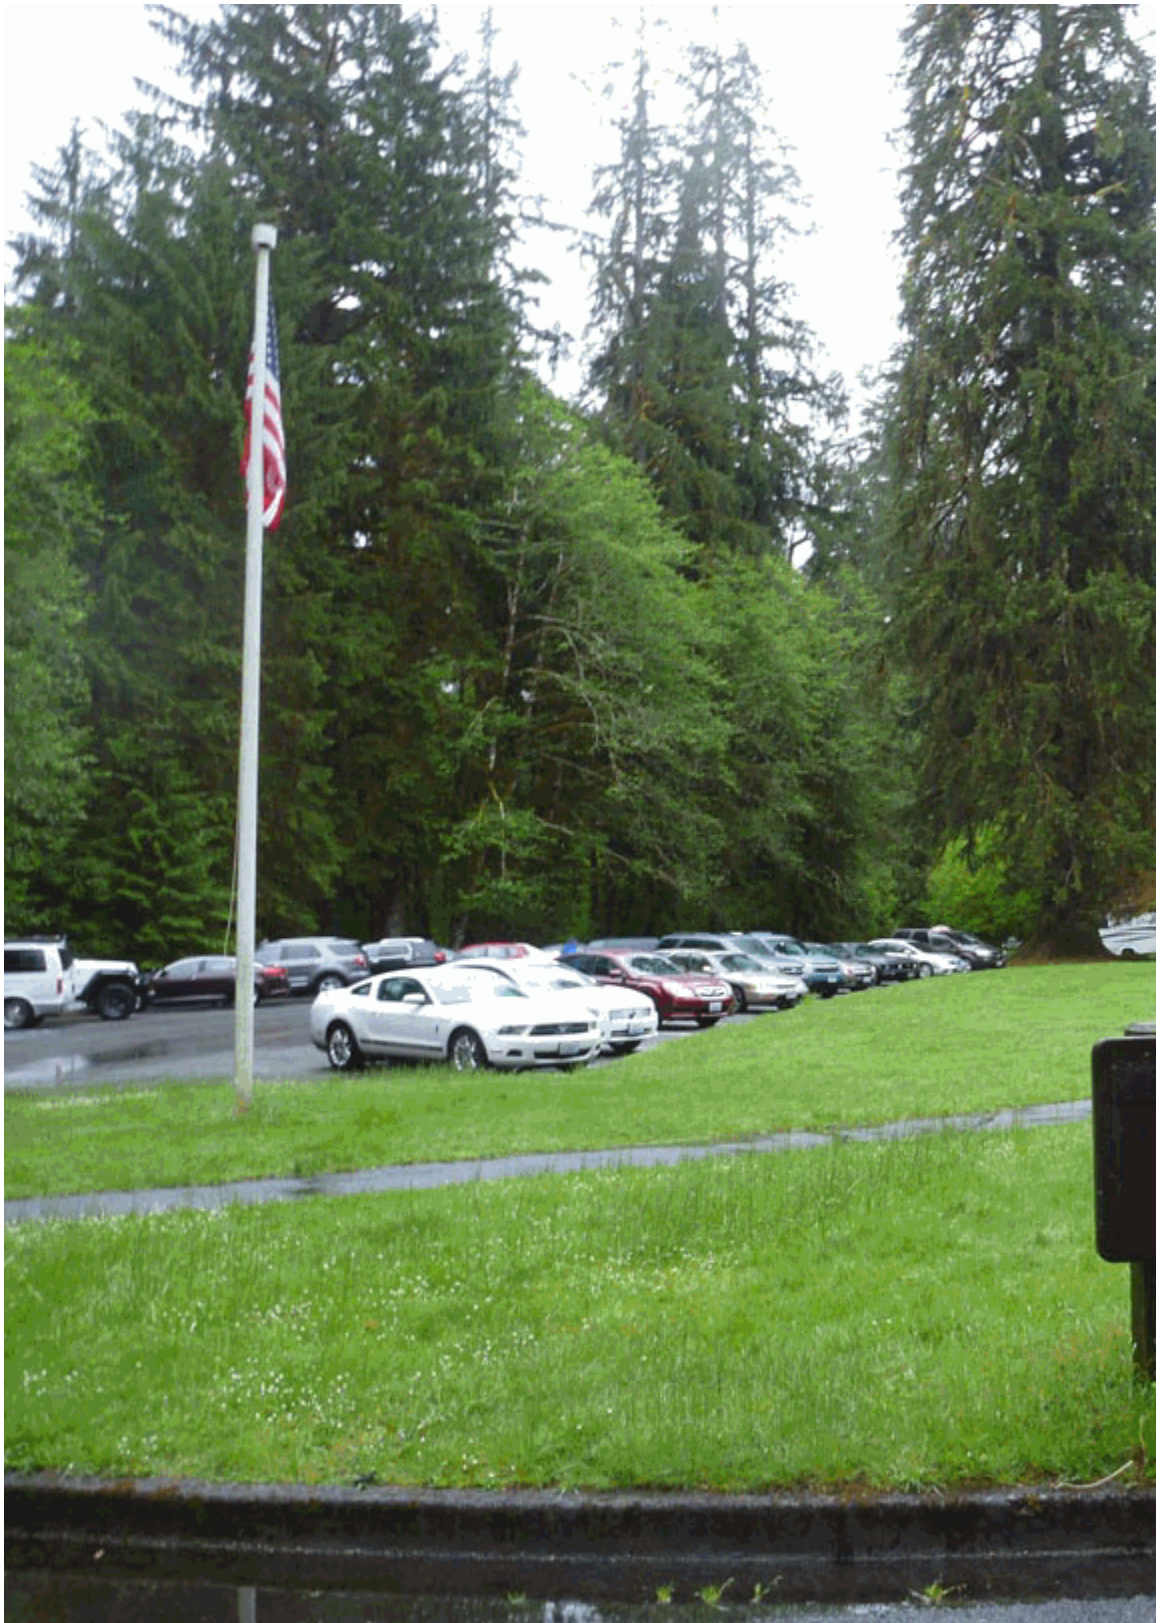
*The visitor center parking lot was constructed in a clearing where the U.S. Forest Service's Jackson Ranger Station existed. The parking lot leads visitors counter-clockwise around the central island providing access to the visitor center, picnic area an*

are found in the central island and the outer walkways to accommodate large Spruce trees. The parking area is surfaced, as it was historically, with asphalt and has historic 6" concrete curbs that edge the majority of the lot, except in the southern end where they were removed to accommodate RV parking. A historically asphalt-surfaced walkway skirts the eastern edge of the parking lot providing visitor access to the Hoh River Trailhead (a backcountry trail). A similar historic walkway traverses the western edge of the island, cutting diagonal across the north end before reaching a visitor center accessible crosswalk.

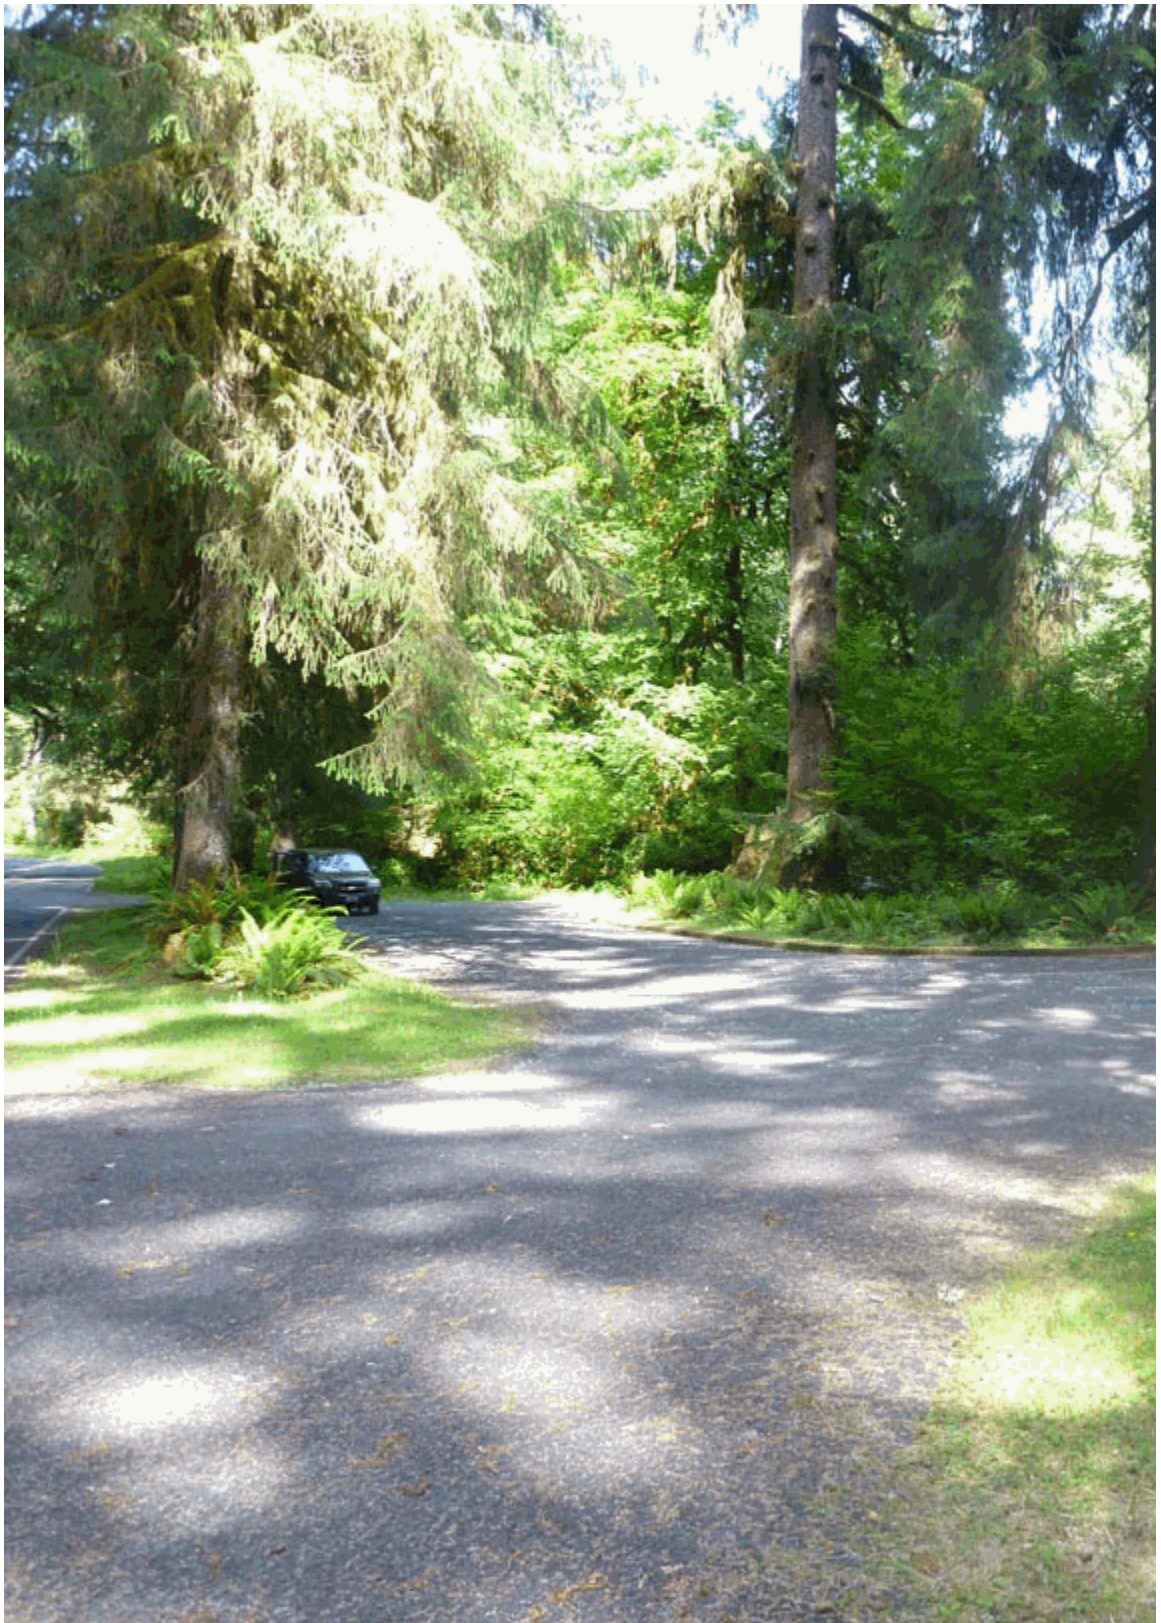
*Roadside parking areas were designed as stopping points along the Upper Hoh Road for access to the Hoh River and for interpretive purposes. (PWRO 2012)*

According to 1959 design drawings there were eight planned small, roadside parking areas along the south side of Upper Hoh Road that were planned to facilitate interpretation of natural resources within the Hoh valley, including the Hoh River and the largest Sitka spruce trees in the area. "As-constructed" drawings for the road have not been found; however, of the eight planned parking areas, there are currently six remaining that are constructed as designed. They are labeled as Parking Area No. 1, 2, 4, 5, 6, 7, and 9, while skipping No. 3. The easternmost historic roadside parking area (No. 9) was removed in the late 1990s following a flood event that eroded the nearby river bank. Another historic parking area was located near the park boundary (No. 1) and was likely lost during a storm event that damaged that portion of the road.

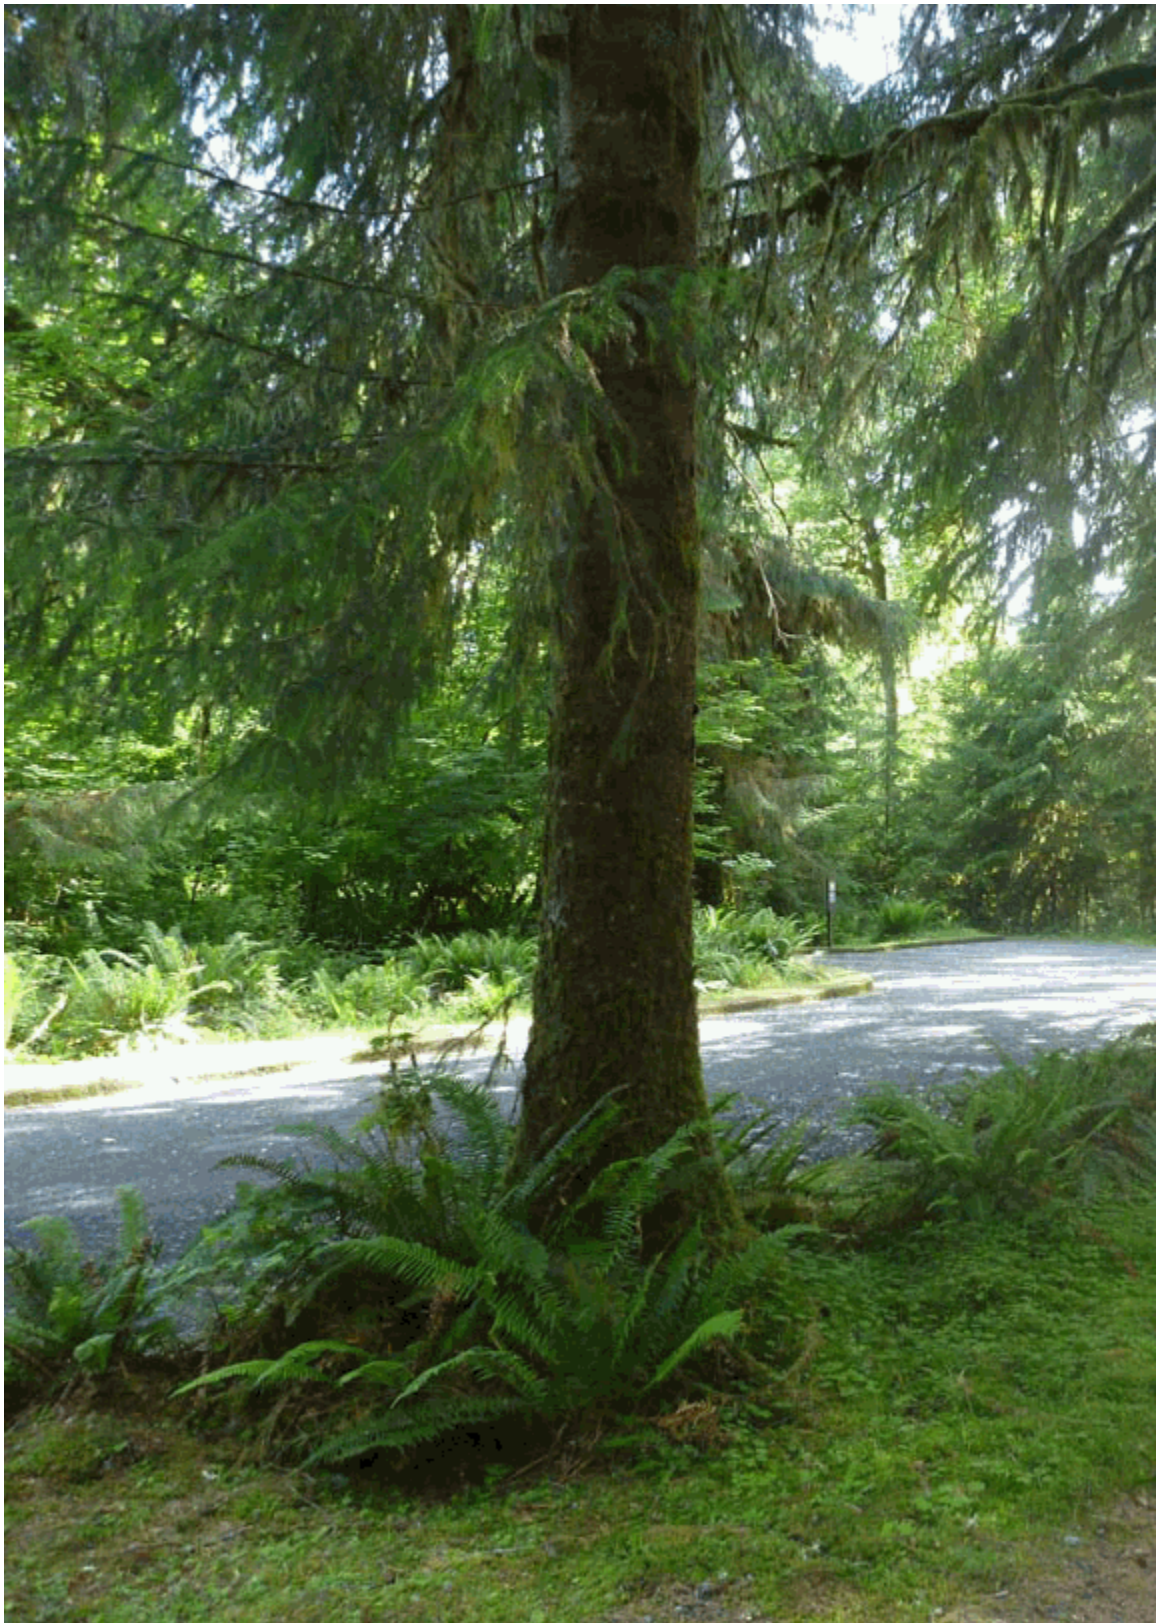
*Roadside parking areas are separated from the Upper Hoh Road by narrow islands historically created by a log that have since become nurse logs to trees and ferns. (PWRO 2012)*

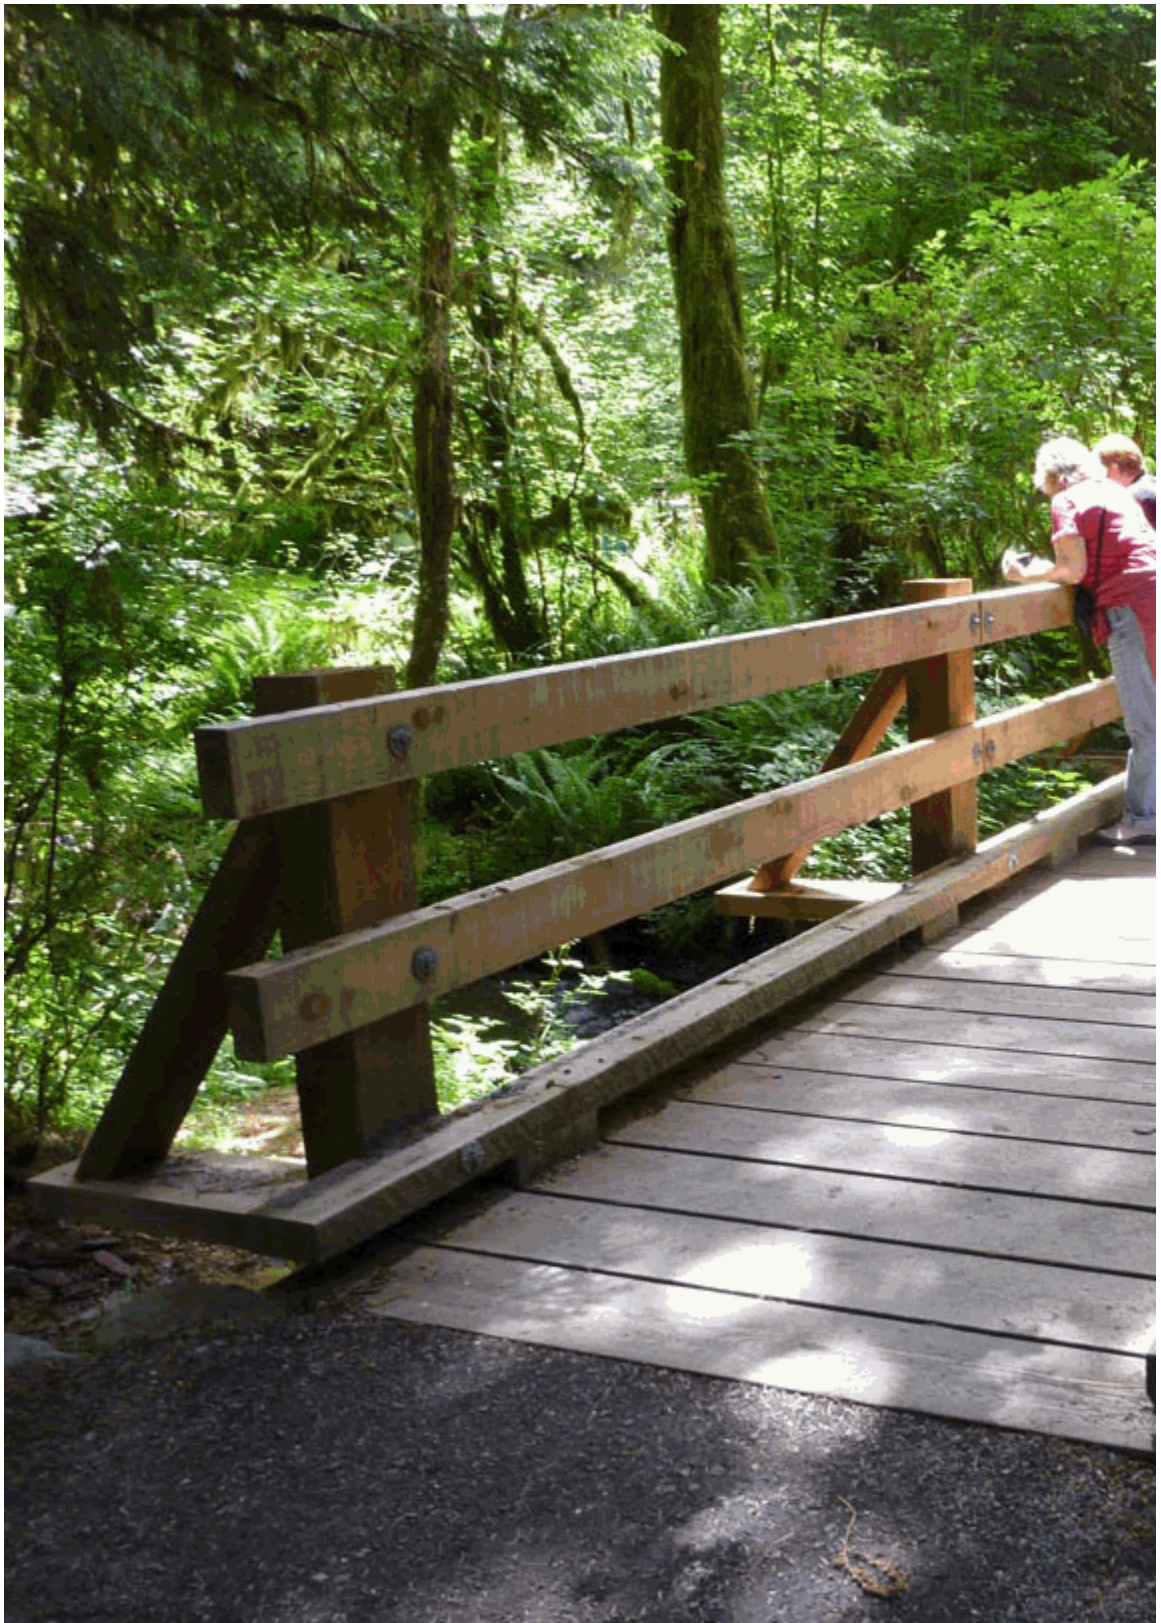
*Photograph of a non-historic bridge on the Spruce Nature Trail. Design of the nature trail system in the Hoh Developed Area Historic District was integral to providing visitor access to the unique rain forest resource that brings tens of thousands of vis*

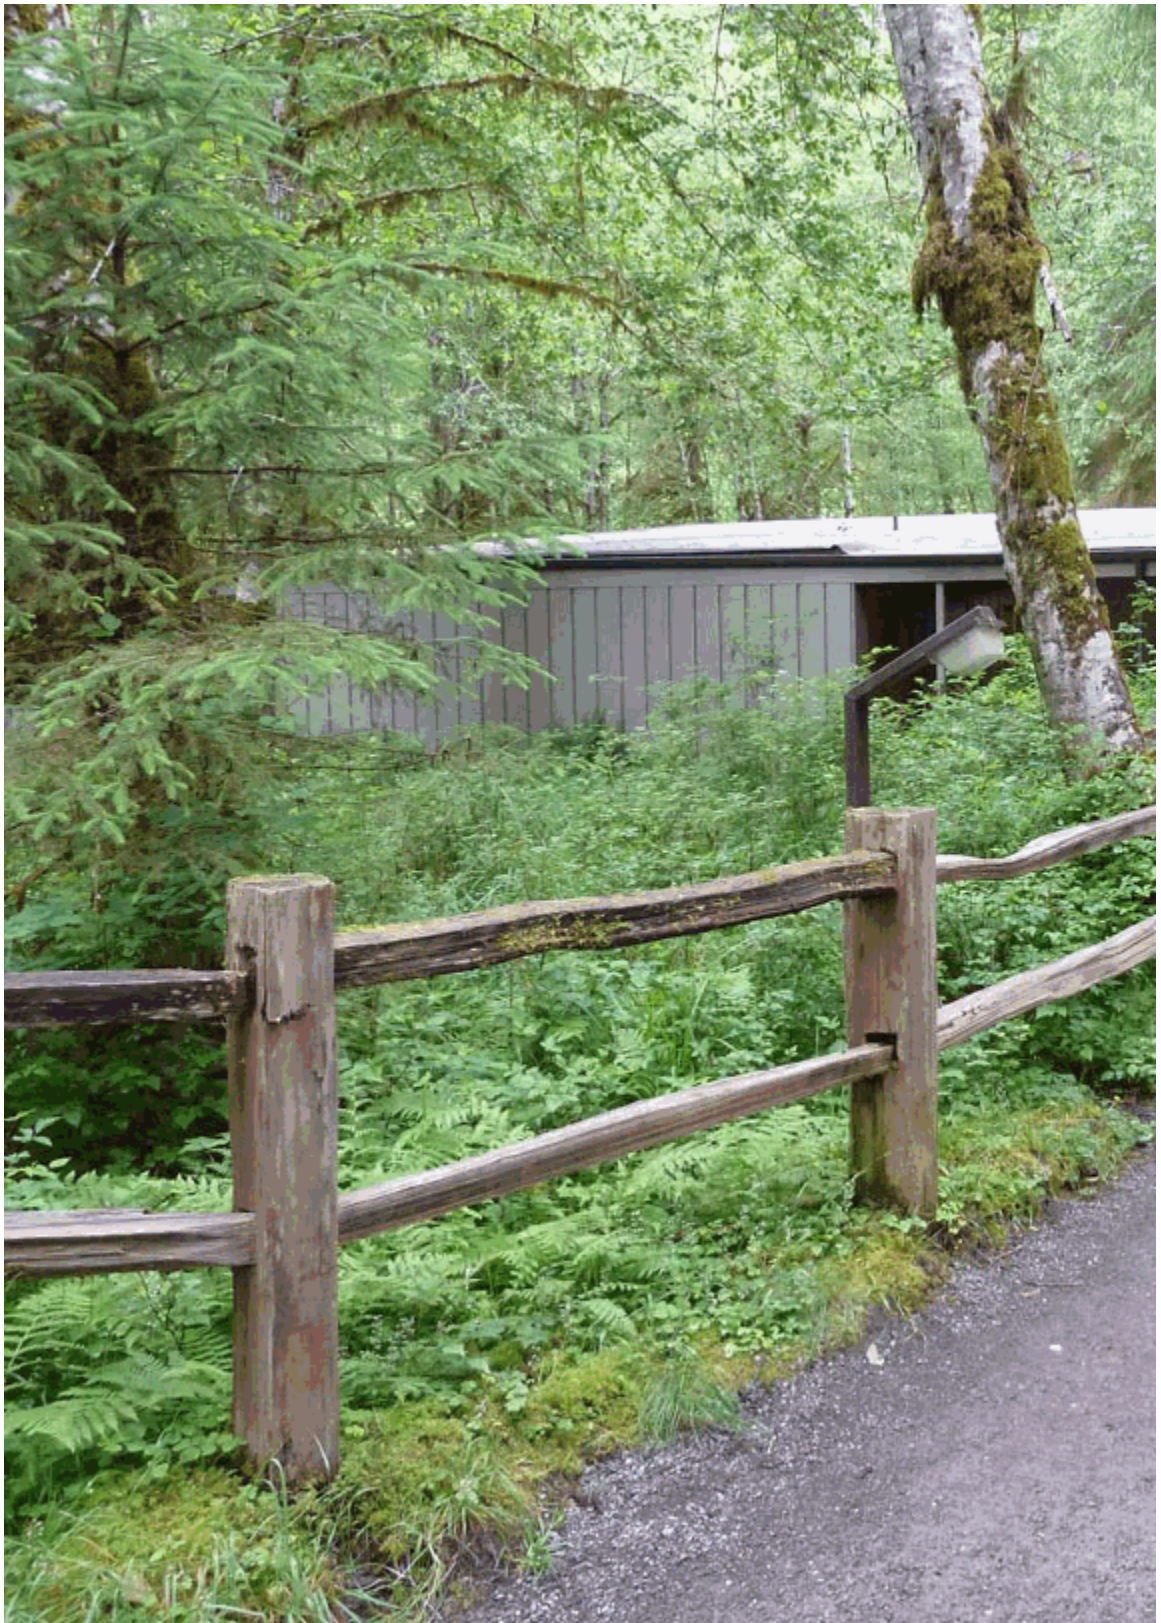
*The Hoh Visitor Center, designed by Cecil Doty, is a contributing resource to the Developed area. (PWRO 2012)*

The south façade is clad with reverse board and batten siding and has no windows other than the plate glass of the entry doors. The concrete slab foundation extends from this side of the building forming a small rectangular gathering area between the main entrance and the restrooms, and continues as a walkway around the west side. The roof structure is constructed with exposed rafters and covers the gathering area supported by a colonnade of 4x4 posts on 4' center. Originally the columns were set back approximately 3' beneath the roof and lined an 8' walkway leading from the entrance to the restrooms. In 1996 to provide ADA access and accommodate increased numbers of visitors, the size of the restrooms more than doubled. This alteration also resulted in the removal of a designed fern garden that was located between the walkway and the building.

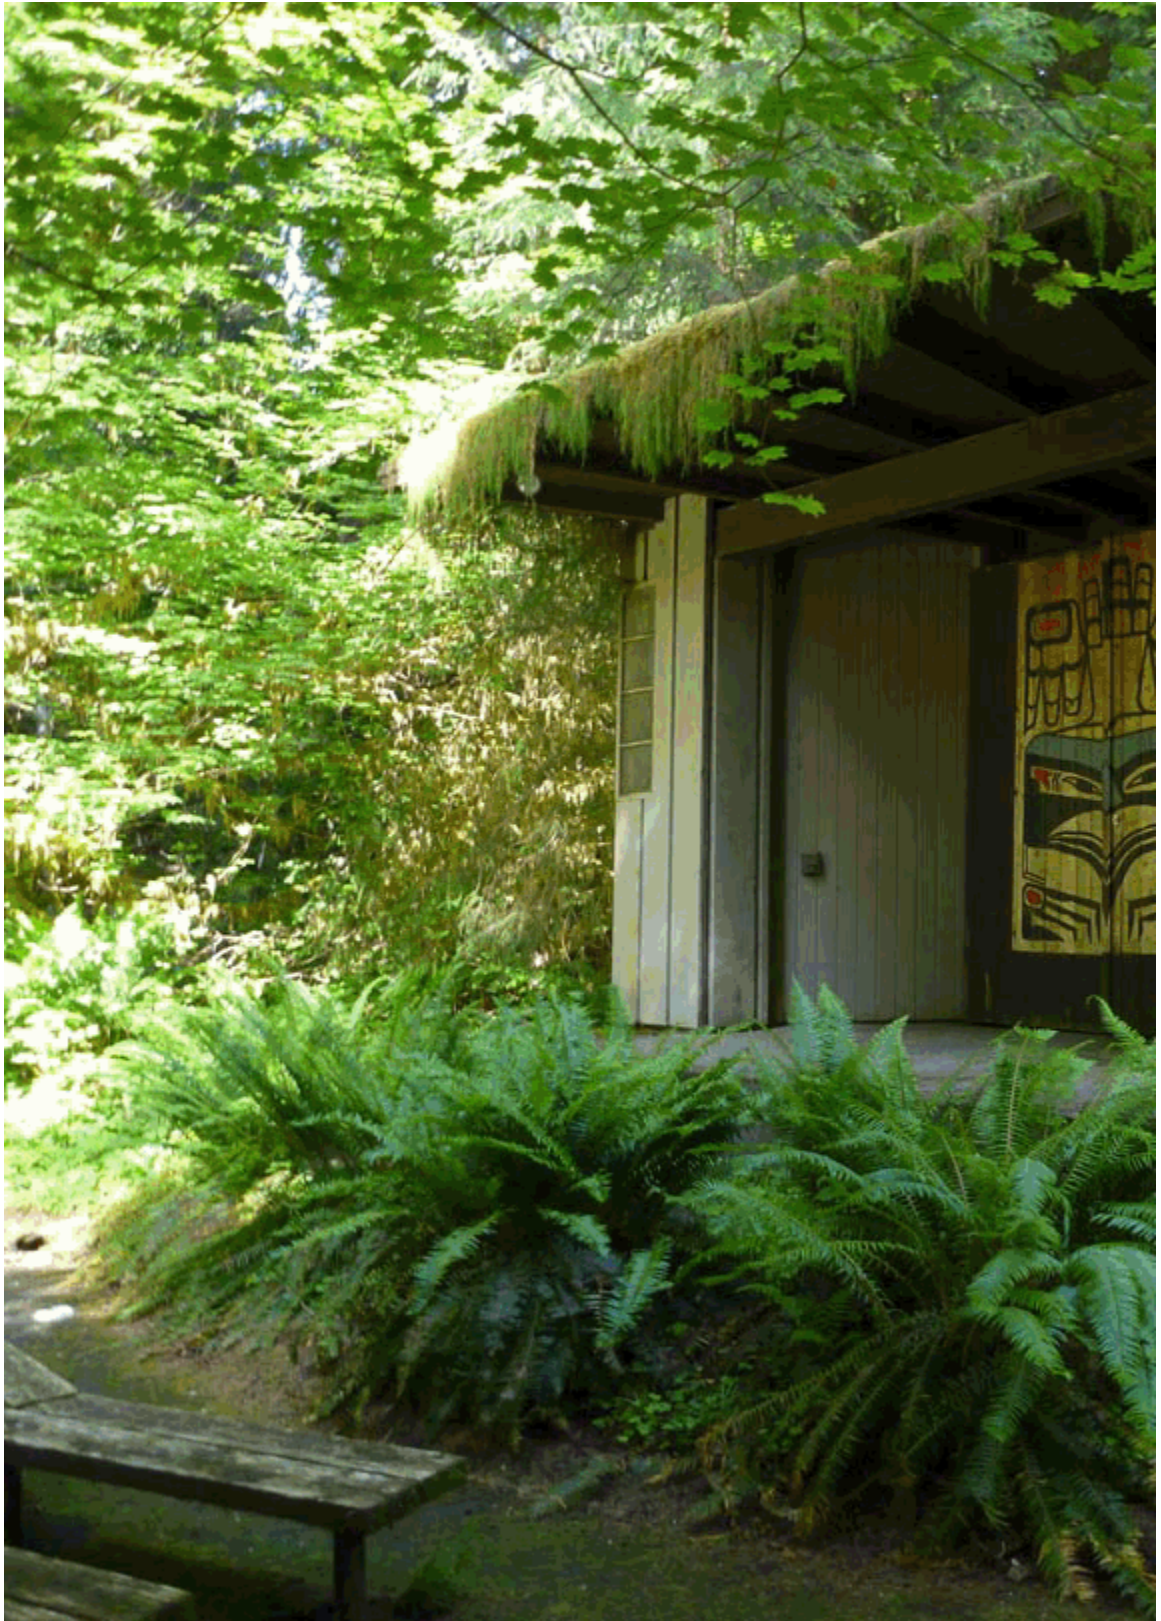
*Photograph of the amphitheater stage. The Mission 66 amphitheater was a place to provide visitors with natural and cultural interpretation through evening ranger talks. (PWRO 2012)*

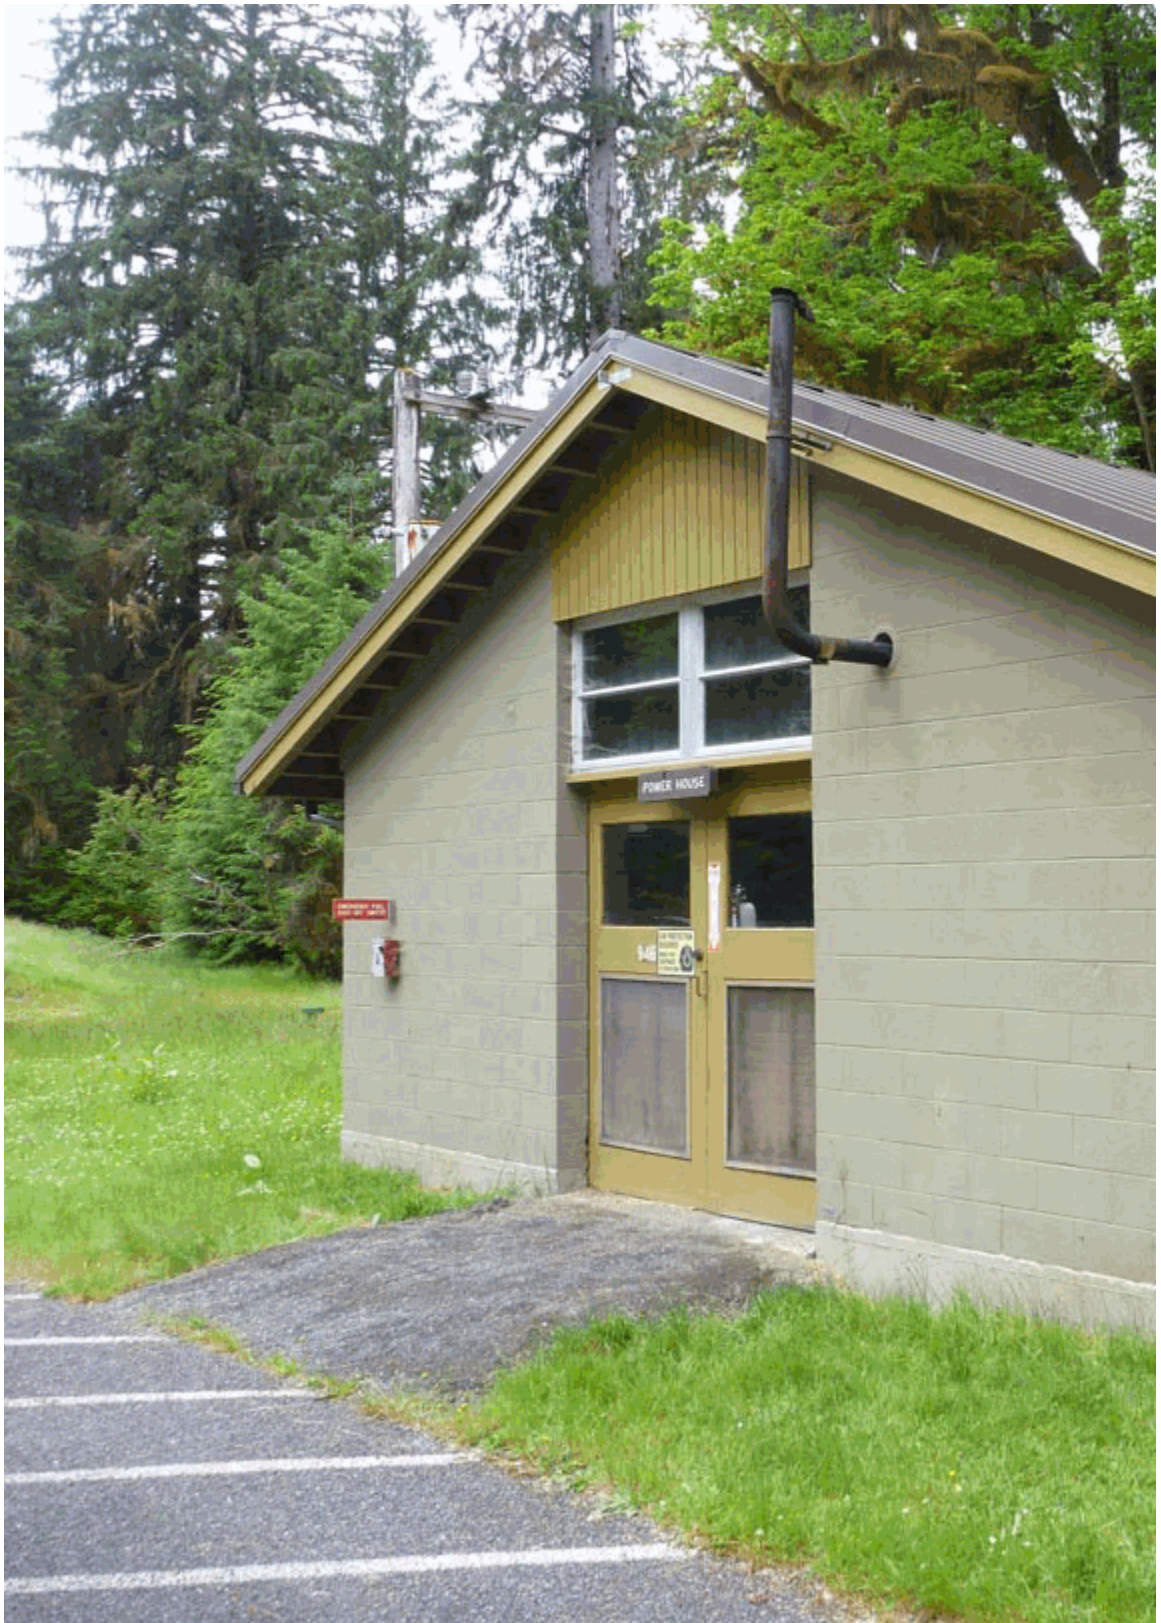
*Photograph of the Utility Generator Building in the maintenance area. (PWRO 2012)*

The generator building, completed in 1961, is located on the western edge of the maintenance area. It is a nearly square building measuring 21'5" x 24'6". The gable roof has a brown, standing seam metal roof that replaced the historic cedar shakes in 2009 and overhangs the entire perimeter of the building. Set on a concrete foundation, the walls of the building are constructed of CMU blocks and painted Beachwood gray with Green-gold fascia on the eaves. Access to the building is provided by double-doors central to the east façade of the building. Directly above the double-doors are two, side by side aluminum framed double-windows and directly above the windows there is a small section of vertical grooved, wood paneling. The south façade is entirely concrete block with the majority of utilities entering from this side. The

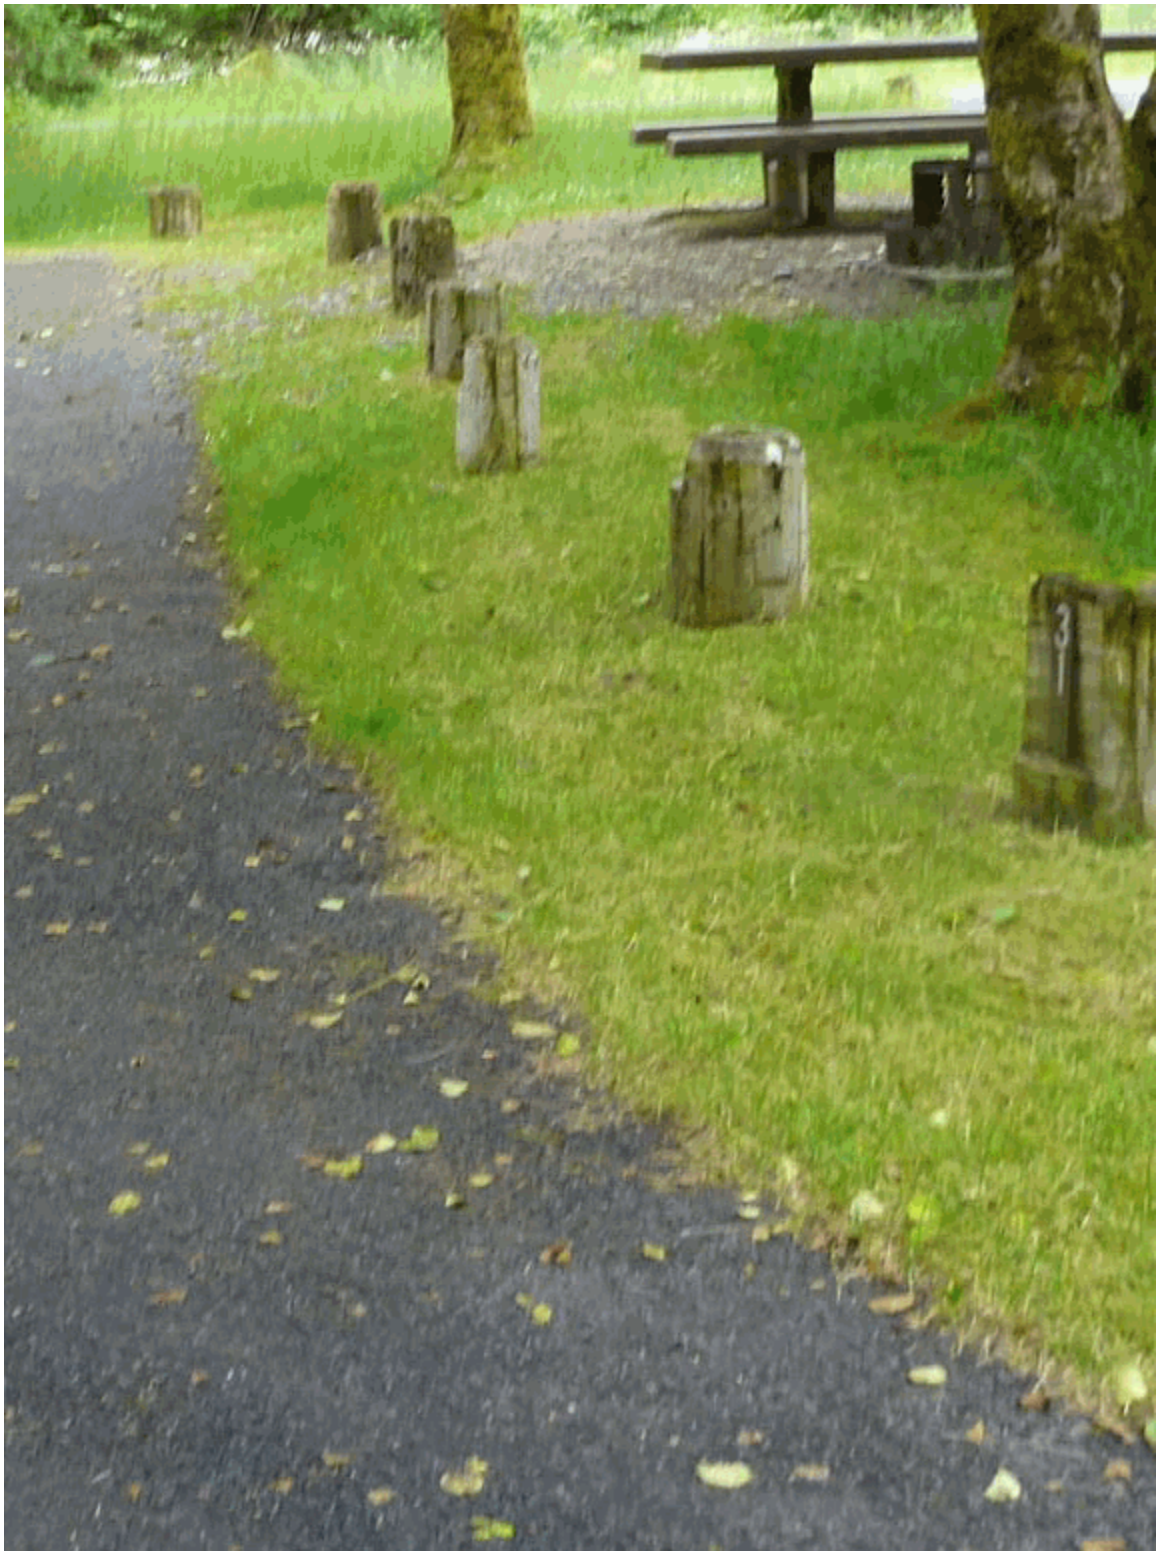
*Photograph of the wooden bollards along a campground spur. These are a contributing feature of the original Mission 66 design. (PWRO 2012)*

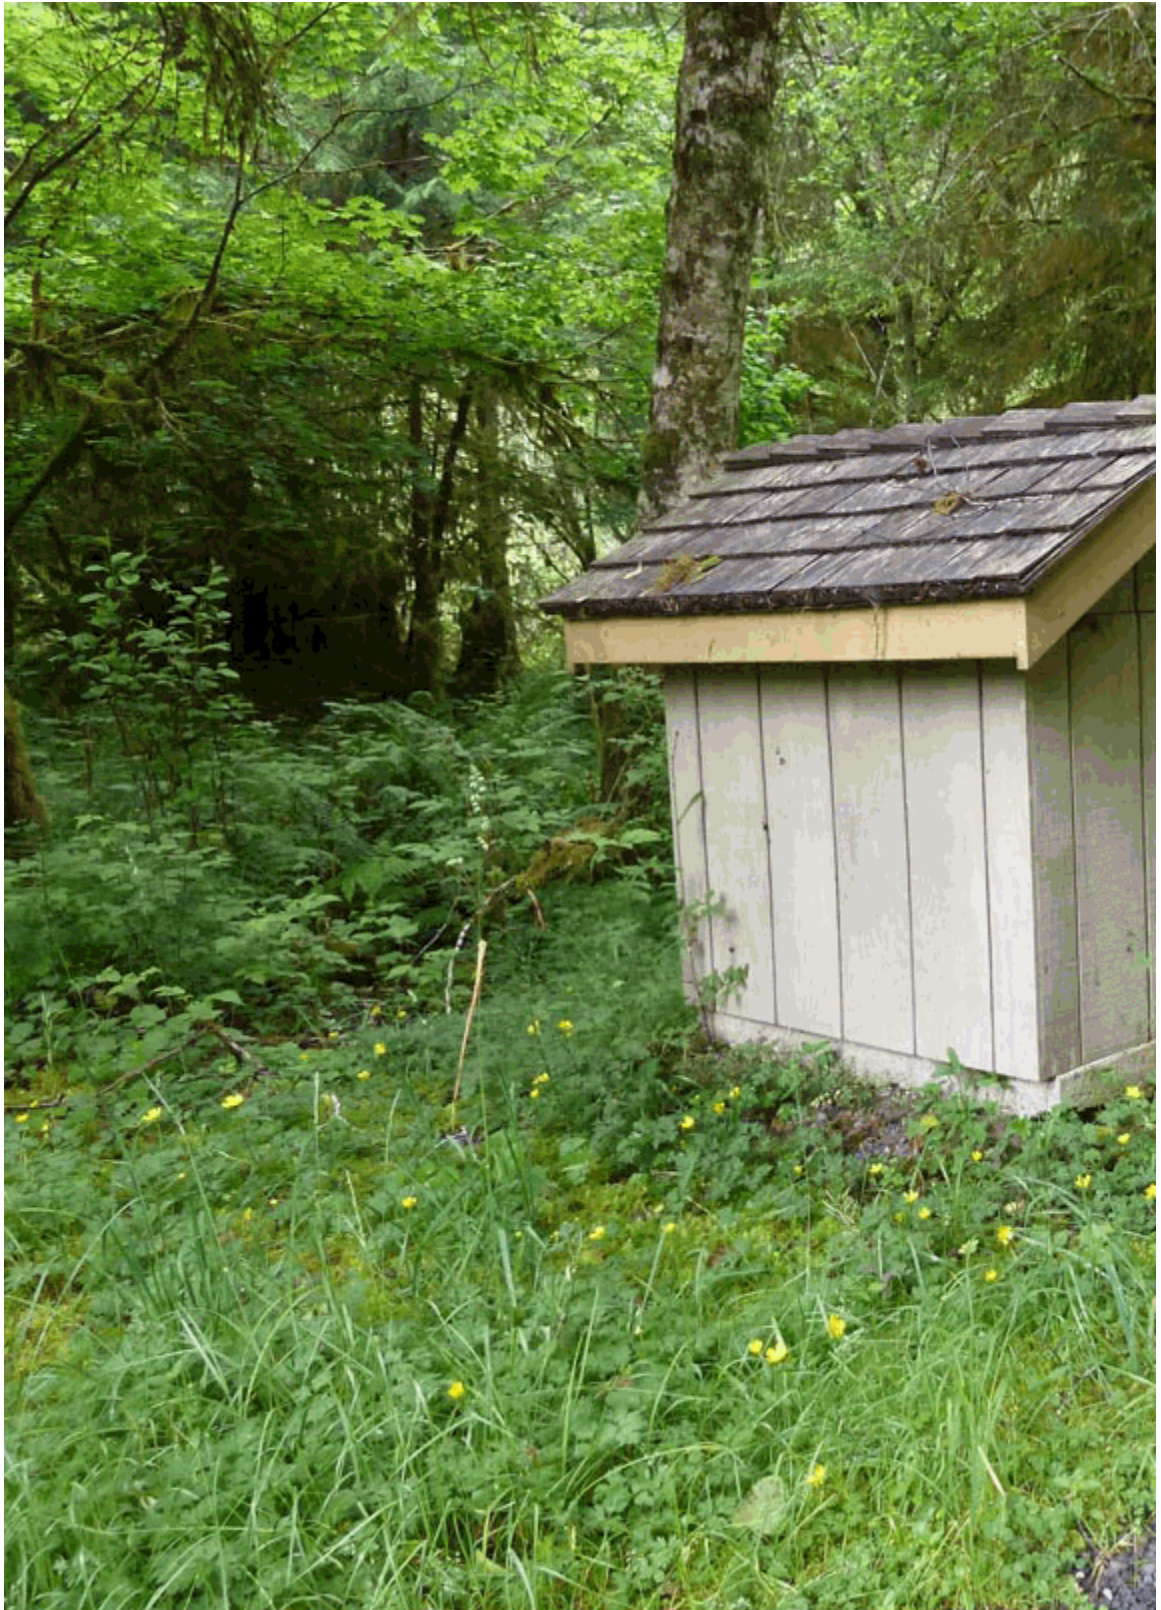
*Photograph of one of the three hose houses that are in the Hoh Developed area. (PWRO 2012)*
